# **PERFORMANCE EVALUATION OF THE MIDWEST GUARDRAIL SYSTEM – UPDATE TO NCHRP 350 TEST NO. 3-10 (2214MG-3)**

MwRSF Research Report No. TRP-03-172-06

October 11, 2006

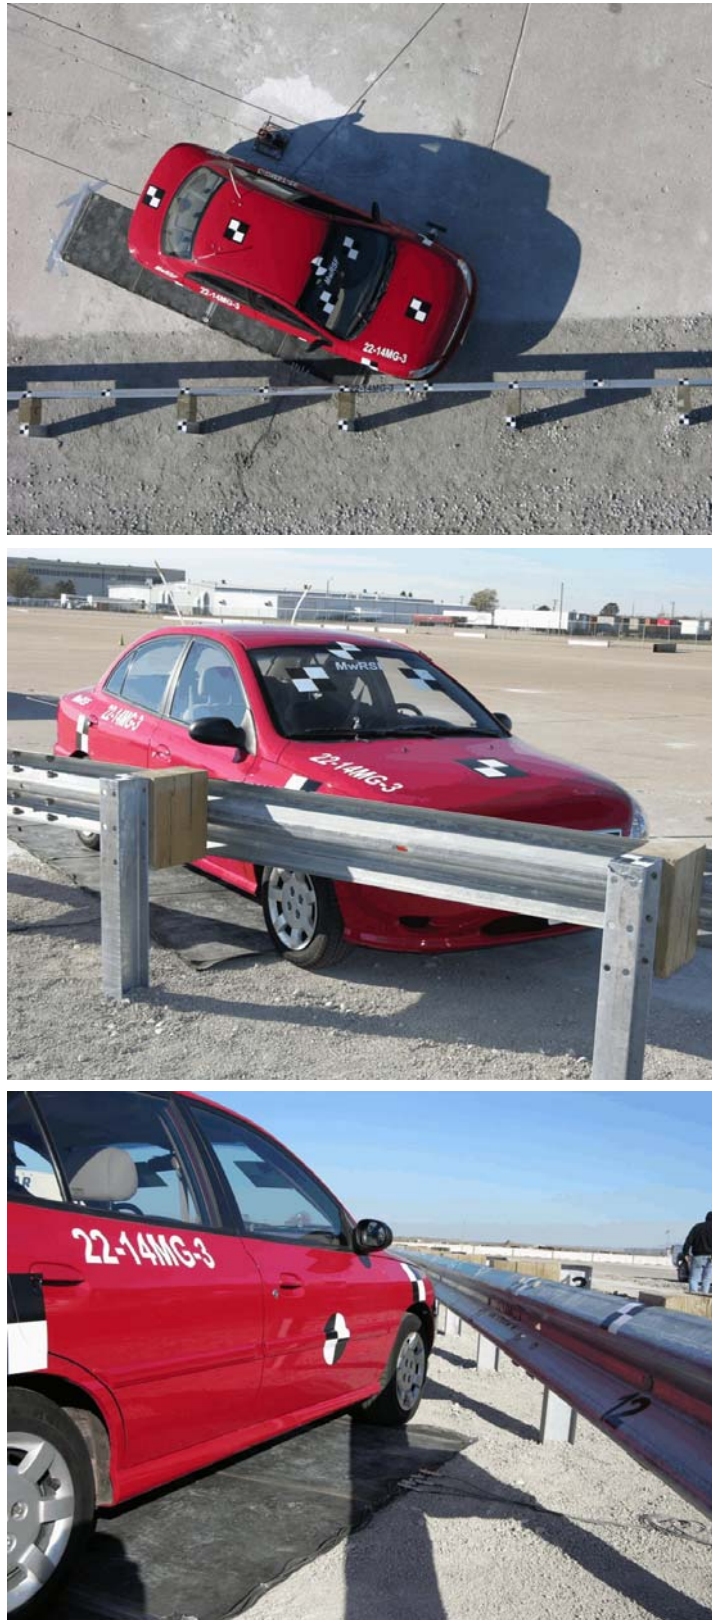
Figure 19. Impact Location, Test 2214MG-3

Initial vehicle impact was to occur between post nos. 13 and 14, or 2.10 m (6 ft - 10.5 in.) upstream from the center of the splice at the midspan between post nos. 14 and 15, as shown in Figure 19. Actual vehicle impact occurred 2.11 m (6 ft - 11 in.) upstream from the center of the splice at the midspan between post nos. 14 and 15. At 0.022 sec, the right-front corner of the hood protrudes over the top of the rail, and the rail deflected backwards. At 0.054 sec, post no. 14 deflected backward and the blockout at post no. 14 split and disengaged from the system. At 0.106 sec, post no. 15 deflected backward and the blockout at post no. 15 split and disengaged from the system. At 0.120 sec, the right-front corner of the vehicle was located at post no. 15 and the right-front tire rides up post no. 15. At this same time, the vehicle rolled clockwise (CW) away from the rail. At 0.166 sec, the right-front corner of the vehicle continued to protrude over the top of the rail. At 0.188 sec, the right-front corner of the vehicle was located at post no. 16 and the blockout at post no. 16 split and disengaged from the system. At 0.216 sec, the vehicle became parallel to the barrier with a resultant velocity of 72.4 km/h (45.0 mph). At 0.294 sec, the right-front corner of the vehicle

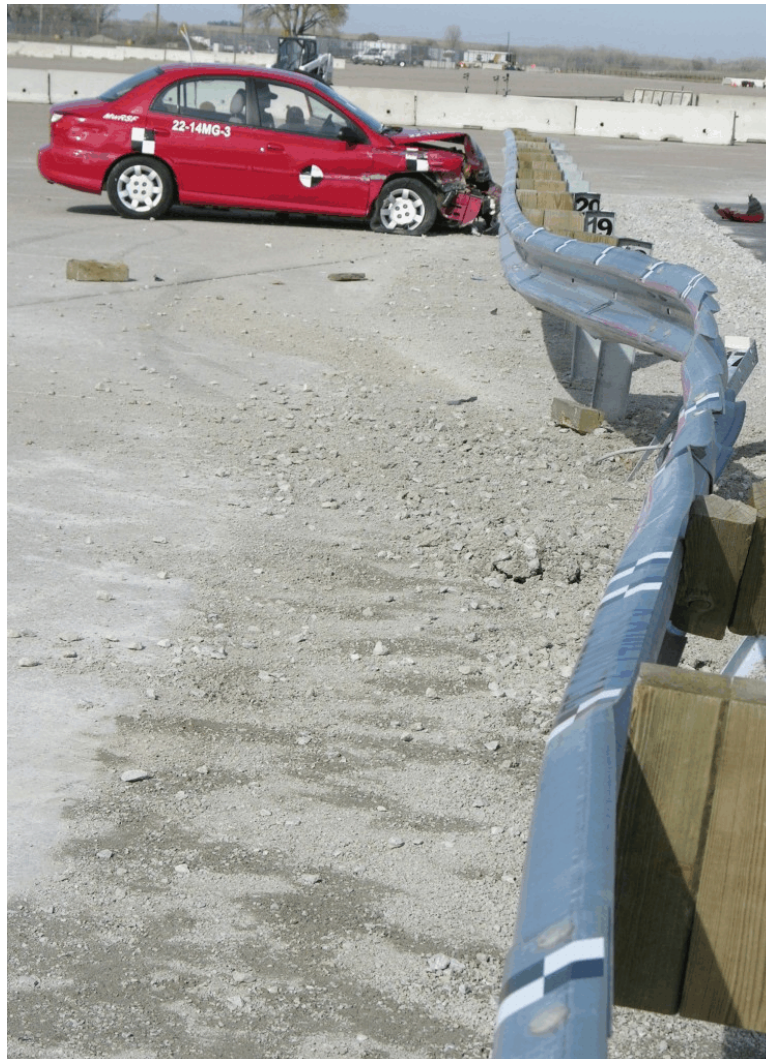
Figure 20. Vehicle Final Position and Trajectory Marks, Test 2214MG-3

was located at post no. 17 which was deflecting backwards. At this same time, the vehicle rolled CCW back toward the system. At 0.332 sec, the blockout at post no. 17 split and disengaged from the system. At 0.374 sec, the rear of the vehicle pitched upward. At 0.404 sec, the vehicle yawed back toward the system with the rear of the vehicle airborne. At 0.530 sec, the vehicle exited the barrier at a trajectory angle of 14.1 degrees and at a resultant velocity of 48.4 km/h (30.1 mph). At 0.636 sec, the vehicle continued to yaw back toward the system as it continued downstream. At 0.886 sec, the vehicle yawed to approximately perpendicular with the system. At 1.738 sec, the vehicle impacted the system again in a near perpendicular orientation. At 1.890 sec, the front of the vehicle crushed inward from the secondary impact. The vehicle came to rest with the front of the vehicle against and perpendicular to the rail at 22.46 m (73 ft - 8 in.) downstream from impact and 0.83 m (2 ft - 9 in.) away from the traffic-side face of the guardrail system. The trajectory and final position of the small car are shown in Figures 13 and 20.

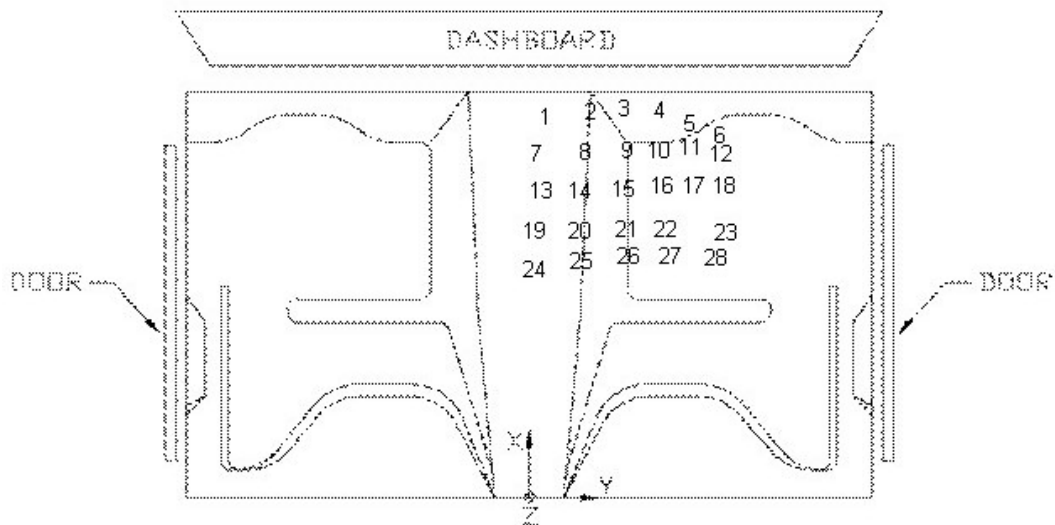
Figure C-1. Occupant Compartment Deformation Data, Test 2214MG-3

Exterior vehicle damage was moderate, as shown in Figures 26 through 28. Occupant compartment deformations to the right side and center of the floorboard were judged insufficient to cause serious injury to the vehicle occupants. Maximum longitudinal deflections of 6 mm (0.25 in.) were located throughout the right-side floor pan. Maximum lateral deflections of 6 mm (0.25 in.) were located throughout the right-side floor pan. Maximum vertical deflections of 6 mm (0.25 in.) were located near the center of the right-side floor pan. Complete occupant compartment deformations and the corresponding locations are provided in Appendix C.
