MASH TL-4 EVALUATION OF THE TXDOT TYPE C2P BRIDGE RAIL

Test Report 9-1002-15-2

TEXAS DEPARTMENT OF TRANSPORTATION

1. Report No. FHWA/TX-17/9-1002-15-2	2. Government Accession No.	3. Recipient's Catalog No.	
4. Title and Subtitle MASH TL-4 EVALUATION OF THE TXDOT TYPE C2P BRIDGE RAIL		5. Report Date February 2017

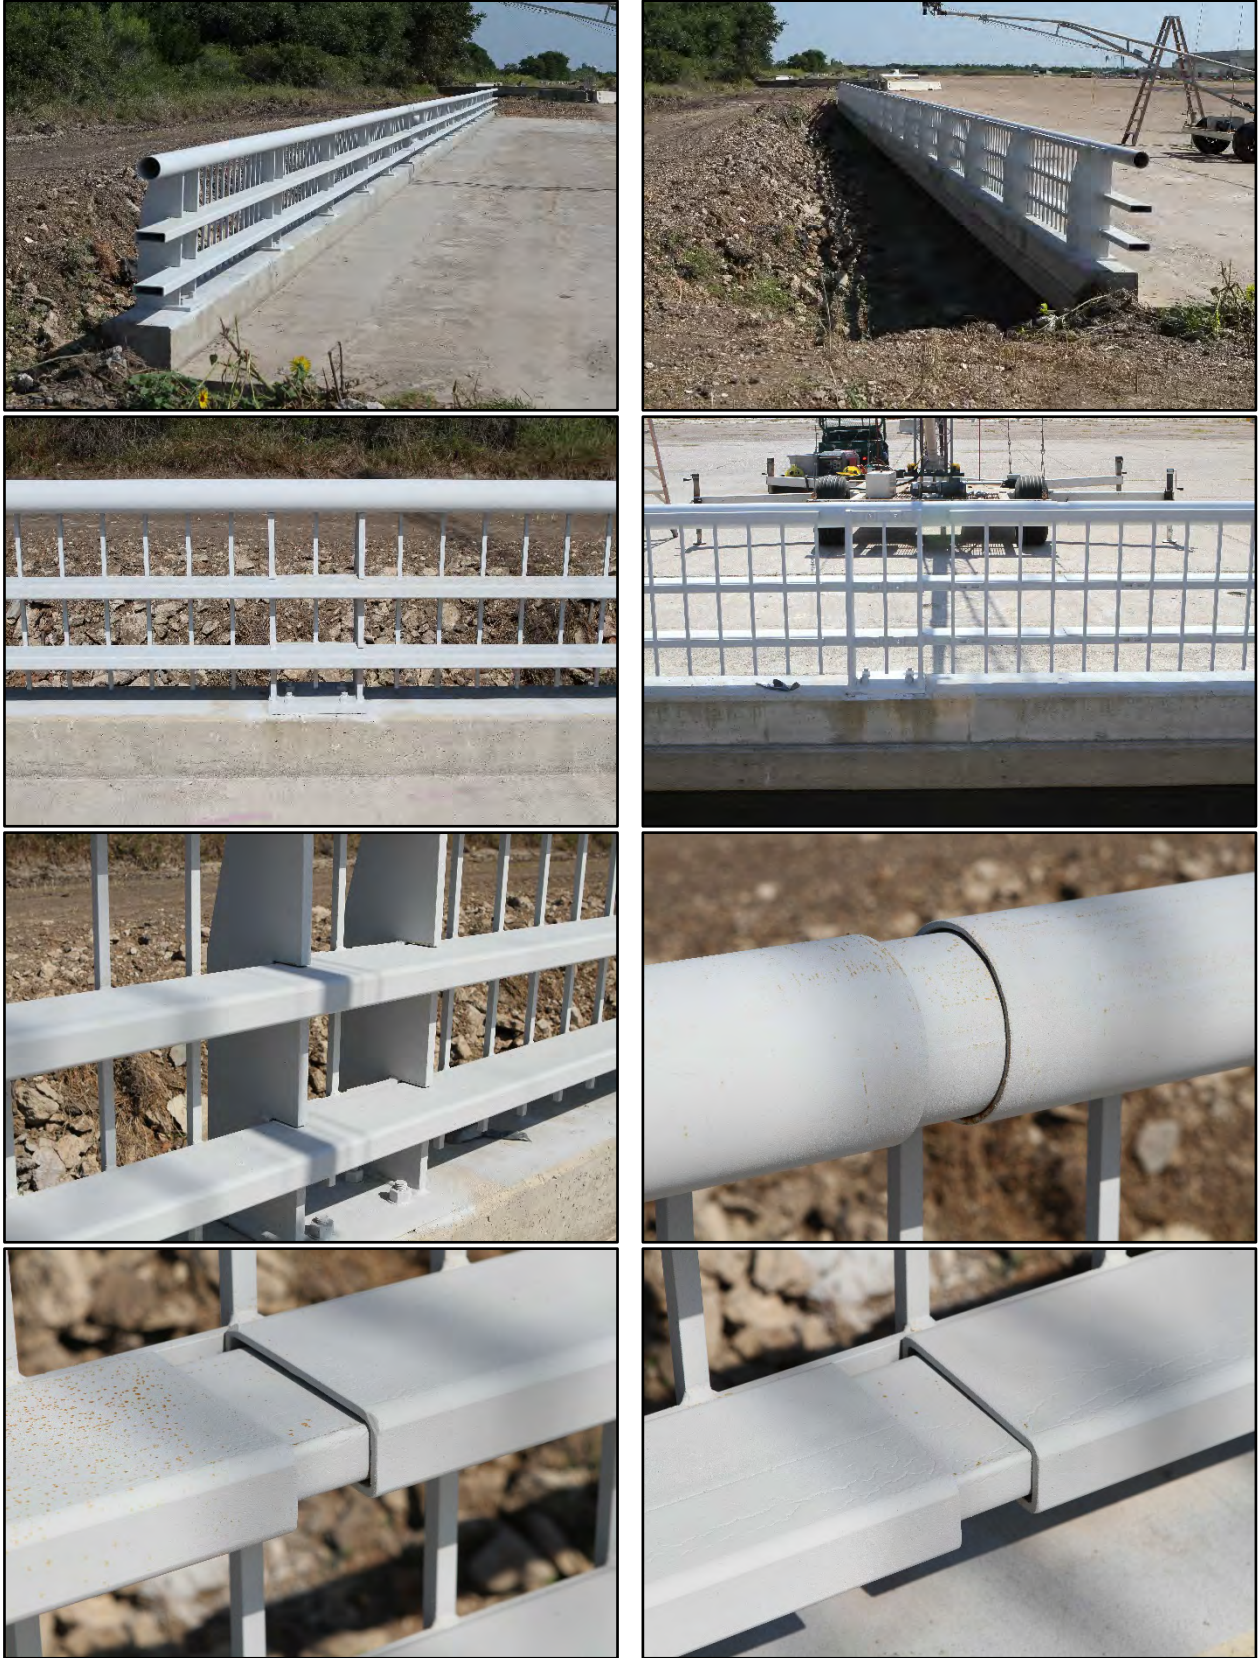
Figure 2-3. TxDOT Type C2P Bridge Rail prior to First Test 4-12.

The first test was test 3 with the single unit truck (*MASH* 4-12), followed by test 2 with the pickup truck (*MASH* 4-11), and finally test 1 with the small car (*MASH* 4-10). During test 3, the base plate welds failed at posts 5, 6, and 7 (refer to Section 7.5). Prior to test 2, the base plates for all 15 posts used for the remaining two tests were removed and new base plates of the same design were welded to the posts.

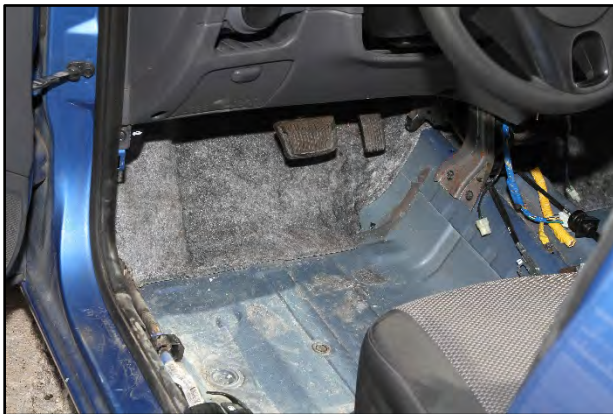
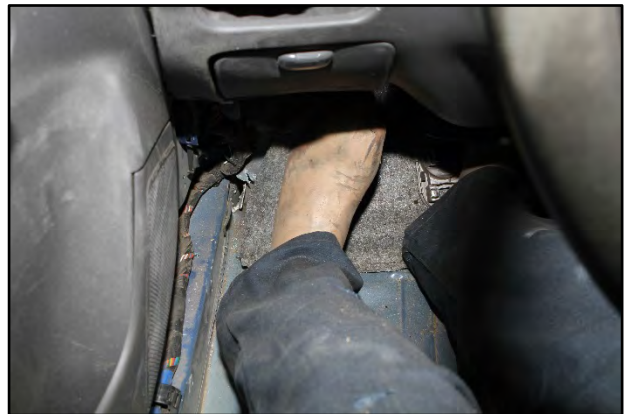
Figure 5-5. Interior of Test Vehicle for Test No. 490026-4-1.

Figure 5-4 shows the damage sustained by the vehicle. The front bumper, hood, left front tire and rim, left front strut and tower, left front fender, left front door and window glass, left rear door, left rear quarter panel, and rear bumper were damaged. The windshield was cracked in the left lower corner, and cracks radiated upward and toward the center. Maximum exterior crush to the vehicle was 13.0 inches in the side plane at the left front corner at bumper height. Maximum occupant compartment deformation was 4.0 inches in the left front firewall area near the toe pan. Figure 5-5 shows the interior of the vehicle. Tables C-2 and C-3 in Appendix D1 provide exterior crush and occupant compartment measurements.

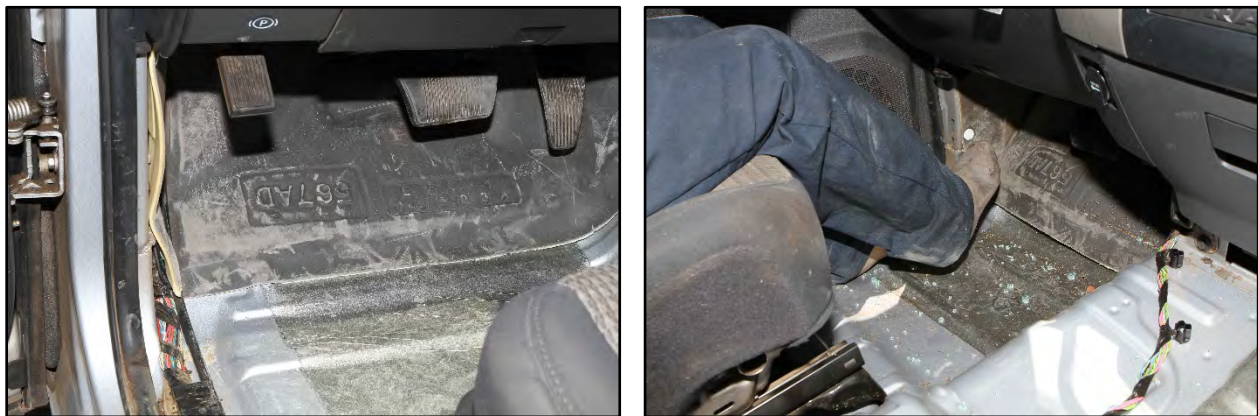
Figure 6-4 shows the damage sustained by the vehicle. The front bumper, grill, hood, left front tire and rim, left upper and lower A-arms, left front fender, left front door and window glass, left rear door, left rear cab corner, left rear exterior bed, left rear tire and rim, left rear bumper, and left rear tailgate were damaged. The windshield sustained stress cracks radiating from the lower left corner of the A-pillar. Maximum exterior crush to the vehicle was 13.0 inches in the side plane at the left front corner at bumper height. Maximum occupant compartment deformation was 2.25 inches in the instrument panel area. Figure 6-5 shows the interior of the
