## CRASH TEST AND EVALUATION OF THE TxDOT T224 BRIDGE RAIL

### Test Report 9-1002-15-5

TEXAS A&M TRANSPORTATION INSTITUTE  
COLLEGE STATION, TEXAS

1. Report No. FHWA/TX-15/9-1002-15-5	2. Government Accession No.	3. Recipient's Catalog No.	
4. Title and Subtitle <b>CRASH TEST AND EVALUATION OF THE TXDOT T224 BRIDGE RAIL</b>		5. Report Date December 2015

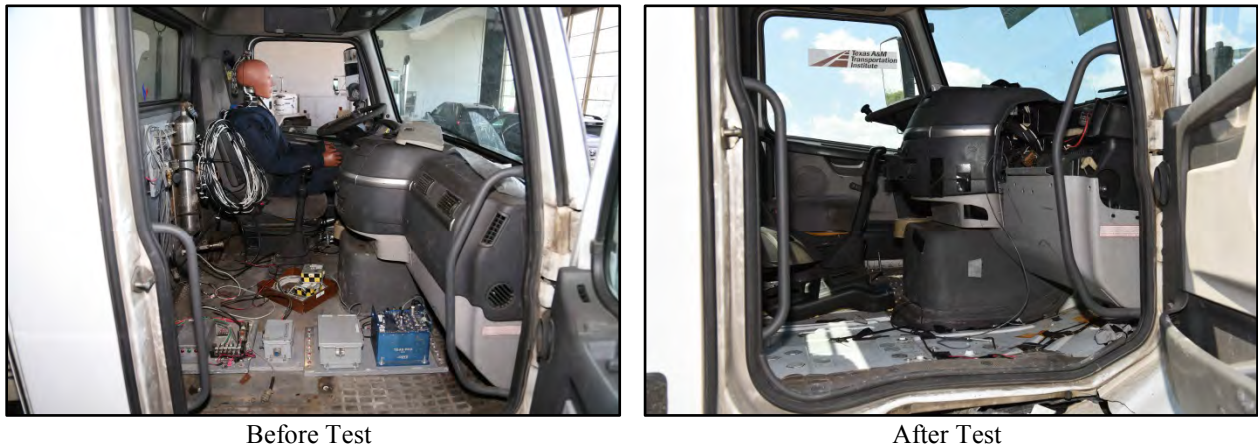
**Figure 7.5. Interior of Test Vehicle for Test No. 490025-2-1.**

Figure 7.4 shows the damage that the vehicle sustained. The front axle was pushed rearward 36 inches, and the right tie rod, right U-bolts, and right front shock and mount were deformed. Also damaged were the front bumper, hood, right front tire and rim, right front fender, right fuel tank, right side steps, and right rear outer tires and wheel rims of the tractor tandem. The right side lower edge of the trailer was also deformed and scraped. Maximum exterior crush to the vehicle was 12.0 inches in the front plane at the right front corner at bumper height. No occupant compartment deformation occurred. Figure 7.5 shows the interior of the vehicle.
