**Test Report No. 607911-1&2**

## **MASH TL-3 TESTING AND EVALUATION OF FREE-STANDING PORTABLE CONCRETE BARRIER**

**Contract No.: T4541 CN**

## **TEXAS A&M TRANSPORTATION INSTITUTE PROVING GROUND**

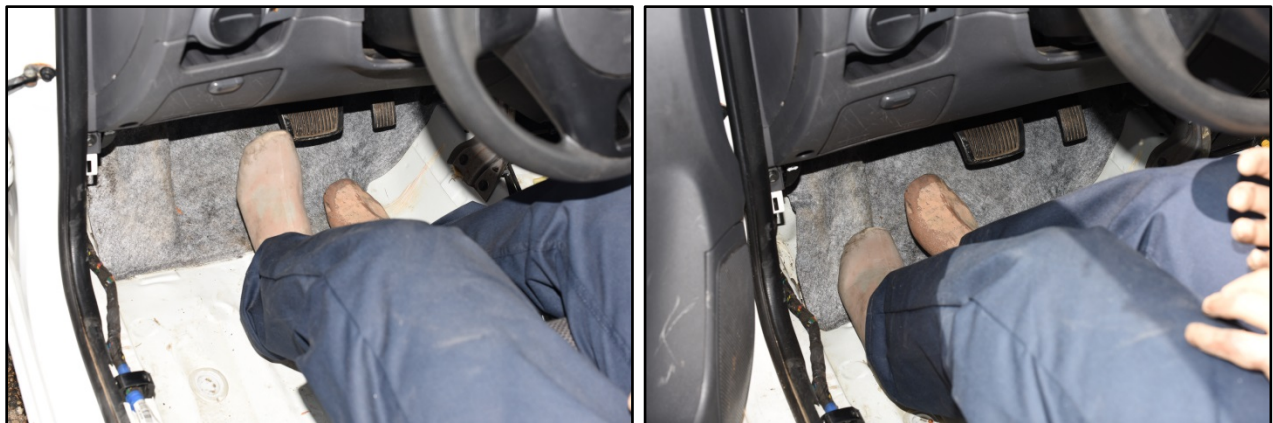
**Figure 5.6. Interior of Test Vehicle for Test No. 607911-1.**

Figure 5.5 shows the damage sustained by the vehicle. The front bumper, hood, left strut and tower, left front tire and rim, left front fender, left front and rear doors, left rear quarter panel, and rear bumper were damaged. The left side floor pan sustained light damage, and the left front door was deformed at the top near the roof/door frame, leaving a small gap. Maximum exterior crush to the vehicle was 9.5 inches in the left side plane at the left front corner at bumper height. Maximum occupant compartment deformation was 0.5 inches in the left firewall and floor pan area. Figure 5.6 shows the interior of the vehicle. Tables C.2 and C.3 in Appendix C1 provides exterior crush and occupant compartment measurements.
