MASH TL-4 CRASH TESTING AND EVALUATION OF THE RESTORE BARRIER

MIDWEST ROADSIDE SAFETY FACILITY

MwRSF Research Report No. TRP-03-318-15

November 3, 2015

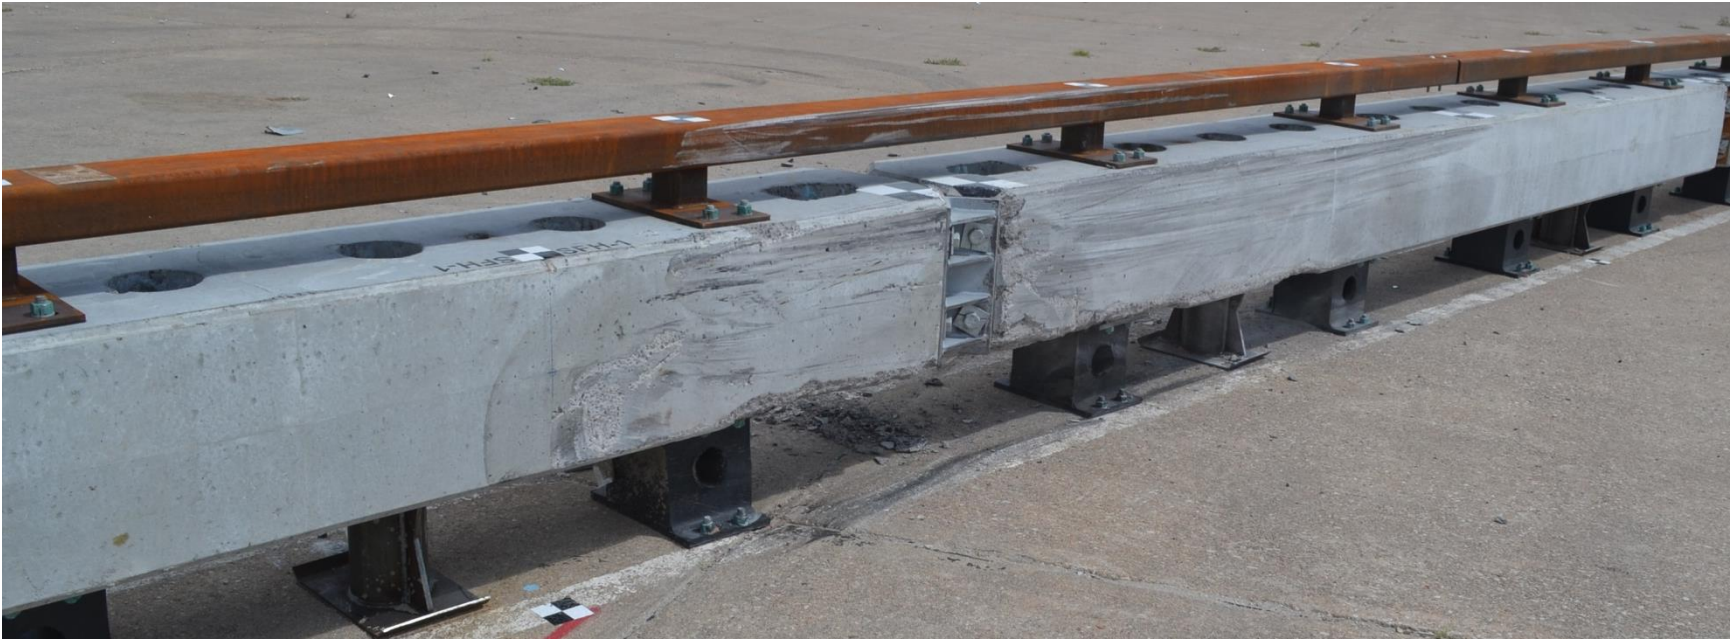
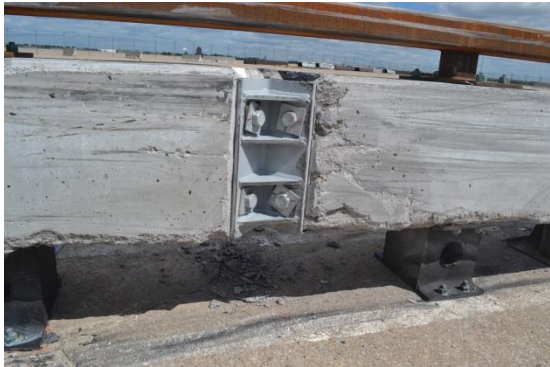
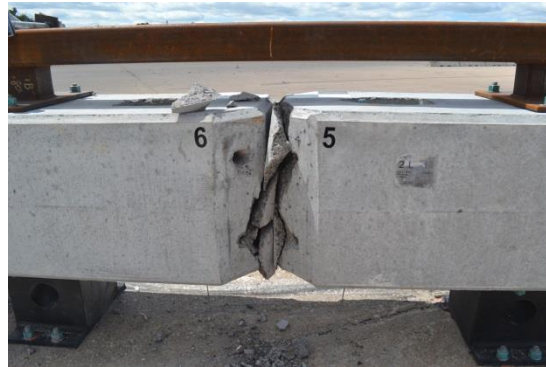
Damage to the barrier was minimal, as shown in Figures 52 and 53. Barrier damage consisted of contact marks, concrete spalling and gouges, and hairline concrete cracks. The

length of vehicle contact along the barrier was approximately 15 ft – ¼ in. (4.6 m), which spanned from 56½ in. (1,435 mm) upstream from the downstream edge of barrier no. 5 to 4 in. (102 mm) downstream from the mid-span of barrier no. 6. Gouging extended from the impact point through the end of the concrete beam along the bottom of the front face of barrier no. 5. Gouging was found along the height of barrier no. 6 located around the upstream splice on the front face. Further gouging was found along the bottom of the front face of barrier no. 6 extending 80 in. (2,032 mm) downstream from the upstream joint. Spalling occurred between barrier nos. 5 and 6 located between the front and back ACJ splices. There were hairline fractures on the back face of barrier no. 6 extending downstream from the bottom splice bolt hole approximately 5 in. (127 mm), as well as underneath the barrier beginning at the center of the upstream end of barrier no. 6 and extending downstream to the hexagonal hole. The first two posts downstream from the splice between barrier nos. 5 and 6 had contact marks along the front face and part of the upstream face.

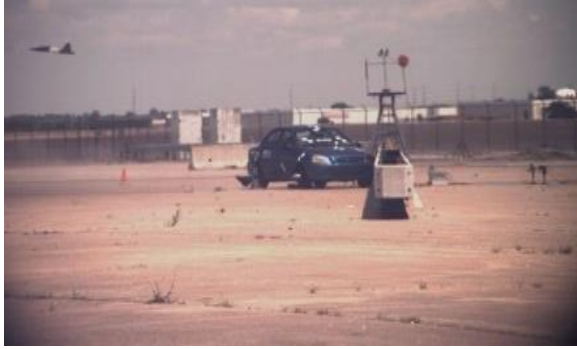
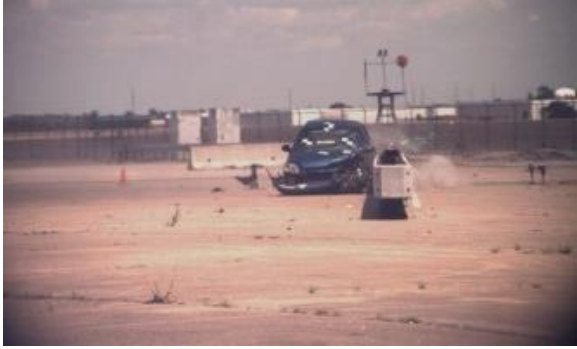
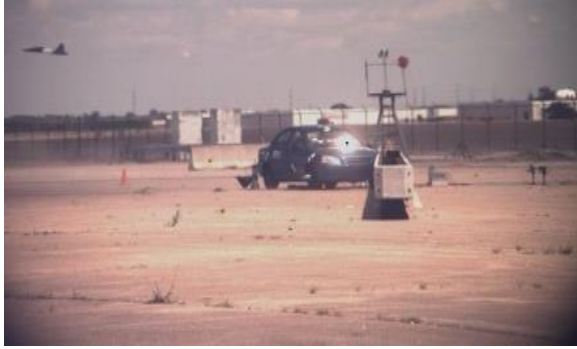
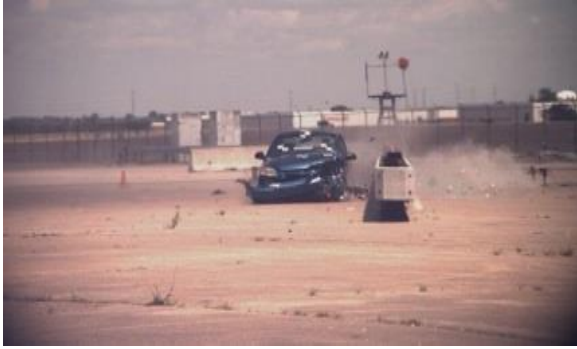
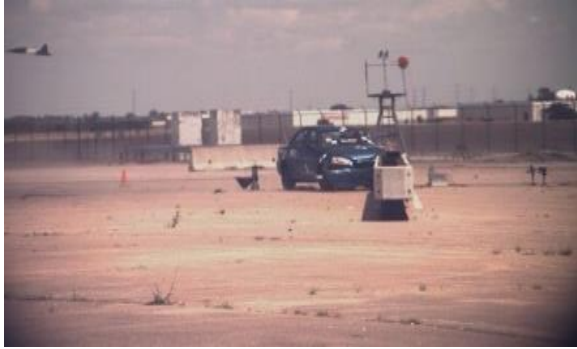
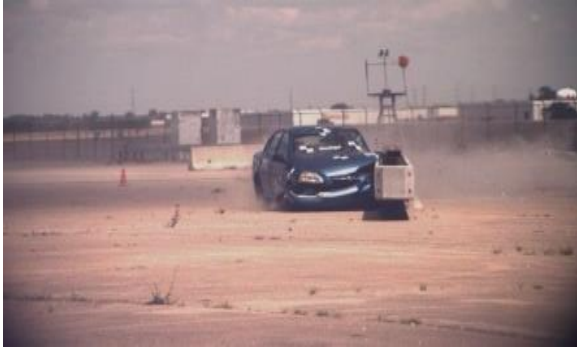
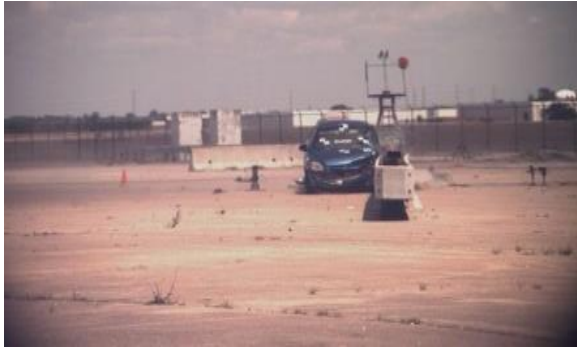
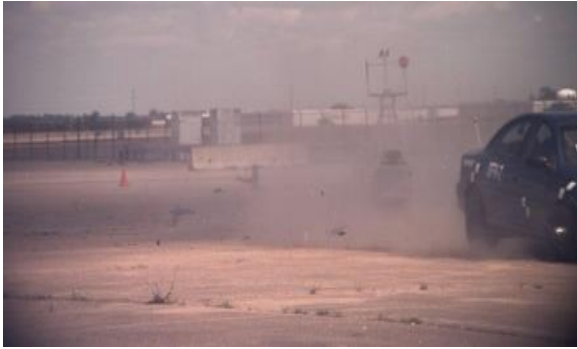
Figure 60. Summary of Test Results and Sequential Photographs, Test No. SFH-2

The 2,406-lb (1,091-kg) small car impacted the RESTORE barrier at a speed of 64.3 mph (103.5 km/h) and an angle of 24.8 degrees. A summary of the test results and sequential photographs are shown in Figure 60. Additional sequential photographs are shown in Figures 61 through 63. Documentary photographs of the crash test are shown in Figures 64 through 66.

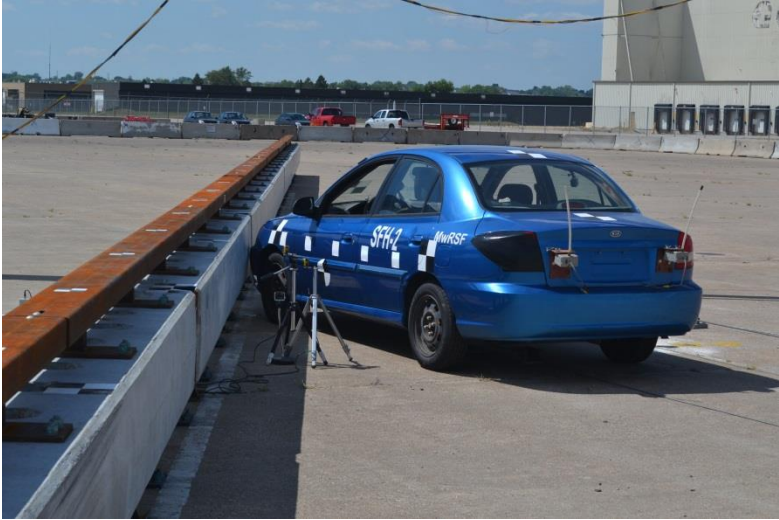
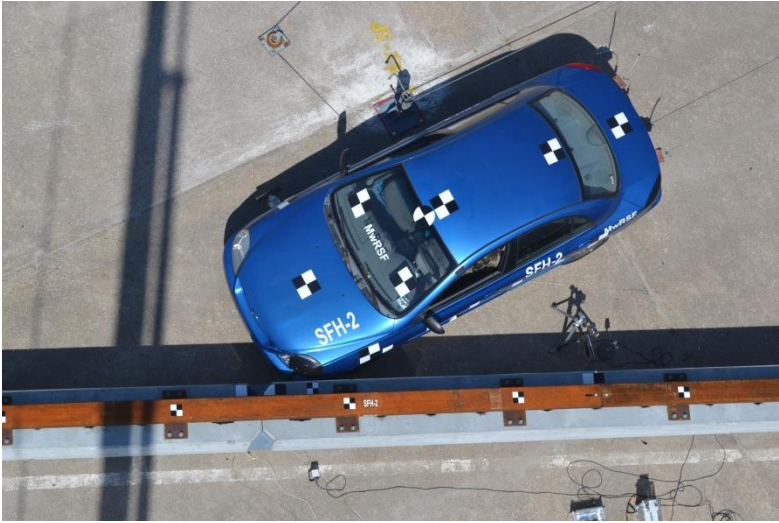
Figure 67. Impact Location, Test No. SFH-2

Initial vehicle impact was to occur 3.6 ft (1.1 m) upstream of the first post downstream of the joint between barrier nos. 7 and 8, as shown in Figure 67. This location was selected based on the recommendation for rigid barrier tests in MASH and verified through LS-DYNA simulation. The impact point was downstream from test no. SFH-1 so damage could be distinguished between the two tests. The actual point of impact was $8\frac{5}{16}$ in. (211 mm) upstream

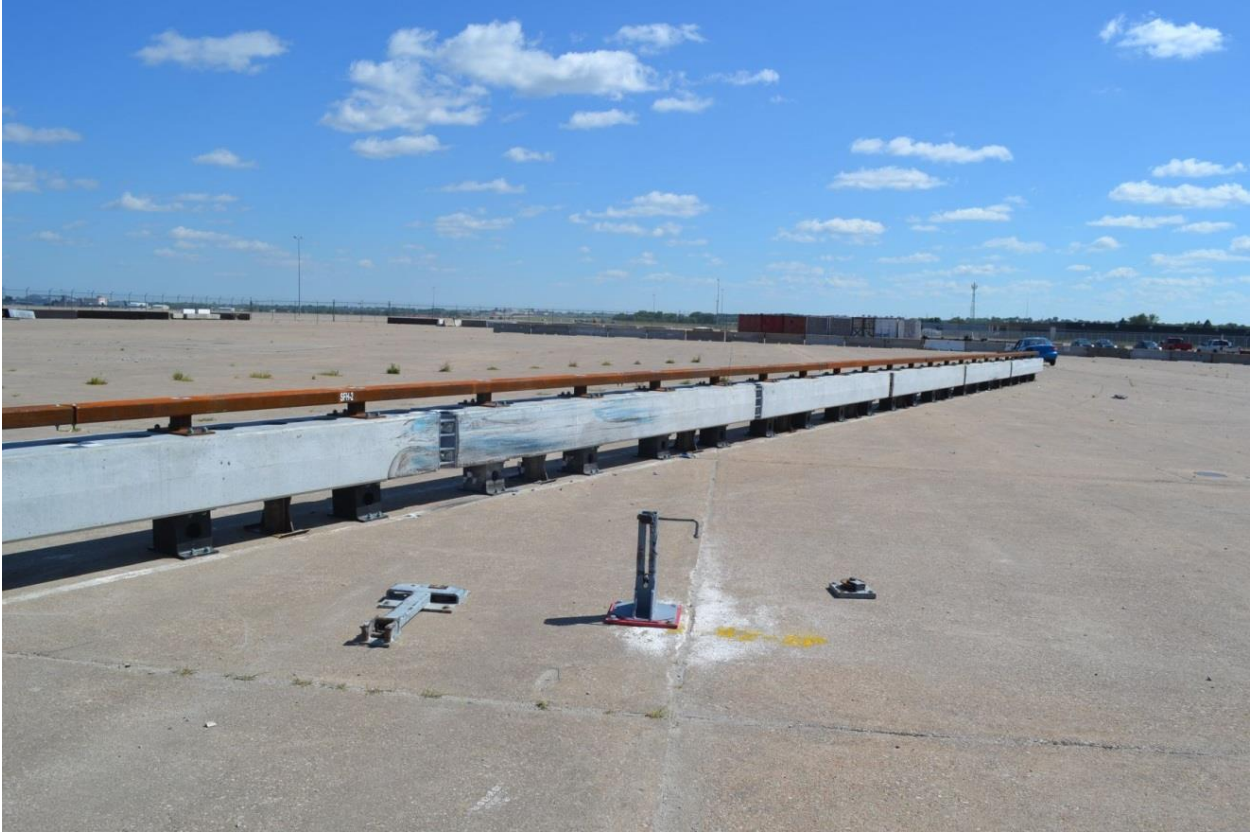
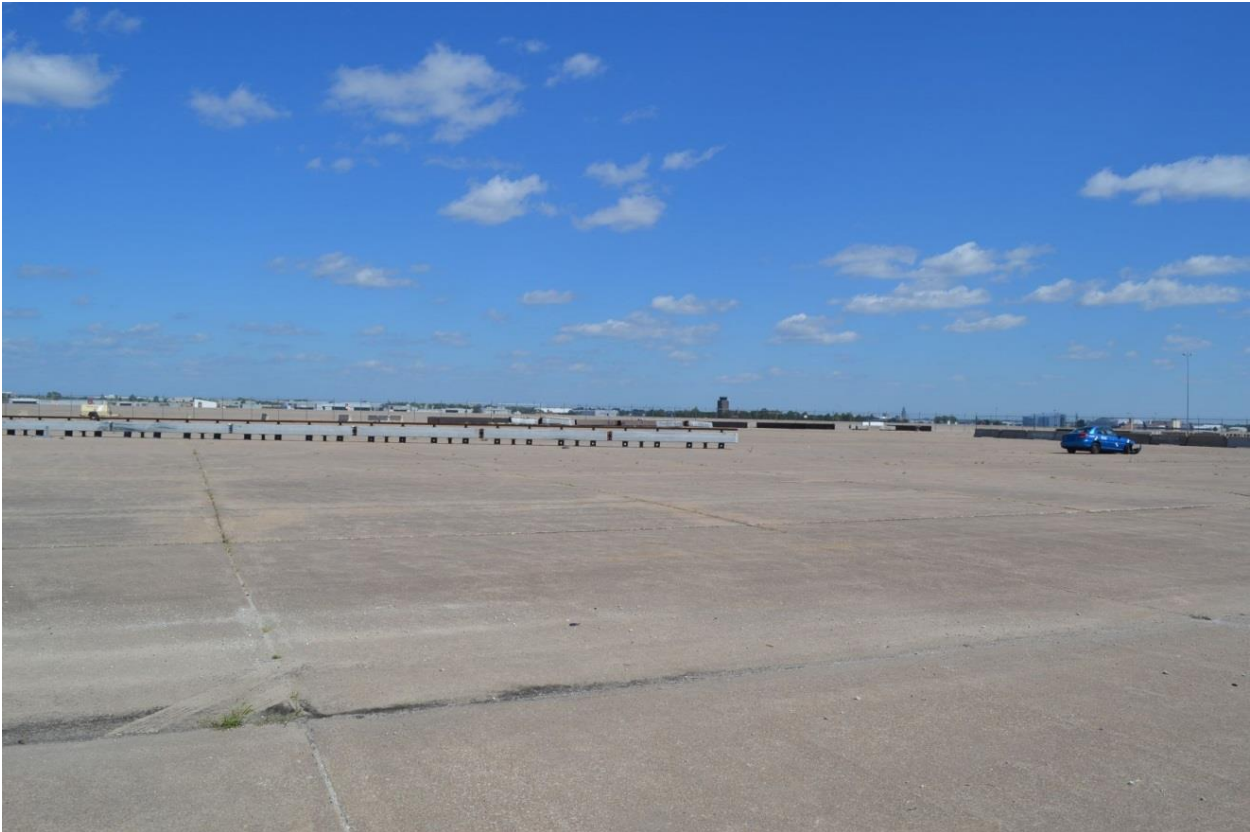
Figure 68. Vehicle Final Position and Trajectory Marks, Test No. SFH-2

of the joint between barrier nos. 7 and 8. A sequential description of the impact events is contained in Table 10. The vehicle came to rest 167 ft (50.9 m) downstream from the original impact point and 14 ft – 2 in. (4.3 m) laterally behind the system. The vehicle trajectory and final position are shown in Figures 60 and 68.

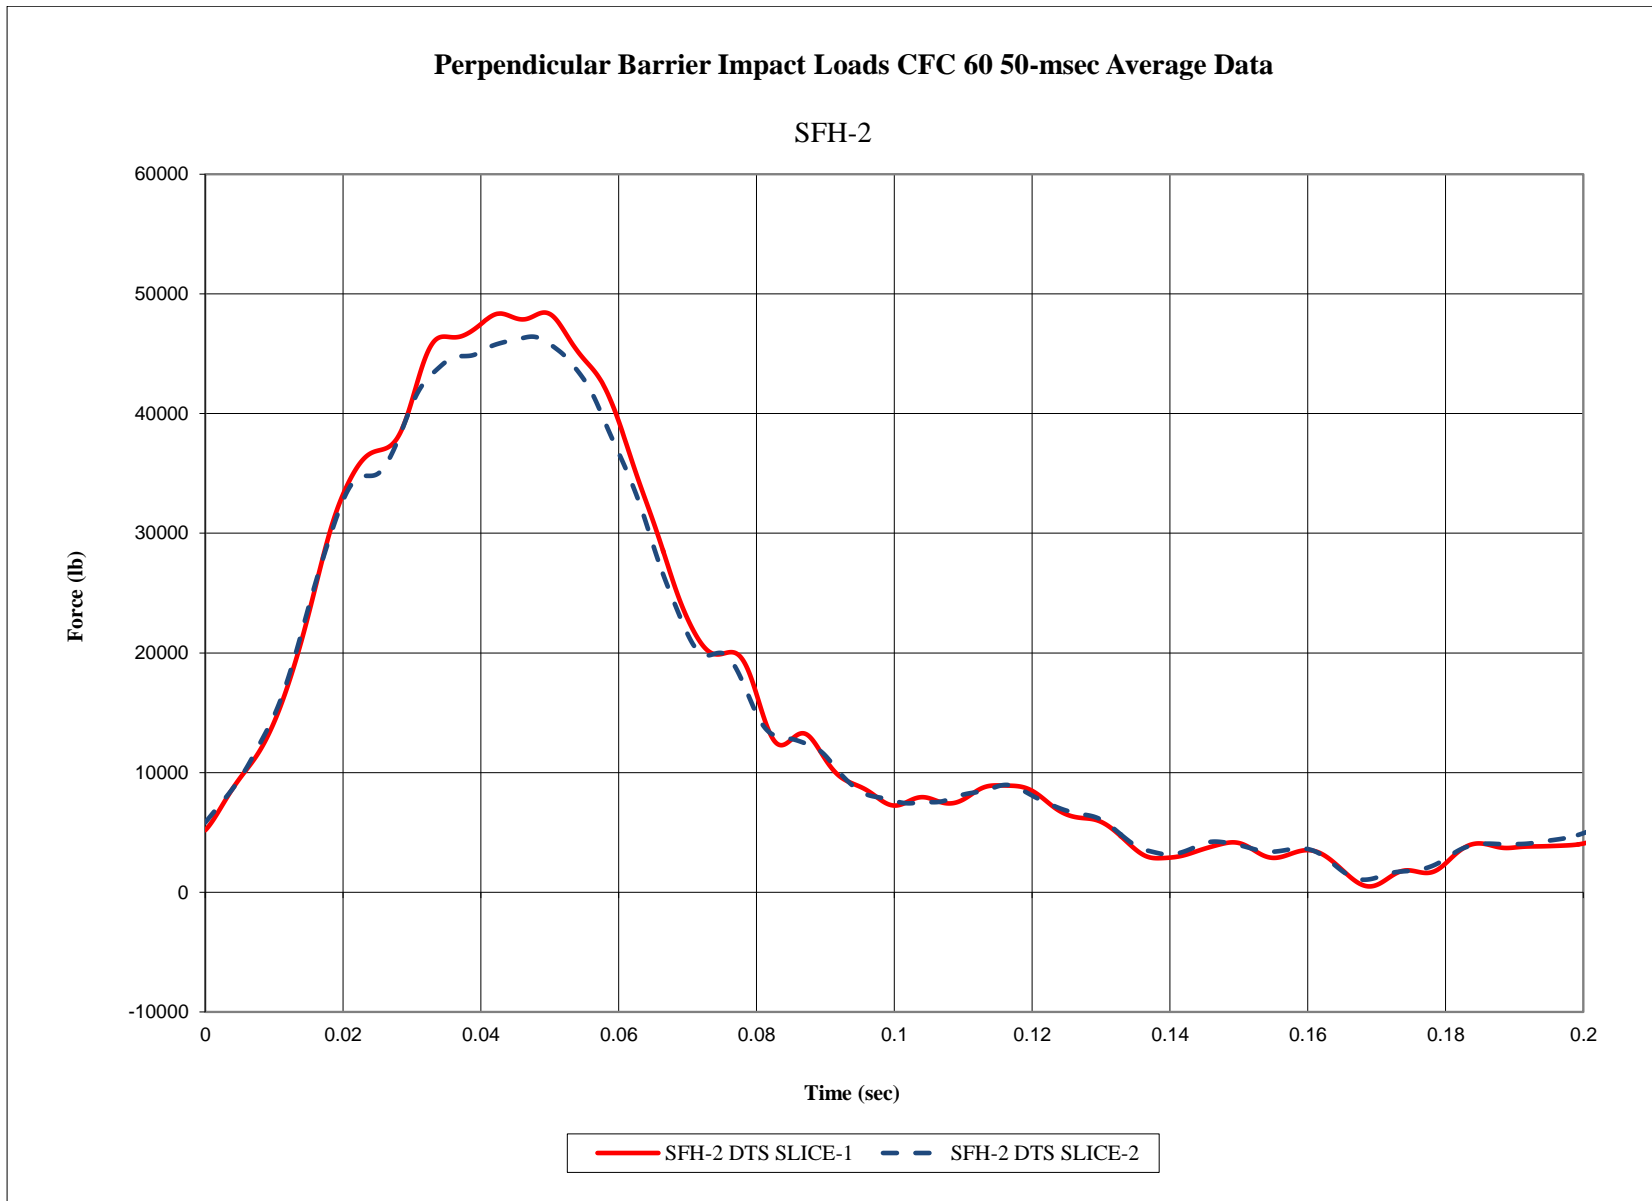
Figure 75. Perpendicular Forces Imparted to the Barrier System, Test No. SFH-2

The longitudinal and lateral vehicle accelerations, as measured at the vehicle's c.g., were also processed using a 50-msec moving average. The 50-msec moving average vehicle accelerations were then combined with the uncoupled yaw angle versus time data in order to estimate the vehicular loading applied to the barrier system. From the data analysis, the perpendicular impact force was determined for the RESTORE barrier, as shown in Figure 75. The maximum perpendicular, or lateral, load imparted to the barrier was 48.4 kips (215 kN) and 46.4 kips (206 kN) as determined by the SLICE-1 and SLICE-2, respectively.

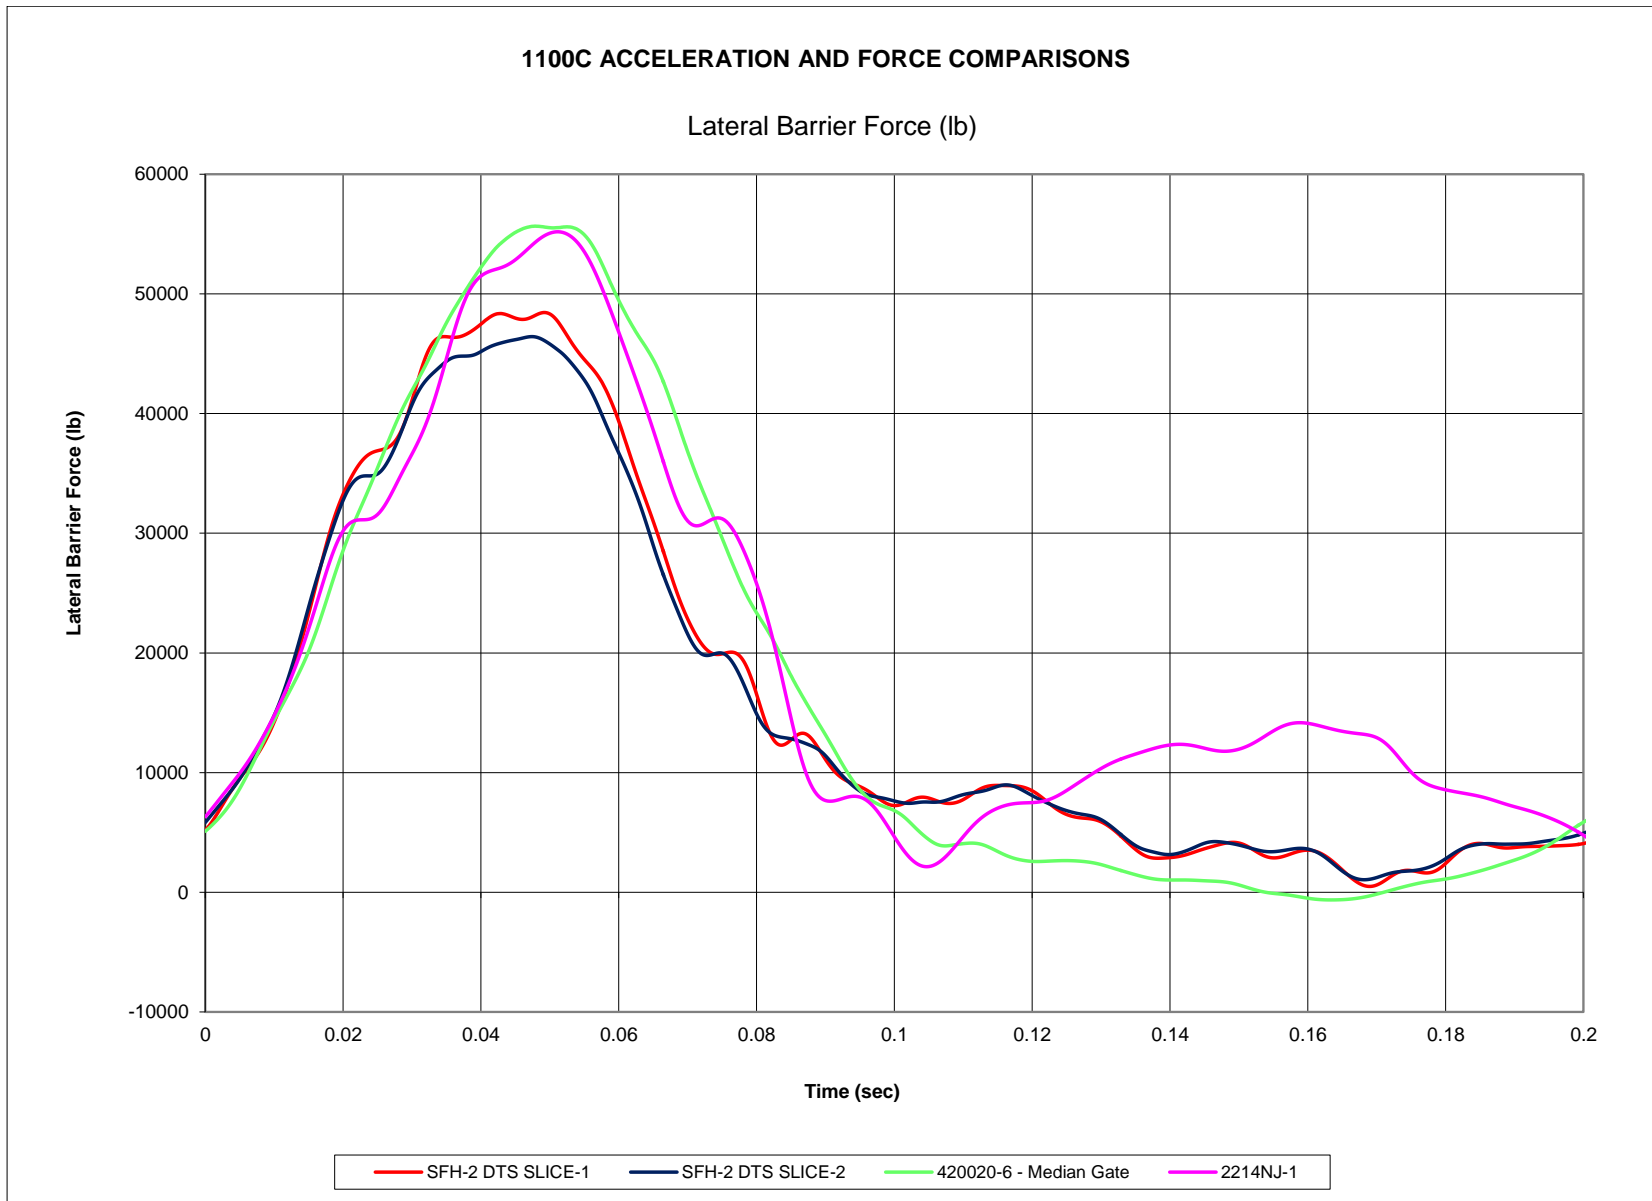
Figure 76. Force Comparisons, 1100C Vehicle

The results of test no. SFH-2 were compared to the results of two different MASH test designation no. 4-10 crash tests, test no. 420020-6 with a vertical, steel median gate [15] and test no. 2214NJ-1 with a New Jersey concrete barrier [16]. Test comparisons are shown in Table 14 and Figure 76. The lateral barrier force was calculated in test nos. 420020-6 and 2214NJ-1 using the same procedure as used in test no. SFH-2. The lateral peak barrier forces were reduced by up to 15 percent than those observed with the vertical, steel median gate and up to 16 percent than those observed to the New Jersey concrete barrier. The peak lateral acceleration increased by up to 23 percent when compared to the vertical, steel median gate and reduced by up to 21 percent when compared to the New Jersey concrete barrier. The peak lateral acceleration may have been lower in the steel median gate; since, it had lower inertia and may have deformed more than a rigid barrier. However, after the peak acceleration, the RESTORE barrier had lower lateral accelerations as compared to the steel median gate and the New Jersey barrier, as shown in

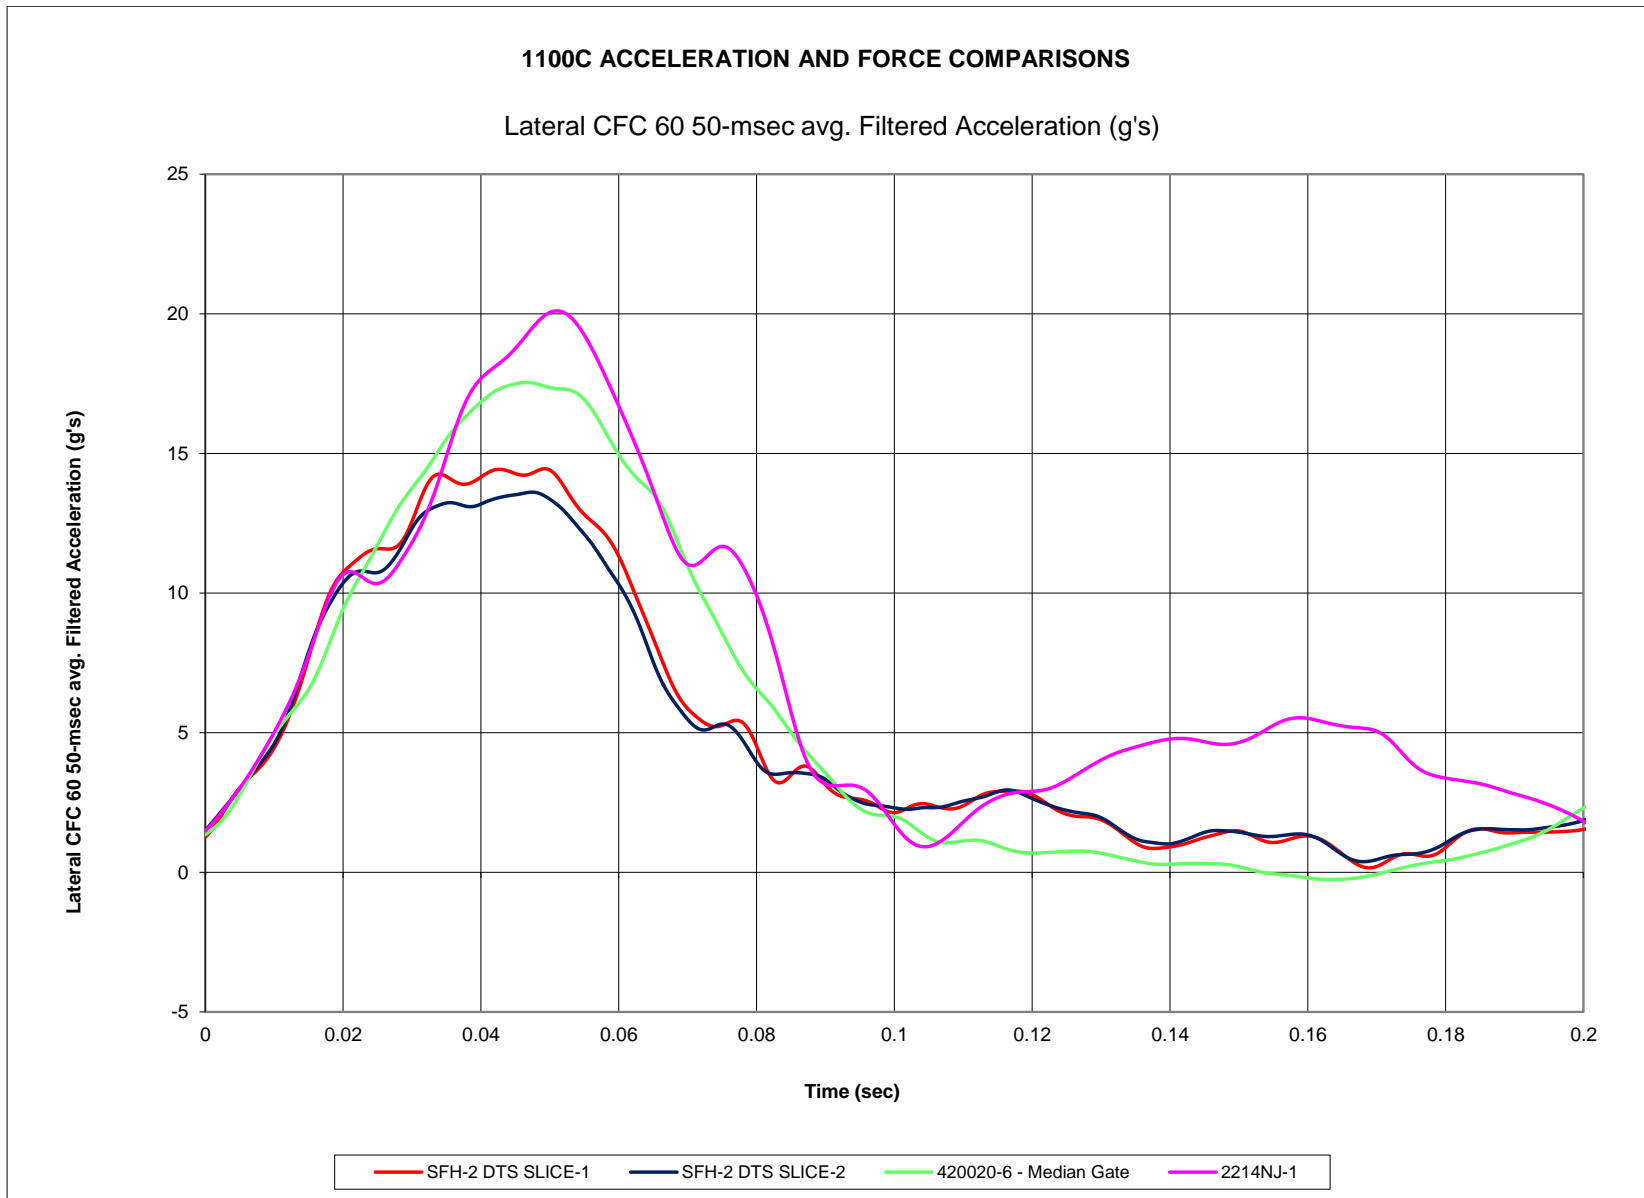
Figure 77. Lateral Acceleration Comparison, 1100C Vehicle

Figures 77 and 78. Additionally, the RESTORE barrier reduced lateral OIV values by up to 31 percent. The lateral and longitudinal ORA values were similar across all tests and had little variances.

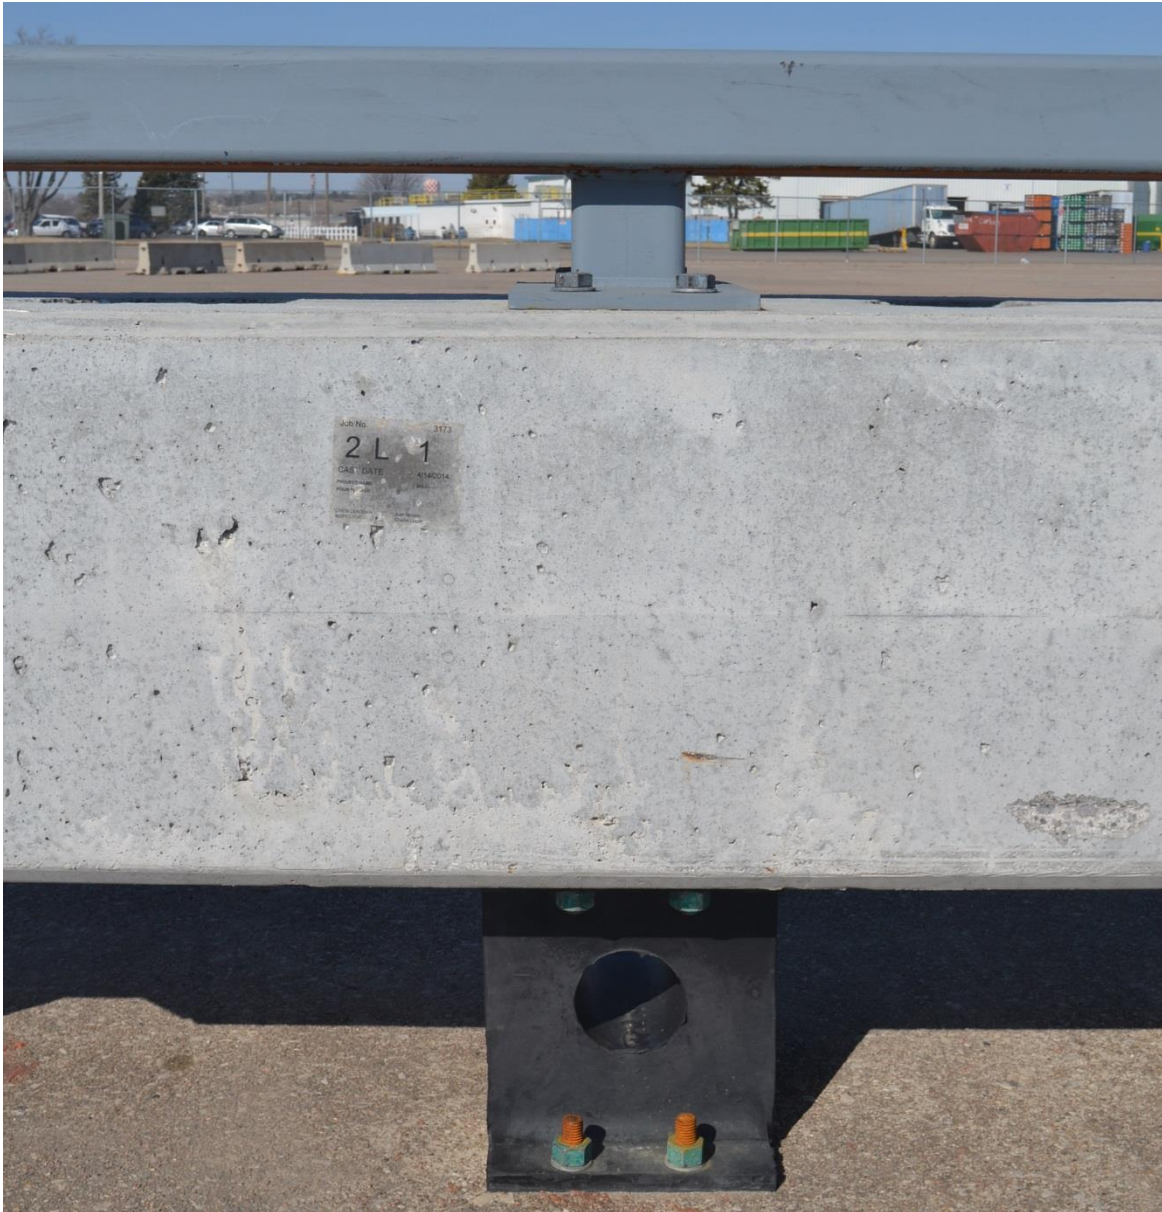
Figure 102. Upper Rail Assembly thru Bolt Connection, Test No. SFH-3

The installation for test no. SFH-3 was similar to the system used in test nos. SFH-1 and SFH-2, as shown in Figures 79 through 101. The impact point was moved, as shown in Figure 79. The components were rearranged to move previously-damaged components out of the impact region. The four threaded rods that attached the upper tube assembly, concrete beams, and rubber posts were replaced with four $\frac{3}{4}$ -in. (19-mm) diameter bolts to minimize the extent that the bolts protrude above the concrete beams and to reduce vehicle snag on the bolts, as shown in Figure 102.

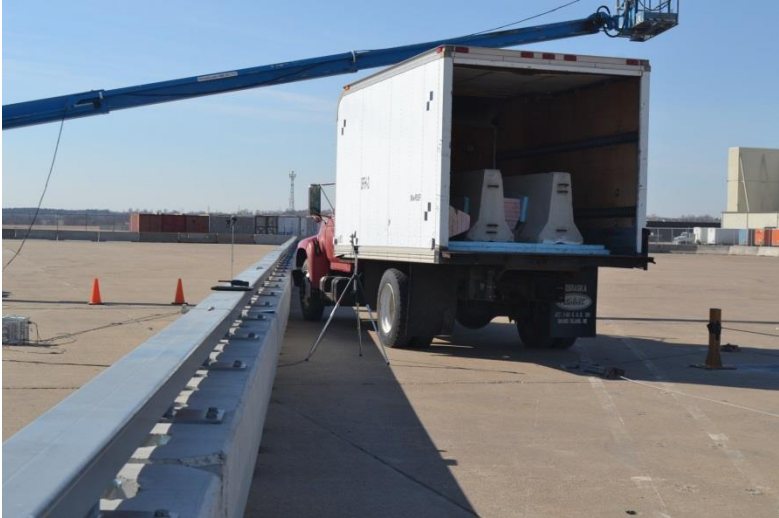
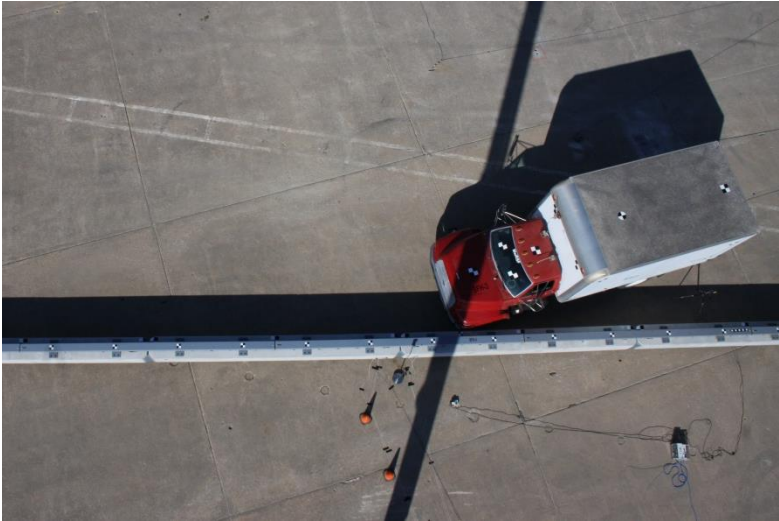
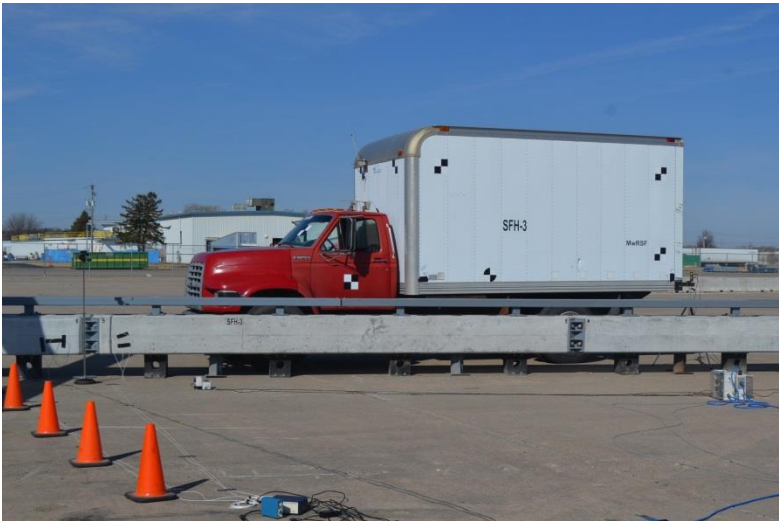
Figure 109. Impact Location, Test No. SFH-3

Initial vehicle impact was to occur 60 in. (1,524 mm) upstream from the joint between barrier nos. 5 and 6, as shown in Figure 109. This location was selected based on recommendation for rigid barrier tests in MASH and verified through LS-DYNA simulation. The actual point of impact was 55.75 in. (1,416 mm) upstream from the joint between barrier nos. 5 and 6, as determined from video analysis. A sequential description of the impact events is contained in Table 16. The vehicle came to rest 270 ft (82.3 m) downstream from the original impact point and 19 ft – 9 in. (6.0 m) laterally behind the system. The vehicle trajectory and final position are shown in Figures 104 and 110.

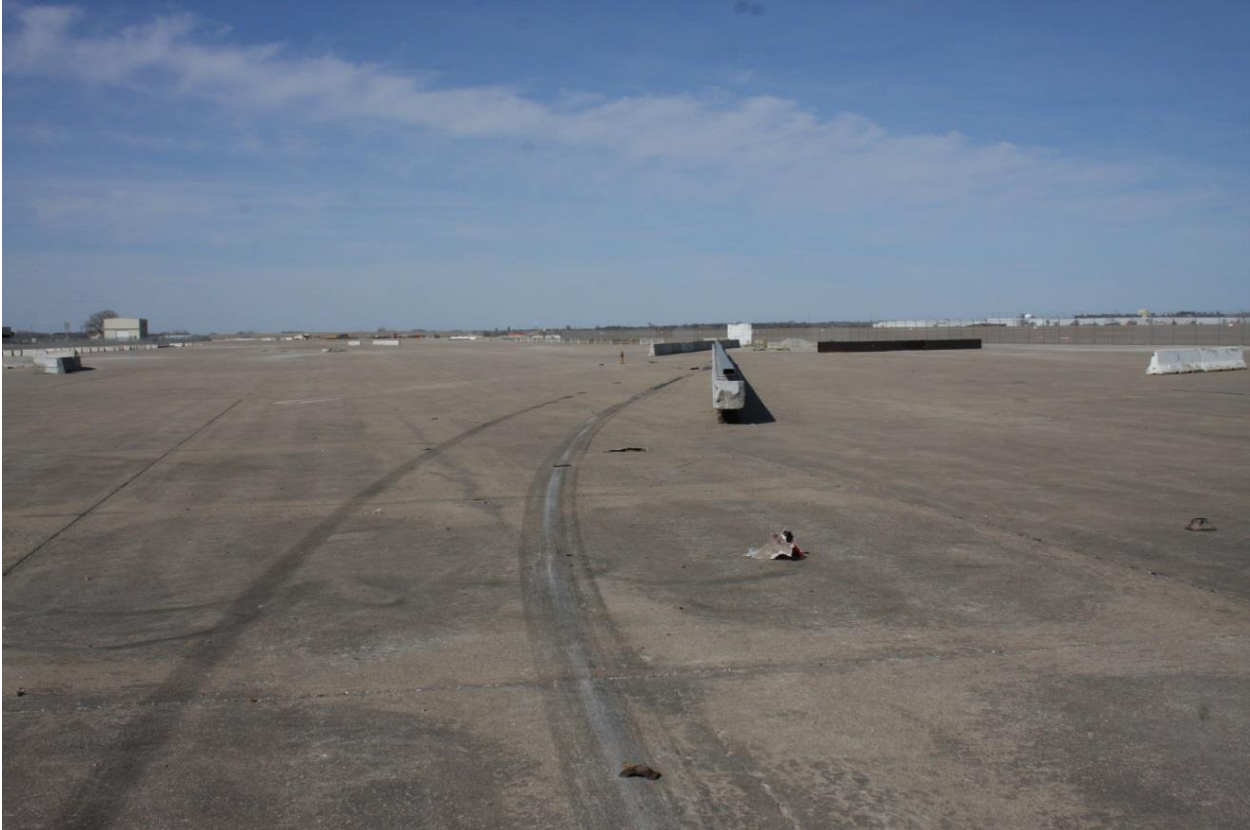
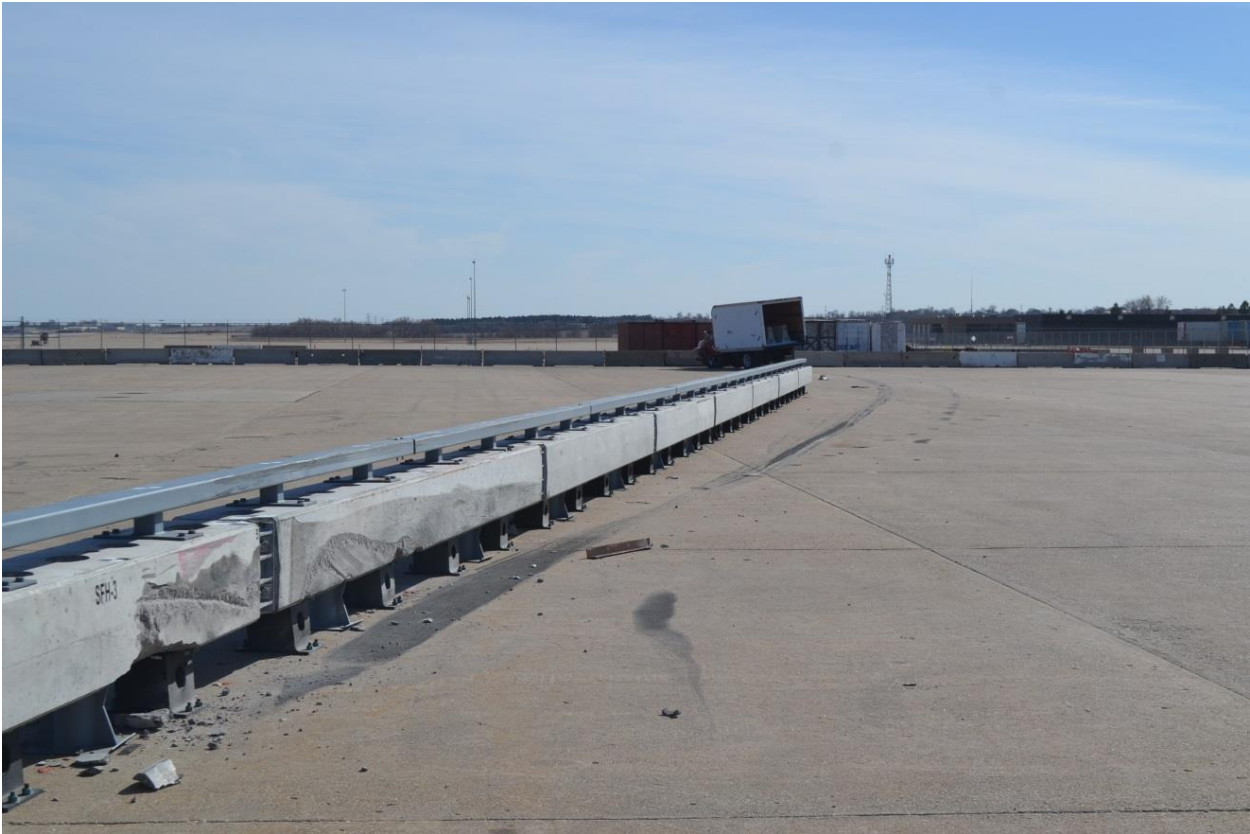
Figure 110. Vehicle Final Position and Trajectory Marks, Test No. SFH-3

Damage to the barrier was minimal, as shown in Figures 110 through 120. Barrier damage consisted of contact marks and gouging on the front face of the concrete beams, cracking and spalling at the joint connections, contact marks along the top of the concrete beams and along the upper tube assembly, and contact with the rubber posts. The length of the vehicle contact along the barrier was approximately 59 ft – 3 in. (18.1 m), which spanned from 60½ in. (1,537 mm) upstream from the joint between barrier nos. 5 and 6 to 29 in. (737 mm) upstream from the joint between barrier nos. 8 and 9. The majority of the contact marks were found on the front face of the concrete beam starting at the impact point and extending through the end of

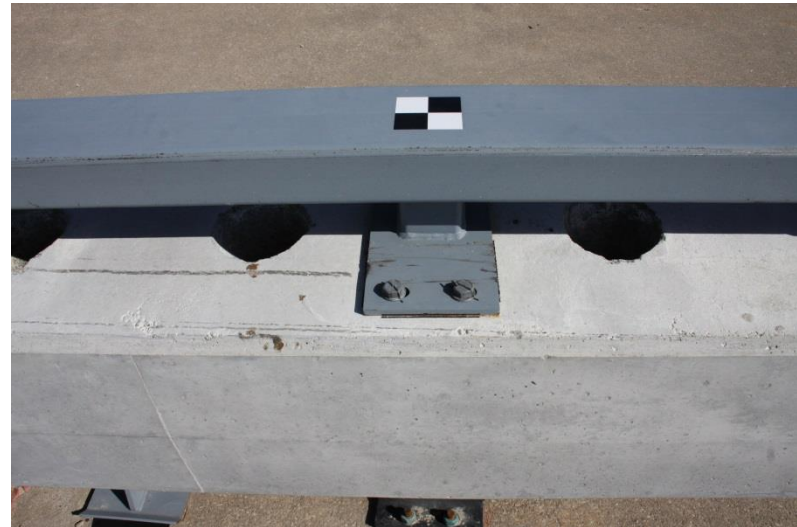
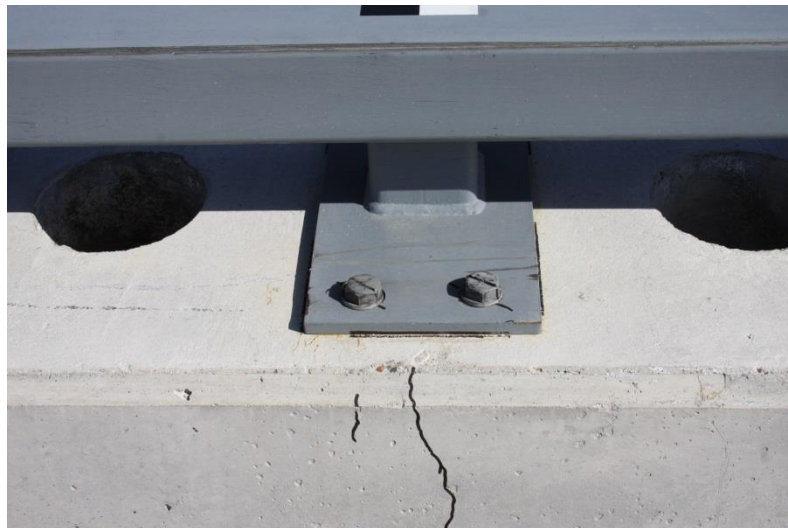
Figure 116. System Damage, Upper Tube Assembly Connection Damage, Barrier No. 7, Test No. SFH-3

First Connection Downstream from Joint No. 6/7

Second Connection Downstream from Joint No. 6/7

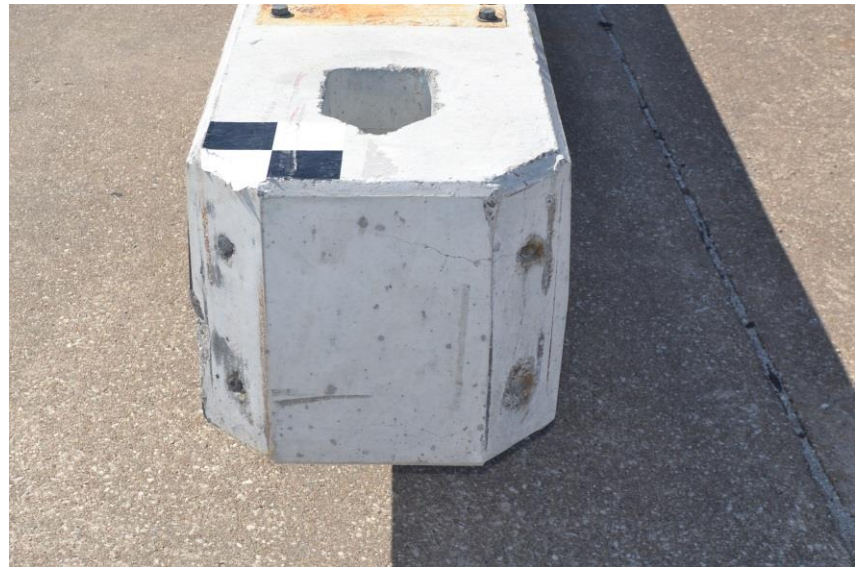
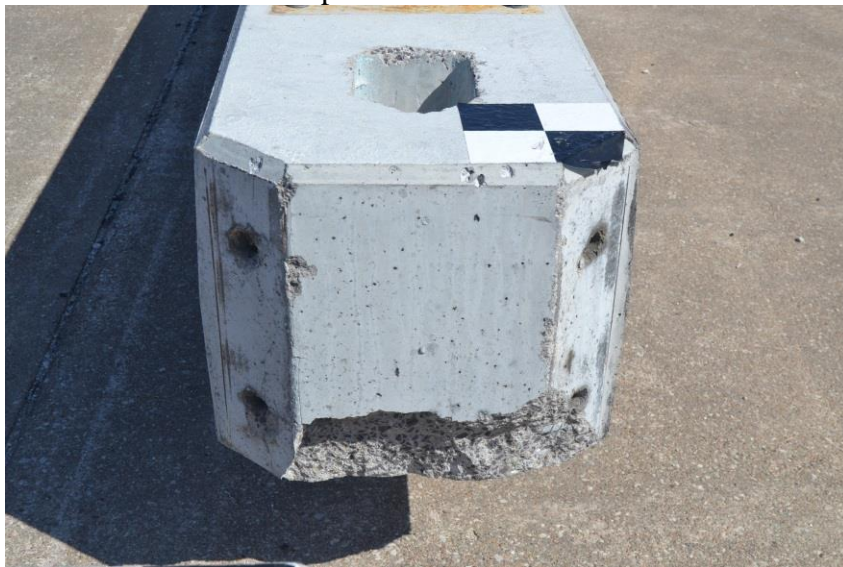
Figure 118. System Damage, Joint Damage, Barrier Nos. 5 and 6, Disassembled, Test No. SFH-3

Barrier No. 5

After test no. SFH-3, five joints experienced varying levels of damage including concrete cracking and spalling between the front and back ACJ hardware components. The concrete spalled and was gouged on the front face of barrier nos. 5 and 6. The top of the concrete beams were gouged from contact with the cargo box from barrier no. 5 through barrier no. 8. Additionally, the first post downstream from the point of impact had a 1-in. (25-mm) diameter semi-circular cut from impact with one of the left-front tire's lugnuts. The concrete beams dynamically deflected 13.9 in. (353 mm), and the barrier had approximately 1½ in. (38 mm) of permanent displacement. The working width was determined to be 60.2 in. (1,529 mm) as determined from video analysis. The system damage should not affect the structural capacity of the system, and test no. SFH-3 was deemed acceptable according to MASH test designation no. 4-12.

Due to the concrete spalling that occurred in all three crash tests, and the post damage in test no. SFH-2, refinements are recommended to eliminate damage and the need for maintenance. The concrete beam may be strengthened near the ends to minimize the spalling and cracking that occurred at the joints in test nos. SFH-1 and SFH-3. The concrete beam surface gouging may also be minimized by changing the concrete mix, by increasing the concrete density, or by adding reinforcing fibers. However, completely eliminating concrete gouges is not likely, as this is common in all concrete barriers. There are several possible modifications to prevent significant wheel contact with the rubber posts, including: reducing the clear opening below the concrete beam; widening the concrete beams; and modifying the posts.

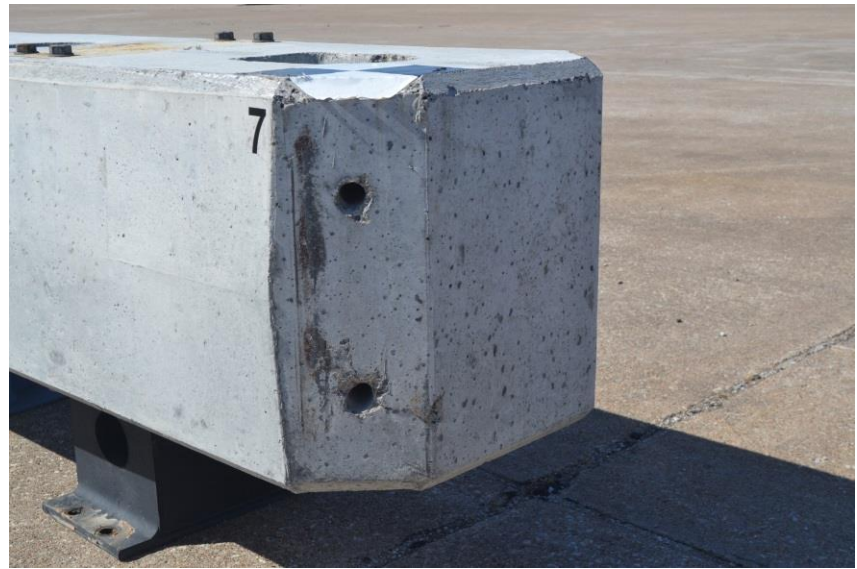
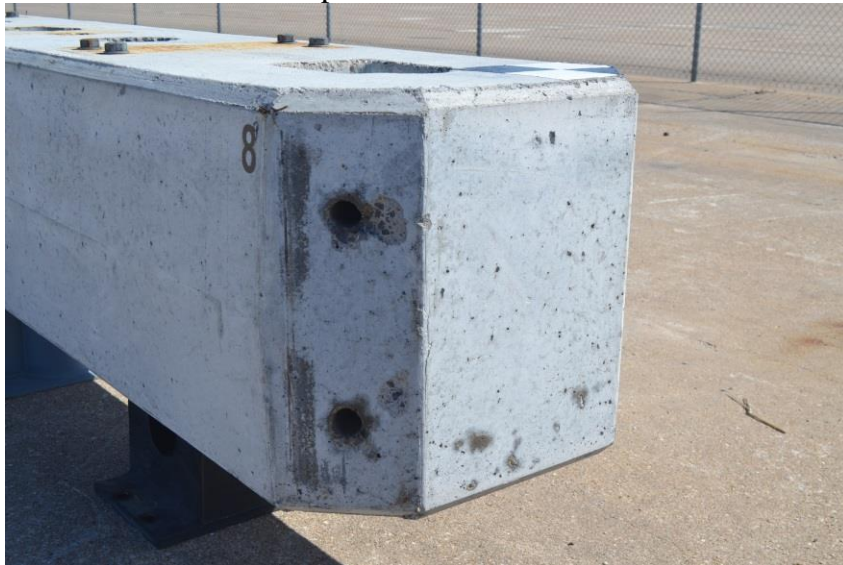
Figure 119. System Damage, Joint Damage, Barrier Nos. 7 and 8, Disassembled, Test No. SFH-3

Barrier No. 7

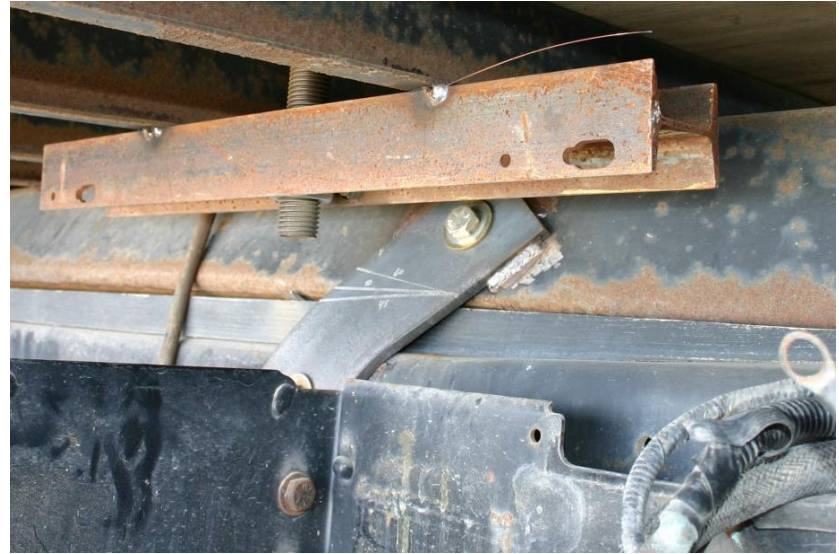
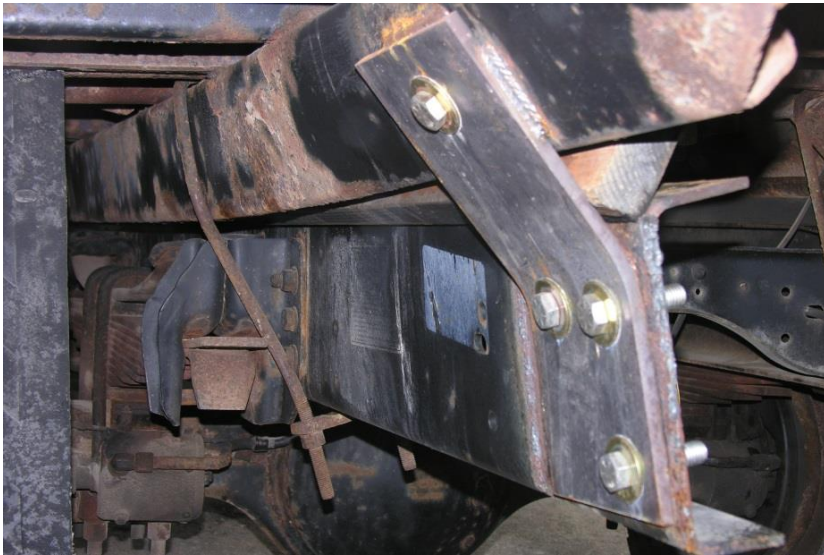
Figure 122. Vehicle Damage, Shear Plate Damage, Test No. SFH-3

- Vehicle Damage..... Moderate
 - VDS [11] 11-LFQ-4
 - CDC [12] 11-LPEW-9
 - Maximum Interior Deformation 2½ in. (60 mm)
