**PERFORMANCE EVALUATION OF THE  
PERMANENT NEW JERSEY SAFETY SHAPE  
BARRIER – UPDATE TO NCHRP 350  
TEST NO. 4-12 (2214NJ-2)**

**MIDWEST ROADSIDE SAFETY FACILITY**

MwRSF Research Report No. TRP-03-178-06

October 13, 2006

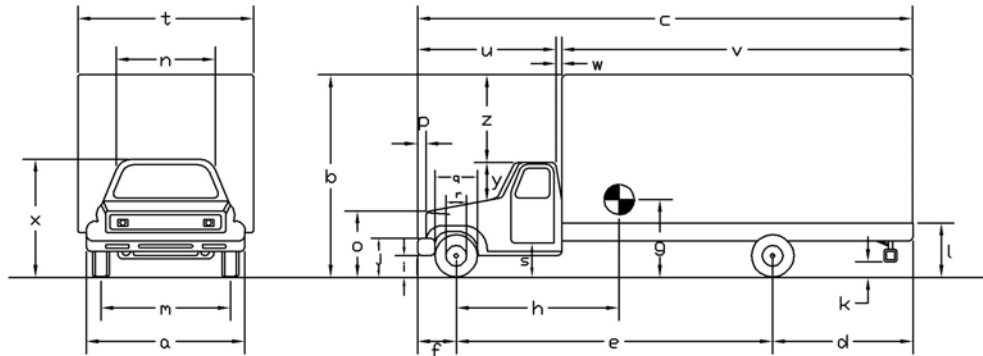
Figure 2. Vehicle Dimensions, Test 2214NJ-2

Note any damage prior to test: Rusty Cab Floor

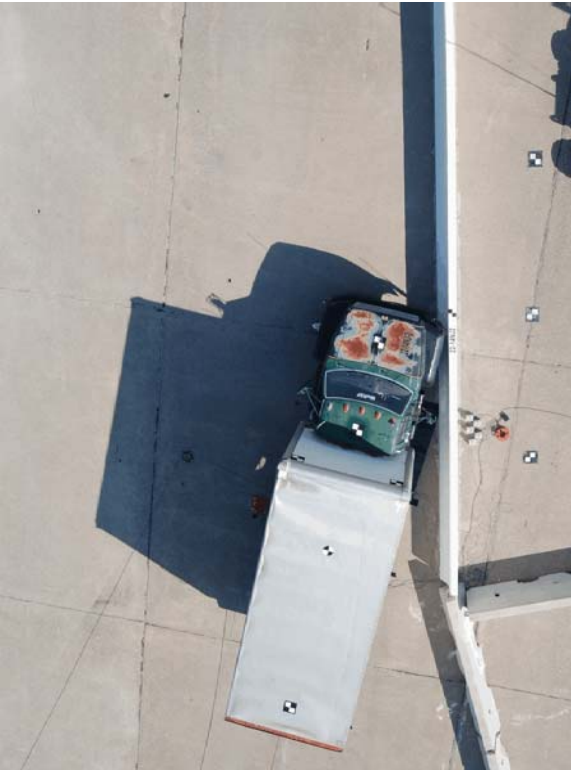
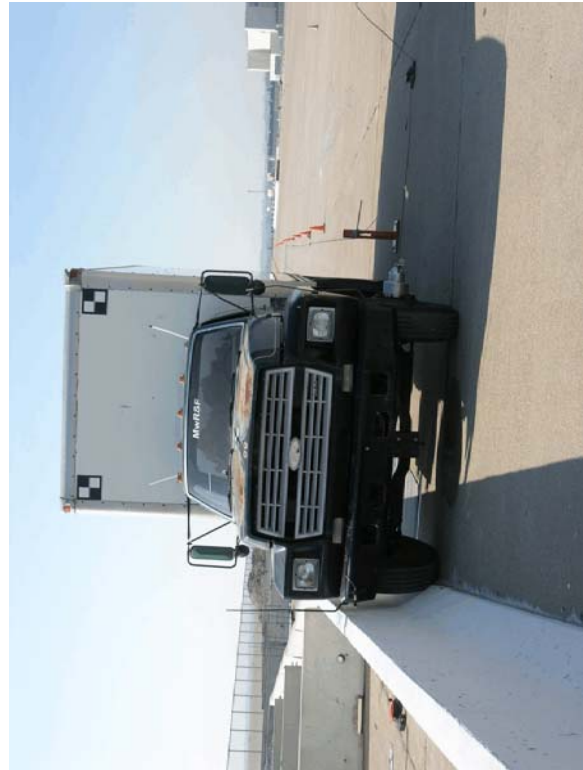
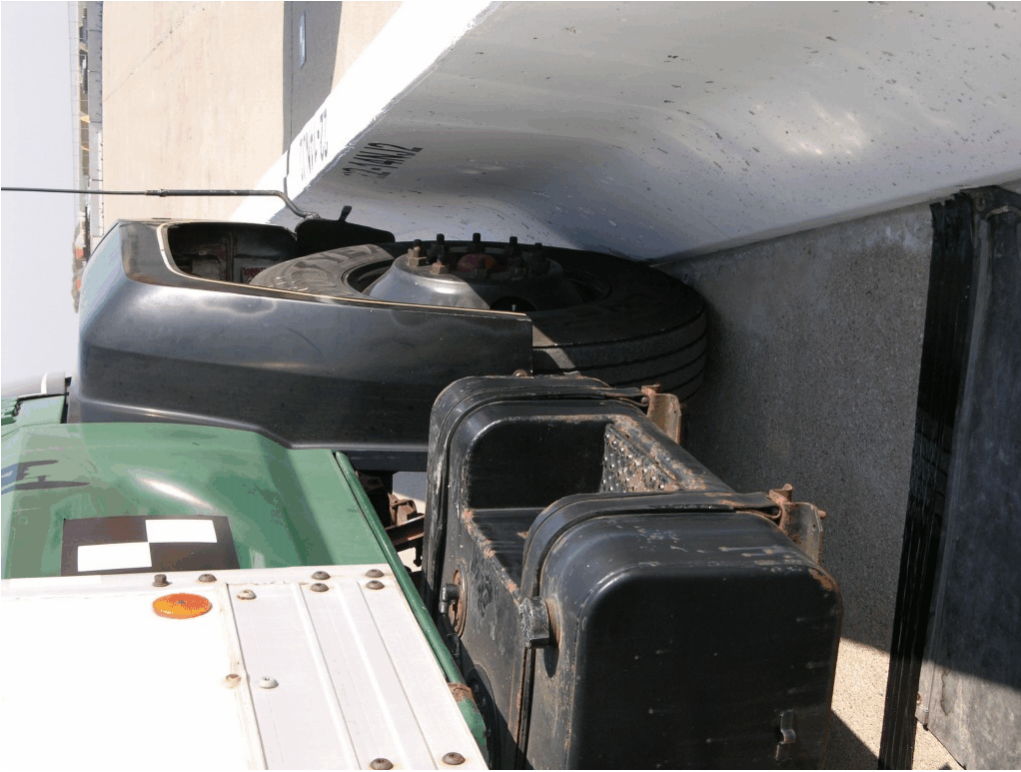
Figure 18. Impact Location, Test 2214NJ-2

Initial vehicle impact was to occur 6.10 m (20 ft) downstream from the upstream end of the barrier, as shown in Figure 18. Actual vehicle impact occurred at the targeted impact. At 0.064 sec after impact, the vehicle began to redirect. At 0.084 sec, the right-front corner of the vehicle protruded over the top of the barrier. At 0.120 sec, the cab portion of the vehicle encountered counter-clockwise (CCW) roll away from the barrier. At this same time, the right side of the cab rode on top of the barrier and the box contacted the barrier. At 0.140 sec, the cab and box twisted while the box rolled clockwise (CW) toward the barrier. At 0.220 sec, the rear of the box redirected into the barrier as the cab continued to slide along the top of the barrier. At 0.264 sec, the CW roll of the box increased significantly. At 0.310 sec, the roll of the cab ceased. At 0.410 sec, the left-rear tire was airborne. At 0.470 sec, the entire truck rolled CW over the top of the barrier. At 0.526 sec, the left-front tire became airborne. At 0.758 sec, the front axle disengaged from the truck. At 0.850 sec, all tires were airborne. At 1.202 sec, the vehicle had rolled CW to a position of the right side being parallel to the ground. At 1.342 sec, the right side of the vehicle contacted the ground behind
