*Midwest States Regional Pooled Fund Research Program
Fiscal Year 2009-2010 (Year 20)
Research Project Number TPF-5(193)
NDOR Sponsoring Agency Code RFPF-10-MGS*

DETERMINATION OF THE MAXIMUM MGS MOUNTING HEIGHT – PHASE I CRASH TESTING

MwRSF Research Report No. TRP-03-255-12

March 9, 2012

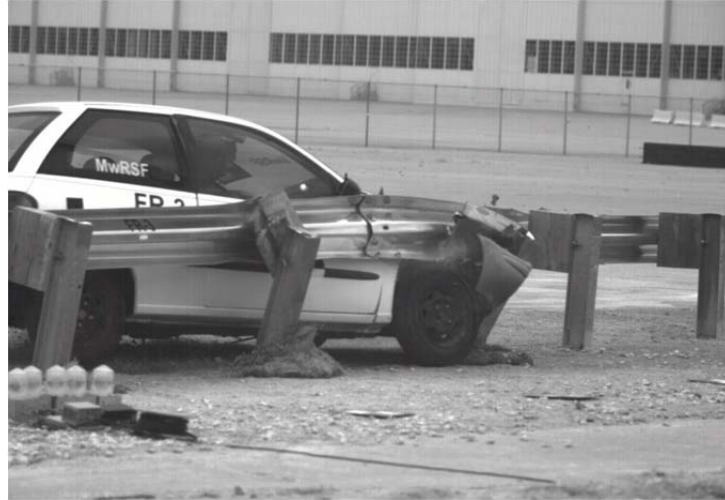
Figure 1. Test No. FR-3, Potential for Wheel Snag

Two concerns arise when wheel snag occurs: (1) the wheel is pushed rearward against the wheel well, which could deform the floorpan and (2) the longitudinal forces on the wheel increase the occupant risk values. Test no. FR-3 showed the propensity for wheel snag, as shown in Figure 1. Additionally, the small car utilized in test no. FR-5 encountered wheel snag on post no. 15, as shown in Figure 2. These flare rate tests, however, were more severe than a standard W-beam test, as the small car impacted at a higher effective angle of 31.8 degrees. As stated before, both of these tests passed the NCHRP Report No. 350 test criteria, and experienced acceptable floorpan deflections and occupant risk values. Thus, wheel snag may not pose a critical risk to the small car at higher rail heights. In test no. 2214MG-3, slight wheel snag occurred that did not abruptly stop the vehicle but caused it to yaw toward the barrier, as shown in Figures 3 and 4.

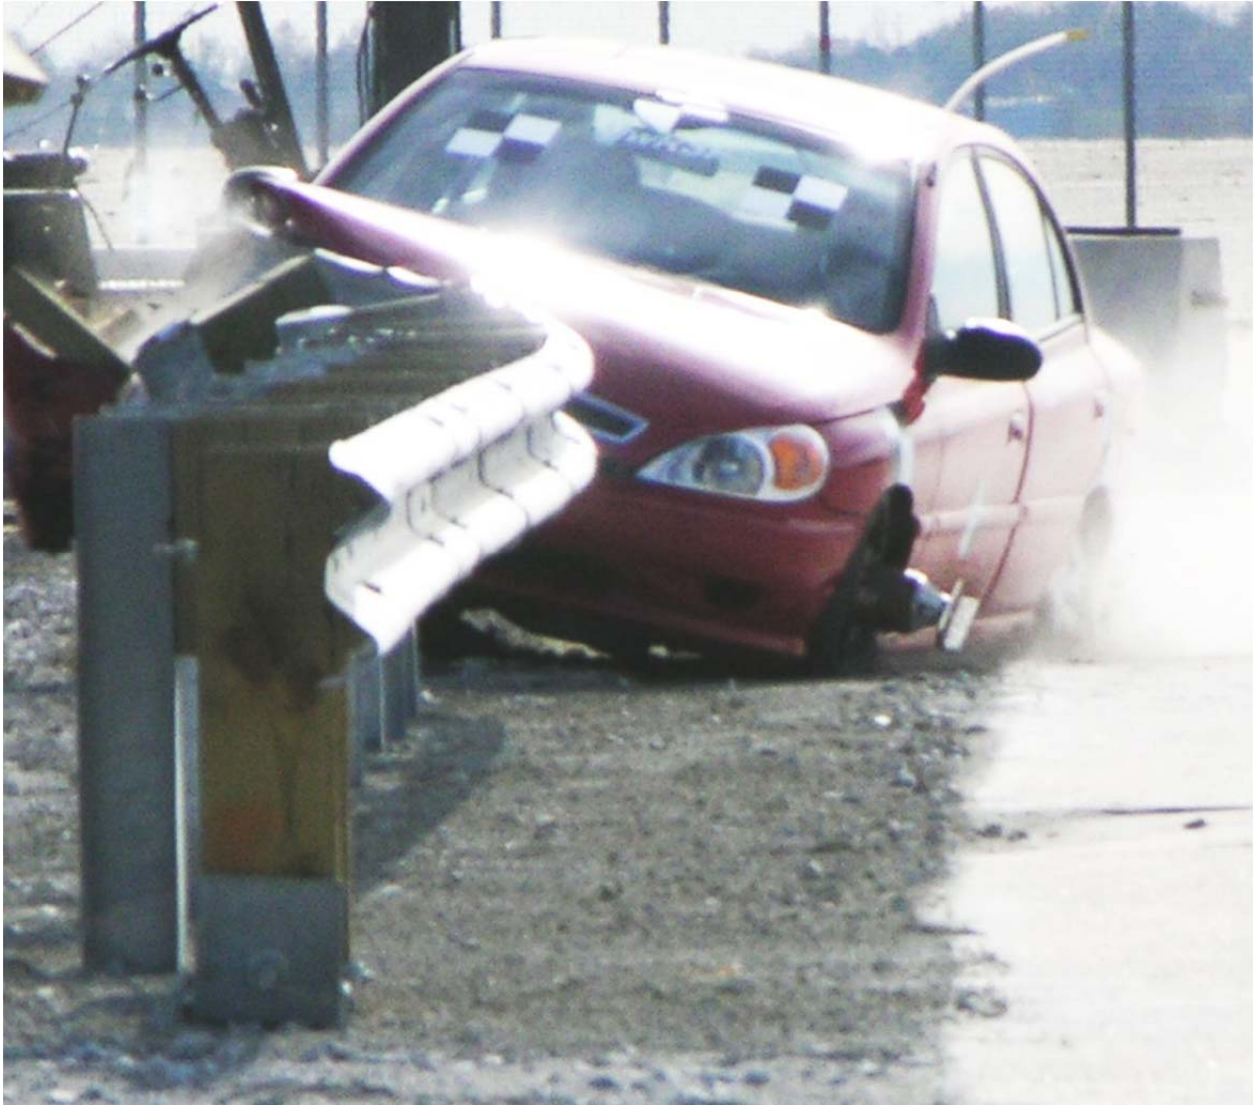
Figure 5. Test No. 2214MG-3, Rail Snags Under the Hood

The potential for barrier underride was seen in several tests. In some tests, the rail contacted the front of the vehicle and began to slide upward, but snagged under the hood and the quarter panel, as shown in Figure 5. The hood snag did not pose a threat to the occupants of the vehicle, but the rail may not be caught under the hood at higher rail heights, which would allow underride to occur.

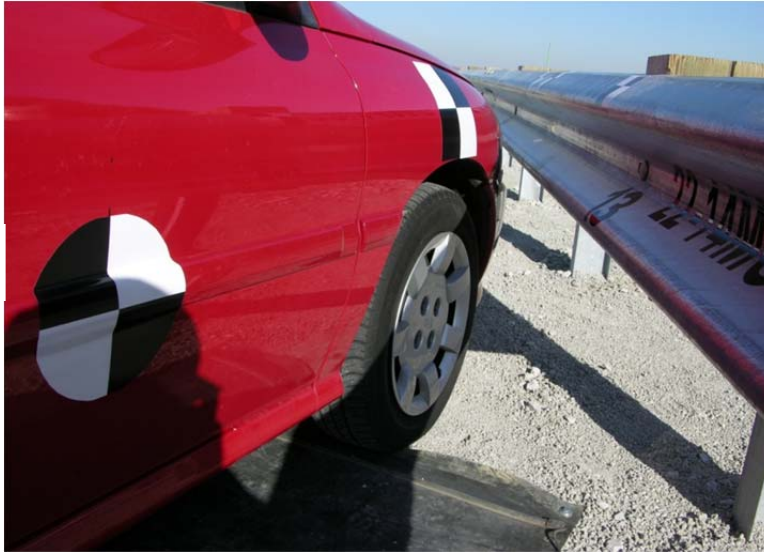
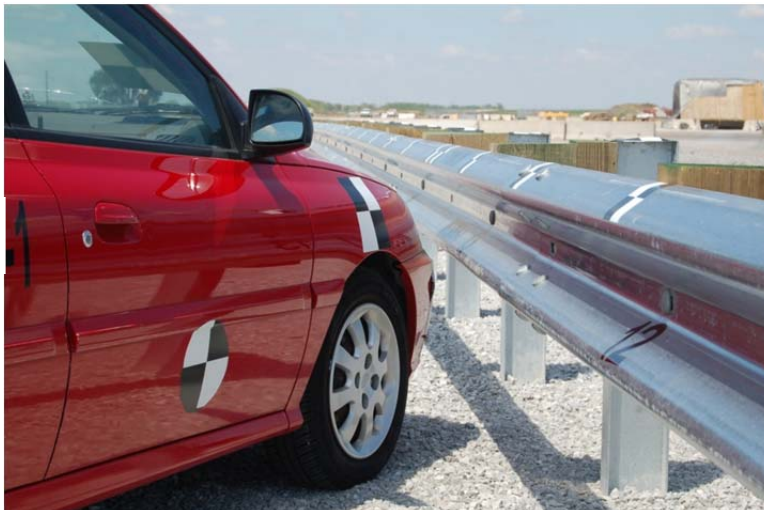
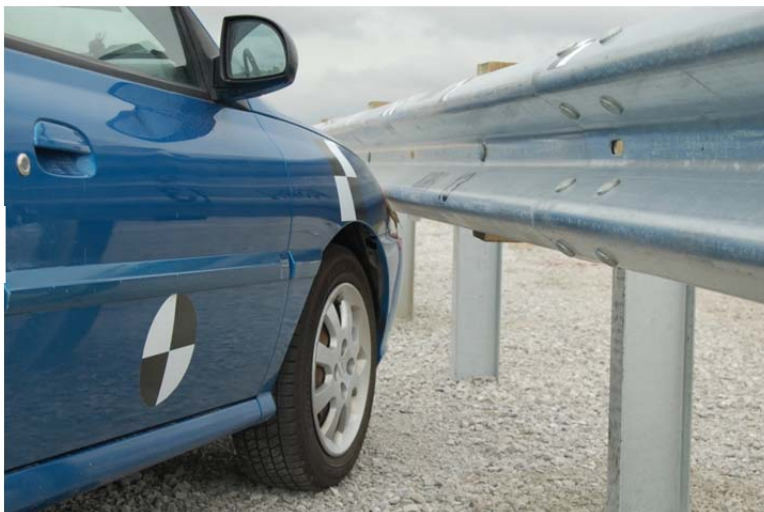
Figure 8. 1100C Next to 32-, 34-, and 36-in. (813-, 864-, and 914-mm) MGS – Rear View

Another key geometric factor is the vehicle to rail relationship, as shown in Figures 8 and 9. When the rail is mounted at a height of 32 in. (813 mm), the rail no longer contacts the bumper—its contact is primarily with the hood and side quarter panel of the vehicle. Because several tests have successfully passed with that type of contact, the height of the rail may be increased several inches and still successfully capture the vehicle. As shown in Figure 6, the distance between the top of the bumper and the upper edge of the side panel is approximately

Rail snag under the hood did not occur for either test. For the 32-in. (813-mm) tall MGS, the corner of the 1100C vehicle hood was located above the top corrugation of the rail. In test nos. MGSMRH-1 and MGSMRH-2, the corner of the hood was located between the corrugations of the rail, as shown in Figures 8 and 9. As a result, the corner of the hood slid into the valley of the W-beam and crumpled, jarring the hood open.

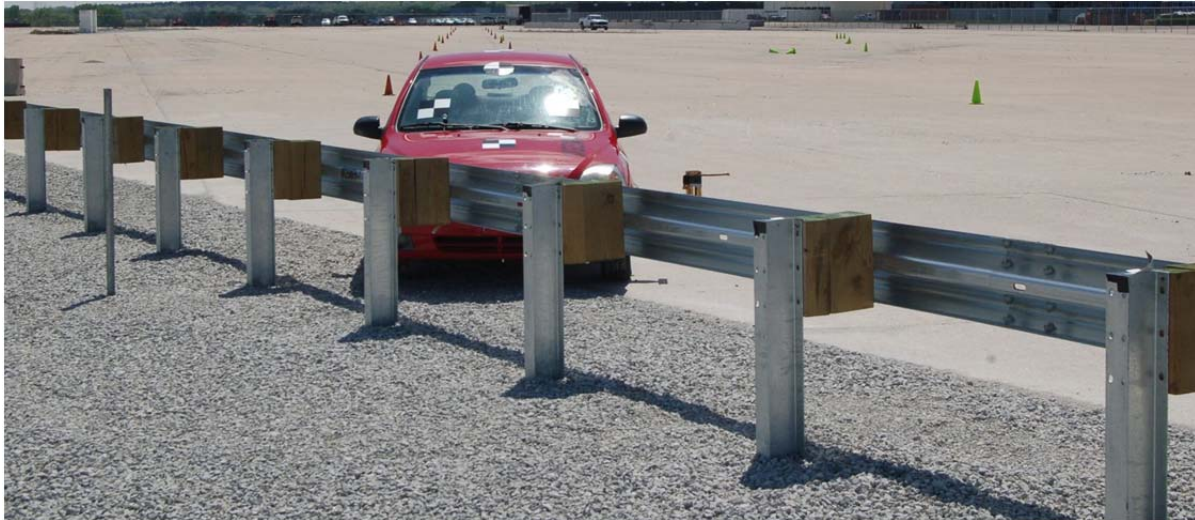
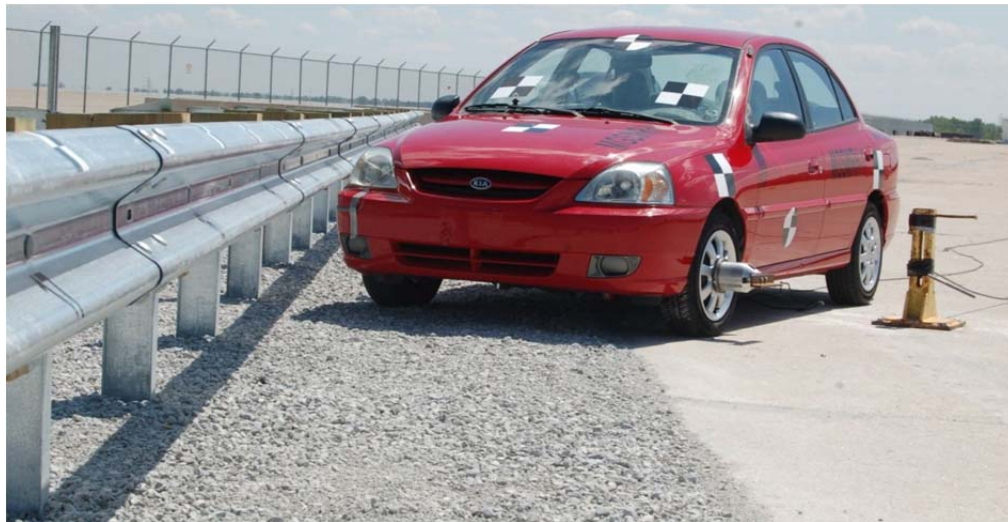
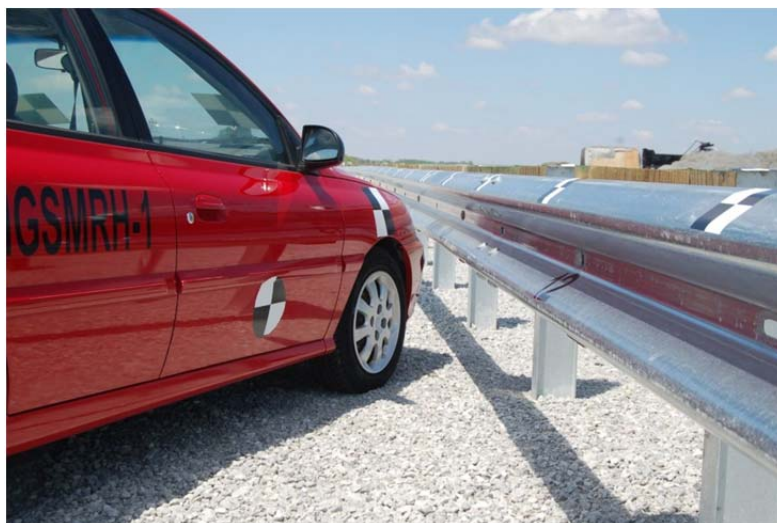
Figure 34. Impact Location, Test No. MGSMRH-1

Initial vehicle impact was to occur 10 ft (3.0 m) upstream of the centerline of post no. 15, as shown in Figure 34, which was selected using the critical impact point (CIP) plots found in Section 2.3 of MASH. The actual point of impact was 10 ft – 1 in. (3.1 m) upstream from the centerline of post no. 15. A sequential description of the impact events is contained in Table 6. The vehicle came to rest facing downstream, located 190 ft – 5 in. (58.0 m) downstream from impact and 5 ft – 11¼ in. (1.8 m) laterally behind the front face of the guardrail. The vehicle trajectory and final position are shown in Figures 29 and 35.

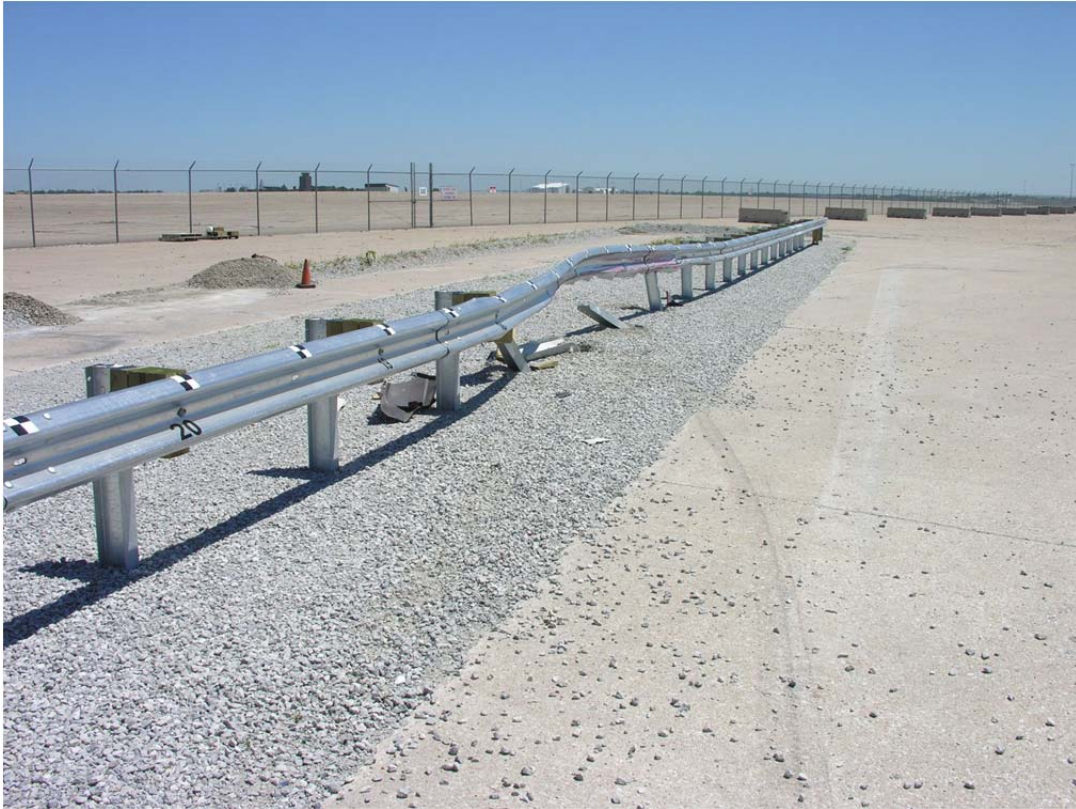
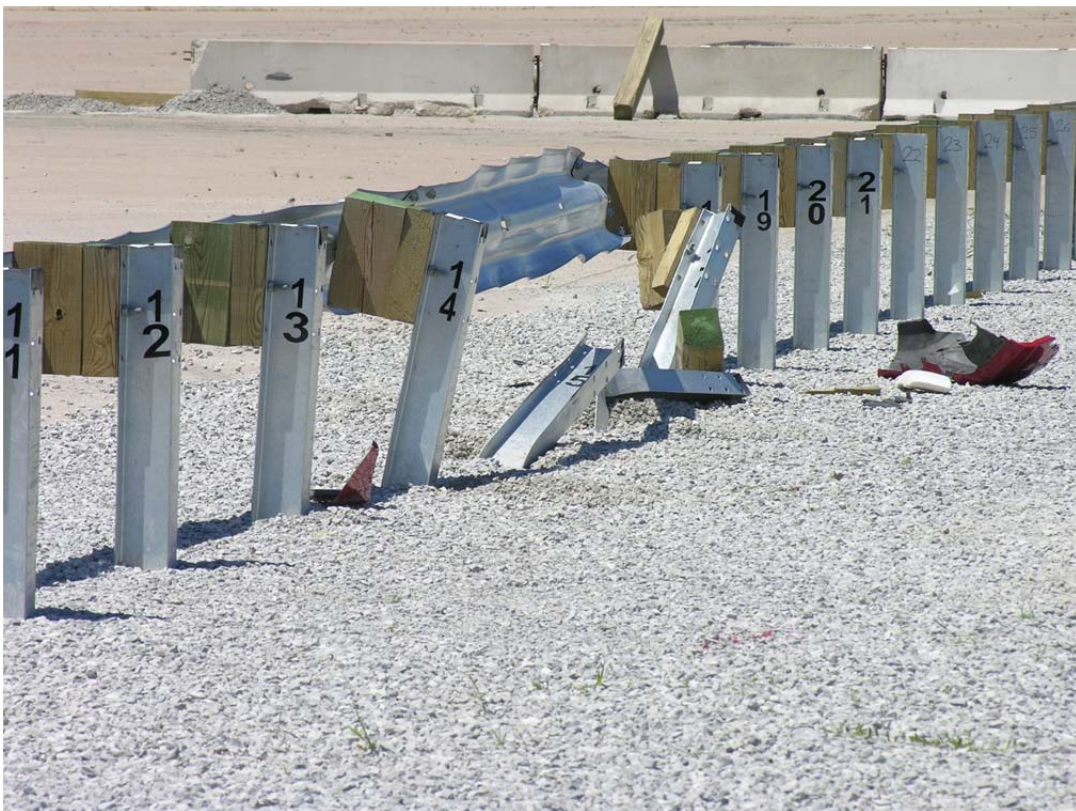
Figure 36. System Damage, Test No. MGSMRH-1

Damage to the barrier was moderate, as shown in Figures 36 through 45. Barrier damage consisted of deformed guardrail posts, disengaged wooden blockouts, contact marks on posts and guardrail, and deformed W-beam rail. The length of vehicle contact along the barrier was approximately 25 ft – 10½ in. (7.9 m) which spanned from 10 ft – 1 in. (3.1 m) upstream of the centerline of post no. 15 to 35½ in. (902 mm) upstream of post no. 18.

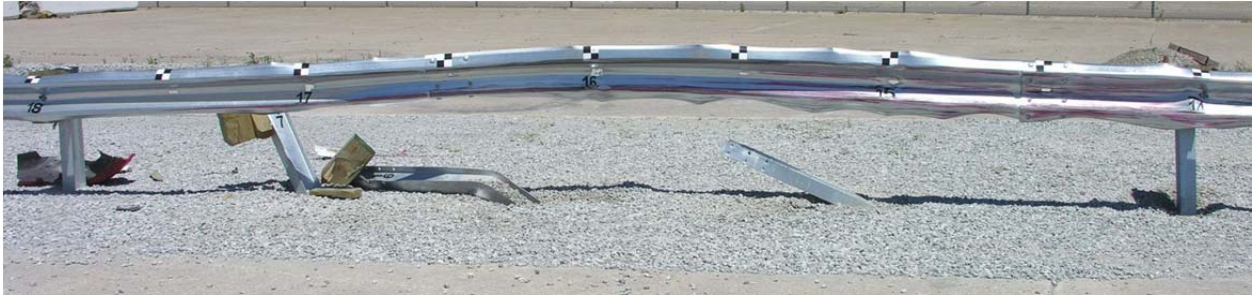
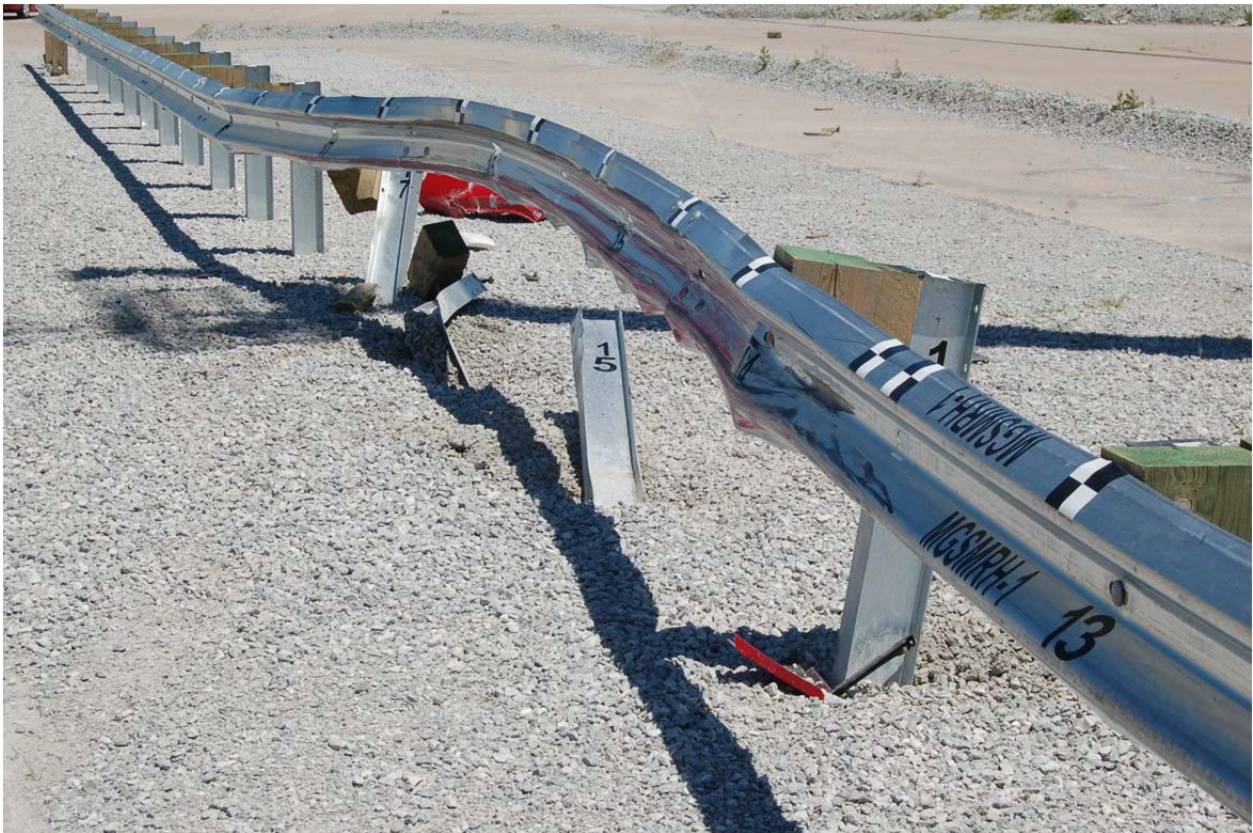
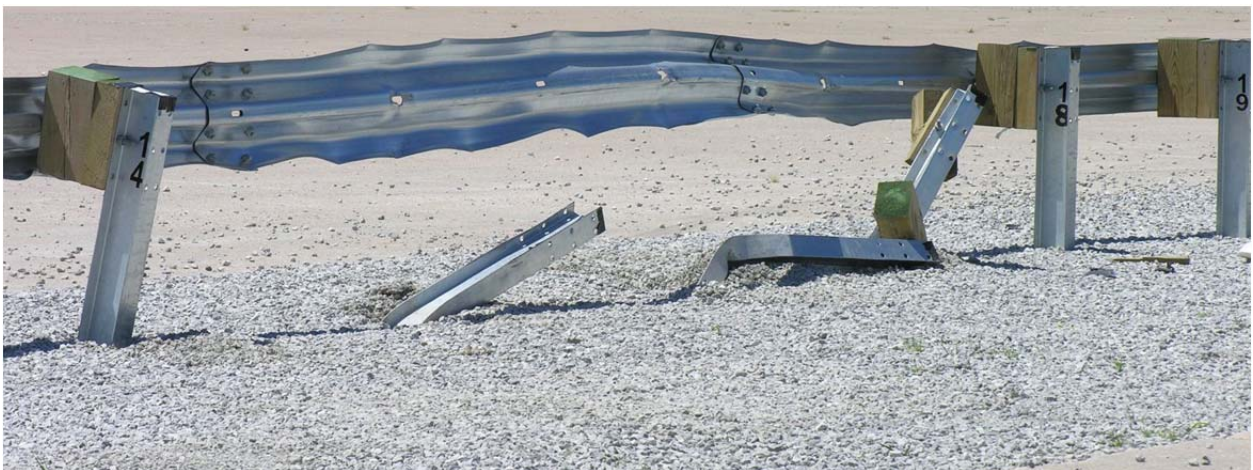
Figure 38. System Damage, Test No. MGSMRH-1

Red paint transfer was found on the rail between the impact location and post no. 18. Minor kinks in the top and bottom corrugations of the rail were found between post nos. 12 and 19, as shown in Figure 38. Flattening and deformation of the rail occurred between post nos. 13 and 18. The bottom corrugation was flattened between post nos. 14 and 16. The bottom edge of the rail was folded upward at post no. 14.

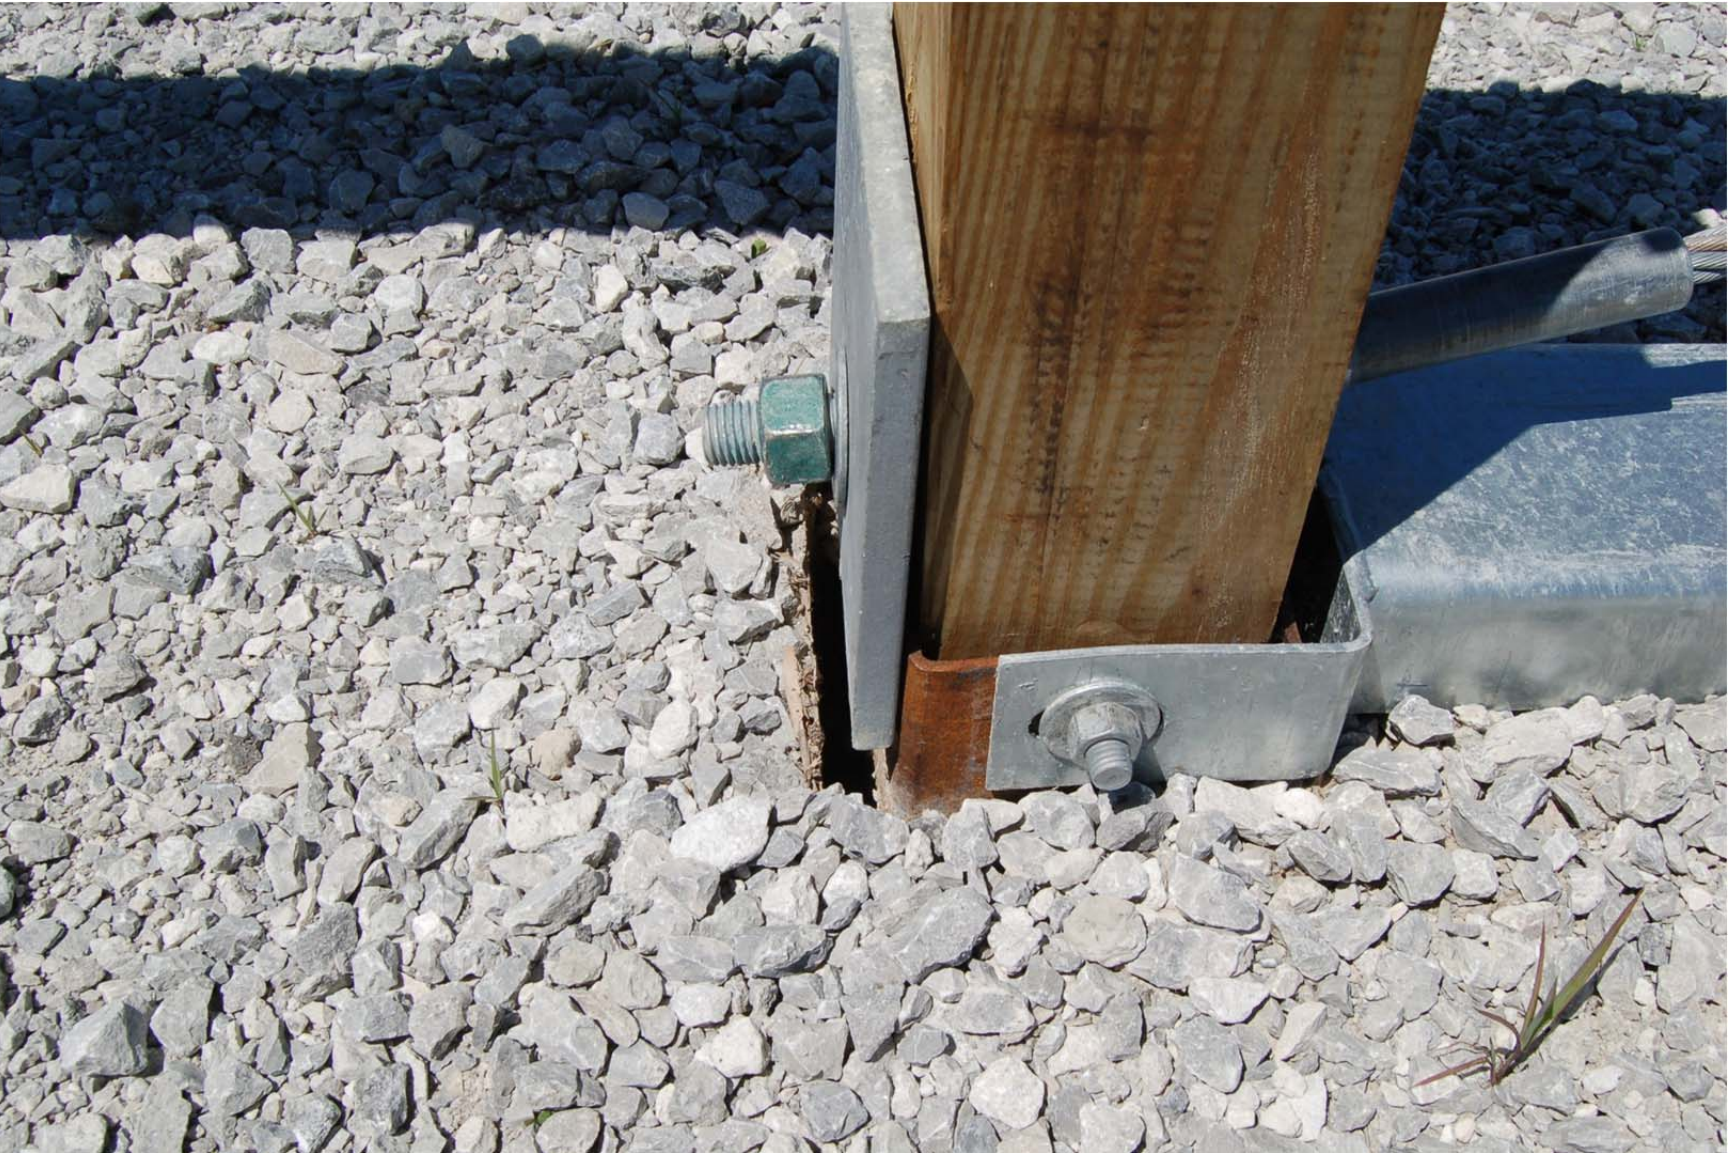
A soil gap measuring $1\frac{1}{2}$ in. (38 mm) was present on the upstream side of post no. 1, as shown in Figure 40. A soil gap measuring $\frac{3}{8}$ in. (10-mm) was present on the downstream side of post no. 2. A $\frac{1}{16}$ -in. (2-mm) soil gap was present on the front face of post nos. 12 and 18. A $1\frac{1}{4}$ -

Figure 40. Soil Gap at Upstream End Anchor, Test No. MGSMRH-1

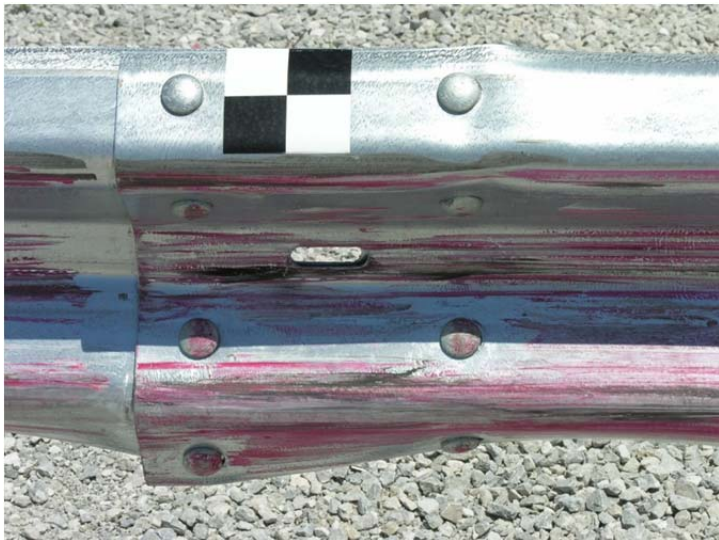
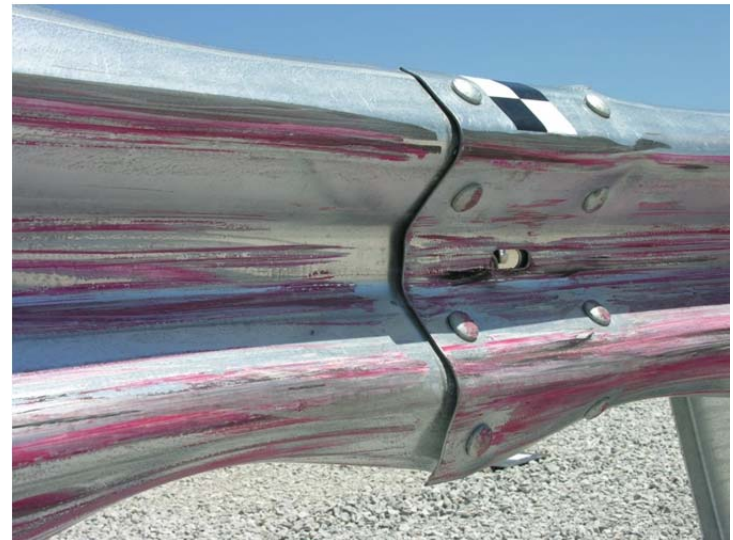
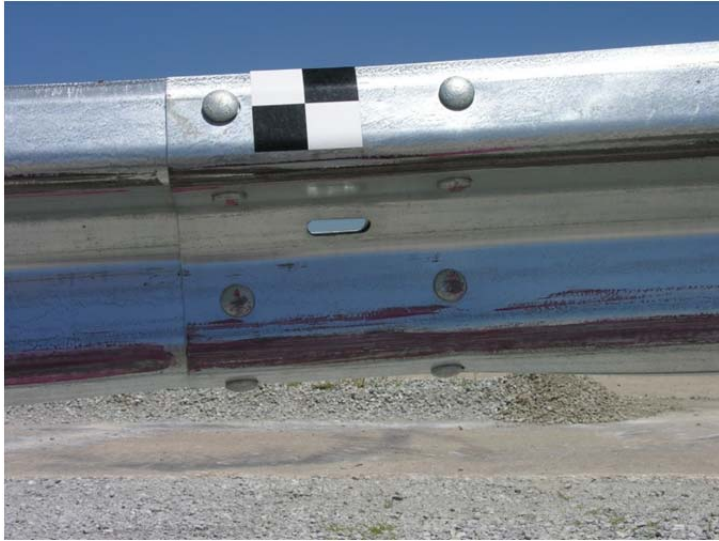
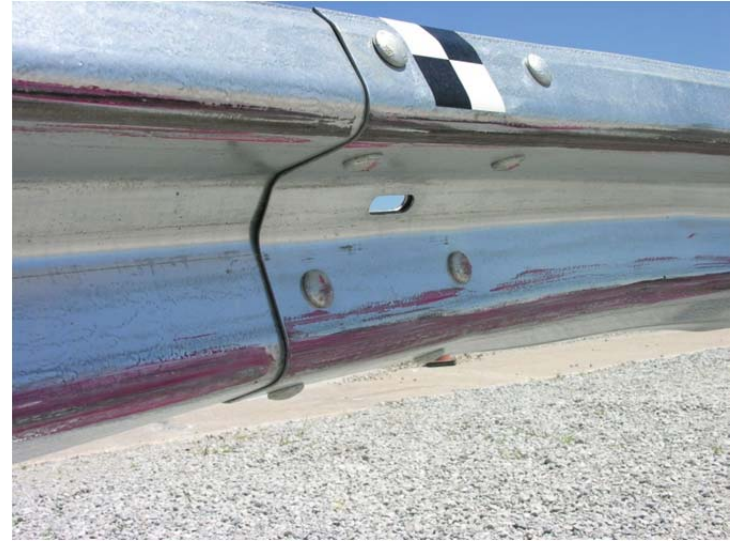
The post bolt pulled through the slots in the rail at post nos. 15 through 17. There was a $\frac{3}{4}$ -in. (19-mm) long tear in the bolt slot at post no. 15. There was a $2\frac{1}{4}$ -in. (57-mm) long tear and a $1\frac{1}{2}$ -in. (38-mm) long tear on the upstream and downstream sides, respectively, of the bolt slot on post no. 16. There was a $1\frac{1}{4}$ -in. (32-mm) long tear and a 1-in. (25-mm) long tear on the upstream and downstream sides, respectively, of the bolt slot on post no. 17. There was a $\frac{3}{8}$ -in. (10-mm) lateral separation between the W-beam sections in the splices between post nos. 12 and 13 and between post nos. 14 and 15. The splices between post nos. 14 and 15, 16 and 17, and 18 and 19 were extended $\frac{1}{8}$ in. (3 mm) longitudinally. The splice damage is shown in Figures 41 and 42.

Figure 41. Splice Damage, Test No. MGSMRH-1

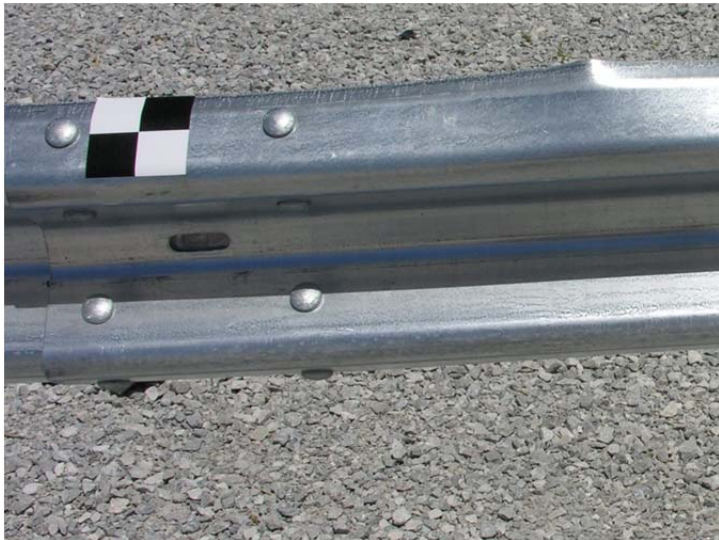
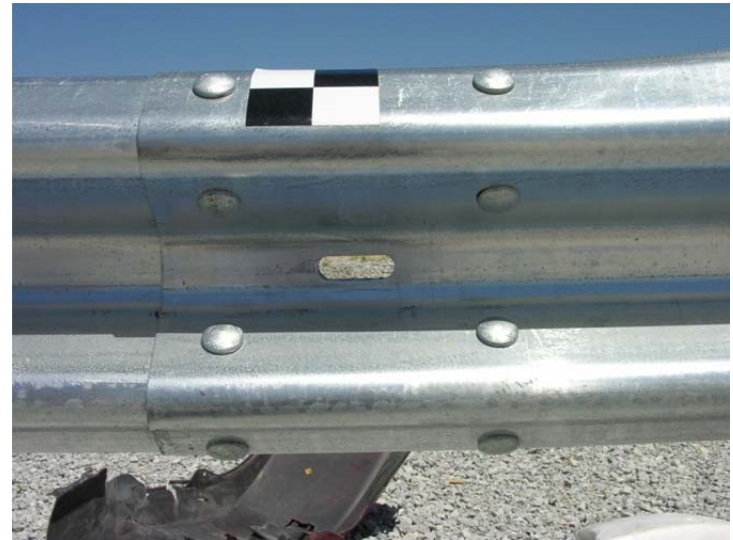
Figure 42. Splice Damage, Test No. MGSMRH-1

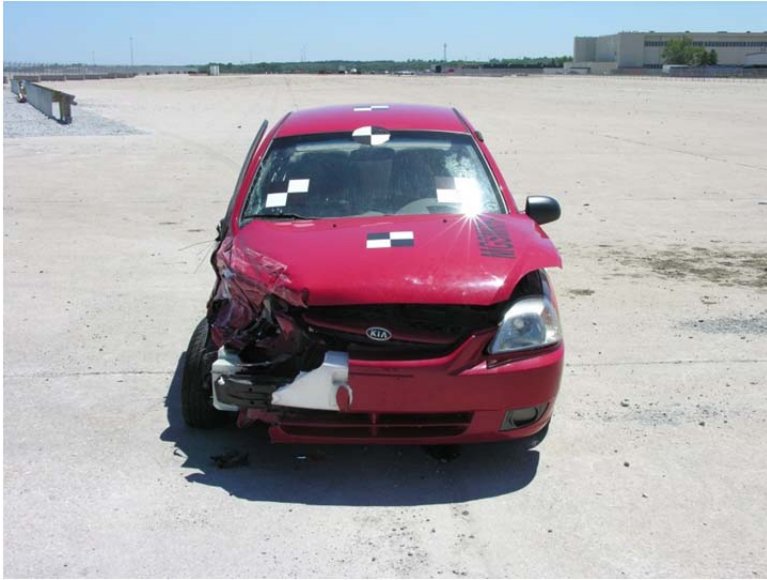
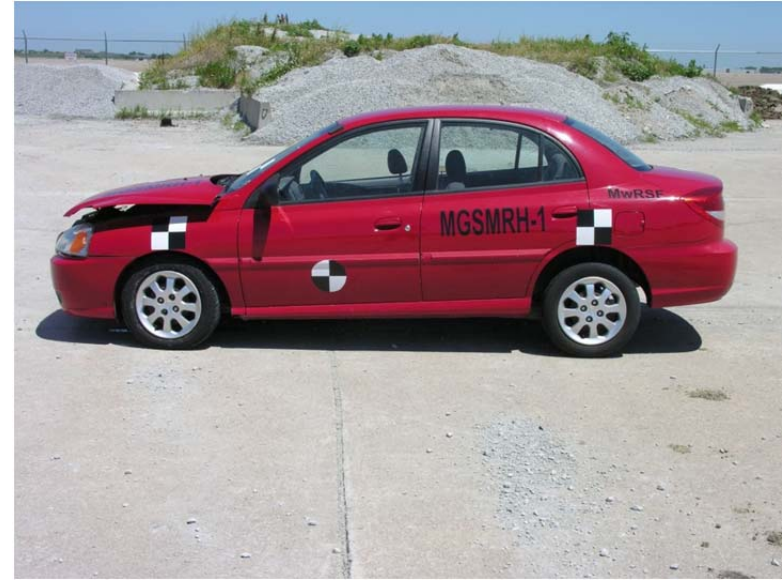
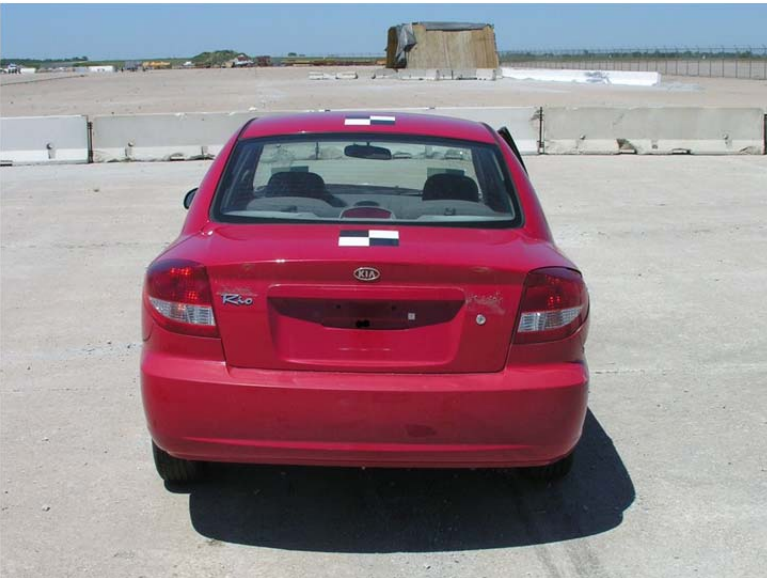
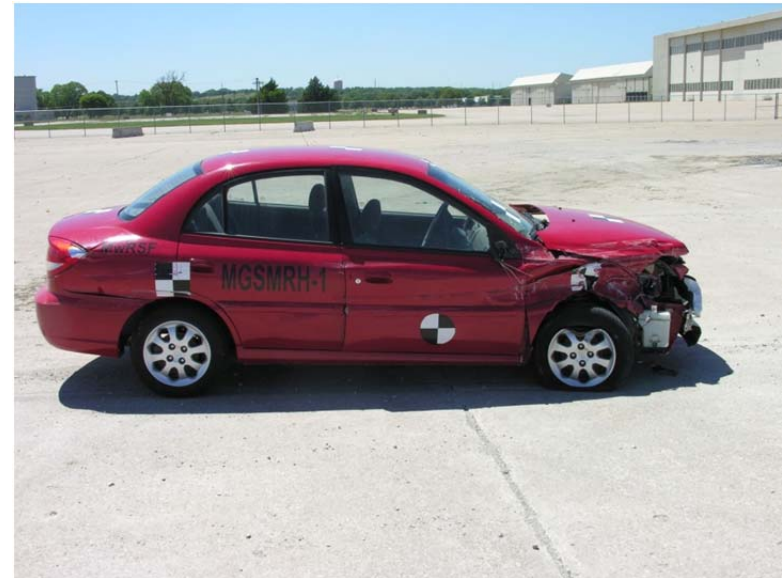
The damage to the vehicle was moderate, as shown in Figures 46 through 49. The maximum occupant compartment deformations are listed in Table 7 alongside the deformation limits established in MASH for various areas of the occupant compartment. It should be noted that none of the MASH established deformation limits were violated. Complete occupant compartment and vehicle deformations and the corresponding locations are provided in Appendix D.

Figure 46. Vehicle Damage, Test No. MGSMRH-1

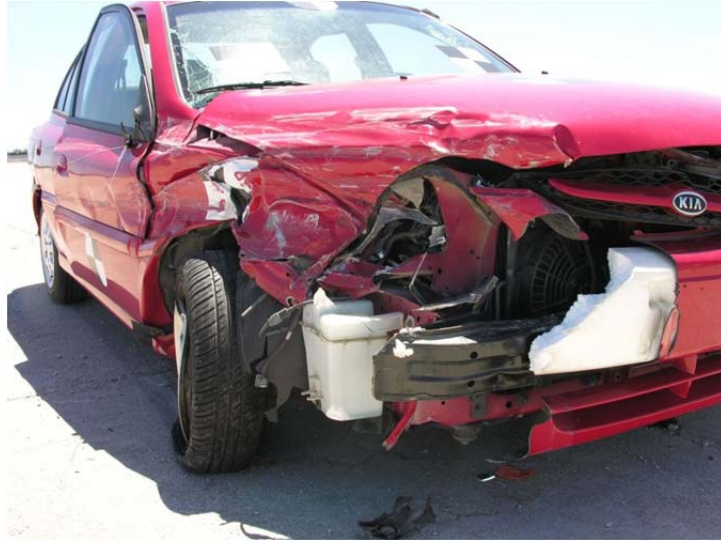
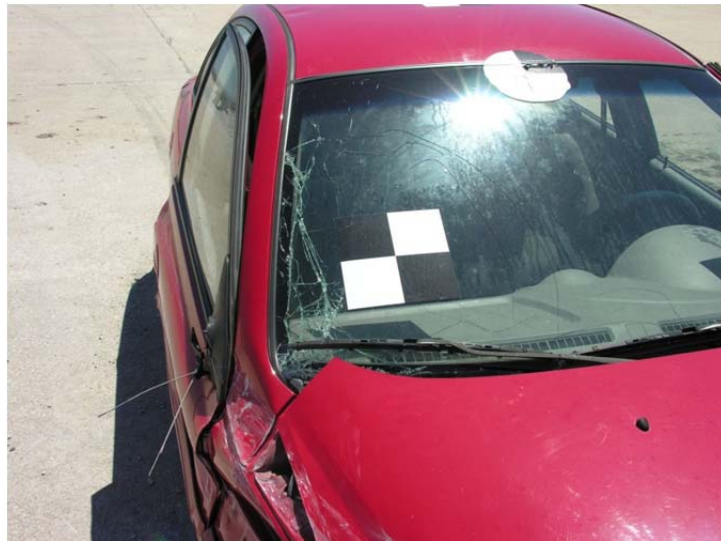
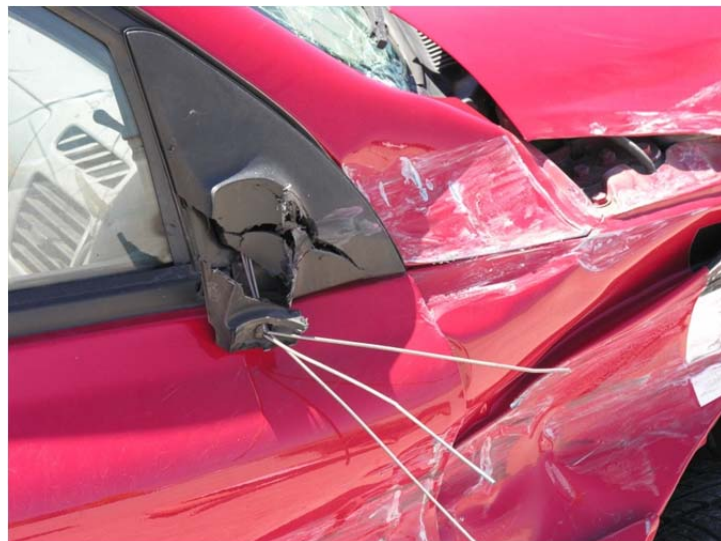
Figure 47. Vehicle Damage, Test No. MGSMRH-1

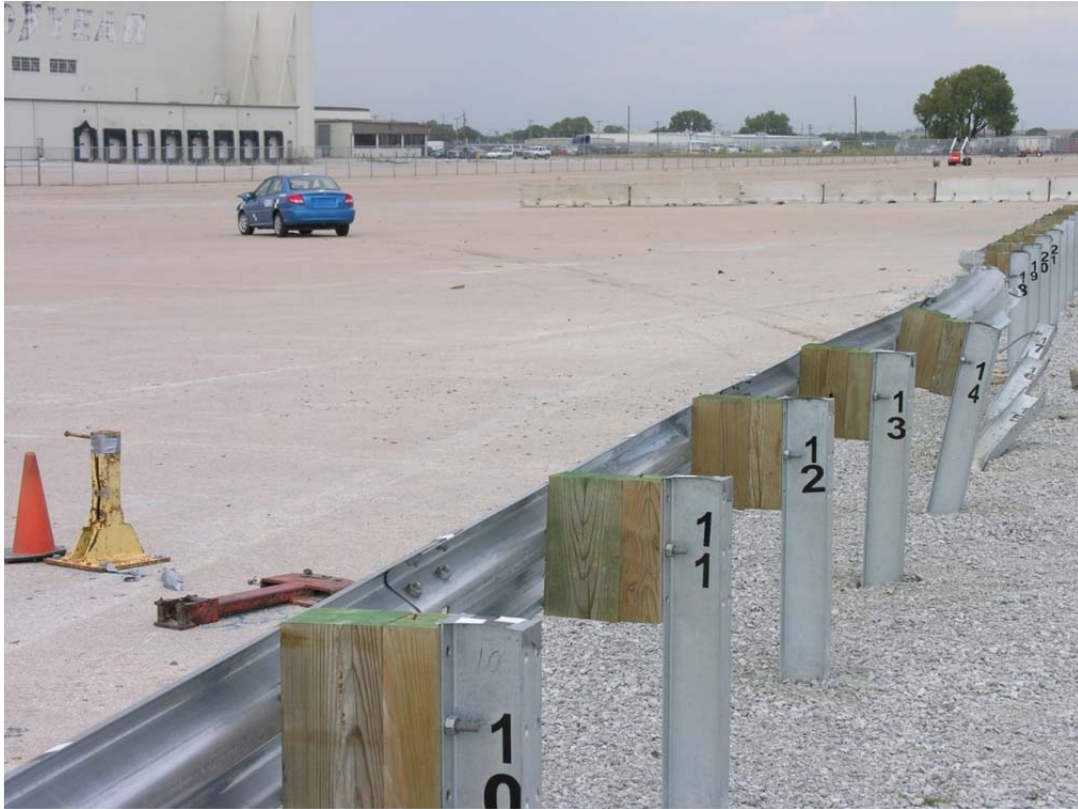
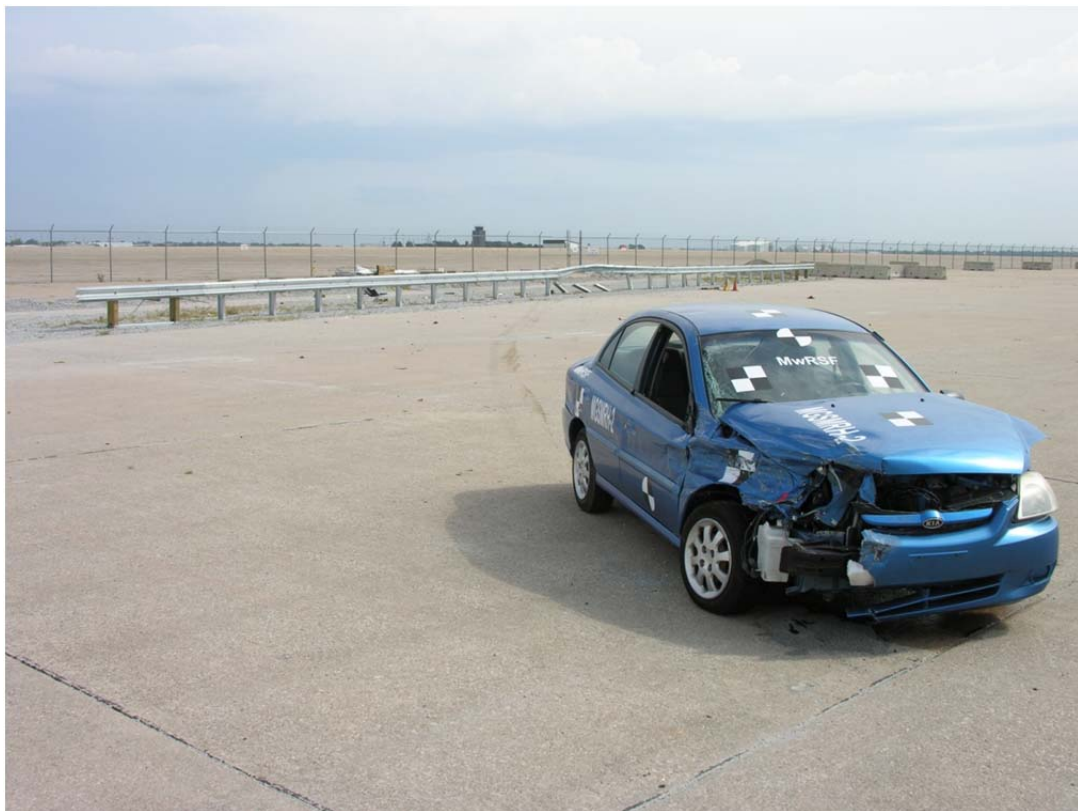
Initial vehicle impact was to occur 10 ft (3.0 m) upstream of the centerline of post no. 15, as shown in Figure 59, which was selected using the CIP plots found in Section 2.3 of MASH. The actual point of impact was 9 ft – 8 in. (2.9 m) upstream of post no. 15. A sequential description of the impact events is contained in Table 10. The vehicle came to rest facing downstream at 129 ft – 9 in. (39.5 m) downstream of the initial impact point and 61 ft – 1 in. (18.6 m) laterally away from the front of the rail. The vehicle trajectory and final position are shown in Figures 54 and 60.

Figure 60. Vehicle Final Position and Trajectory Marks, Test No. MGSMRH-2

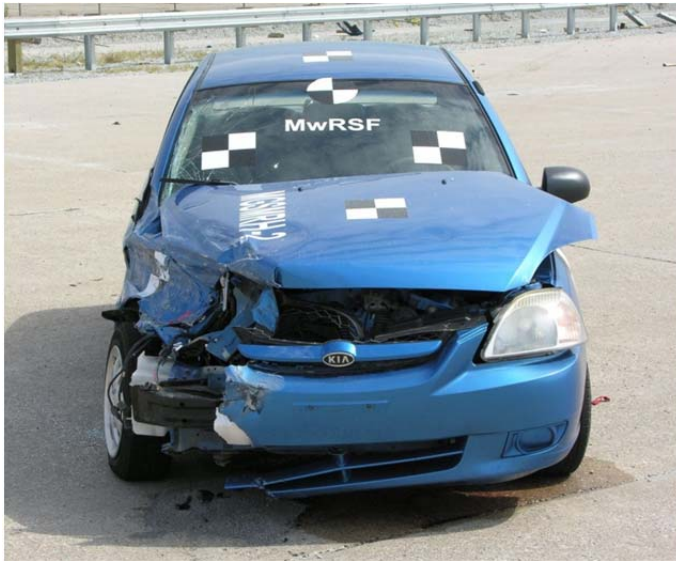
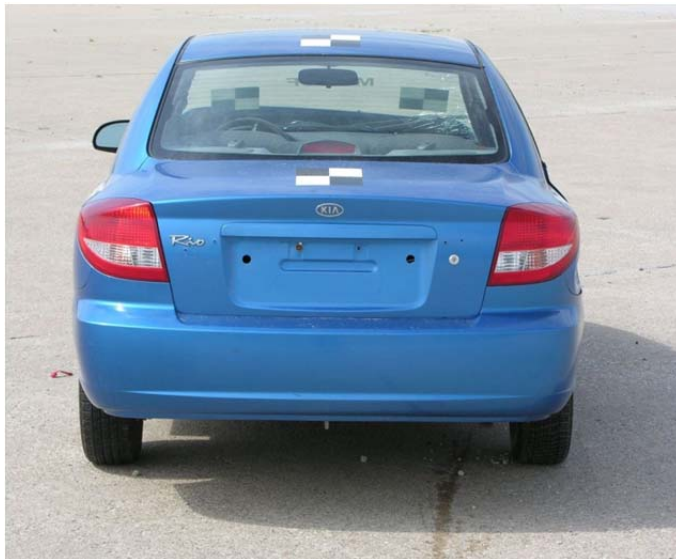
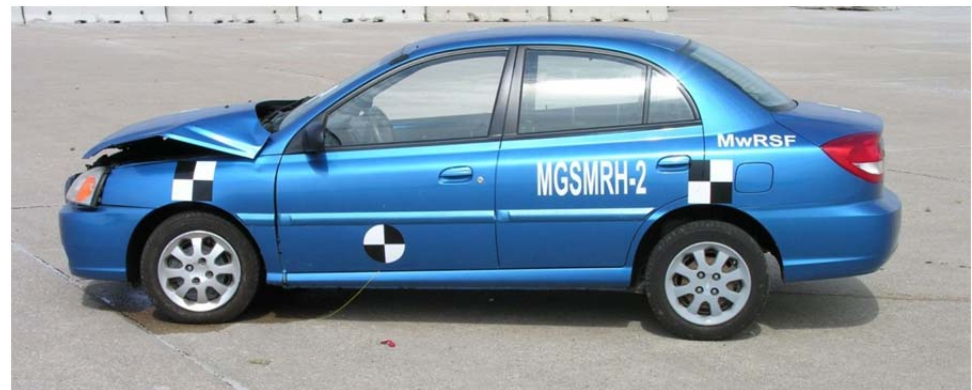
The damage to the vehicle was moderate, as shown in Figures 68 through 71. The maximum occupant compartment deformations are listed in Table 11 with the deformation limits established in MASH for various areas of the occupant compartment. It should be noted that none of the MASH established deformation limits were violated. Complete occupant compartment and vehicle deformations and the corresponding locations are provided in Appendix D.

Figure 68. Vehicle Damage, Test No. MGSMRH-2

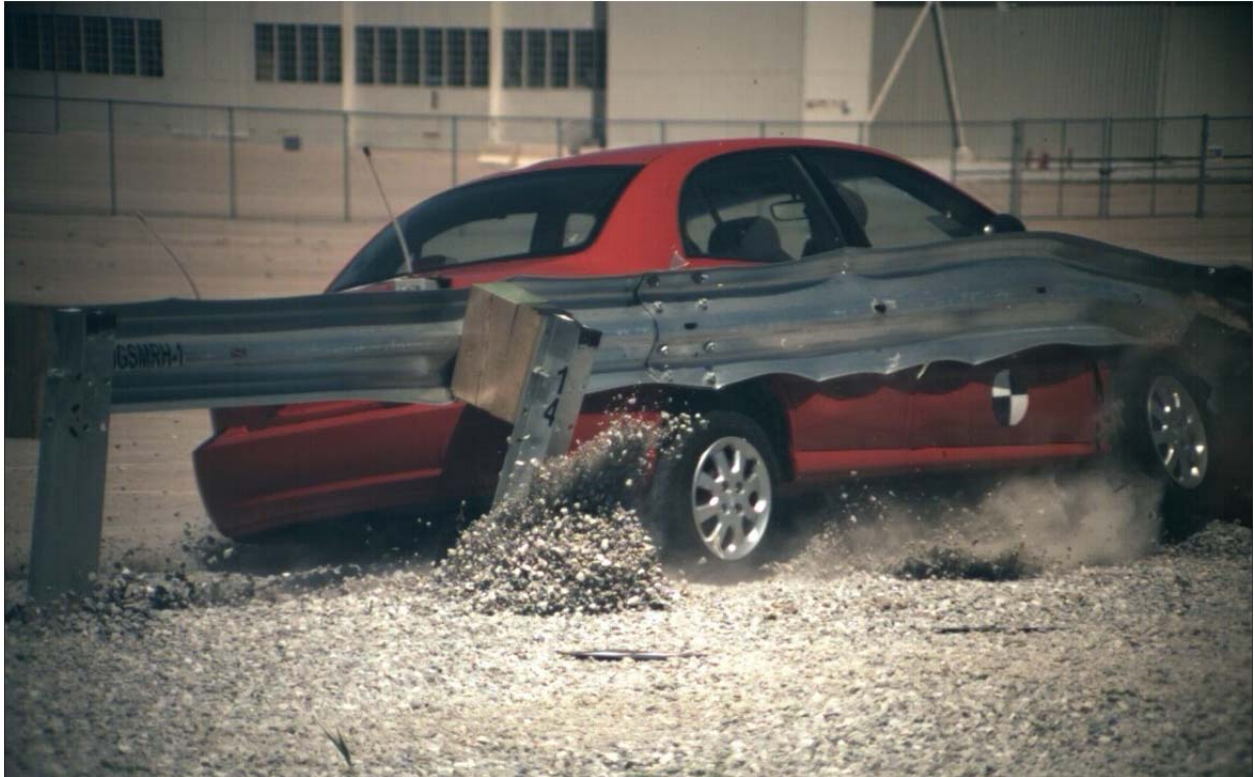
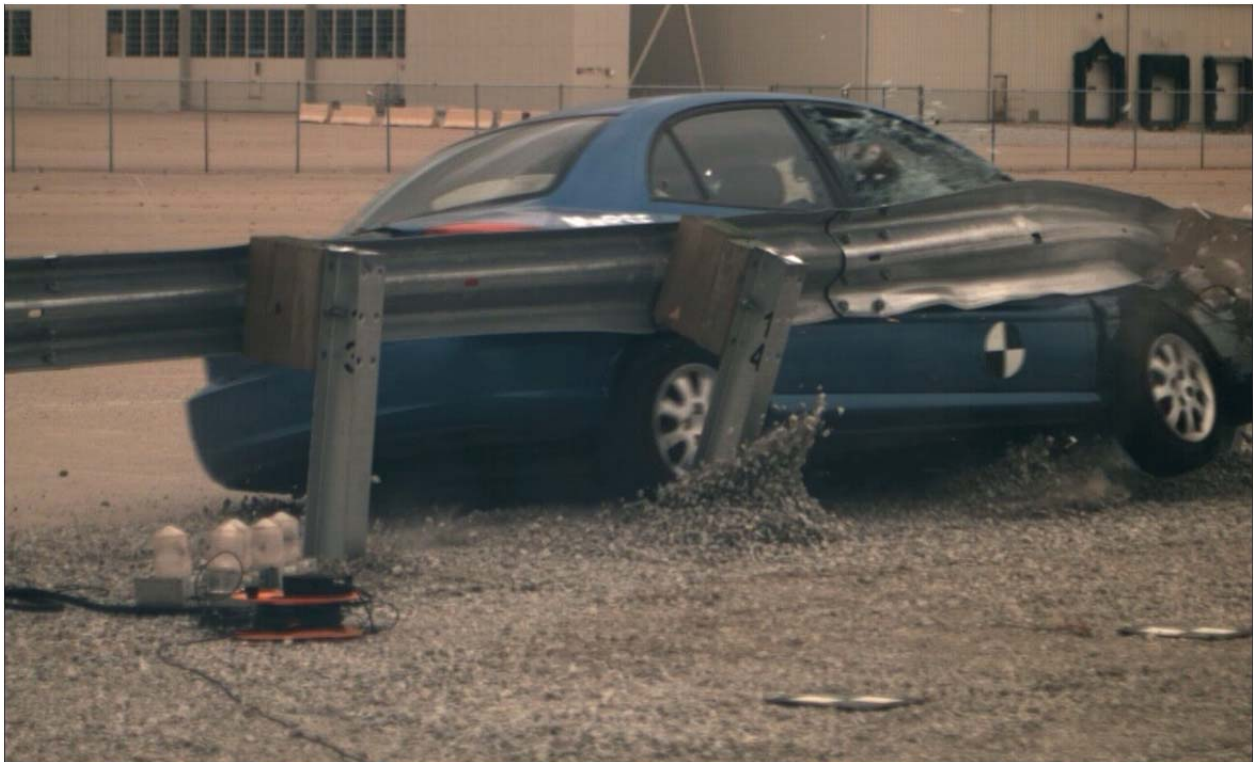
During redirection, the rail deflected upward as it released from the posts and slid up the side of the vehicle. The vehicle contacted the detached posts and overrode them, which caused the vehicle to pitch upward and roll away from the barrier, as shown in Figures 72 and 73. In both tests, the vehicle reached a maximum roll angle of about 11 degrees and pitched upward about 2 degrees. As the vehicle rolled away from the barrier, the right side of the vehicle that was in contact with the rail moved upward. As a consequence, the rail slid up the vehicle, contacted the base of the A-pillar, and did not slide any higher. At this same time, the rail was applying a downward force on the vehicle which counteracted the vehicle roll.

Figure 72. Vehicle-to-Rail Interaction
