MASH EVALUATION OF TxDOT ROADSIDE SAFETY FEATURES – PHASE I

Test Report 0-6946-1

TEXAS A&M TRANSPORTATION INSTITUTE
COLLEGE STATION, TEXAS

1. Report No. FHWA/TX-17/0-6946-1		2. Government Accession No.		3. Recipient's Catalog No.	
4. Title and Subtitle MASH EVALUATION OF TXDOT ROADSIDE SAFETY FEATURES – PHASE I				5. Report Date Published: January 2018

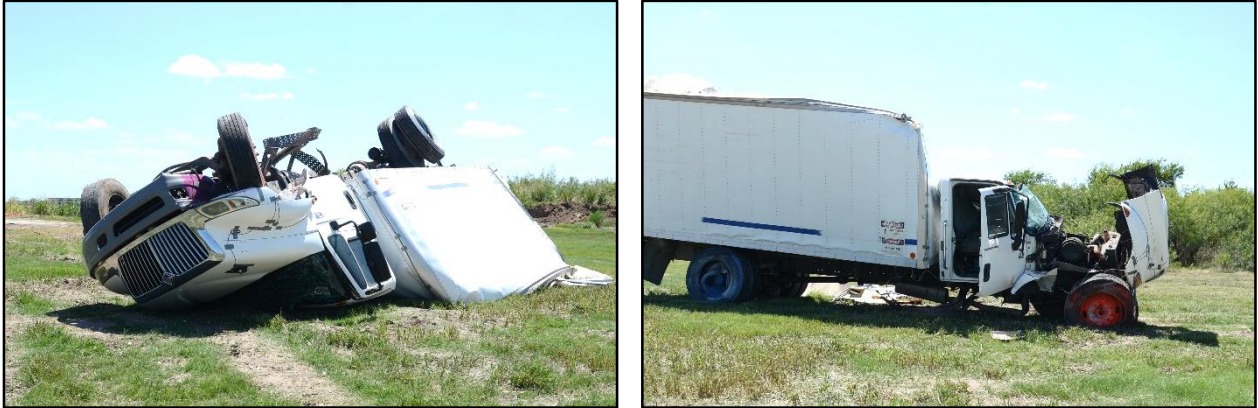
Figure 2.7. Test Vehicle after Test No. 469467-1-1.

Figure 2.7 shows the damage sustained by the test vehicle. The front bumper, hood, right front springs and U-bolts, right front tire and rim, right fuel tank, right side steps, right front door, right rear outer tire and rim, right front corner of the box, and right frame rail. Damage due to the vehicle roll included the cab, windshield, left door, left side of the box, left front springs and U-bolts, hood, and rear door of the box. Maximum exterior crush to the vehicle was 18.0 inches in the side plane at the right front corner at bumper height. No occupant compartment deformation or intrusion occurred. Figure 2.8 shows the interior of the vehicle.

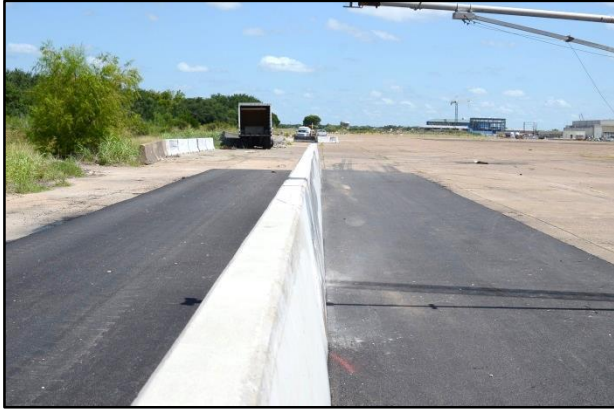
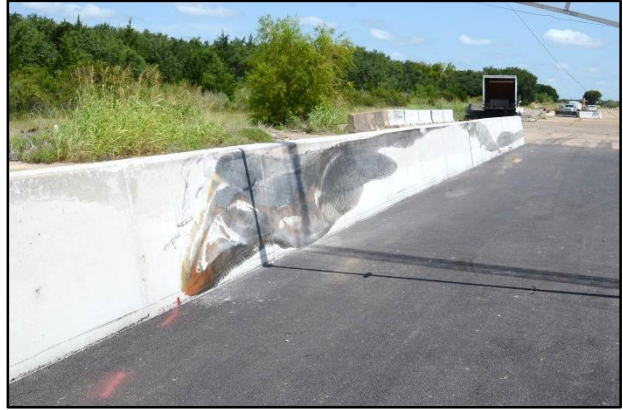
Figure 3.5. TxDOT 42-inch Tall SSCB with 1-inch ACP and Test Vehicle after Test No. 469467-3-1.

Figures 3.5 and 3.6 show the damage to the TxDOT 42-inch tall SSCB with 1-inch ACP Overlay. Cosmetic damage and surface gouging was evident on the traffic face in the impact area and where the vehicle rode off the end of the barrier. Working width was 72.8 inches at a height of 12.9 ft. Dynamic deflection was not measureable during the test due to the vehicle obstructing the view. No measureable permanent deformation was noted.

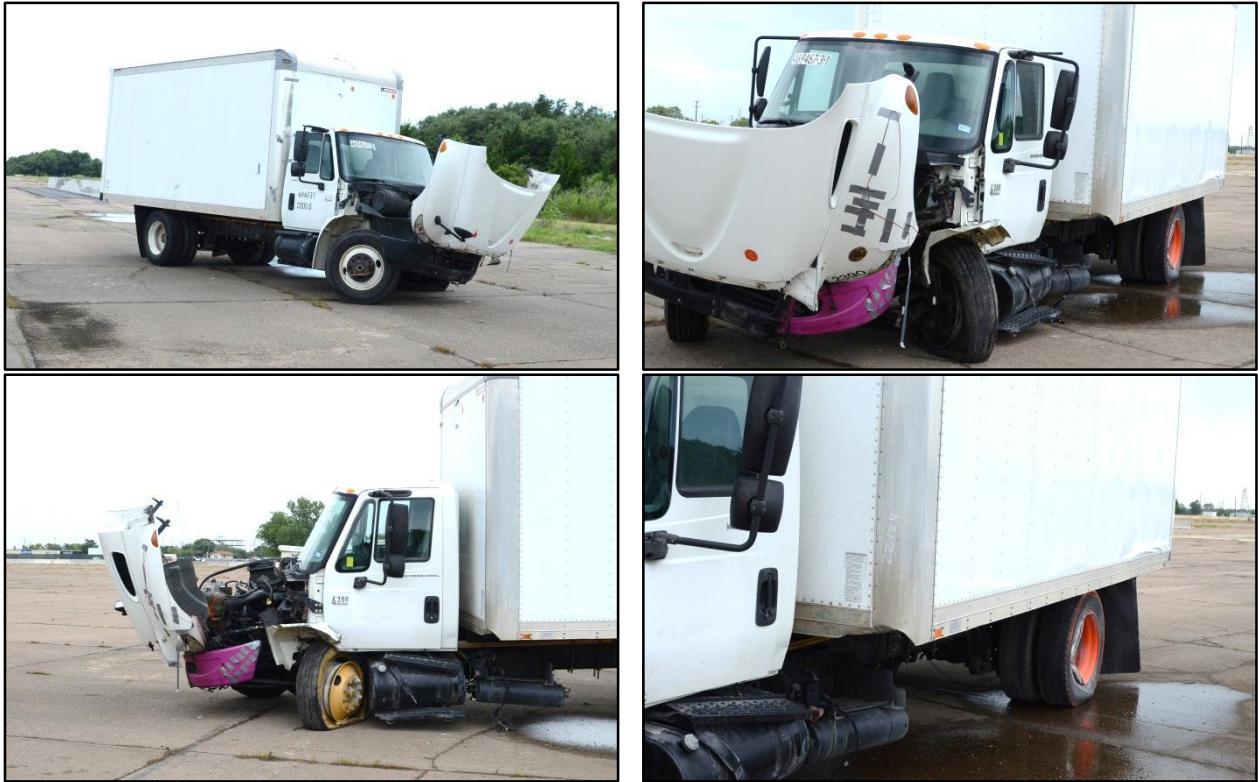
Figure 3.7. Test Vehicle after Test No. 469467-3-1.

Figure 3.7 shows the damage sustained by the test vehicle. The front bumper, hood, left front fender, left front tire and rim, left axle, left front springs, left front U-bolts, left door, left fuel tank and side steps, left front corner of the box, left side of lower box, left outer tire and rim, drive shaft, left battery box, and rear air bags were damaged. Maximum exterior crush to the vehicle was 14.0 inches in the front plane at the left front corner at bumper height. No occupant compartment deformation or intrusion was noted. Figure 3.8 shows the interior of the vehicle.

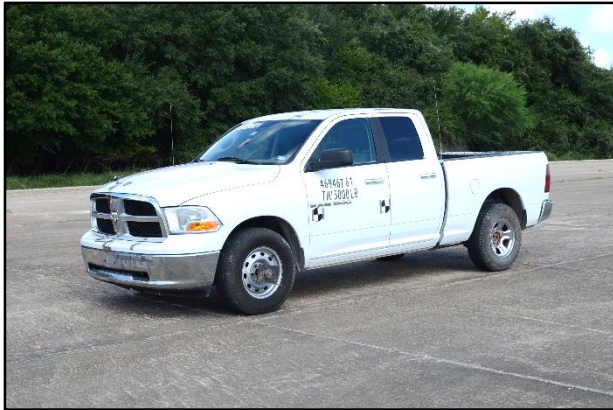
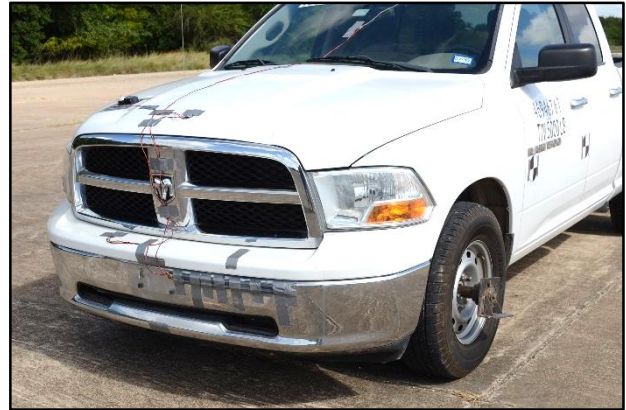
Figure 5.6. Test Vehicle after Test No. 469467-6-1.

Figure 5.6 shows damage sustained by the vehicle. The front bumper and hood had a small dent at the quarter point. Maximum exterior crush to the vehicle was not measureable in the front plane at the left quarter point at bumper height. No occupant compartment deformation or intrusion was noted. Figure 5.7 shows the interior of the vehicle. Table D.3 in Appendix D.1 provides occupant compartment measurements.

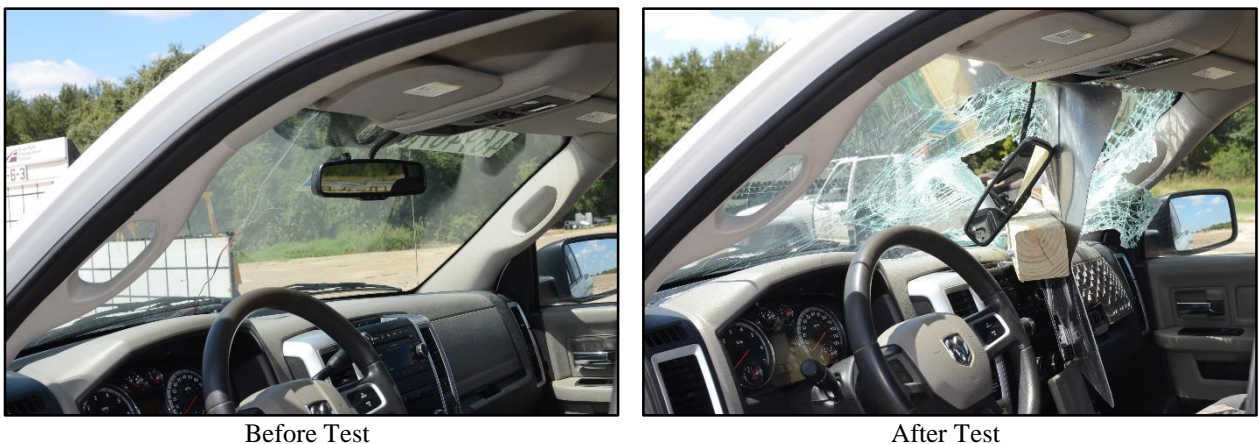
Figure 5.15. Interior of Test Vehicle for Test No. 469467-6-3.

Figure 5.14 shows damage sustained by the vehicle. The front bumper and hood had a small dent at the quarter point. The sign panel and support tore a 20 × 20-inch hole in the windshield just left of centerline. The sign panel and support also caused damage to the instrument panel, glove box, and roof. Maximum exterior crush to the vehicle was not measureable in the front plane at the left quarter point at bumper height. Penetration of the windshield occurred. Figure 5.15 shows the interior of the vehicle. Table D.6 in Appendix D.2 provides occupant compartment measurements.

The TxDOT single embedded wood post sign system for 90° impact fractured as designed. An 80-inch section of wood post and the sign panel penetrated through the windshield. The 2270P vehicle remained upright during and after the collision event. Maximum roll and pitch angles were 2.8° and 3.2°, respectively. No occupant contact occurred. The 2270P vehicle came to rest 355 ft downstream of impact.

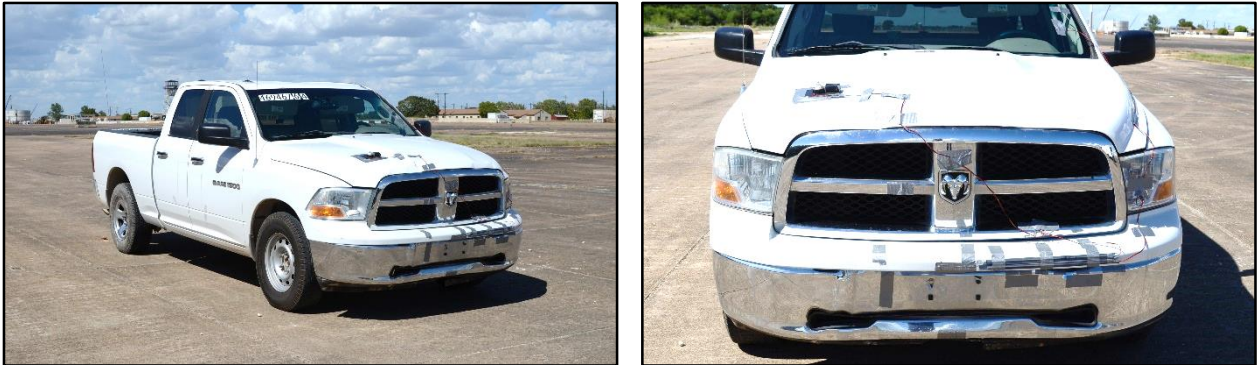
Figure 5.22. Test Vehicle after Test No. 469467-6-4.

Figures 5.22 and 5.23 show damage sustained by the vehicle. The front bumper and hood had small dents at the left quarter point and to the right of centerline. The exterior roof was depressed over an area of 50 inches \times 50 inches had a maximum depth of 3.0 inches. Maximum occupant compartment deformation was 3.0 inches in the center of the roof. Figure 5.24 shows

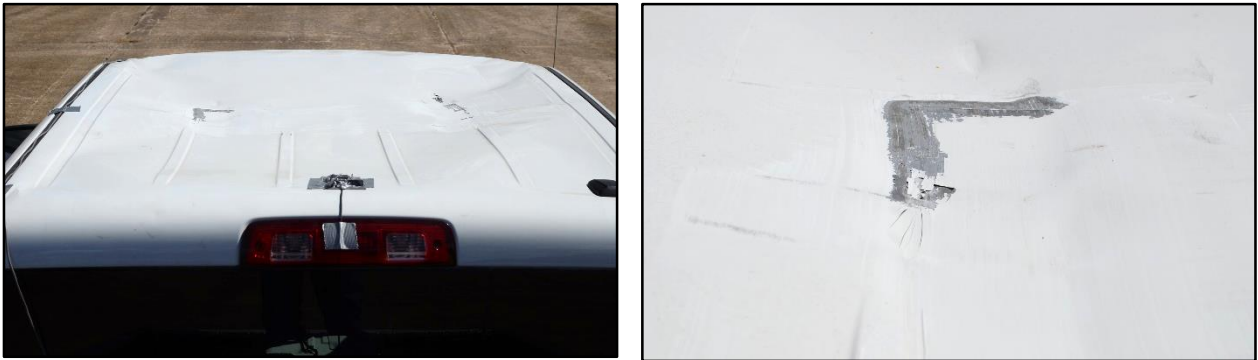
Figure 5.23. Test Vehicle Roof Damage after Test No. 469467-6-4.

The supports fractured in two locations (near ground level and at bumper height). The sign panel and fractured support posts rotated toward the vehicle and impacted the roof. Roof deformation was within the limits recommended in *MASH*. The TxDOT dual embedded wood post sign system performed acceptably for *MASH* Test 3-62 at 0°.

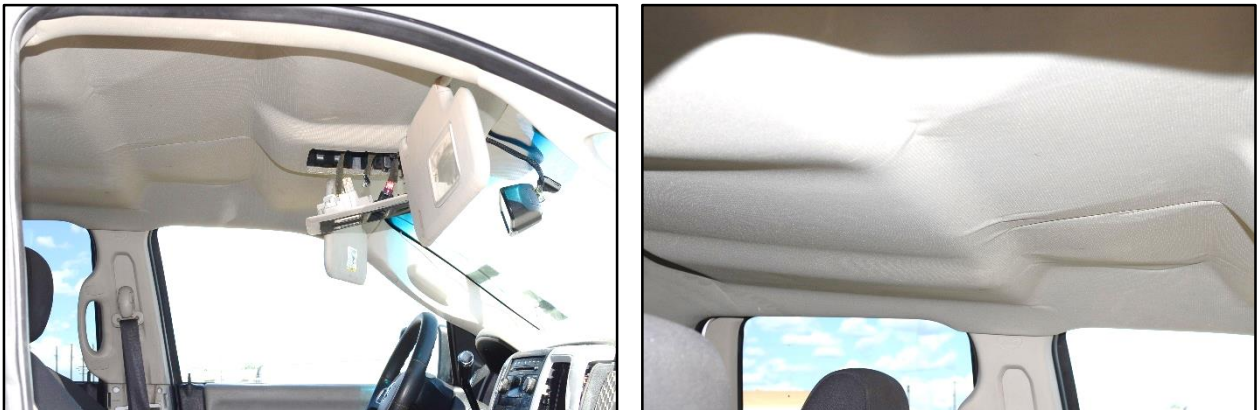
Figure 5.24. Interior of Test Vehicle after Test No. 469467-6-4.

the interior of the vehicle. Table D.9 in Appendix D.3 provides occupant compartment measurements.

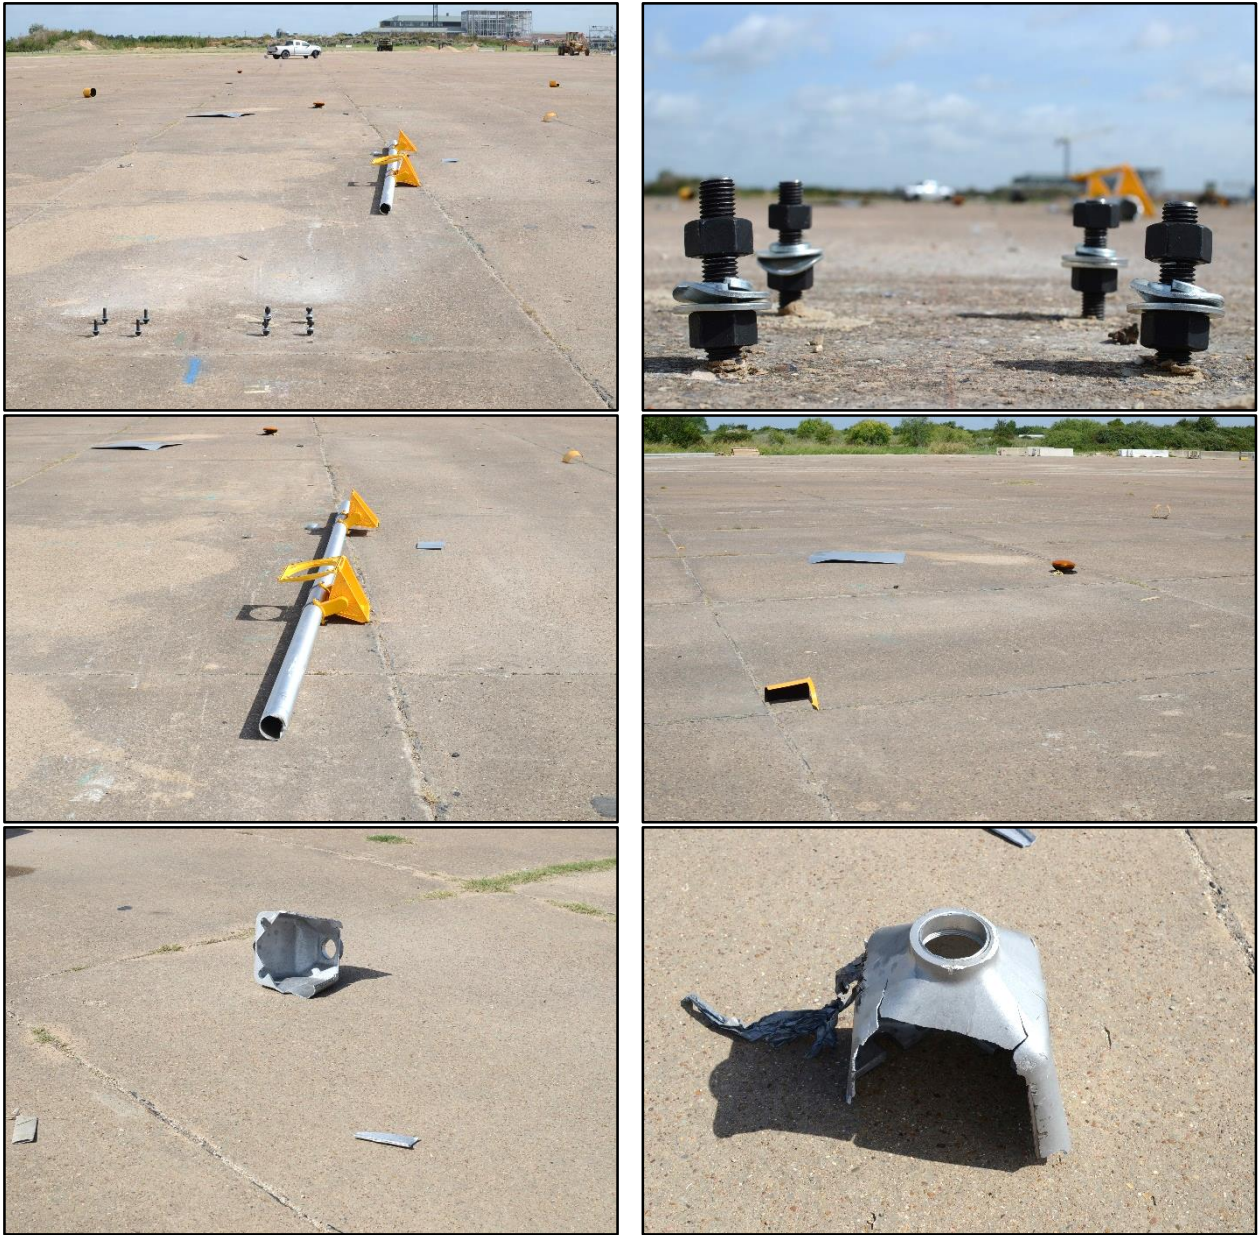
Figure 6.5. TxDOT Pedestal Pole with Beacons without Solar Assembly after Test No. 469467-7-1.

Figure 6.5 shows the damage to the TxDOT pedestal pole with beacons without solar assembly. The breakaway base fractured and released from the anchor bolts and pole. The anchor bolts on the impact side were deformed. The pole was resting 20 ft downstream of impact and 5 ft to the left of centerline. The sign panel detached from the pole after contact with the ground and was resting 51 ft downstream of impact and 6 ft to the left. One of the beacons was resting 58 ft downstream of impact, and the other was resting 150 ft downstream of impact and 10 ft to the left.

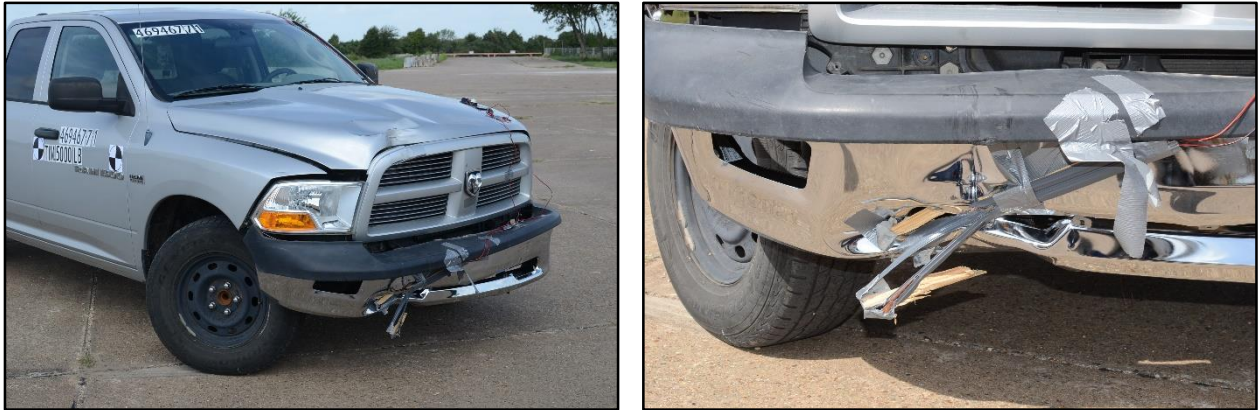
Figure 6.6. Test Vehicle after Test No. 469467-7-1.

Figure 6.6 shows the damage sustained by the vehicle. The front bumper, right bumper bracket, hood, and grill were deformed. Maximum exterior crush to the vehicle was 6.5 inches in the front plane at the right front quarter point at bumper height. No occupant compartment deformation or intrusion occurred. Figure 6.7 shows the interior of the vehicle. Tables E.3 and E.4 in Appendix E.2 provide exterior crush and occupant compartment measurements.

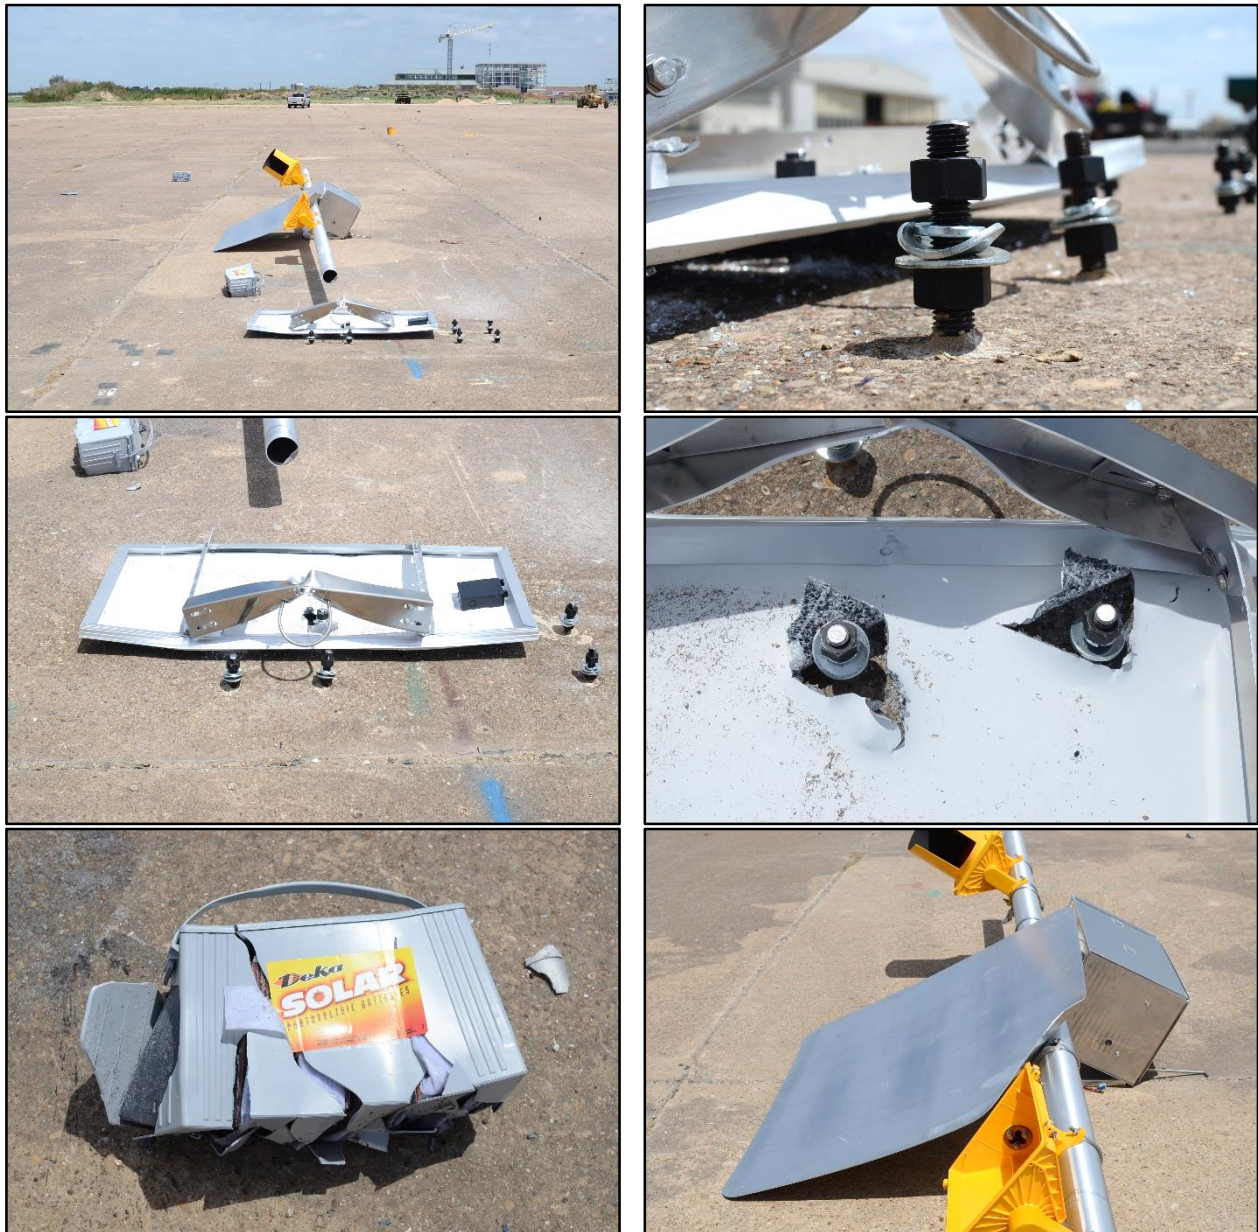
Figure 6.13. TxDOT Pedestal Pole with Beacons and Solar Assembly after Test No. 469467-7-2.

Figure 6.13 shows the damage to the TxDOT pedestal pole with beacon and solar assembly. The base of the pole fractured and released from the anchor bolts and pole. The anchor bolts on the impact side were deformed. The solar panel released from the pole and came to rest near the point of impact. The pole with top beacon, battery box, sign panel, and part of the lower beacon still attached was resting 10 ft downstream of impact. Both batteries released from the battery box; one was resting 5 ft downstream of impact and one was resting 36 ft downstream and 7 ft to the left of centerline. The broken lower beacon was resting 265 ft downstream and 26 ft to the right of centerline. The base lodged beneath the left front A-frame of the vehicle and rode along with the vehicle where it came to rest 377 ft downstream and 7 ft to the left of centerline.

The TxDOT Pedestal Pole with Beacons and Solar Assembly yielded to the 2270P vehicle as designed by fracturing at the base. None of the detached fragments penetrated or showed potential for penetrating the occupant compartment or to present hazard to others in the area. No occupant compartment deformation or intrusion occurred. The 2270P vehicle remained upright during and after the collision event. Maximum roll and pitch angles were both 2°. Occupant risk factors were within the preferred limits of *MASH*. The 2270P vehicle came to rest 377 ft downstream of impact.

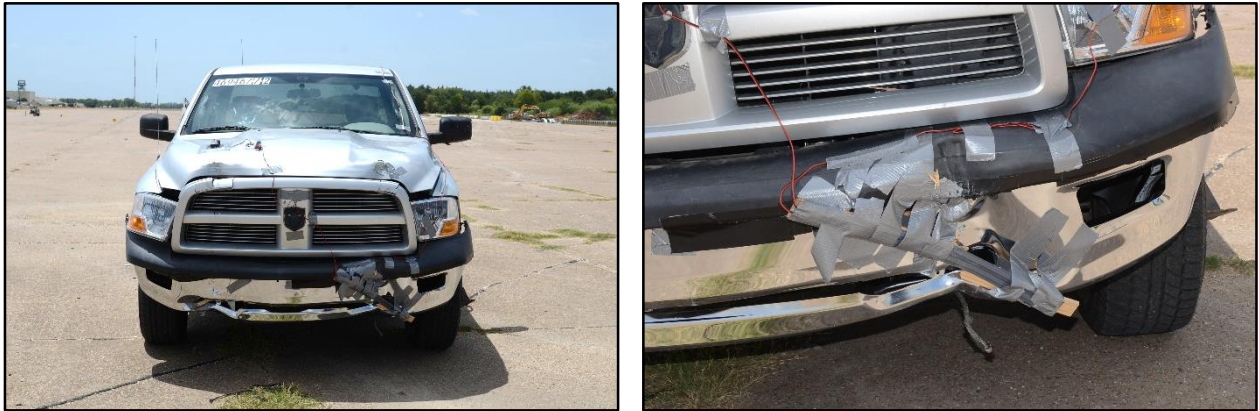
Figure 6.14. Test Vehicle after Test No. 469467-7-2.

Figure 6.14 shows the damage sustained by the vehicle. The front bumper, left bumper bracket, hood, and grill were deformed. Maximum exterior crush to the vehicle was 6.5 inches in the front plane at the left front quarter point at bumper height. No occupant compartment deformation or intrusion occurred. Figure 6.15 shows the interior of the vehicle. Tables E.7 and E.8 in Appendix E.3 provide exterior crush and occupant compartment measurements.

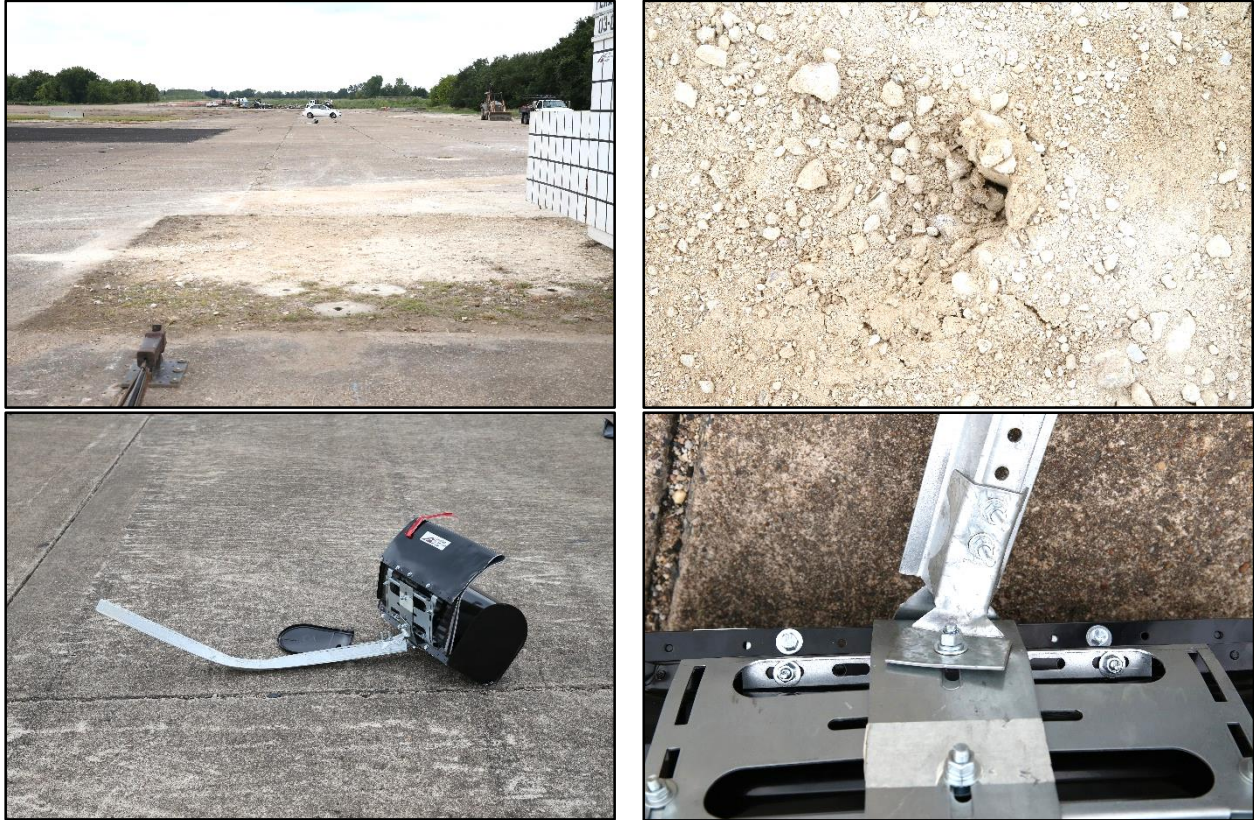
Figure 7.6. TxDOT Double Mailbox System on Winged Channel Post with Type 3 Foundation after Test No. 469467-8-4.

Figure 7.6 shows the damage to the TxDOT mailbox system on winged channel post with type 3 foundation. The mailbox support fractured 3 inches below grade. The mailboxes (minus the doors) remained attached to the mailbox support and came to rest 188 ft downstream of impact.

The TxDOT double mailbox system on winged channel post with type 3 foundation fractured and released as designed. The mailboxes and support contacted the hood of the vehicle and then rotated up and over the vehicle without any secondary contact with the windshield. None of the detached fragments penetrated or showed potential for penetrating the occupant compartment or to present hazard to others in the area. No occupant compartment deformation or intrusion occurred. The 1100C vehicle remained upright during and after the collision event. Maximum roll and pitch angles were 1.2° and 2.0°, respectively. No occupant contact occurred. The 1100C vehicle came to rest 270 ft downstream of impact.

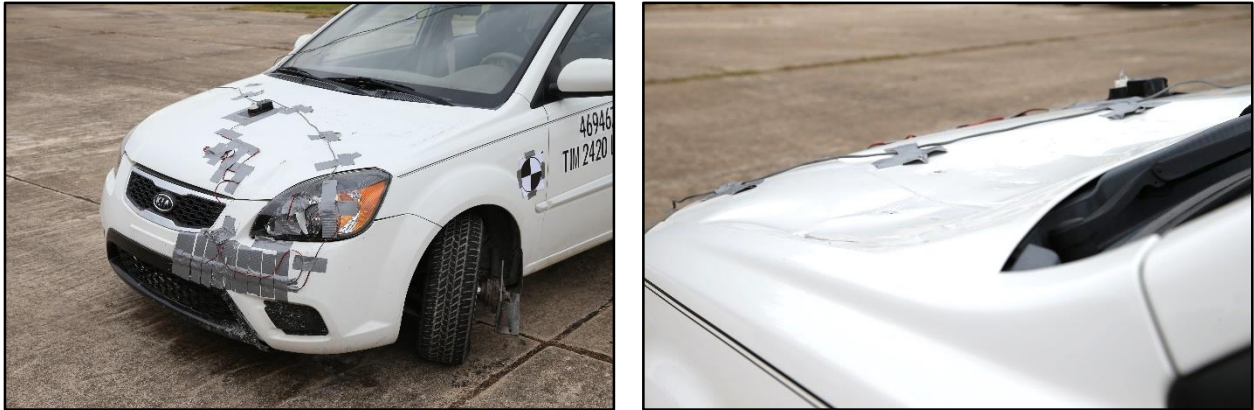
Figure 7.7. Test Vehicle after Test No. 469467-8-4.

Figure 7.7 shows damage sustained by the vehicle. The front bumper and hood had a small dent at the left quarter point. The left side of the hood was depressed downward 1.25 inches over an area 24 inches wide \times 20 inches long. Maximum exterior crush to the vehicle was 1.25 inches on the hood. No occupant compartment deformation or intrusion was noted. Figure 7.8 shows the interior of the vehicle. Table F.2 in Appendix F.2 provides occupant compartment measurements.

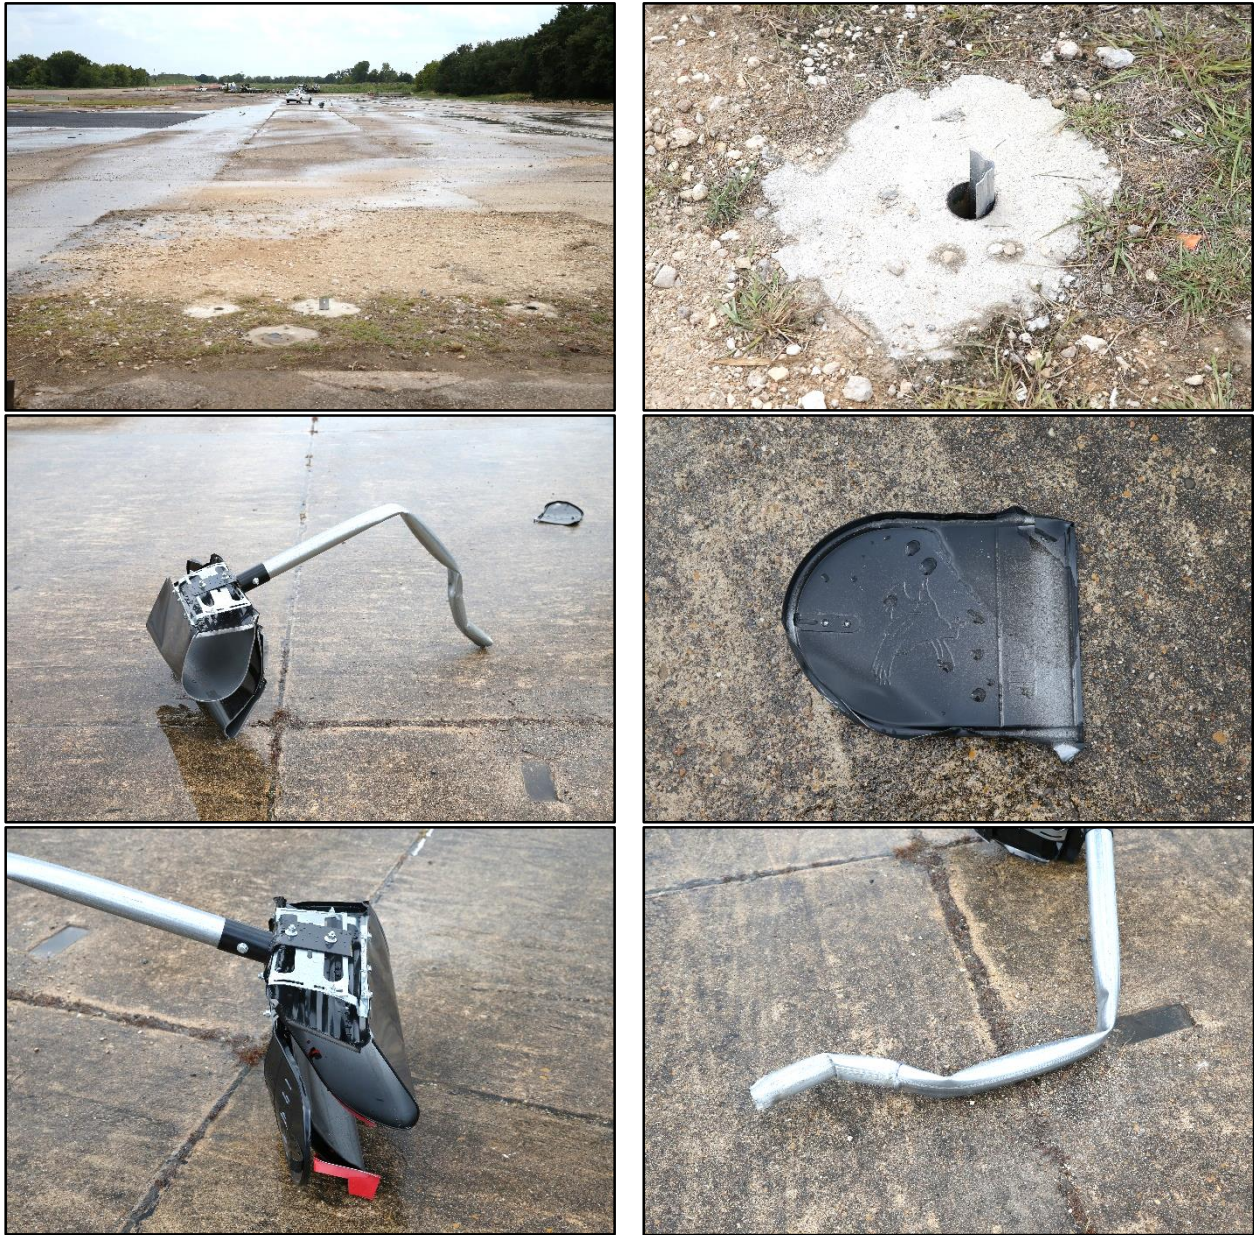
Figure 7.14. TxDOT Double Mailbox System on Thin-Walled Galvanized Tube with Type 2 Foundation after Test No. 469467-8-3.

Figure 7.14 shows the damage to the TxDOT double mailbox system on thin-walled galvanized tube with type 2 foundation. The mailbox support pulled out of the ground socket. The mailboxes (minus one door) came to rest 206 ft downstream and 8 ft to the right of centerline.

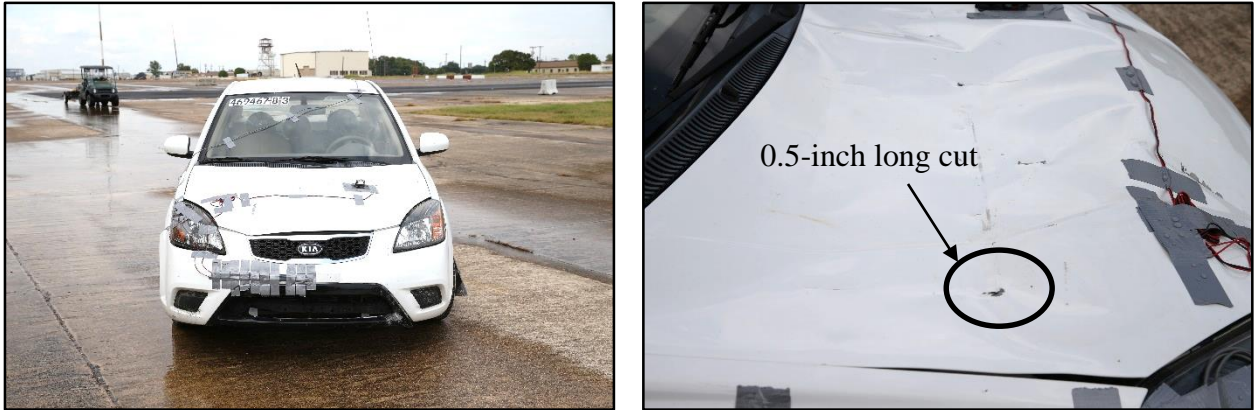
Figure 7.15. Test Vehicle after Test No. 469467-8-3.

Figure 7.15 shows damage sustained by the vehicle. The front bumper and hood had a small dent at the right quarter point. The right side of the hood was depressed downward 2.25 inches over an area 30 inches × 30 inches. Maximum exterior crush to the vehicle was 2.25 inches on the hood. A 0.5-inch cut was also noted in the depressed area. No occupant compartment deformation or intrusion was noted. Figure 7.16 shows the interior of the vehicle. Table F.4 in Appendix F.2 provides occupant compartment measurements.

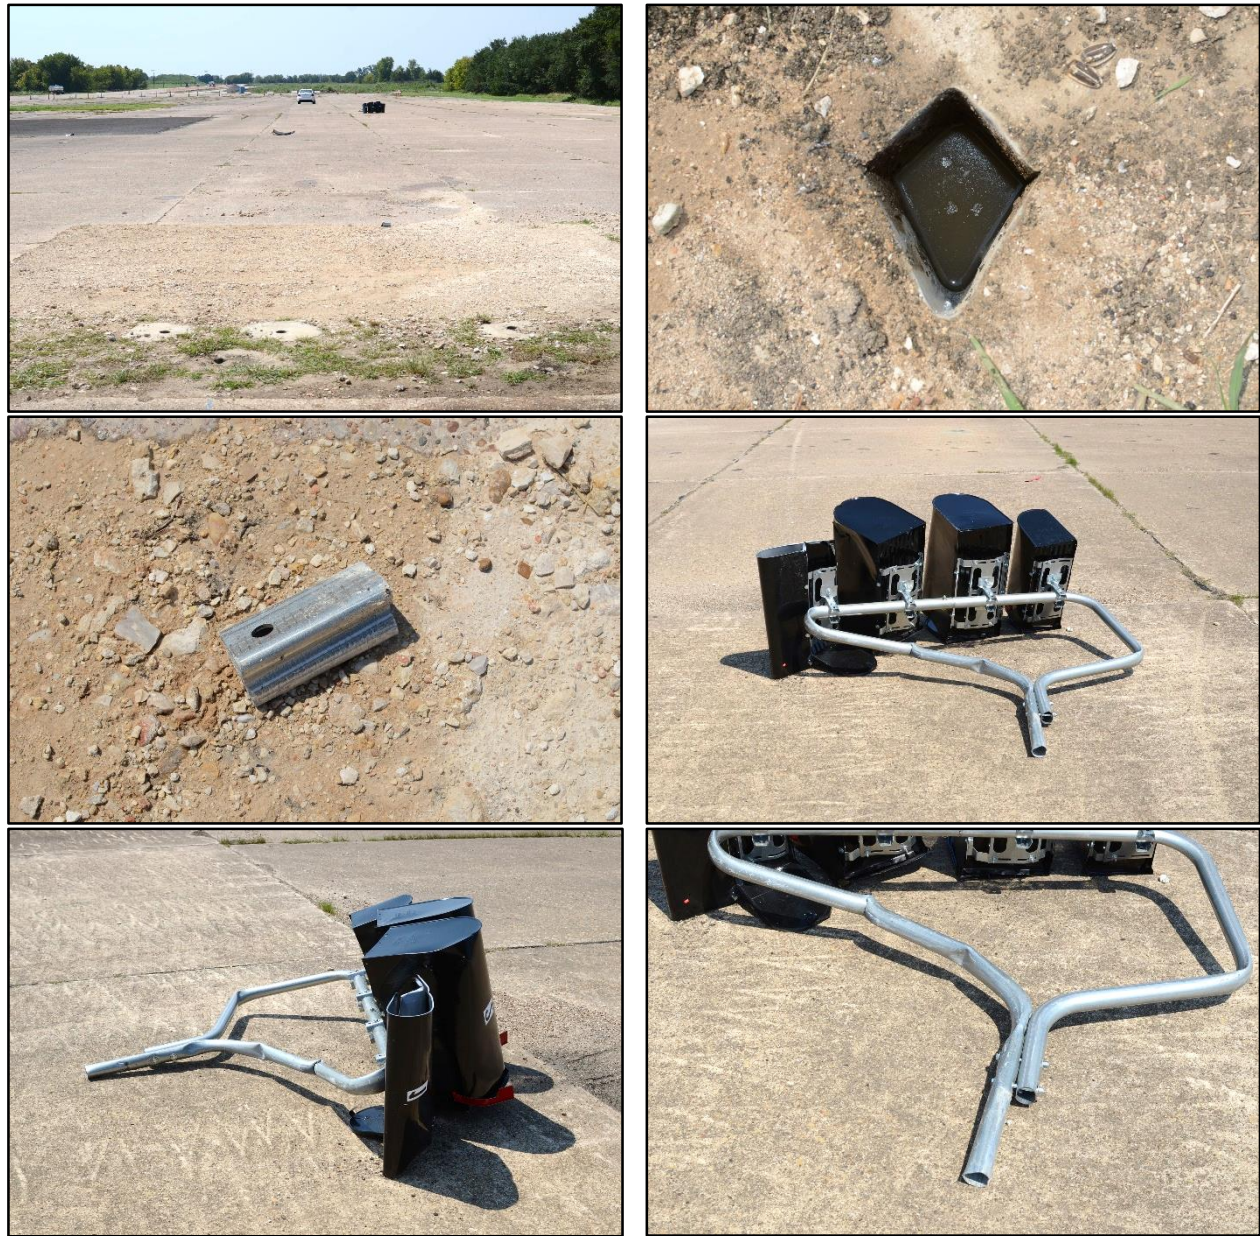
Figure 7.22. TxDOT Multiple Mailbox System on 56-inch Hanger-Type Thin-Walled Galvanized Tube with Type 1 Foundation after Test No. 469467-8-2.

Figure 7.22 shows the damage to the TxDOT multiple mailbox system on 56-inch hanger-type thin-walled galvanized tube with type 1 foundation. The mailbox assembly remained intact and the support post pulled out of the socket. The mailbox assembly came to rest 164 ft downstream of impact and 9 ft to the right of centerline.

The TxDOT multiple mailbox system on 56-inch hanger-type thin-walled galvanized tube with type 1 foundation yielded to the vehicle by pulling out of the foundation socket as designed. None of the detached pieces penetrated or showed potential for penetrating the occupant compartment or to present hazard to others in the area. Maximum occupant compartment deformation was 1.7 inches in the left windshield area. The 1100C vehicle remained upright during and after the collision event. Maximum roll and pitch angles were 1.2° and 0.7°, respectively. No occupant contact occurred. The 1100C vehicle came to rest 297 ft downstream of impact.

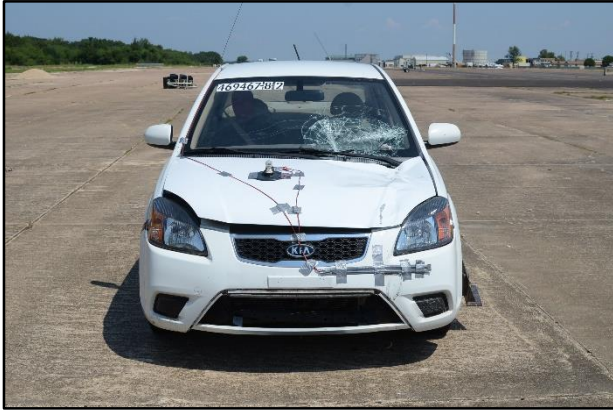
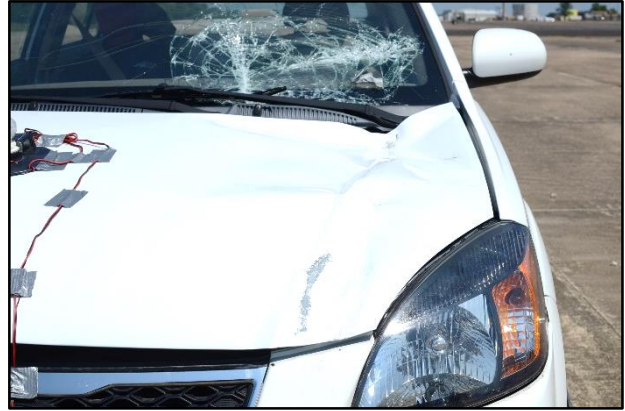
Figure 7.23. Test Vehicle after Test No. 469467-8-2.

Figures 7.23 and 7.24 show damage sustained by the vehicle. The front bumper and hood had small dents at the left quarter point. The top of the hood was depressed over an area 19 inches wide \times 22 inches long with a maximum depth of 2.1 inches. The windshield was shattered over an area 24 inches wide \times 15 inches long with a maximum depth of 1.7 inches. No evidence of a puncture or hole in the windshield was noted. Maximum occupant compartment deformation was 1.7 inches in the windshield area. Figure 7.25 shows the interior of the vehicle. Table F.6 in Appendix F.3 provides occupant compartment measurements.
