MASH EVALUATION OF TXDOT ROADSIDE SAFETY FEATURES – PHASE I

Test Report 0-6946-1

TEXAS A&M TRANSPORTATION INSTITUTE COLLEGE STATION, TEXAS

TEXAS DEPARTMENT OF TRANSPORTATION

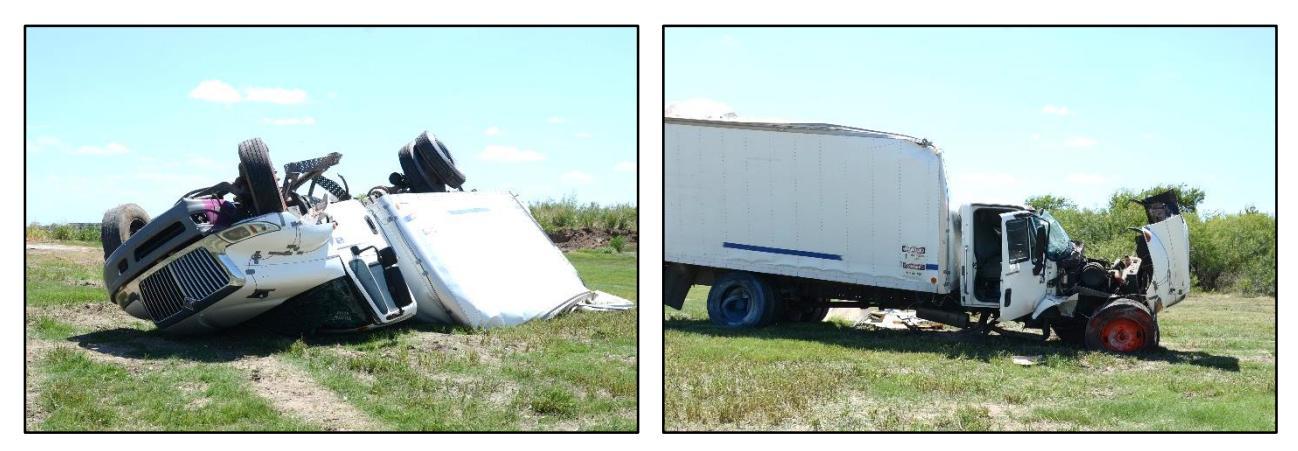
Figure 2.7. Test Vehicle after Test No. 469467-1-1.

Figure 2.7 shows the damage sustained by the test vehicle. The front bumper, hood, right front springs and U-bolts, right front tire and rim, right fuel tank, right side steps, right front door, right rear outer tire and rim, right front corner of the box, and right frame rail. Damage due to the vehicle roll included the cab, windshield, left door, left side of the box, left front springs and U-bolts, hood, and rear door of the box. Maximum exterior crush to the vehicle was 18.0 inches in the side plane at the right front corner at bumper height. No occupant compartment deformation or intrusion occurred. Figure 2.8 shows the interior of the vehicle.

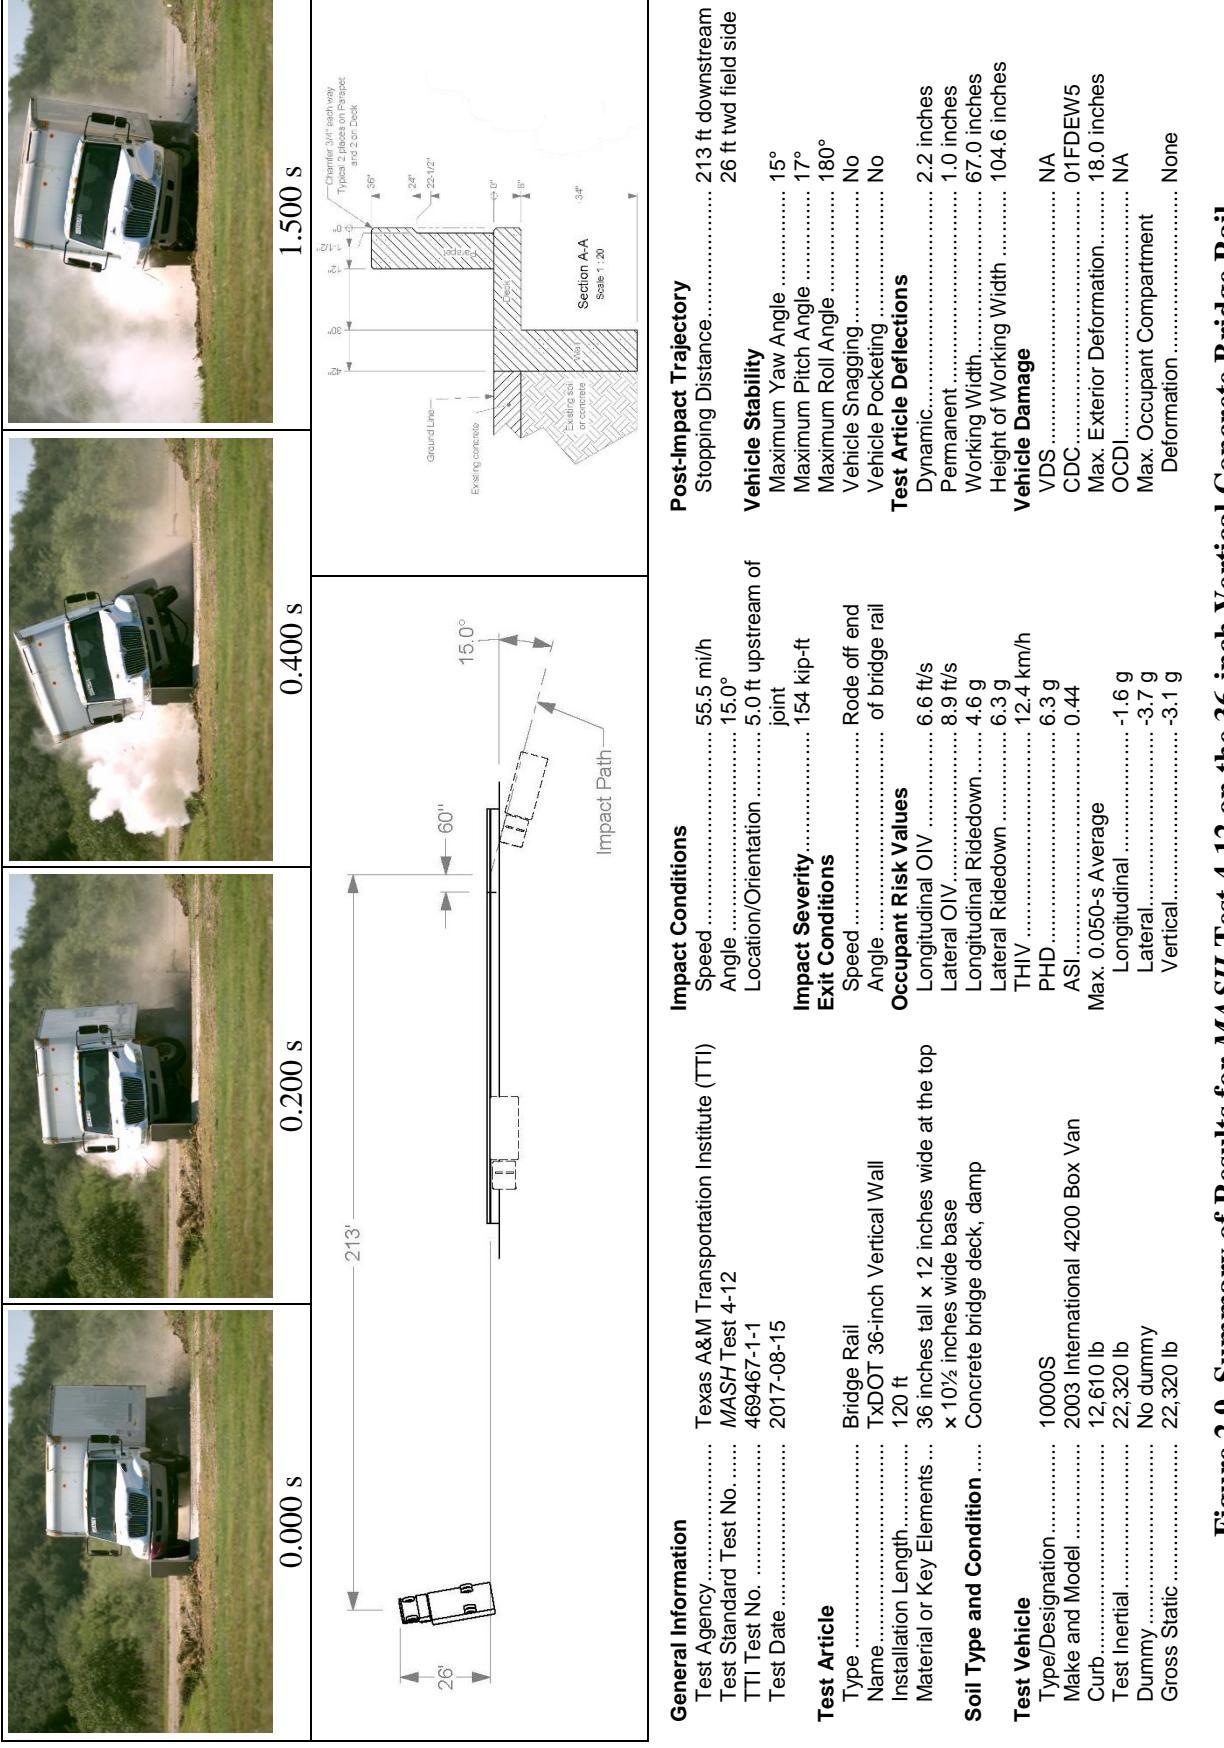
Figure 2.9. Summary of Results for MASH Test 4-12 on the 36-inch Vertical Concrete Bridge Rail.

The 36-inch vertical wall contained and redirected the 10000S vehicle. The vehicle did not penetrate, underride, or override the installation. Maximum dynamic deflection during the test was 2.2 inches. Slight cracking of the concrete parapet occurred in the impact region near the expansion joint in the rail. No detached elements, fragments, or other debris from the test article were present to penetrate or show potential for penetrating the occupant compartment or present hazard to others in the area. No occupant compartment deformation or intrusion occurred. The 10000S vehicle rolled onto its left side and roof after exiting the barrier and traversing unpaved terrain.

The 36-inch Vertical Concrete Bridge Rail performed acceptably for MASH Test 4-12.

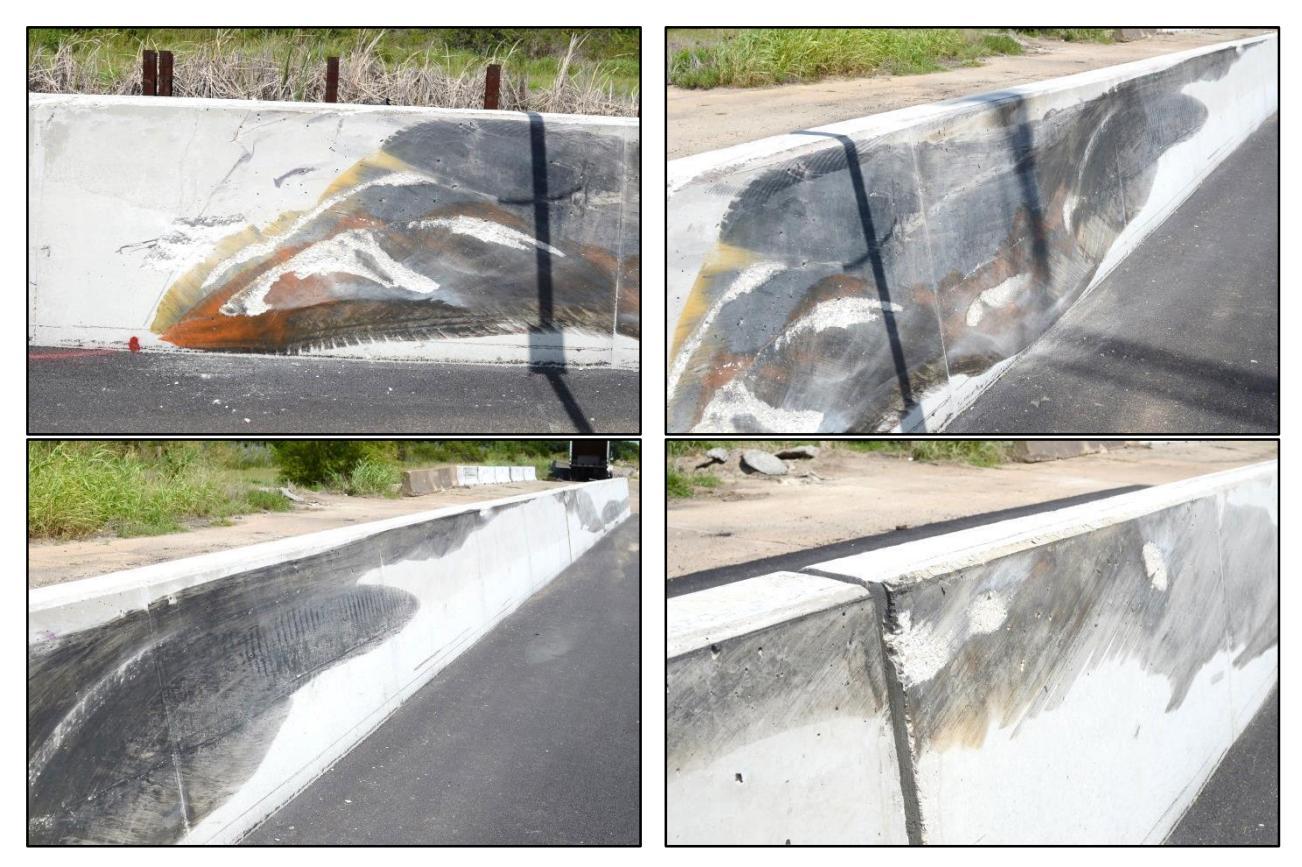
Figure 3.6. TxDOT 42-inch Tall SSCB with 1-inch ACP Overlay after Test No. 469467-3-1.

The TxDOT 42-inch SSCB with 1-inch ACP overlay contained and redirected the 10000S vehicle. The vehicle did not penetrate, underride, or override the installation. No lateral deflection was noted during the test. No detached elements, fragments, or other debris was present to penetrate or show potential for penetrating the occupant compartment or to present hazard to others in the area. The 10000S vehicle remained upright during and after the collision event.

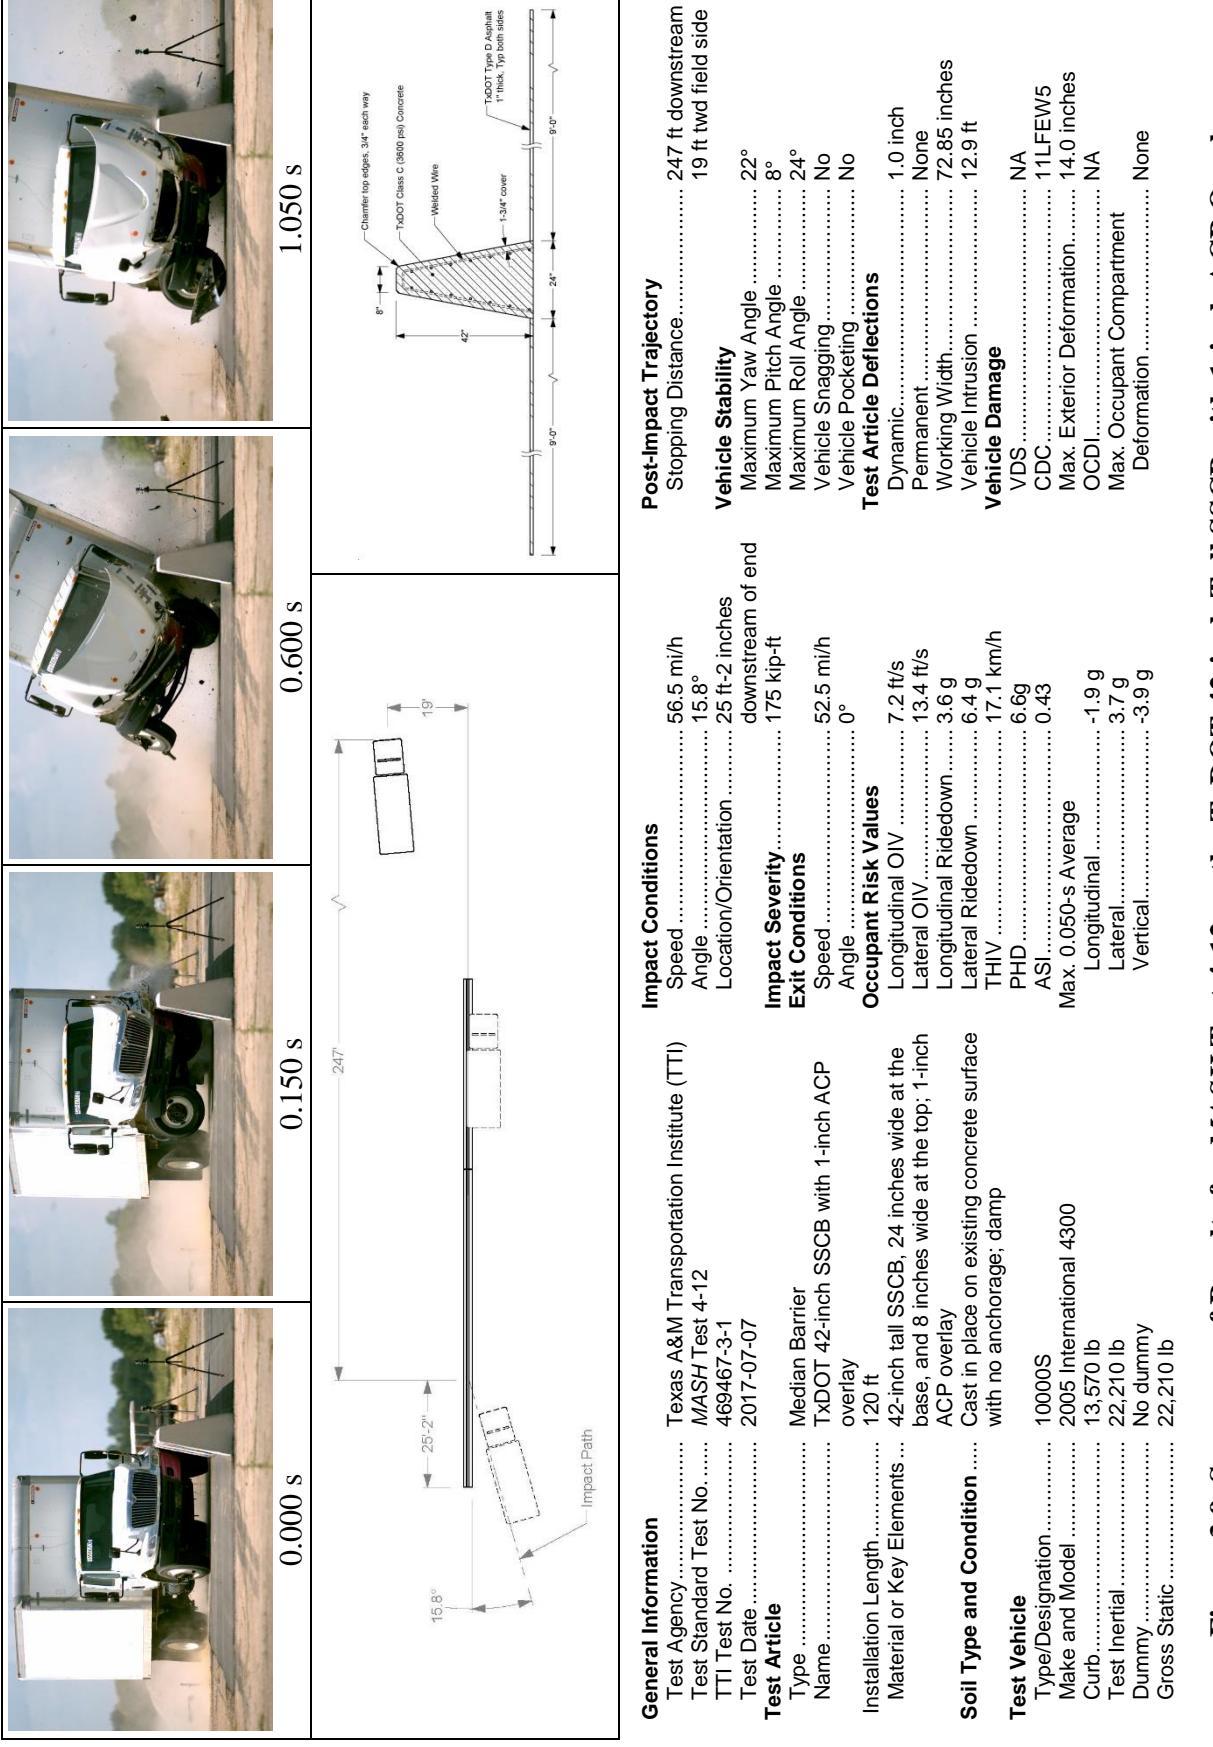
Figure 3.9. Summary of Results for MASH Test 4-12 on the TxDOT 42-inch Tall SSCB with 1-inch ACP Overlay.

The TxDOT 42-inch tall SSCB with 1-inch ACP overlay performed acceptably for *MASH* Test 4-12.

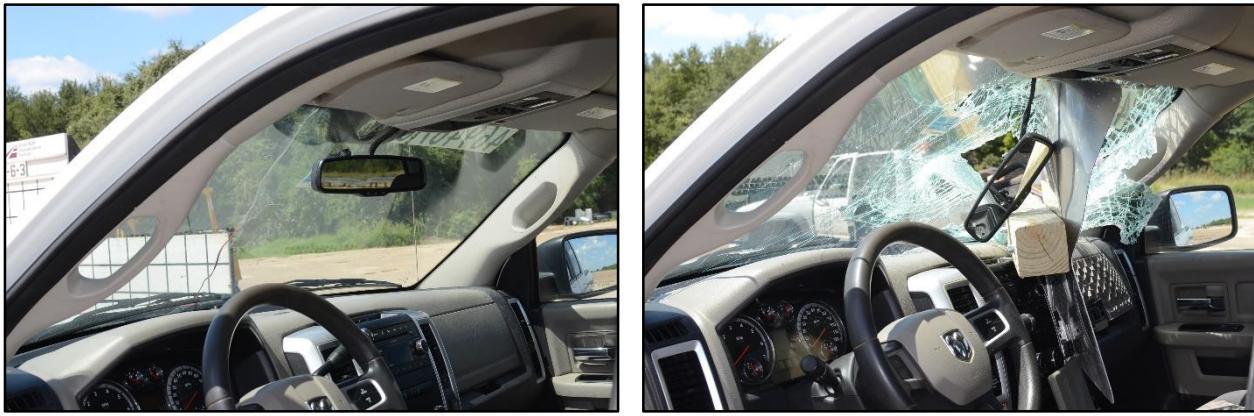
Figure 5.14 shows damage sustained by the vehicle. The front bumper and hood had a small dent at the quarter point. The sign panel and support tore a 20×20 -inch hole in the windshield just left of centerline. The sign panel and support also caused damage to the instrument panel, glove box, and roof. Maximum exterior crush to the vehicle was not measureable in the front plane at the left quarter point at bumper height. Penetration of the windshield occurred. Figure 5.15 shows the interior of the vehicle. Table D.6 in Appendix D.2 provides occupant compartment measurements.

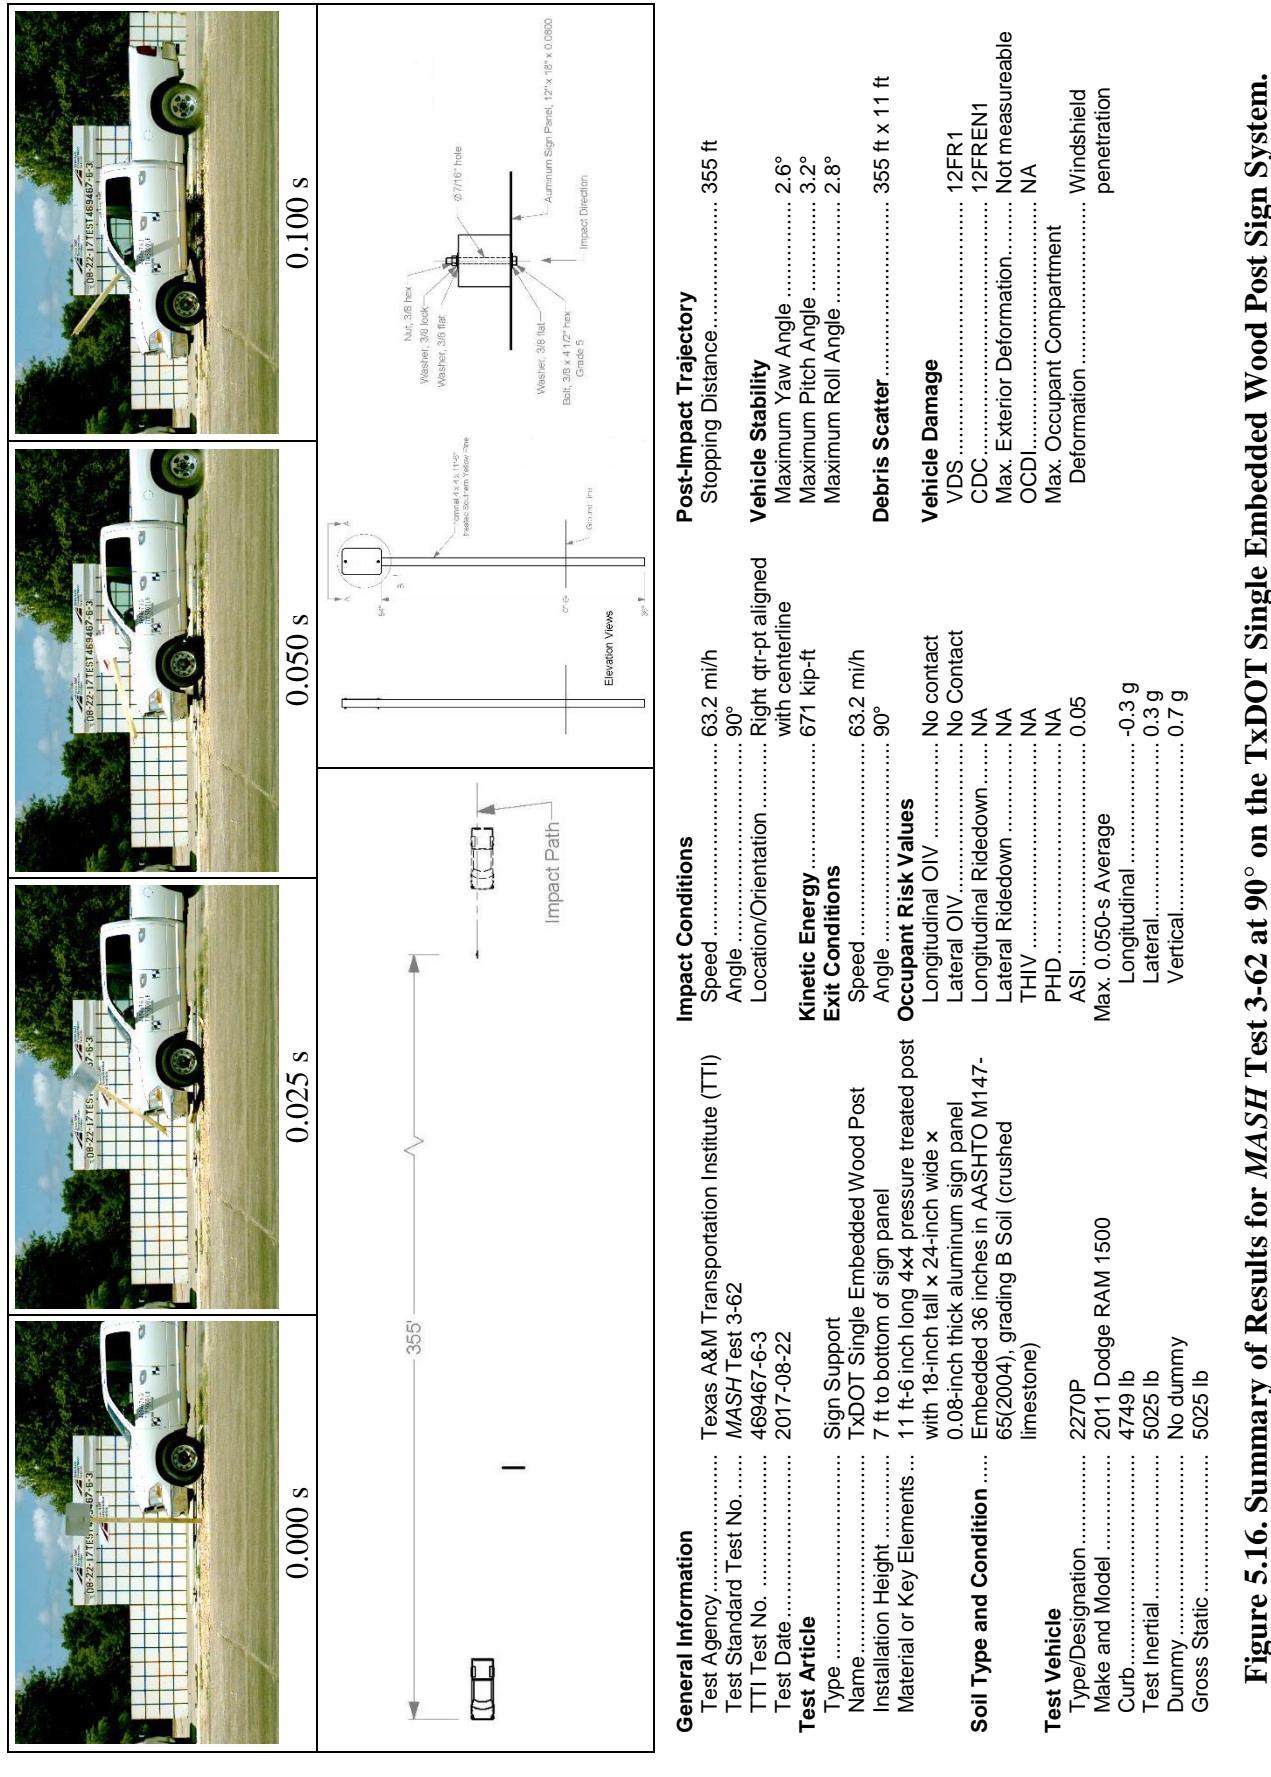
The TxDOT single embedded wood post sign system for 90° impact fractured as designed. An 80-inch section of wood post and the sign panel penetrated through the windshield. The 2270P vehicle remained upright during and after the collision event. Maximum roll and pitch angles were 2.8° and 3.2°, respectively. No occupant contact occurred. The 2270P vehicle came to rest 355 ft downstream of impact.

The support post fractured near ground line and at bumper height. The fractured support and sign panel then rotated into the vehicle windshield, resulting in penetration of the windshield. The TxDOT single embedded wood post sign system did not perform acceptably for *MASH* Test 3-62 at 90° due to penetration of the windshield.

Tes	t Agency: Texas A&M Transportation Institute	Test No.: 469467-6-3	est Date: 2017-08-22
	MASH Test 3-62 Evaluation Criteria	Test Results	Assessment
$\frac{\text{Str}}{B}$.	uctural Adequacy The test article should readily activate in a predictable manner by breaking away, fracturing, or yielding.	The TxDOT single embedded wood post sign system fractured as designed.	Pass
0 C	supant Risk

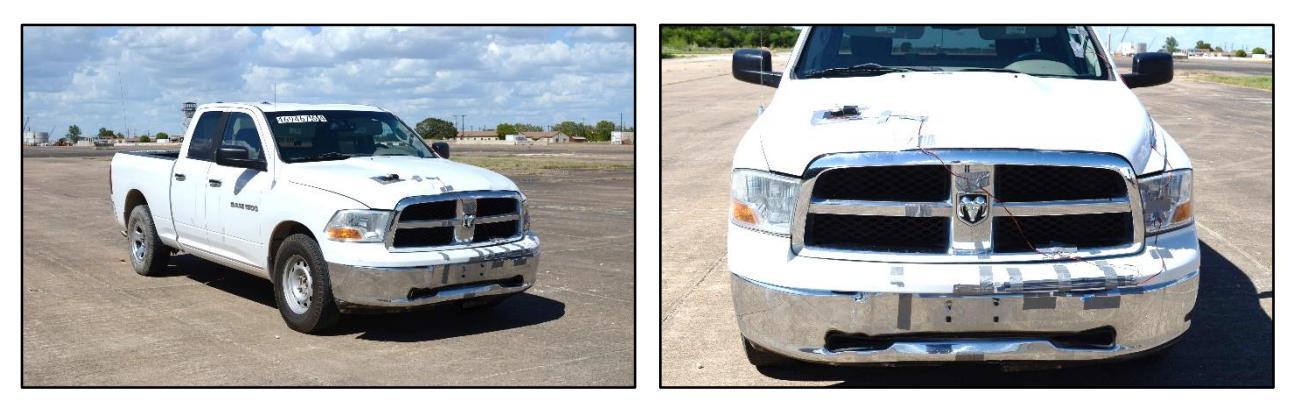
Figure 5.22. Test Vehicle after Test No. 469467-6-4.

Figures 5.22 and 5.23 show damage sustained by the vehicle. The front bumper and hood had small dents at the left quarter point and to the right of centerline. The exterior roof was depressed over an area of 50 inches \times 50 inches had a maximum depth of 3.0 inches. Maximum occupant compartment deformation was 3.0 inches in the center of the roof. Figure 5.24 shows

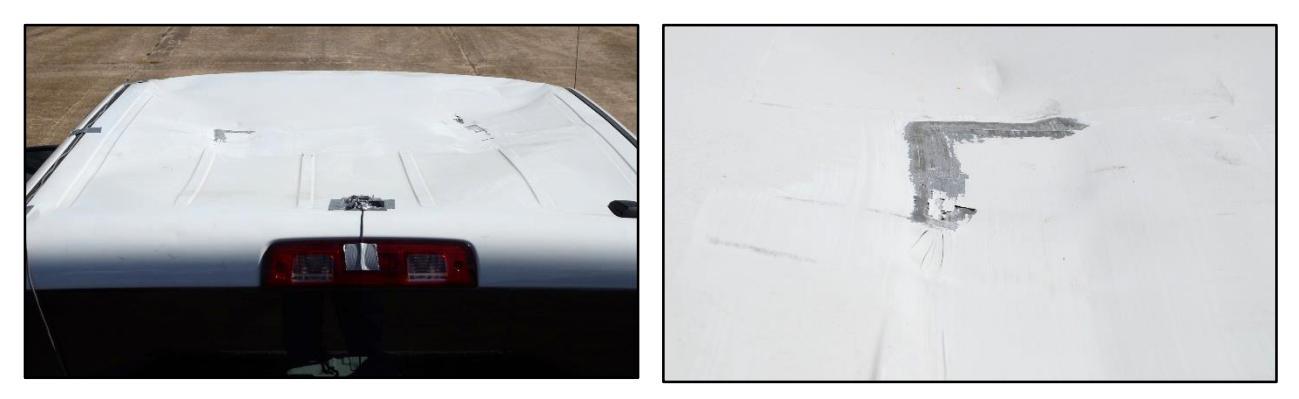
Figure 5.23. Test Vehicle Roof Damage after Test No. 469467-6-4.

The supports fractured in two locations (near ground level and at bumper height). The sign panel and fractured support posts rotated toward the vehicle and impacted the roof. Roof deformation was within the limits recommended in *MASH*. The TxDOT dual embedded wood post sign system performed acceptably for *MASH* Test 3-62 at 0°.

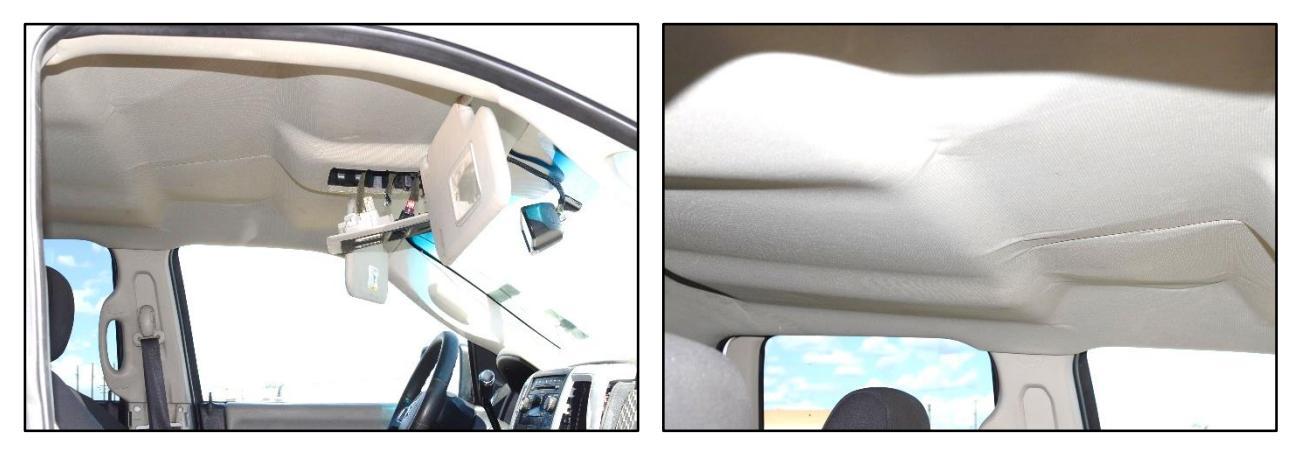
Figure 5.24. Interior of Test Vehicle after Test No. 469467-6-4.

the interior of the vehicle. Table D.9 in Appendix D.3 provides occupant compartment measurements.

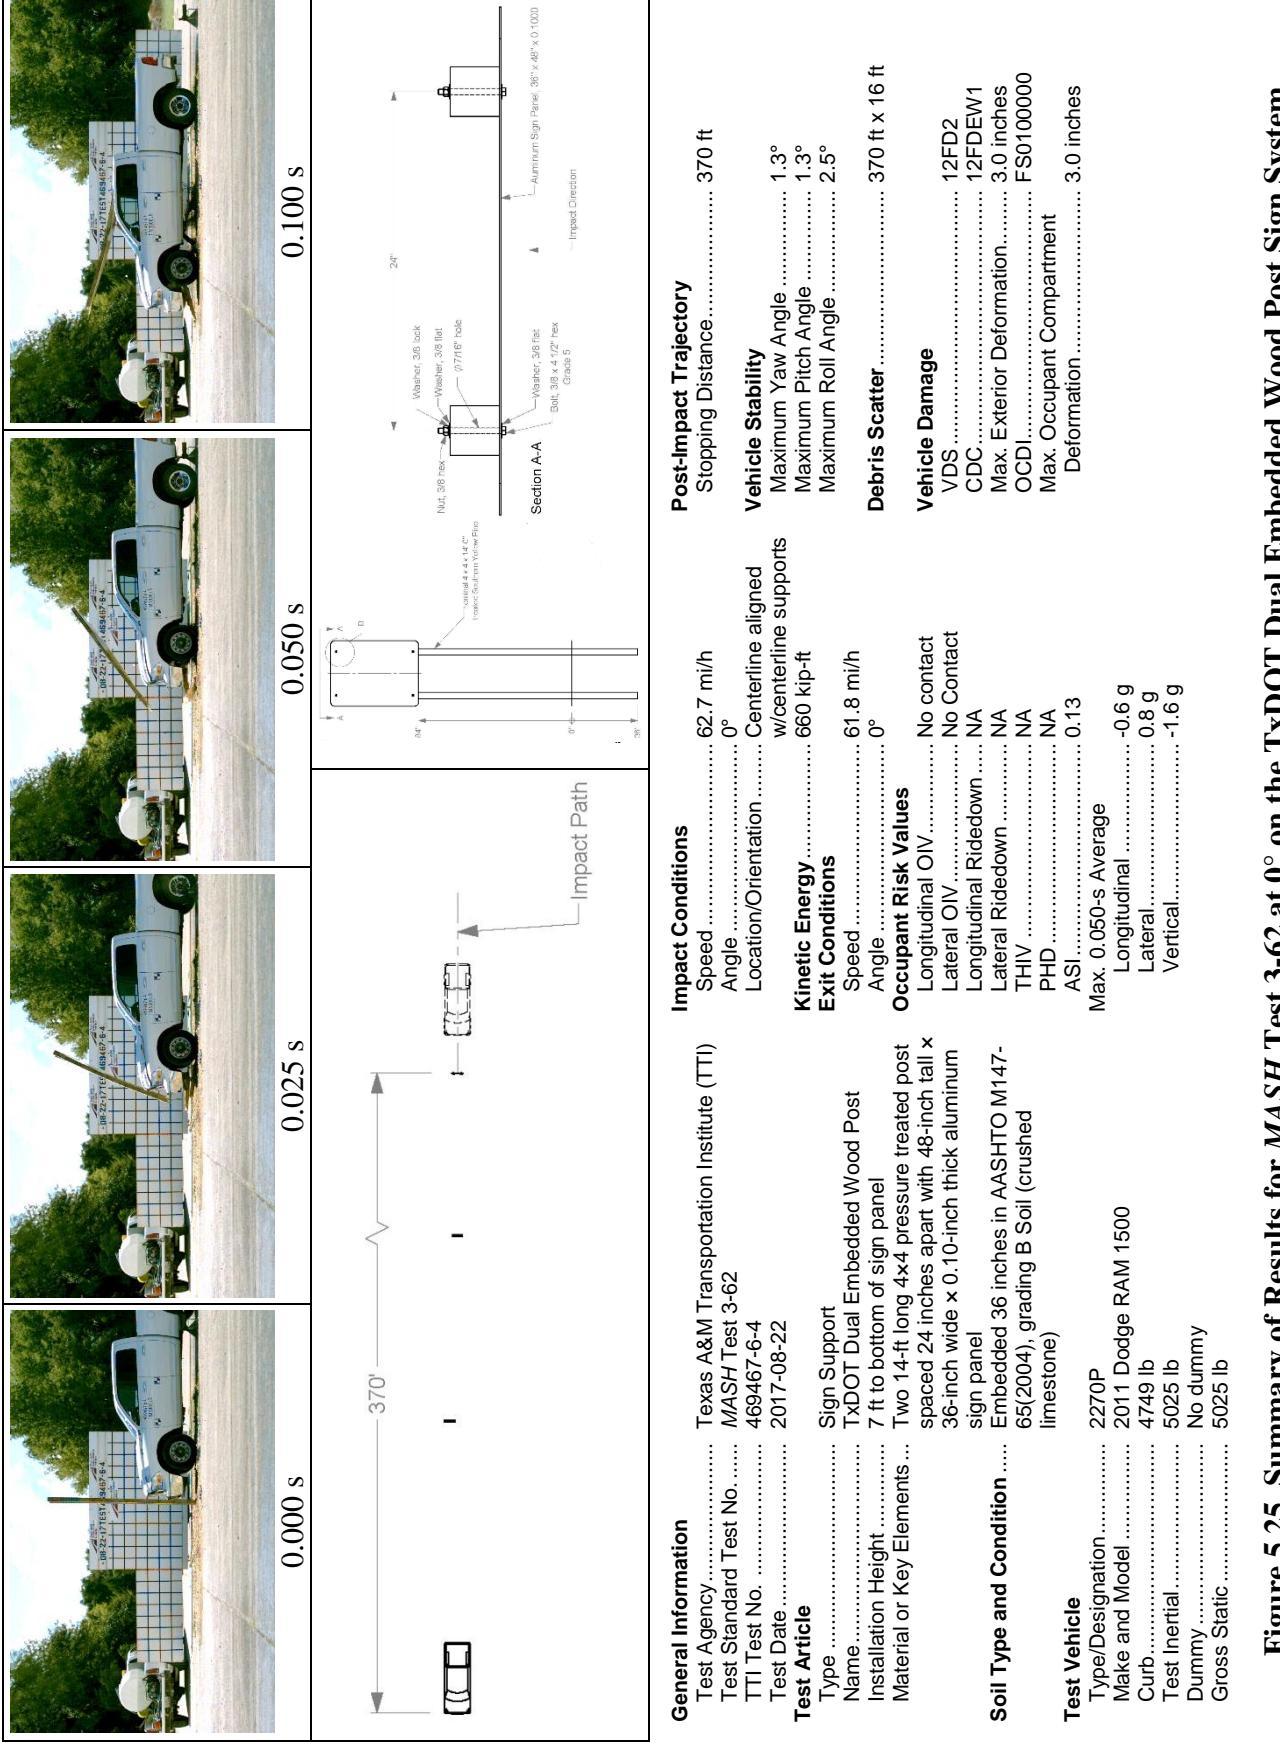
Figure 5.25. Summary of Results for MASH Test 3-62 at 0° on the TxDOT Dual Embedded Wood Post Sign System.

The TxDOT dual embedded wood post sign system fractured as designed. None of the detached fragments penetrated or showed potential for penetrating the occupant compartment or to present hazard to others in the area. Maximum occupant compartment deformation was 3.0 inches in the center roof area. The 2270P vehicle remained upright during and after the collision event. Maximum roll and pitch angles were 2.5° and 1.3°, respectively. No occupant contact occurred. The 2270P vehicle came to rest 370 ft downstream of impact.

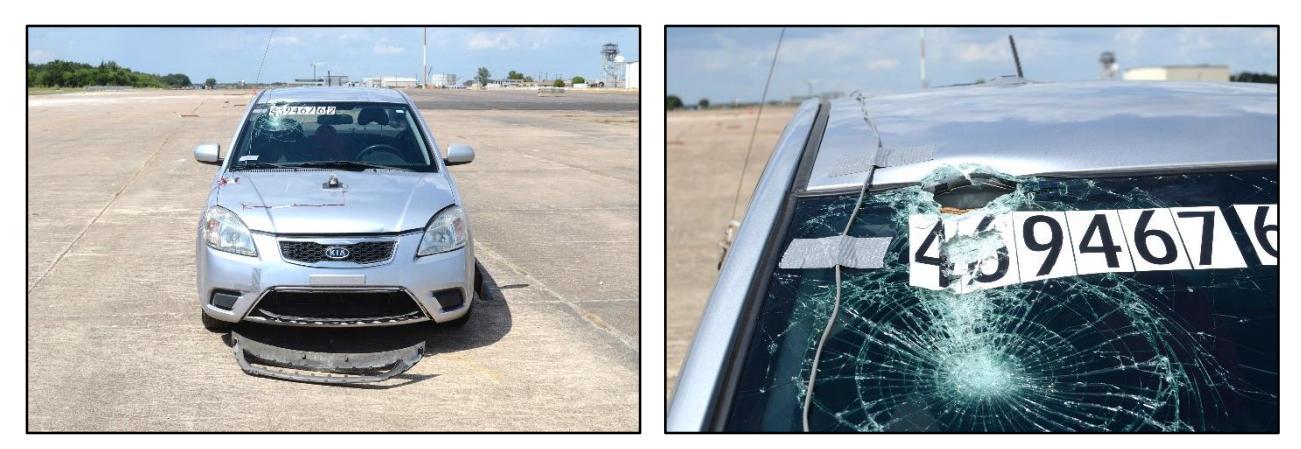
Figure 5.29. Test Vehicle after Test No. 469467-6-2.

Figure 5.29 shows damage sustained by the vehicle. The front bumper and hood had a small dent at the right quarter point and just to the left of centerline. The sign panel and supports contacted the windshield and punctured a 2-inch \times 4-inch hole in the windshield adjacent to the roof on the right side. The windshield was pushed inward toward the occupant compartment 1.5 inches. Maximum exterior crush to the vehicle was not measureable in the front plane at the left quarter point at bumper height. Penetration of the windshield occurred. Figure 5.30 shows

Both support posts fractured at bumper height, and as the vehicle continued to move forward, the fractured end of the right support contacted and punctured the windshield. The TxDOT dual embedded wood post sign system did not perform acceptably for *MASH* Test 3-61 at 0° due to puncture of the windshield.

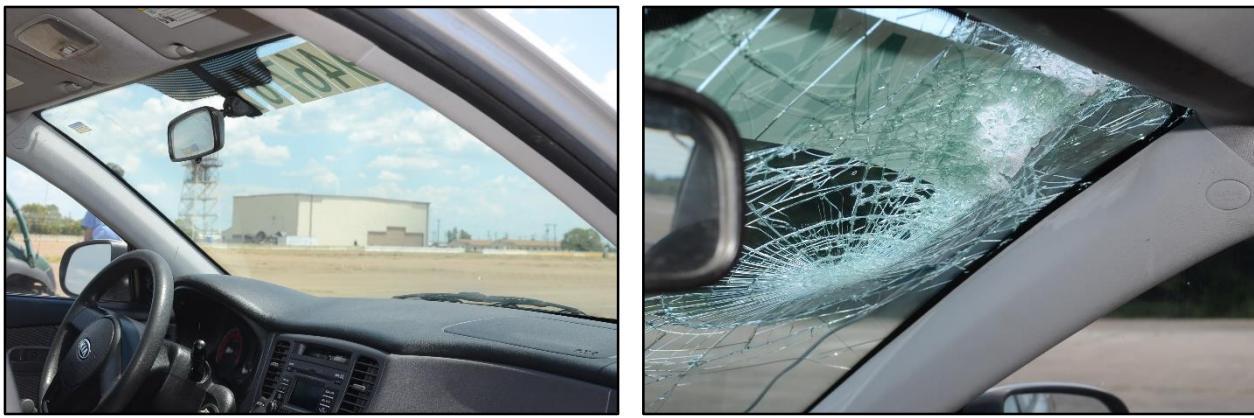
the interior of the vehicle. Table D.11 in Appendix D.4 provides occupant compartment measurements.

The TxDOT dual embedded wood post sign system fractured as designed. The sign panel and portions of the wood post contacted the windshield and punctured a hole adjacent to the roof line. The windshield was shattered, depressed inward toward the occupant compartment 1.5 inches, and punctured near the roof line on the right side. The 1100V vehicle remained upright during and after the collision event. Maximum roll and pitch angles were 1.7° and 2.8°, respectively. Occupant risk factors were within the preferable limits specified in *MASH*. The 1100C vehicle came to rest 284 ft downstream of impact.

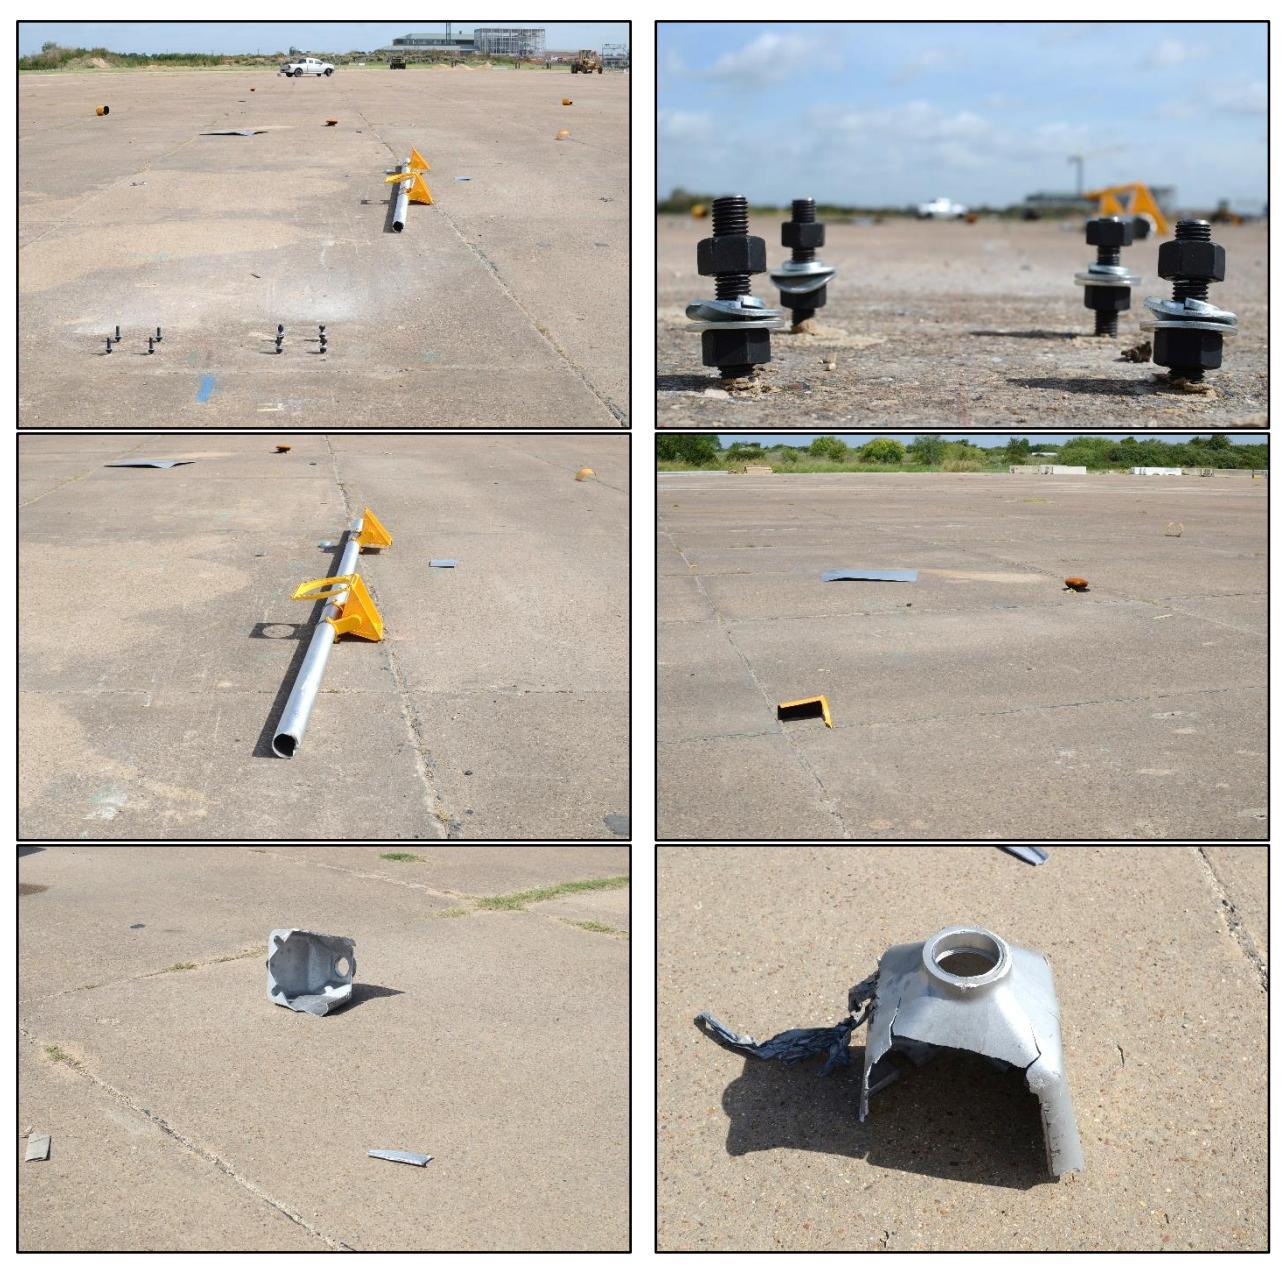
Figure 6.5. TxDOT Pedestal Pole with Beacons without Solar Assembly after Test No. 469467-7-1.

Figure 6.5 shows the damage to the TxDOT pedestal pole with beacons without solar assembly. The breakaway base fractured and released from the anchor bolts and pole. The anchor bolts on the impact side were deformed. The pole was resting 20 ft downstream of impact and 5 ft to the left of centerline. The sign panel detached from the pole after contact with the ground and was resting 51 ft downstream of impact and 6 ft to the left. One of the beacons was resting 58 ft downstream of impact, and the other was resting 150 ft downstream of impact and 10 ft to the left.

The TxDOT Pedestal Pole with Beacons without Solar Assembly yielded to the 2270P vehicle as designed by fracturing at the base. None of the detached fragments penetrated or showed potential for penetrating the occupant compartment or to present hazard to others in the

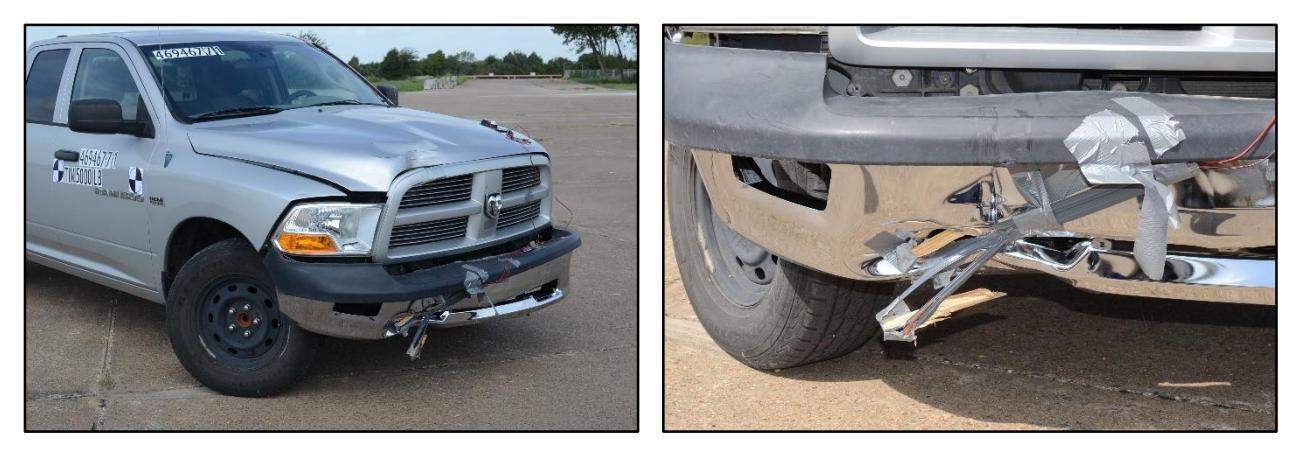
Figure 6.6. Test Vehicle after Test No. 469467-7-1.

Figure 6.6 shows the damage sustained by the vehicle. The front bumper, right bumper bracket, hood, and grill were deformed. Maximum exterior crush to the vehicle was 6.5 inches in the front plane at the right front quarter point at bumper height. No occupant compartment deformation or intrusion occurred. Figure 6.7 shows the interior of the vehicle. Tables E.3 and E.4 in Appendix E.2 provide exterior crush and occupant compartment measurements.

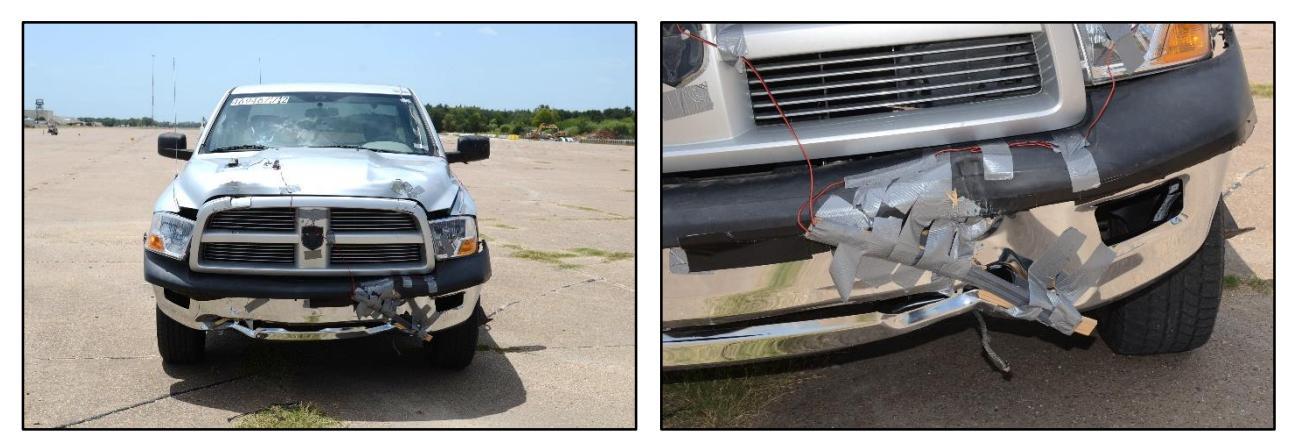
Figure 6.14. Test Vehicle after Test No. 469467-7-2.

Figure 6.14 shows the damage sustained by the vehicle. The front bumper, left bumper bracket, hood, and grill were deformed. Maximum exterior crush to the vehicle was 6.5 inches in the front plane at the left front quarter point at bumper height. No occupant compartment deformation or intrusion occurred. Figure 6.15 shows the interior of the vehicle. Tables E.7 and E.8 in Appendix E.3 provide exterior crush and occupant compartment measurements.

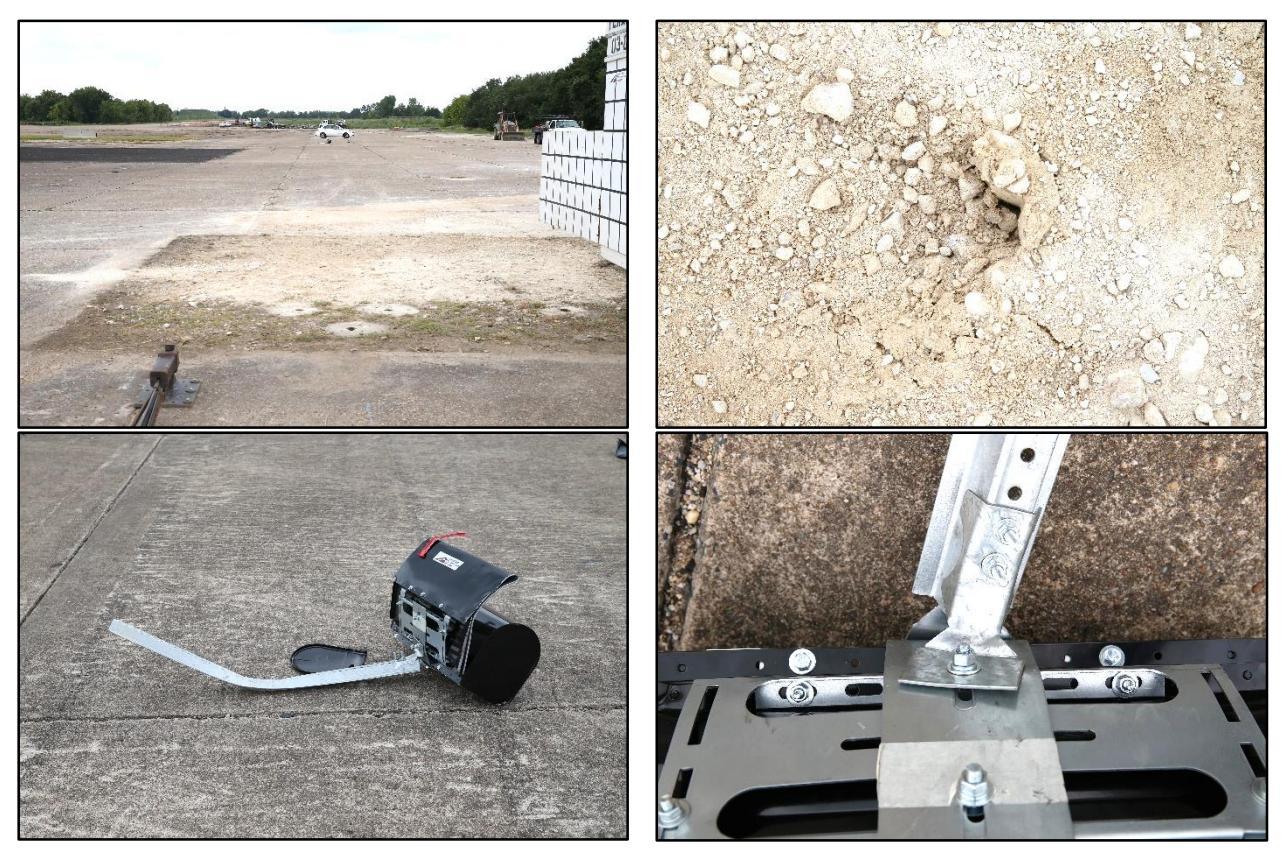
Figure 7.6. TxDOT Double Mailbox System on Winged Channel Post with Type 3 Foundation after Test No. 469467-8-4.

Figure 7.6 shows the damage to the TxDOT mailbox system on winged channel post with type 3 foundation. The mailbox support fractured 3 inches below grade. The mailboxes (minus the doors) remained attached to the mailbox support and came to rest 188 ft downstream of impact.

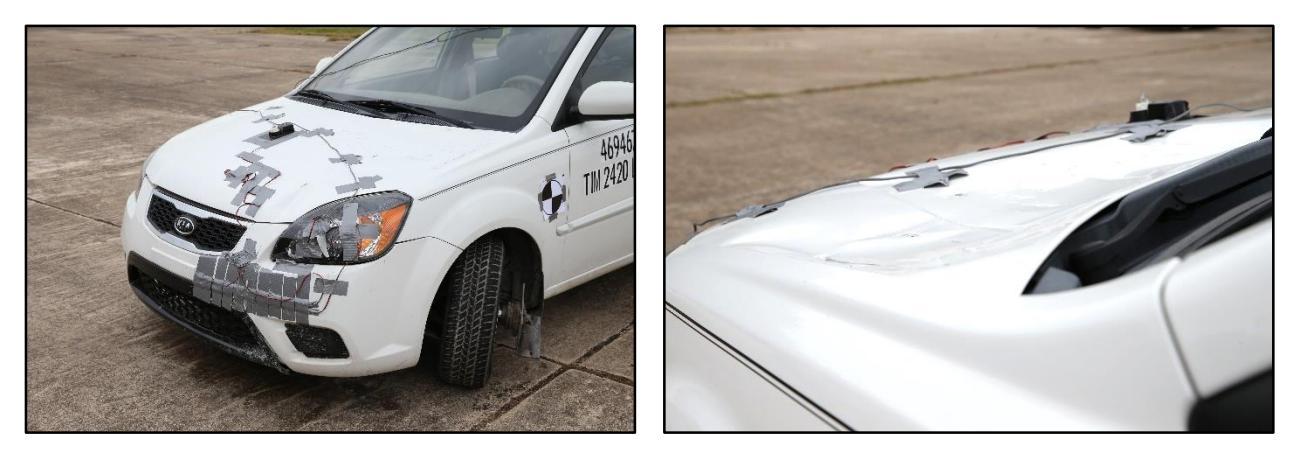
Figure 7.7. Test Vehicle after Test No. 469467-8-4.

Figure 7.7 shows damage sustained by the vehicle. The front bumper and hood had a small dent at the left quarter point. The left side of the hood was depressed downward 1.25 inches over an area 24 inches wide \times 20 inches long. Maximum exterior crush to the vehicle was 1.25 inches on the hood. No occupant compartment deformation or intrusion was noted. Figure 7.8 shows the interior of the vehicle. Table F.2 in Appendix F.2 provides occupant compartment measurements.

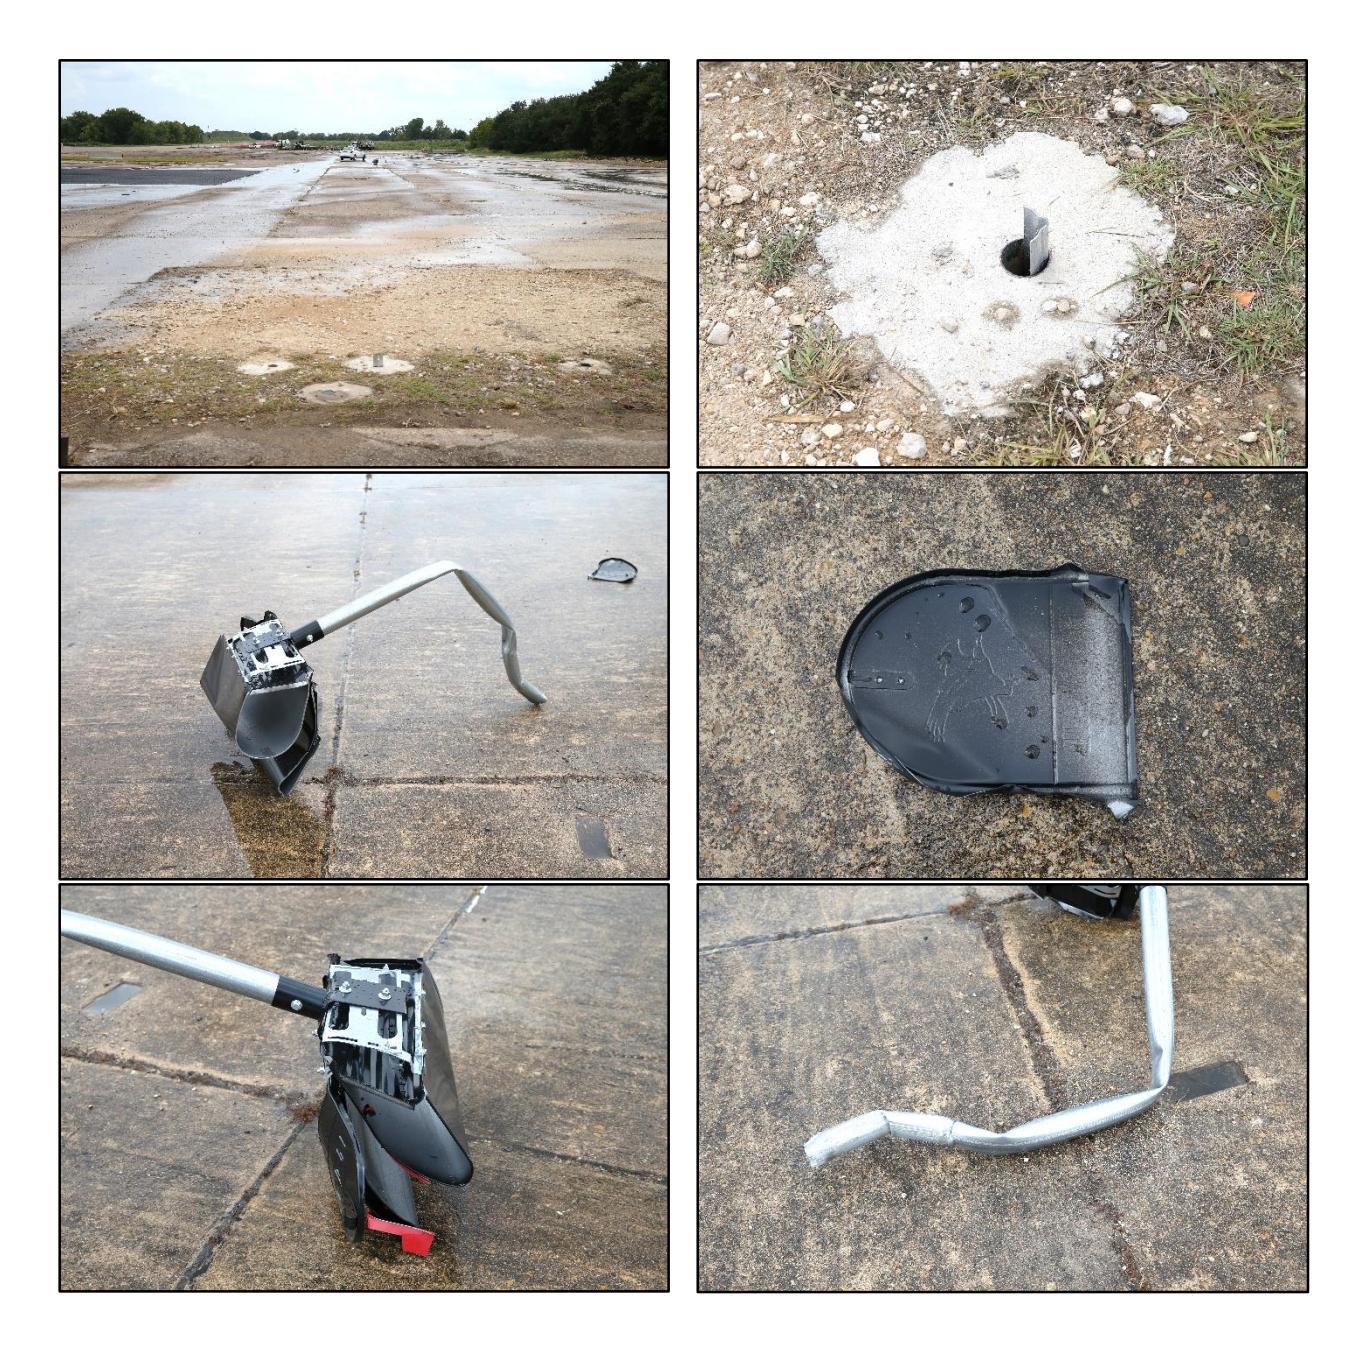
Figure 7.14. TxDOT Double Mailbox System on Thin-Walled Galvanized Tube with Type 2 Foundation after Test No. 469467-8-3.

Figure 7.14 shows the damage to the TxDOT double mailbox system on thin-walled galvanized tube with type 2 foundation. The mailbox support pulled out of the ground socket. The mailboxes (minus one door) came to rest 206 ft downstream and 8 ft to the right of centerline.
