MASH EVALUATION OF TXDOT ROADSIDE SAFETY FEATURES – PHASE I

Test Report 0-6946-1

TEXAS A&M TRANSPORTATION INSTITUTE COLLEGE STATION, TEXAS

TEXAS DEPARTMENT OF TRANSPORTATION

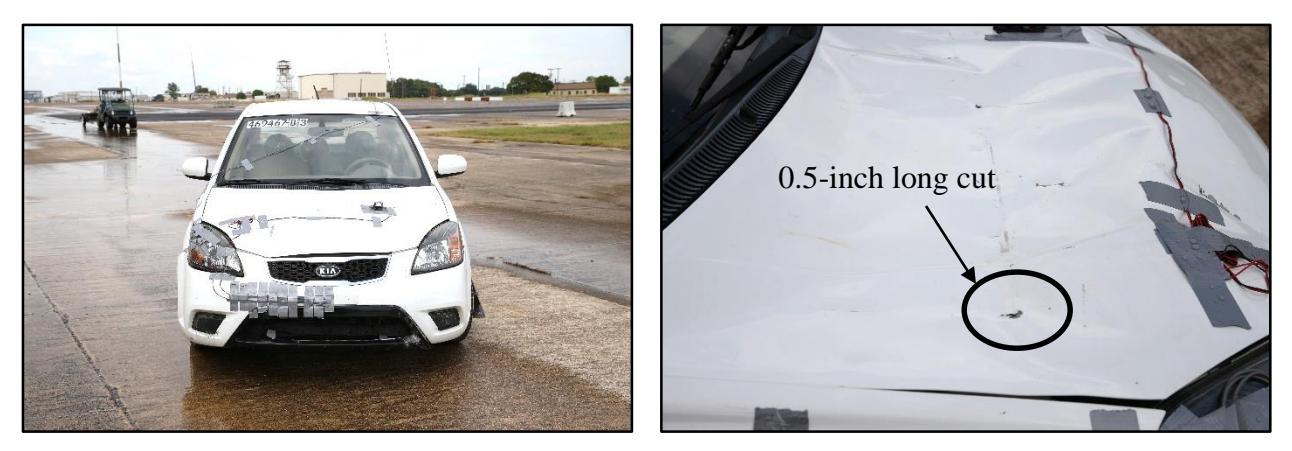
Figure 7.15. Test Vehicle after Test No. 469467-8-3.

Figure 7.15 shows damage sustained by the vehicle. The front bumper and hood had a small dent at the right quarter point. The right side of the hood was depressed downward 2.25 inches over an area 30 inches \times 30 inches. Maximum exterior crush to the vehicle was 2.25 inches on the hood. A 0.5-inch cut was also noted in the depressed area. No occupant compartment deformation or intrusion was noted. Figure 7.16 shows the interior of the vehicle. Table F.4 in Appendix F.2 provides occupant compartment measurements.

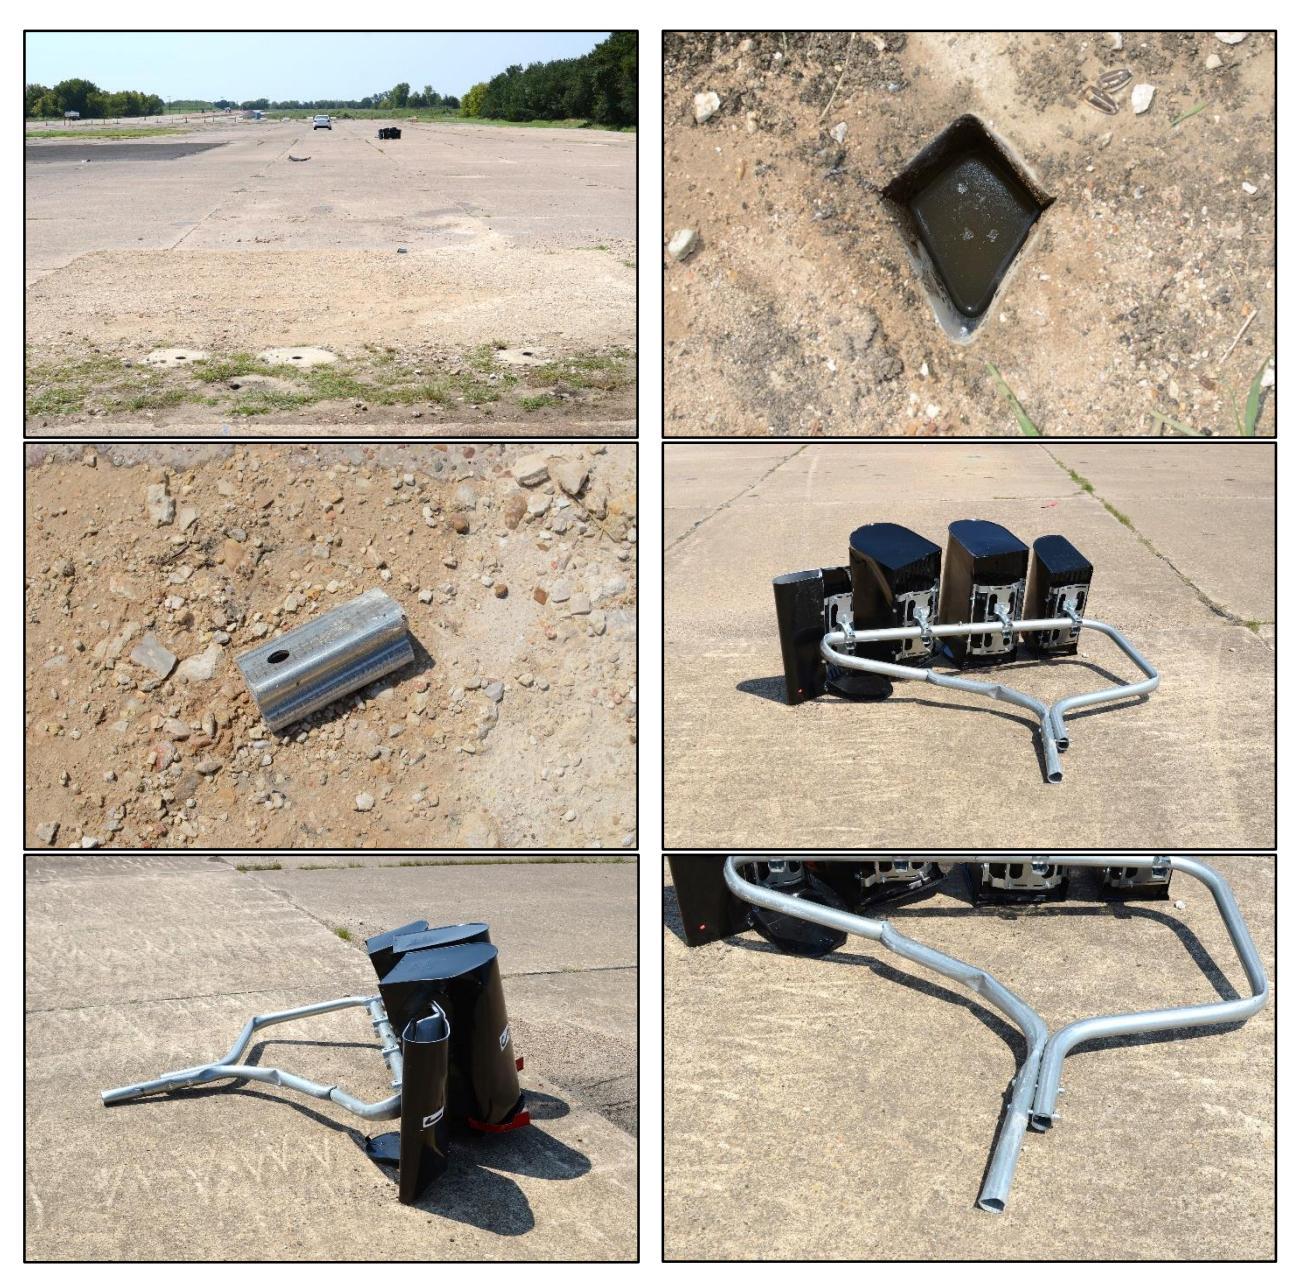
Figure 7.22. TxDOT Multiple Mailbox System on 56-inch Hanger-Type Thin-Walled Galvanized Tube with Type 1 Foundation after Test No. 469467-8-2.

Figure 7.22 shows the damage to the TxDOT multiple mailbox system on 56-inch hanger-type thin-walled galvanized tube with type 1 foundation. The mailbox assembly remained intact and the support post pulled out of the socket. The mailbox assembly came to rest 164 ft downstream of impact and 9 ft to the right of centerline.

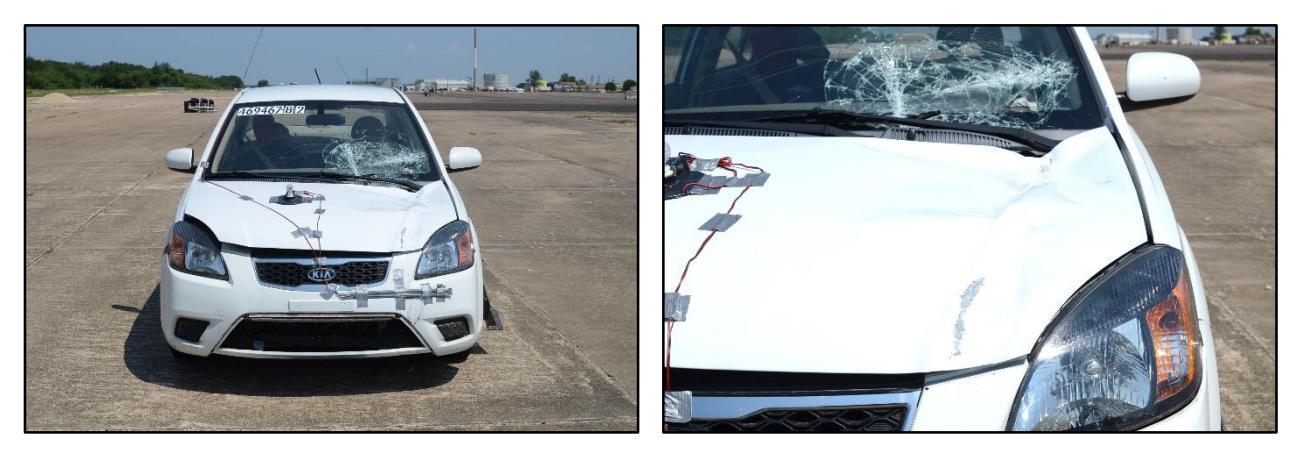
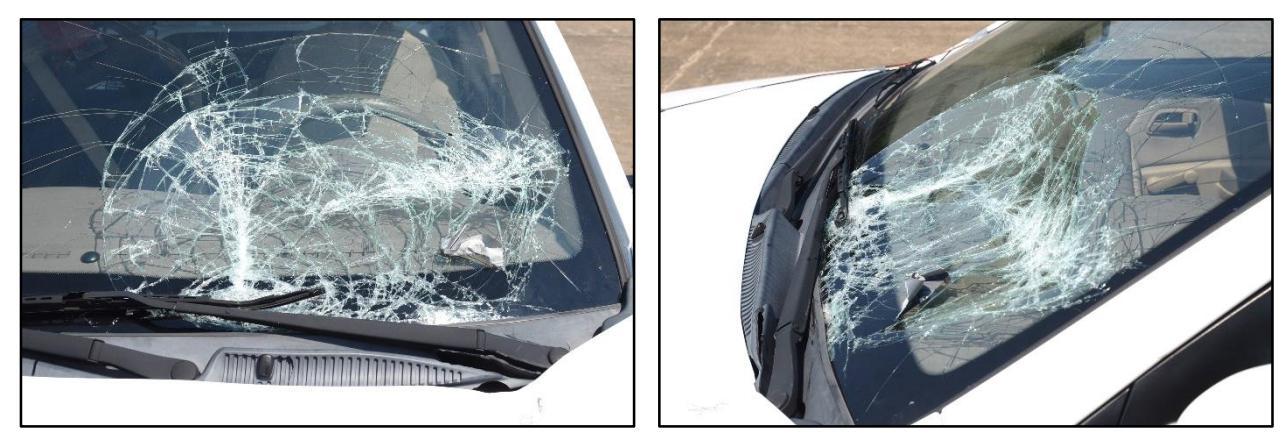
Figure 7.23. Test Vehicle after Test No. 469467-8-2.

Figures 7.23 and 7.24 show damage sustained by the vehicle. The front bumper and hood had small dents at the left quarter point. The top of the hood was depressed over an area 19 inches wide \times 22 inches long with a maximum depth of 2.1 inches. The windshield was shattered over an area 24 inches wide \times 15 inches long with a maximum depth of 1.7 inches. No evidence of a puncture or hole in the windshield was noted. Maximum occupant compartment deformation was 1.7 inches in the windshield area. Figure 7.25 shows the interior of the vehicle. Table F.6 in Appendix F.3 provides occupant compartment measurements.
