MASH EVALUATION OF ALTERNATIVE SUPPORT MATERIALS FOR PORTABLE ROLL-UP SIGNS

Test Report 0-6639-13-1

TEXAS A&M TRANSPORTATION INSTITUTE COLLEGE STATION, TEXAS

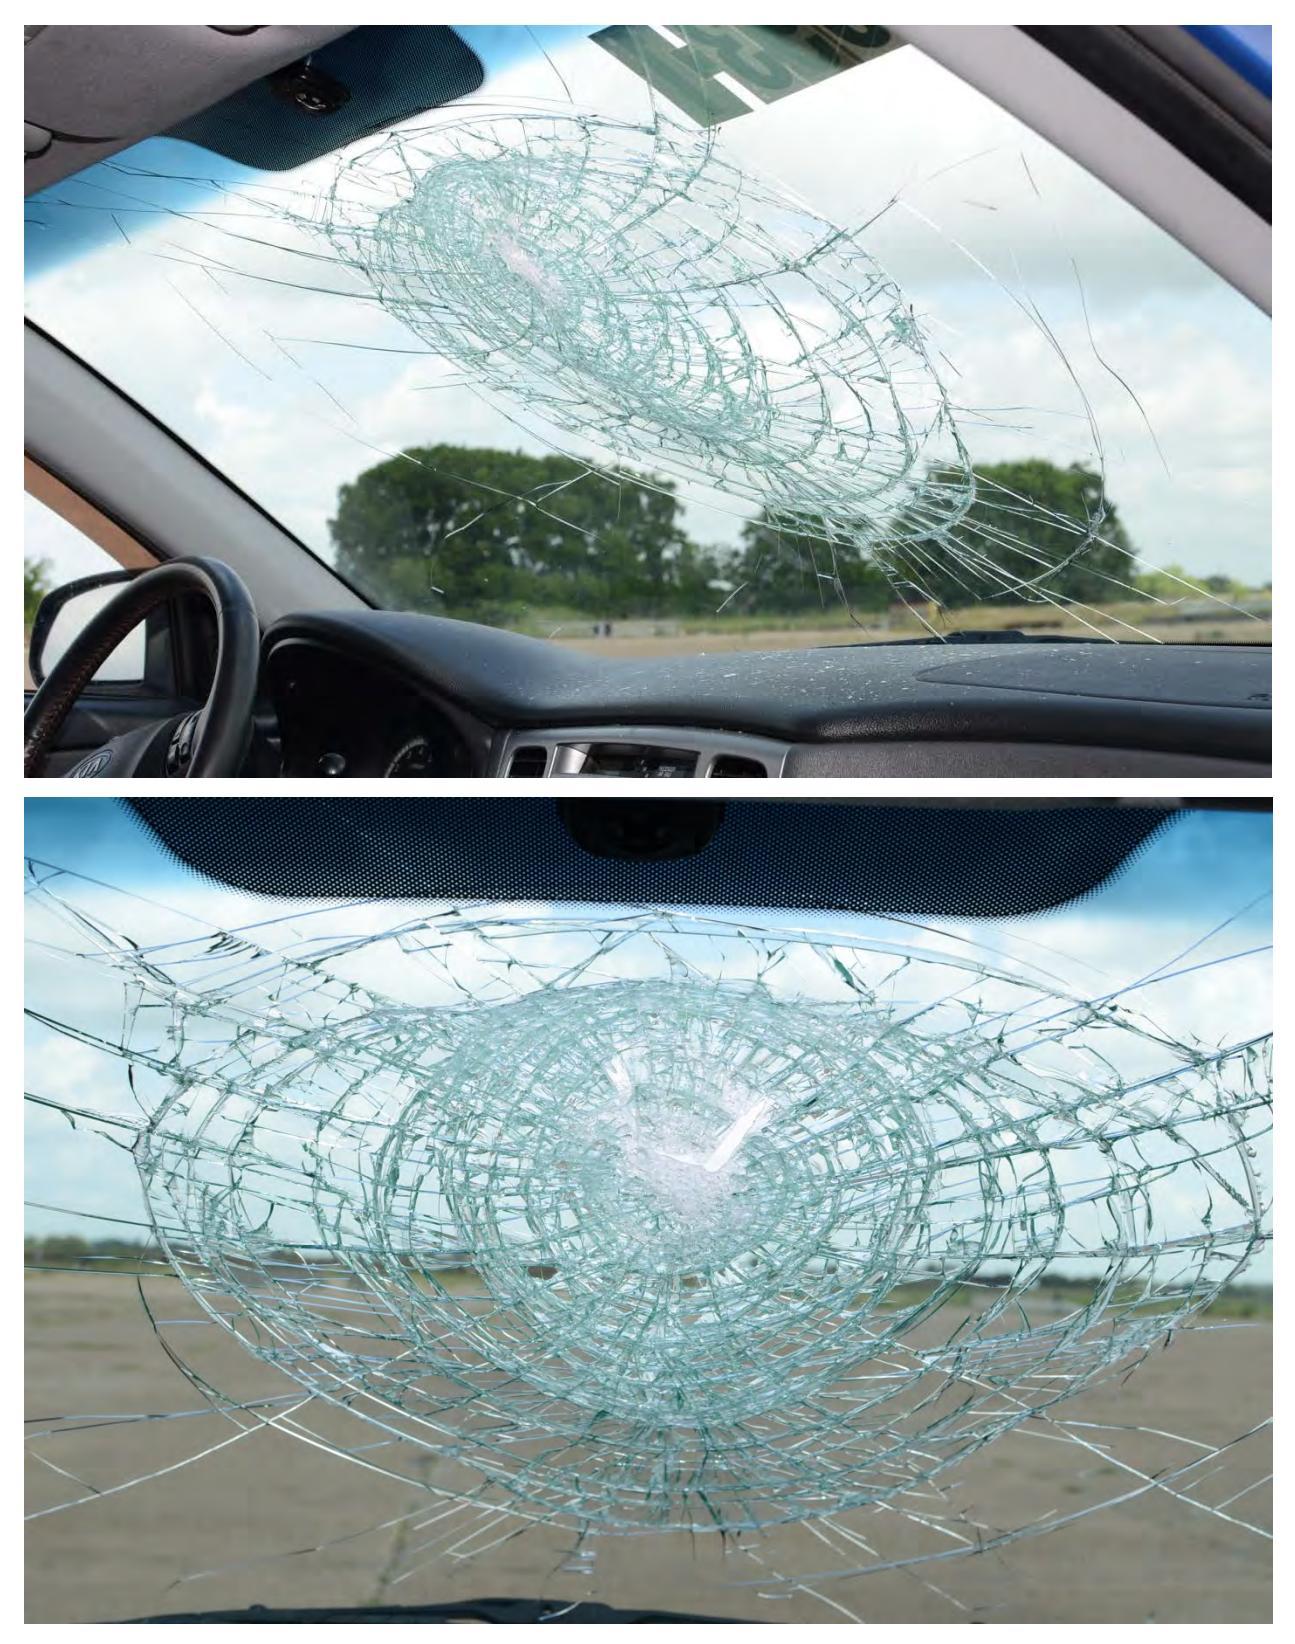
Figure 5.6. Interior of Vehicle for Test No. 466393-1.

Figure 5.5 shows damage to the 1100C vehicle. The bottom of the front bumper cover was fractured, and the hood sustained scuff marks. No measureable deformation was noted to the exterior hood or bumper. The windshield was punctured/cut by the top corner of the sign panel, leaving a 2-inch \times 1.5-inch hole. The area around the puncture was depressed into the occupant compartment 1.5 inches, and the total area shattered measured 20 inches \times 17.25 inches. Figure 5.6 shows the windshield damage from inside the occupant compartment. Table D2 and D3 in Appendix D provides exterior crush and occupant compartment measurements.

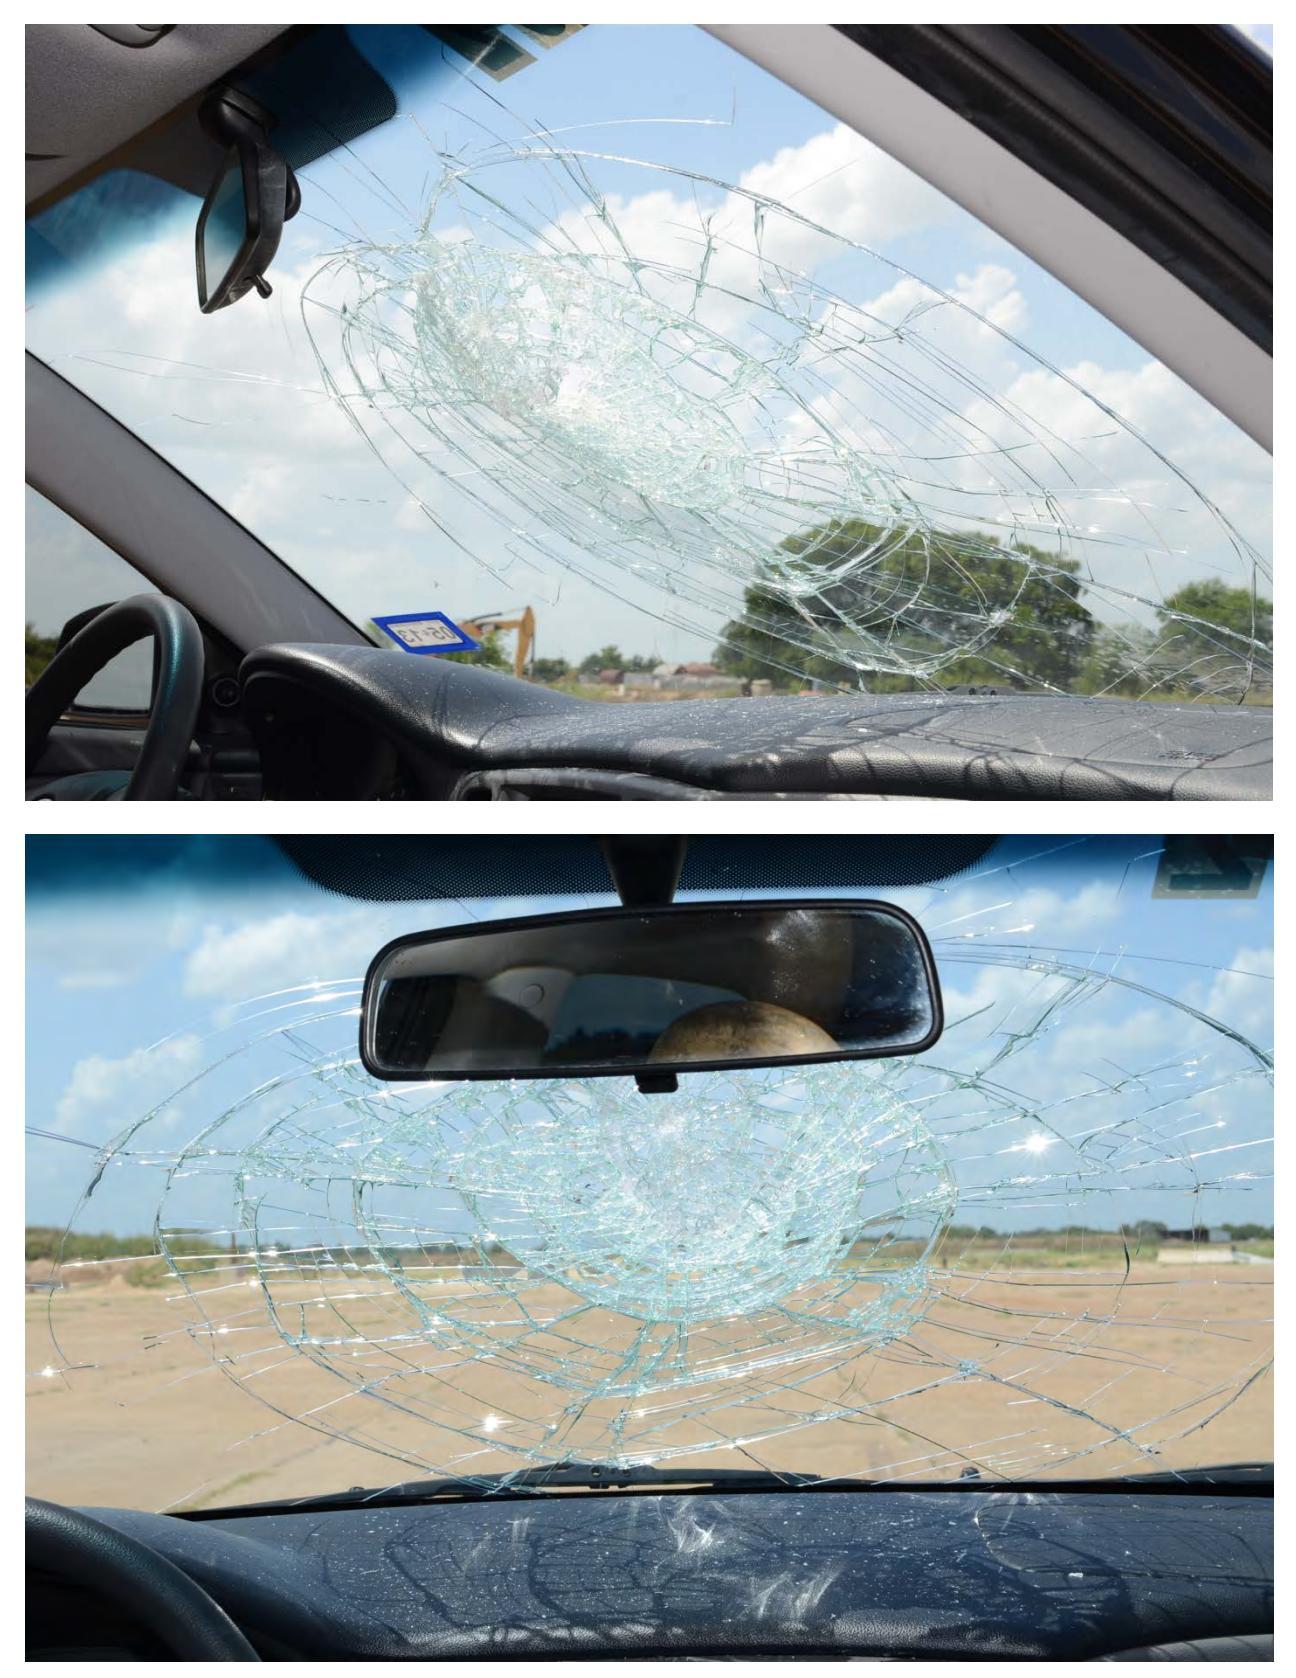
Figure 5.13. Interior of Vehicle for Test No. 466393-2.

Figure 5.12 shows damage to the 1100C vehicle. The hood sustained scuff marks. No measureable deformation was noted to the exterior hood or bumper. The windshield had a 4-inch \times 1.5-inch hole. The area around the hole was depressed into the occupant compartment 1.5 inches, and the total shattered area on the windshield measured 15 inches \times 13 inches. Figure 5.13 shows the windshield damage from inside the occupant compartment. Table D5 and D6 in Appendix D provides exterior crush and occupant compartment measurements.

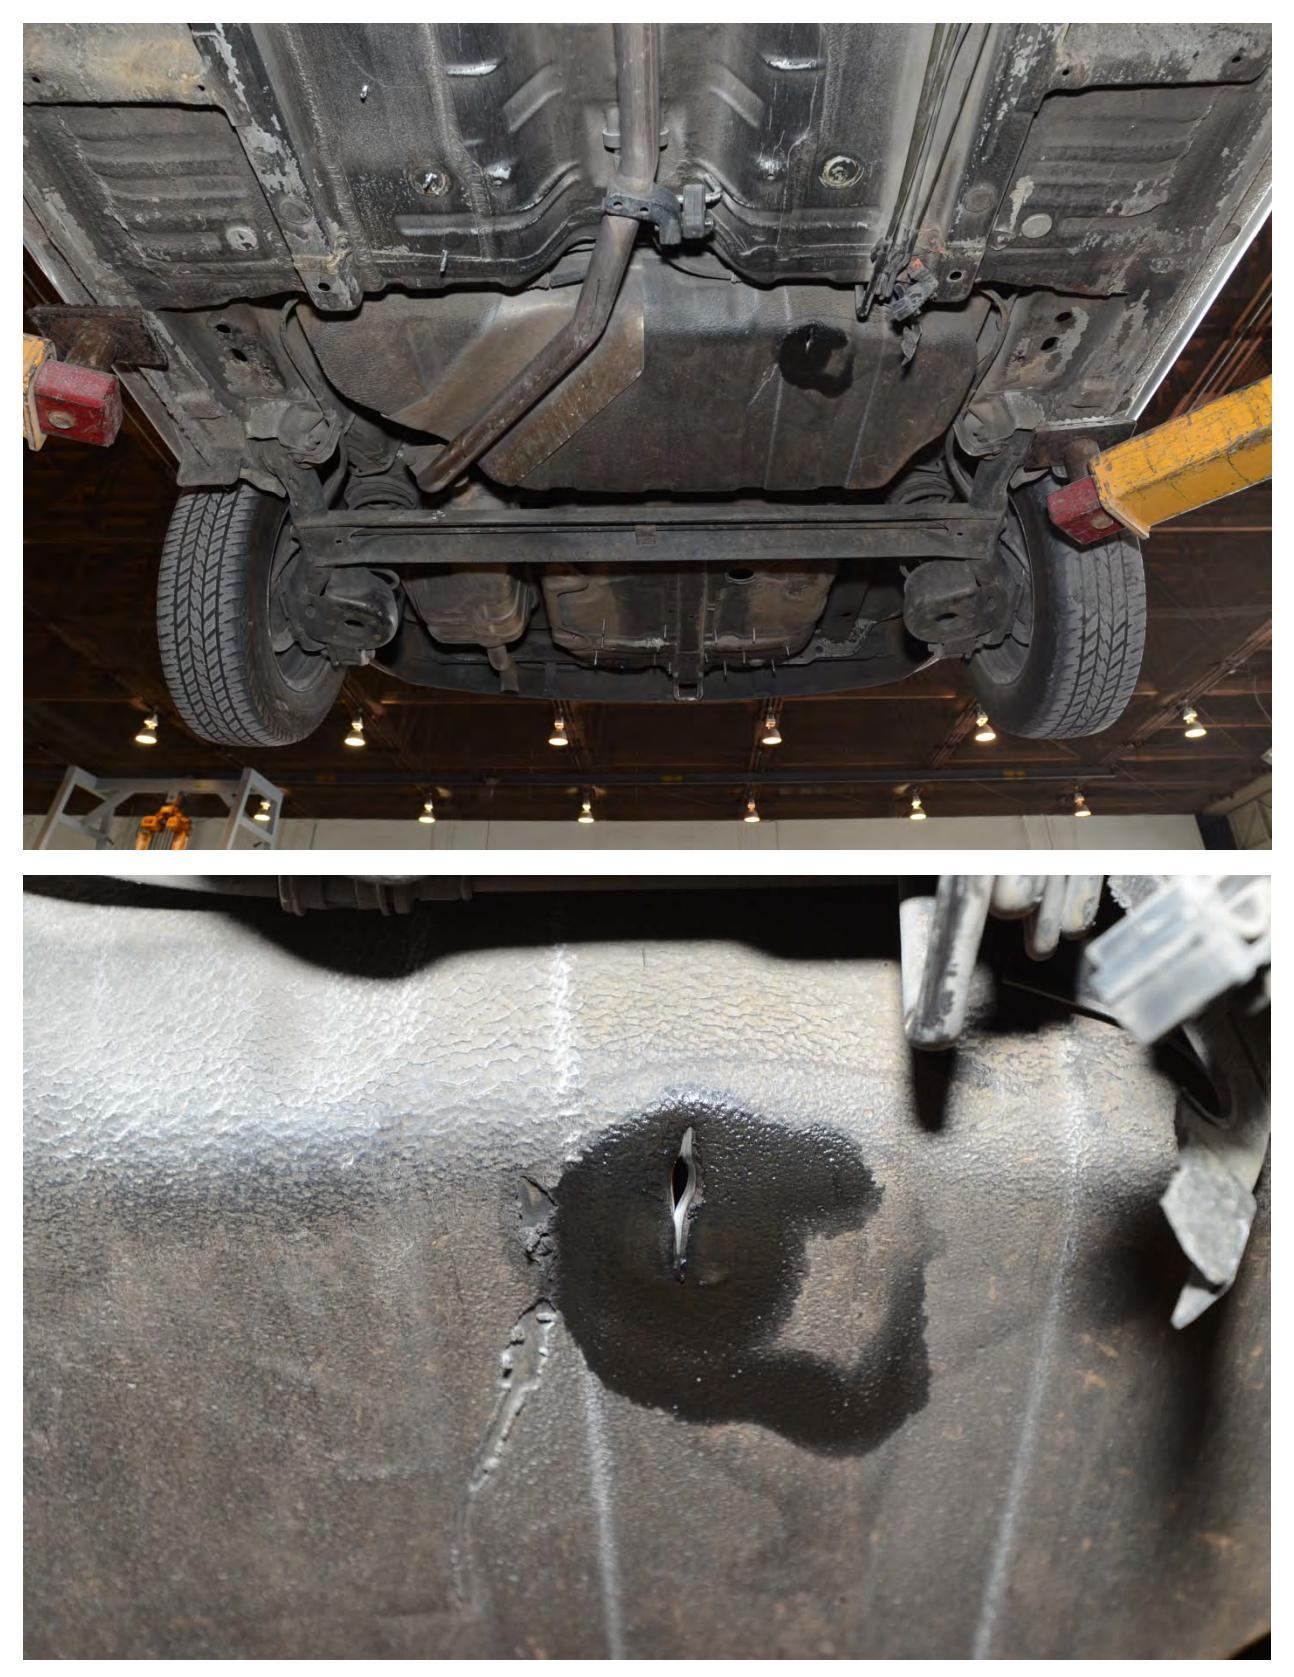
Figure 5.21. Vehicle Gas Tank after Test No. 466393-3.

Figure 5.20 shows damage to the 1100C vehicle. The hood sustained scuff marks. No measureable deformation was noted to the exterior hood or bumper. Contact with the top corner of the first fabric roll-up sign panel caused the windshield to shatter over an area measuring 3 inches \times 3.5 inches. This area was deformed toward the occupant compartment 0.75 inches, but there was no penetration or tear of the plastic liner. Contact of the plastic corner pocket from the second roll-up sign caused cracking of the windshield in two other small areas measuring 2.5-inch \times 2-inch and 1.5-inch \times 1-inch. There was no deformation of these areas into the occupant compartment. The gas tank had a puncture measuring 1.85 inches \times 0.26 inch. Figure 5.21 shows the damage to the gas tank. Table D8 and D9 in Appendix D provides exterior crush and occupant compartment measurements.
