PERFORMANCE LIMITS FOR 6-IN. (152-MM) HIGH CURBS PLACED IN ADVANCE OF THE MGS USING MASH VEHICLES PART II: FULL-SCALE CRASH TESTING

MwRSF Research Report No. TRP-03-221-09

October 30, 2009

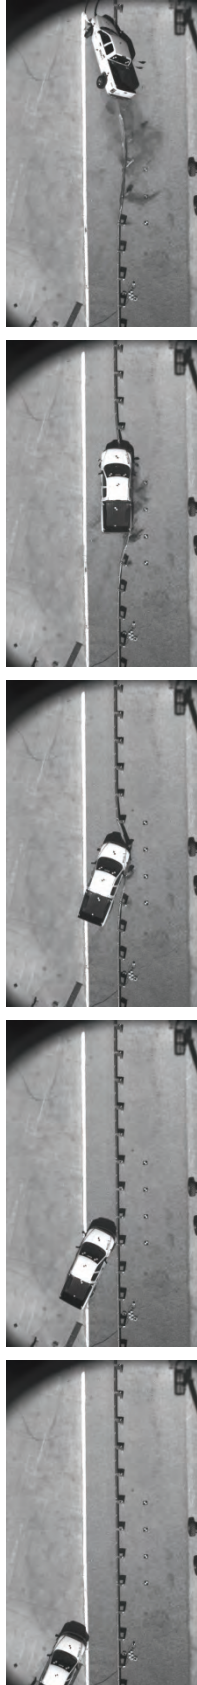
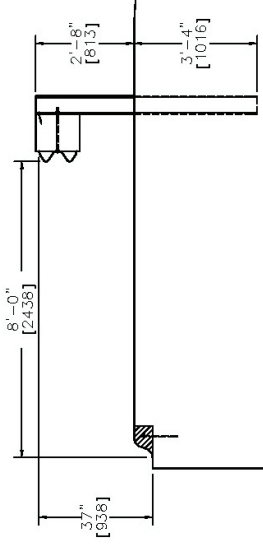
Figure 20. Summary of Test Results and Sequential Photographs, Test No. MGSC-5

The analysis of the test results for test no. MGSC-5 showed that the MGS guardrail and curb configuration did not adequately contain nor redirect the 2270P vehicle, since the vehicle did not remain upright after collision with the barrier. There were no detached elements nor fragments which showed potential for penetrating the occupant compartment nor presented undue hazard to other traffic. Deformations of, or intrusions into the occupant compartment that could have caused serious injury did occur with the deformation of the vehicle's roof. Vehicle roll, pitch, and yaw angular displacements were noted, as shown in Appendix E, and were deemed unacceptable because they adversely influenced occupant risk safety criteria. Therefore, test no. MGSC-5 conducted on the MGS offset 8 ft (2.438 m) behind a 6-in. (152-mm) high curb was determined to be unacceptable according to test designation no. 3-11 of the TL-3 safety performance criteria found in MASH.

Following the unacceptable test results, the causes of vehicle rollover were determined from a series of events. As the vehicle impacted the guardrail, redirection was initiated; however, due to the upward lift of the truck following curb contact, the right-front wheel contacted the guardrail. As the system rotated, post no. 15 applied an upward force on the vehicle's front end, causing the front of the vehicle to pitch upward and the front bumper to rise above the guardrail. At this same time, the right-front wheel snagged on post no. 15, causing the pickup to roll toward the system. Subsequently, the right-front wheel detached from the vehicle due to the snag and was pulled underneath the pickup truck. As the vehicle continued along its path, the right-rear wheel then contacted the disengaged right-front wheel and overrode it. This caused the rear end of the vehicle to pitch upward, and shortly thereafter the vehicle became airborne. The pickup, which previously began to roll due to wheel snag, lost contact with the guardrail and continued to roll while airborne. This in turn caused the vehicle to roll over completely.

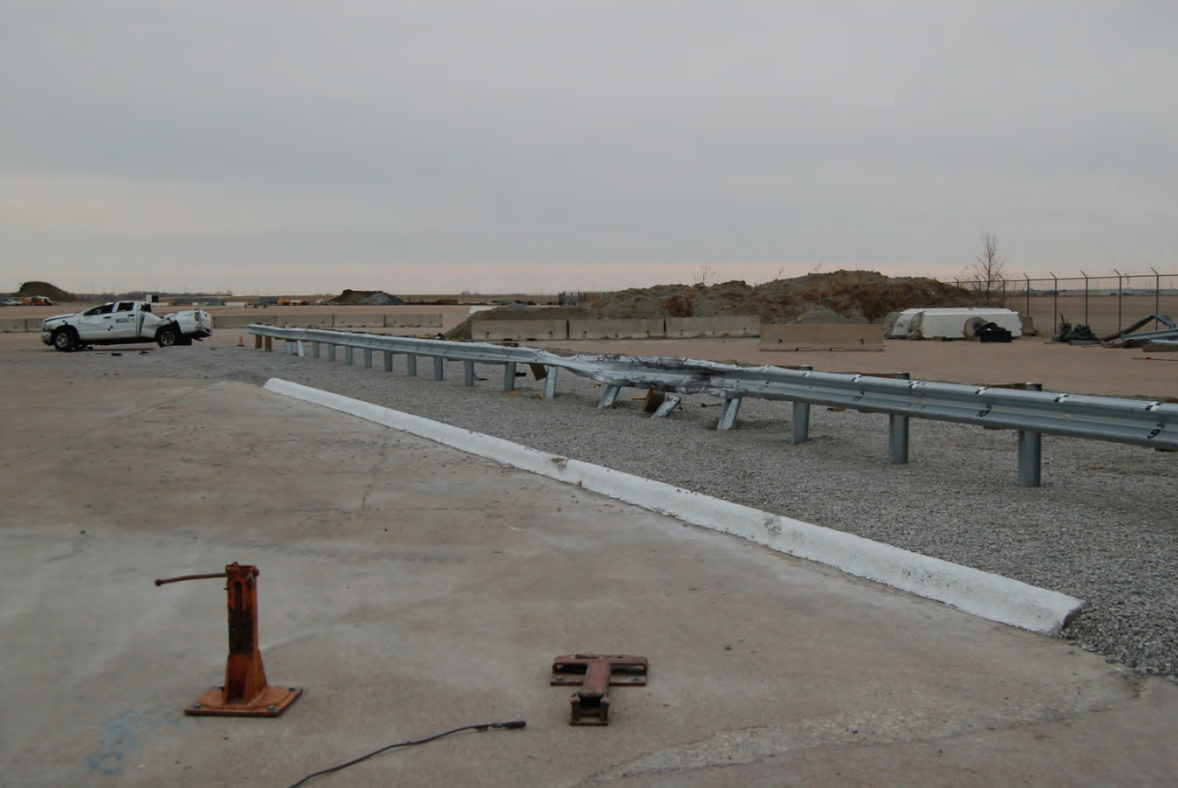
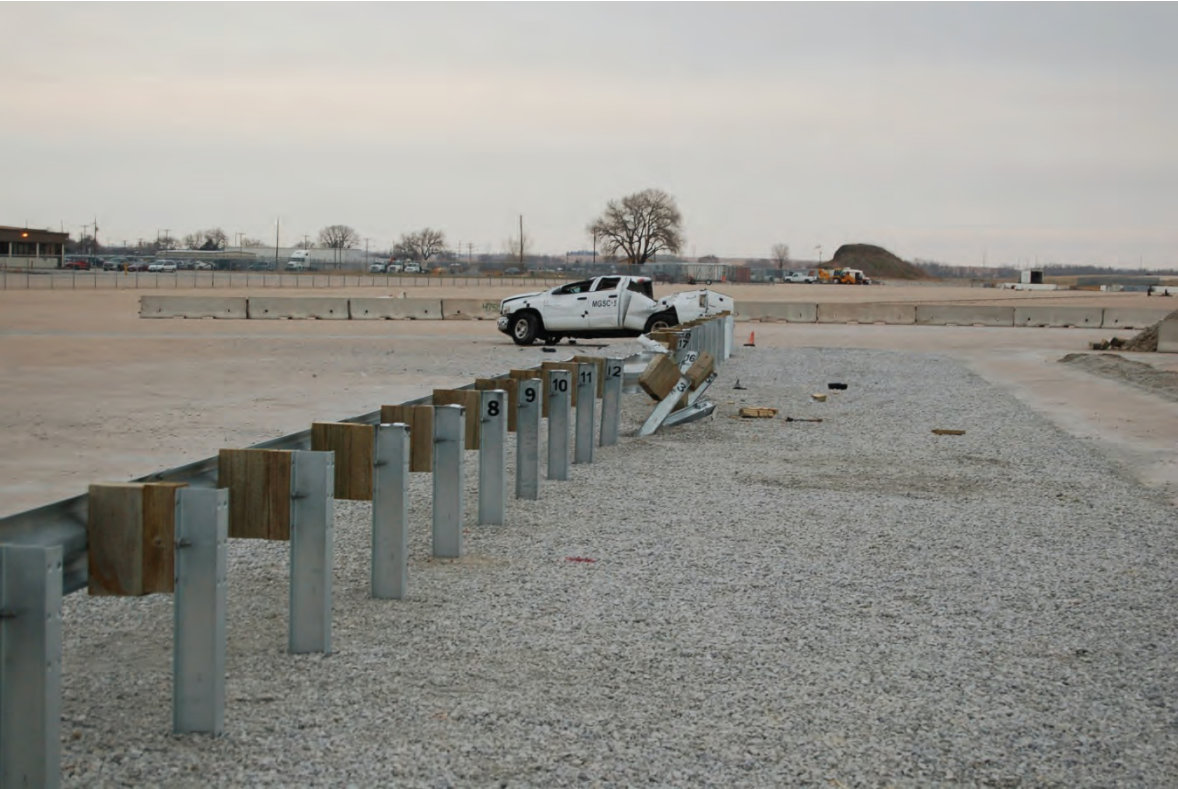
Figure 25. Impact Location, Test No. MGSC-5

Initial vehicle impact with the guardrail was to occur between post nos. 12 and 13, or 14 ft-11 in. (4.55 m) upstream of the splice between post nos. 14 and 15, as shown in Figure 25. The actual point of impact was 14 ft-7 ½ in. (4.46 m) upstream of the splice between post nos. 14 and 15. A sequential description of the impact events is contained in Table 4. The final position of the vehicle was determined to be 130 ft-8 ½ in. (39.84 m) downstream from impact and 22 ft-10 in. (6.96 m) laterally away from the traffic-side face of the barrier, as shown in Figures 20 and 26.

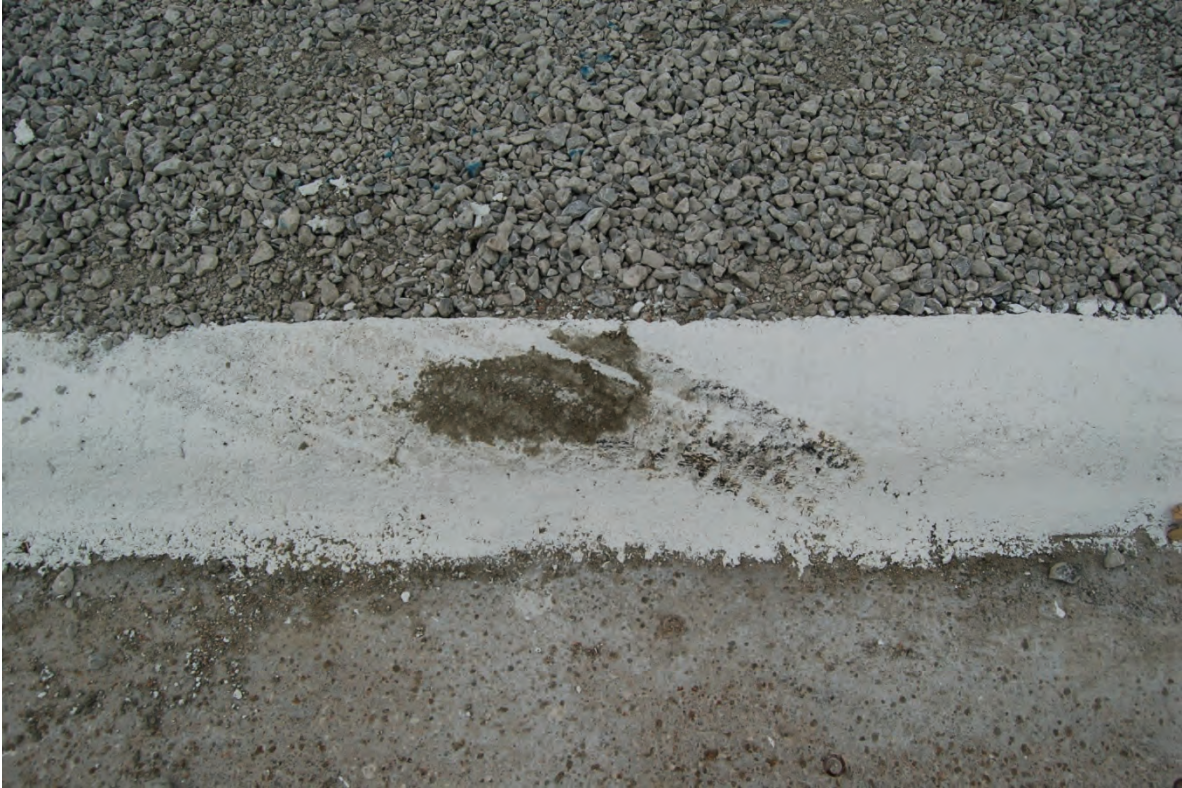
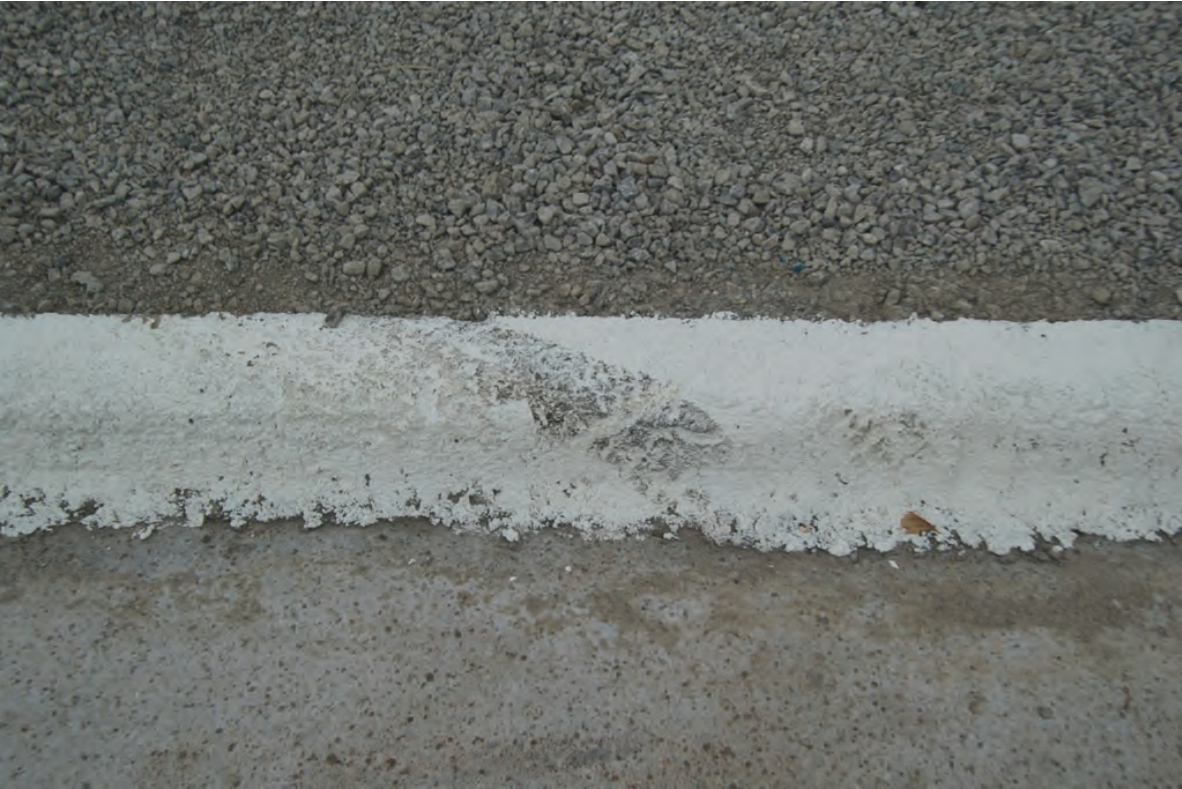
Figure 27. System Damage, Test No. MGSC-5

Damage to the barrier was moderate, as shown in Figures 27 through 38. Barrier damage consisted of deformed guardrail posts, disengaged wooden blockouts, contact marks on several sections of guardrail and the curb, and deformed W-beam rail. Five areas of contact between the vehicle and guardrail occurred, with the most substantial damage occurring at the original impact point. Three regions of light scuff marks occurred downstream of the original impact as the vehicle rolled. The final contact area occurred when the vehicle landed upside-down on the guardrail. The length of the original vehicle contact along the system was approximately 30 ft-3 in. (9.22 m), which spanned from 12 in. (305 mm) downstream of post no. 12 through the centerline of post no. 17.

The permanent set of the barrier system is shown in Figure 27. The maximum permanent set rail and post deflections were 24 in. (610 mm) at post no. 15 and 28 in. (711 mm) at post no. 14, respectively, as measured in the field. The maximum lateral dynamic rail and post deflections were 50.5 in. (1,283 mm) at post no. 14 and 28.5 in. (724 mm) at post no. 13, respectively, as determined from high-speed digital video analysis. The working width was not determined due to vehicle rollover.

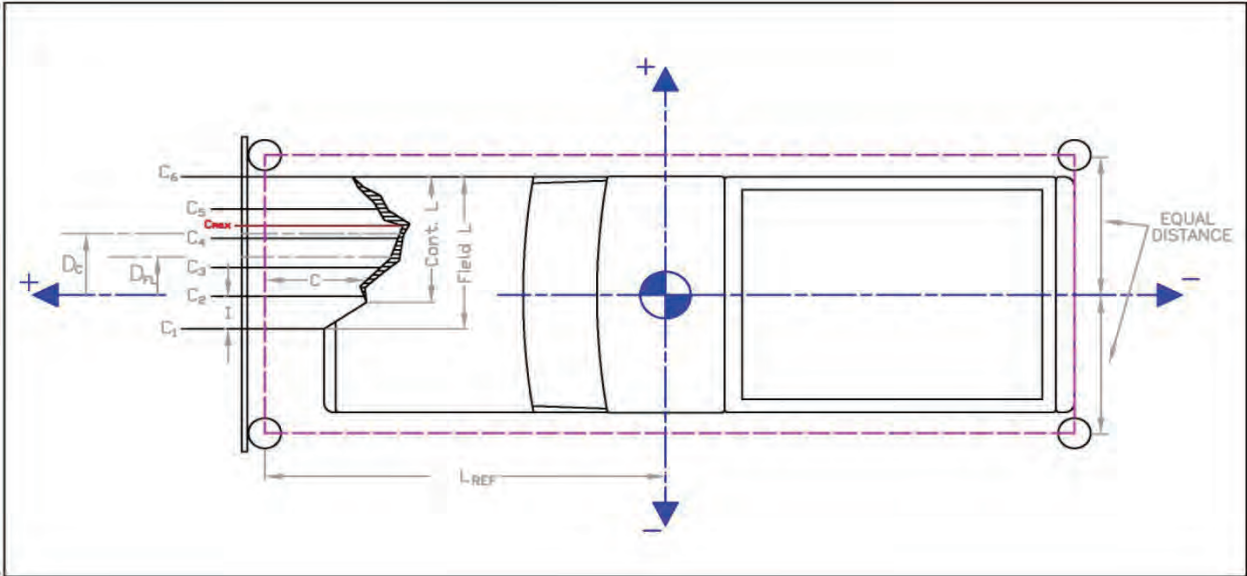
Figure D-4. Exterior Vehicle Crush (NASS) - Front, Test No. MGSC-5

in.	(mm)
Distance from C.G. to reference line - L _{REF} :	105	(2667)
Width of contact and induced crush - Field L:	27.25	(692)
Crush measurement spacing interval (L/5) - I:	5.45	(138)
Distance from center of vehicle to center of Field L - D _{FL} :	25.625	(651)
Width of Contact Damage:	27.25	(692)
Distance from center of vehicle to center of contact damage - D _C :	25.75	(654)

Crush Measurement		Lateral Location		Original Profile Measurement		Dist. Between Ref. Lines		Actual Crush	
	in.	(mm)	in.	(mm)	in.	(mm)	in.	(mm)	in.	(mm)
C ₁	3.75	(95)	12	(305)	11	(279)	-7.0818	-(180)	-0.1682	-(4)
C ₂	6.25	(159)	17.45	(443)	11.9844	(304)			1.34742	(34)
C ₃	12.5	(318)	22.9	(582)	13.2344	(336)			6.34742	(161)
C ₄	na	#####	28.35	(720)	15.3594	(390)			#####	#####
C ₅	na	#####	33.8	(859)	19.0313	(483)			#####	#####
C ₆	na	#####	39.25	(997)	29	(737)			#####	#####
C _{MAX}	24.5	(622)	29	(737)	15.6875	(398)			15.8943	(404)

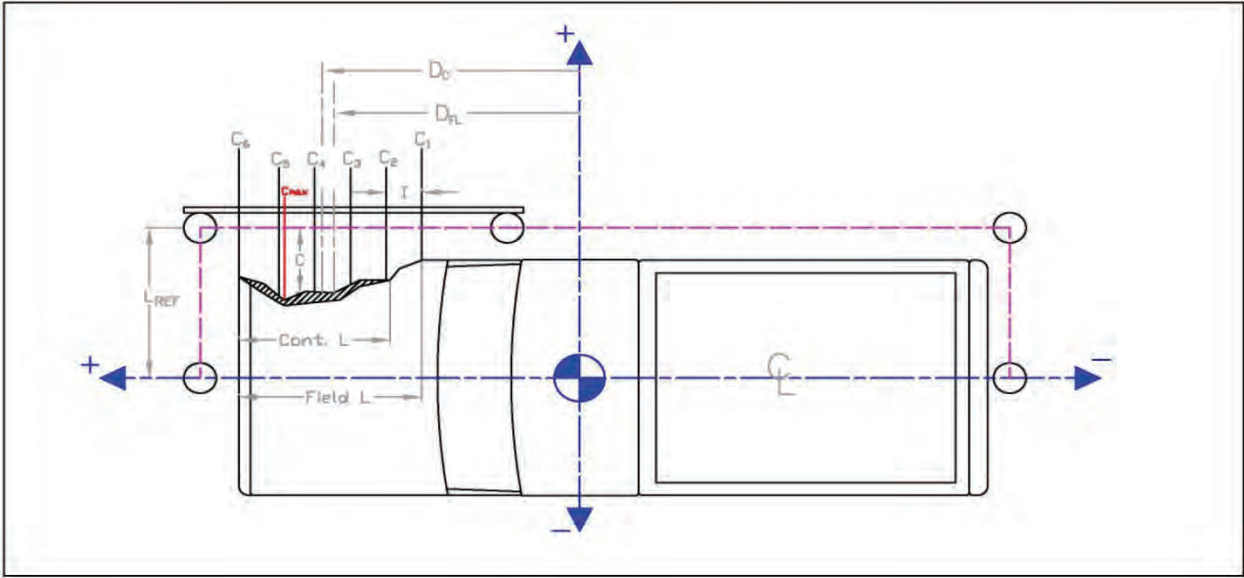
Figure D-5. Exterior Vehicle Crush (NASS) - Side, Test No. MGSC-5

Distance from centerline to reference line - L_{REF}: 45 (1143)

Width of Contact Damage: 67.625 (1718)
