**Test Report No. 608431-01-1&2**  
**Test Report Date: October 2018**

**MASH TESTS 3-34 AND 3-35 ON THE 31-INCH BURIED-IN-  
BACKSLOPE TERMINAL COMPATIBLE WITH MGS GUARDRAIL**

Contract No.: T4541-CQ (1705445/C2005312.70)  
Test No.: 608431-01-1 / 608431-01-2  
Test Date: 2018-04-30 / 2018-06-01

Sponsored by  
**Roadside Safety Research Program Pooled Fund**  
**Study No. TPF-5(114)**

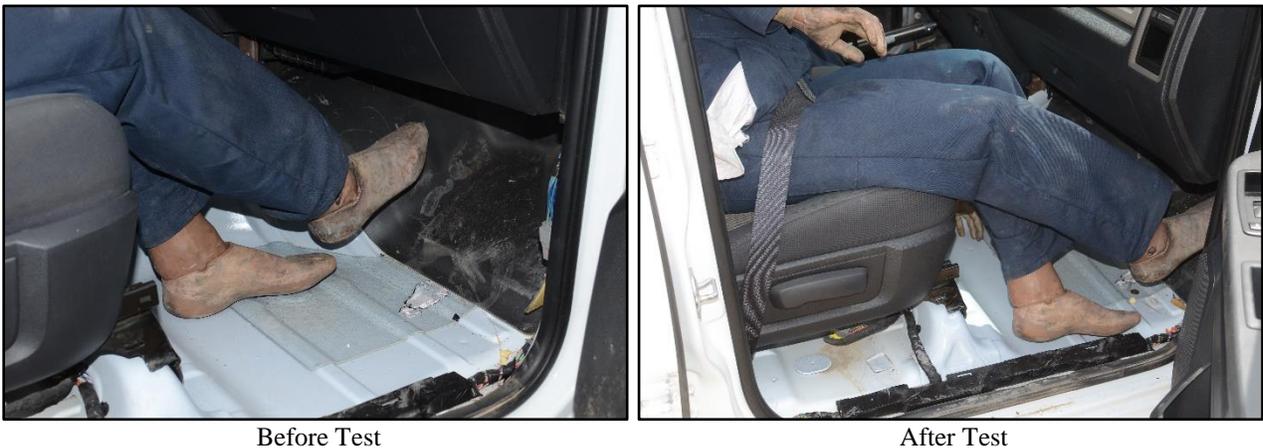
**Figure 6.7. Interior of Test Vehicle for Test No. 608431-01-1.**

Figure 6.6 shows the damage sustained by the vehicle. The front bumper grill, right front tire and rim, right front and rear doors, rear exterior bed, right rear tire and rim, and rear bumper were damaged. Maximum exterior crush to the vehicle was 10.0 inches in the front plane at the right front corner at bumper height. No occupant compartment deformation or intrusion was noted. Figure 6.7 shows the interior of the vehicle. Tables D.3 and D.4D.4 in Appendix D1 provide exterior crush and occupant compartment measurements.
