Test Report No. 608551-01-1-5

Test Report Date: April 2019

***MASH TL-3 EVALUATION OF 31-INCH W-BEAM GUARDRAIL
WITH WOOD AND STEEL POSTS IN CONCRETE MOW STRIP***

Contract No.: T4541-CS

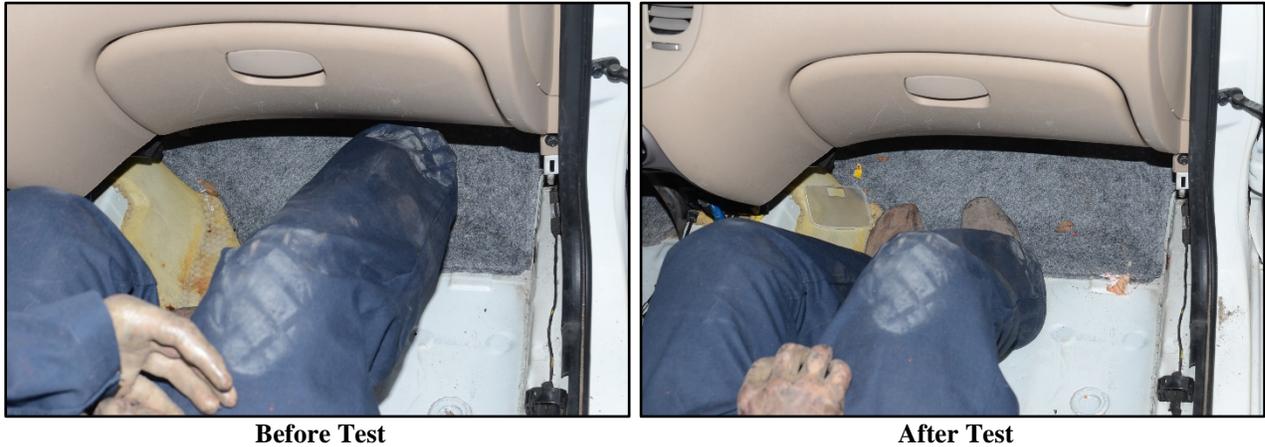
Figure 4.8. Interior of Test Vehicle for Test No. 608551-1.

Figure 4.7 shows the damage sustained by the vehicle. The front bumper, hood, right front fender, right front tire and rim, right front and rear doors, right rear quarter panel, and the rear bumper were damaged. Maximum exterior crush to the vehicle was 10.0 inches in the side plane at the right front corner at bumper height. No occupant compartment deformation or intrusion occurred. Figure 4.8 shows the interior of the vehicle. Tables D.2 and D.3 in Appendix D1 provide exterior crush and occupant compartment measurements.

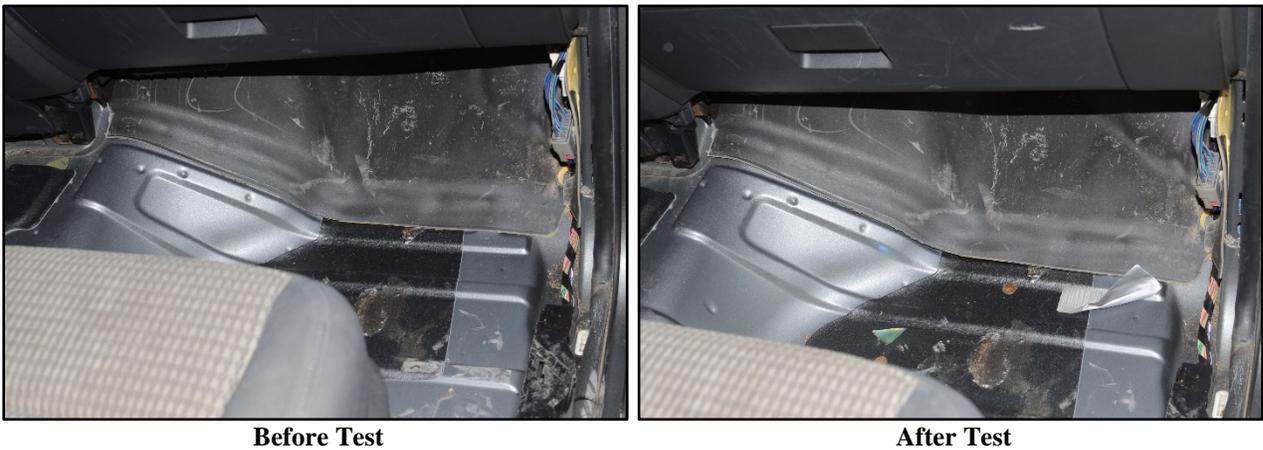
Figure 4.14. Interior of Test Vehicle for Test No. 608551-2.

Figure 4.13 shows the damage sustained by the vehicle. The front bumper, grill, radiator, left front fender, left front and rear doors, left rear exterior bed, right front fender, and right front tire were damaged. Maximum exterior crush to the vehicle was 24.0 inches in the front plane at the right front quarter point at bumper height. No occupant compartment deformation or intrusion was noted. Figure 4.14 shows the interior of the vehicle. Tables E.3 and E.4 in Appendix E1 provide exterior crush and occupant compartment measurements.

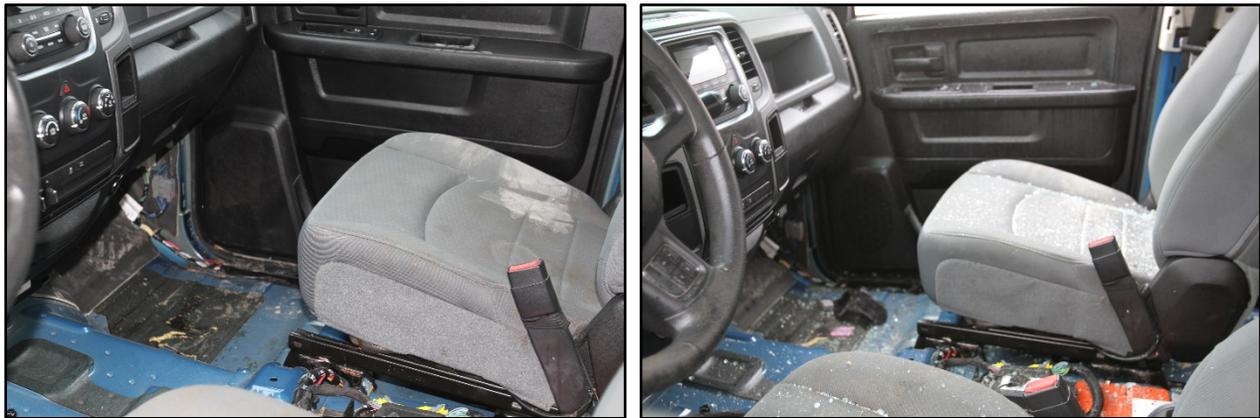
Figure 5.6 shows the damage sustained by the vehicle. The front bumper, hood, grill, upper and lower A-arms, upper and lower ball joint mounts, right front fender, right front tire and rim, right front door and window glass, right rear door, and right rear exterior bed were damaged in the initial impact. After losing contact with the guardrail, the vehicle rolled clockwise 360°, thereby damaging the roof, windshield, left front fender, left front and rear doors, left front door window glass, left rear exterior bed, right A and B posts, and right rear door window glass. Maximum exterior crush to the vehicle was 8.0 inches in the front and side planes at the right front corner at bumper height. Maximum occupant compartment deformation was 12.0 inches in the right front passenger roof area. Figure 5.7 shows the interior of the vehicle. Tables F.2 and F.3 in Appendix F1 provide exterior crush and occupant compartment measurements.

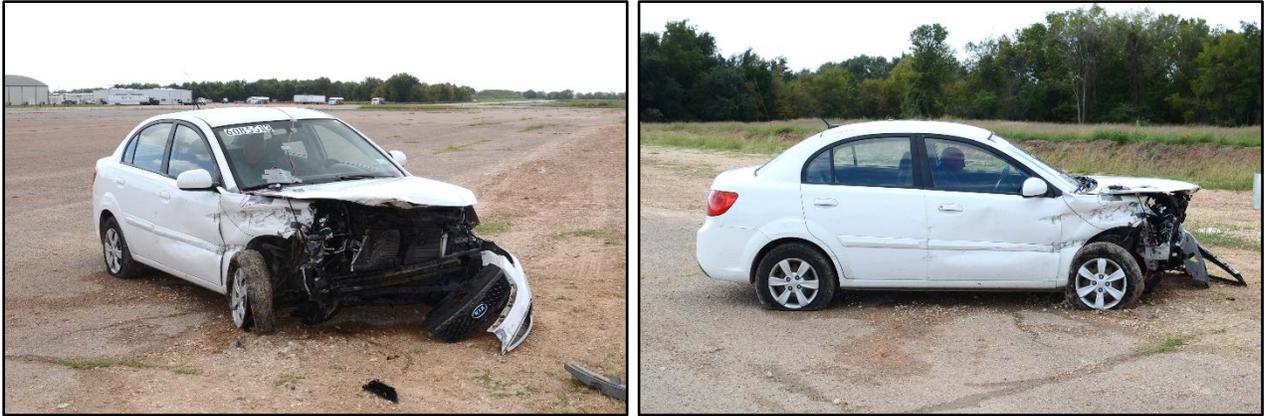
Figure 6.7. Test Vehicle after Test No. 608551-3.

Figure 6.7 shows the damage sustained by the vehicle. The front bumper, hood, radiator and support, right front fender, and right front door were deformed. The right front strut, right front tire and rim, and right rear tire were also damaged. Maximum exterior crush to the vehicle was 11.0 inches in the side plane at the right front corner at bumper height. No occupant compartment deformation or intrusion occurred. Figure 6.8 shows the interior of the vehicle. Tables G.2 and G.3 in Appendix G1 provide exterior crush and occupant compartment measurements.

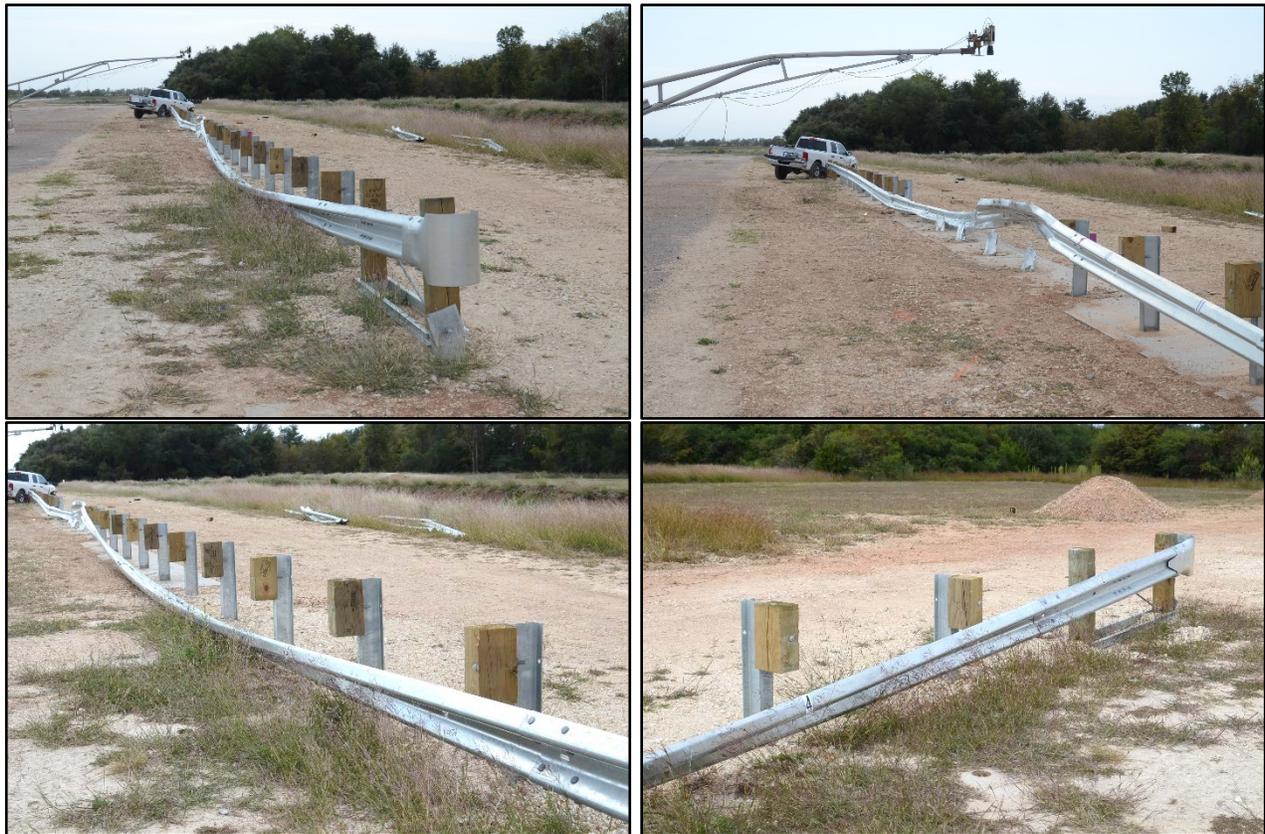
Figure 6.12. Guardrail after Test No. 608551-4.

Figures 6.12 through 6.14 show the damage to the guardrail. Post 1 was pulled downstream 3.0 inches, and post 2 was pulled downstream 0.5 inch at ground level. Posts 3 through 11 showed no apparent movement, and the rail element was separated from posts 2 through 12. Post 12 had rotated 10° clockwise, but the grout was not disturbed. Post 13 was displaced 1.0 inches toward field side and rotated 30° clockwise, but remained attached to the rail element. The blockouts separated from posts 14 through 18, and the posts were leaning downstream 15°. Post 19 had rotated 50° clockwise with evidence of vehicle contact on the flanges on the impact side of the post. The rail element released from posts 14-23 and 25-28. The soil around posts 29 and 30 was disturbed. Working width was 53.9 inches, and height of working width was 60.1 inches. Maximum dynamic deflection during the test was 50.6 inches, and maximum permanent deformation was 21.0 inches.

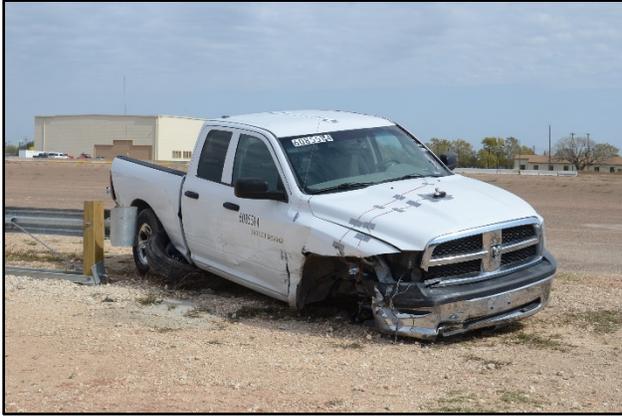
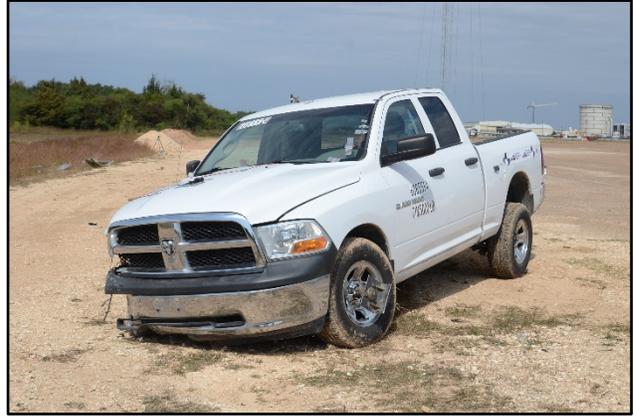
Figure 6.15. Test Vehicle after Test No. 608551-4.

Figure 6.15 shows the damage sustained by the vehicle. The front bumper, grill, right front fender, right upper and lower ball joints, right front tire and rim, right front and rear doors, right exterior bed, and rear bumper were damaged. Maximum exterior crush to the vehicle was 10.0 inches in the side plane at the right front corner just above the bumper. No occupant compartment deformation or intrusion occurred. Figure 6.16 shows the interior of the vehicle. Tables E.3 and D. in Appendix D1 provide exterior crush and occupant compartment measurements.
