Research Project Number 20180380-01-NEB

FULL-SCALE CRASH TEST OF A TWO-BAR METAL BRIDGE RAIL

MwRSF Research Report No. TRP-03-419-19

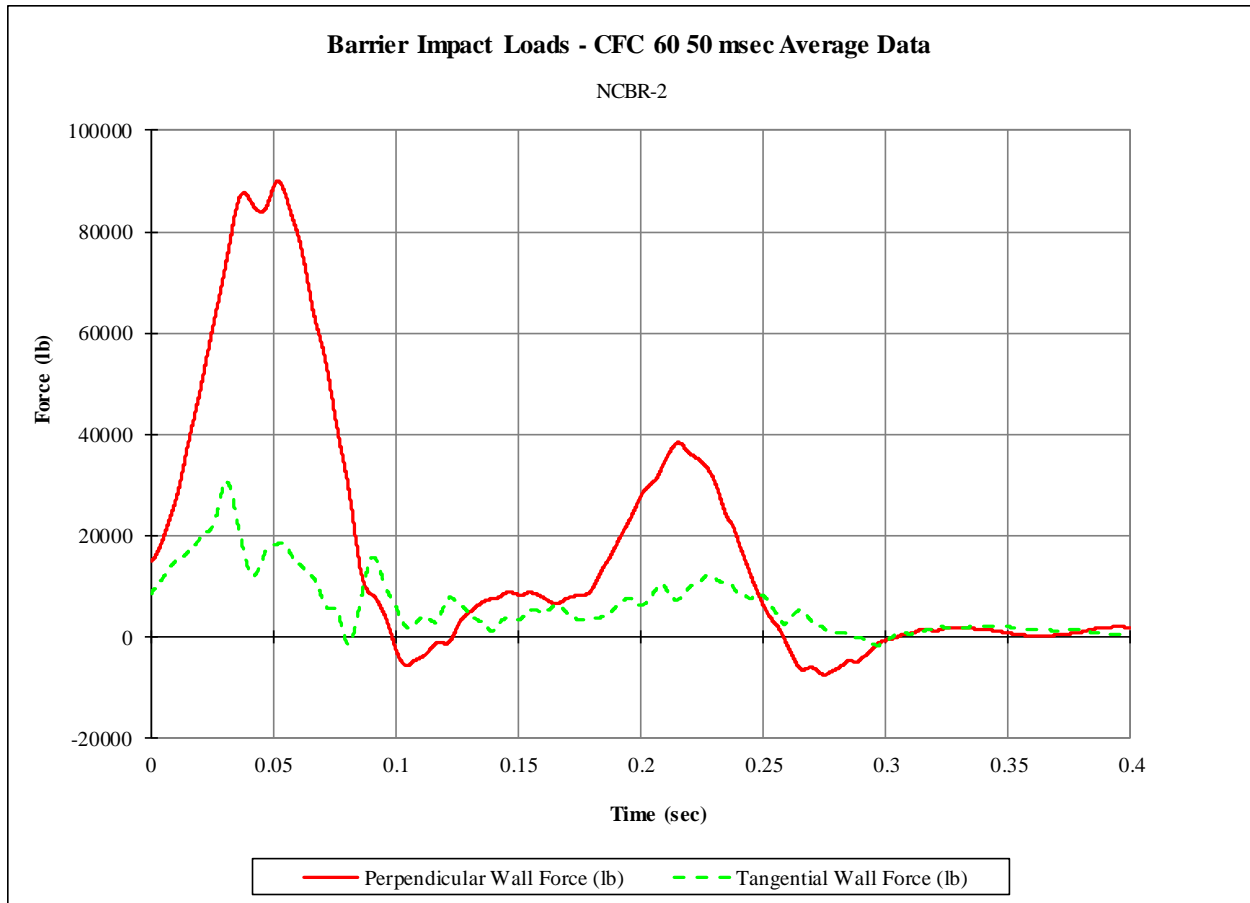
Figure 86. Estimated Barrier Impact and Friction Loads, Test No. NCBR-2

The longitudinal and lateral vehicle accelerations, as measured at the vehicle's c.g., were processed using an SAE CFC-60 filter and a 50-msec moving average. The 50-msec moving average vehicle accelerations were then combined with the uncoupled yaw angle versus time data in order to estimate the vehicular loading applied to the barrier system. The results of the barrier load estimate are shown in Figure 86. A peak load of 89.9 kip was noted at 0.052 s after impact, with a peak longitudinal wall force of approximately 30.6 kip. The resulting average overall estimated vehicle-barrier sliding friction coefficient was 0.237 measured over the first 0.1 s of impact. The vehicle exhibited a "tail slap" effect in which two separate peaks were observed, the first corresponding to the redirection of the front of the vehicle, and the second corresponding to the tail end of the vehicle contacting the barrier system. The initial redirection load was more than twice as large as the tail slap load.

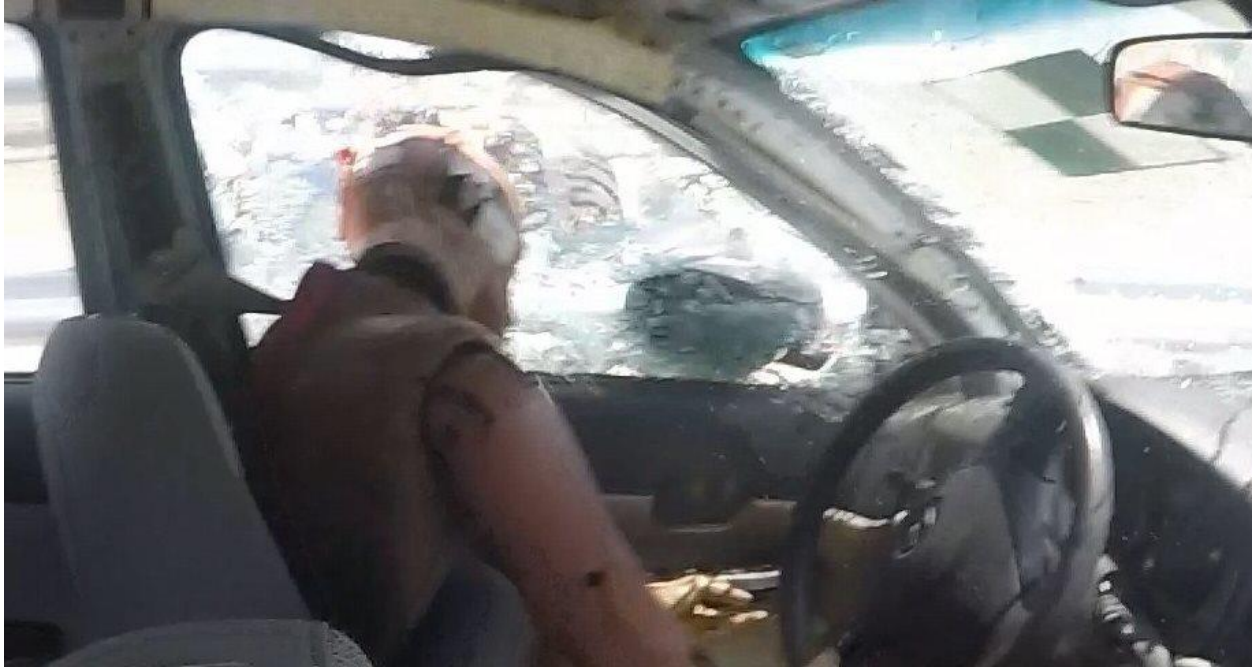
Figure 94. Maximum Occupant Head Protrusion, Test No. NCBR-1

Onboard high-speed footage for test nos. NCBR-1 and NCBR-2 is shown in Figures 88 through 91. Onboard camera views of the occupant's head movement are shown in Figures 92 through 95. For test no. NCBR-1, the maximum head protrusion occurred at 0.109 s, and a close-up view of maximum head extension is shown in Figure 94. For test no. NCBR-2, the maximum head protrusion occurred at 0.142 s, and is shown in Figure 95.

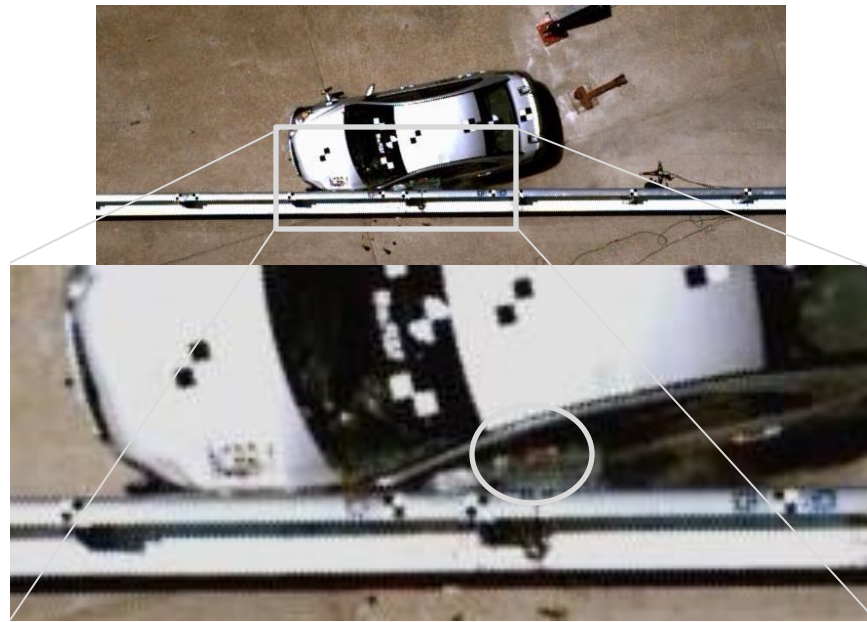
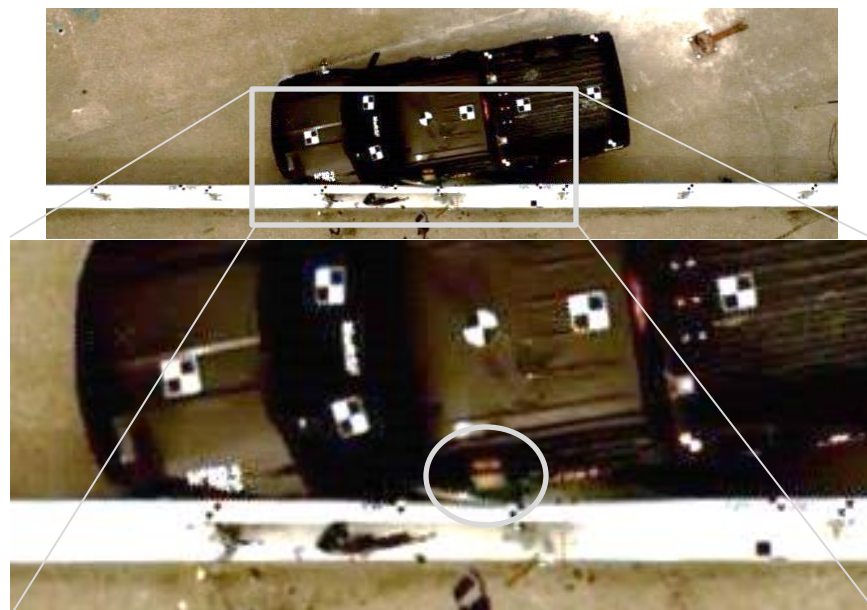
Figure 96. Vehicle Position and Dummy Head Protrusion at Maximum Dummy Movement, Test Nos. NCBR-1 and NCBR-2

Video analysis of the velocity profile and positioning of the dummy's head during both tests suggested that head contact did not occur. The velocity profiles, taken from onboard views, were smooth and lacked any abrupt transitions in speed or position, which would have indicated an impact. Vehicle positions at 0.109 sec for test no. NCBR-1 and 0.142 sec for test no. NCBR-2 are shown in Figure 96. Although significant head protrusion was visible in the overhead video, the protrusion did not appear to overlap the rail in either test. It was concluded that the dummy did not contact the test article in either of test nos. NCBR-1 or NCBR-2. Therefore, both tests were deemed to have successfully passed MASH 2016 evaluation criteria, using a stringent interpretation of the occupant risk criteria.
