*Research Project Number TPF-5(193) Supplement #113  
WisDOT Sponsoring Agency Code RFPF-WISC-6*

## **DYNAMIC TESTING AND EVALUATION OF CULVERT-MOUNTED, STRONG-POST MGS TO TL-3 GUIDELINES OF MASH 2016**

### **MIDWEST ROADSIDE SAFETY FACILITY**

MwRSF Research Report No. TRP-03-383-20-R1

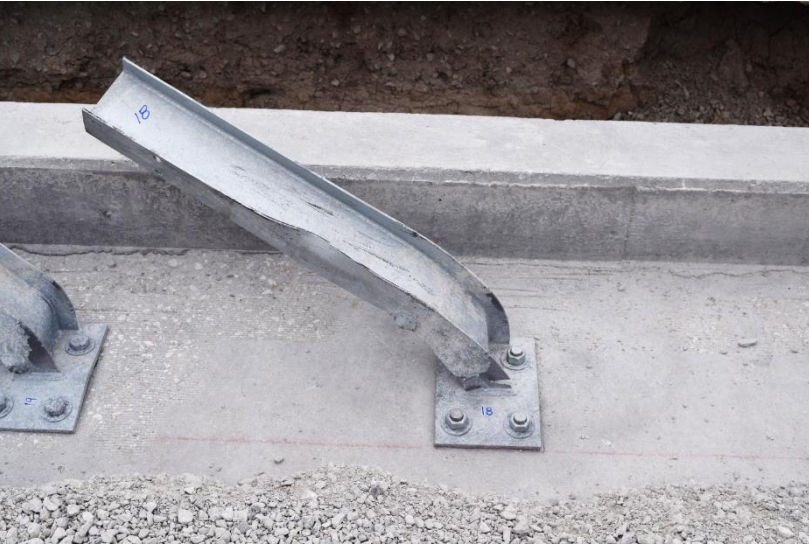
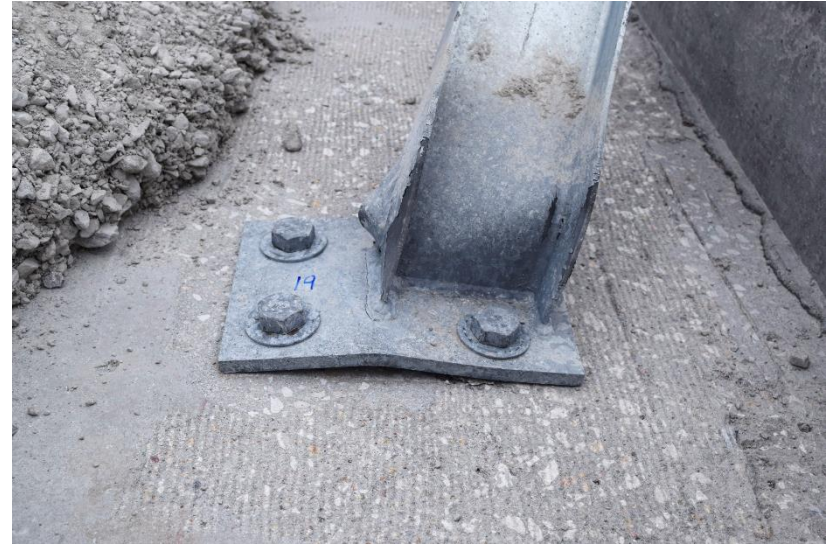
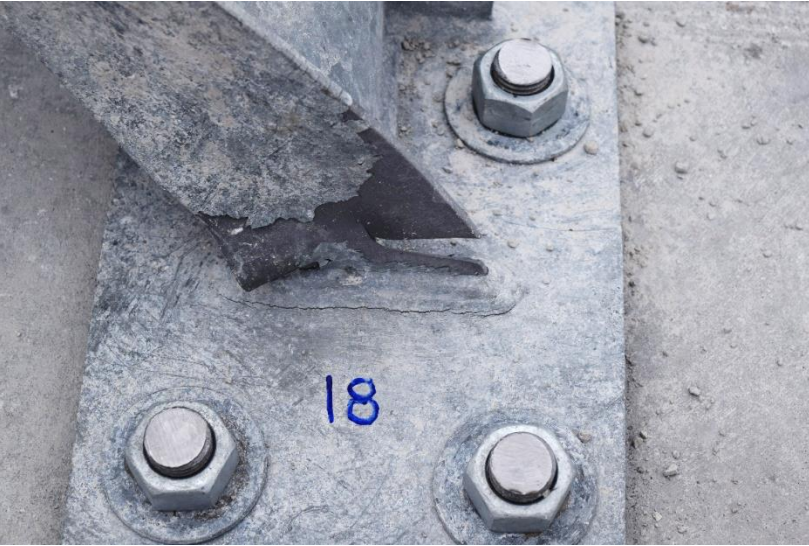
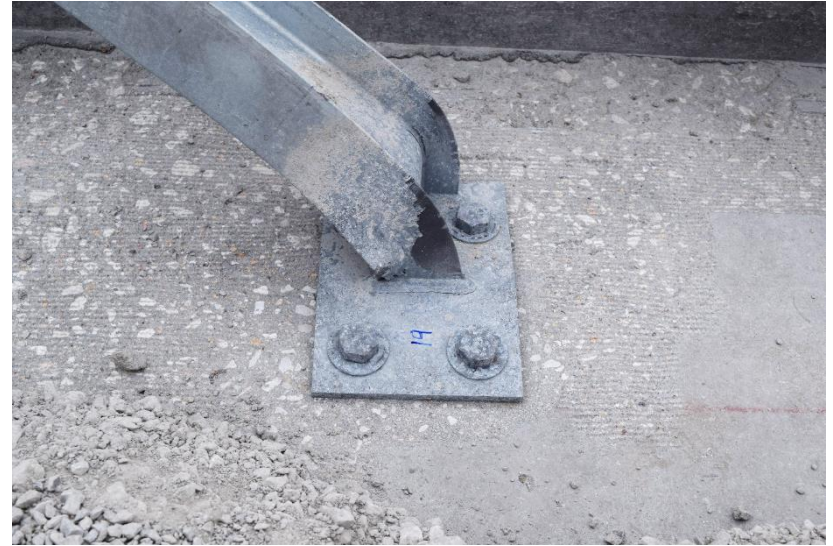
Figure 63. Damage to Post and Base Plate Nos. 18 and 19, Test No. CMGS-1

Post no. 17 slightly deflected backward. Post nos. 18 and 19 were bent longitudinally toward the ground in the downstream direction. Post no. 20 was bent slightly longitudinally downstream. Contact marks were found on the front face of post nos. 18 and 19. No significant post damage occurred to post nos. 1 through 16 nor 21 through 41. The upstream and downstream anchorage systems remained unmoved and the posts in both anchorage systems were not damaged. The wooden blockout at post nos. 18, 19, and 21 disengaged from the system. The blockout at post no. 20 rotated but did not disengage. The blockouts at post nos. 3 through 17 and 22 through 39 were undamaged.

Following the test, the soil on top of the culvert headwall was removed for inspection of the damage to the posts and base plates as well as to review any potential damage to the culvert. Deformation of the post base plates was observed on post nos. 17 through 21. Minor cracking was observed on the weld at the front flange of the base plate of post no. 17. The upstream side of the front flange of post no. 18 was torn up to the web near the base plate weld. All anchorage bolts and epoxied threaded rods were intact and remained secure, although some minor deformation of the bolts and rods was observed. No damage was observed to the concrete culvert slab or the headwall.

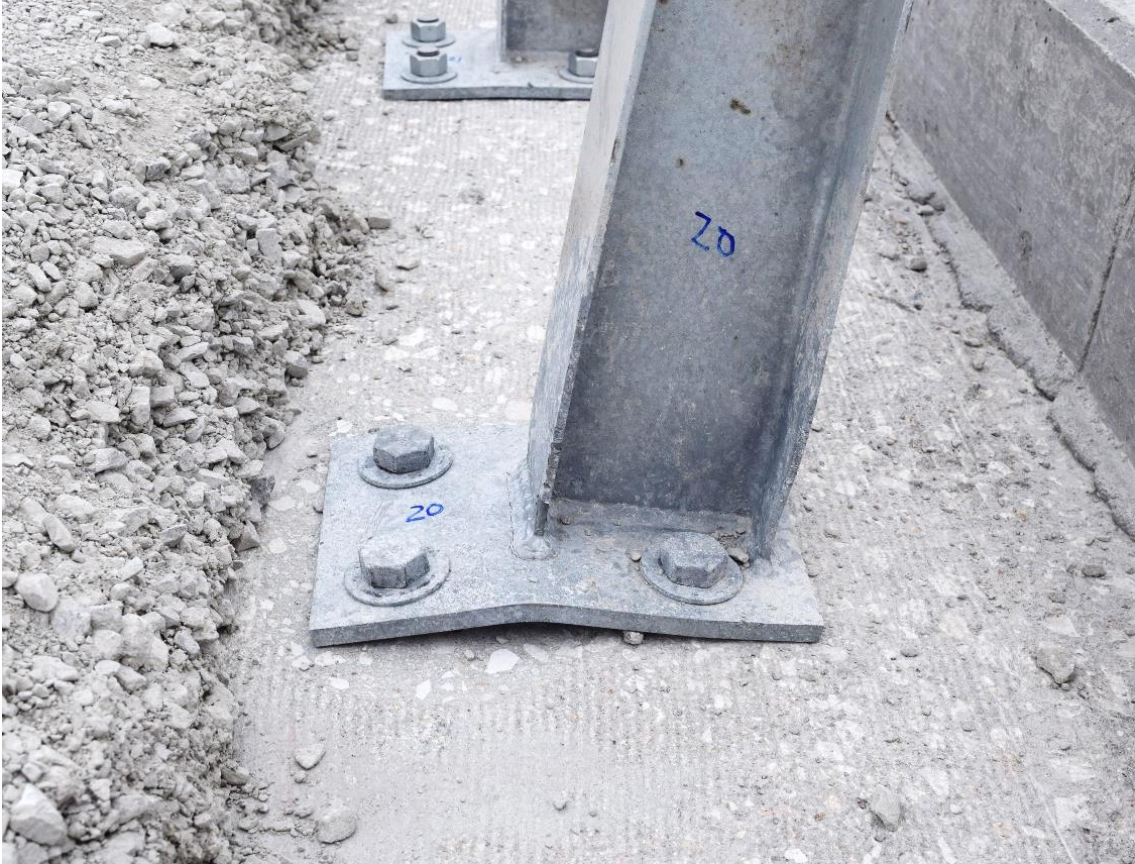
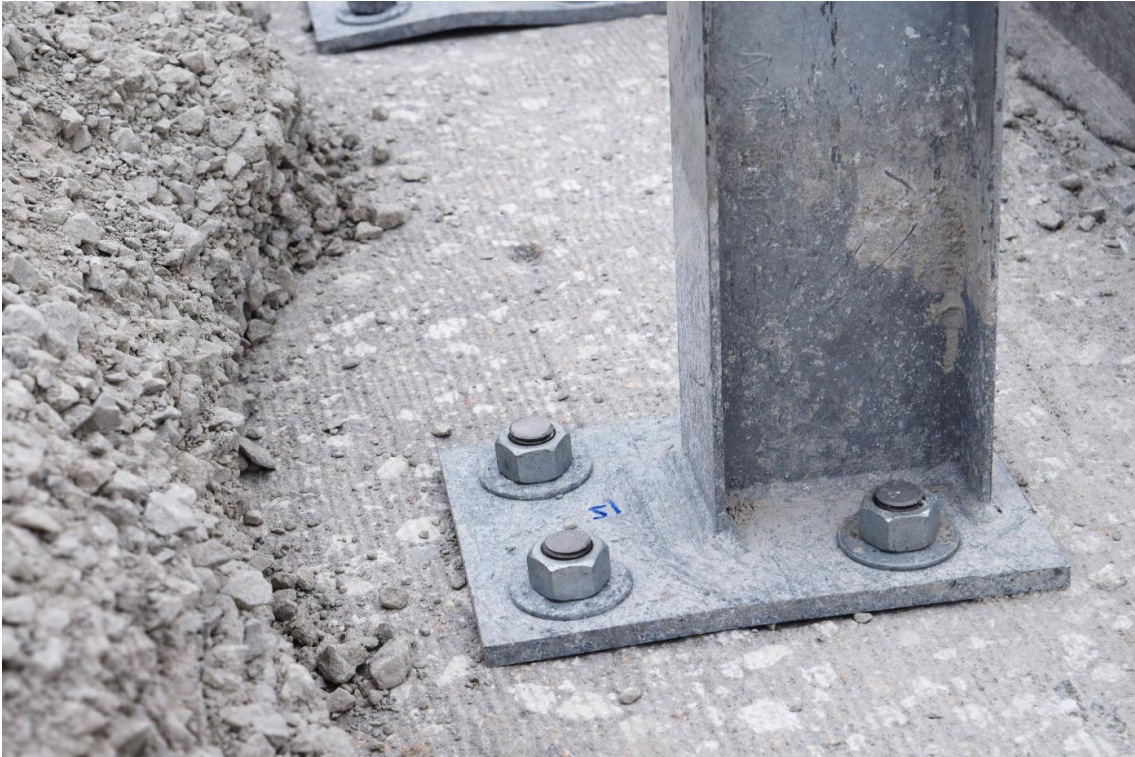
Figure 64. Damage to Post and Base Plate No. 21, Test No. CMGS-1

| TIME (sec) | EVENT |
|---|--|
| 0.196 | Blockout no. 21 fractured. |

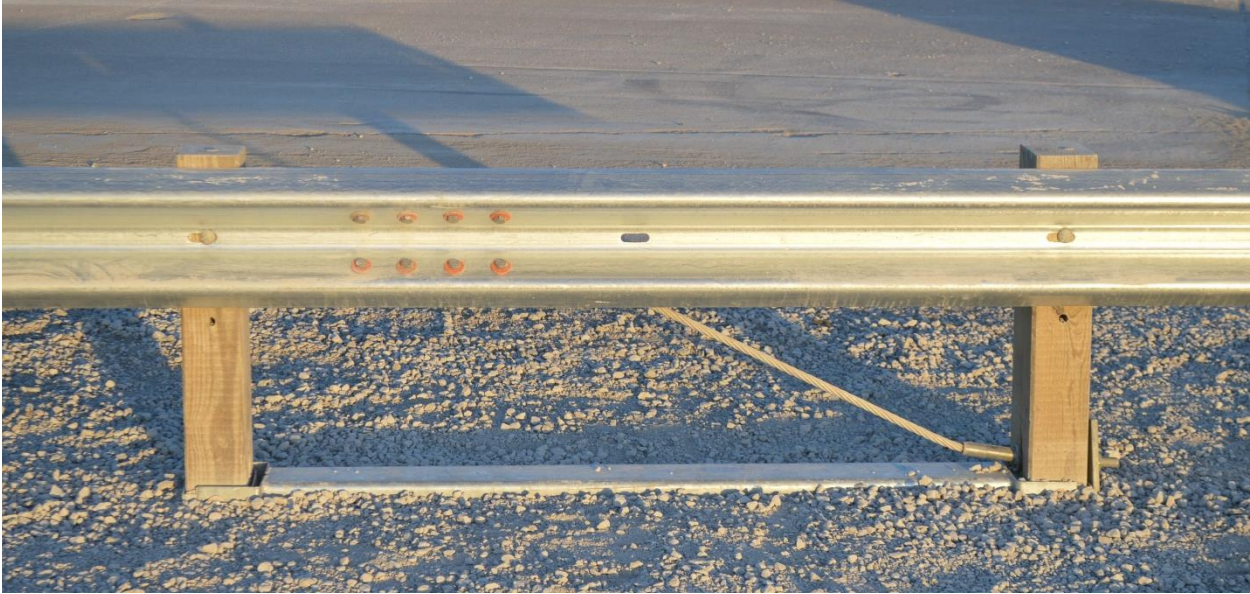
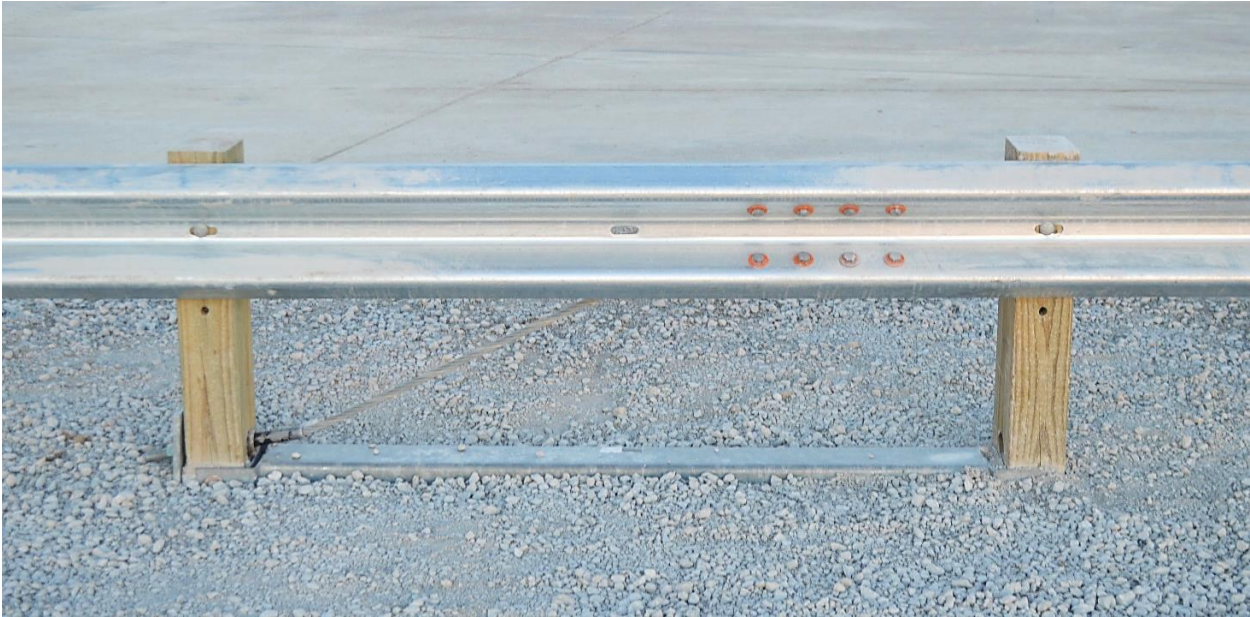
Damage to the barrier was moderate, as shown in Figures 60 through 66. Barrier damage consisted mostly of deformed W-beam, contact marks on the guardrail sections, and deformed posts. The length of vehicle contact along the barrier was approximately 16 ft which spanned from 12 $\frac{5}{8}$  in. (321 mm) downstream from post no. 16 to 15 $\frac{1}{2}$  in. (394 mm) downstream from post no. 21.

Figure 66. (a) Upstream Anchorage System After Test, and (b) Downstream Anchorage System After Test, Test No. CMGS-1

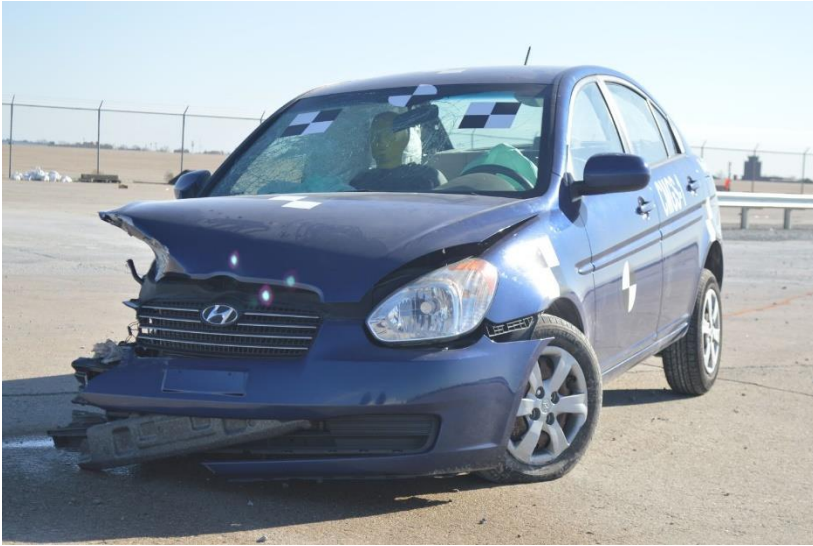
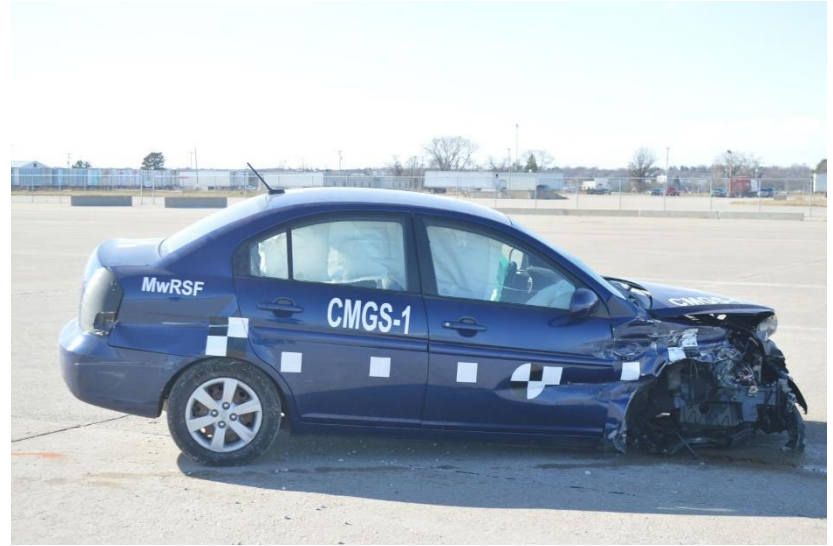
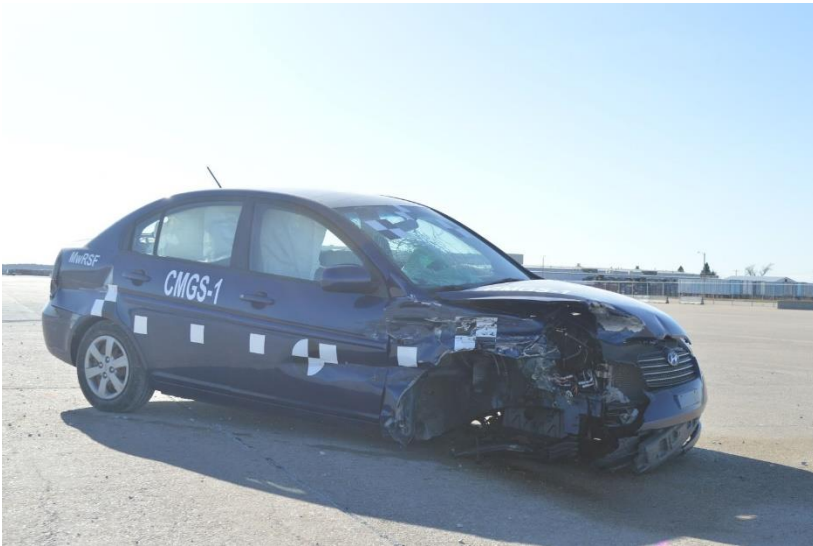
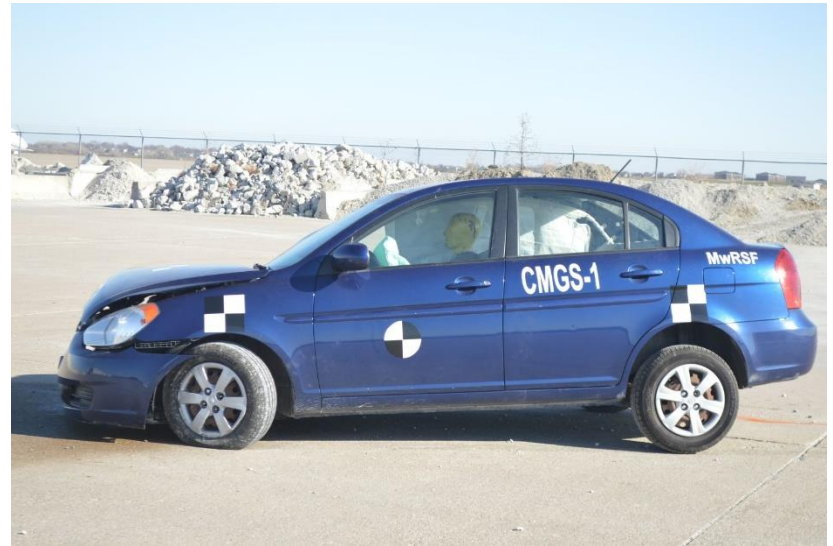
Figure 68. Vehicle Damage, Test No. CMGS-1

The damage to the vehicle was moderate, as shown in Figures 68 through 72. The maximum occupant compartment deformations are listed in Table 6 along with the intrusion limits established in MASH 2016 for various areas of the occupant compartment. MASH 2016 defines intrusion or deformation as the occupant compartment being deformed and reduced in size with no observed penetration. The maximum deformation of the windshield was measured to be 3<sup>3</sup>/<sub>8</sub> in. (86 mm) which was not observed on the test day, as shown in Figure 70. Prior to the vehicle deformation measurements, the snow and ice on the windshield caused an additional caving in deformation. Therefore, this deformation exceeding the MASH deformation criteria was not due to the impact event and is not critical to the test evaluation. All other occupant compartment deformations were within MASH limits. Complete occupant compartment and vehicle deformations as well as the corresponding locations are provided in Appendix D.

Majority of the vehicle damage was concentrated on the right-front corner, where primary impact occurred. The right-front wheel contacted post nos. 18 and 19 and was disengaged, and the left-front tire was deflated. The right corner of the hood buckled. The side and front airbags on both the passenger and driver side deployed, which caused the windshield on the passenger side to shatter but remain intact. The right-rear quarter panel was crushed inward.

The roof, the left side, and the rear of the vehicle remained undamaged. The left-side and rear window glass also remained undamaged. The front right strut broke at the weld point on the top of the gas cylinder, and only the top portion of the shock absorber was still intact. The right-side wheel hub attachment point detached from the steering rack, and the tie rod was bent. The right-front brake assembly disengaged from the car. There was no damage to the vehicle's frame, rear suspension, or rear shocks and springs.

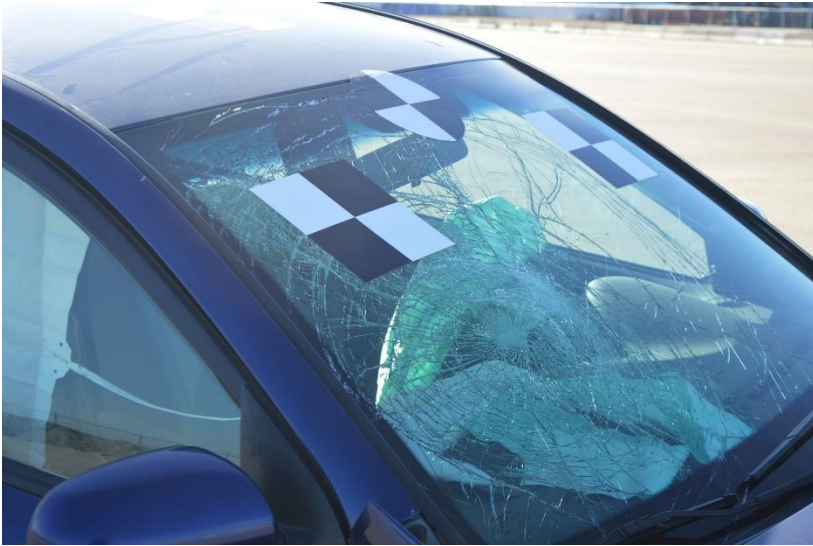
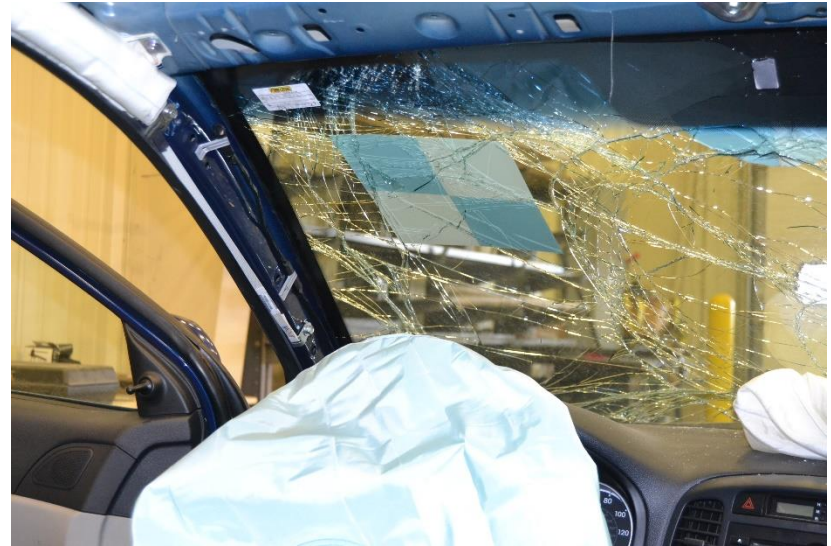
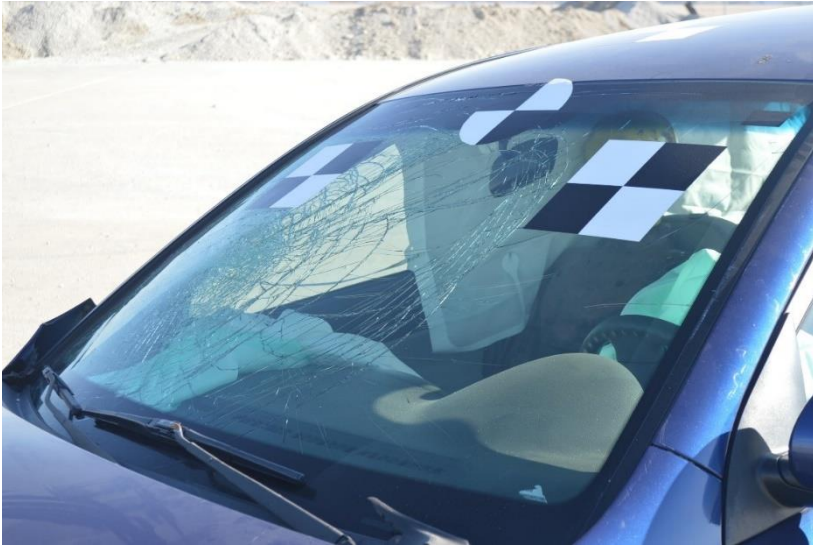
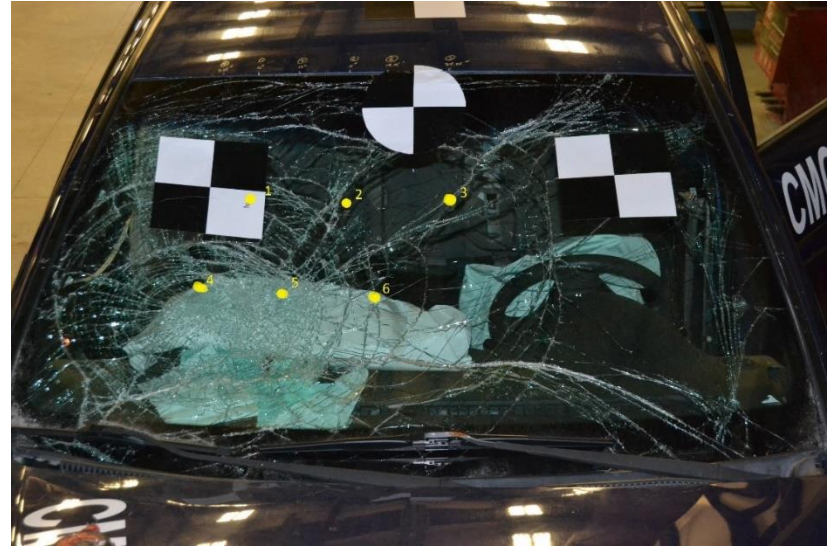
Figure 70. Vehicle Windshield Damage, (a) on Test Site on Test Day, (b) in Vehicle Shop Prior to Measurement, Test No. CMGS-1

<sup>2</sup> – Deformation was not present on test day but occurred after snow and ice on windshield caused deformation prior to measurement

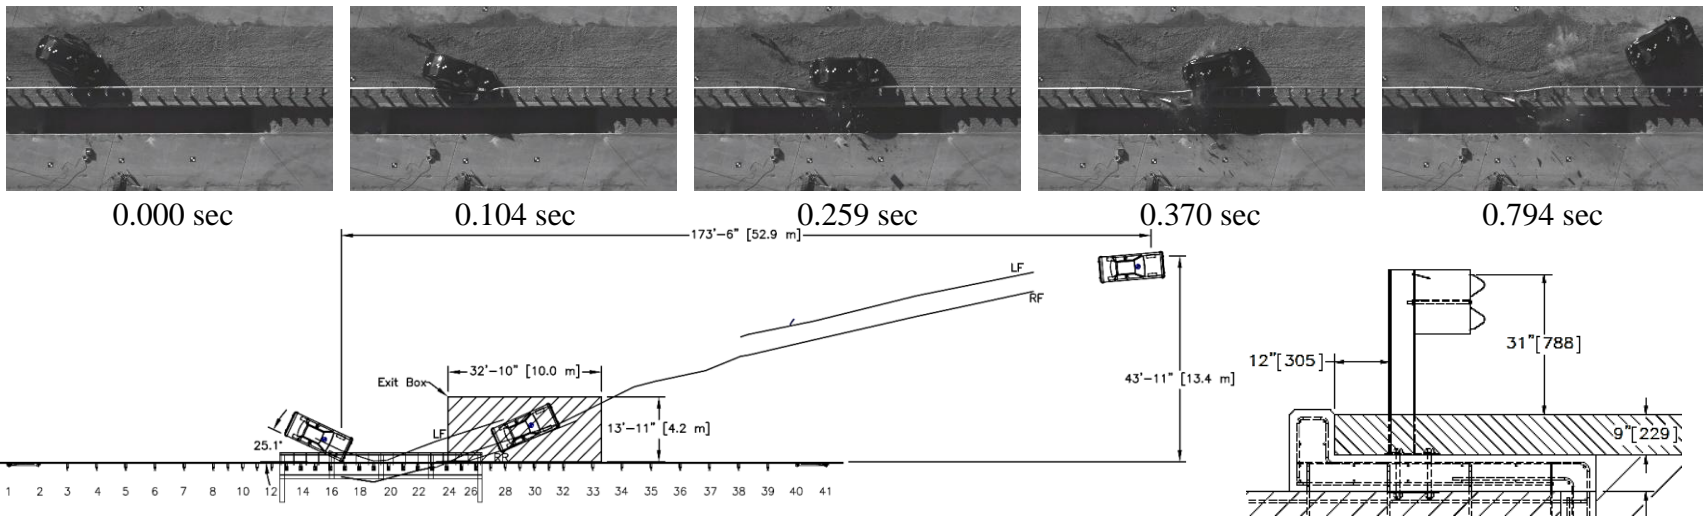
Figure 73. Summary of Test Results and Sequential Photographs, Test No. CMGS-1

The analysis of the test results for test no. CMGS-1 showed that the strong post MGS attached to the culvert's top slab adequately contained and redirected the 1100C vehicle with controlled displacement of the barrier. A summary of the test results and sequential photographs are shown in Figure 73. Detached elements, fragments, or other debris from the test article did not penetrate or show potential for penetrating the occupant compartment, or present an undue hazard to other traffic, pedestrians, or work-zone personnel. Deformations of, or intrusions into, the occupant compartment that could have caused serious injury did not occur. Note, the maximum windshield deformation of 3<sup>3</sup>/<sub>8</sub> in. (86 mm) was not from the impact event, and therefore, it was not critical to the test evaluation.

- Vehicle Damage..... Moderate
  - VDS [14] ..... 1-RFQ-6
  - CDC [15]..... 1-RZAK-5
  - Maximum Interior Deformation ..... 3¼ in. (86 mm)
- Test Article Damage ..... Moderate
- Maximum Test Article Deflections
  - Dynamic..... 12.0 in. (305 mm)
  - Working Width..... 33.1 in. (842 mm)
  - Permanent Set ..... 117% in. (302 mm)
- Transducer Data

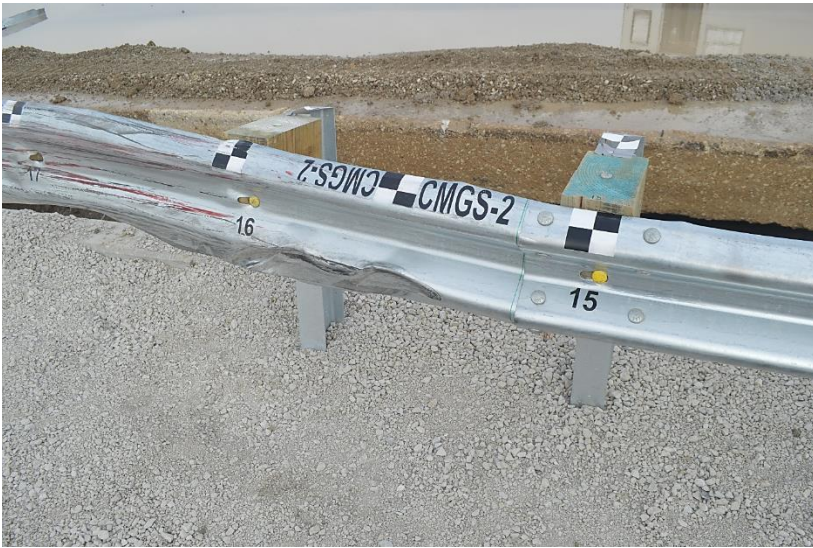
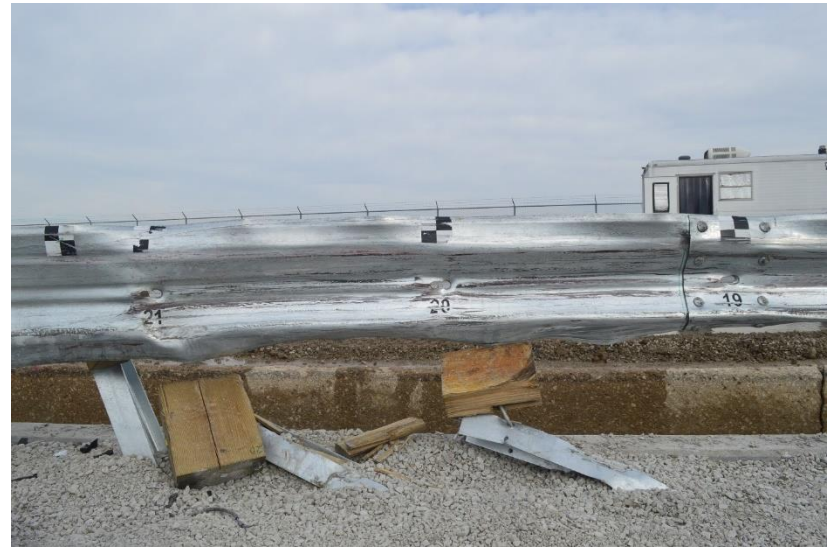
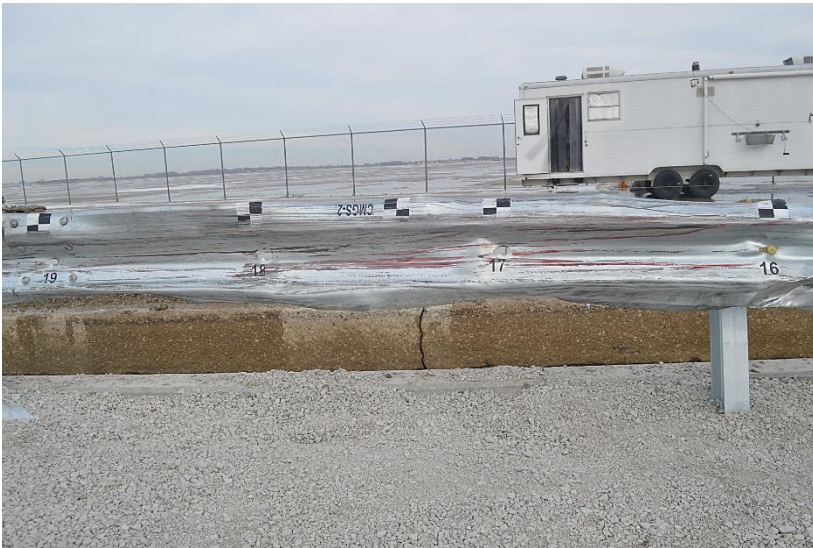
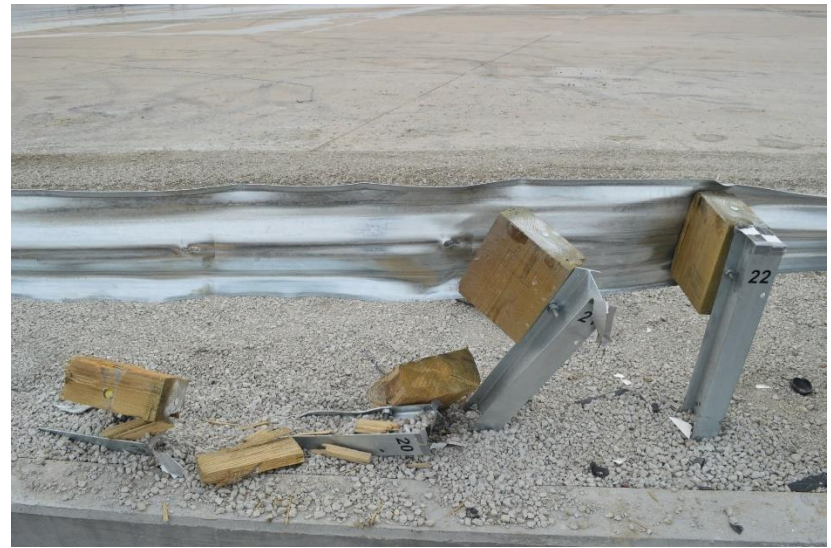
Figure 80. System Damage, Test No. CMGS-2

Damage to the barrier was moderate, as shown in Figures 80 through 89. Barrier damage consisted mostly of deformed W-beam, contact marks on the guardrail sections, and deformed posts. The length of vehicle contact along the barrier was approximately 24 ft – 1 in. (7.3 m) which spanned from 7 in. (178 mm) downstream from post no. 15 to the downstream edge of the rail splice at post no. 23.

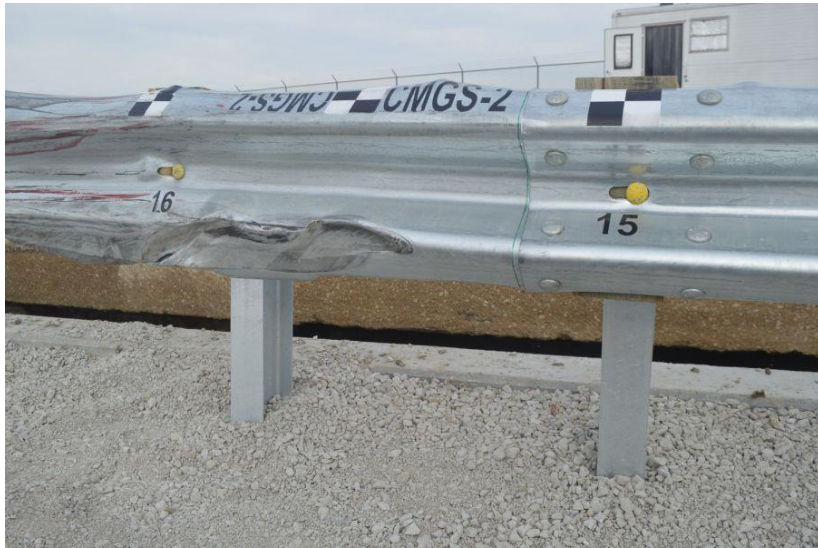
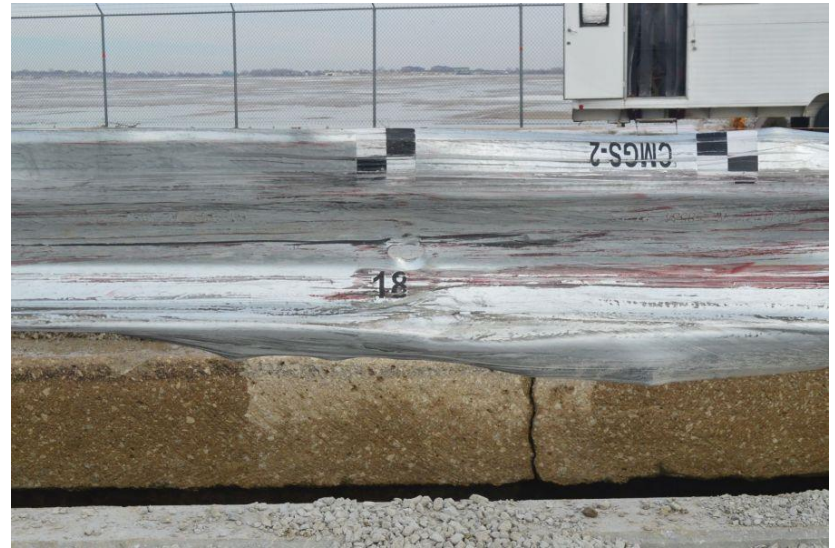
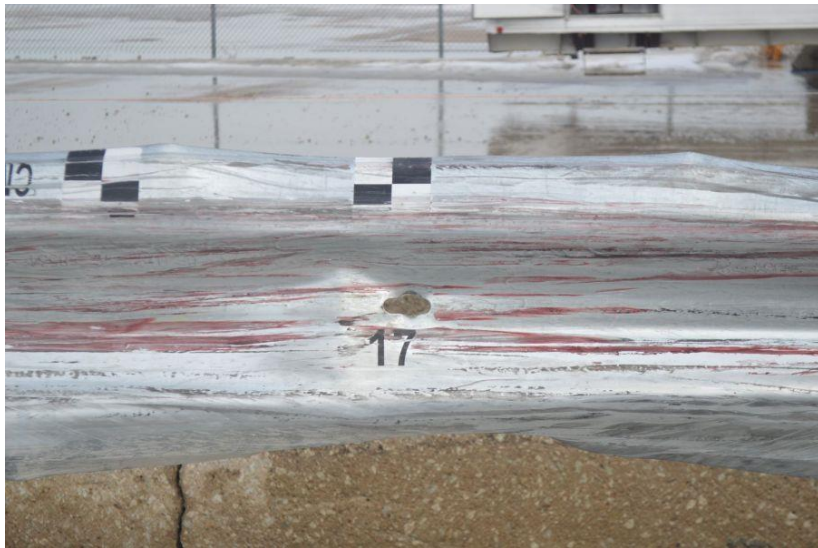
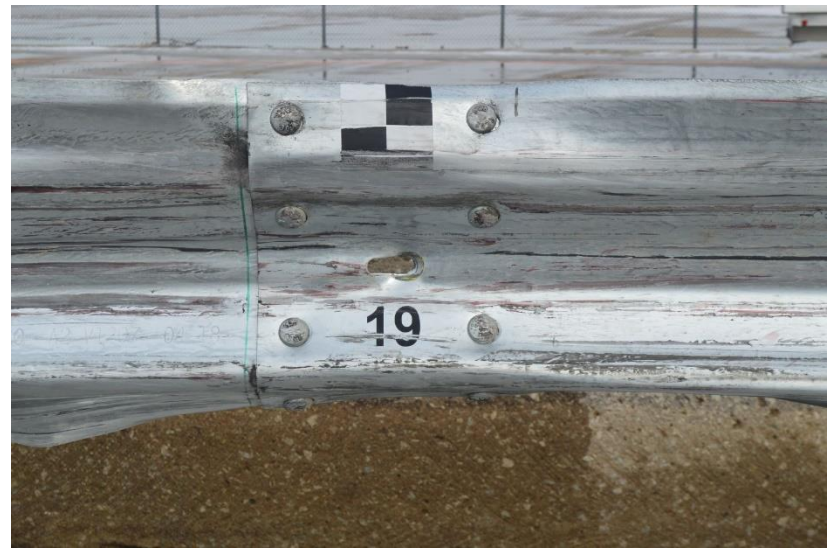
Figure 81. Damage to Post Nos. 15 through 21, Test No. CMGS-2

Post nos. 15 and 16 slightly deflected backward. Post nos. 17 and 18 broke away from the base plate and were pulled out of the soil. However, this did not adversely affect the system's performance, and the disengaged posts did not pose secondary hazard to traffic. Post nos. 19 through 21 also deflected longitudinally toward the ground in the downstream direction but remained attached to the culvert. Contact marks were found on the front face of post nos. 18 and 19. No significant post damage occurred to post nos. 1 through 15 or 24 through 41. The upstream anchorage system was displaced nearly 1 in. (25 mm) and the downstream anchorage system remained unmoved. The posts in both the upstream and downstream anchorage systems were not damaged. The wooden blockouts at post nos. 17 through 20 disengaged from the system. The blockout at post no. 21 rotated but did not disengage from the rail. The blockouts at post nos. 3 through 16 and 22 through 39 remained undamaged.

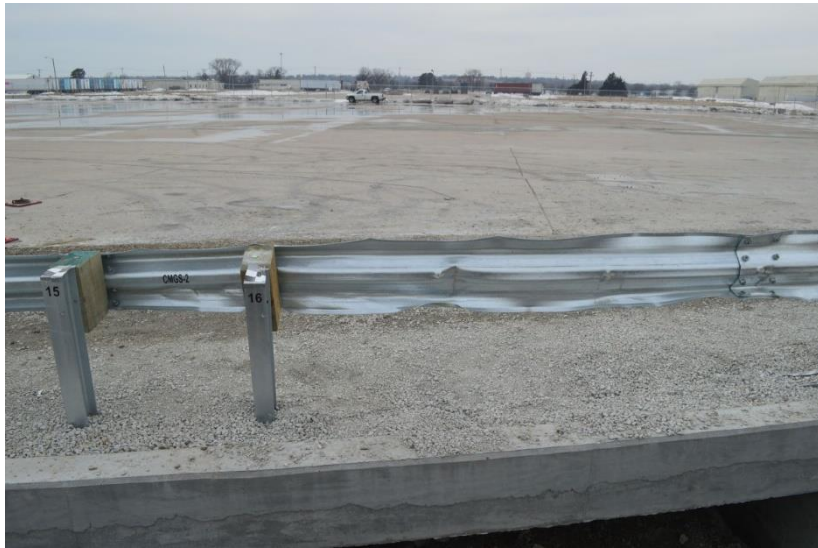
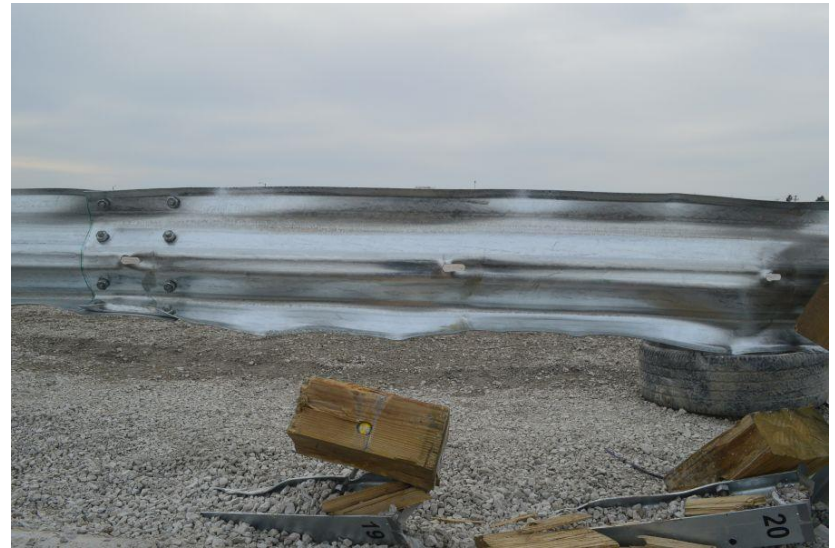
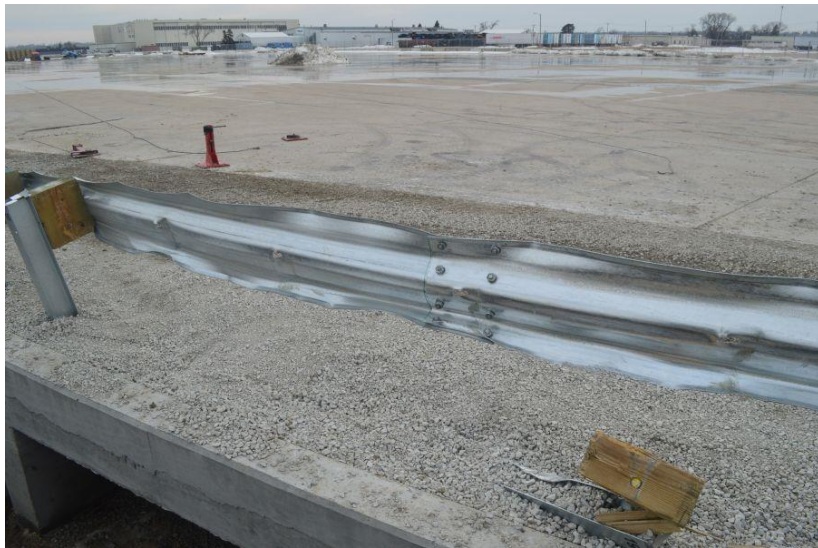
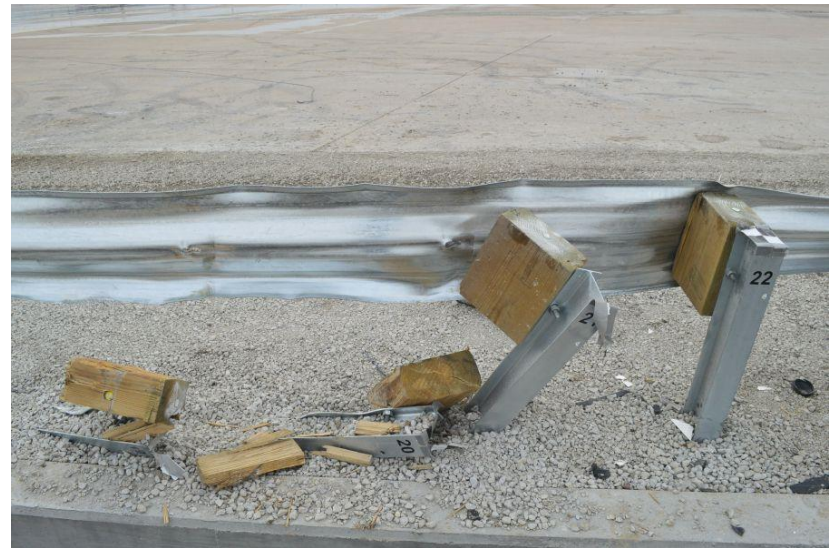
Figure 82. Guardrail Damage, Post Nos. 15 through 19, Test No. CMGS-2

The guardrail damage consisted moderate deformation and flattening of the impacted section of the W-beam between post nos. 15 and 23. The W-beam disengaged from post nos. 17 through 21. Contact marks were found on the guardrail between post nos. 15 through 23. Small horizontal rail tearing was observed at and upstream from post no. 16, as shown in Figure 84. No significant guardrail damage occurred upstream from post no. 15 nor downstream from post no. 23.

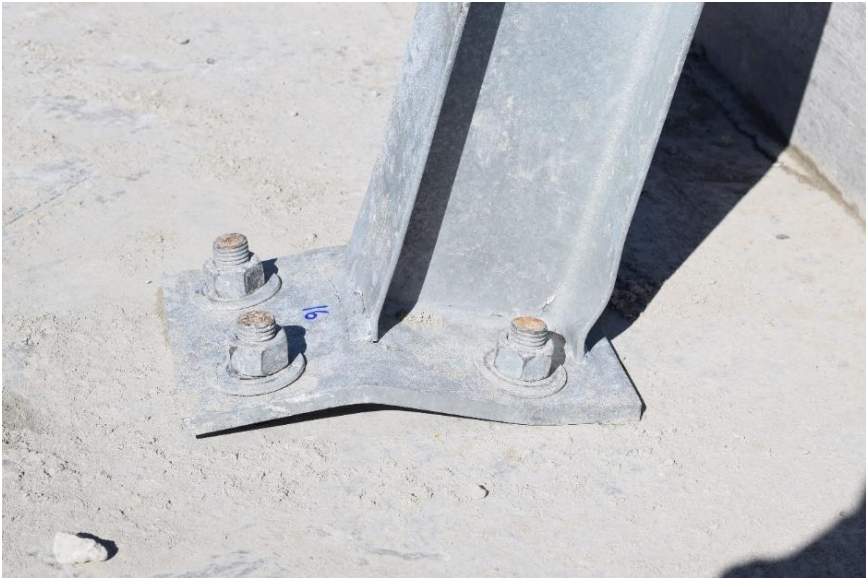
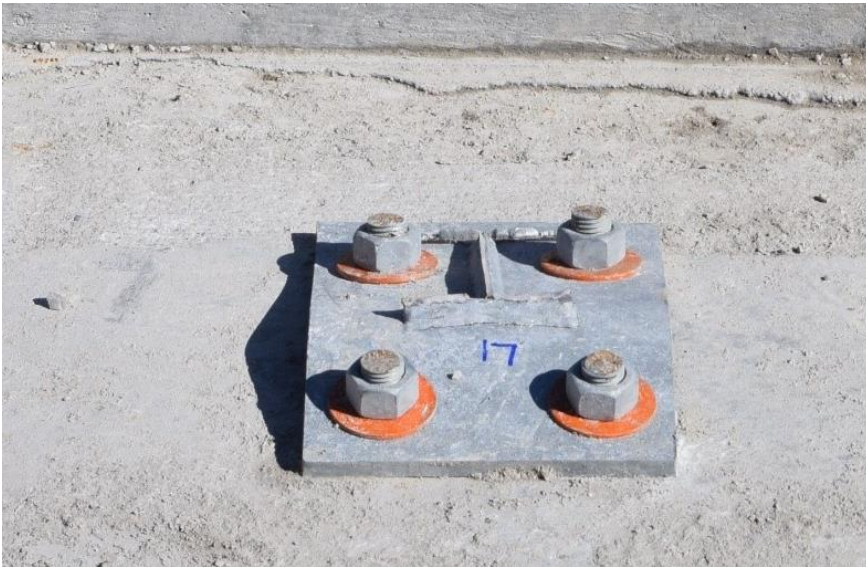
Figure 85. Damage to Base Plates of Post Nos. 17 through 22, Test No. CMGS-2

Following the test, the soil on top of the culvert headwall was removed for inspection of the damage to the posts and base plates as well as to review any potential damage to the culvert. Deformation of the post base plates was observed on post nos. 16 through 22. Post nos. 17 and 18 fractured at the base of the post above the weld line at the front flange and web of the post and through the weld at the back flange of the post. The upstream side of the front flange of post nos. 20 and 21 was torn up to the web near the base plate weld. All anchorage bolts and epoxied threaded rods were intact and remained secure, although some minor deformation of the bolts and rods was observed. No damage was observed to the concrete culvert slab or the headwall.

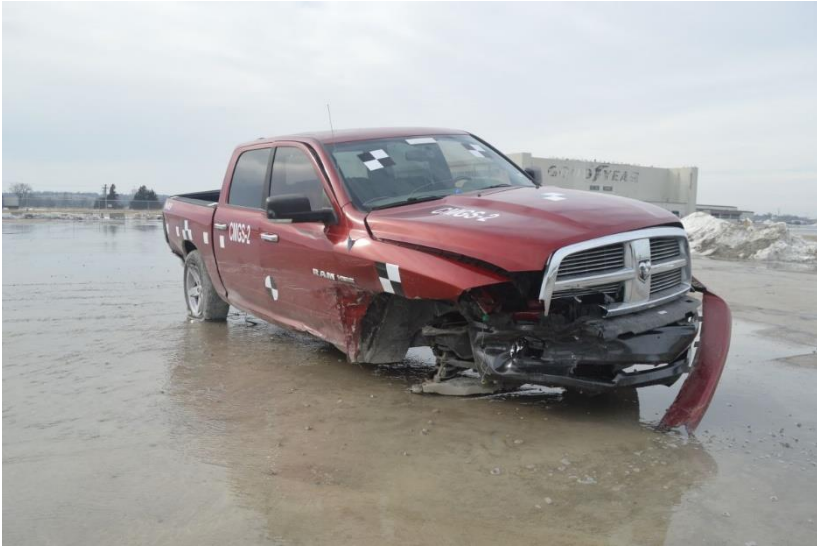
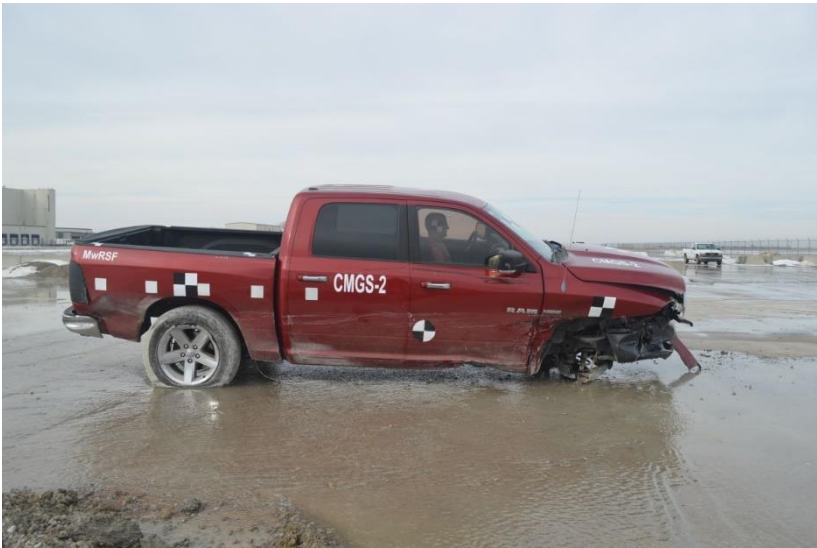
Figure 91. Vehicle Damage, Test No. CMGS-2

The majority of the vehicle damage was concentrated on the right-front corner, where primary impact occurred. The vehicle's front bumper was crushed inward. The lower passenger side grille was broken. The front bumper cover was torn off except for the two bolts on the driver side. The vehicle right-front wheel was disengaged, and right-rear tire was deflated. The airbags did not deploy during the impact. The right corner of the rear bumper on the passenger side buckled inward and the rear corner of the right-rear fender was deformed from the impact with the barrier.

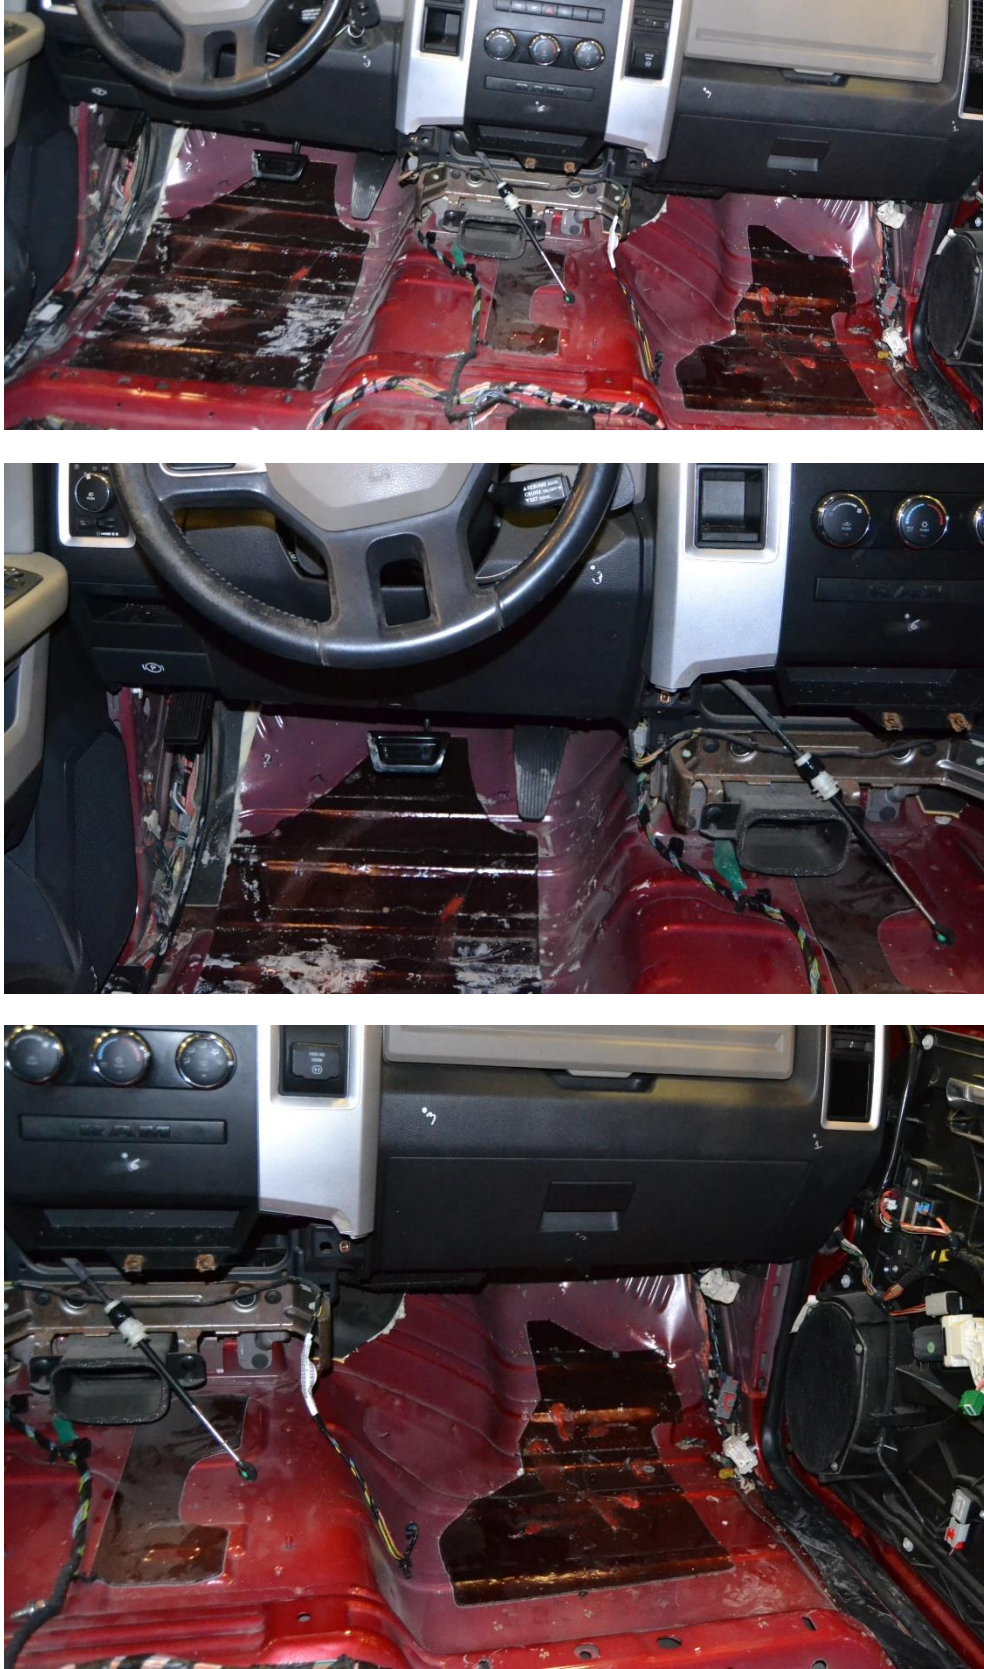
Figure 94. Vehicle Occupant Compartment Damage, Test No. CMGS-2

The roof, the hood, and the left side remained undamaged. The left-side and rear window glass also remained undamaged. The airbags did not deploy during the impact. The overall undercarriage damage included a 2-in. (51 mm) bend in the lower control arm, and the steering knuckle broke along with the steering arm on the passenger side. The front passenger-side brake line was disconnected. Interior occupant compartment deformations were moderate with a maximum of 1 1/8 in. (29 mm), which did not violate the limits established in MASH 2016.
