*Research Project Number TPF-5(193) Supplement #113  
WisDOT Sponsoring Agency Code RFPF-WISC-6*

## **DYNAMIC TESTING AND EVALUATION OF CULVERT-MOUNTED, STRONG-POST MGS TO TL-3 GUIDELINES OF MASH 2016**

### **MIDWEST ROADSIDE SAFETY FACILITY**

MwRSF Research Report No. TRP-03-383-20-R1

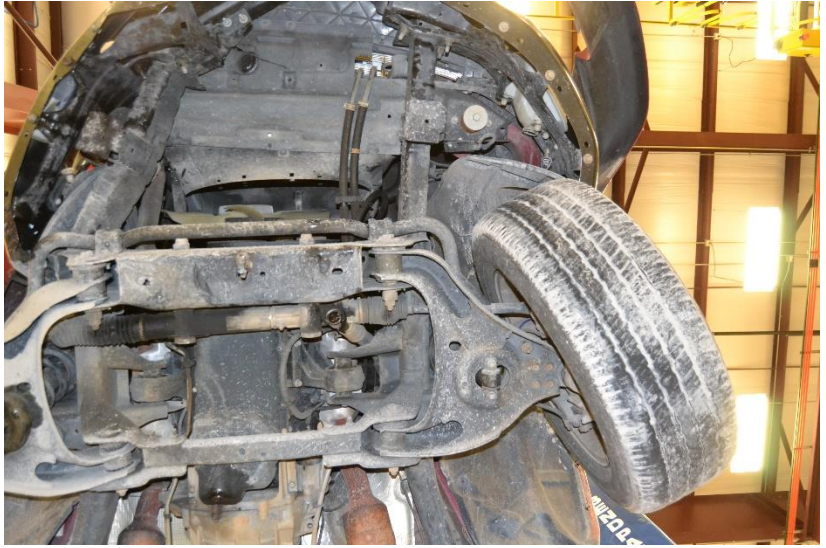
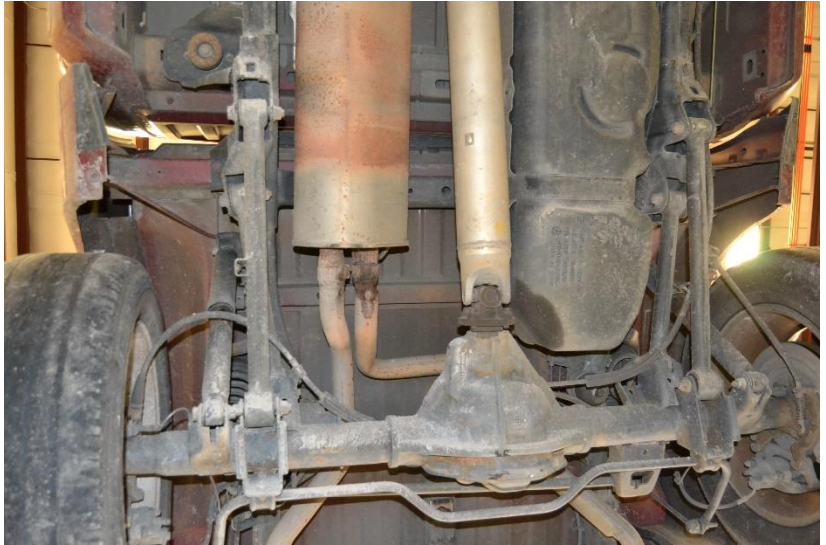
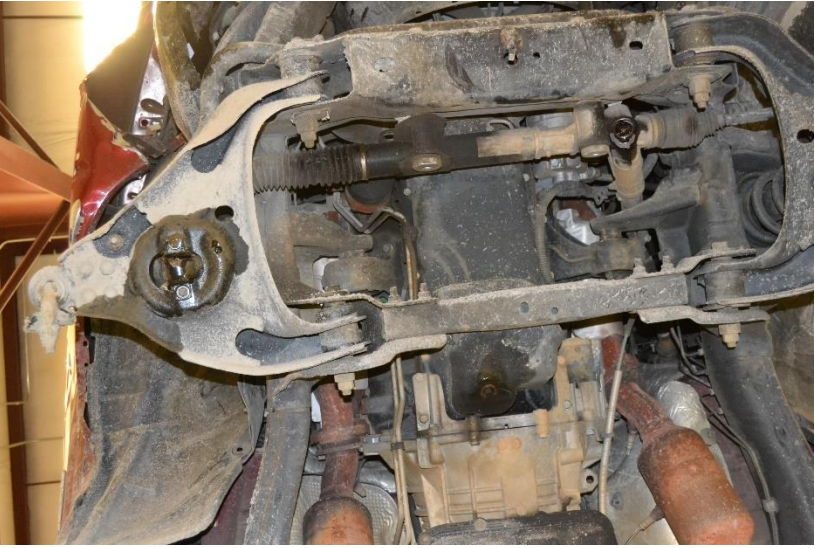
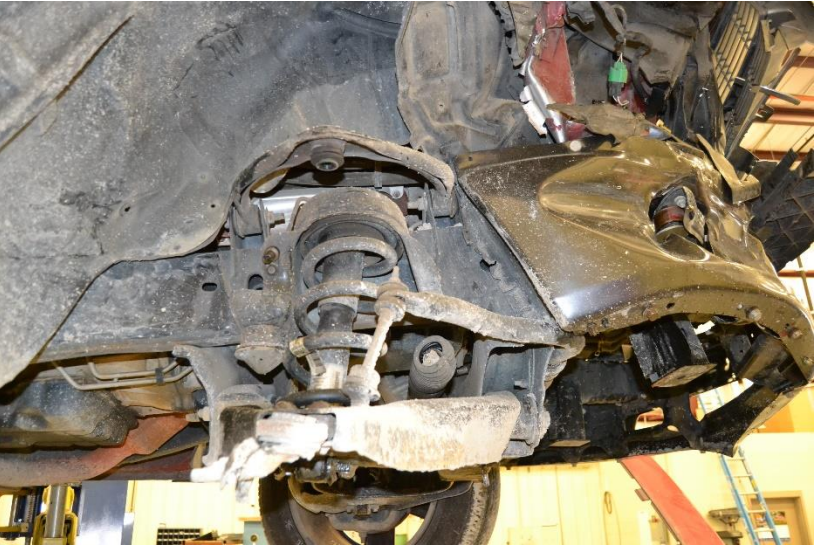
Figure 95. Vehicle Undercarriage Damage, Test No. CMGS-2

The roof, the hood, and the left side remained undamaged. The left-side and rear window glass also remained undamaged. The airbags did not deploy during the impact. The overall undercarriage damage included a 2-in. (51 mm) bend in the lower control arm, and the steering knuckle broke along with the steering arm on the passenger side. The front passenger-side brake line was disconnected. Interior occupant compartment deformations were moderate with a maximum of 1 1/8 in. (29 mm), which did not violate the limits established in MASH 2016.
