PERFORMANCE EVALUATION OF MISSOURI DOT DUAL-POST, U-CHANNEL SIGN SUPPORT ACCORDING TO MASH 2016

MIDWEST ROADSIDE SAFETY FACILITY

MwRSF Research Report No. TRP-03-426-20

December 16, 2020

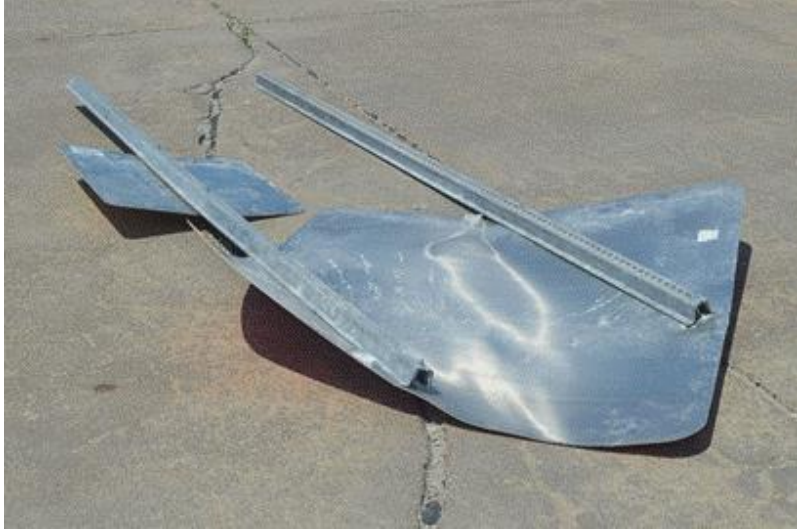
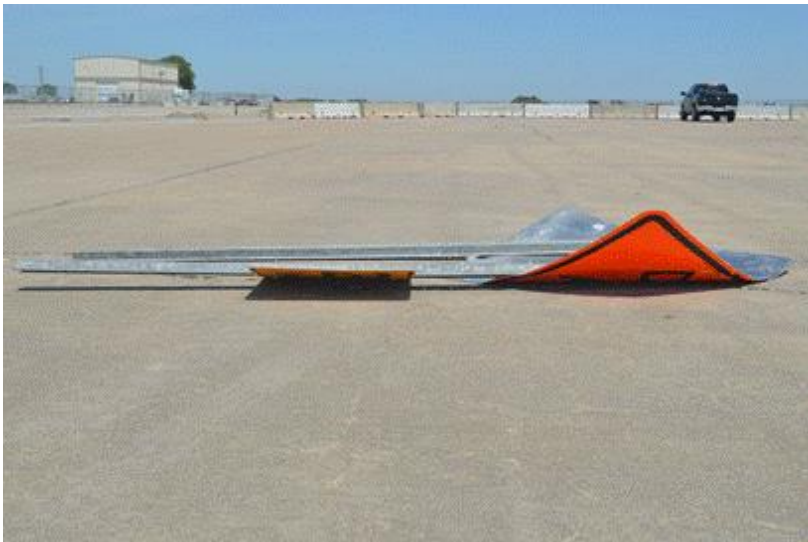
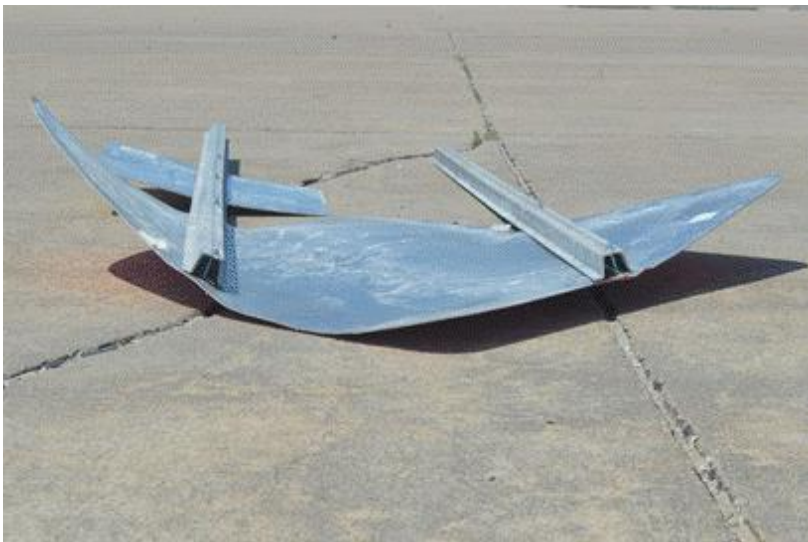
Figure 39. System Damage, Sign Panels, Test No. MOS-5

The left and right edges of the upper sign panel bent in the downstream direction such that the left edge was 13 in. (330 mm) out of plane and the right edge was 7½ in. (191 mm) out of plane. The right post sheared 26½ in. (673 mm) above the ground line, and the left post sheared 27¾ in. (705 mm) above the ground line. The upper portion of both posts remained attached to the sign panels and the posts were minimally damaged.

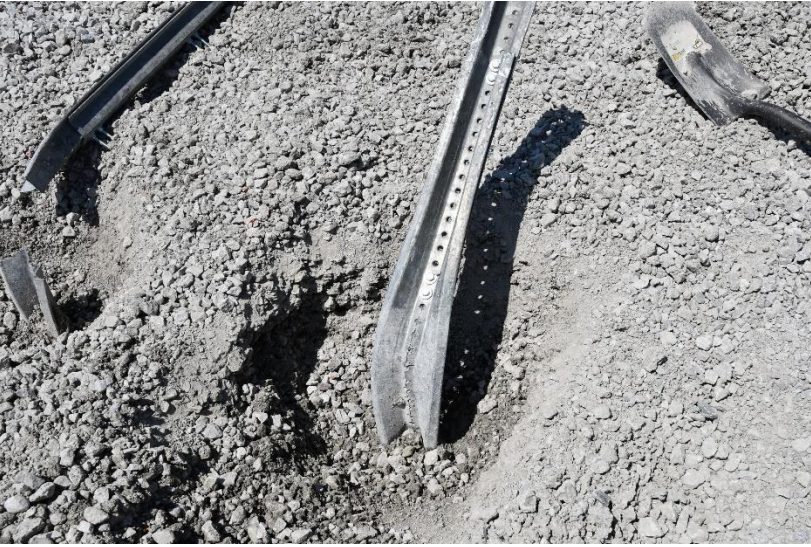
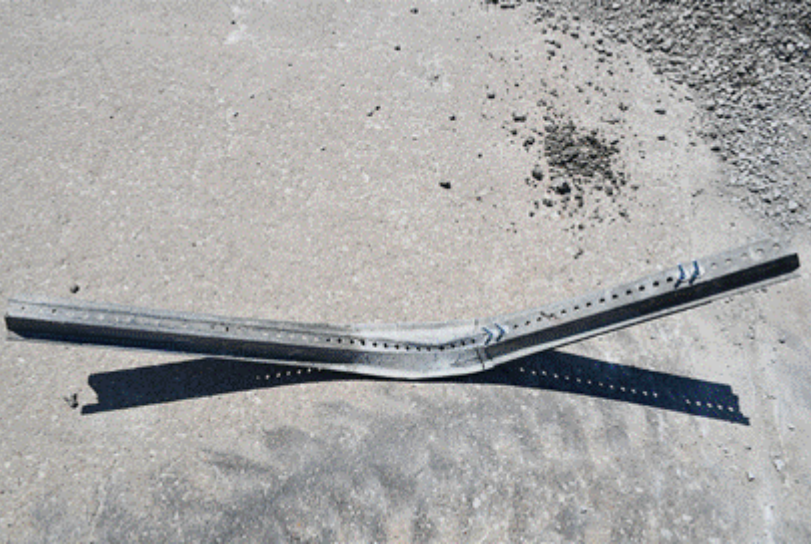
Figure 42. System Damage, Embedded Stubs, Test No. MOS-5

Both embedded stubs bent at the ground line in the downstream direction, and the bending deformed the U-channel stub cross sections to a width of 4¾ in. (121 mm). Cracking along the centerline of both U-channel stubs was visible beginning at the ground line and extending up 3¾ in. (95 mm), stopping below the bolted connection to the post. The height of the remaining stub in its deformed state was greater than 4 in. (102 mm) above the ground line. Removing the stubs from the ground revealed that the left post had fractured below the ground line. Both stubs had additional centerline cracking along the embedded portion of the stub, extending approximately 6 in. below the ground line. The bolted connections between the embedded stubs and the U-channel posts remained intact. On the right post, 11-in. (279 mm) long contact marks started at the sheared top and extended down. Contact marks on the left edge of the left post started 21¾ in. (552 mm) from the sheared top and extended down. Additional contact marks on the right edge of the left post started 22¾ in. (578 mm) from the sheared top and extended down.

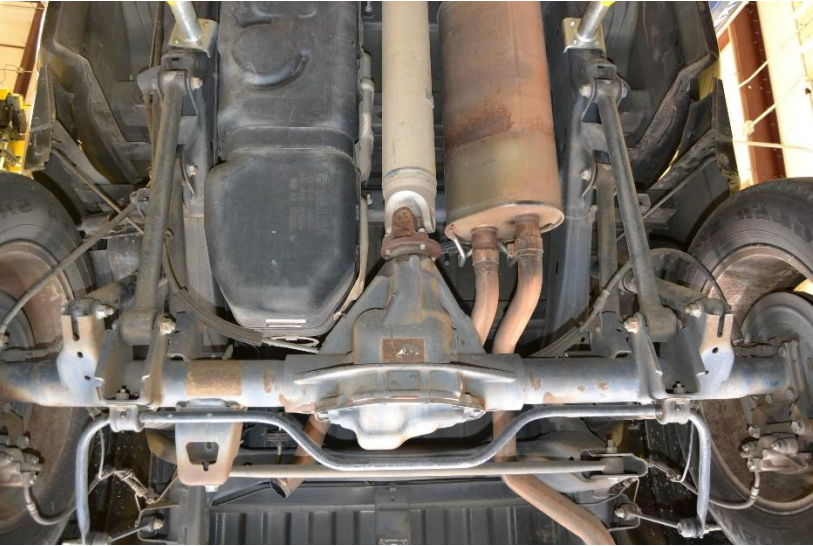
Figure 44. Vehicle Undercarriage Damage, Test No. MOS-5

The majority of damage was concentrated on the front of the vehicle where the impact occurred. The grille was cracked on both sides of the vehicle and was fractured on the left side. The front bumper was dented and bent downward. The hood of the vehicle was slightly ajar. Scrapes were observed along the undercarriage. The lower control arms and muffler were slightly dented. The roof was slightly dented. No damage was observed to the sides of the vehicle, and the windshield and windows remained intact.

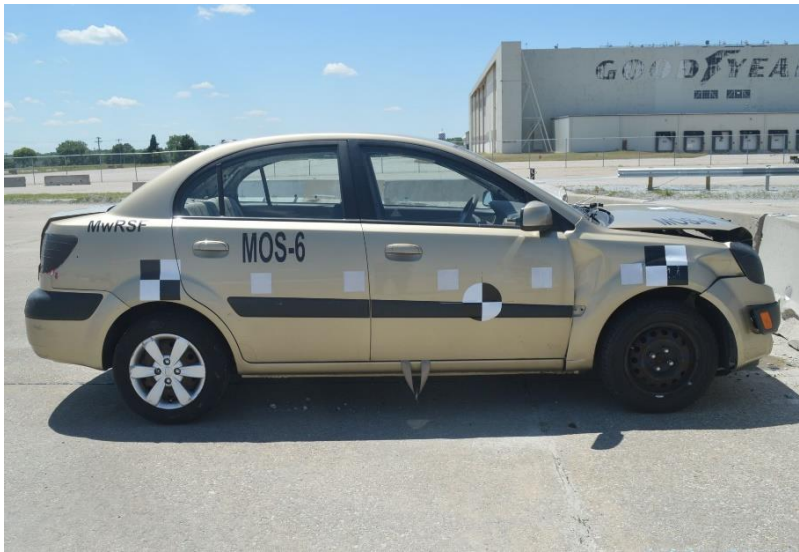
Figure 58. Vehicle Damage, Test No. MOS-6

The majority of the damage was concentrated on the front of the vehicle where the impact occurred. The grille and hood were crushed inward. The left-side running light disengaged from the vehicle. The bumper insert disengaged from the top mounts. The right fender deformed outward at the middle. The left side of the trunk was crushed downward into the trunk compartment. The right frame horn was dented inward toward the engine compartment. The floor pan and gas tank experienced minor scraping. The windshield and side windows remained intact.

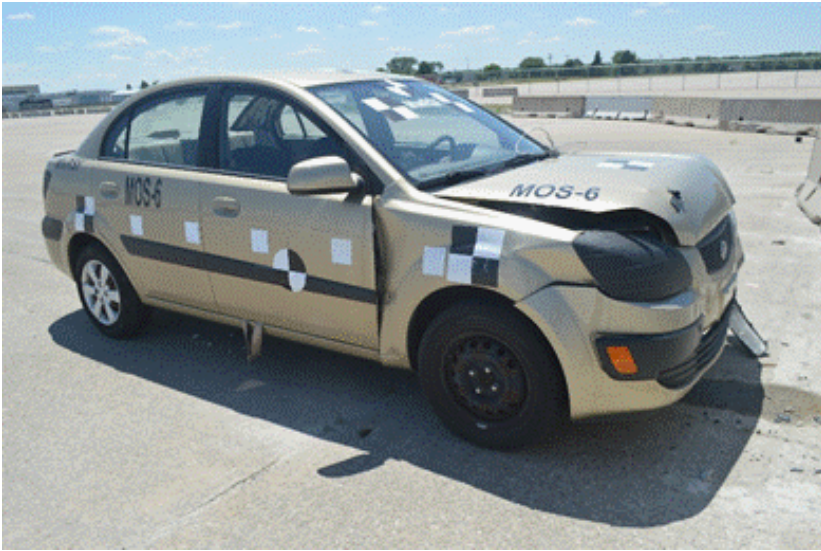
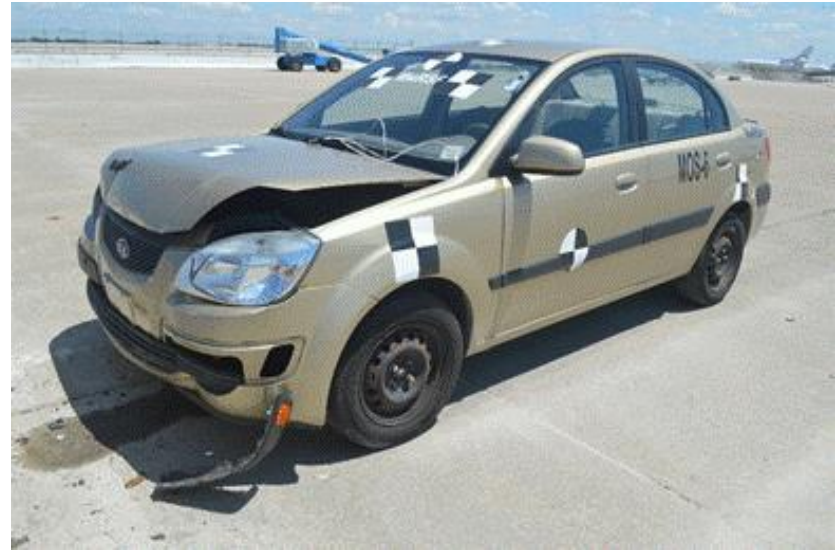
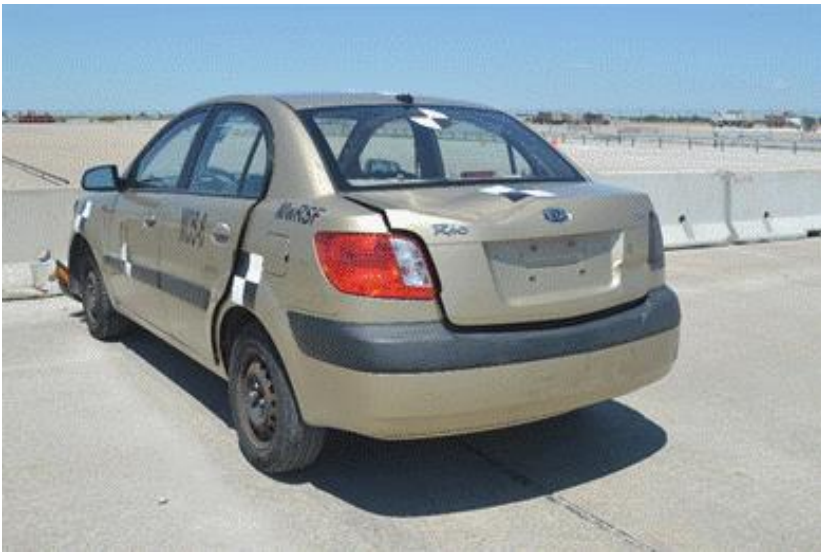
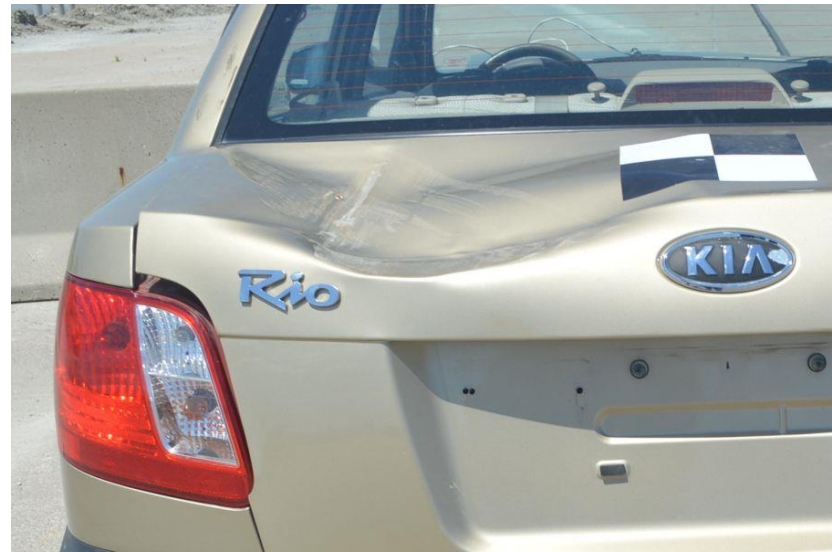
The damage to the vehicle was minimal, as shown in Figure 58. The maximum occupant compartment intrusions are listed in Table 9 along with the intrusion limits established in MASH 2016 for various areas of the occupant compartment. Complete occupant compartment and vehicle deformations and the corresponding locations are provided in Appendix D. MASH 2016 defines intrusion or deformation as the occupant compartment being deformed and reduced in size with no observed penetration. There were no penetrations into the occupant compartment and none of the established MASH 2016 deformation limits were violated. Outward deformations, which are denoted as negative numbers in Appendix D are not considered crush toward the occupant and are not evaluated by MASH 2016 criteria.

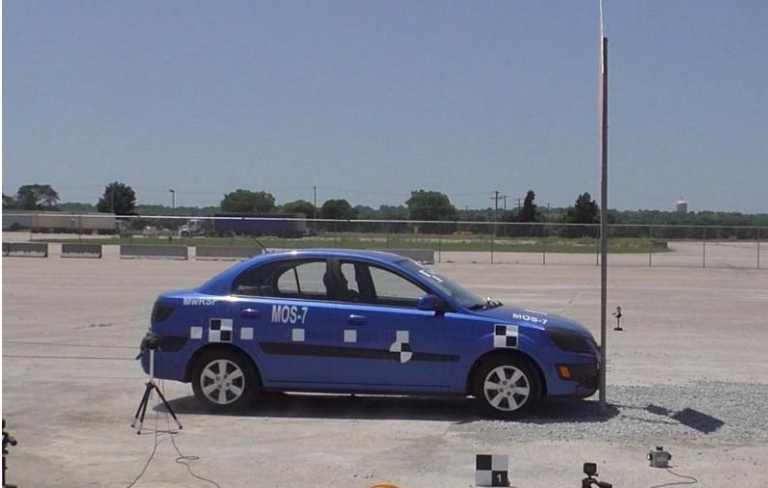
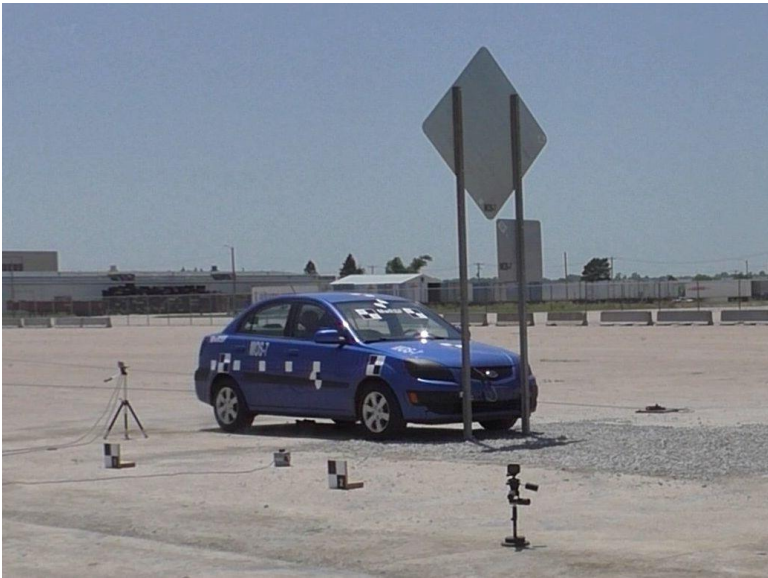
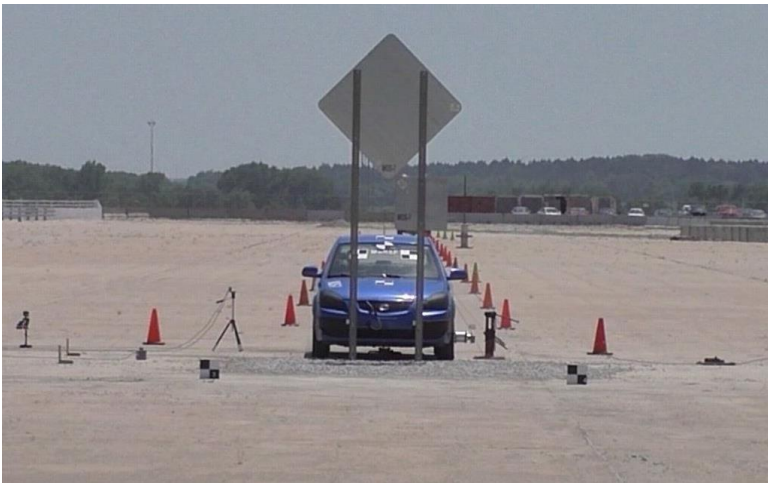
Figure 62. Impact Location, Test No. MOS-7

Initial vehicle impact was to occur with the vehicle centerline aligned with the centerline of the system, as shown in Figure 62. The 2,435-lb (1,104-kg) small car impacted the U-channel sign system oriented at 0 degrees, or head-on to the vehicle, at a speed of 20.0 mph (32.2 km/h). The vehicle came to rest 44 ft – 7 in. (13.6 m) longitudinally downstream and 5 ft – 7 in. (1.7 m) laterally to the right of the centerline after brakes were applied. A detailed description of the sequential impact events is contained in Table 12. Sequential photographs are shown in Figures 63 and 64. Documentary photographs of the crash test are shown in Figures 65 through 67. The vehicle trajectory and final position are shown in Figure 68.

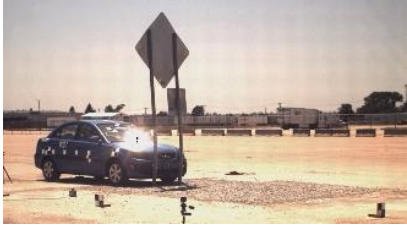
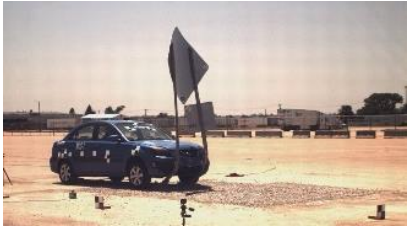
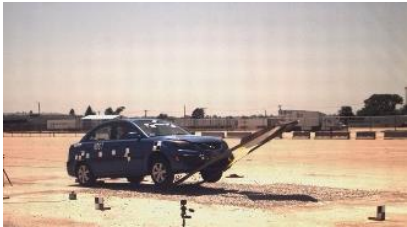
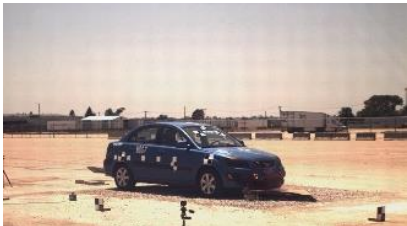
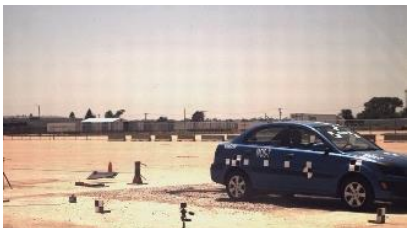
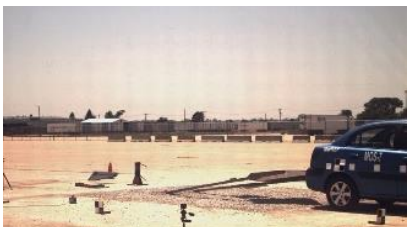
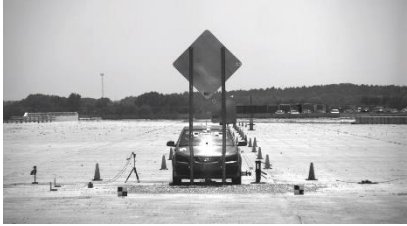
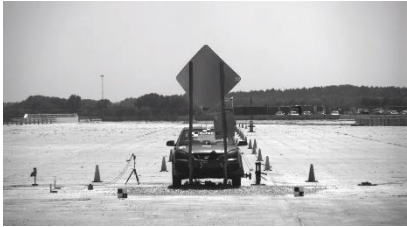
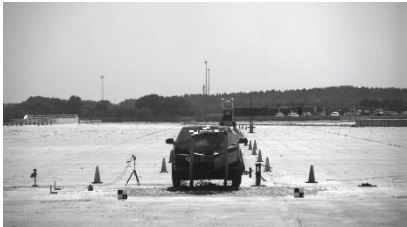
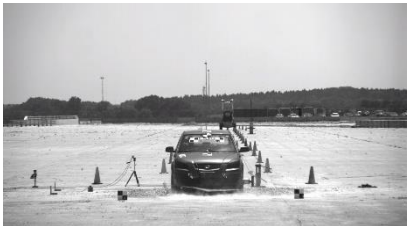
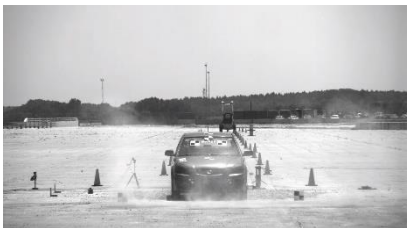
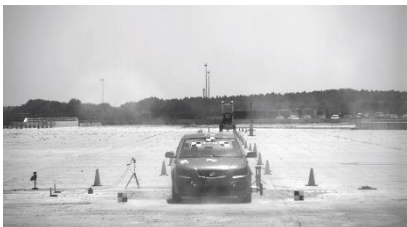
Figure 63. Sequential Photographs, Test No. MOS-7

TIME (sec)	EVENT
0.000	Vehicle's front bumper contacted left and right posts.
0.006	Vehicle's front bumper deformed.
0.008	Left and right posts bent downstream.
0.012	Lower sign deformed due to post flexure.
0.014	Upper sign deformed due to post movements.
0.016	Both posts deflected downstream.
0.062	Vehicle's hood deformed.
0.176	Vehicle's right-front tire became airborne.
0.182	Vehicle's left-front tire became airborne.
0.328	Vehicle pitched upward.
0.356	Vehicle pitched downward.
0.358	Top of sign contacted ground as vehicle began to traverse over system.
0.462	Vehicle's right-front tire regained contact with ground.
0.470	Vehicle's undercarriage contacted the system. Vehicle's left-front tire regained contact with ground.
0.540	Bottom corner of the upper sign bent.
2.474	System lost contact with vehicle.

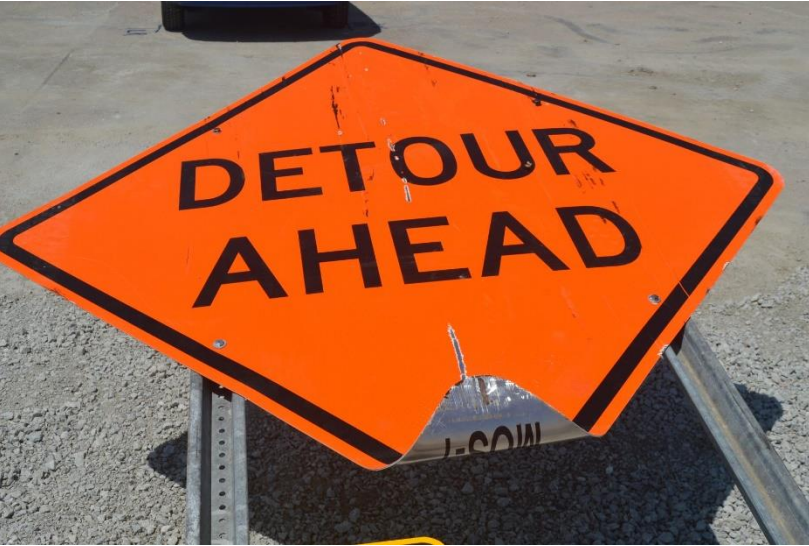
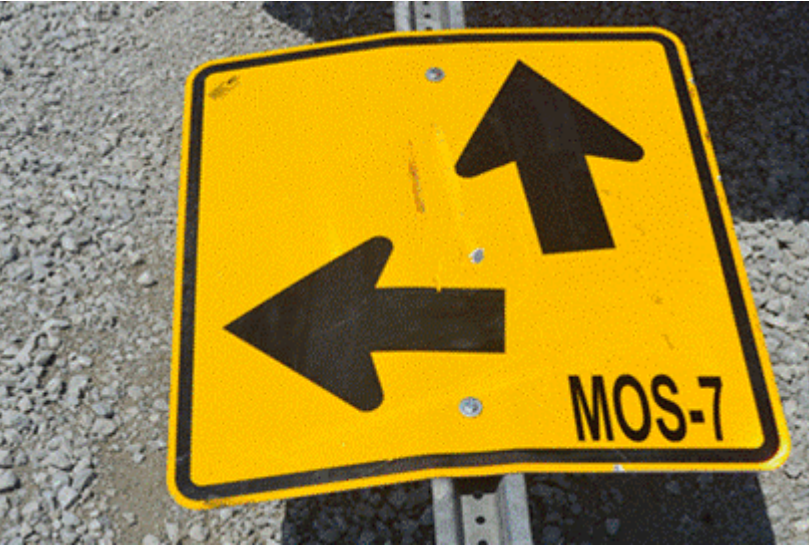
Figure 70. System Damage, Sign Panels, Test No. MOS-7

Damage to the system was severe, as shown in Figures 69 through 72. System damage consisted of contact marks on the posts, bending of the posts, and bending of the upper sign panel.

The left and right posts bent downstream at the ground line and the bolted connections to the embedded stubs remained intact. The sign panels remained attached to the posts, and the bottom edge of the upper sign panel was bent. The system in its deformed state was greater than 4 in. (102 mm) above the ground line. Removing the embedded stubs from the ground revealed cracking along the centerline of the U-channel that extended several inches below the ground line. In addition, both embedded stubs were bent.

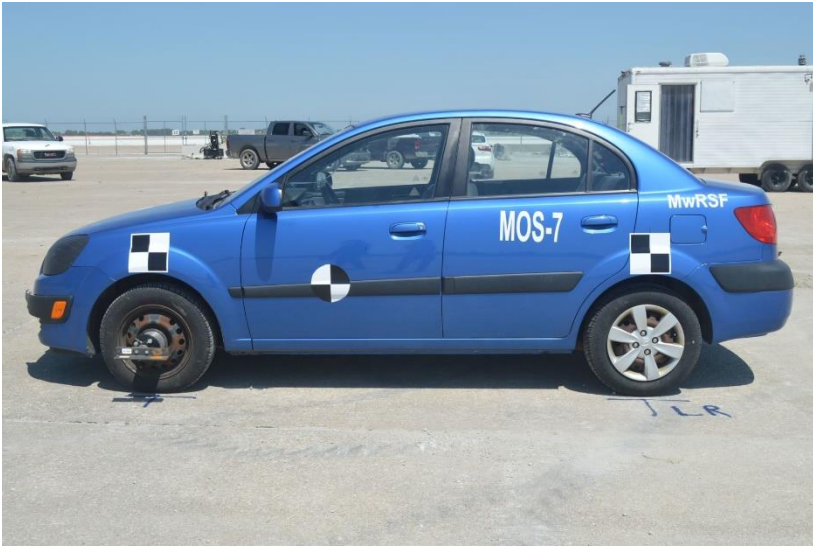
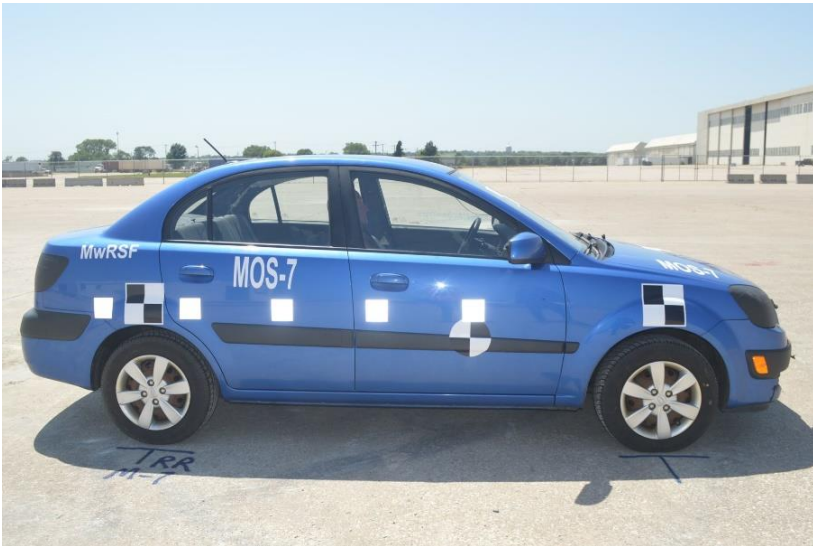
Figure 73. Vehicle Damage, Test No. MOS-7

The damage to the vehicle was minimal, as shown in Figure 73. The maximum occupant compartment intrusions are listed in Table 13 along with the intrusion limits established in MASH 2016 for various areas of the occupant compartment. Complete occupant compartment and vehicle deformations and the corresponding locations are provided in Appendix D. MASH 2016 defines intrusion or deformation as the occupant compartment being deformed and reduced in size with no observed penetration. There were no penetrations into the occupant compartment and none of the established MASH 2016 deformation limits were violated. Outward deformations, which are denoted as negative numbers in Appendix D are not considered crush toward the occupant and are not evaluated by MASH 2016 criteria.

The majority of the damage was concentrated on the front of the vehicle where the impact occurred, and on the undercarriage of the vehicle where the system contacted the vehicle. The bumper was scraped and cracked at the two points where the bumper impacted the posts of the system. Scraping occurred along a majority of the undercarriage of the vehicle. The windshield, windows, and remainder of the vehicle remained undamaged.
