MASH 2016 TEST LEVEL 3 EVALUATION OF MNDOT BICYCLE AND PEDESTRIAN RAIL

MIDWEST ROADSIDE SAFETY FACILITY

MwRSF Research Report No. TRP-03-443-20

December 11, 2020

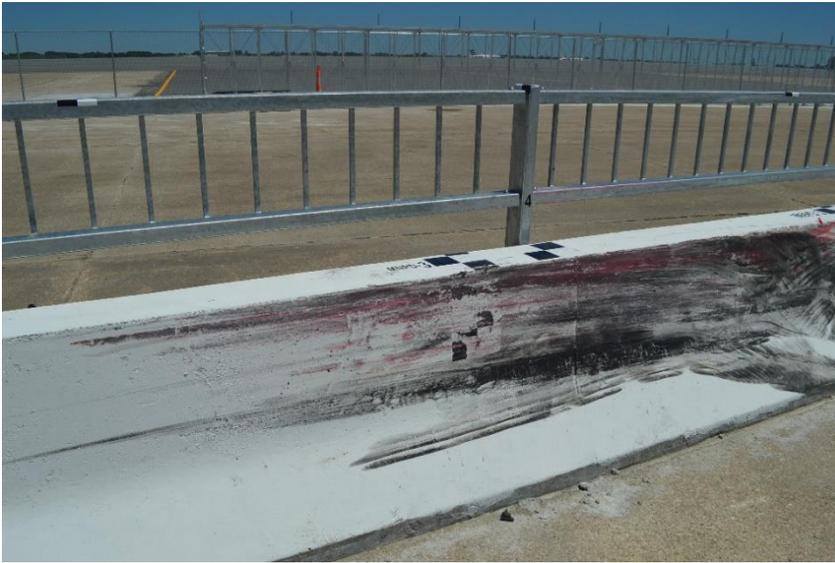
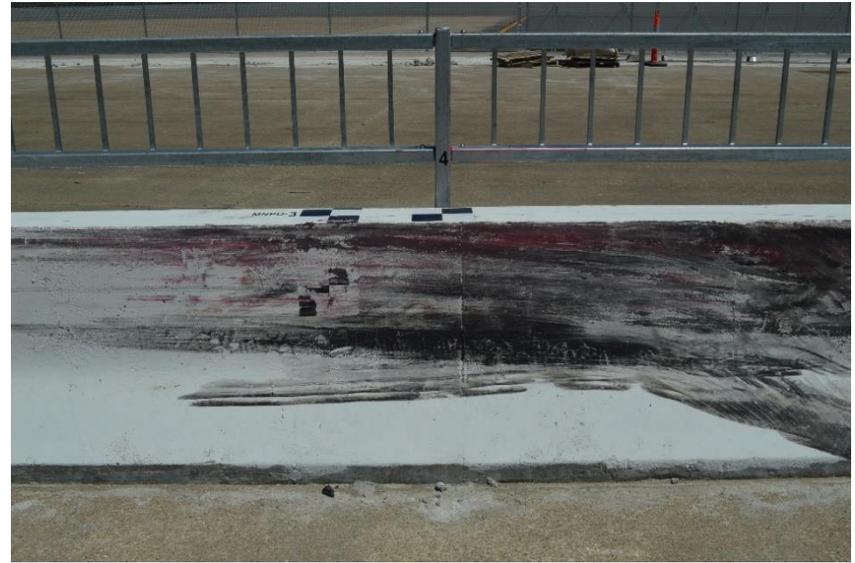
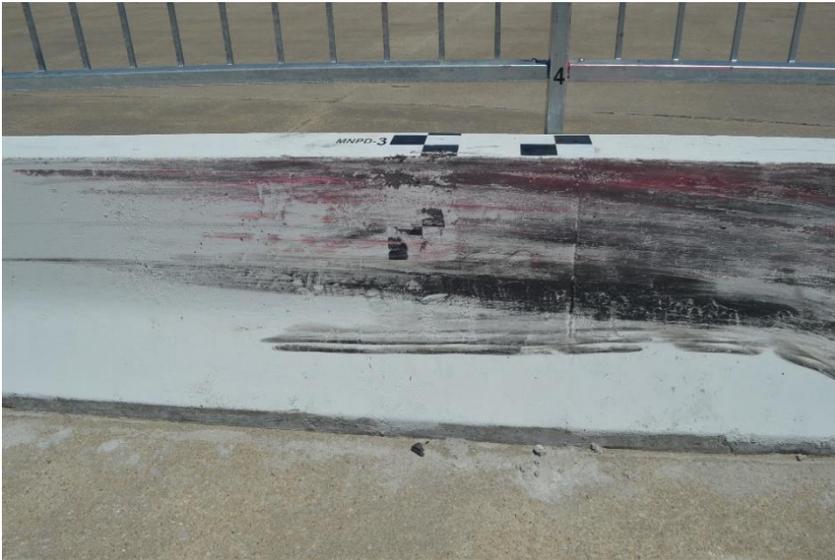
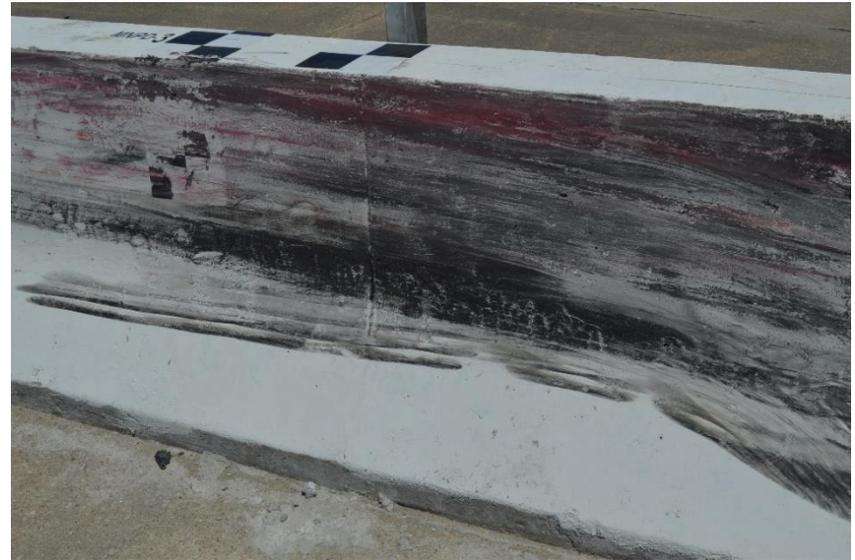
Figure 52. Tire Marks and Concrete Scraping, Test No. MNPD-3

Tire marks were visible on the front face of the J-shape concrete barrier, starting 14½ in. upstream from impact and extending 167 in. downstream across the traffic side of the barrier. Scuff marks were also found along the length of vehicle contact. Gouging was found on the front face of the barrier measuring 4½ in. long and located 15 in. from the top edge and extending 5½ in. downstream from the impact point with a height of 4 in. and a width of ¼ in. Scraping measuring 10 in. long was located 31 in. downstream from the impact point and 7 in. from the top front corner of the concrete barrier with a width of ½ in. Chipping, measuring 2½ in. long, was located 17 in. downstream from the impact point and 13¼ in. below the top front corner of the concrete barrier with a width of ¾ in. Additional chipping, measuring 11¼ in. long, was located on the top traffic-side corner of the concrete barrier 24½ in. downstream from post no. 4 with a height of ¾ in.

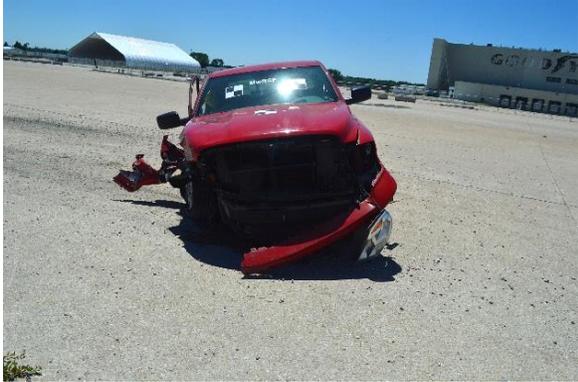
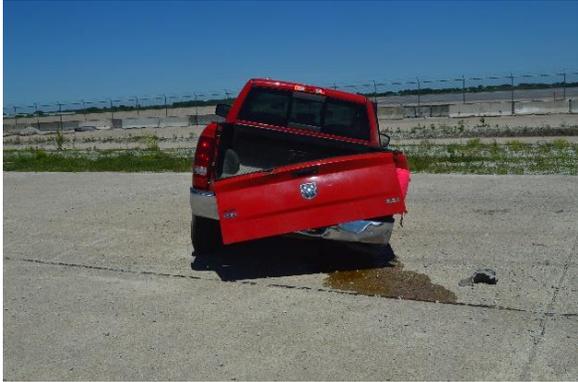
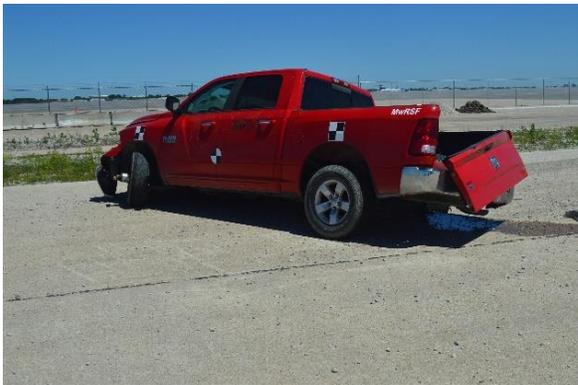
Figure 60. Vehicle Damage, Test No. MNP-3

The majority of the damage was concentrated on the right-front corner and right side of the vehicle, where impact had occurred, as shown in Figure 60. The vehicle's steel engine hood was deformed across its entirety, and the right edge was deformed inward, as shown in Figures 60, 61, and 62. The left side of the front bumper was pushed downward. The right side of the bumper was crushed inward. The right-front fender was dented, torn front to back, and pushed upward near the
