MASH 2016 TEST LEVEL 4 EVALUATION OF MNDOT CONCRETE PARAPET WITH BRUSH CURB AND UPPER BEAM AND POST RAIL WITH NEW TAPERED END SECTION

MINNESOTA DEPARTMENT OF TRANSPORTATION

MwRSF Research Report No. TRP-03-403-21

March 26, 2021

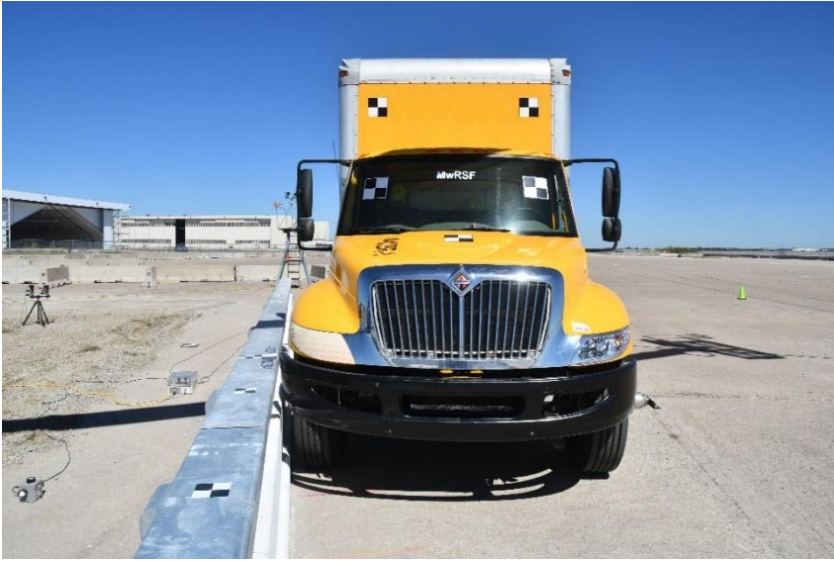
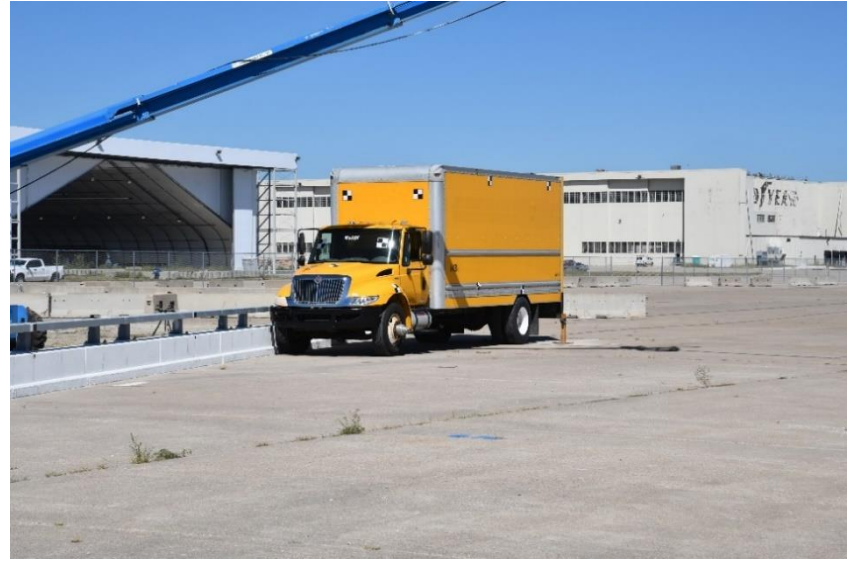
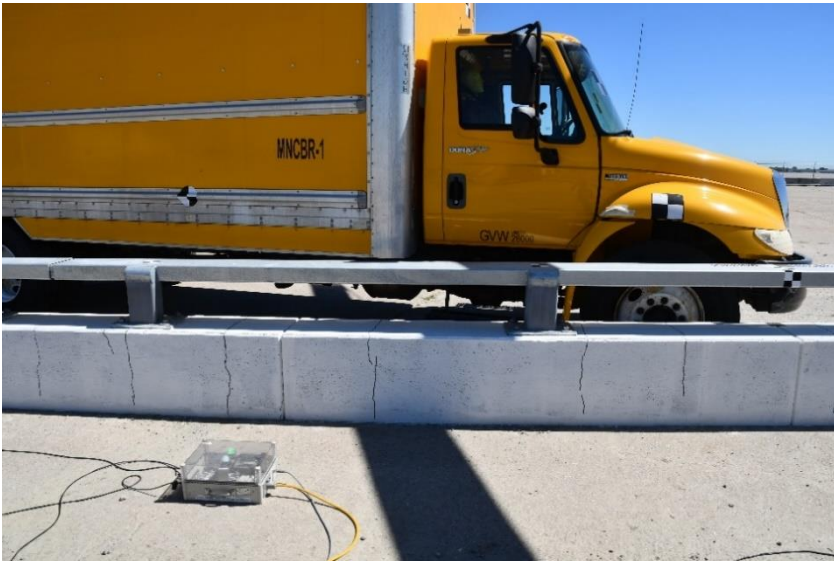
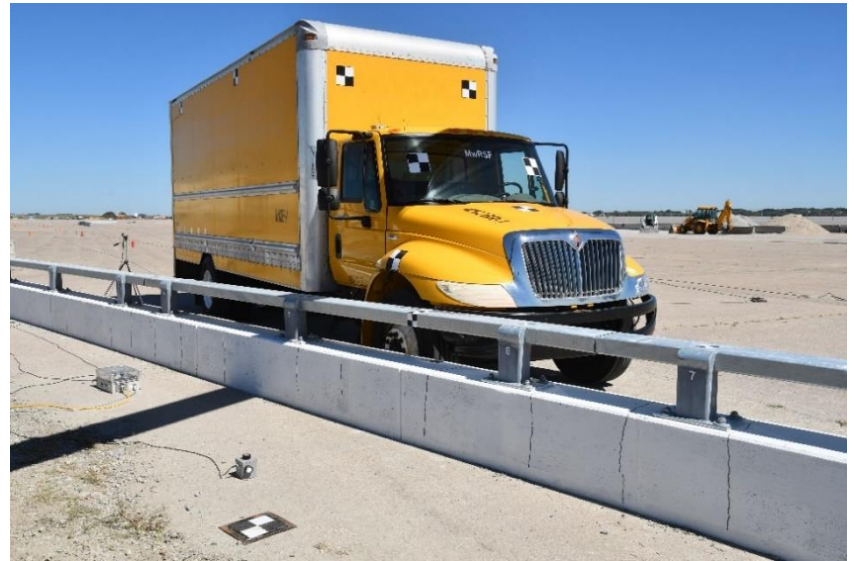
Figure 61. Impact Location, Test No. MNCBR-1

Initial vehicle impact was to occur 60 in. upstream from the centerline of splice between post nos. 6 and 7, as shown in Figure 61, which was selected as discussed in Chapter 2.2. The 22,042-lb single-unit box truck impacted the concrete parapet with a brush curb and upper beam and post rail with a new tapered end section at a speed of 57.4 mph and at an angle of 15.4 degrees. The actual point of impact was 60½ in. upstream from the target impact location. In the test, the vehicle was captured and redirected by the concrete parapet with brush curb and upper beam and post rail with new tapered end section.

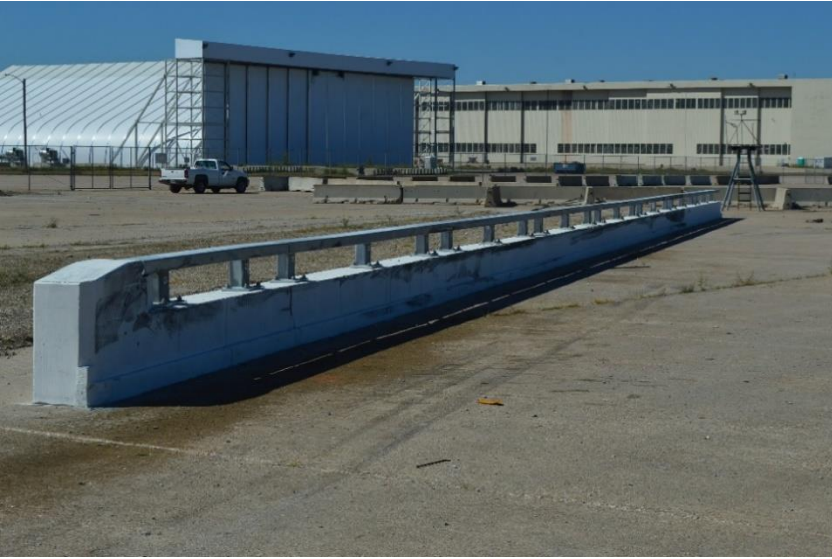
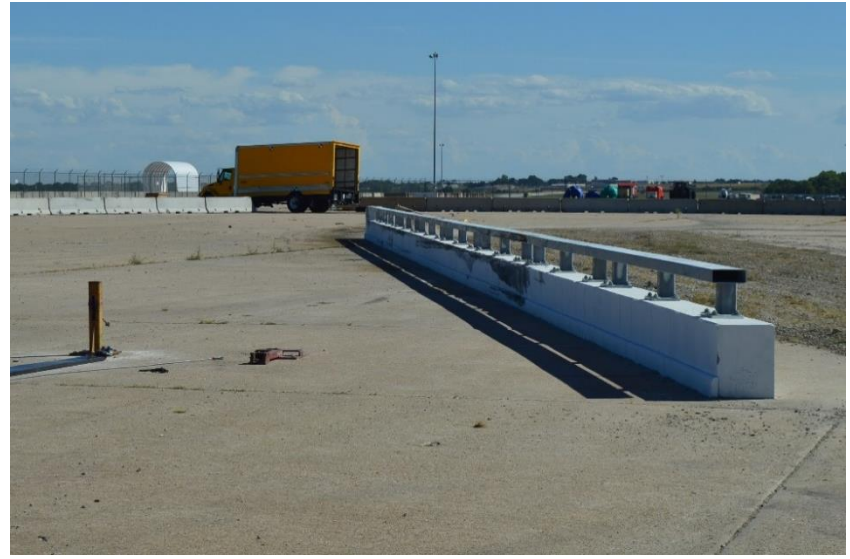
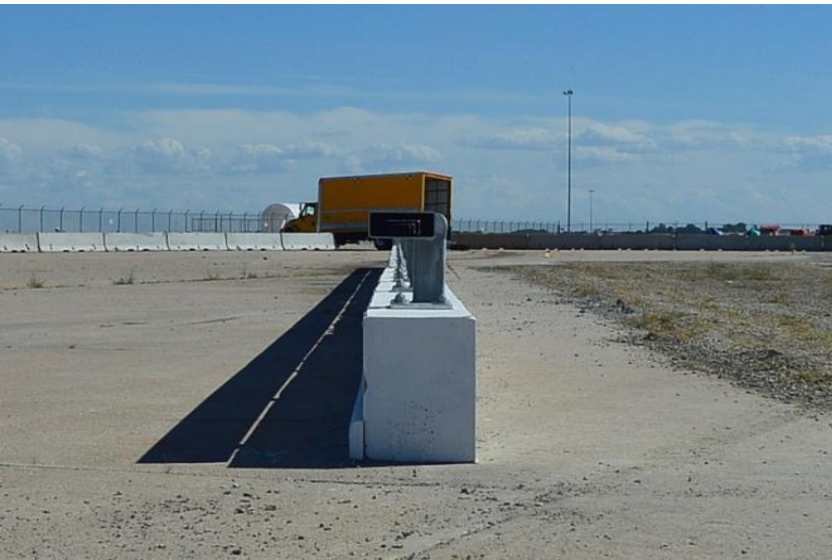
Figure 68. System Damage, Test No. MNCBR-1

Damage to the barrier was minimal, as shown in Figures 68 through 84. Barrier damage largely consisted of contact marks on the front face of the concrete barrier, gouging and spalling of the concrete, and contact marks on the upper steel rail. Note that the cracking shown in the system photographs was identified before the test and was related to shrinkage, which was not a result of test no. MNCBR-1. The length of vehicle contact along the barrier extended downstream approximately 122 ft – 3½ in., starting 8½ in. upstream from the centerline of post no. 5.

Contact marks measuring 5 in. wide were found across the front face of the brush curb, starting 5 in. upstream from the impact point and extending 158 in. downstream. Contact marks 4 in. wide were found across the front face of the brush curb, starting 15 in. upstream from the centerline of post no. 9 and extending 152 in. downstream. Contact marks 2½ in. wide were found across the front face of the brush curb, starting 75 in. upstream from the centerline of post no. 18 and extending 122 in. downstream. Contact marks were found on across the entire top face of the upper steel rail, starting 24 in. upstream from the impact point and extending 98 ft – 2½ in. downstream. Contact marks were found across the entire front face of the upper steel rail, starting 8½ in. upstream from the centerline of post no. 5 and extending 82 ft – 4½ in. downstream. Contact marks were found across the entire front face of the upper steel rail, starting 97¼ in. downstream from the centerline of splice between post nos. 15 and 16 and extending 115 in. downstream from the centerline of splice between post nos. 18 and 19. Contact marks were found on the front face of the bridge railing system, starting 20½ in. upstream from the centerline of splice between post nos. 21 and 22 and extending 40 in. upstream. Contact marks were found on the front face of the bridge railing system, starting 28 in. downstream from the centerline of the splice between post nos. 21 and 22 and extending 11½ in. downstream. Contact marks were found across the entire front face of the upper steel rail, starting 1 in. upstream from the downstream side of the new tapered end and extending 44½ in. downstream. Contact marks 1 in. wide were found on the bottom face of the upper steel rail, starting 15¾ in. downstream from the impact point and extending 32½ in. downstream from the centerline of post no. 7. Contact marks 6¼ in. wide were found on the bottom face of the upper steel rail, starting 16¼ in. downstream from the centerline of post no. 8 and extending 15 in. downstream from the centerline of post no. 12.

Tire marks were visible on the front face of the 21-in. tall concrete barrier, starting 62 in. upstream from the impact point and extending 118 ft – 6 in. downstream across the traffic side of the concrete barrier. Contact marks 1¼ in. wide were found on the top face of base plate of post no. 7, starting 2½ in. from the traffic-side edge and extending 12½ in. downstream. Contact marks 2½ in. wide were found across the entire length of the traffic side of post no. 10. A 3½-in. tall contact mark was found across the entire traffic side of post no. 10, starting 4 in. above the base plate. Contact marks 6½ in. wide were found on the traffic side of post no. 11, starting 1 in. above the base plate and extending 6½ in. downstream from the upstream corner. Contact marks 1 in. wide were found on the non-traffic side of post no. 12, starting 6 in. from the top of post and extending downward. Contact marks 3 in. wide were found on top of the traffic side of post no. 13 and extended across the entire length of post. Contact marks 2½ in. wide were found on the top of traffic side on post no. 18, starting on the upstream edge and extending 7 in. downstream.

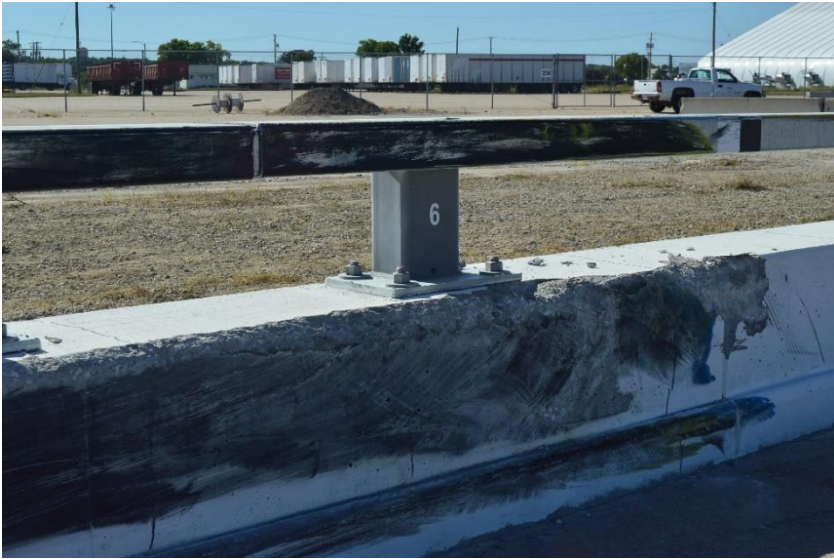
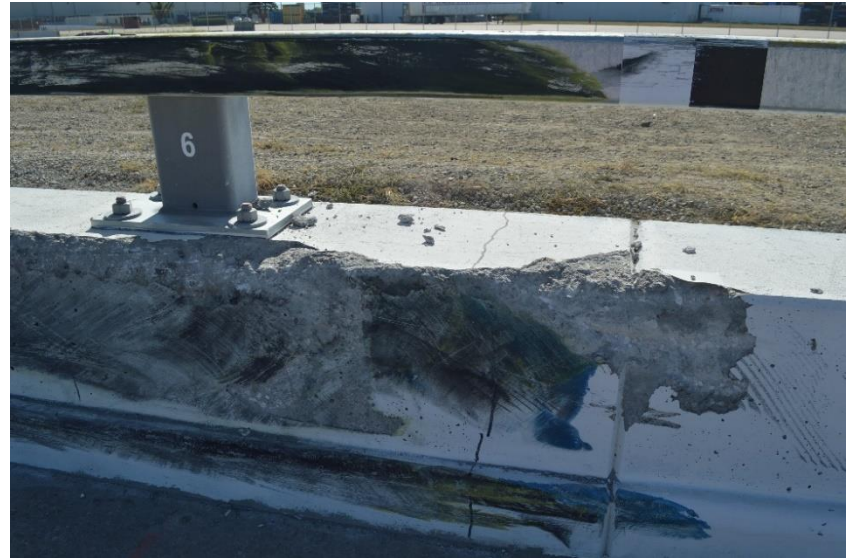
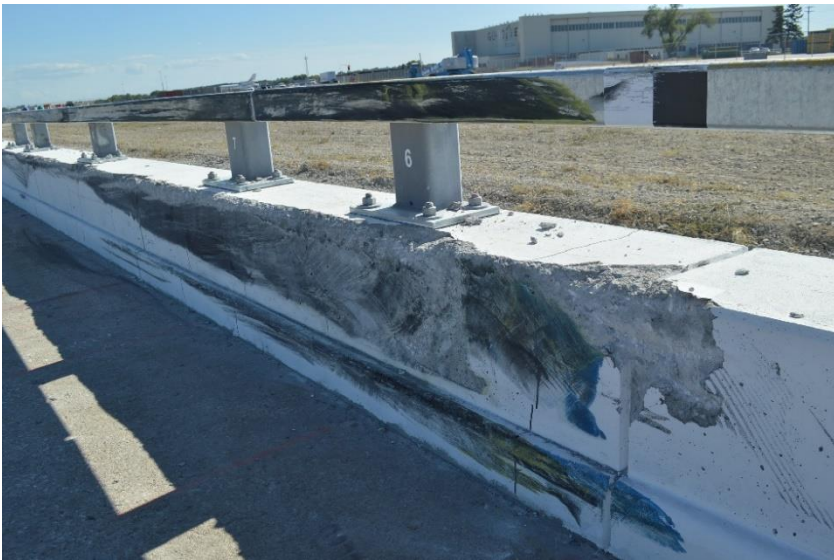
Figure 70. Concrete Gouging and Spalling, Test No. MNCBR-1

Scuff marks were also found along the length of vehicle contact. Gouging, measuring ¼ in. wide by 77 in. long, was found on the front face of the concrete parapet and located 21 in. upstream

from post no. 6 and 15 in. above the ground. Gouging, measuring 25 in. wide by 34 in. long, was located 33 in. upstream from post no. 20. Gouging, measuring 2½ in. wide by 28 in. long, was located 90 in. upstream from post no. 21. Gouging, measuring ½ in. wide by 19½ in. long, was located 46 in. upstream from post no. 21. Concrete chipping, measuring 9½ in. wide by 9 in. long, was located 36 in. upstream from the new tapered end and 26 in. above the ground.

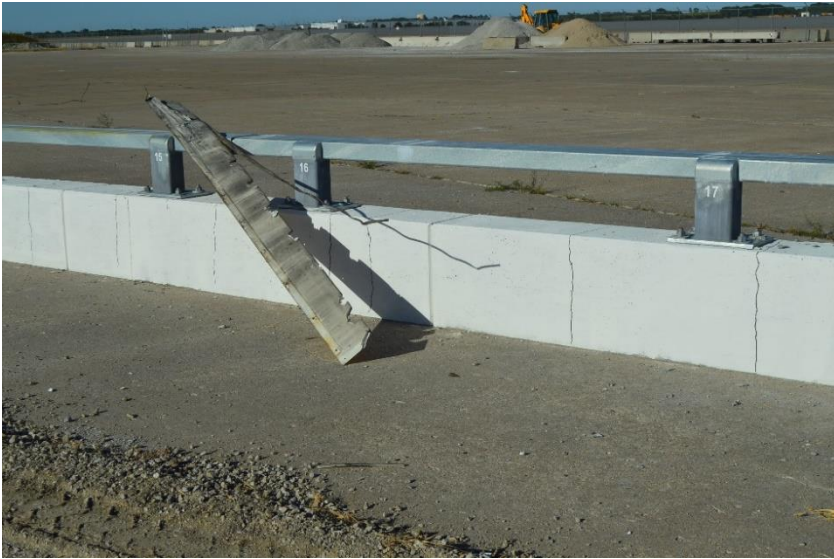
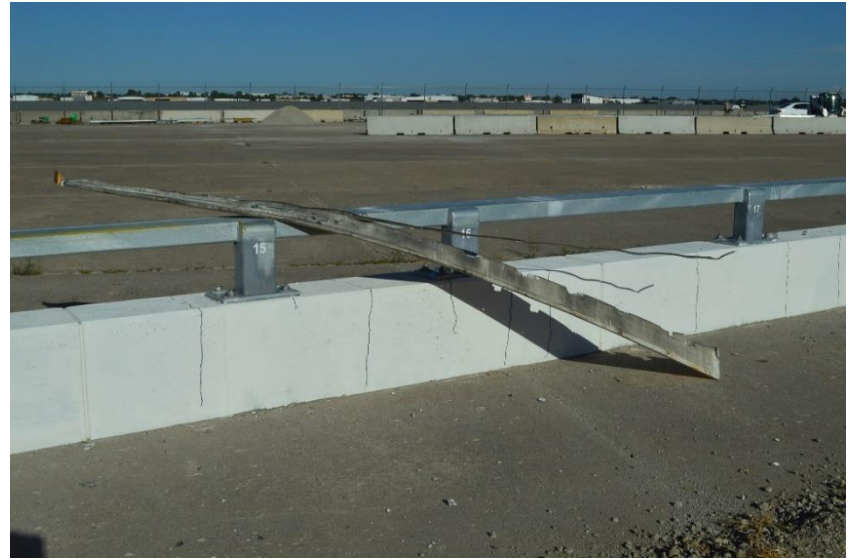
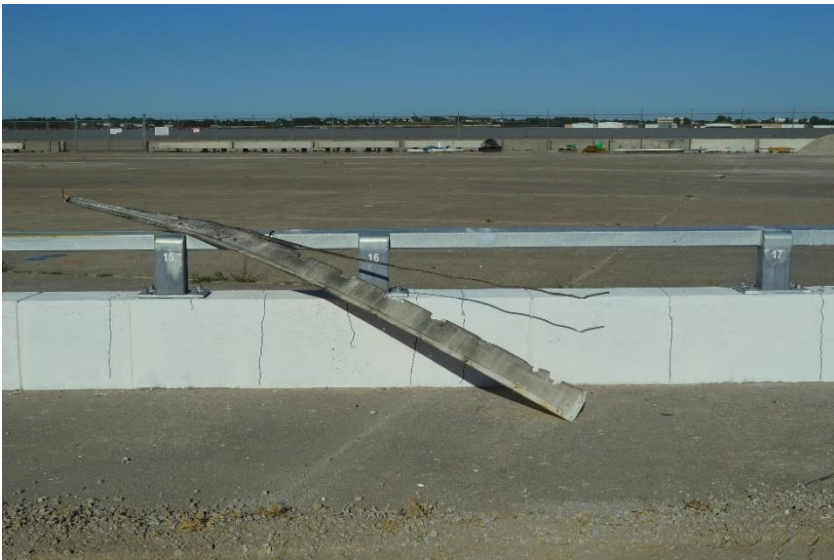
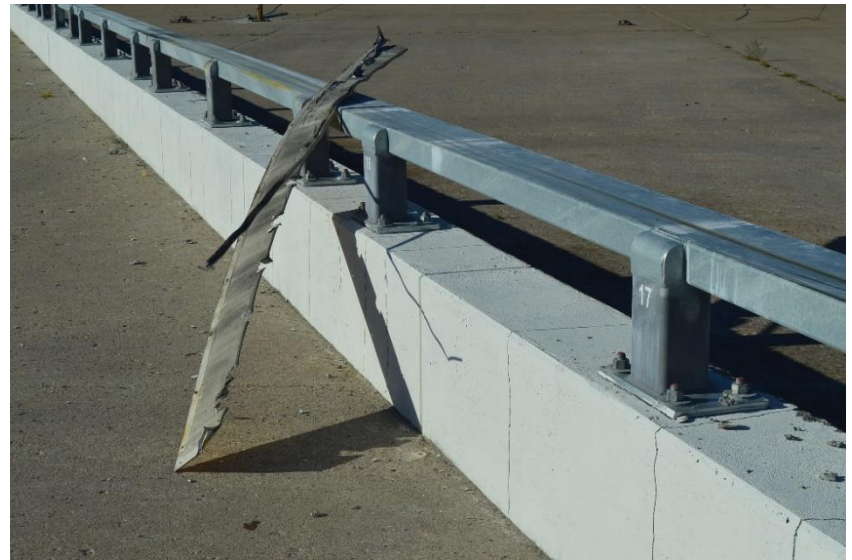
Figure 79. Vehicle Debris on Bridge Railing, Test No. MNCBR-1

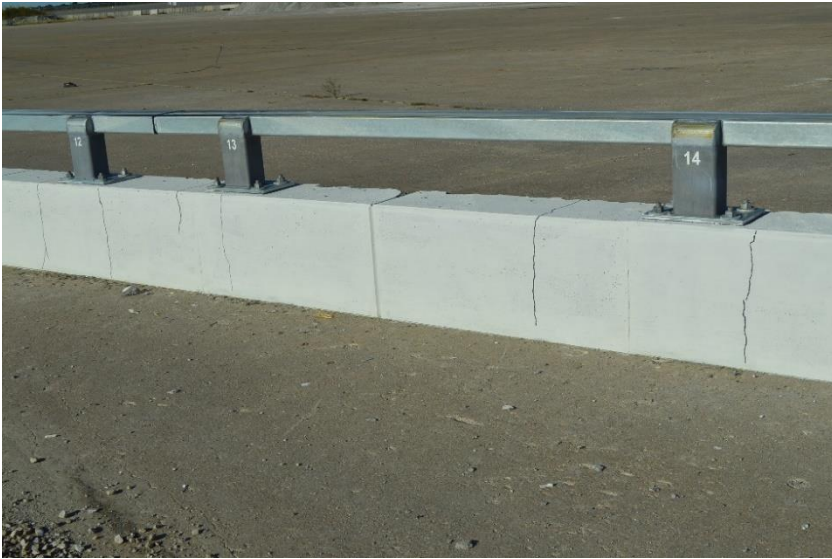
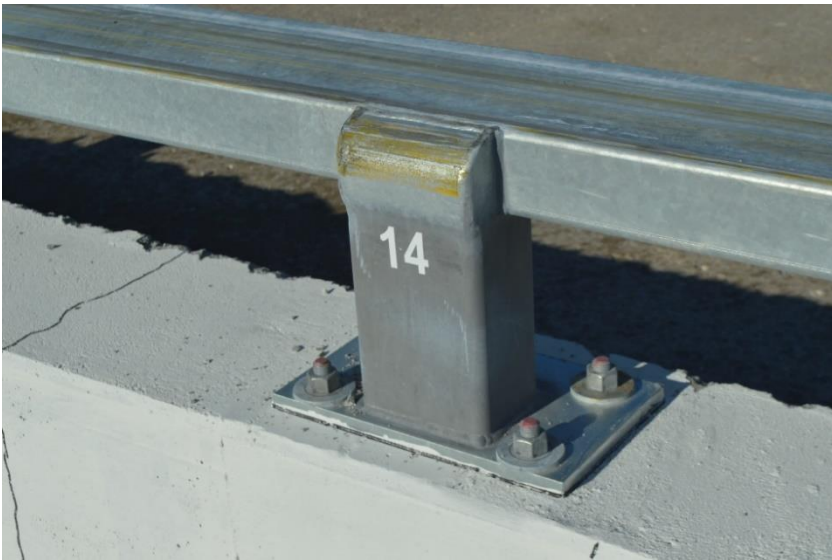
Figure 80. Non-Traffic Side Rail and Post Damage, Post No. 14, Test No. MNCBR-1

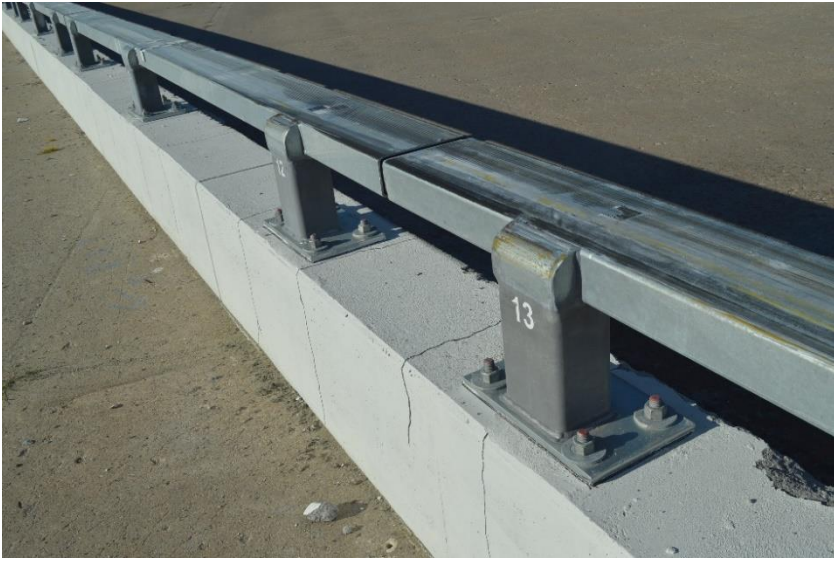
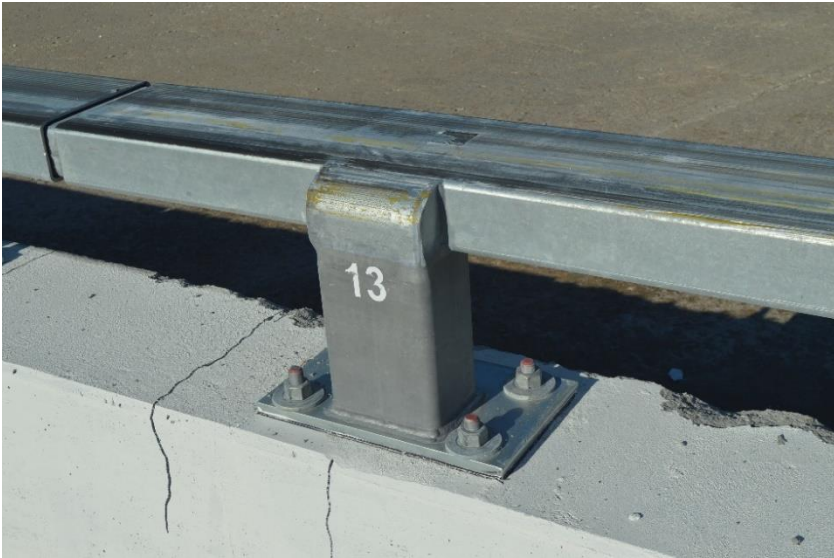
Figure 81. Rail and Post Damage, Post No. 13, Test No. MNCBR-1

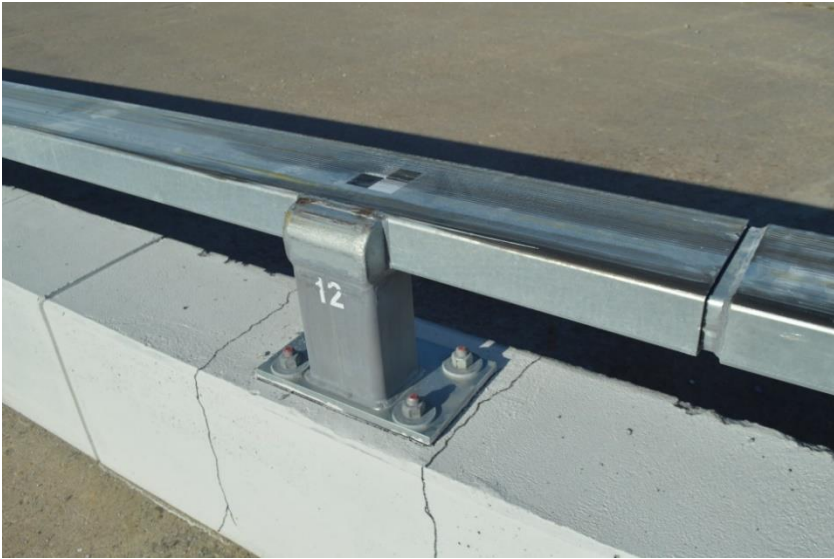
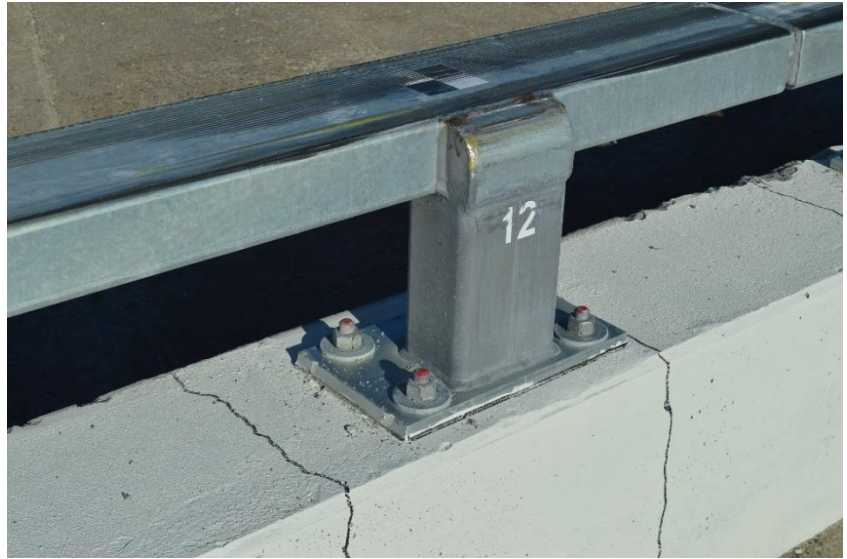
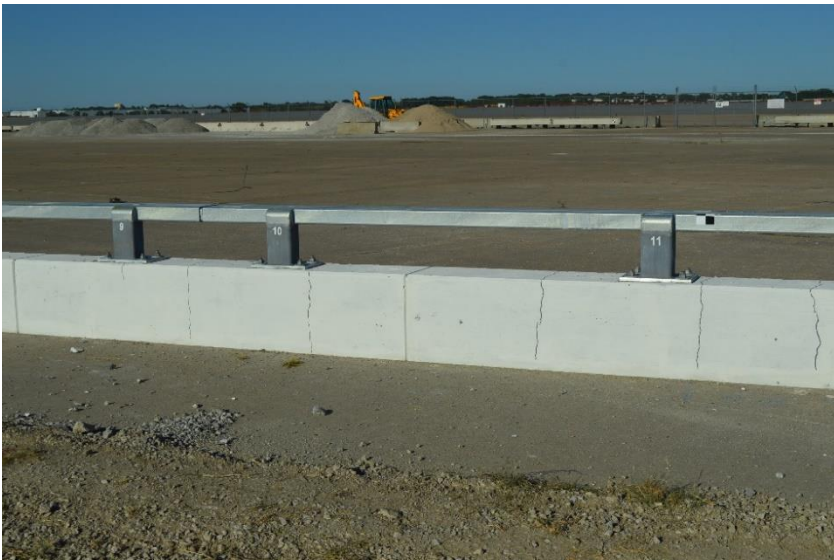
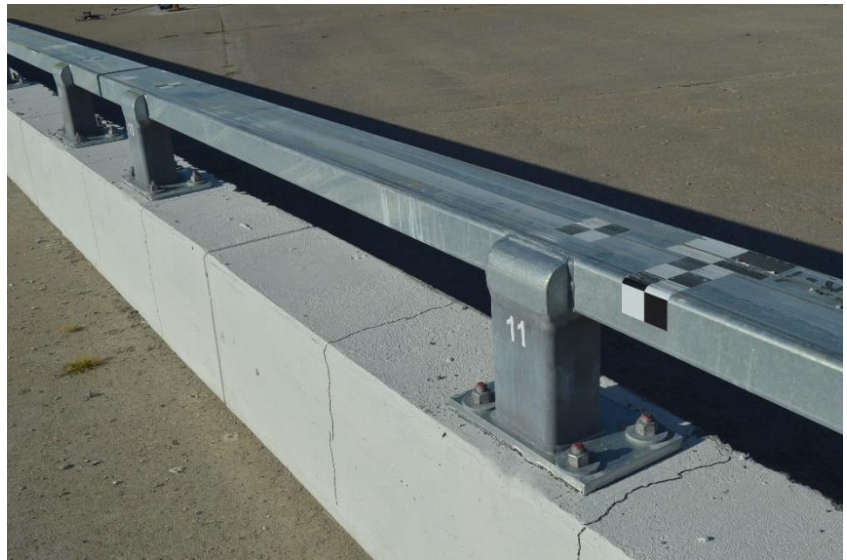
Figure 82. Rail and Post Damage, Post Nos. 12 and 11, Test No. MNCBR-1

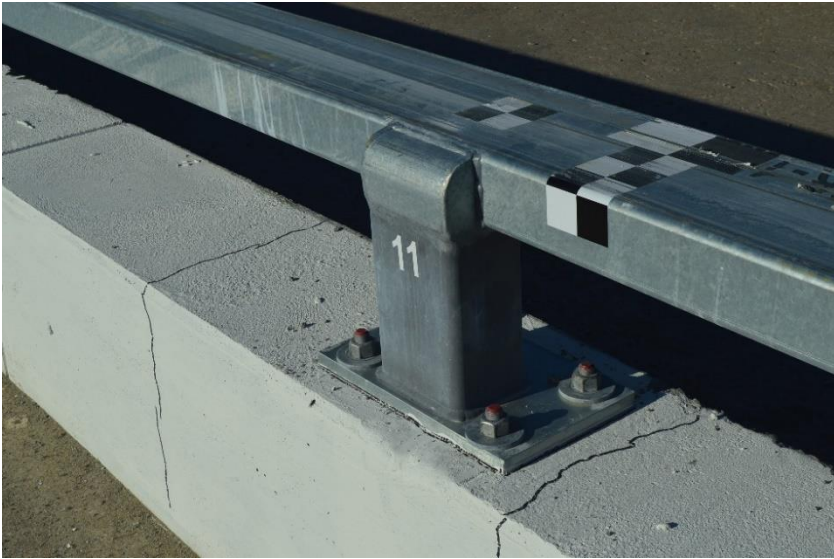
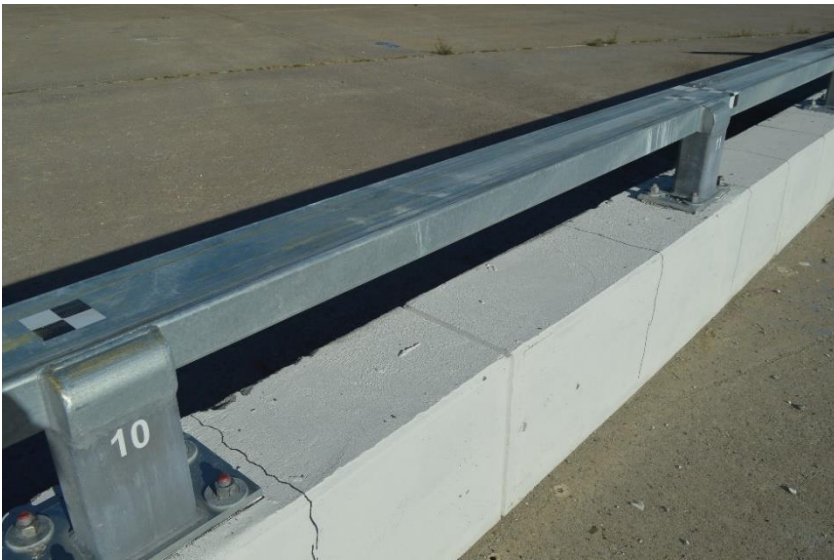
Figure 83. Rail and Post Damage, Post Nos. 11 and 10, Test No. MNCBR-1

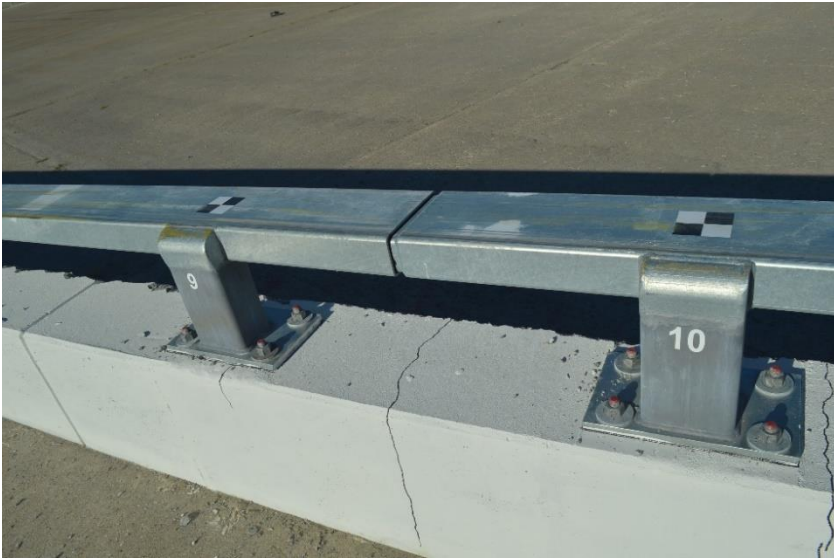
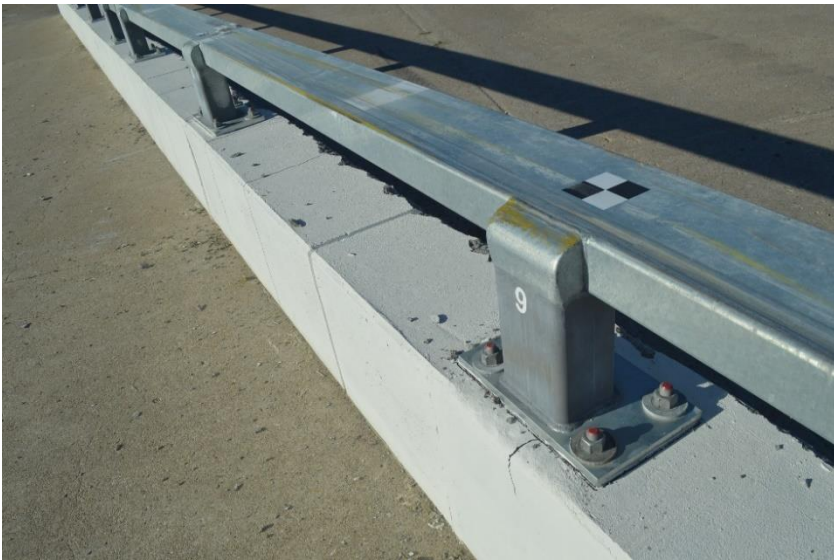
Figure 84. Rail and Post Damage, Post Nos. 10 and 9, Test No. MNCBR-1

The maximum lateral permanent set of the barrier system was 0.2 in. at post no. 9, as measured in the field. The maximum lateral dynamic barrier deflection, including tipping of the upper metal rail along the top surface, was 0.9 in., as determined from high-speed digital video analysis. The working width of the system was found to be 51.6 in., also determined from high-speed digital video analysis. The Zone of Intrusion (ZOI) was determined to be 49.6 in. Barrier deflections are shown schematically in Figure 85.

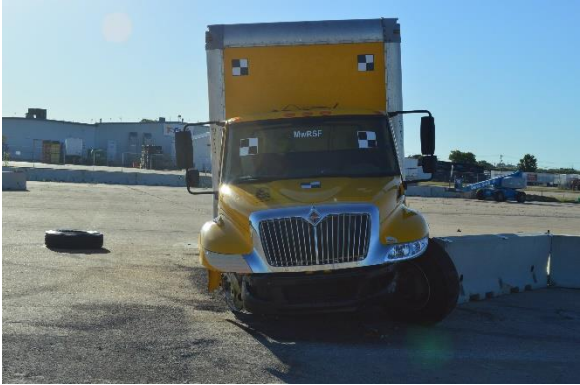
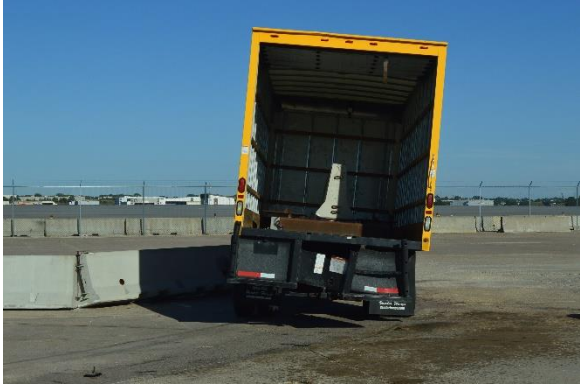
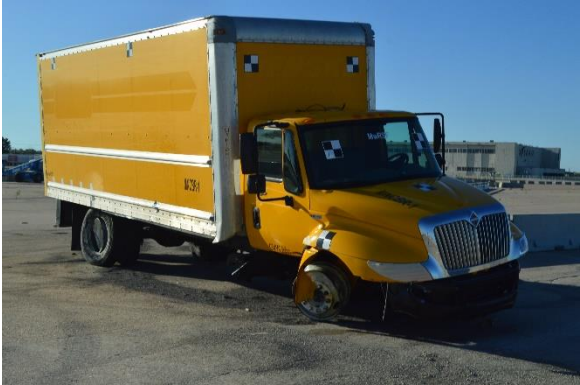
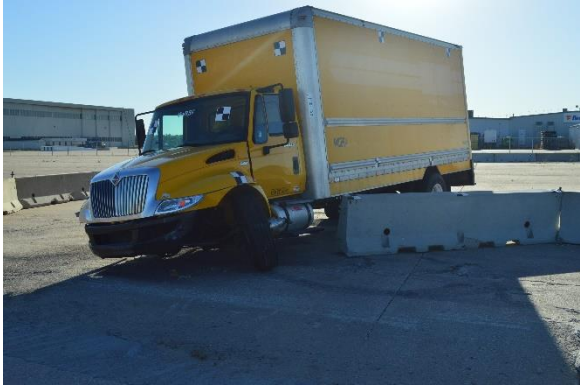
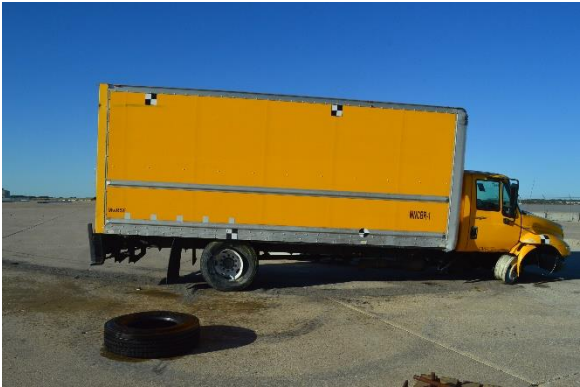
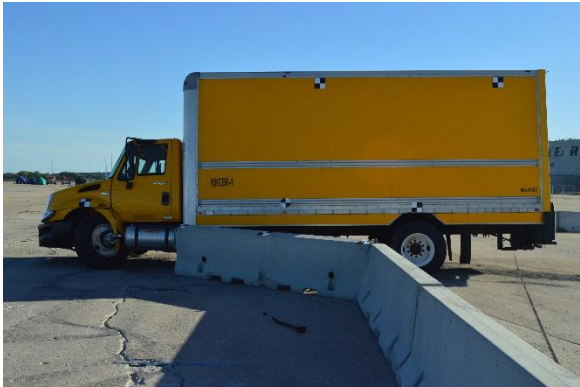
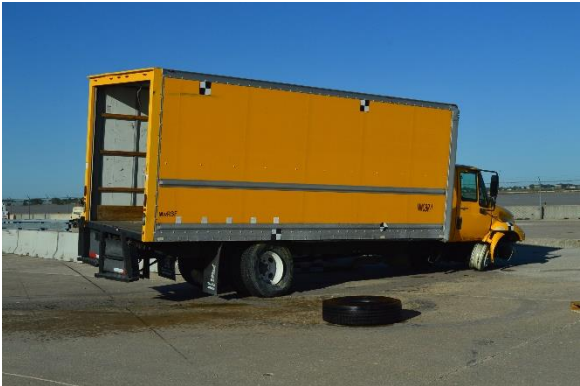
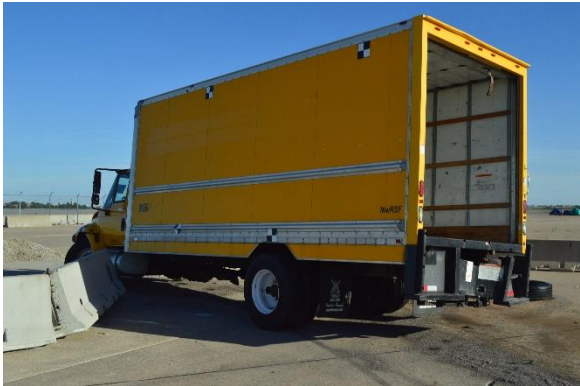
The majority of the damage was concentrated on the right-front corner and right side of the vehicle, where impact had occurred, as shown in Figure 86. The left side of the front bumper was crushed inward due to the vehicle impact into a downstream portable concrete barrier far beyond the bridge railing system. The right side of the bumper was crushed inward. The right-front fender was pushed upward near the door panel and torn behind the right-front wheel, as shown in Figure 87. The right-side upper control arm was bent. The right-front steel rim was moderately deformed with concentrated crushing along the edge, as shown in Figure 87.

Figure 86. Vehicle Damage, Test No. MNCBR-1

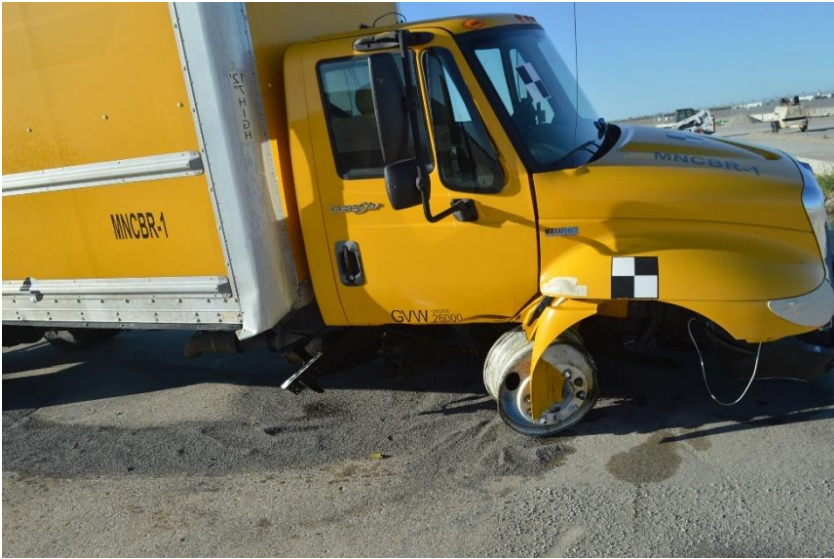
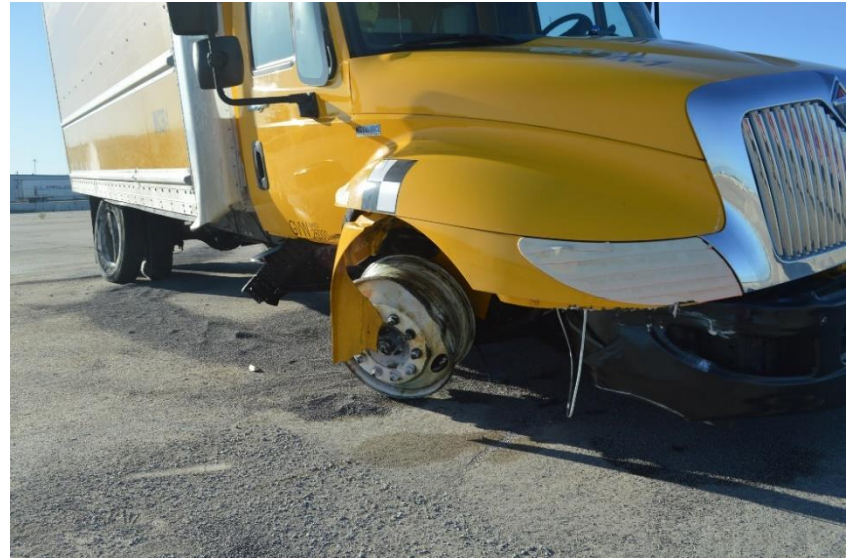
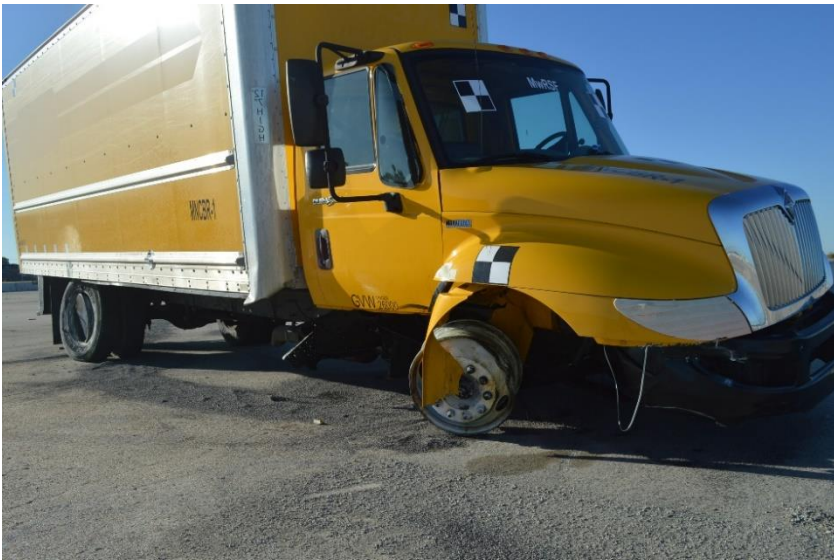
Denting and scraping were observed across the entire right side. The right-front door was slightly ajar, and creases were found in the door's sheet metal. The right-side window glass shattered, as shown in Figures 87 through 90. The right-rear door was dented and ajar. The right side of the truck bed was dented, and the fuel hatch was ajar. The right-rear wheel detached, as shown in Figures 87 through 90. The right side of the rear bumper was torn and pushed downward. The roof and remaining window glass remained undamaged. The undercarriage and the box were scraped, as shown in Figure 91.

Figure 87. Vehicle Damage, Test No. MNCBR-1

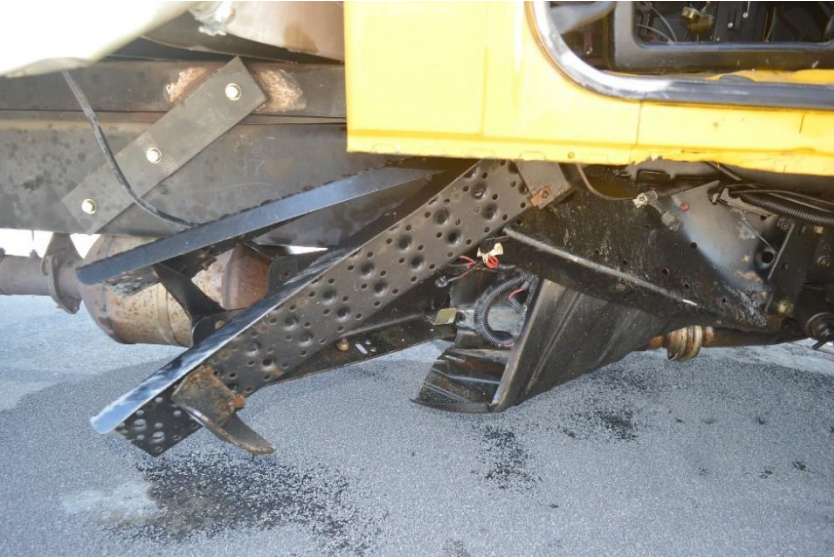
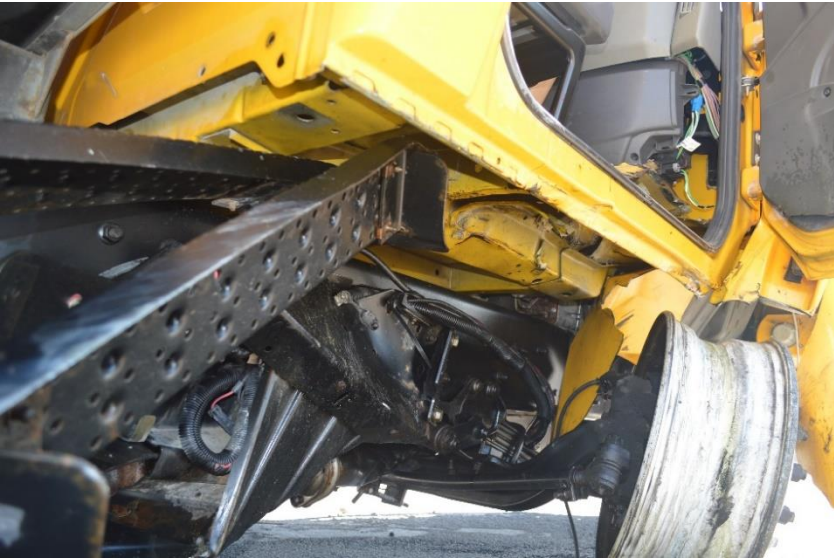
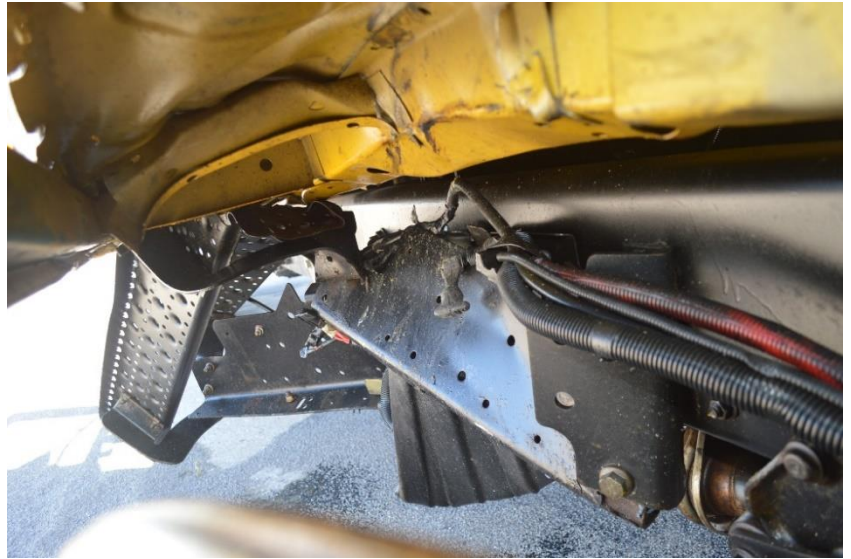
Figure 88. Undercarriage Damage, Test No. MNCBR-1

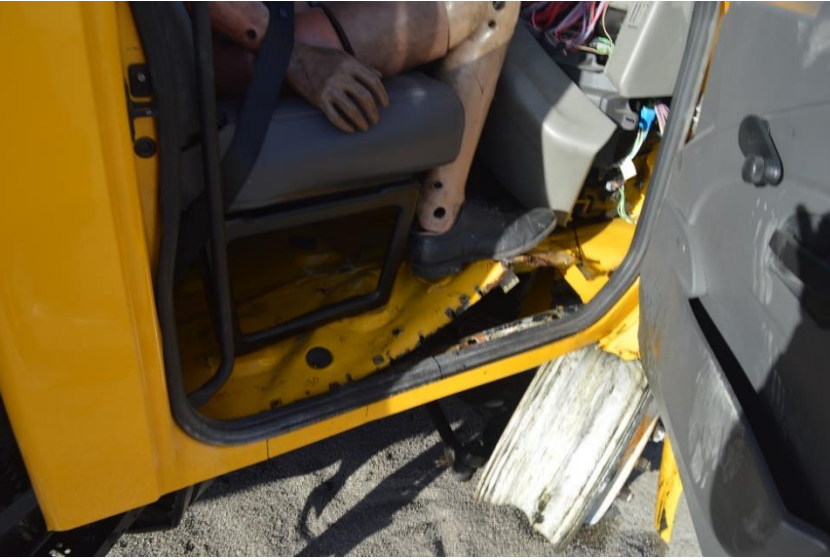
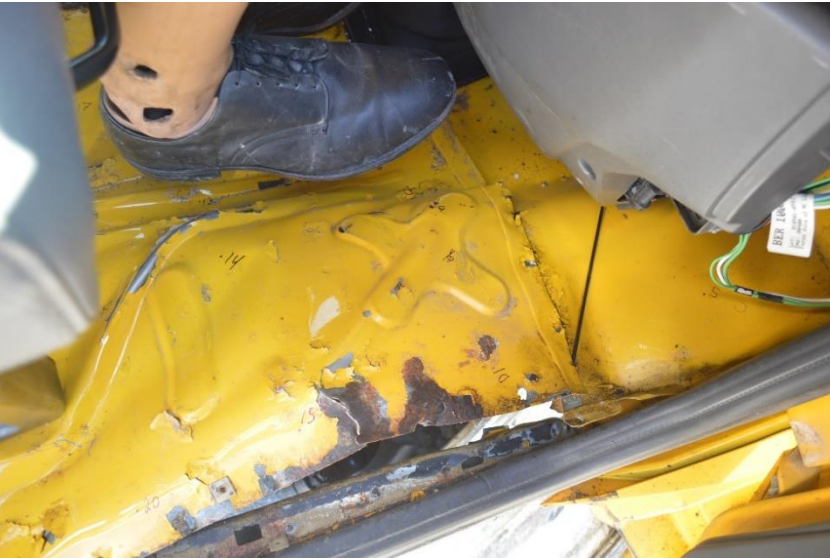
The right-side edge or seam of the floor pan released, as shown in Figures 88 and 89. The right-front wheel and/or rubber tire pushed on the supporting member and the floor pan was held in place at the edge until the partially-rusted spot welds along the seam failed. As such, the spot-weld region was pulled downward along this seam in more of a tensile loading manner, where the spot welds eventually tore out of the fabricated holes. Based on a review of the post-test results, researchers confirmed that the right-front wheel and/or rubber tire did not penetrate at the floor edge or seam since the floor did not reveal upward bending (prying up) at the edge but rather downward bending (tension down with tear out) at the edge, as shown in Figures 88 and 89. The maximum measured floor pan deformation was 5.6 in., which is within AASHTO MASH 2016 [3] occupant compartment deformation limits. The doorsill remained intact and did not show evidence of vehicle components prying through the edge opening at the doorsill region.

Figure 89. Vehicle Floor Pan Damage, Test No. MNCBR-1

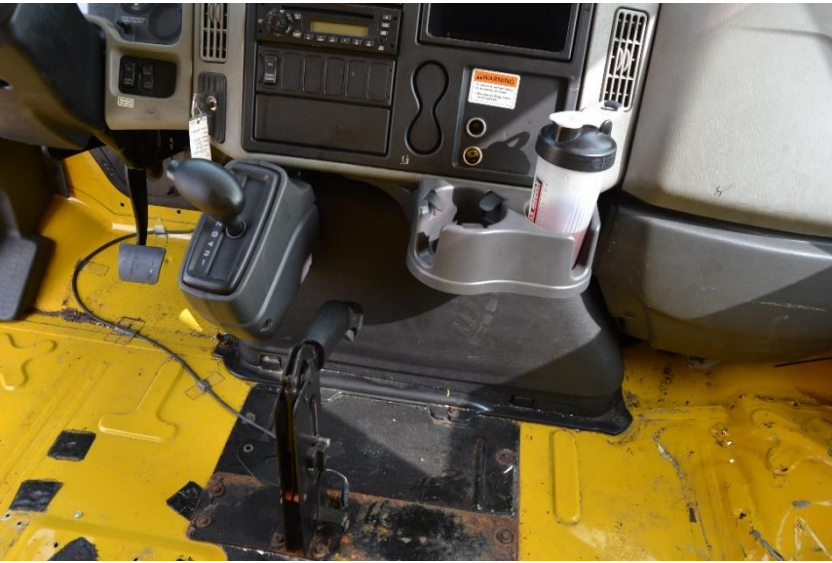
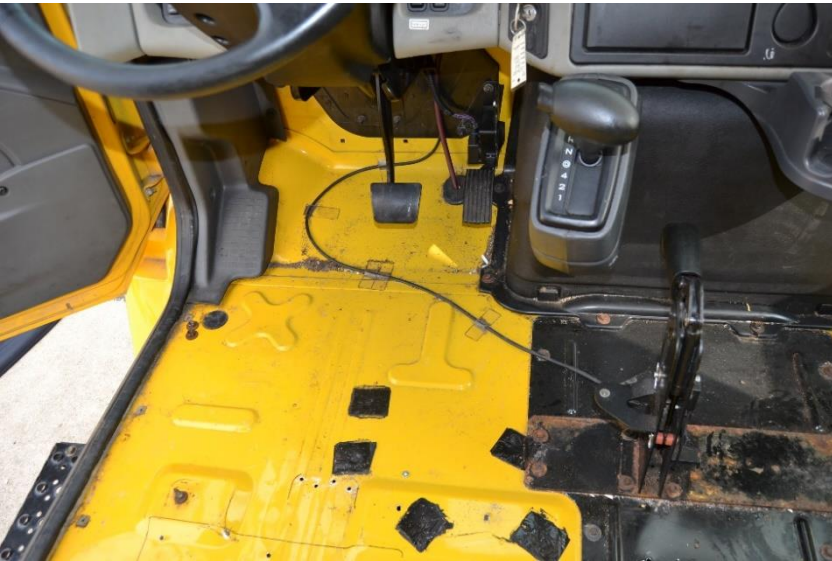
Figure 90. Vehicle Floor Pan Damage, Test No. MNCBR-1

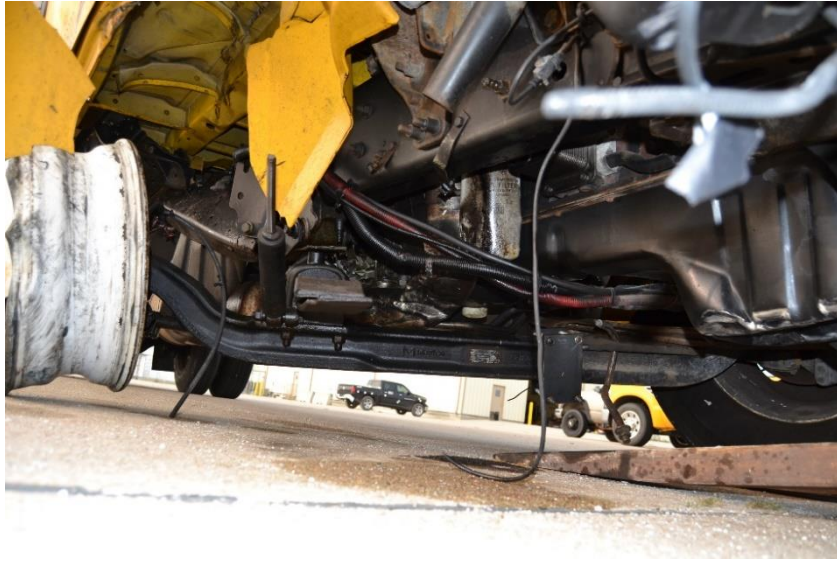
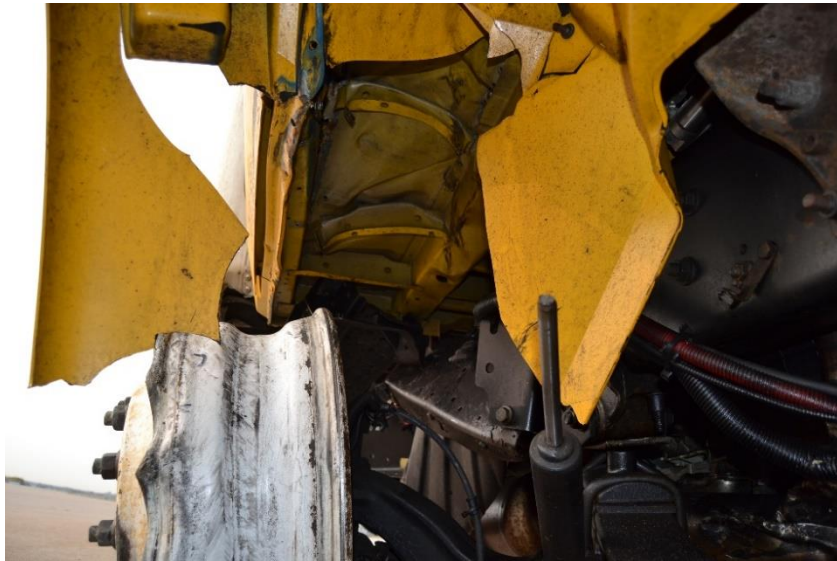
Figure 91. Undercarriage Damage, Test No MNCBR-1
