MASH 2016 TEST LEVEL 4 EVALUATION OF MNDOT CONCRETE PARAPET WITH BRUSH CURB AND UPPER BEAM AND POST RAIL WITH NEW TAPERED END SECTION

MINNESOTA DEPARTMENT OF TRANSPORTATION

MwRSF Research Report No. TRP-03-403-21

March 26, 2021

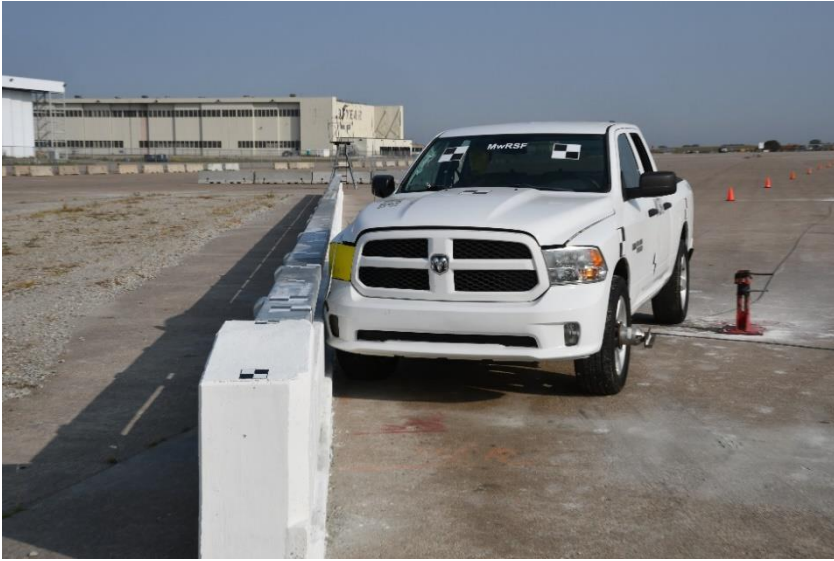
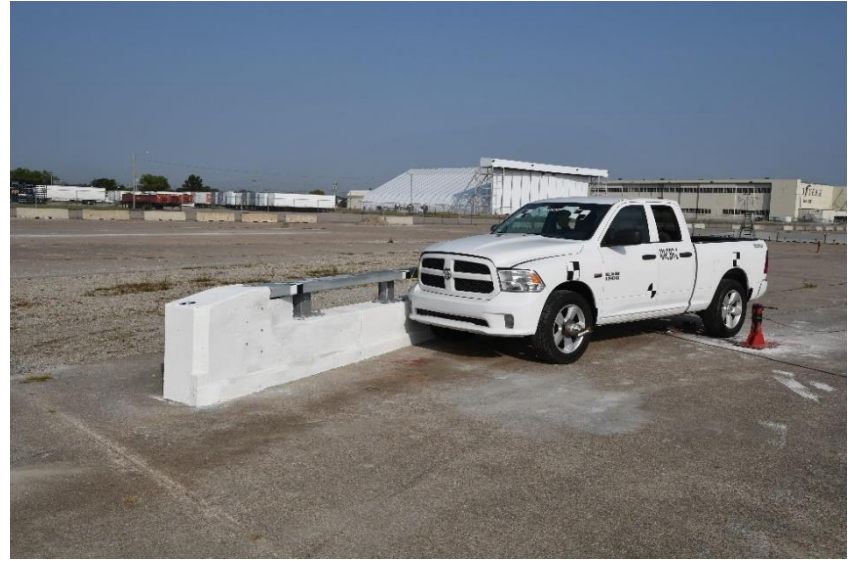
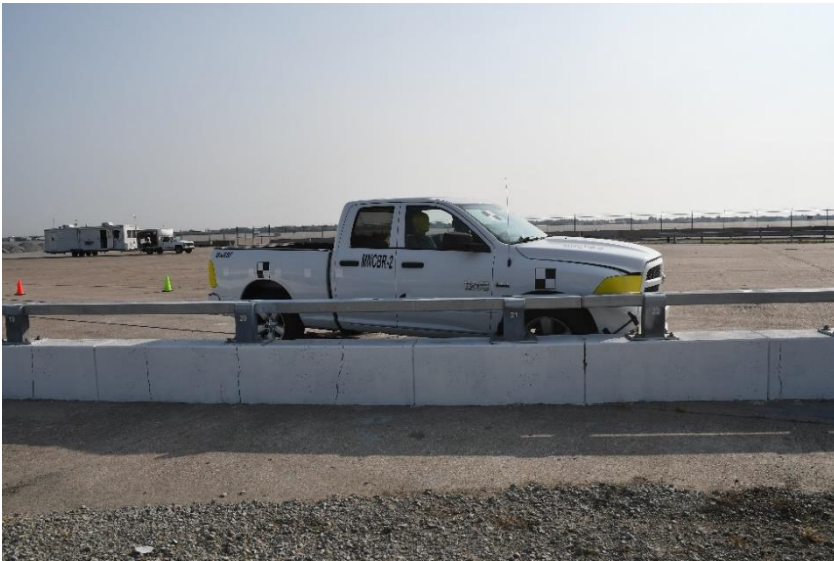
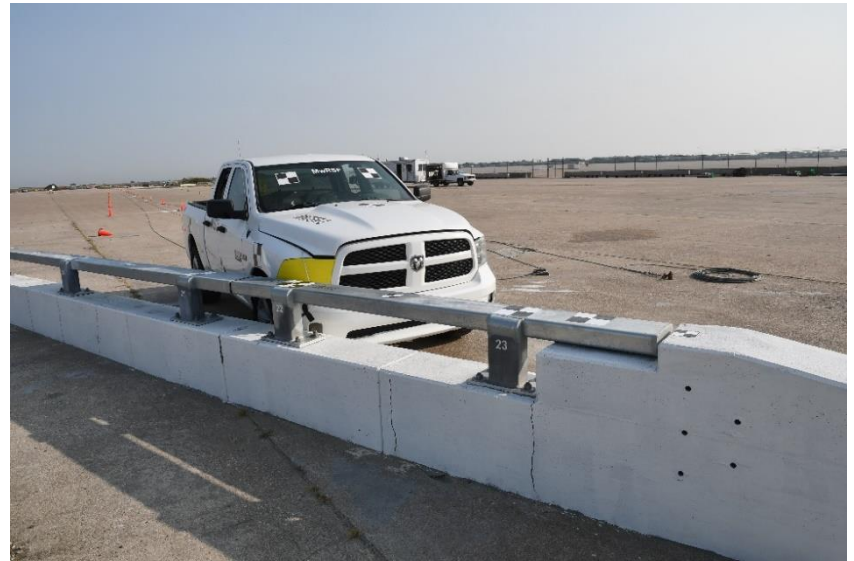
Figure 96. Impact Location, Test No. MNCBR-2

Initial vehicle impact was to occur 70¹/₁₆ in. upstream from the centerline of post no. 23, as shown in Figure 96, which was selected as discussed in Chapter 2.2. The 5,003-lb crew cab pickup truck impacted the concrete parapet with a brush curb and upper beam and post rail with a new tapered end section at a speed of 63.9 mph and at an angle of 25.1 degrees. The actual point of impact was 0.78 in. downstream from the target impact point. In the test, the vehicle was captured and redirected by the concrete parapet with brush curb and upper beam and post rail with new tapered end section.

For test no. MNCBR-2, the 5,003-lb crew cab pickup truck impacted the combination bridge railing system at a speed of 63.9 mph and at an angle of 25.1 degrees. The initial vehicle impact was to occur $70\frac{1}{16}$ in. upstream from the centerline of post no. 23, as shown in Figure 96. The actual point of impact was 0.78 in. upstream from the target impact location. The vehicle was captured and safely redirected by the bridge railing. During vehicle redirection, the right-front fender and right-front corner of the engine hood contacted the upstream side of the post

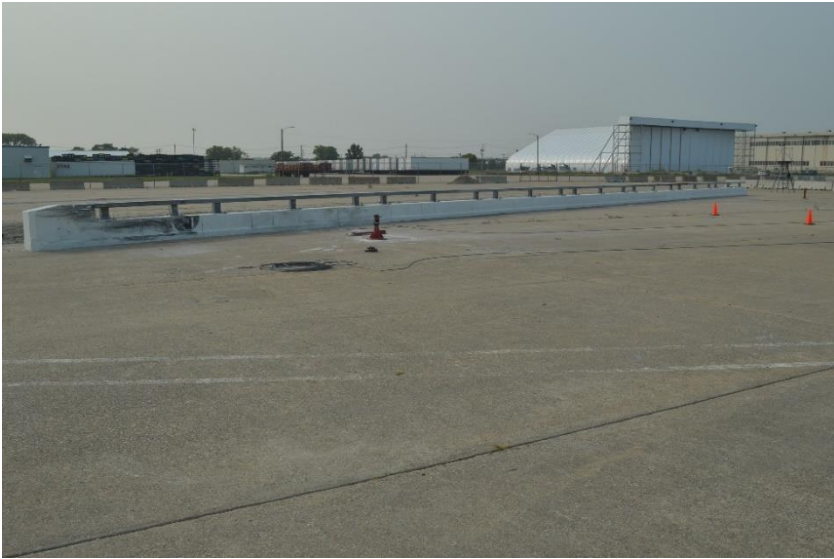
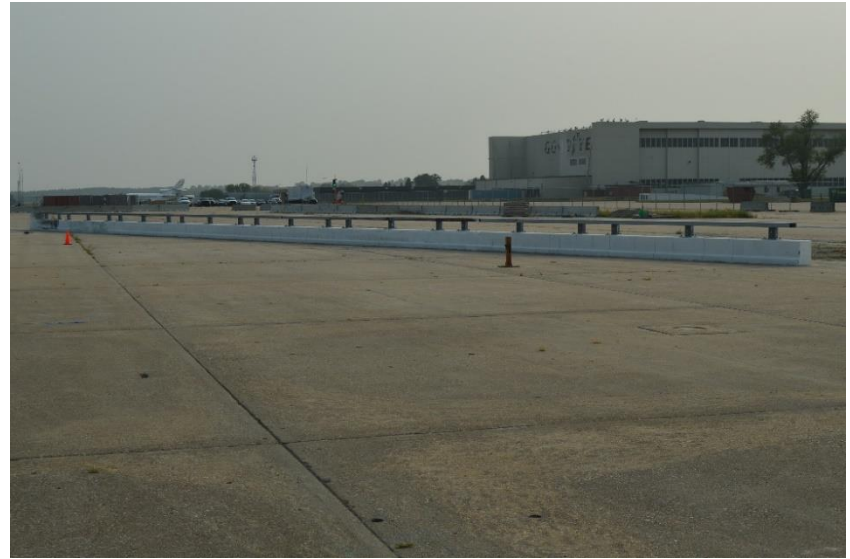
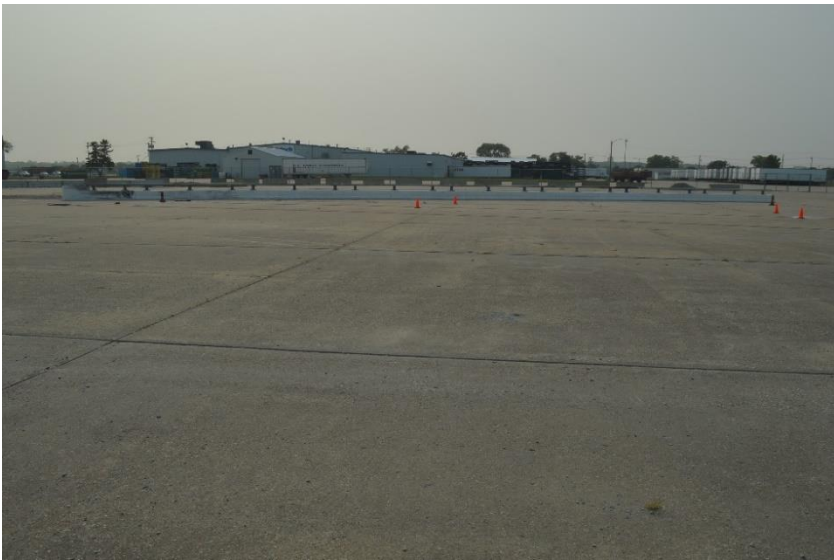
Figure 101. System Damage, Test No. MNCBR-2

Damage to the barrier was minimal, as shown in Figures 101 through 111. Barrier damage largely consisted of contact marks on the front face of the concrete barrier and spalling of the concrete. Note that the cracking shown in the system photographs was identified before the test as being related to shrinkage, and was not a result of test no. MNCBR-2. The length of vehicle contact along the barrier extended downstream approximately 12 ft – 10 in., starting at 21½ in. upstream from post no. 22.

Tire marks were visible on the front face of the 21-in. tall concrete barrier, starting 16 in. upstream from the centerline of post no. 22 and extending 9 ft – 9 in. downstream across the traffic side of the barrier. Contact marks 15 in. wide were found across the front face of the concrete barrier above the brush curb, starting 21½ in. upstream from the centerline of post no. 22 and extending 9 ft – 11 in. downstream. Contact marks 15 in. wide were found across the entire length of the front face of the end post, including the horizontal tapered end, starting 9 in. downstream from the centerline of post no. 23 and extending 56 in. downstream. Contact marks measuring 4 in. wide were found on front face of the steel upper rail, starting 6½ in. downstream from the centerline of the splice between post nos. 21 and 22 and extending 9 ft – 9 in. downstream. Contact marks measuring 8½ in. wide were found on the top face of the steel upper rail, starting 7 in. downstream from the centerline of splice between post nos. 21 and 22 and extending 9 ft – 8 in. downstream. Contact marks measuring 5½ in. wide were found on the front face of the steel upper rail, starting 13 in. downstream from the centerline of the splice between post nos. 21 and 22 and extending 8 ft – 8½ in. downstream. Contact marks measuring ⅛ in. wide were found on the upstream face of post no. 22, starting 12 in. from the top of plate and extending 1 in. downward. Contact marks measuring 1 in. wide were found on the upstream face of post no. 23, starting 6½ in. from the top of the plate and extending 2 in. upward. Contact marks measuring 6½ in. were found on the front face of post no. 23, starting ½ in. from the top of the plate and extending 8½ in. upward. Contact marks measuring ½ in. wide were found on the upstream corner of the front face of post no. 23, starting at the post base plate and extending across the entire height of the post. The vehicle's lateral overlap/contact distance at the upstream end of the tapered end section was 1 in. The vehicle's overlap/contact distance at the upstream corner of the front face of post no. 23 was ½ in.

Scuff marks were also found along the length of vehicle contact. Gouging was found on the top corner of the front face of the concrete parapet, measuring 75 in. long and located 2 in. upstream from post no. 22 with a width of 7 in. Gouging with a width of 3 in. and measuring 25 in. long was located 48 in. upstream from post no. 23. Gouging was found on the upstream face of the mid horizontal tapered section measuring ¾ in. long located 8 in. from the top front corner of the upstream face. Gouging was found on the upstream face of the mid horizontal tapered section measuring ½ in. long located 3½ in. from the top front corner of the upstream face. Gouging with a width of 1½ in. and measuring 10 in. long was located 20 in. upstream from post no. 23. Gouging with a width of 1½ in. and measuring 17½ in. long was located 11½ in. upstream from post no. 23. Concrete chipping, measuring 21½ in. long, was located at upstream edge of end post with a width of 9 in.

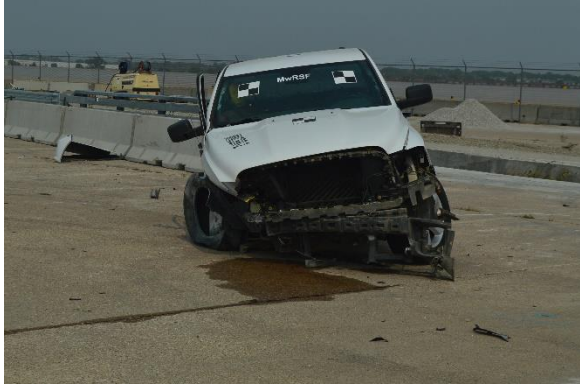
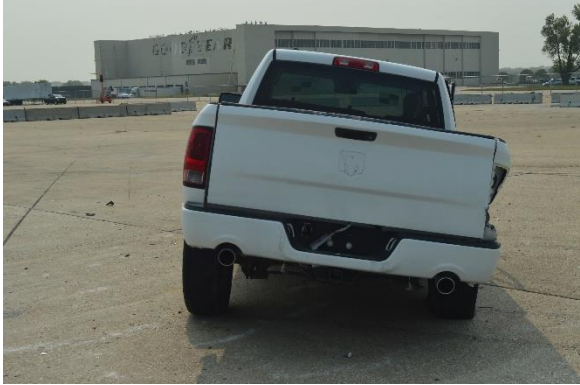
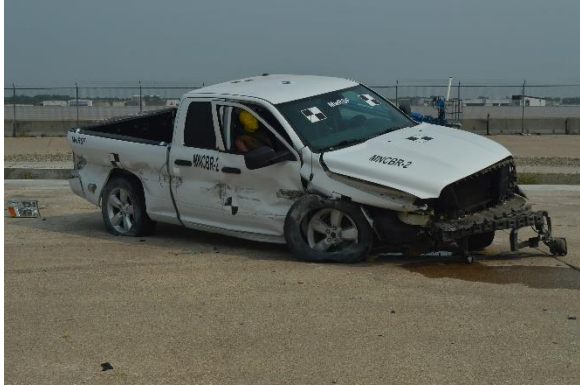
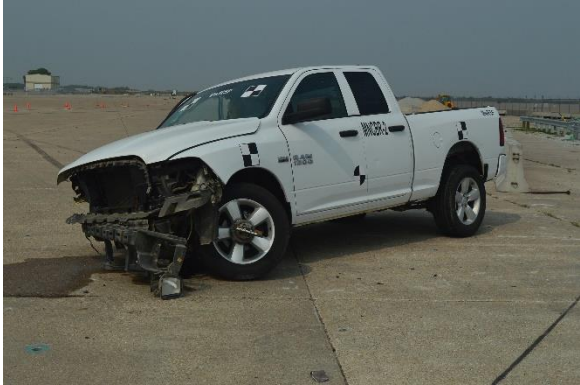
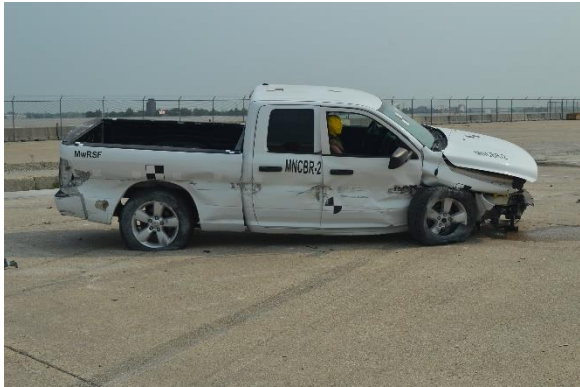
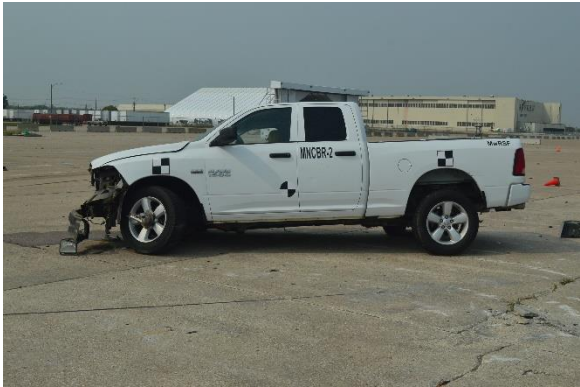
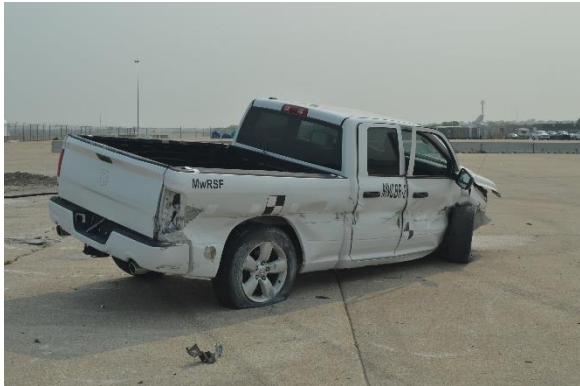
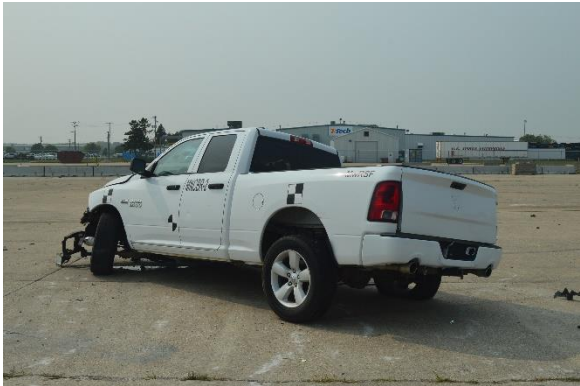
Figure 113. Vehicle Damage, Test No. MNCBR-2

The majority of the damage was concentrated on the right-front corner and right side of the vehicle, where impact had occurred, as shown in Figure 113. The right side of the front bumper plastic cover was shattered after impact, and the entire front bumper detached soon thereafter. The right-front fender was pushed inward and dented and torn behind the right-front wheel, as shown in Figure 114. The right-front cast aluminum rim was severely deformed with tears and significant crushing, as shown in Figures 114 and 116. The grille disengaged and fractured soon after impact. Both headlights were disengaged from the vehicle, as shown in Figure 115. The right side of the radiator was pushed backward. Denting and scraping were observed across the entire right side. The right-front door was slightly ajar, and creases were found in the door's sheet metal. The right-side window glass shattered, as shown in Figure 117. The right-rear door was dented and ajar. The right side of the truck bed was dented, and the fuel hatch was ajar, as shown in Figure 118. The right side of the rear bumper was scraped and pushed downward. The roof and remaining window glass remained undamaged. The floor pan was pushed inward, as shown in Figure 119. The right-side upper control arm was fractured, and undercarriage was scraped, as shown in Figure 121 and Figure 122.

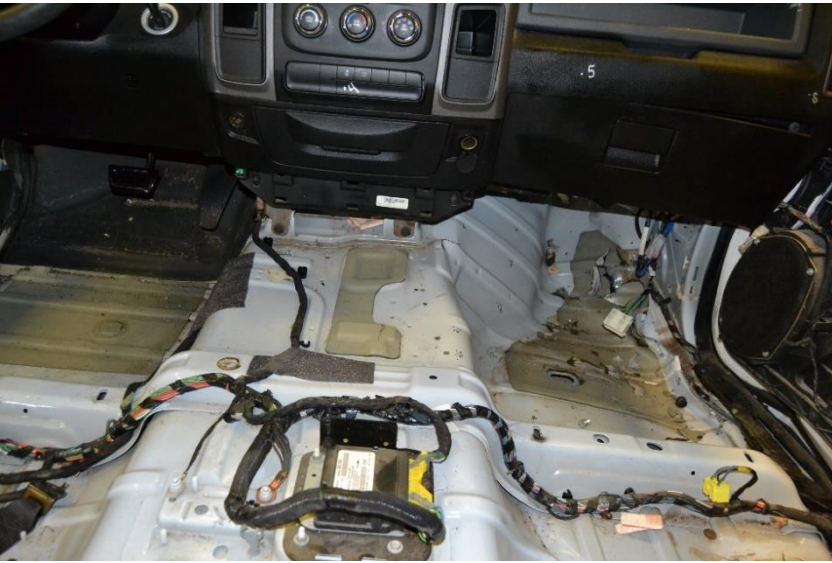
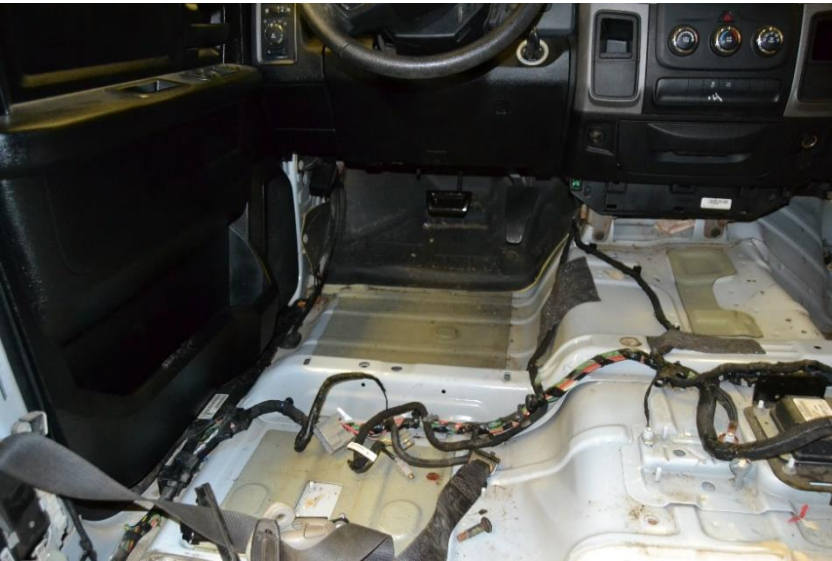
Figure 119. Vehicle Floor Pan Damage, Test No. MNCBR-2

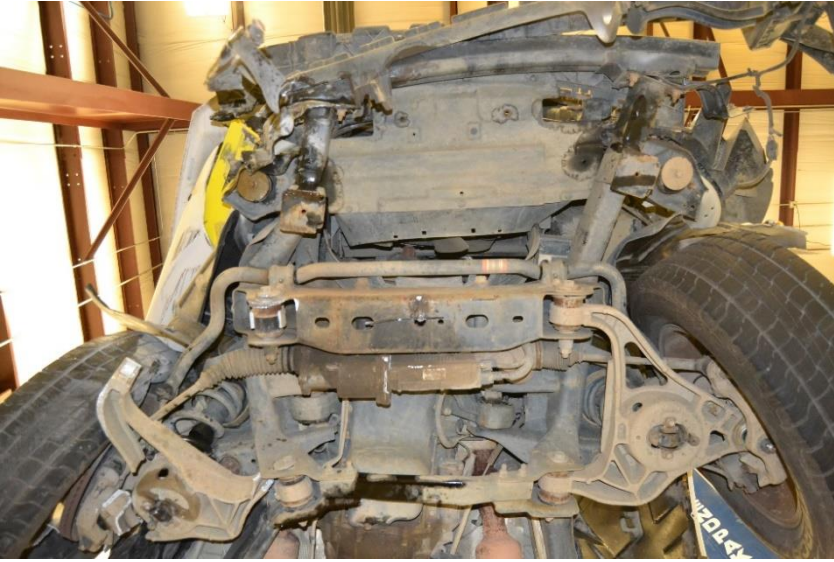
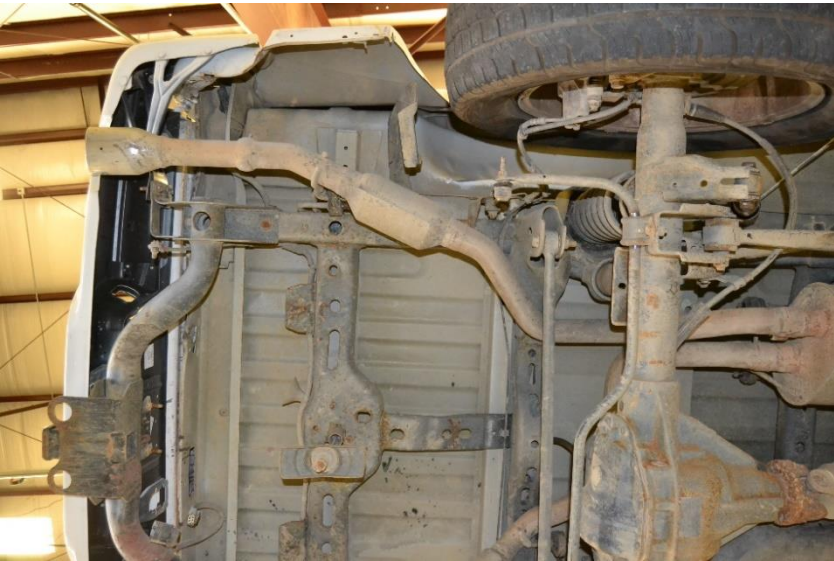
Figure 120. Undercarriage Damage, Test No. MNCBR-2

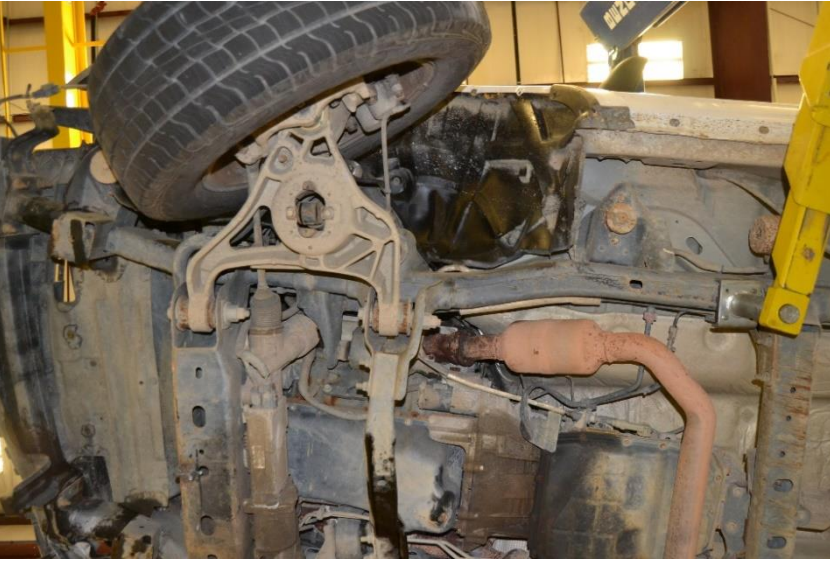
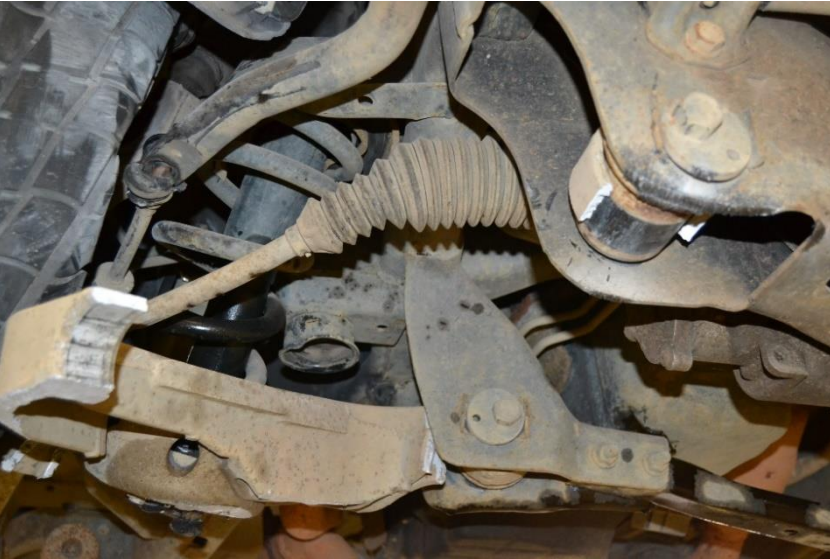
Figure 121. Undercarriage Damage, Test No. MNCBR-2

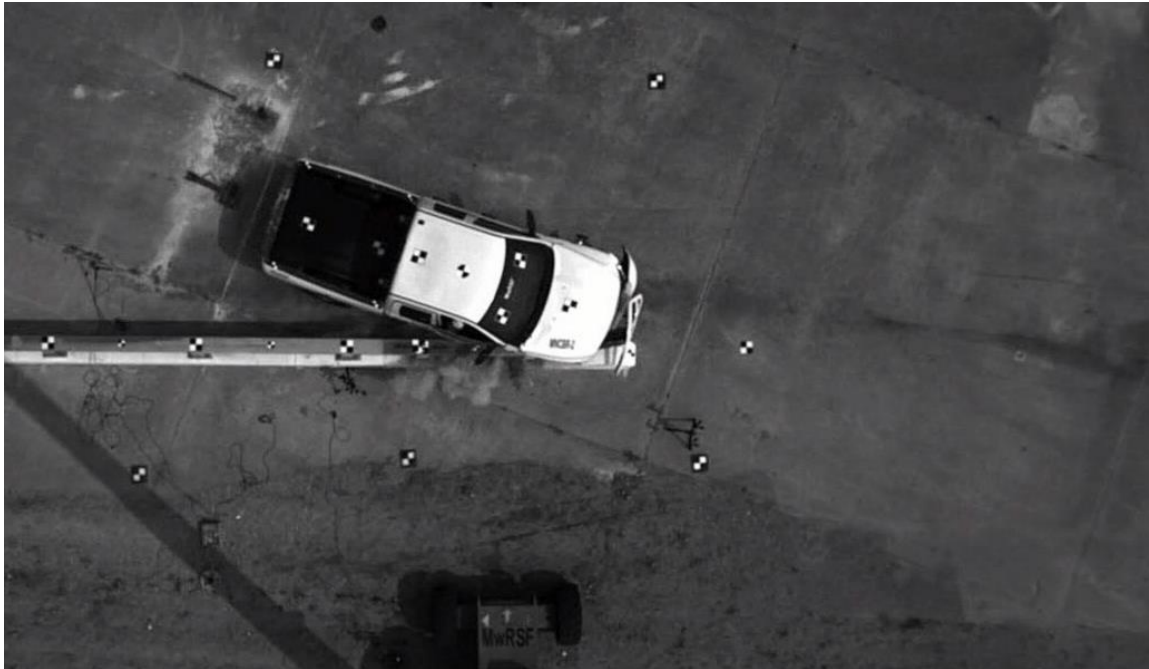
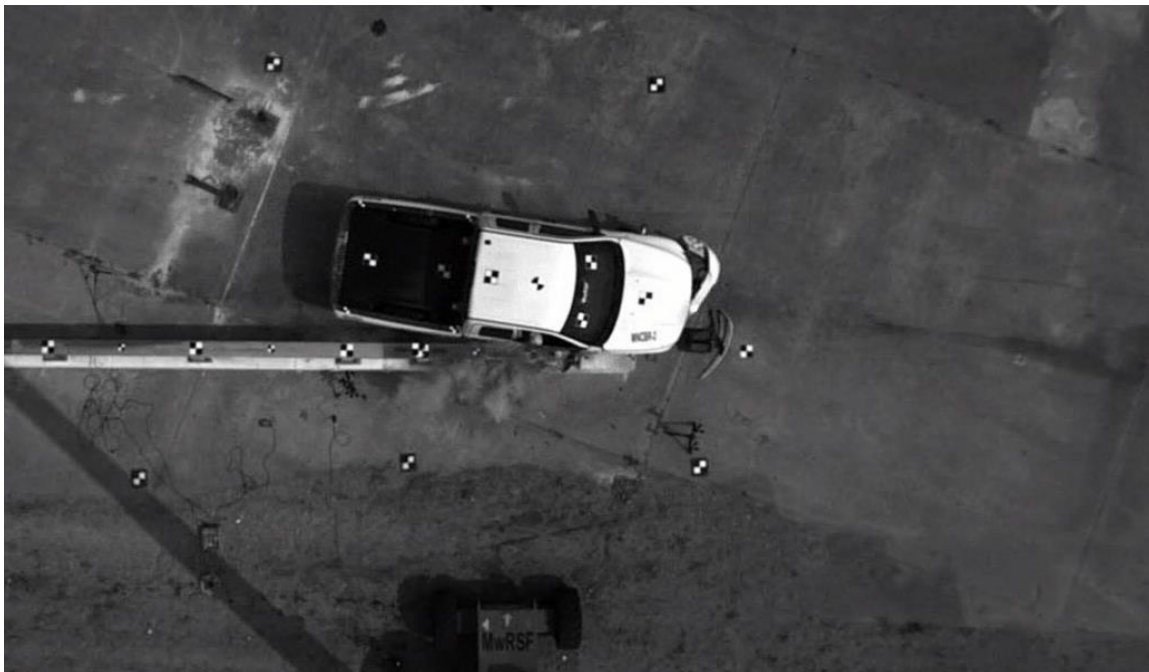
High-speed footage with camera views of the occupant's head movement for test no. MNCBR-2 are shown in Figures 122 and 123. Video analysis of the positioning of the dummy's head during test no. MNCBR-2 showed that head contact did not occur, as shown in Figures 123 and 124. Therefore, the test was deemed to have successfully passed MASH 2016 evaluation criteria using a stringent interpretation of the occupant risk criteria.

Figure 123. Overhead View of Head Ejection During Impact Event, Test No. MNCBR-2

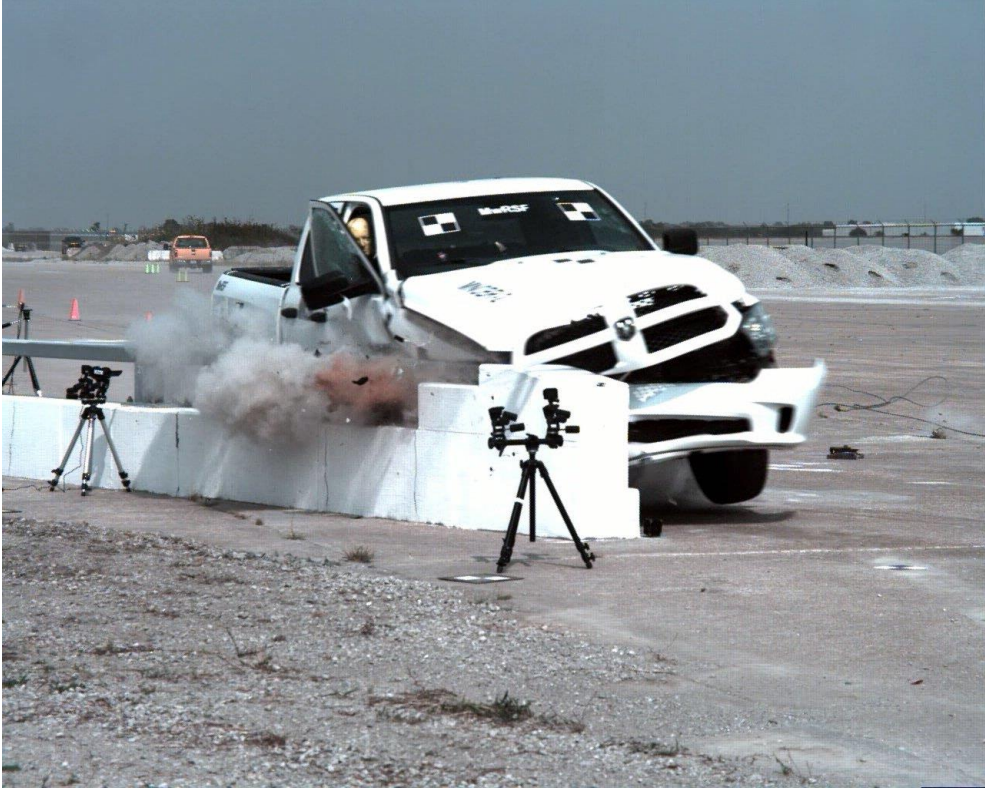
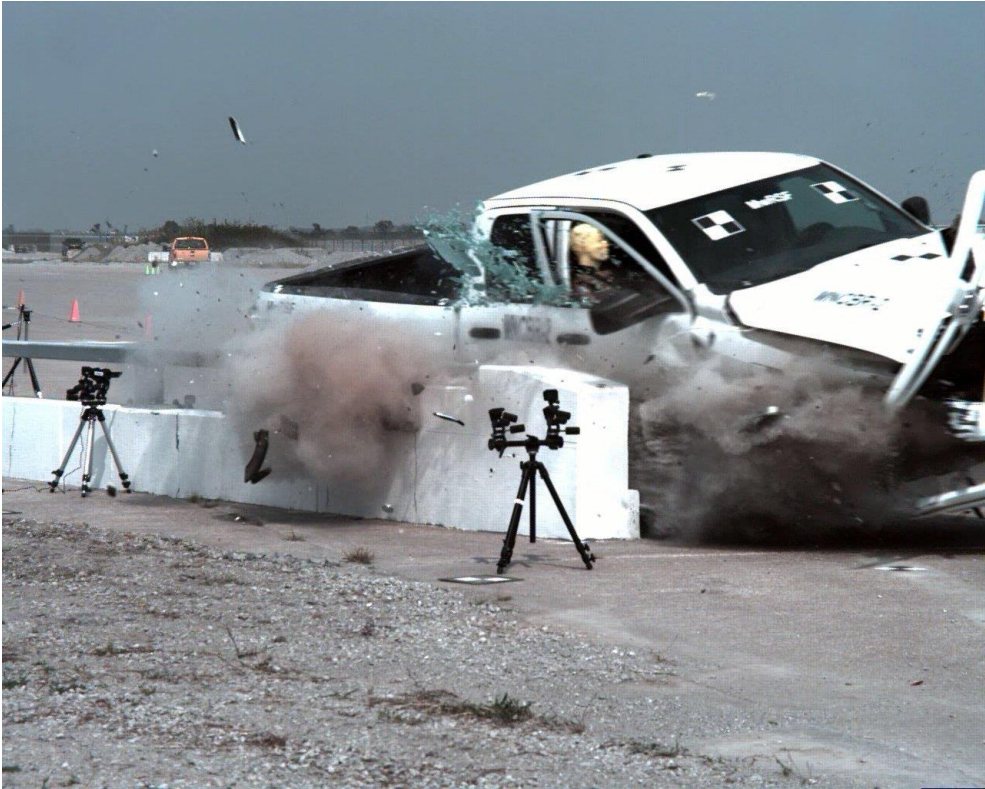
Figure 124. Downstream Behind View of Head Ejection During Impact Event, Test No. MNCBR-2

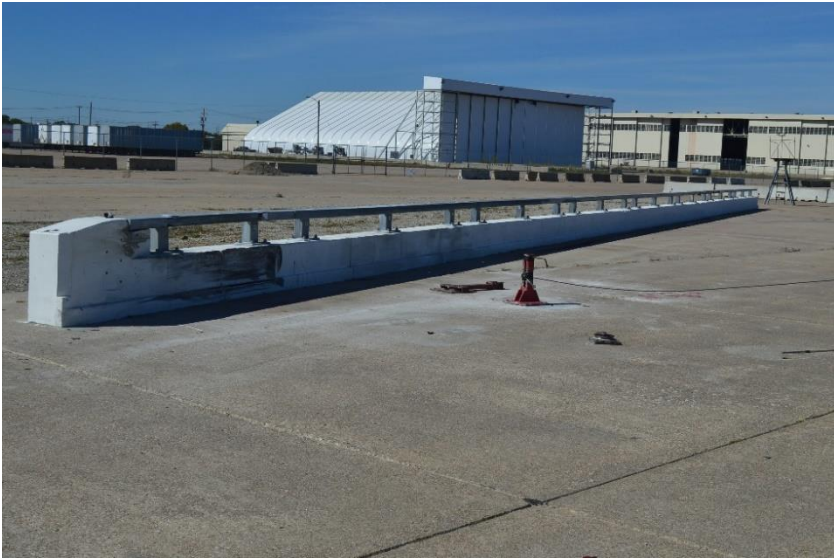
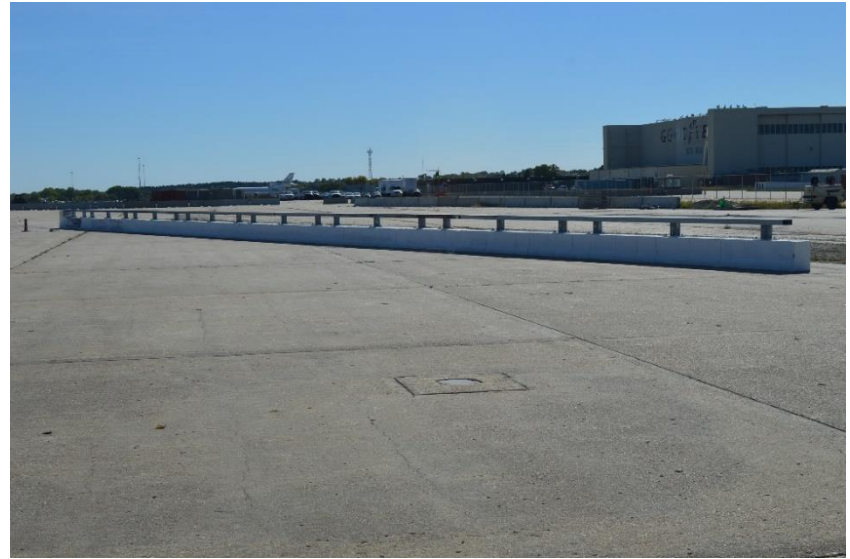
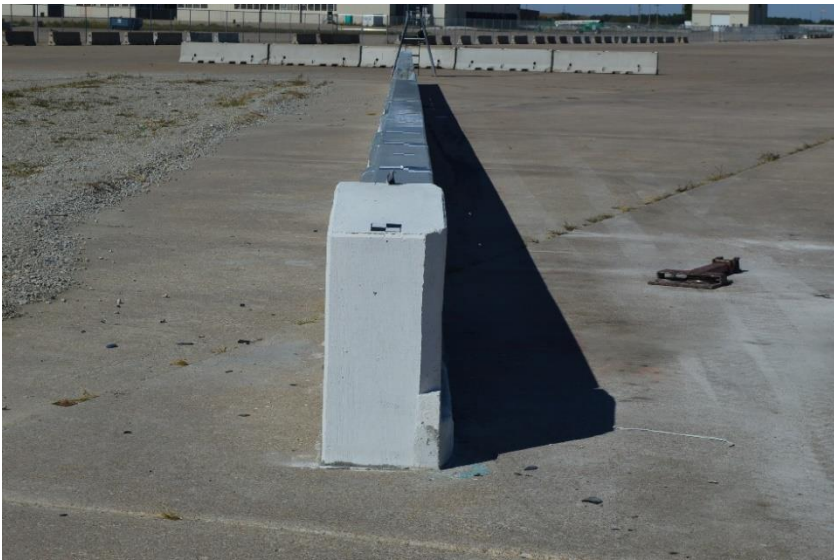
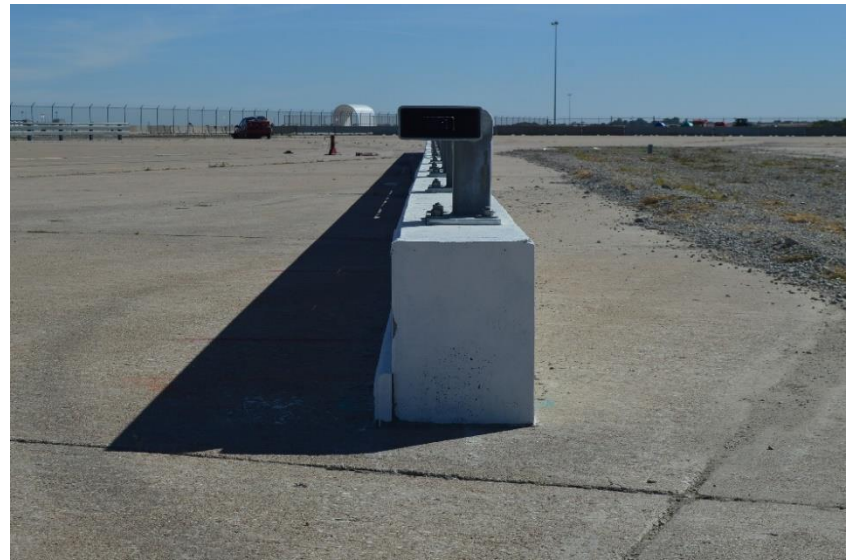
Figure 132. System Damage, Test No. MNCBR-3

Damage to the barrier was minimal, as shown in Figures 132 through 138. Barrier damage largely consisted of contact marks on the front face of the concrete barriers and spalling of the concrete. Note that the cracking shown in the system photographs was identified before the test as being related to shrinkage, and was not a result of test no. MNCBR-3. The length of vehicle contact along the barrier extended downstream approximately 10 ft starting at 18 in. upstream from the impact point.

Tire marks were visible on the front face of the 21-in. tall concrete barrier, starting 18 in. upstream from the centerline of post no. 22 and extending 110 in. downstream across the traffic side of the barrier. Contact marks 15 in. wide were found across the front face of the concrete barrier above the brush curb, starting 18 in. upstream from the impact point and extending 102 in. downstream. Contact marks 9 in. wide were found across the entire length of the front face of mid-horizontal taper section of end post, starting 95 in. downstream from the impact point and extending 24 in. downstream. Contact marks measuring $9\frac{1}{2}$ in. wide were found on front face of steel upper rail, starting 98 in. downstream from the impact point and extending 12 in. downstream. Contact marks measuring $4\frac{1}{2}$ in. wide were found on the front face of steel upper rail, starting $9\frac{1}{2}$ in. downstream from the impact point and extending $100\frac{1}{2}$ in. downstream. Contact marks measuring 1 in. wide were found on the top face of the steel upper rail, starting $70\frac{1}{2}$ in. downstream from the impact point and extending 6 in. downstream. Contact marks measuring $\frac{1}{2}$ in. wide were found on the bottom face of the upper steel rail, starting 67 in. downstream from the impact point and extending $24\frac{1}{2}$ in. downstream. Contact marks measuring $7\frac{3}{4}$ in. wide were found on the front face of post no. 23 and extending $5\frac{1}{2}$ in. downward. Contact marks measuring 8 in. were found on the upstream front corner of the upstream face of post no. 23 and extending 1 in. downward. Contact marks measuring 1 in. wide were found on the upstream face of post no. 23 and extended 8 in. upward from the post base plate. The vehicle's lateral overlap/contact distance at the upstream end of the tapered end section was $1\frac{1}{2}$ in. The vehicle's lateral overlap/contact distance at the upstream corner of the front face of post no. 23 was $2\frac{1}{2}$ in.

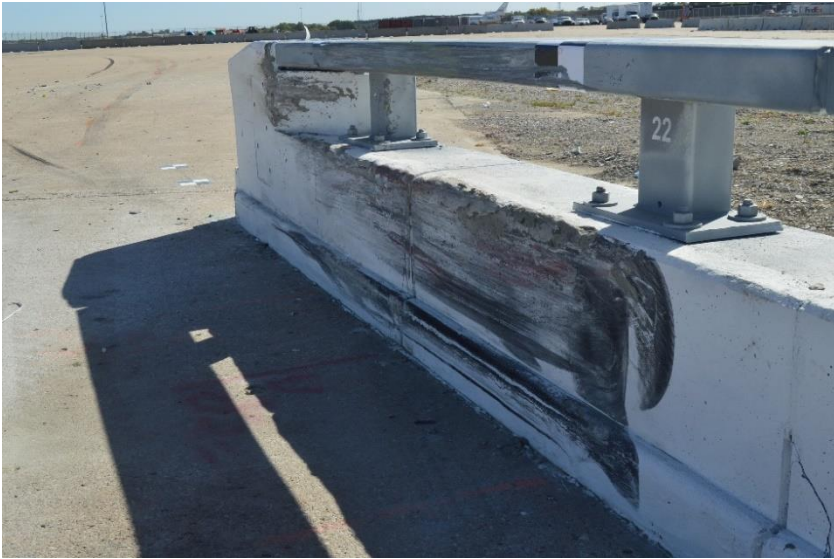
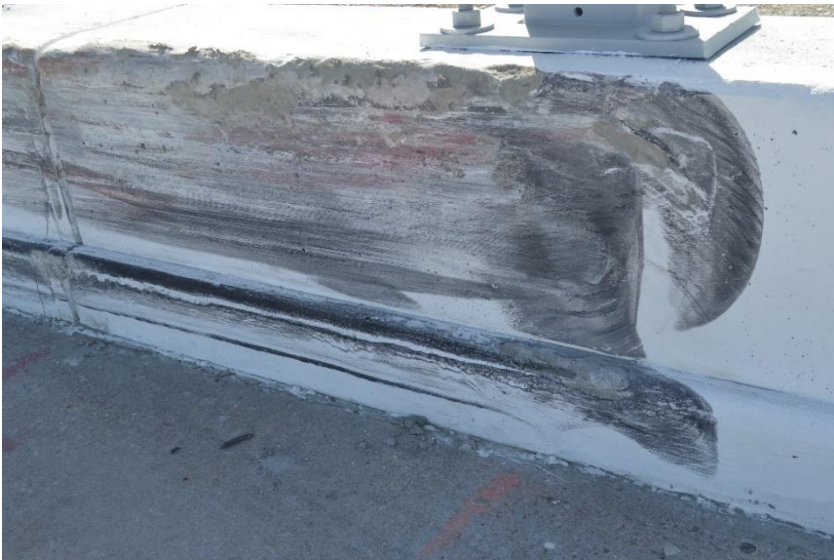
Figure 134. Concrete Gouging, Test No. MNCBR-3

Scuff marks were also found along the length of vehicle contact. Gouging was found on the front face of the concrete parapet measuring $36\frac{1}{2}$ in. long and located 32 in. upstream from the impact point with a width of 2 in. Gouging, measuring 2 in. wide by 28 in. long, was located $64\frac{1}{2}$ in. downstream from the impact point. Gouging was found on the upstream face of the middle horizontal tapered end section, measuring $\frac{1}{4}$ in. long and located 2 in. from the top front corner of the upstream face. Gouging, measuring $9\frac{1}{2}$ in. wide by 24 in. long, was located 95 in. upstream from the impact point. Gouging, measuring $2\frac{1}{2}$ in. wide by 18 in. long, was located $6\frac{1}{2}$ in. upstream from the impact point.

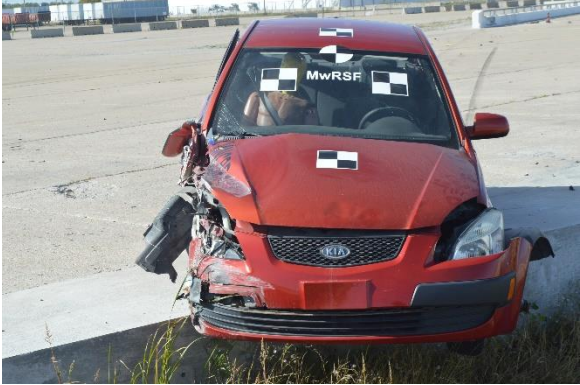
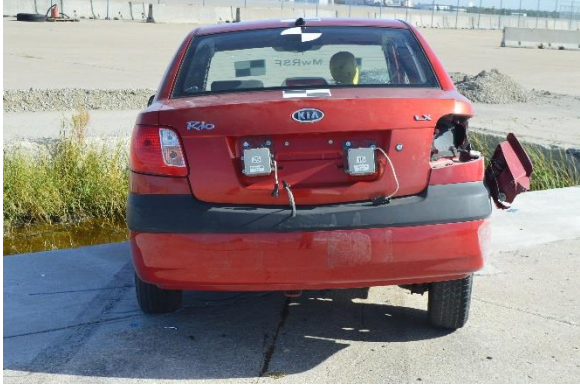
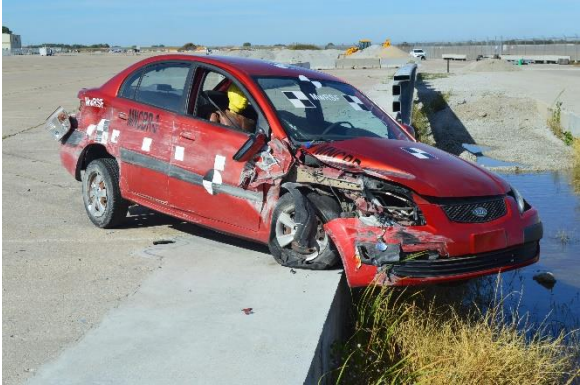
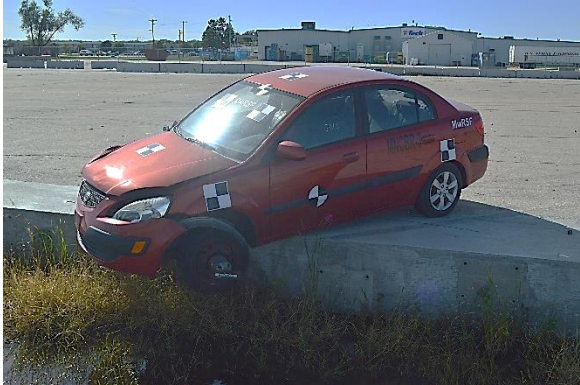
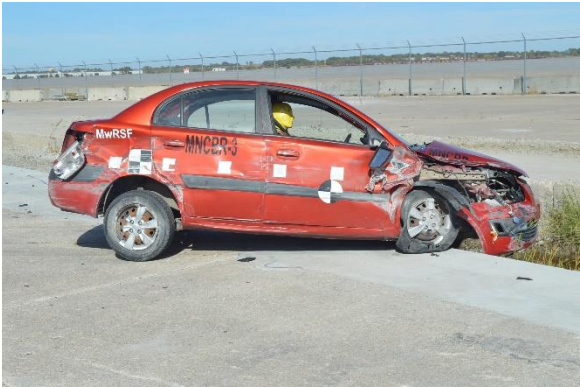
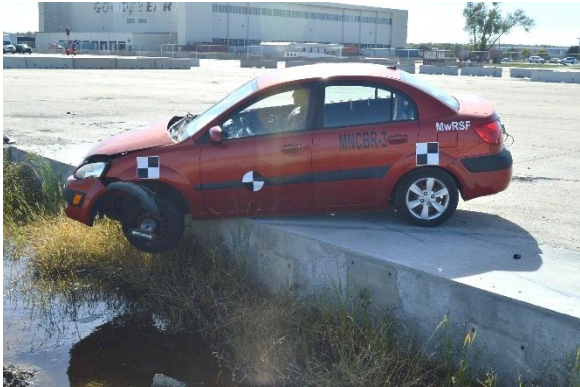
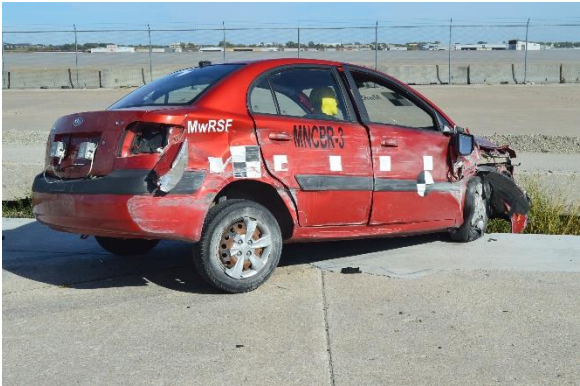
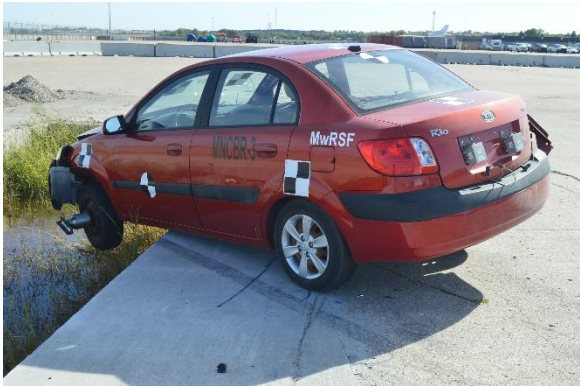
Figure 140. Vehicle Damage, Test No. MNCBR-3

The majority of the damage was concentrated on the right-front corner and right side of the vehicle, where impact had occurred, as shown in Figure 140. The vehicle's steel engine hood was deformed across its entirety, and the right edge was torn from front to back. The left side of the front bumper was pushed downward. The right side of the bumper was torn and crushed inward. The right-front fender was pushed upward near the door panel, and torn behind the right-front wheel, as shown in Figure 141. The right-front steel rim was deformed with significant crushing, as shown in Figure 142. The right-side headlight was disengaged from the vehicle, as shown in Figure 141. Denting and scraping were observed across the entire right side. The right-front door was crushed inward at the leading edge, and it was slightly ajar. The right-side front window glass was shattered by the simulated occupant's head, as shown in Figure 142. The right-rear door was scraped along its entirety and dented at the door handle. The right-side quarter panel was slightly crushed inward and scraped across its entire length, as shown in Figure 142. The floor panel was crushed inward, as shown in Figure 143. The right side of the rear bumper was slightly scraped. The right side of the windshield had a various hairline cracks, as shown in Figure 145. The roof and remaining window glass remained undamaged.

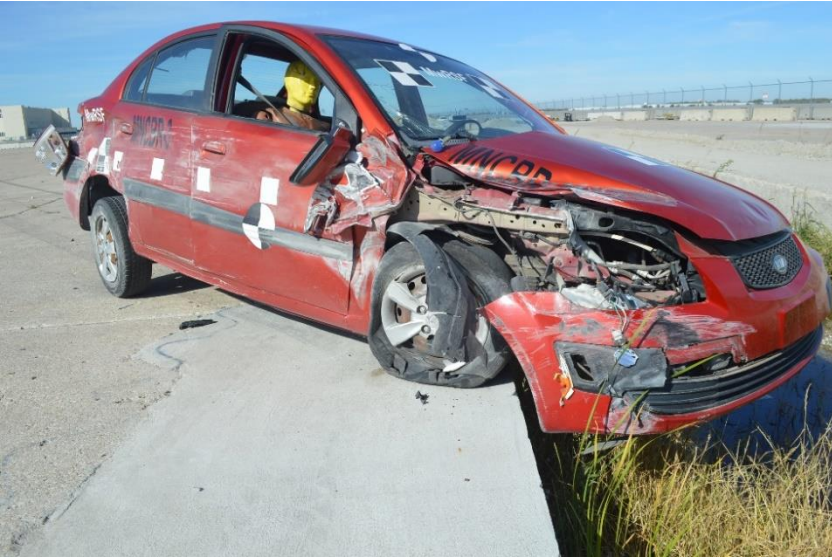
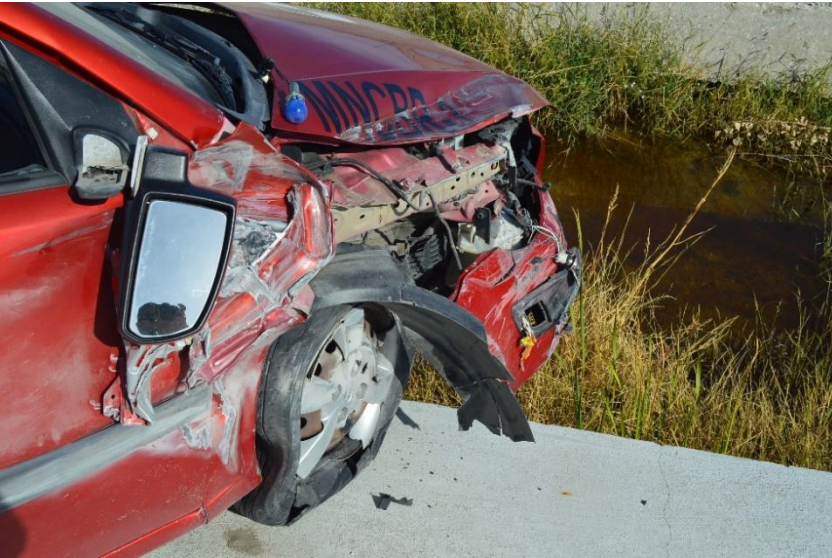
Figure 141. Vehicle Damage, Test No. MNCBR-3

The damage to the vehicle was moderate, as shown in Figures 140 through 145. The maximum occupant compartment intrusions are listed in Table 13 along with the intrusion limits established in MASH 2016 for various areas of the occupant compartment. Complete occupant compartment and vehicle deformations and the corresponding locations are provided in Appendix C. MASH 2016 defines intrusion or deformation as the occupant compartment being deformed and reduced in size with no observed penetration. There were no penetrations into the occupant compartment, and none of the established MASH 2016 deformation limits were violated. Outward deformations, which are denoted as negative numbers in Appendix C, are not considered crush toward the occupant, and are not evaluated by MASH 2016 criteria.

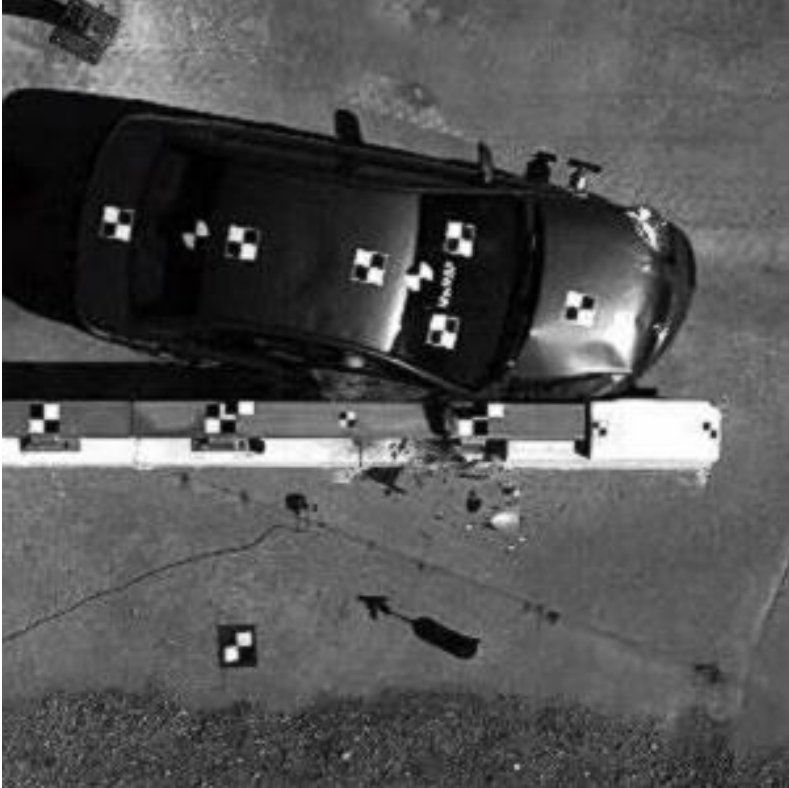
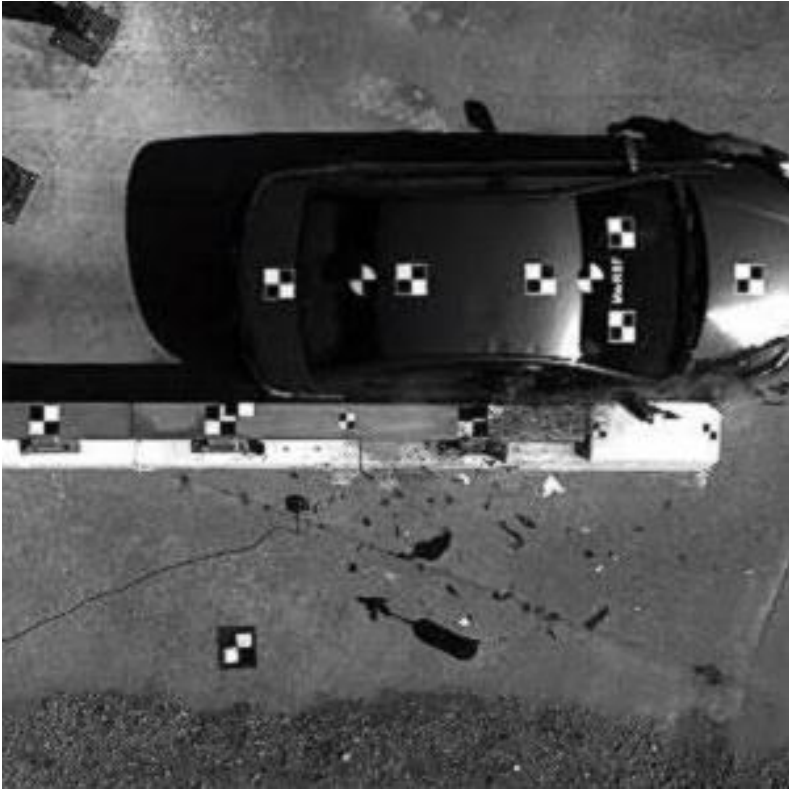
Figure 148. Overhead View of Head Ejection During Impact Event, Test No. MNCBR-3

Onboard high-speed footage with camera views of the occupant's head movement for test no. MNCBR-3 are shown in Figures 146 and 147. Video analysis of the positioning of the dummy's head during test no. MNCBR-3 showed that head contact did not occur, as shown in Figures 148 and 151. Therefore, the test was deemed to have successfully passed MASH 2016 evaluation criteria using a stringent interpretation of the occupant risk criteria.
