> **Texas A&M Transportation Institute** Proving Ground

Test Report No. 610211-01 Test Report Date: April 2022

MASH CRASH TESTING AND EVALUATION OF THE MGS WITH REDUCED POST SPACING

Contract No.: T4541-CW Test Nos.: 610211-1 / -2 / -4 / -3 / -6 / -5 Test Dates: 2018-10-04 / 2018-10-22 / 2018-11-27 / 2019-02-18 / 2021-03-0 / 2021-03-12

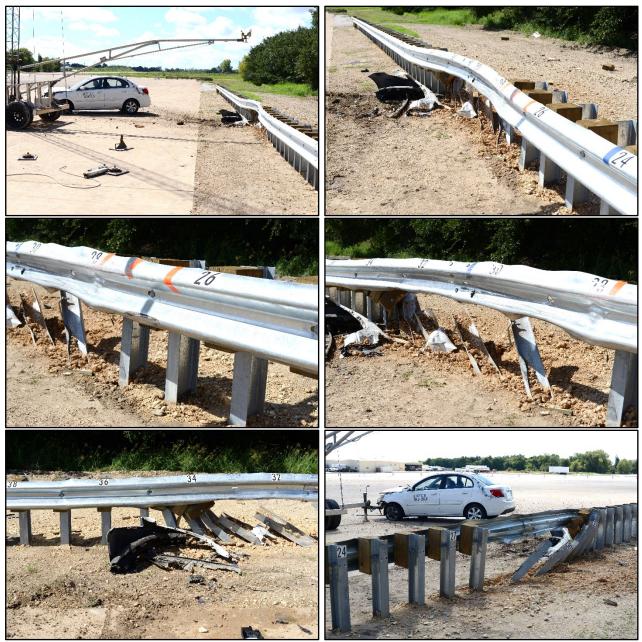
Figure 4.5. MGS with Quarter Post Spacing after Test No. 610211-01-1.

Figure 4.5 shows the damage to the MGS with quarter post spacing. No visible movement was noted at posts 1 through 24. Posts 29-34 were all deformed and leaning downstream. The soil around post 37 was disturbed, and there was no movement noted at posts 38 to the end. Table 4.2 provides additional measurements regarding the posts movement through the soil. Working width was 16.4 inches, and height of working width was 29.0 inches. Maximum dynamic deflection during the test was 16.4 inches, and maximum permanent deformation of the W-beam rail was 7.5 inches.

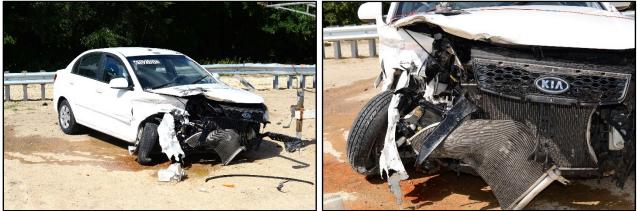
Figure 4.6. Test Vehicle after Test No. 610211-01-1.

Figure 4.6 shows the damage sustained by the vehicle. The front bumper, hood, radiator and support, right front fender, right front strut and tower, right front tire and rim, right front door, and right front floor pan were damaged. The windshield sustained a stress crack from the right lower A-pillar. No damage to the fuel tank was observed. Maximum exterior crush to the vehicle was 15.5 inches in the side plane at the right front corner at bumper height. Maximum occupant compartment deformation was 0.75 inch in the right front firewall area. Figure 4.7 shows the interior of the vehicle. Tables D.2 and D.3 in Appendix D1 provide exterior crush and occupant compartment measurements.

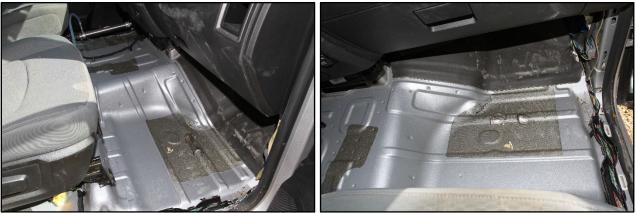
Figure 5.7. Interior of Test Vehicle after Test No. 610211-01-3.

Figure 5.6 shows the damage sustained by the vehicle. The front bumper, hood, grill, radiator and support, right and left front fenders, right front and rear doors, rear exterior bed, rear bumper, right front and rear tires and rims, and left front tire were damaged. No damage to the fuel tank was observed. Maximum exterior crush to the vehicle was 22.0 inches in the front plane at the center at bumper height. Maximum occupant compartment deformation was 0.5 inch in the right floorpan. Figure 5.7 shows the interior of the vehicle. Tables G.3 and G.4 in Appendix G1 provide exterior crush and occupant compartment measurements.

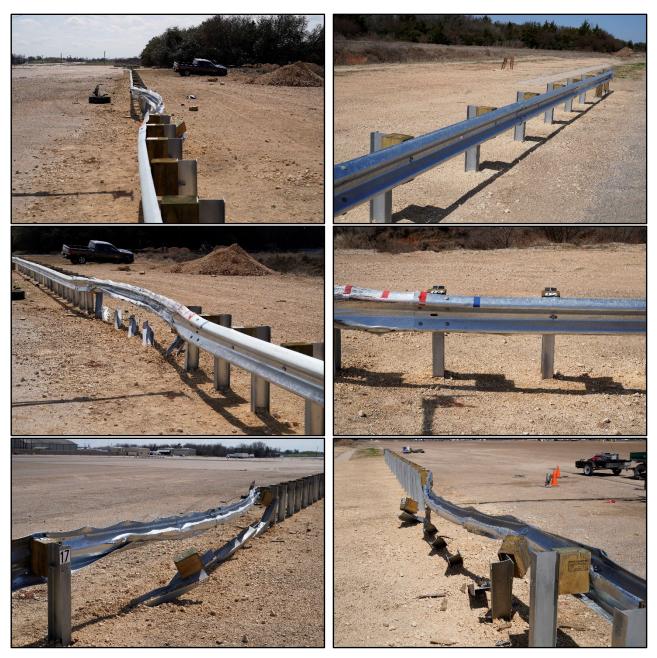
Figure 5.21. MGS with half Post Spacing and Shortened Blockouts after Test No. 610211-01-6.

Figure 5.21 shows the damage to the MGS with half post spacing and shortened blockouts. The soil was disturbed at posts 3-11, 13-14, 24-37, and 40. Starting at post 5 and continuing until post 15, the posts had a slight clockwise twist, with the exception of post 12, which was not connected to the rail due the splice location. Posts 18-22 were laid over nearly horizontal, and posts 19-22 were missing their blockouts. Those blockouts were behind the installation in a debris field that was 39 ft towards the field side, and 101 ft downstream from impact. There was a secondary contact from the vehicle redirecting back into the installation at the joint in the rail between posts 38 and 39. Table 5.5 provides additional measurements. Working width was 37.3 inches, and height of working width was 39.9 inches. Maximum dynamic deflection during the test was 25.6 inches, and maximum permanent deformation was 21.2 inches.

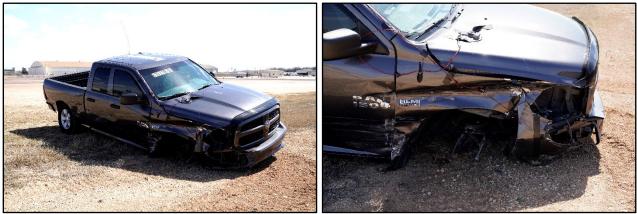
Figure 5.22. Test Vehicle after Test No. 610211-01-6.

Figure 5.22 shows the damage sustained by the vehicle. The front bumper, hood, grill, right front fender, right frame rail, right upper and lower control arms, right front tire and rim, right front and rear doors, right cab corner, right rear exterior bed, and rear bumper were damaged. No damage to the fuel take was observed. Maximum exterior crush to the vehicle was 14.0 inches in the front plane at the right front corner at bumper height. No occupant compartment deformation or intrusion occurred. Figure 5.23 shows the interior of the vehicle. Tables I.3 and I.4 in Appendix I1 provide exterior crush and occupant compartment measurements.

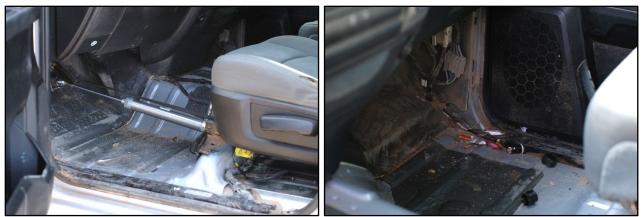
Figure 6.7. Interior of Test Vehicle for Test No. 610211-01-4.

Figure 6.6 shows the damage sustained by the vehicle. The front bumper, grill, hood, radiator and support, right front fender, right front tire and rim, right front and rear doors, right rear exterior bed, and right rear tire and rim were damaged. No damage to the fuel tank was observed. Maximum exterior crush to the vehicle was 18.0 inches in the front plane near the center at bumper height. No occupant compartment deformation or intrusion occurred. Figure 6.7 shows the interior of the vehicle. Tables K.3 and K.4 in Appendix K1 provide exterior crush and occupant compartments.

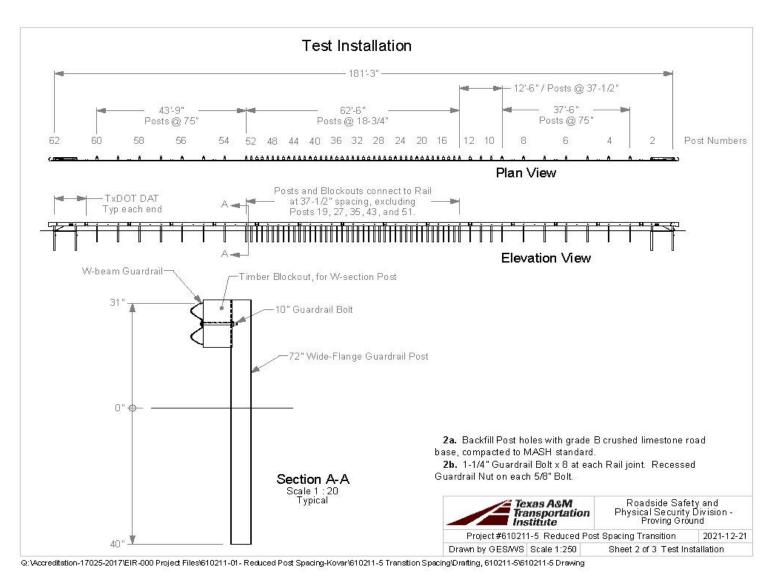
Figure 6.16. Details of the Longer Transition from Full to Quarter-Post Spacing.

Following the failed *MASH* test 3-21 on the transition from full to quarter post spacing, the research team modified the transition with the addition of a post. This was intended to lengthen the transition and minimize the pocketing behavior seen in the failed crash test. The research team evaluated this change through computer simulation. Further discussion on this modification can be found in Section 6.3.

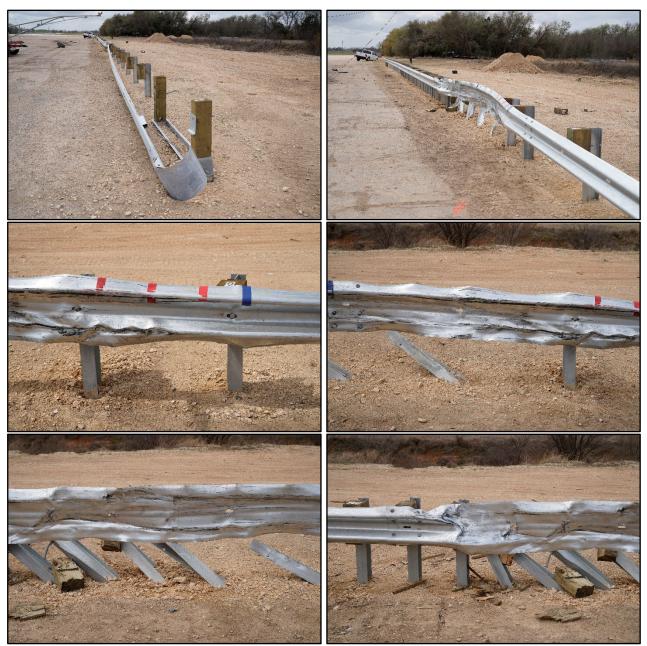
Figure 6.20. Longer Transition from Full to Quarter Post Spacing after Test No. 610211-01-5.

Figure 6.19 through Figure 6.21 show the damage to the installation. The rail released from posts 1 through 8, 11 through 16, and post 18. Post 2 was split in half vertically. Posts 11 through 13 and post 15 were missing their blockouts, and post 16 had only a partial blockout remaining. The debris field of the blockouts extended 58 ft downstream and 35 ft towards the field side. The soil was disturbed at posts 2 through 8 and 19 through 21. Table 6.5 provides additional measurements. Working width was 36.9 inches, and height of working width was 60.7 inches. Maximum dynamic deflection during the test was 23.9 inches, and maximum permanent deformation was 15.0 inches.

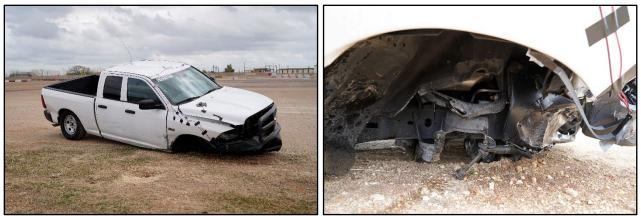
Figure 6.22. Test Vehicle after Test No. 610211-01-5.

Figure 6.22 shows the damage sustained by the vehicle. The front bumper, grill, radiator and support, right front fender, right front tire and rim, right frame rail, right upper and lower control arms, right front and rear doors, right rear exterior bed, and rear bumper were damaged. No damage to the fuel tank was observed. Maximum exterior crush to the vehicle was 16.0 inches in the front plane at the right front corner at bumper height. No occupant compartment deformation or intrusion occurred. Figure 6.23 shows the interior of the vehicle. Tables M.3 and M.4 in Appendix M1 provide exterior crush and occupant compartment measurements.
