Test Report No. 616011-01

EVALUATION OF A NON-PROPRIETARY SIGN SUPPORT SYSTEM

TEXAS A&M TRANSPORTATION INSTITUTE PROVING GROUND

15. Supplementary Notes Name of Contacting Representative: Carlos Torres		14. Sponsoring Agency Code	
16. Abstract <p>The purpose of the tests reported herein was to assess the performance of the U-Channel Sign Support System according to the safety-performance evaluation guidelines included in the second edition of the American Association of State Highway and Transportation Officials (AASHTO) <i>Manual for Assessing Safety Hardware (MASH)</i> (1). The initial objective was to evaluate the U-Channel Sign Support System according to the complete MASH Test Level 3 (TL-3) matrix. However, only MASH Test 3-62 was performed on the U-Channel Sign Support System due to excessive vehicle deformation observed during the crash test. The crash tests were performed in accordance with <i>MASH</i> Test 3-62:</p> <p style="text-align: center;">MASH Test 3-62: An 2270P vehicle weighing 5000 lb impacting the Support Structures while travelling at 62 mi/h and 0 and 90 degrees.</p> <p>This report provides details on the U-Channel Sign Support System, the crash tests and

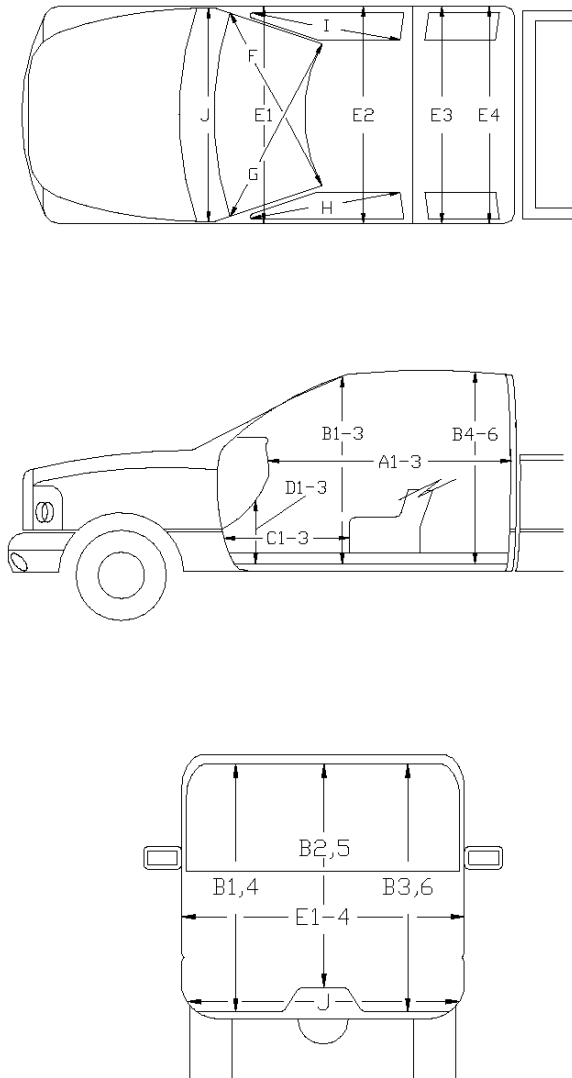
Figure C.3. Occupant Compartment Measurements for Test 616011-01-6.

Before	After (inches)	Differ.
A1	65.00	65.00	0.00
A2	63.00	63.00	0.00
A3	65.50	65.50	0.00
B1	45.00	45.00	0.00
B2	38.00	38.00	0.00
B3	45.00	45.00	0.00
B4	39.50	39.50	0.00
B5	43.00	43.00	0.00
B6	39.50	39.50	0.00
C1	26.00	26.00	0.00
C2	0.00	0.00	0.00
C3	26.00	26.00	0.00
D1	11.00	11.00	0.00
D2	0.00	0.00	0.00
D3	11.50	11.50	0.00
E1	58.50	58.50	0.00
E2	63.50	63.50	0.00
E3	63.50	63.50	0.00
E4	63.50	63.50	0.00
F	59.00	59.00	0.00
G	59.00	59.00	0.00
H	37.50	37.50	0.00
I	37.50	37.50	0.00
J*	25.00	25.00	0.00
