**Test Report No. 616411-01**

**EVALUATION OF TYPE III BARRICADES WITH MOUNTED SIGNS**

**TEXAS A&M TRANSPORTATION INSTITUTE PROVING GROUND**

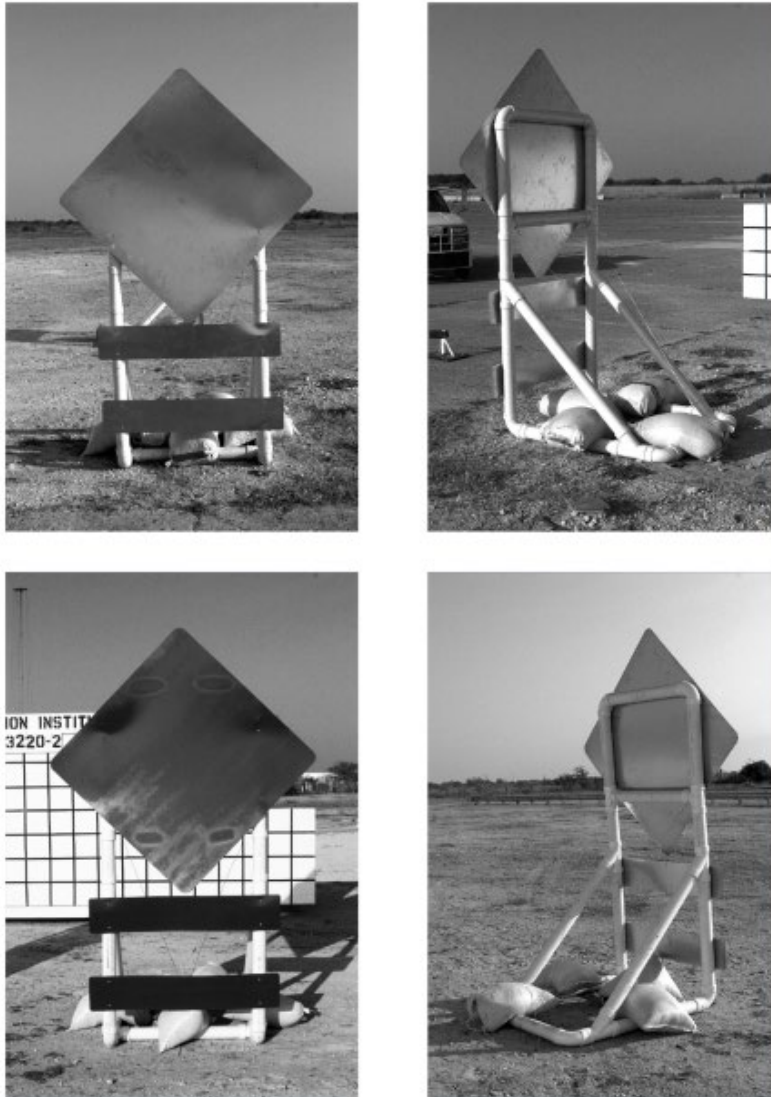
**Figure 2.10: New Jersey Type III PVC Barricade (5)**

The PVC barricade separated into multiple pieces, and the end of the second barricade's middle cross member punctured a hole in the windshield. This puncture was measured to be 178

mm long and approximately 19-25 mm wide. Additionally, the maximum deformation to the occupant compartment was measured to be 44 mm. The roof deformed over an area of 800 mm x 400mm to a depth of 55 mm. This system failed to meet NCHRP Report 350 criteria because of the windshield damage caused by a cross member of the barricade. (5).

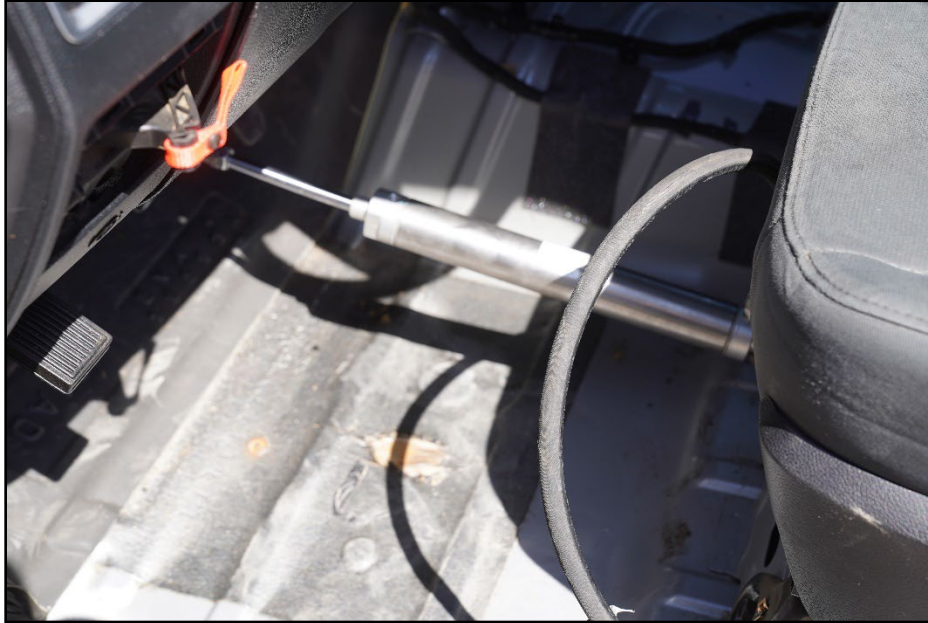
**Figure 9.10. Interior of Test Vehicle on Impact Side after Test 616411-01-3.**

Side Windows	Side windows remained intact
Maximum Exterior Deformation	0.5 inches in the front plane at bumper height
VDS	12FC1
CDC	12FCAN1
Fuel Tank Damage	None
Description of Damage to Vehicle:	The front bumper, grill, hood, and windshield were damaged. There were two small dents on the front bumper, 30 inches apart and measuring 0.5 inch deep. The hood had two dents, 0.5 inches deep and 2 inches wide. One was 6 inches long and the other was 3 inches long. The windshield had some cracks but no holes or tears in the laminate.

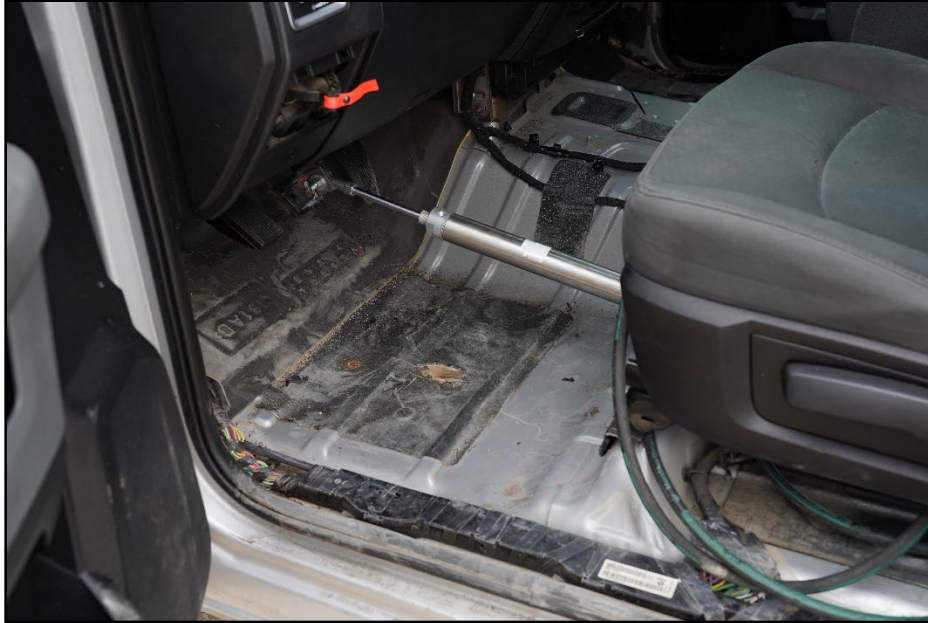
**Figure 10.10. Interior of Test Vehicle on Impact Side after Test 616411-01-4.**

Side Windows	Side windows remained intact
Maximum Exterior Deformation	14 inches in the front plane at bumper height
VDS	12FC2
CDC	12FCAN2
Fuel Tank Damage	None
Description of Damage to Vehicle:	The front bumper, hood, grill, radiator and support, and windshield were damaged. The windshield sustained a few small cracks but no holes or tears in the laminate. The hood had a 14-inch × 15-inch × 3-inch deep dent, and a 1¼-inch × 1½-inch hole in the front center.

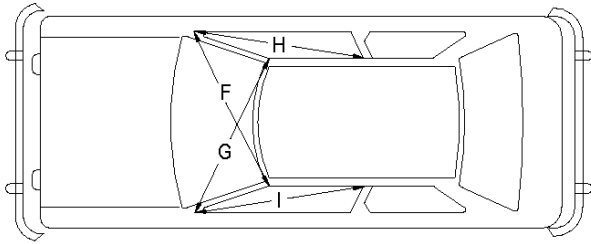
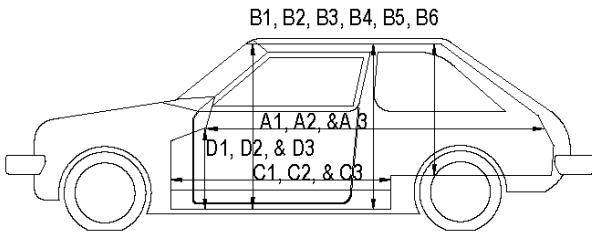
**Figure C.3. Occupant Compartment Measurements for Test No. 616411-01-2.**

Before	After (inches)	Differ.
A1	67.50	67.50	0.00
A2	67.25	67.25	0.00
A3	67.75	67.75	0.00
B1	40.50	40.50	0.00
B2	39.00	36.25	-2.75
B3	40.50	40.50	0.00
B4	36.25	36.25	0.00
B5	36.00	36.00	0.00
B6	36.25	36.25	0.00
C1	26.00	26.00	0.00
C2	0.00	0.00	0.00
C3	26.00	26.00	0.00
D1	9.50	9.50	0.00
D2	0.00	0.00	0.00
D3	9.50	9.50	0.00
E1	51.50	51.50	0.00
E2	51.00	51.00	0.00
F	51.00	51.00	0.00
G	51.00	51.00	0.00
H	37.50	37.50	0.00
I	37.50	37.50	0.00
J*	51.00	51.00	0.00
