Test Report No. 609971-01

**TESTING AND EVALUATION OF FLARED MGS SYSTEM AT
MASH TEST LEVEL 3 CONDITIONS**

Sponsored by
Washington State Department of Transportation (WsDOT)

TEXAS A&M TRANSPORTATION INSTITUTE PROVING GROUND

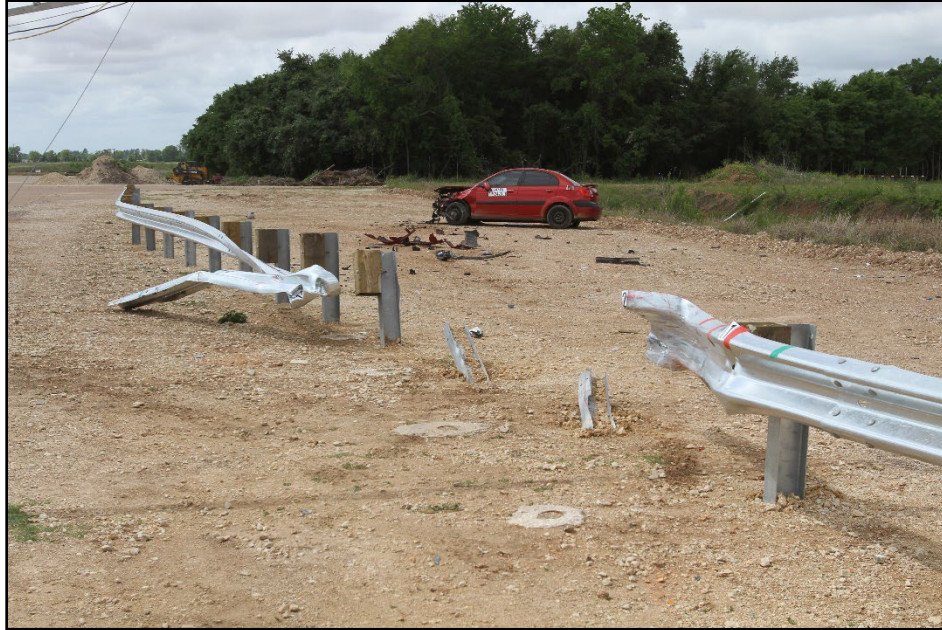
The W-beam guardrail ruptured at post 12 and released from post 11 through post 17. The soil was disturbed at posts 1 and 2, post 11 was leaning toward the field side at 2 degrees from vertical, and posts 12 and 13 were leaning toward the field side at 75 degrees from vertical and downstream at 5 degrees from vertical. Post 14 was leaning downstream at 17 degrees from vertical and toward the field side at 2 degrees from vertical. Table 5.6 describes the damage to the MGS guardrail with flare. Figure 5.5 and Figure 5.6 show the damage to the MGS guardrail with flare.

Figure 5.5. MGS Guardrail with Flare after Test at Impact Location for Test 609971-01-1.

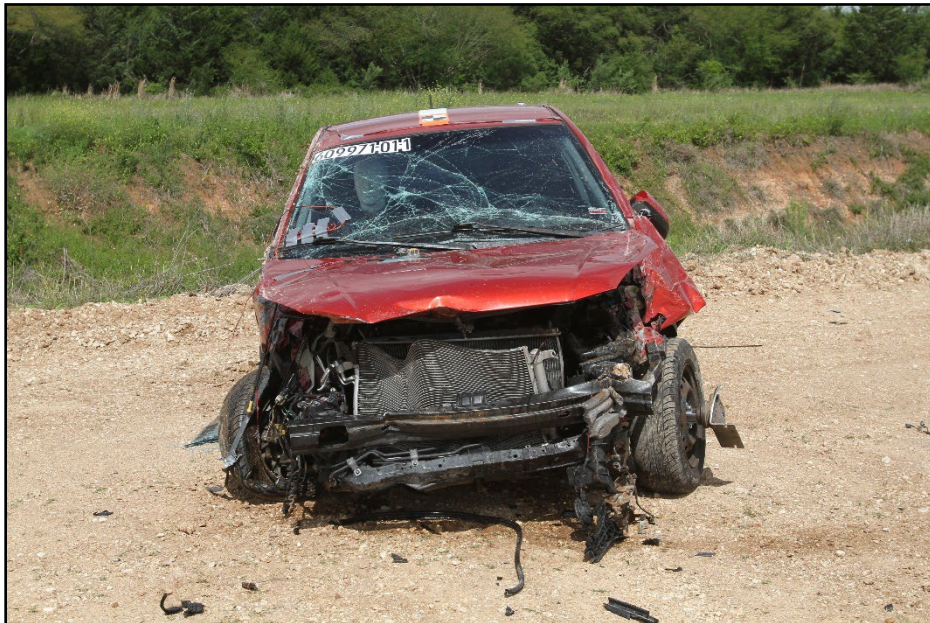
Figure 5.8. Front View of the Test Vehicle after Test 609971-01-1.

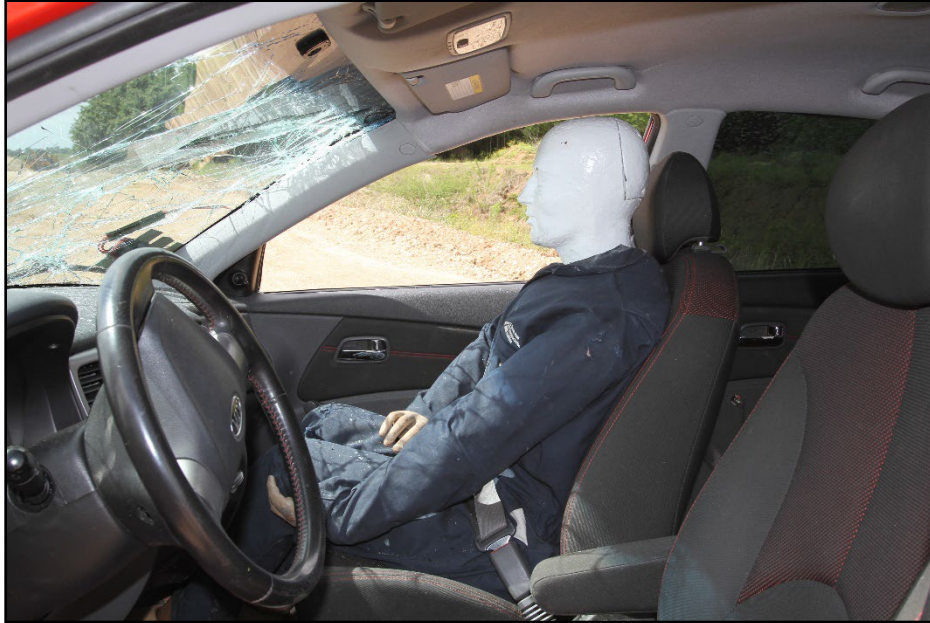
Figure 5.9. Overall Interior of Test Vehicle after Test 609971-01-1.

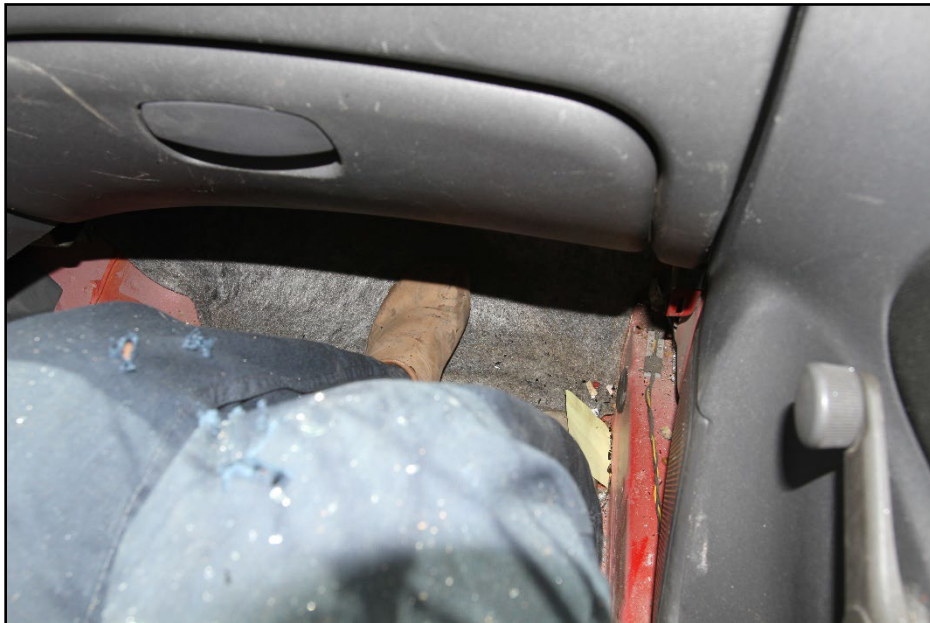
Figure 5.10. Interior of Test Vehicle on Impact Side after Test 609971-01-1.

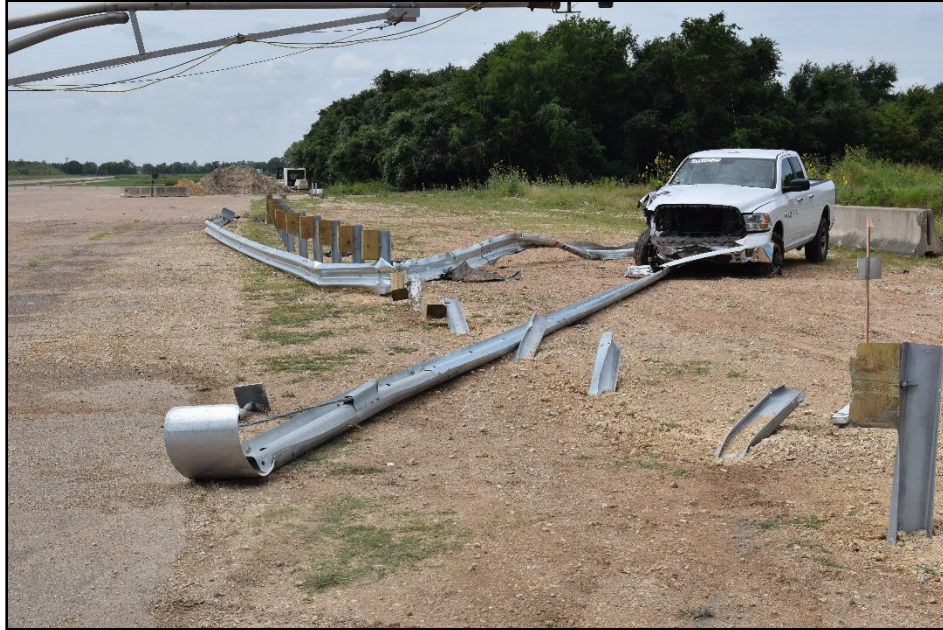
Table 6.6 describes the damage to the MGS guardrail with flare. Figure 6.5 and Figure 6.6 show the damage to the MGS guardrail with flare.

Figure 6.5. MGS Guardrail with Flare after Test at Impact Location for Test 609971-03-1.

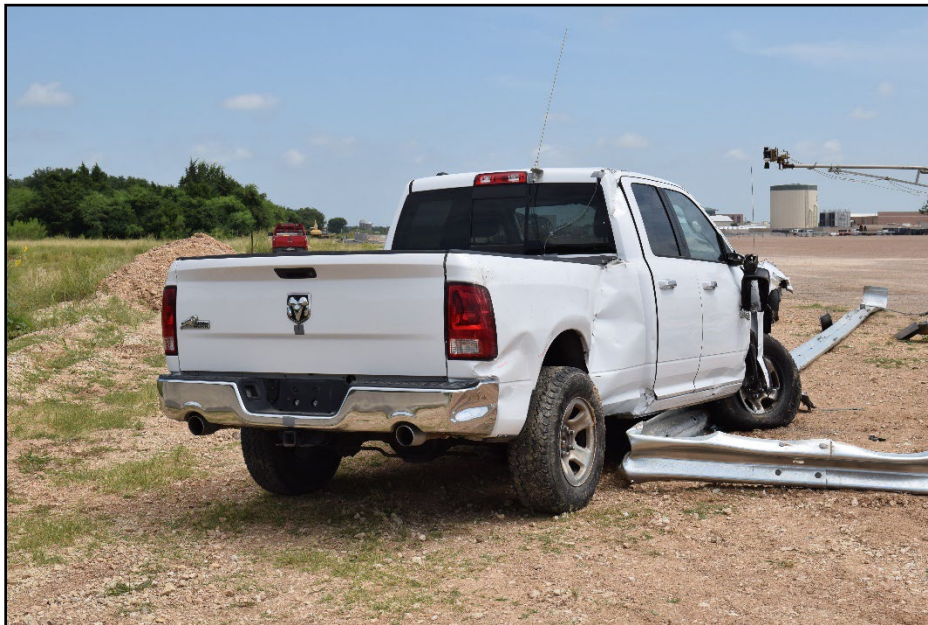
Figure 6.8. Rear Impact Side of Test Vehicle after Test 609971-03-1.

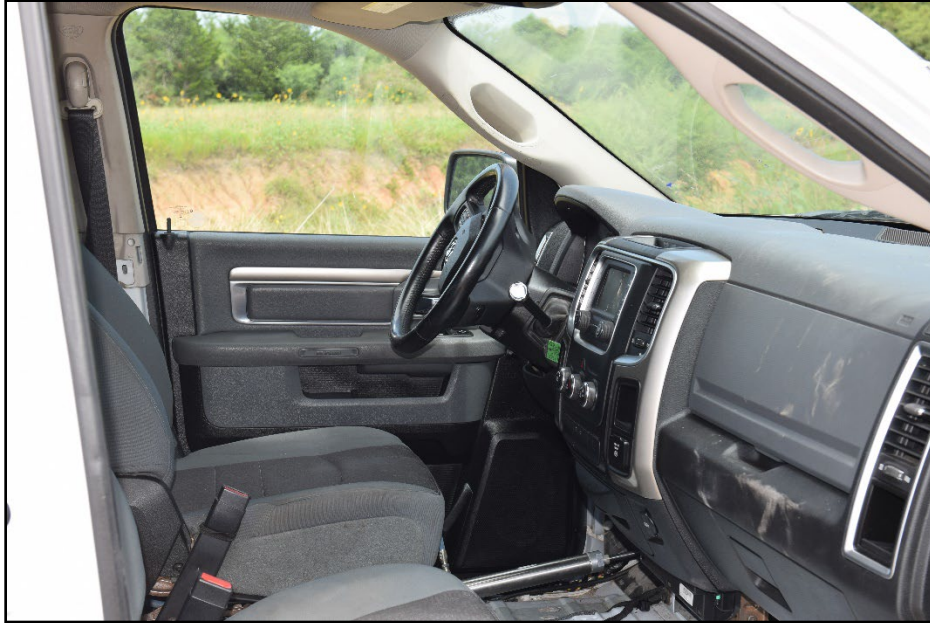
Figure 6.9. Overall Interior of Test Vehicle after Test 609971-03-1.

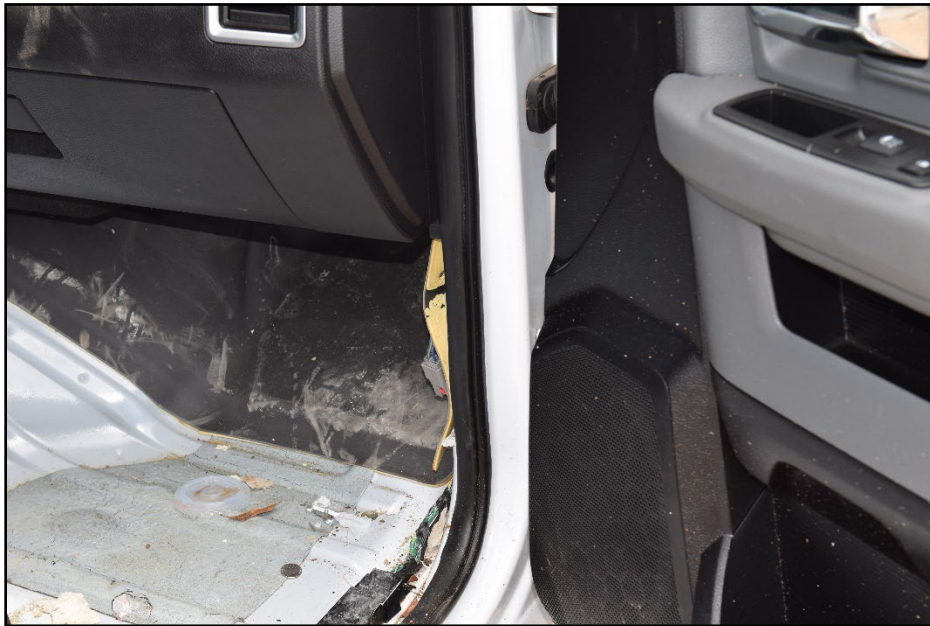
Figure 6.10. Interior of Test Vehicle on Impact Side after Test 609971-03-1.

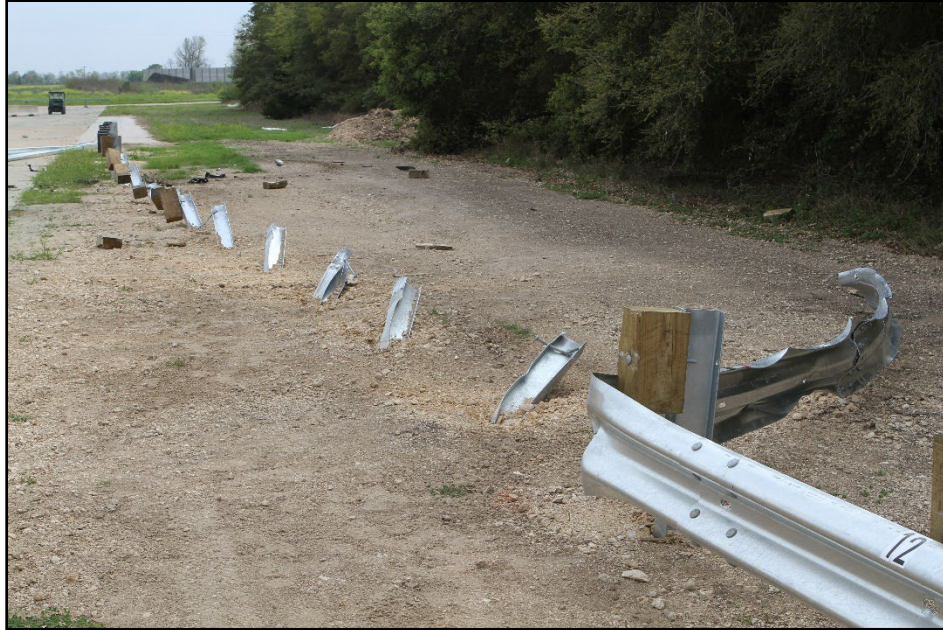
Figure 7.5. MGS Guardrail with Flare after Test at Impact Location for Test 609971-03-2.

The right anchor post pulled downstream 1 inch, and the soil was disturbed at post 1. The rail element released at post 8 until the end of the installation. Post 13 was pushed back 1½ inches at grade. Posts 14–18 were leaning downstream at approximately 60 degrees from vertical, with the blockouts missing. Posts 19–23 were also leaning downstream at approximately 60 degrees from vertical, but the blockouts remained intact. Posts 18–21 showed impact damage on the field-side flange, and post 19 had a tear on the field-side flange as well. The rail and head released from and pushed the anchor posts downstream 7 ft. Post 31 was leaning 10 degrees downstream from vertical. The rail ruptured 20 inches upstream of the joint between posts 16 and 17.

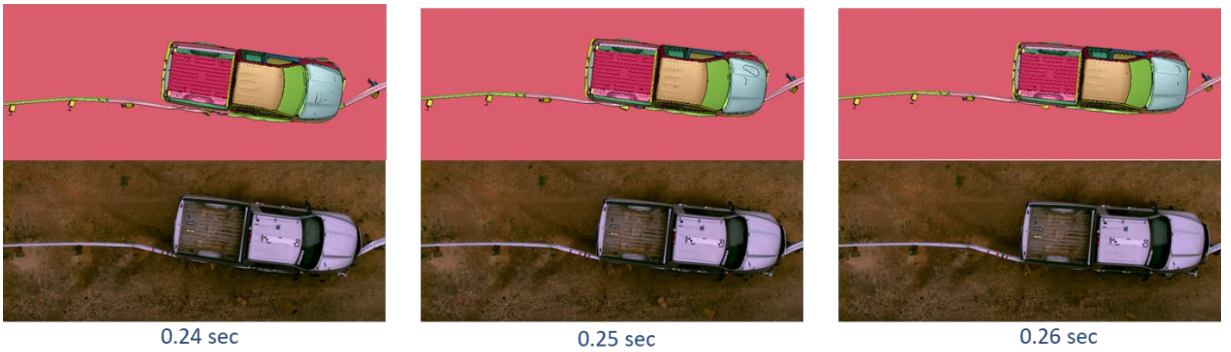
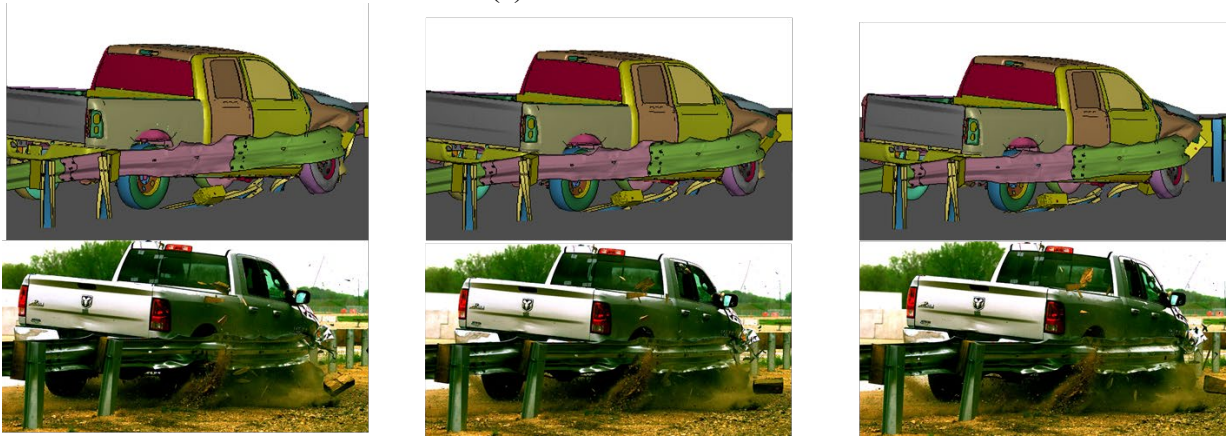
Figure 8.4. Sequential Frames to Compare FE Simulation (Top) to Crash Testing (Bottom) Immediately Leading to Rail Rupture Event.

Figure 8.3 shows the sequential photos taken from the full-scale test and simulation to compare vehicular behavior. In the test, the W-beam rail ruptured at 0.2440 s after the vehicle impacted the flared MGS. Figure 8.4 shows the detailed view right before and after the rail rupture. Table 8.1 compares the vehicular behavior by showing the main event and the time of event. Compared to the full-scale test, the FE model shows good agreement before the rail ruptured.

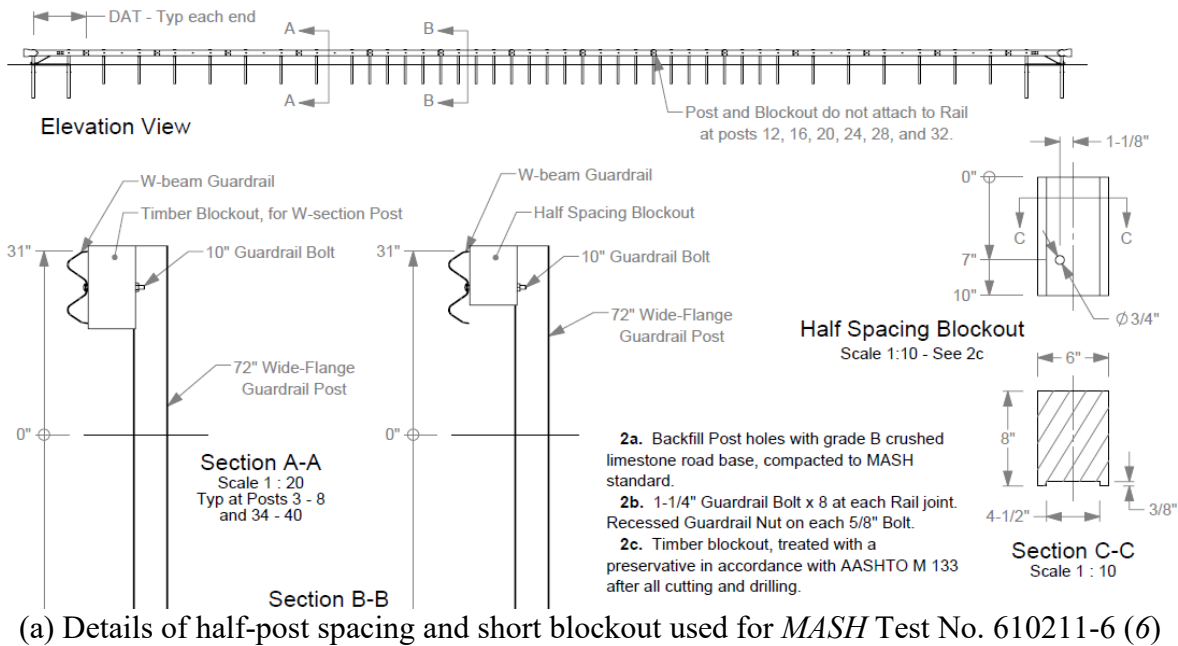
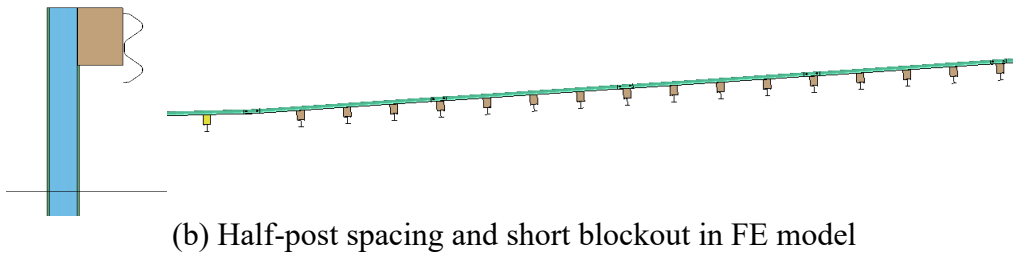
Figure 8.8. Details of Half-Post Spacing and Short Blockout.

Therefore, the first considered retrofit flared MGS option was to include “short” blockouts to prevent rail high concentration stresses and potential tearing due to direct contact/interaction between the blockout and the rail. Use of short blockouts that were 10 inches high and 8 inches deep was successful in previous MGS design/testing, such as in the MGS with half-post spacing (6). Therefore, it was decided to utilize the short blockout and pair it with half-post spacing (37½-inch post spacing) to investigate the crashworthiness of the flared MGS. This combination of system design changes was chosen to limit the lateral deflection of the system during impact and limit rail stress concentrations due to blockout interaction, with the ultimate goal of reducing the probability of vehicle pocketing and rail rupture during the event.

Figure 8.8 presents the details of the short blockout system. The figure shows the post spacing, blockout geometry, and rail connections used for Test No. 610211-6 (6), and the same geometrical characteristics were adopted for the MGS flared system.

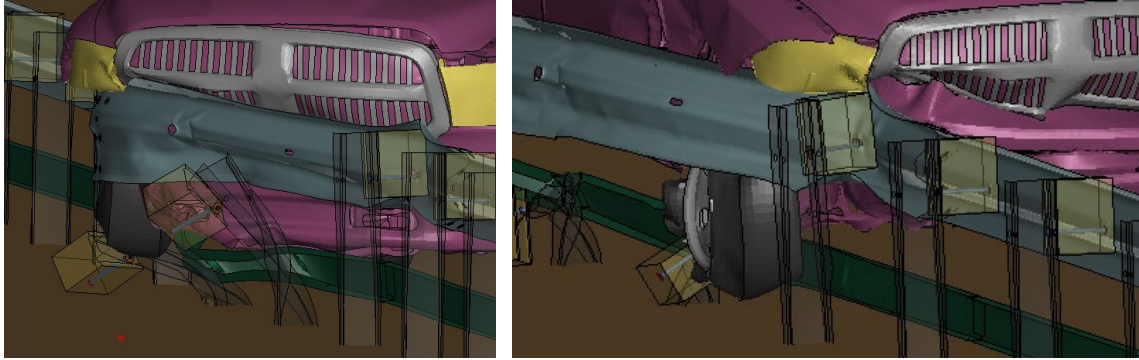
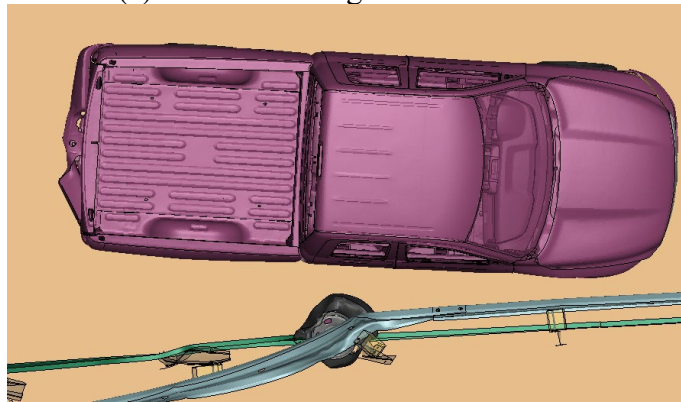
Figure 8.16. FE Pickup Truck Tire Model Behavior.

For the pickup truck FE simulations on the flared MGS retrofitted with a channel rubrail, the passenger-side front tire rode on the rubrail, and when the vehicle was exiting, the tire went beyond the rubrail, as shown in Figure 8.16. During this event, a numerical issue was also found, showing a part of the tire element tangled with an edge of the channel rubrail element. However, since the issue was detected after maximum occupant risk factors (e.g., occupant impact velocity and ridedown acceleration) and rail deflection were observed, the numerical issue may not affect the simulation results.

(a) Tire Overriding Channel Rubrail

(b) Tire Tangling

Since resolving the numerical issue became a concern due to project resource (time and budget) constraints, another simulation for each vehicle type impacting at CIP was performed on the 18:1 flared MGS retrofitted with a channel rubrail. In addition to modifying a contact command between the rubrail and the tire to resolve the numerical issue, the channel rubrail was raised by 3 inches to have a 12-inch distance from the center of the channel to the ground. By raising the rubrail, the gap between the W-beam and channel was decreased, which should reduce the possibility of tire tangling.

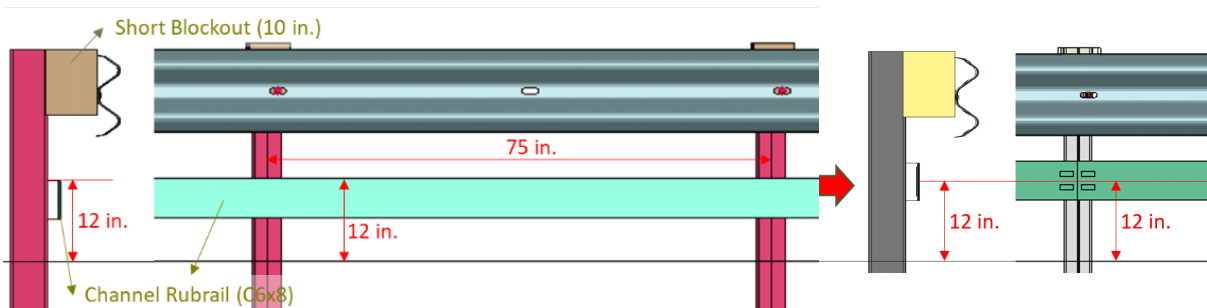
Figure 8.17. Modified Channel Rubrail Location.

Figure 8.17 describes the difference between the initial retrofitted MGS model and the modified retrofitted model. As aforementioned, the vertical location of the channel increased by 3 inches. Figure 8.18 and Figure 8.19 show the close-up view and sequential frames, respectively, for the modified FE pickup truck simulation results to illustrate the improvements. As seen in the figures, the tire overrode the channel less, and it did not tangle with any MGS FE model element. Without tire FE element tangling, the vehicle exited and redirected more smoothly.

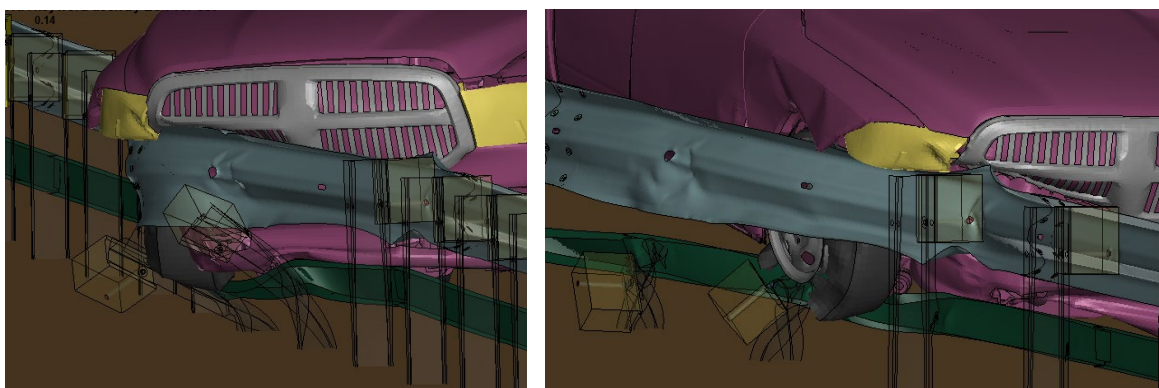
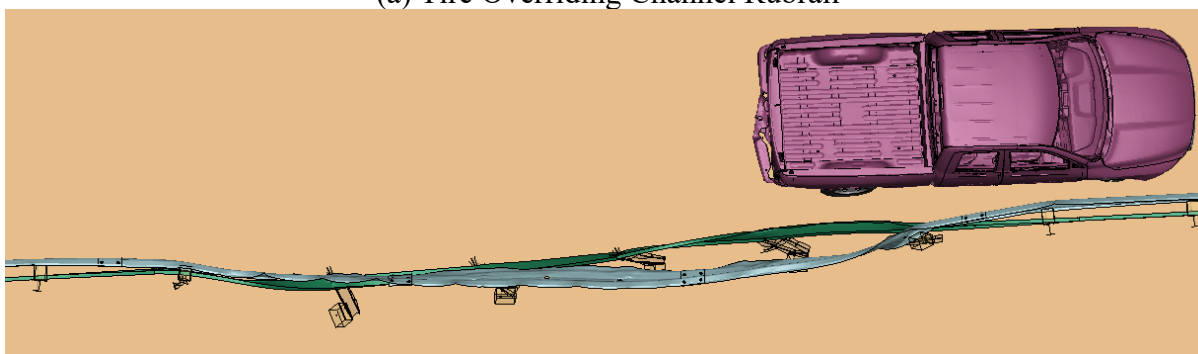
Figure 8.18. Modified FE Simulation with 18:1 Flared MGS Retrofitted with Channel Rubrail.

(a) Tire Overriding Channel Rubrail

(b) Vehicle Exiting

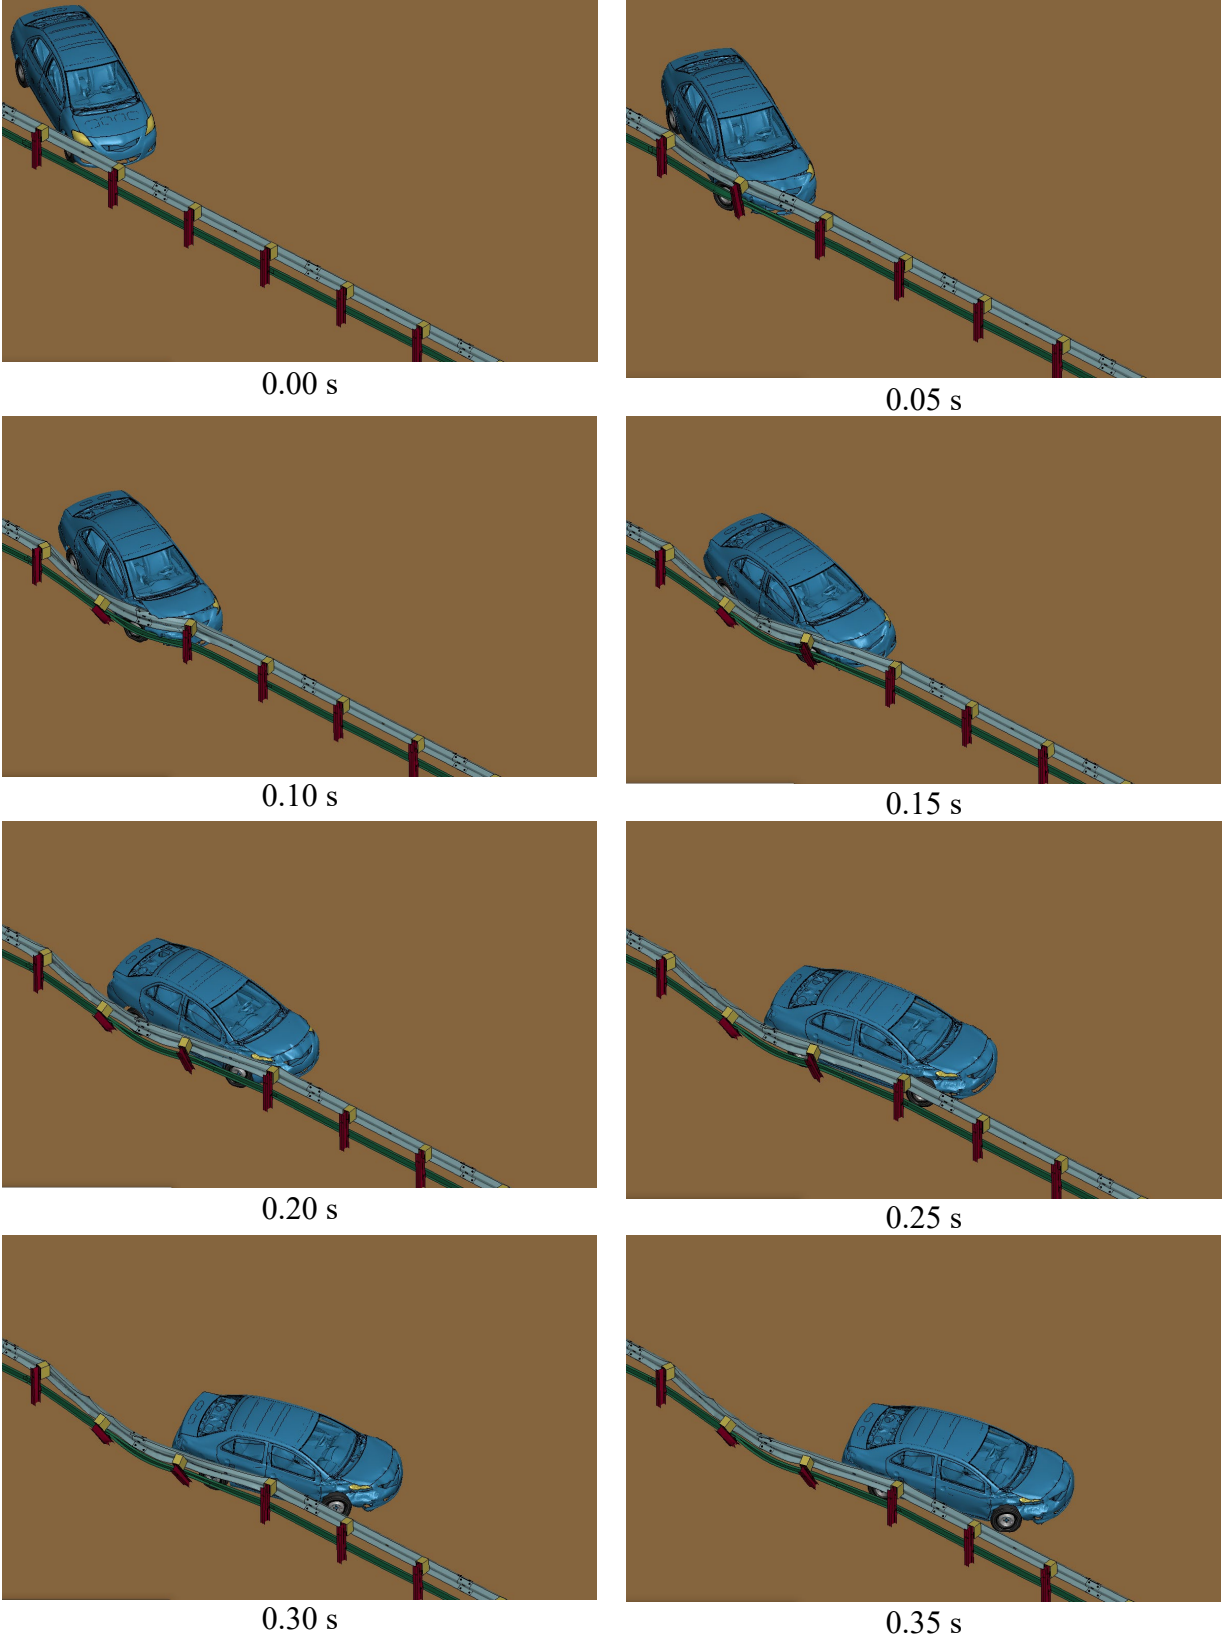
Figure 8.20. Sequential Frames for Small Car Impact at CIP on Modified 18:1 Flared MGS Retrofitted with Channel Rubrail.

To evaluate the modified retrofitted MGS model, a small car impact simulation was also performed under the same TL-3 conditions. Figure 8.20 shows the sequential frames with the small car behavior after impacting the CIP of the modified retrofitted MGS.

Table 8.8 lists the occupant risk factors and maximum lateral dynamic W-beam rail deflection to compare the simulation results of the different channel rubrail heights. For both the pickup truck and small car, the retrofitted MGS with the channel rubrail located higher improved the overall system behavior.

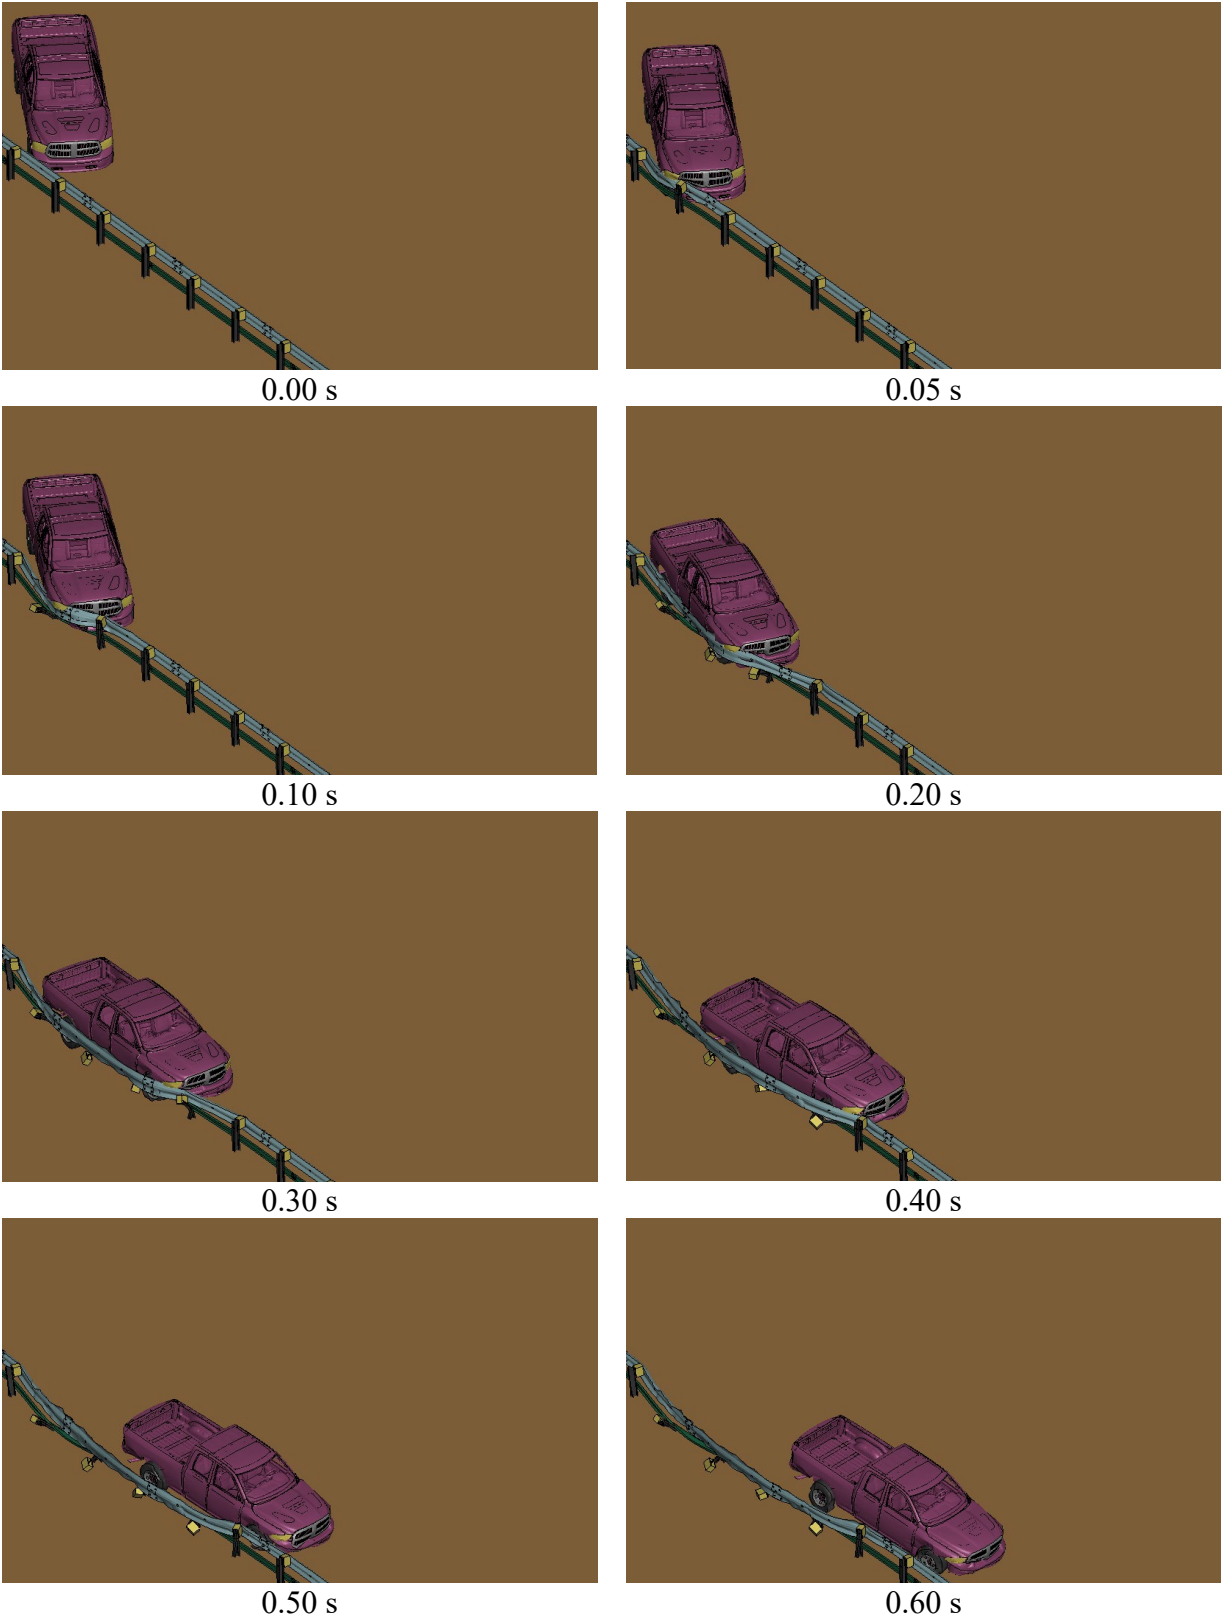
Figure 8.21. Sequential Frames for Pickup Truck Impact at CIP on Modified 15:1 Flared MGS Retrofitted with Channel Rubrail.

To investigate performance of the system in steeper flare rate, another simulation for each vehicle type impacting at CIP was performed on the 15:1 flared MGS retrofitted with a channel rubrail. Figure 8.21 shows sequential frames, for the modified FE pickup truck. As seen in the figures, without tire FE element issue, the vehicle exited and redirected more smoothly.

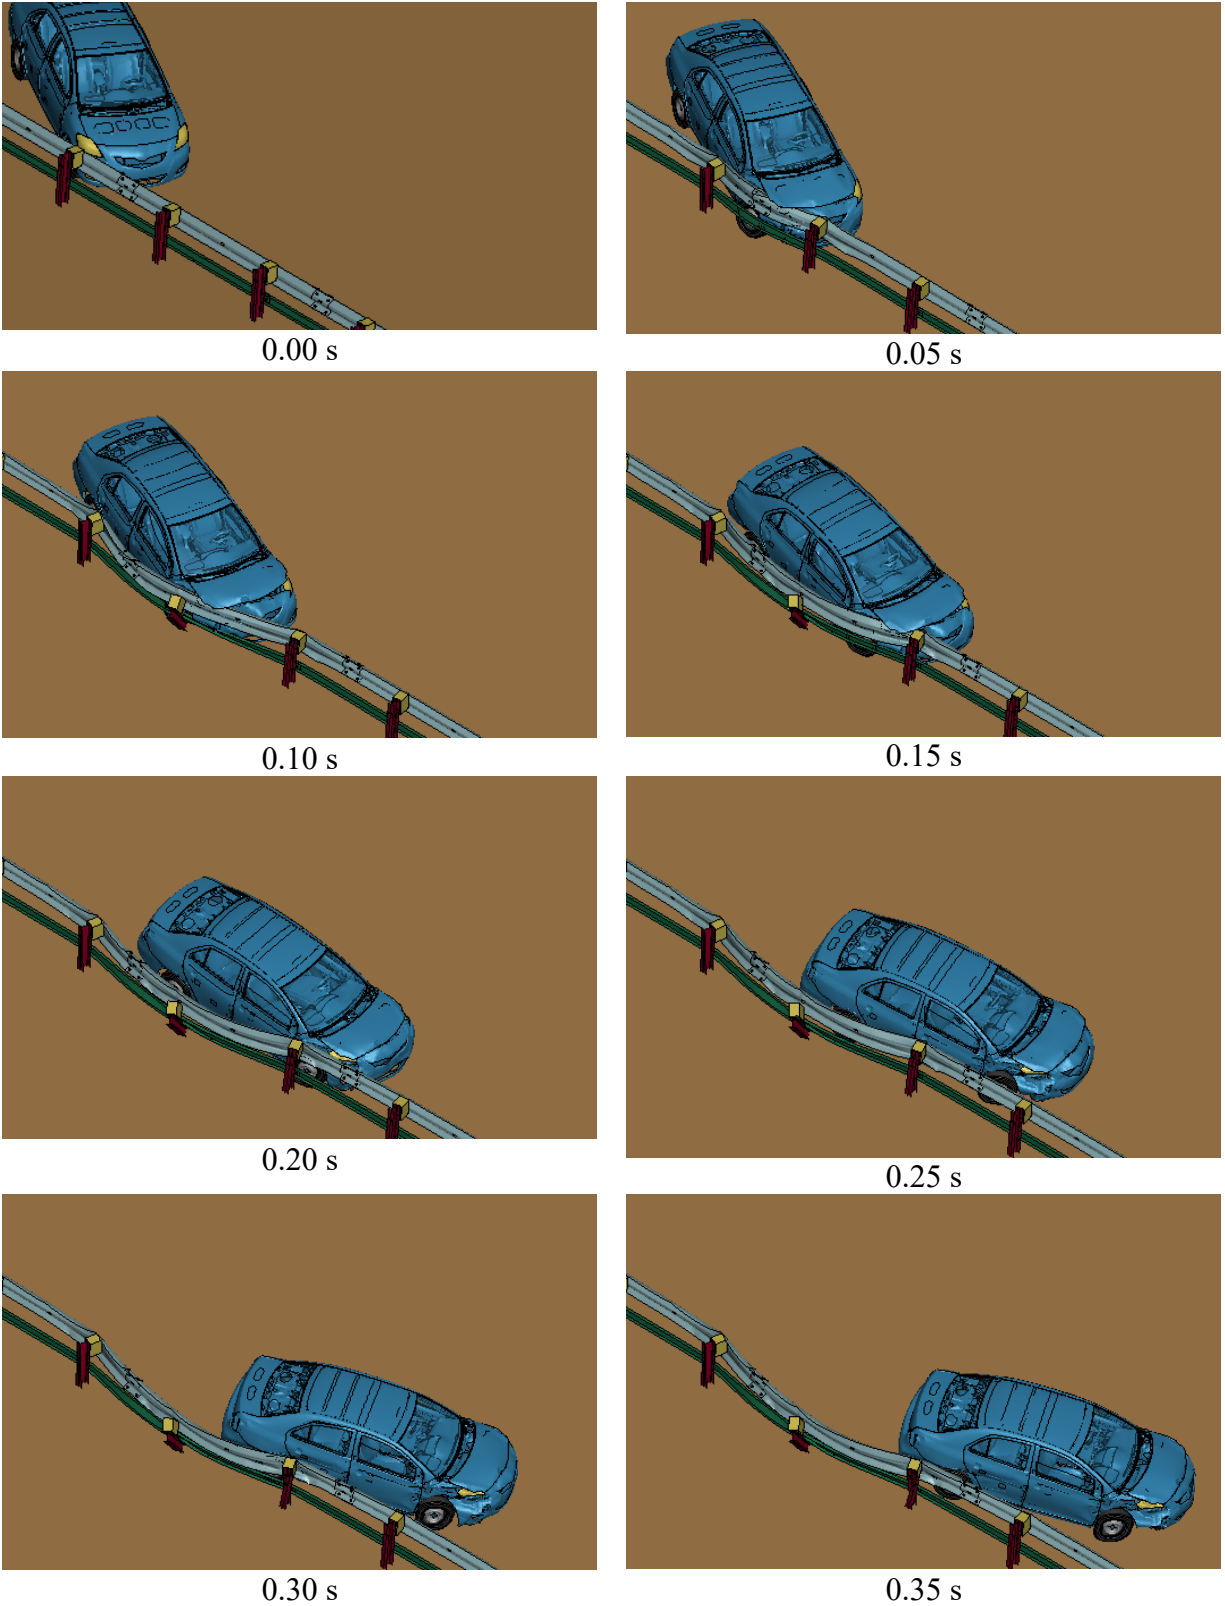
Figure 8.22. Sequential Frames for Small Car Impact at CIP on Modified 15:1 Flared MGS Retrofitted with Channel Rubrail.

With better performance with a pickup truck, a small car impact simulation was also performed under the same TL-3 conditions. Figure 8.22 shows the sequential frames with the small car behavior after impacting the CIP of the modified retrofitted MGS.

Table 8.10 lists the occupant risk factors and maximum lateral dynamic W-beam rail deflection to compare the simulation results of the different channel rubrail heights. For both the pickup truck and small car, the retrofitted MGS with the channel rubrail located higher improved the overall system behavior.
