## **CRASH TESTING AND EVALUATION OF THE HIGH-TENSION CABLE GUARDRAIL AT HIGH IMPACT ANGLE**

Contract No. T4541-AD  
Report/Test No. 405160-2-1  
Date of Test: 05-11-2006

**Roadside Safety Research Program Pooled Fund  
Study No. TPF-5(114)**

**TEXAS TRANSPORTATION INSTITUTE  
THE TEXAS A&M UNIVERSITY SYSTEM  
COLLEGE STATION, TEXAS 77843**

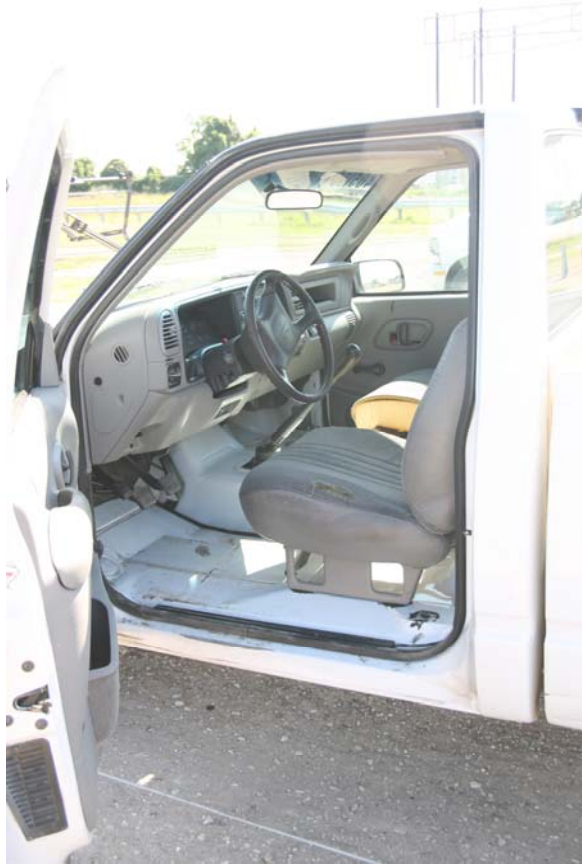
Before test

Damage to the vehicle is shown in figure 11. No structural damage was sustained by the pickup during the initial collision event. The front bumper, right front quarter panel, right door, right rear exterior bed were deformed and the right front tire and rim and right rear tire and rim were damaged from the initial collision event. During rollover, the left A-pillar and B-pillar and left front quarter panel deformed, and the right door glass shattered and windshield cracked. Maximum exterior crush to the vehicle was 260 mm (10.2 in) in the side plane at the right front corner at bumper height. Maximum occupant compartment deformation from the initial impact was 14 mm (0.6 in) in the lateral area across the floor pan (from kickpanel to kickpanel). Maximum occupant compartment deformation from the rollover event was 27 mm (1.1 in) in the diagonal distance between the lower edge of the A-pillar and the upper edge of the B-pillar on the left side. Photographs of the interior of the vehicle are shown in figure 12. Exterior vehicle crush and occupant compartment measurements are shown in appendix B, tables 2 and 3.
