TEMPORARY LARGE GUIDE SIGNS

Test Report 0-6782-1

TEXAS A&M TRANSPORTATION INSTITUTE
COLLEGE STATION, TEXAS

TEXAS DEPARTMENT OF TRANSPORTATION

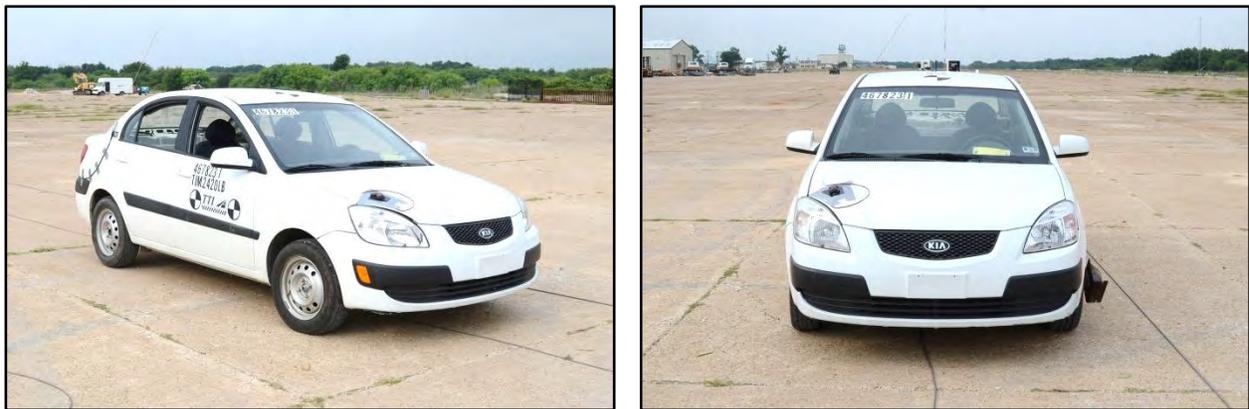
A 2008 Kia Rio, shown in Figure 4.3, was used for the crash test. Test inertia weight of the vehicle was 2443 lb, and its gross static weight was 2612 lb. The height to the lower edge of the vehicle bumper was 7.12 inches, and it was 21.0 inches to the upper edge of the bumper. Table B1 in Appendix B gives additional dimensions and information on the vehicle. The vehicle was directed into the installation using the cable reverse tow and guidance system and was released to be free-wheeling and unrestrained just prior to impact.

Figure 4.3. Vehicle before Test No. 467823-1.

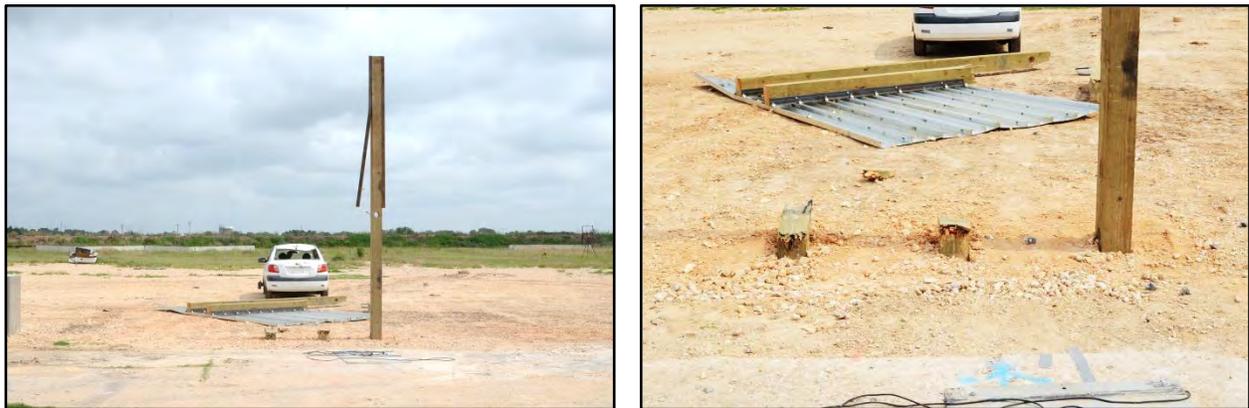
Figure 4.4 shows damage to the wood post sign support system after the test. The left support leg fractured at the hole near ground level and remained connected to the sign panel. The middle support leg fractured at the hole the hole near ground level and below the sign panel. The upper portion of the middle support leg remained attached to the sign panel. The right support leg remained intact and the soil around the post was only disturbed. The sign panel separated from the right support leg and contacted the roof of the vehicle before coming to rest on the ground.

Figure 4.4. Direct Embedded Wood Support Temporary Guide Sign System after Test No. 467823-1.

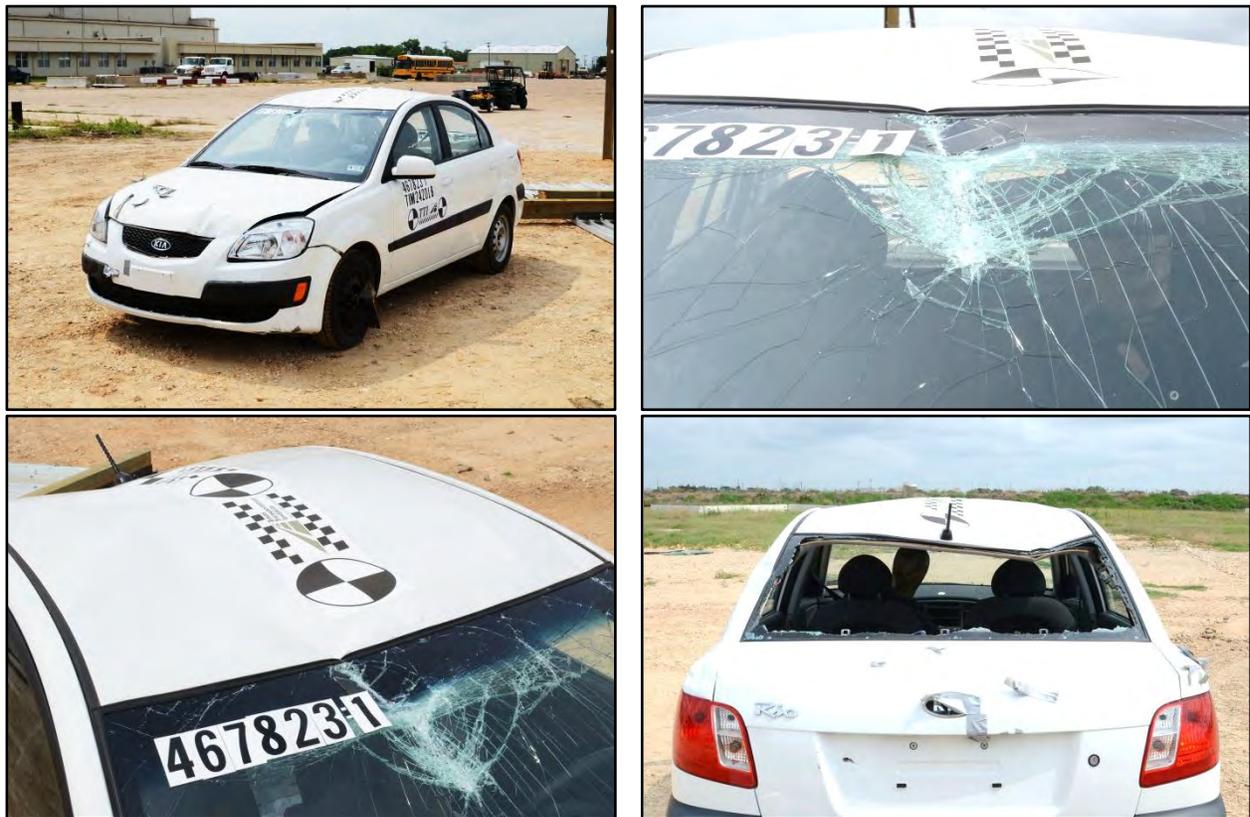
Figure 4.5 shows the damage sustained by the vehicle during the test, which included the front bumper, hood, windshield, right A-post, roof, left C-post, top of trunk lid, and left rear quarter panel. The hood was deformed 2.0 inches in the front plane just left of centerline of the

vehicle. The windshield shattered over an area of 12 inches \times 16 inches near the top center, and just above this area the roof was pushed downward towards the occupant compartment 1.75 inches. Just right of centerline of the roof over the rear passenger compartment was an area measuring 23 inches \times 24 inches that was deformed downward towards the occupant compartment. Maximum occupant compartment deformation was 3.5 inches in the roof over the right rear occupant compartment. Exterior crush and occupant compartment measurements can be found in Tables B2 and B3 of Appendix B.

Figure 4.5. Vehicle after Test No. 467823-1.

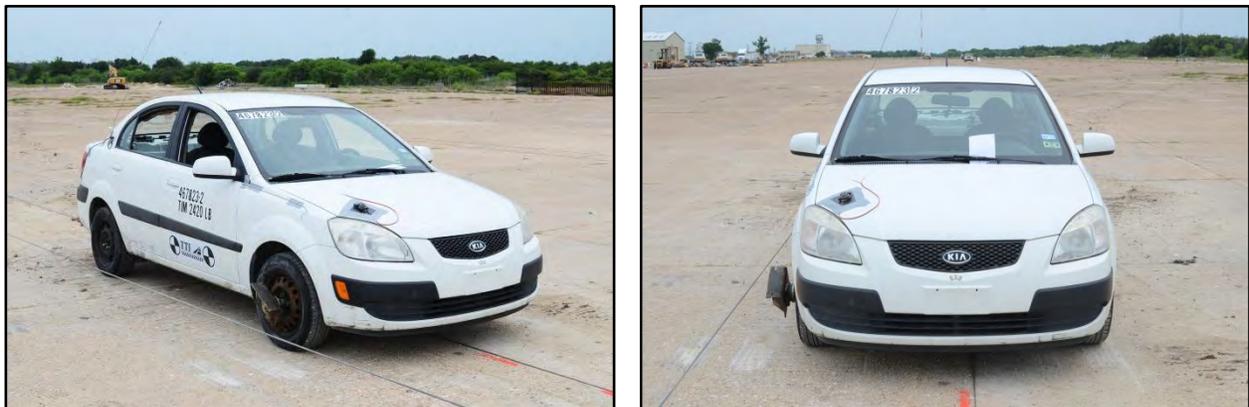
A 2006 Kia Rio, shown in Figure 4.7, was used for the crash test. Test inertia weight of the vehicle was 2432 lb, and its gross static weight was 2611 lb. The height to the lower edge of the vehicle bumper was 7.12 inches, and the height to the upper edge of the bumper was 21.0 inches. Table C1 in Appendix C gives additional dimensions and information on the vehicle. The vehicle was directed into the installation using the cable reverse tow and guidance system and was released to be free-wheeling and unrestrained just prior to impact.

Figure 4.7. Vehicle before Test No. 467823-2.

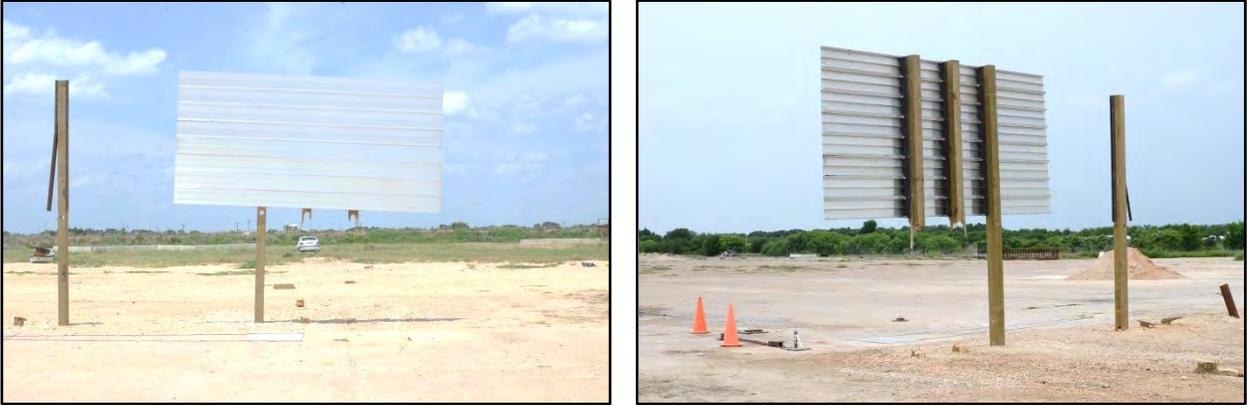
Figure 4.8. Direct Embedded Wood Support Temporary Guide Sign System after Test No. 467823-2.

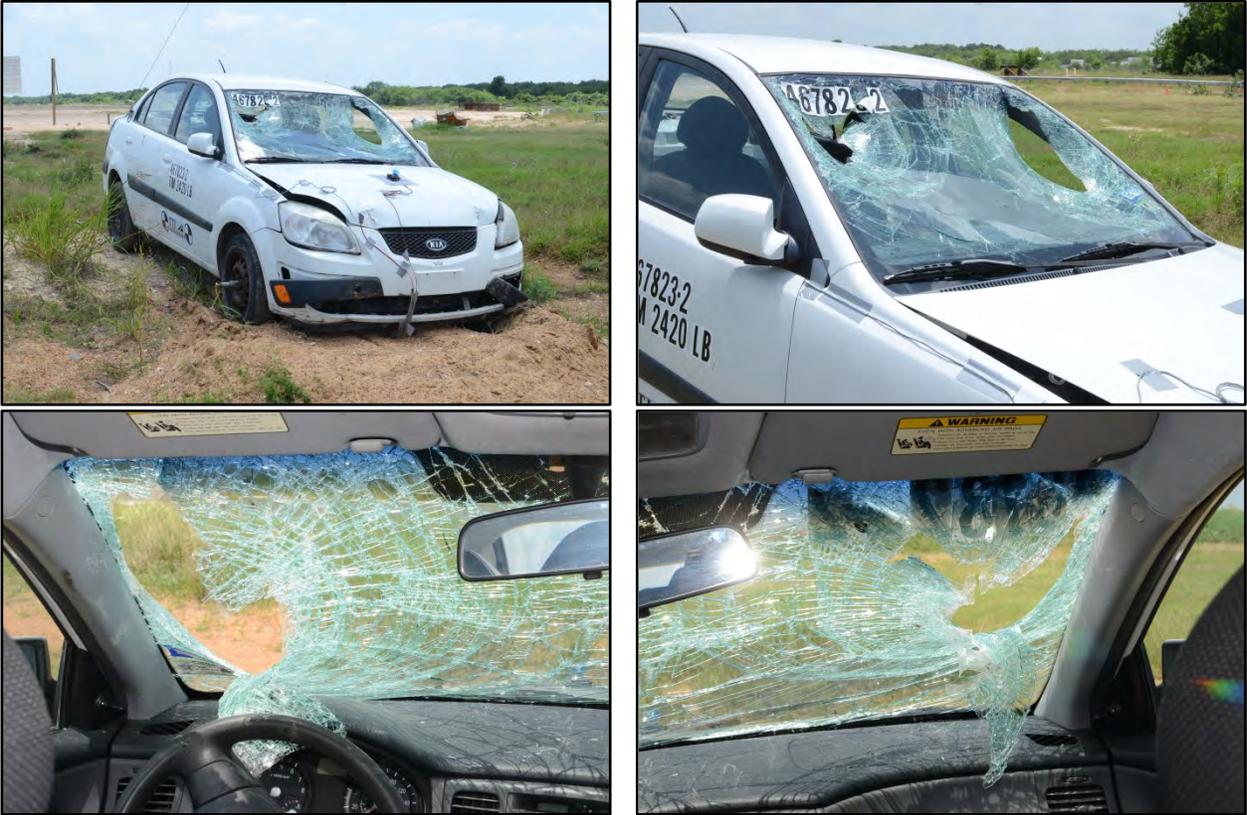
Figure 4.9 shows the damage sustained by the vehicle during the test, which included the front bumper, hood, and windshield. The front bumper was deformed inward 1.0 inch right of centerline of the vehicle. Both supports penetrated through the windshield and into the occupant compartment. The windshield had two holes: one on the driver side measuring 7 inches × 14 inches and one on the passenger side measuring 7 inches × 8 inches. Exterior crush and occupant compartment measurements can be found in Tables C2 and C3 of Appendix C.

Figure 4.9. Vehicle after Test No. 467823-2.

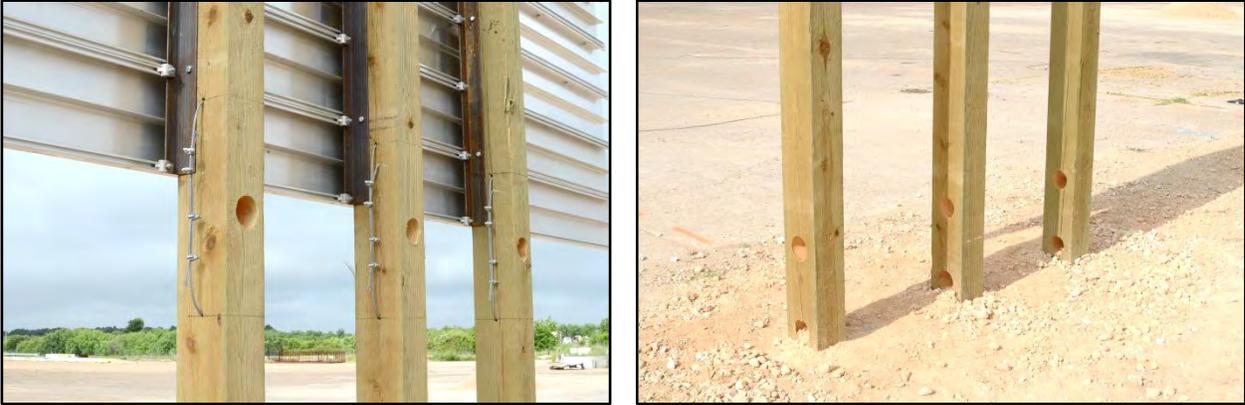
sign system, and Appendix D includes further details. Figure 4.13 shows photographs of the installation prior to testing.

Figure 4.13. Modified Direct Embedded Wood Support Temporary Guide Sign System before Test Nos. 467823-2b and 467823-3.

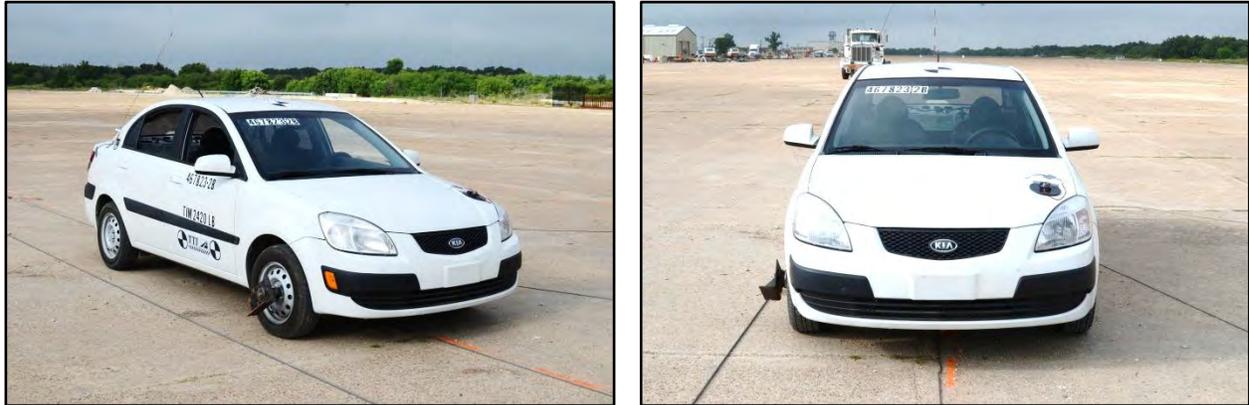
Figure 4.14 shows the 2006 Kia Rio used for the crash test. Test inertia weight of the vehicle was 2425 lb, and its gross static weight was 2604 lb. The height to the lower edge of the vehicle bumper was 7.12 inches, and the height to the upper edge of the bumper was 21.0 inches. Table E1 in Appendix E gives additional dimensions and information on the vehicle. The vehicle was directed into the installation using the cable reverse tow and guidance system and was released to be free-wheeling and unrestrained just prior to impact.

Figure 4.14. Vehicle before Test No. 467823-2b.

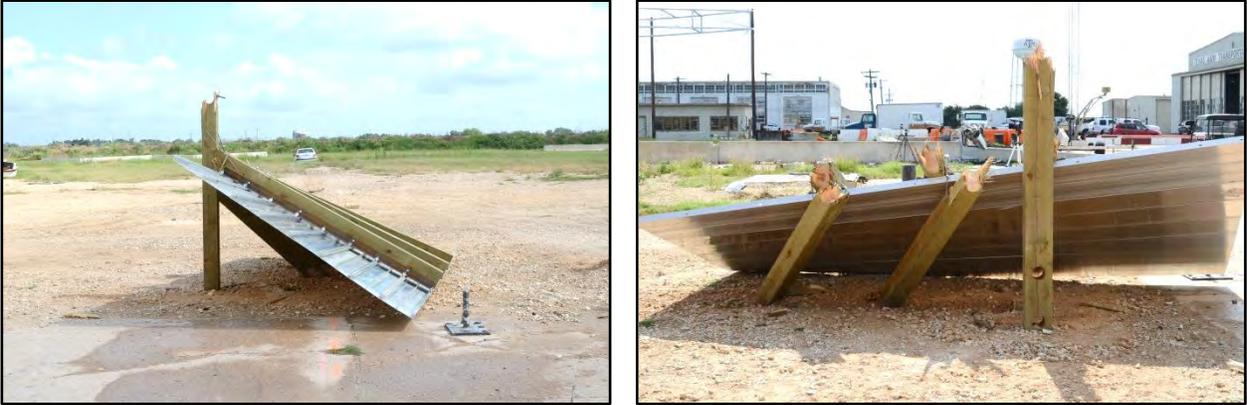
Figure 4.15 shows damage to the wood post sign support system after the test. The right and middle support legs fractured at the holes at bumper height, near ground level, and below the sign panel as designed. The upper sections of right and middle support legs remained attached to the sign panel and to the fractured lower sections via the restraining cable. The left support leg fractured at the hole below the sign panel with minimal displacement in the soil. The sign panel remained attached to the lower section of the left support leg via the restraining cable.

Figure 4.15. Modified Direct Embedded Wood Support Temporary Guide Sign System after Test No. 467823-2b.

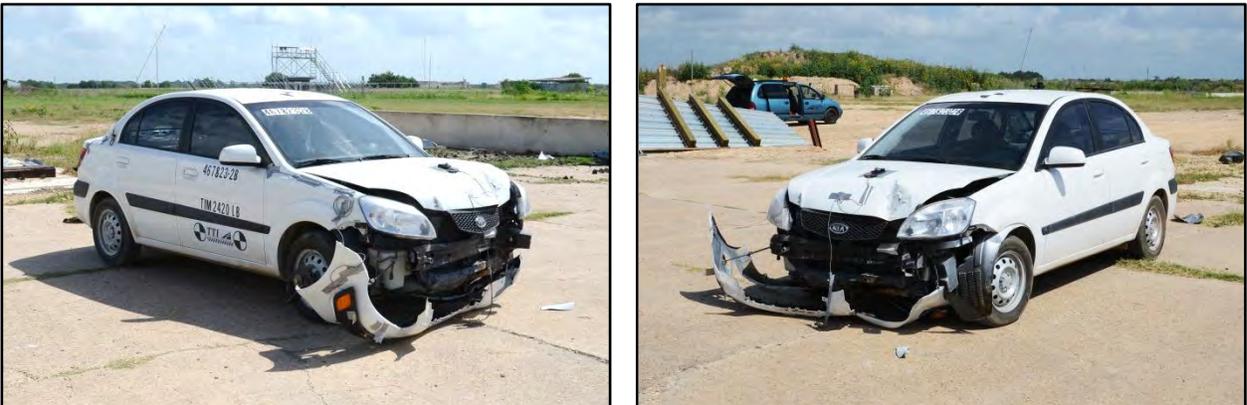
Figure 4.16 shows the damage sustained by the vehicle during the test, which included the front bumper, hood, radiator and radiator support. The front end was deformed 6.5 inches on the left of centerline and 3.0 inches on the right of centerline just below bumper height. No occupant compartment deformation or penetration occurred during the test. Exterior crush and occupant compartment measurements can be found in Tables E2 and E3 of Appendix E.

Figure 4.16. Vehicle after Test No. 467823-2.

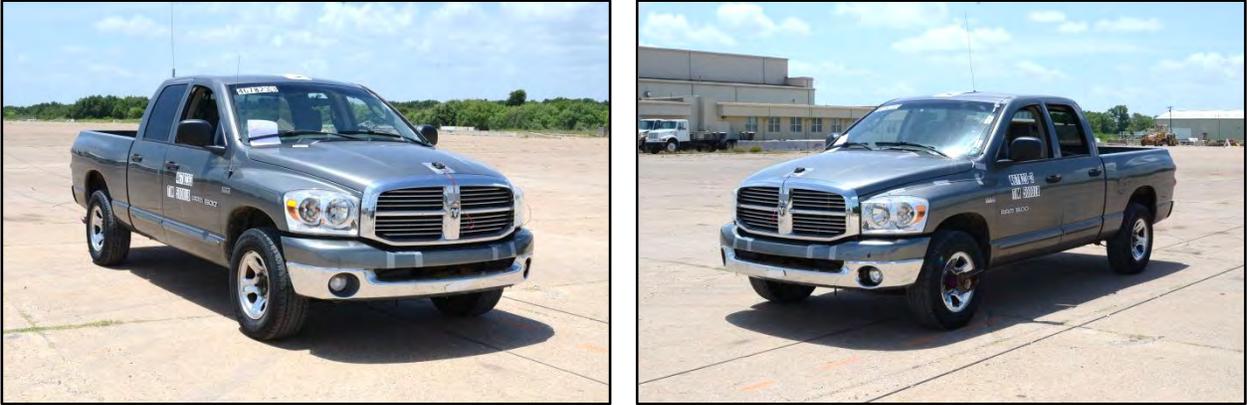
Figure 4.18 shows the 2007 Dodge Ram 1500 pickup truck used for the crash test. Test inertia weight of the vehicle was 5015 lb, and its gross static weight was 5015 lb. The height to the lower edge of the vehicle bumper was 15.5 inches, and the height to the upper edge of the bumper was 28.0 inches. The height to the center of gravity was 28.38 inches. Tables F1 and F2 in Appendix F gives additional dimensions and information on the vehicle. The vehicle was directed into the installation using the cable reverse tow and guidance system, and was released to be free-wheeling and unrestrained just prior to impact.

Figure 4.18. Vehicle before Test No. 467823-3.

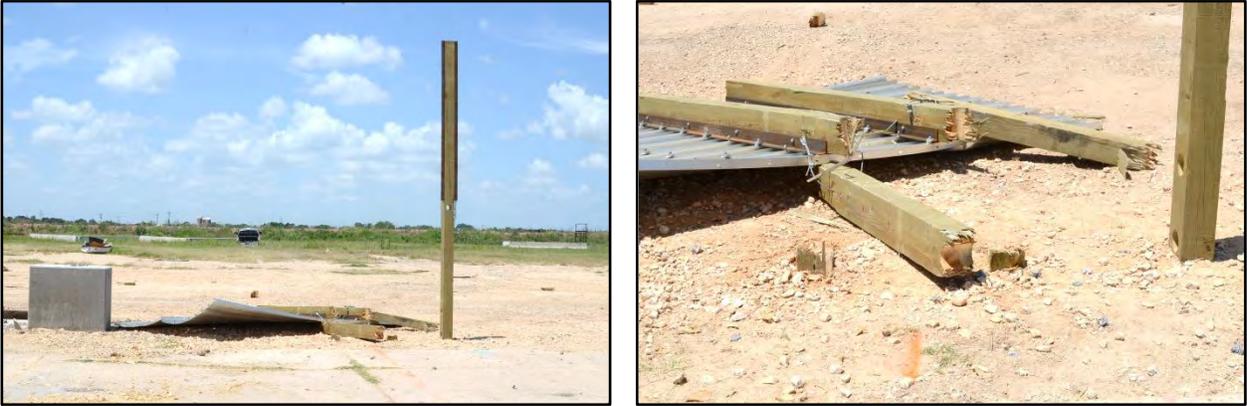
Figure 4.19. Modified Direct Embedded Wood Support Temporary Guide Sign System after Test No. 467823-3.

Figure 4.19 shows damage to the wood post sign support after the test. The left and middle support legs fractured at the holes at bumper height, near ground level, and below the sign panel. The upper sections of fractured support legs remained attached to the sign panel and to the fractured lower sections via the restraining cables. The right support leg remained intact with minimal movement in the soil. The sign panel separated from the right support leg and fell to the ground.

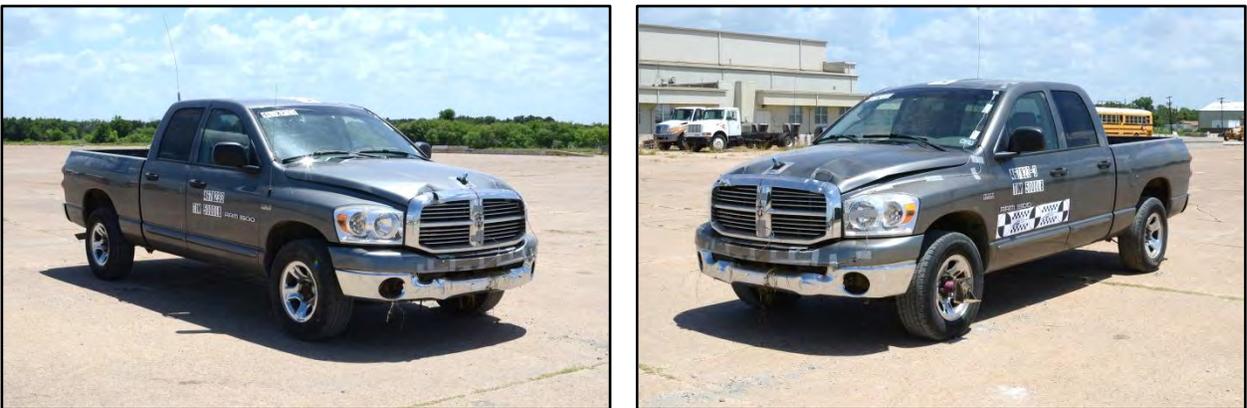
Figure 4.20. Vehicle after Test No. 467823-3.

Figure 4.20 shows the damage sustained by the vehicle during the test, which included the front bumper, hood, and roof. The front of the vehicle was deformed 1.0 inch both left and right of centerline of the vehicle at bumper height. There were two small dents in the roof, one measuring 1.5 inches wide \times 26 inches long \times 1.12 inches deep, and another 2.5 inches wide \times 25 inches long and 0.25 inch deep. No occupant compartment deformation or penetration occurred during the test. Exterior crush and occupant compartment measurements can be found in Tables F3 and F4 of Appendix F.

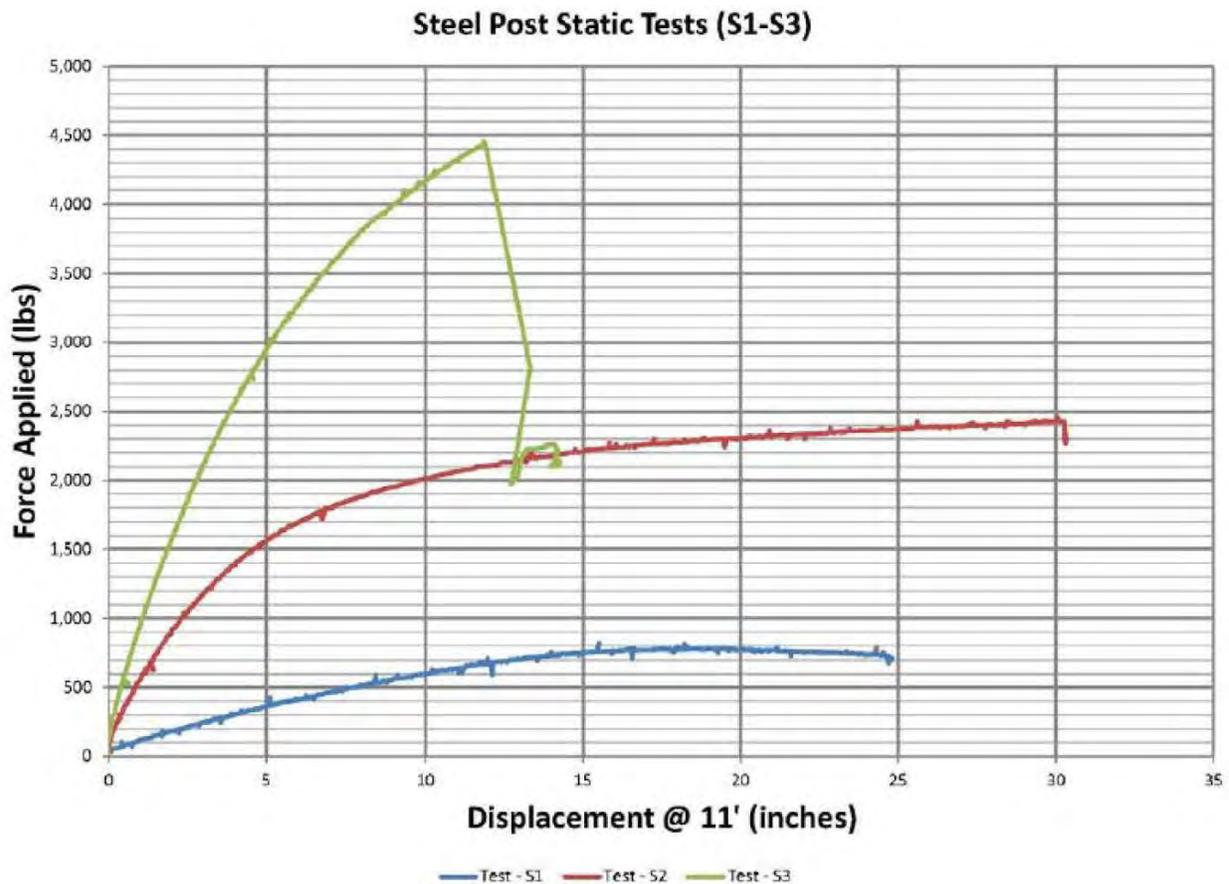
Figure 5.1. Static Test Results for S3x5.7 (Test S1), W6x9 (Test S2), and W8x18 (Test S3).

Figure 5.1 shows the force-deflection plots obtained from the static tests. In the test of the S3×5.7 foundation post, the post failed in lateral torsional buckling at a peak force of 0.82 kips. Given the force was applied at a height of 11 ft above grade, the resulting moment capacity is $0.82 \text{ kips} \times 11 \text{ ft} = 9.0 \text{ kip-ft}$. This value significantly exceeds the post capacity of 1.7 kip-ft.

In the test of the W6×9 post, the force-deflection curve was leveling off, and the test was halted due to significant deflection. The peak force at the time the test was halted was 2.46 kips. The corresponding moment capacity is 27.1 kip-ft, which is more than twice the post capacity of 11.8 kip-ft from Table 5.2.

In the test of the W8×18 foundation post, the test was halted when a weld on the slip base failed on the tension side of the post. The maximum force reached at time of failure was 4.45 kips. This corresponds to a moment capacity of 49.0 kip-ft, which exceeds the 36.4 kip-ft moment capacity of a W8×18 post section.

In summary, the measured static load capacity of all three foundation posts exceeded the calculated moment capacities of the corresponding steel support posts. This verifies the analytical procedure used to design the foundation posts and indicates the suitability of the foundation posts for the temporary installation of large guide signs.

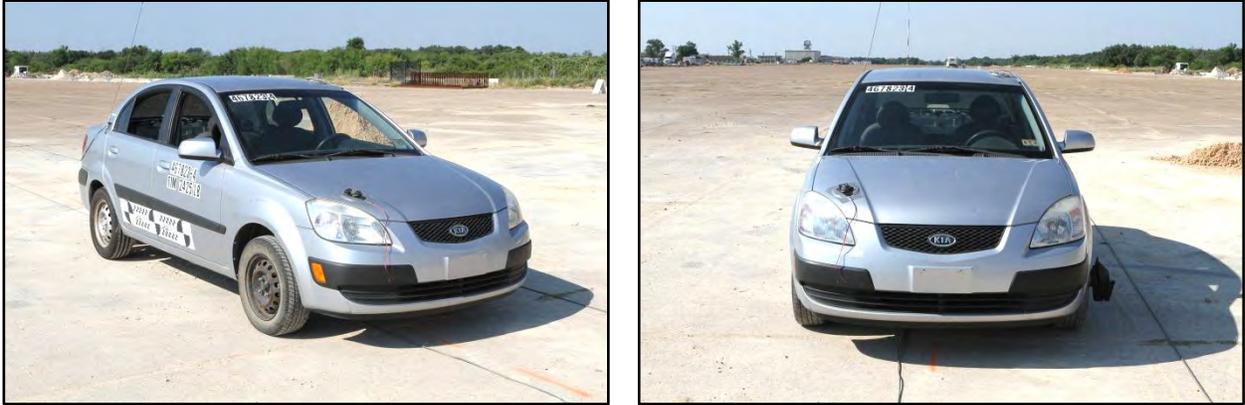
Figure 5.4. Vehicle before Test No. 467823-4.

Figure 5.4 shows the 2007 Kia Rio used for the crash test. Test inertia weight of the vehicle was 2425 lb, and its gross static weight was 2608 lb. The height to the lower edge of the vehicle bumper was 7.12 inches, and the height to the upper edge of the bumper was 21.0 inches. Table H1 in Appendix H gives additional dimensions and information on the vehicle. The vehicle was directed into the installation using the cable reverse tow and guidance system and was released to be free-wheeling and unrestrained just prior to impact.

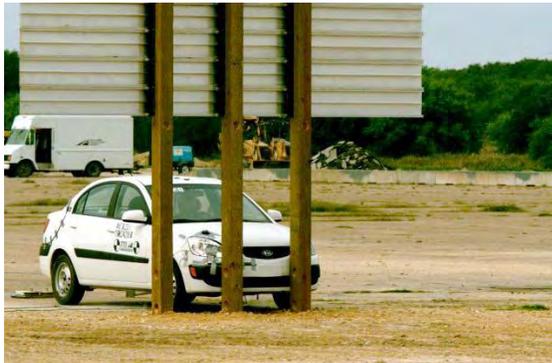
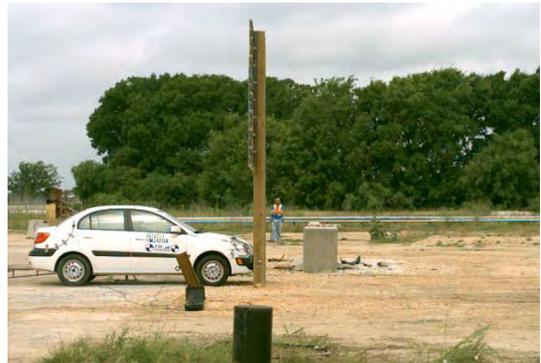
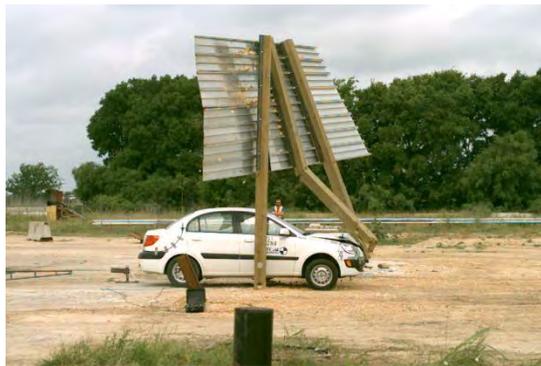
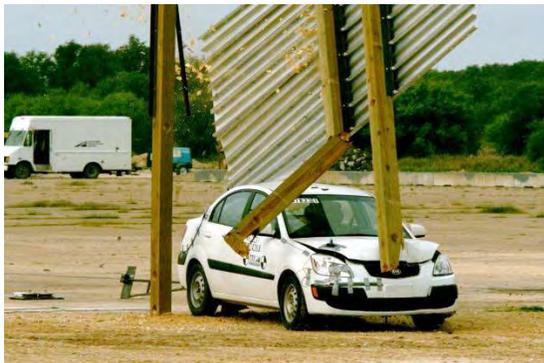
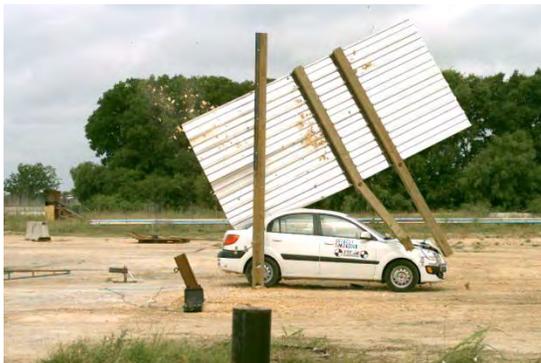
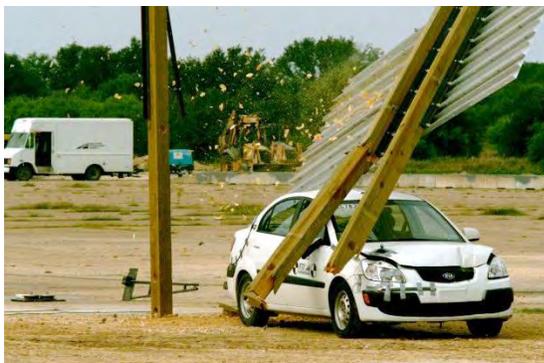
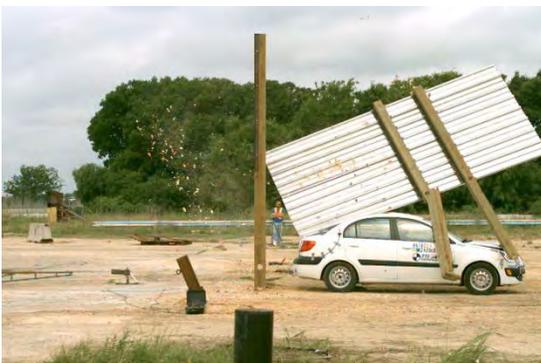
Figure B1. Sequential Photographs for Test No. 467823-1(Oblique and Perpendicular Views).

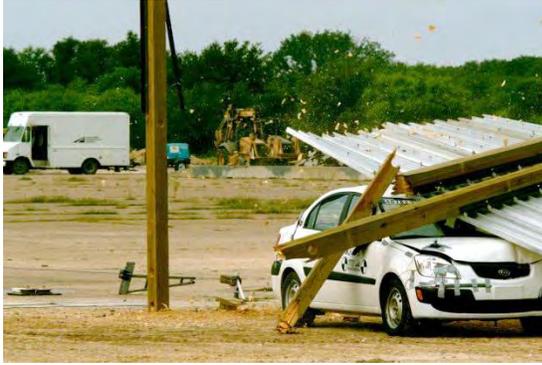
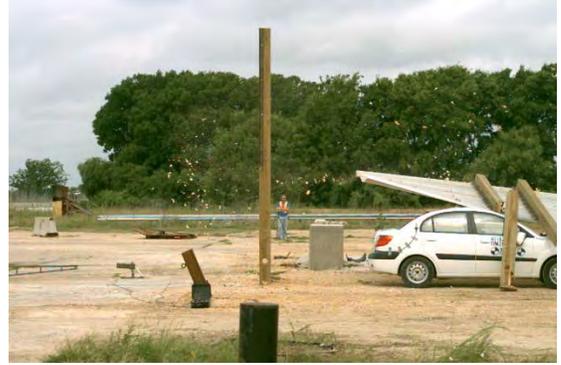
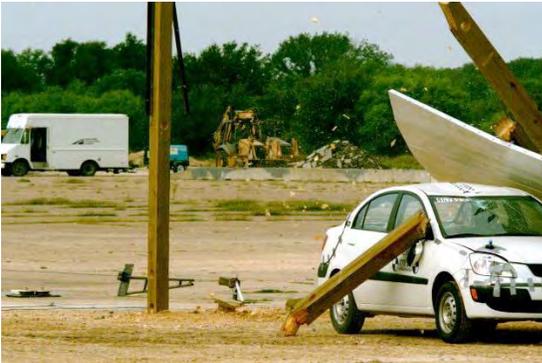
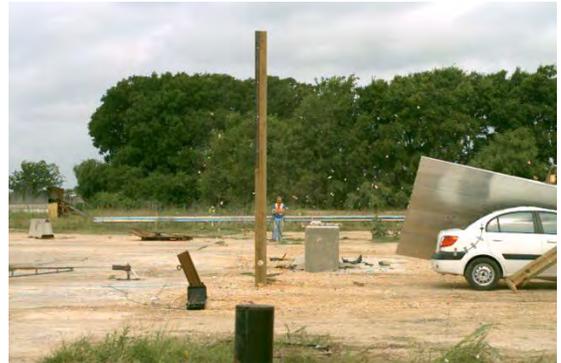
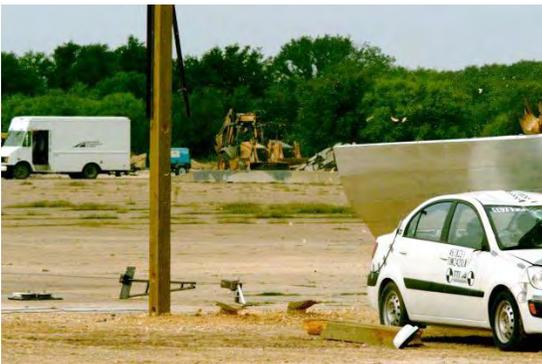
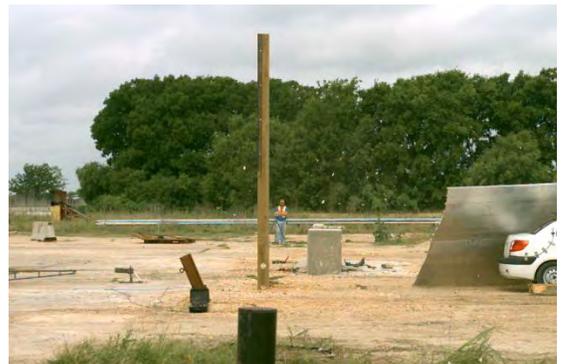
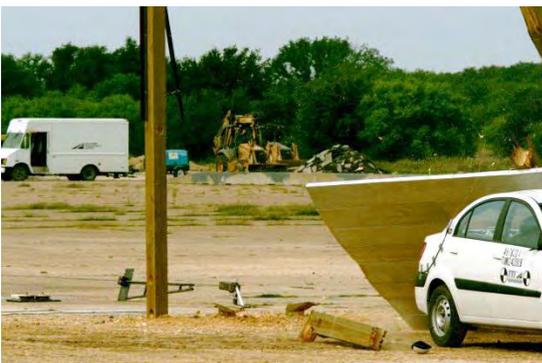
Figure B1. Sequential Photographs for Test No. 467823-1(Oblique and Perpendicular Views) (Continued).

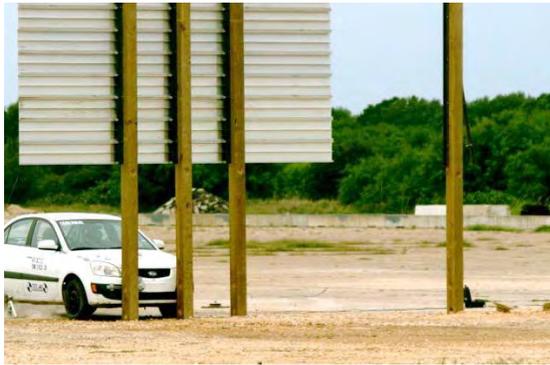
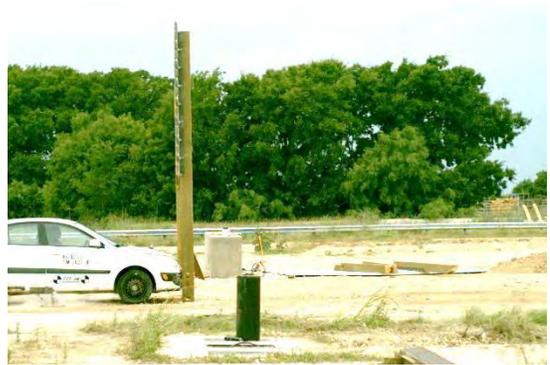
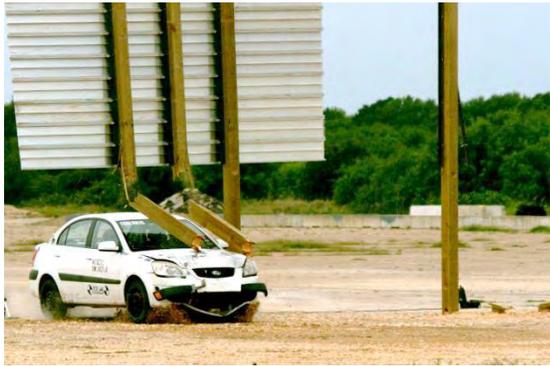
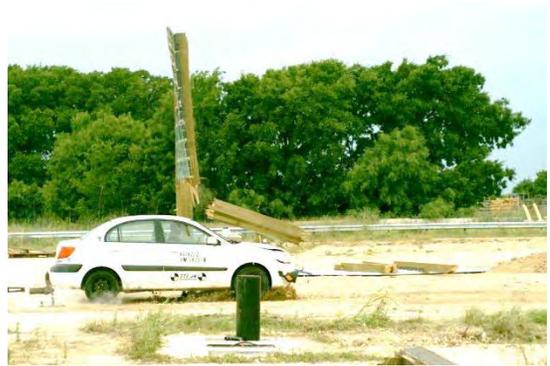
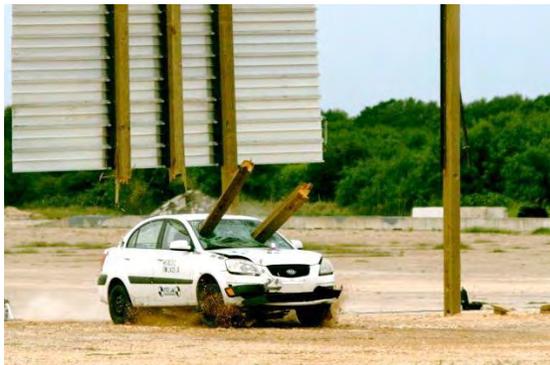
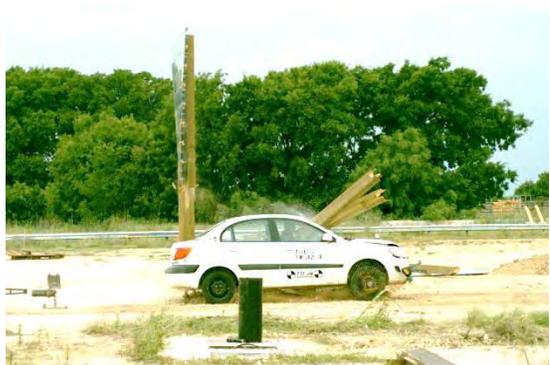
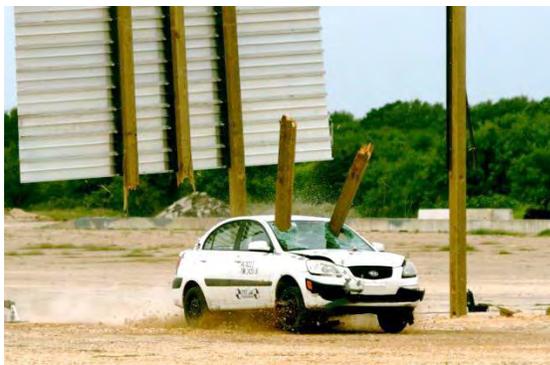
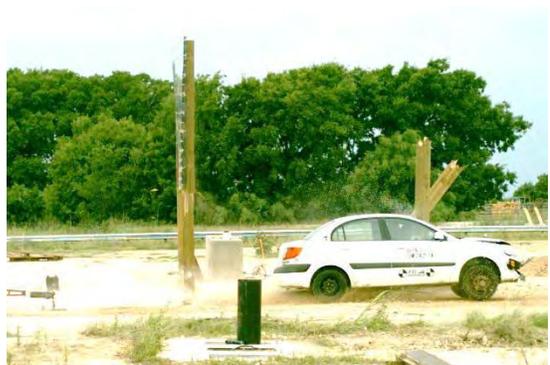
Figure C1. Sequential Photographs for Test No. 467823-2(Oblique and Perpendicular Views).

C.2 SEQUENTIAL PHOTOGRAPHS

0.000 s

0.076 s

0.152 s

0.228 s

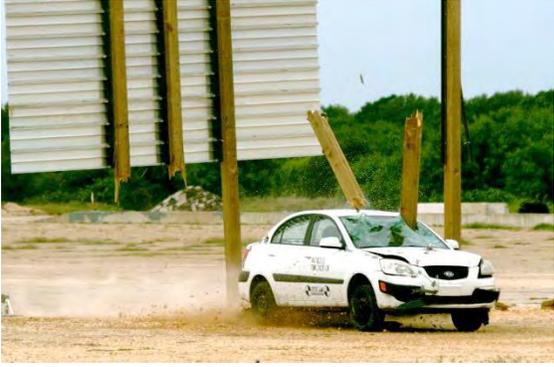
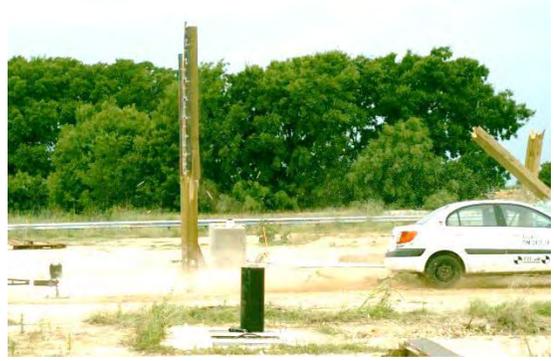
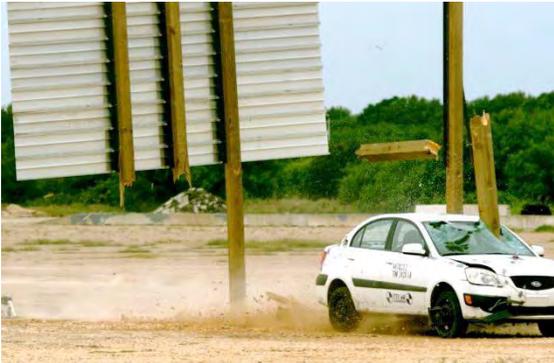
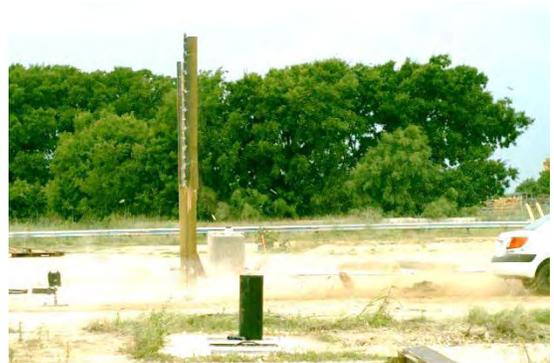
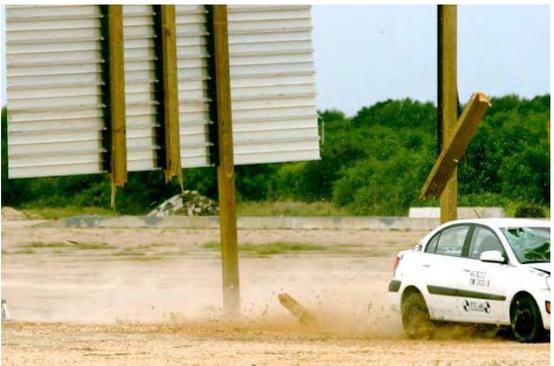
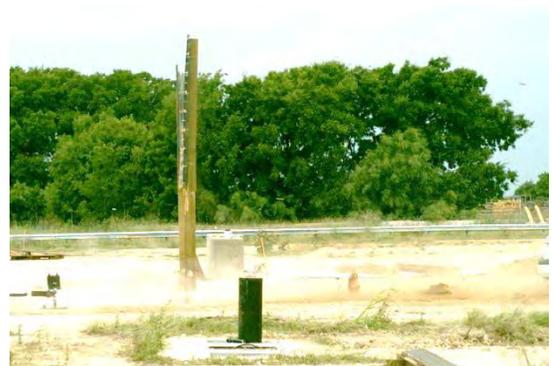
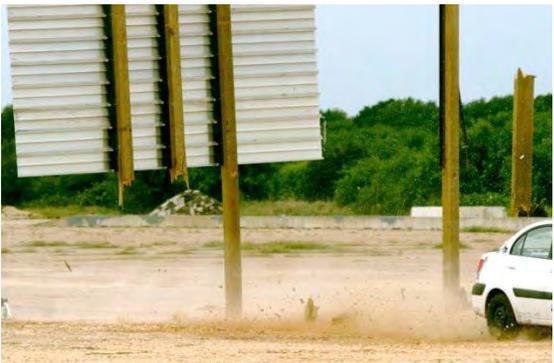
Figure C1. Sequential Photographs for Test No. 467823-2 (Oblique and Perpendicular Views) (Continued).

0.304 s

0.380 s

0.456 s

0.532 s

Vehicle out of view

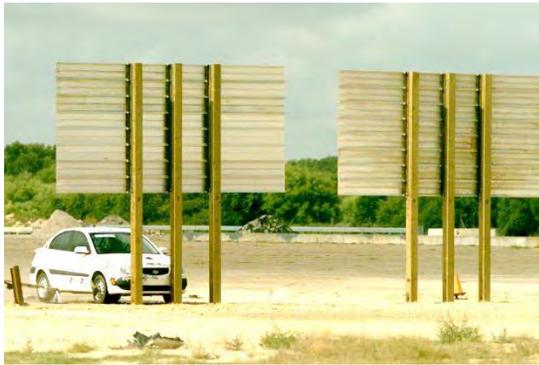
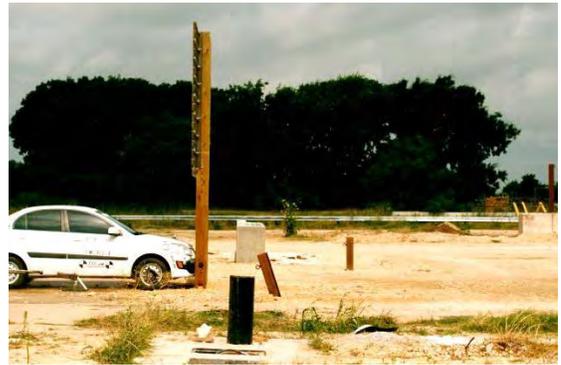
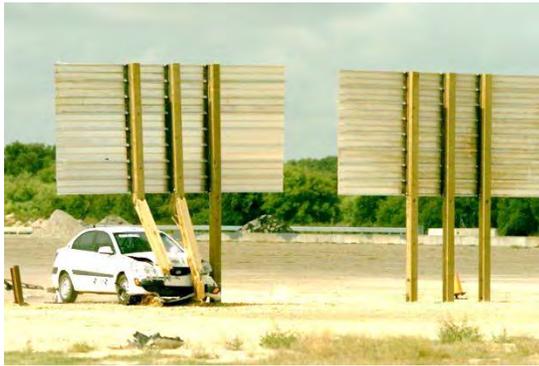
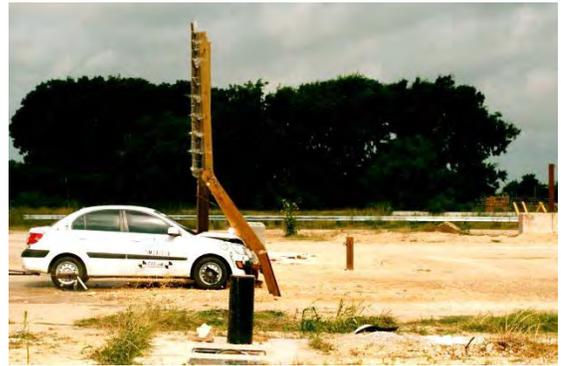
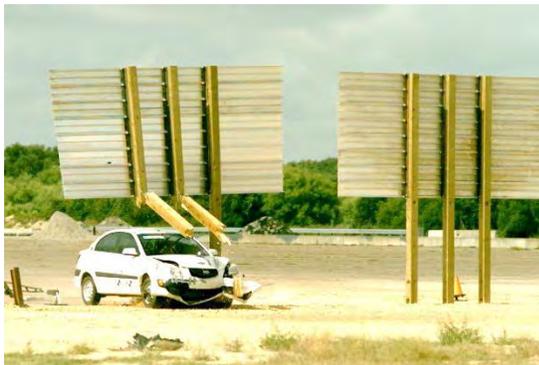
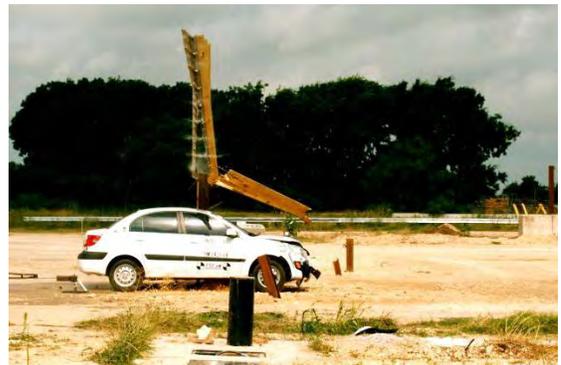
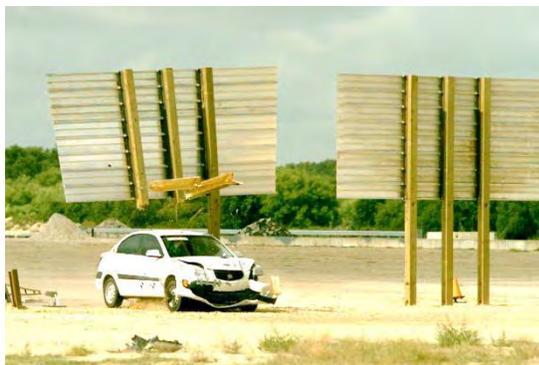
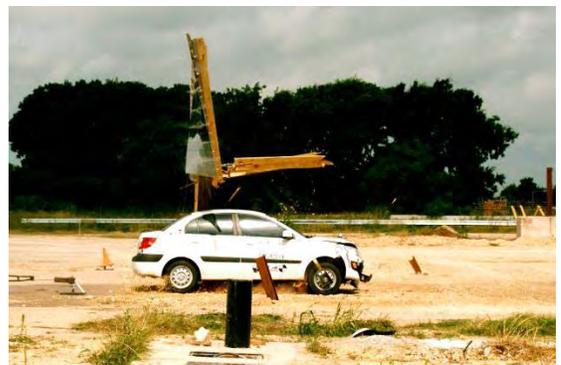
Figure E1. Sequential Photographs for Test No. 467823-2b(Oblique and Perpendicular Views).

E.2 SEQUENTIAL PHOTOGRAPHS

0.000 s

0.040 s

0.080 s

0.120 s

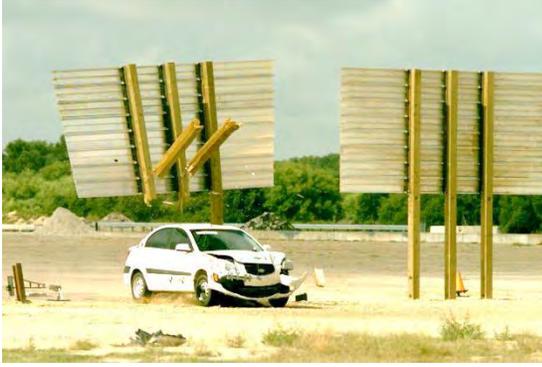
0.160 s

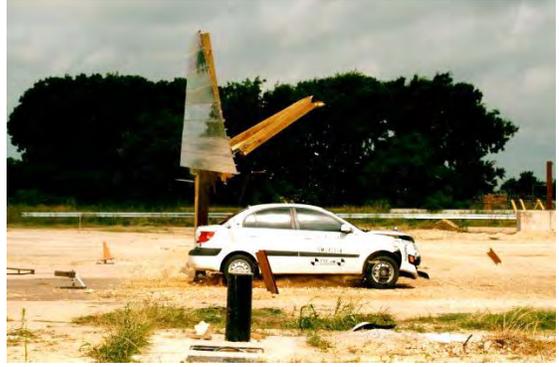
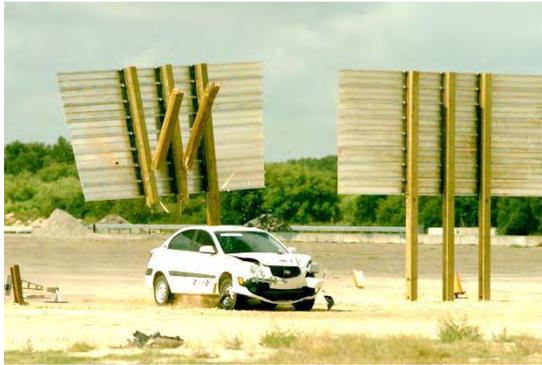
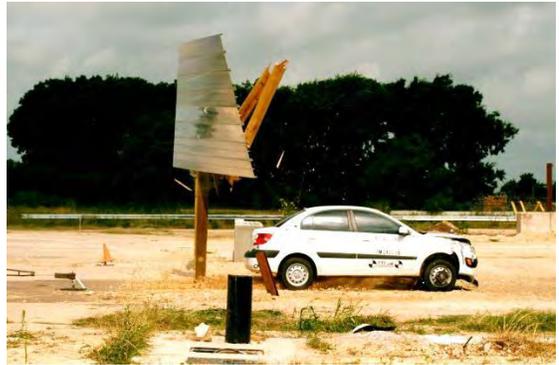
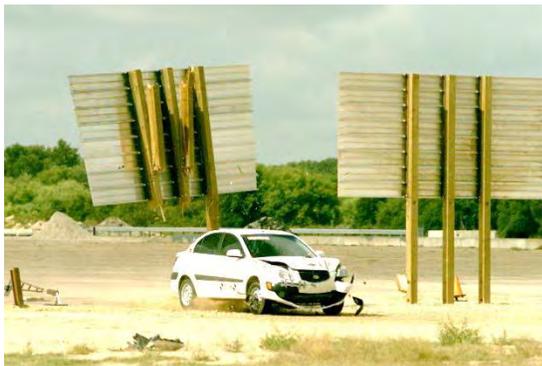
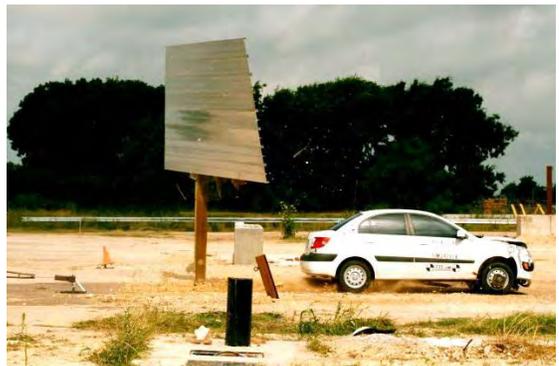
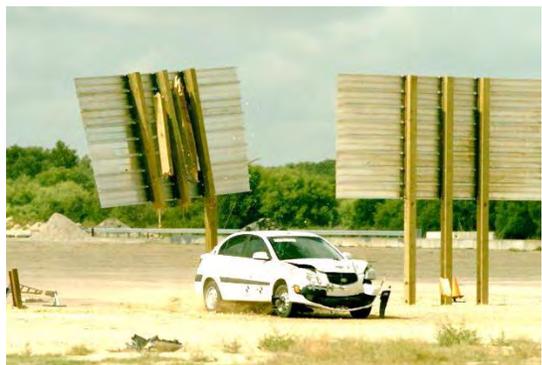
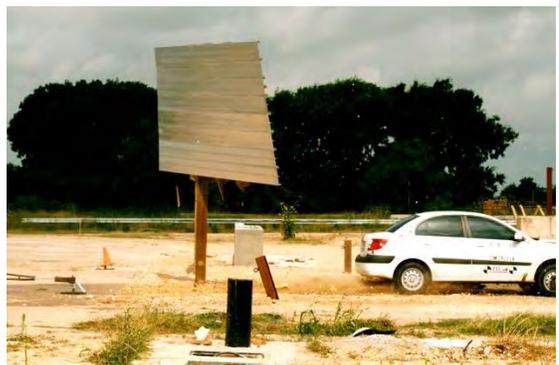
**Figure E1. Sequential Photographs for Test No. 467823-2b
(Oblique and Perpendicular Views) (Continued).**

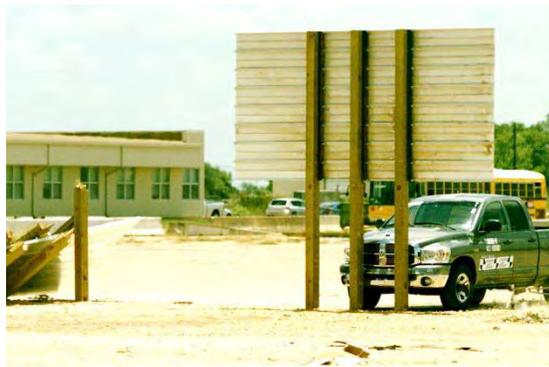
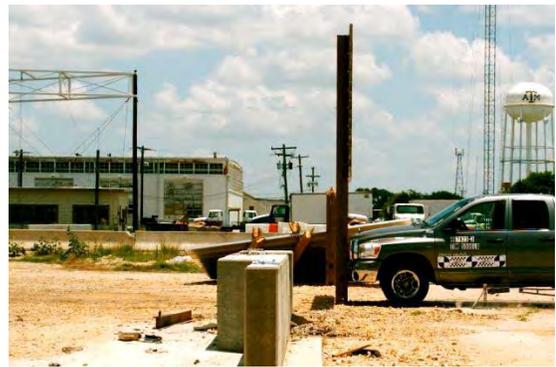
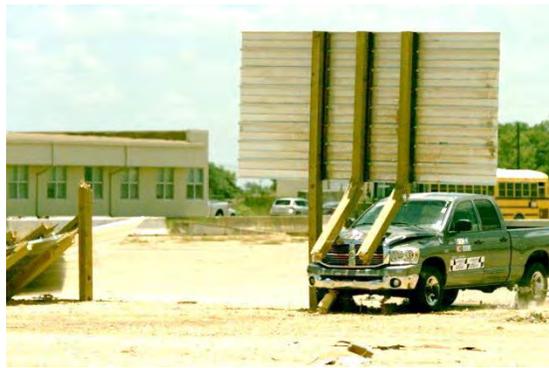
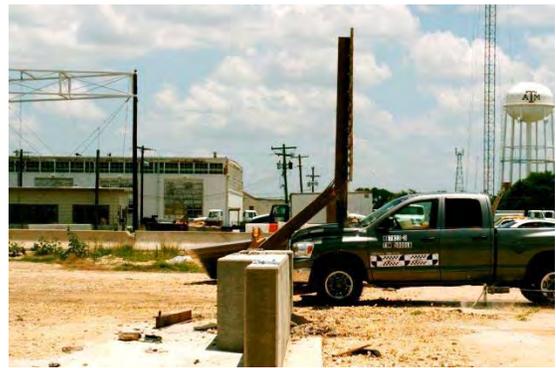
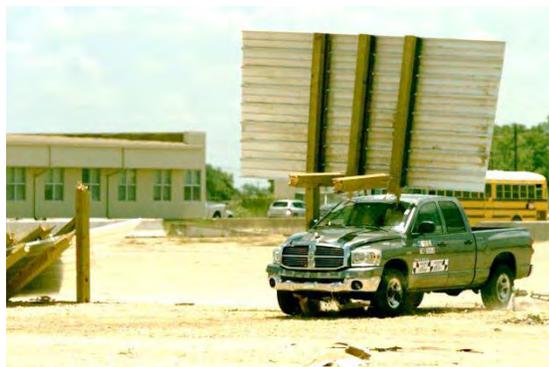
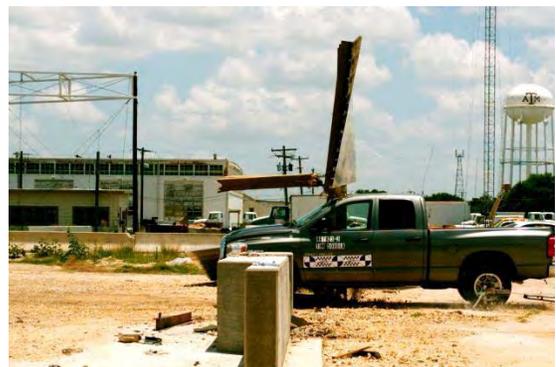
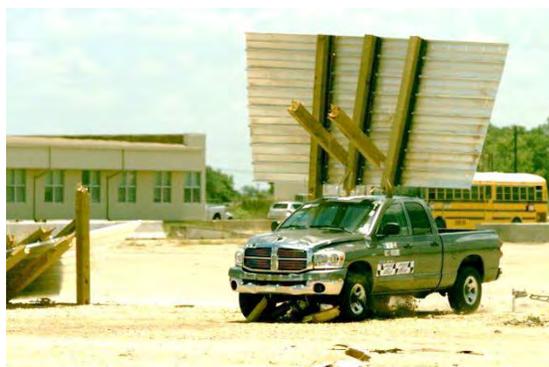
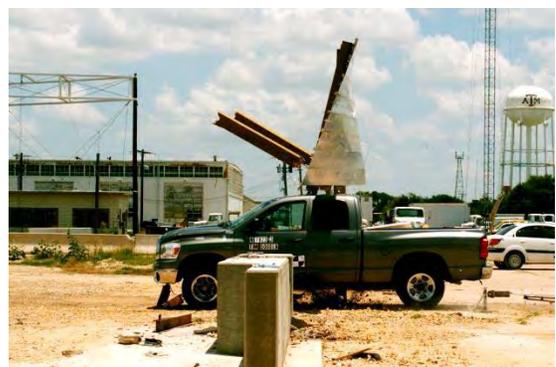
Figure F1. Sequential Photographs for Test No. 467823-3(Oblique and Perpendicular Views).
