TEMPORARY LARGE GUIDE SIGNS

Test Report 0-6782-1

TEXAS A&M TRANSPORTATION INSTITUTE
COLLEGE STATION, TEXAS

TEXAS DEPARTMENT OF TRANSPORTATION

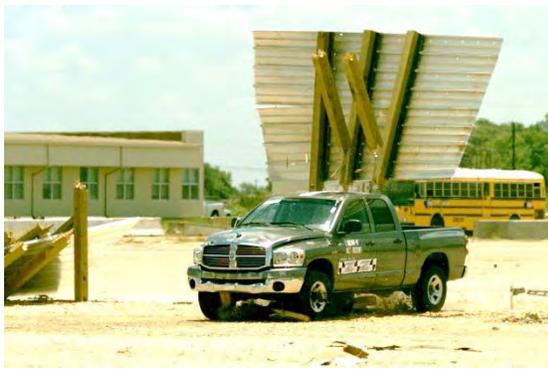
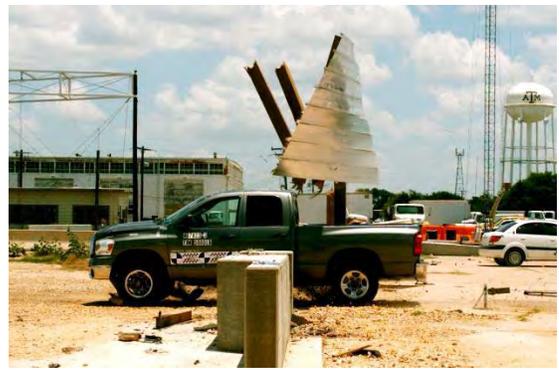
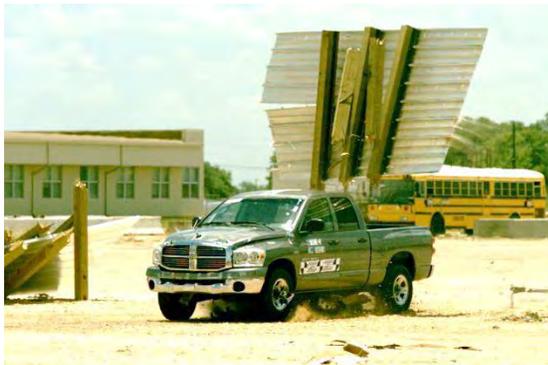
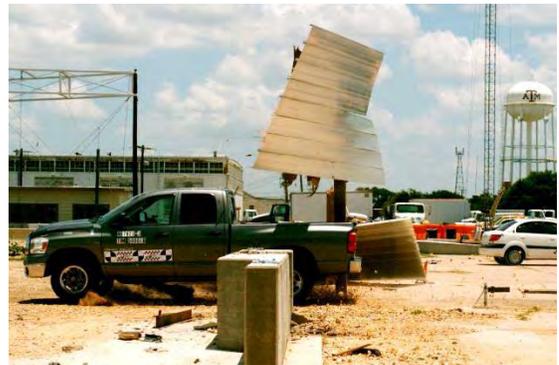
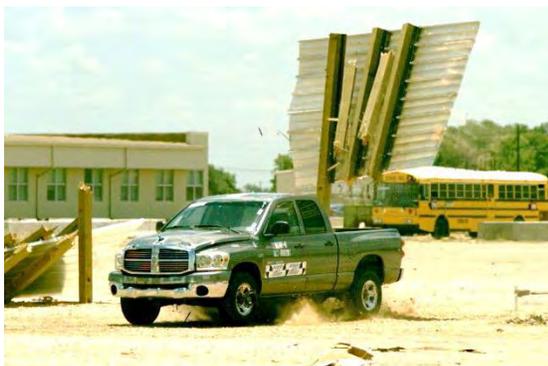
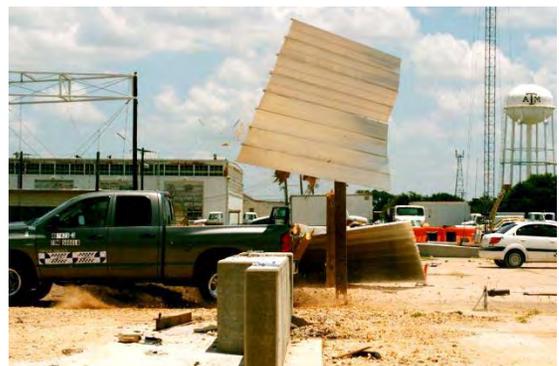
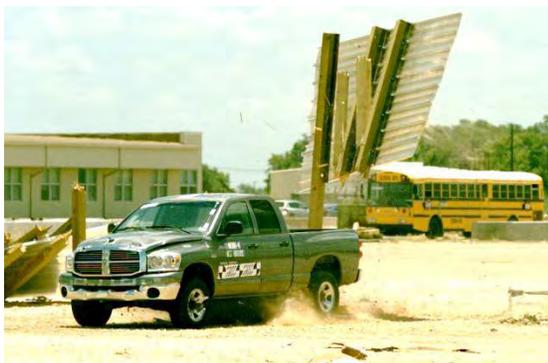
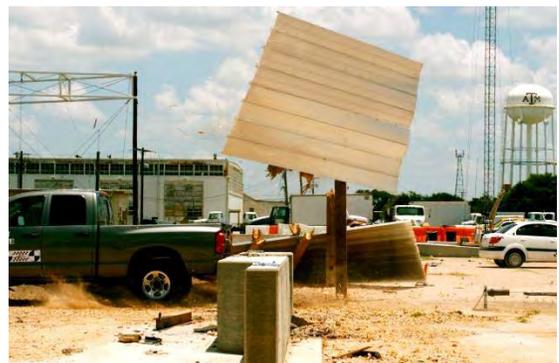
Figure F1. Sequential Photographs for Test No. 467823-3 (Oblique and Perpendicular Views) (Continued).

cable met all applicable *MASH* evaluation criteria for Test 3-62. Occupant impact velocity was 4.6 ft/sec, which is below the preferred value. The roof deformation resulting from secondary contact with pieces of wood projecting from the fractured supports was minor in nature and did not result in any occupant compartment deformation.
