Report No. 405160-29

**IN-FIELD INSPECTION METHODOLOGY FOR
WEATHERING STEEL W-BEAM GUARDRAIL**

Sponsored by
Roadside Safety Research Program Pooled Fund
Study No. TPF-5(114)

TEXAS A&M TRANSPORTATION INSTITUTE

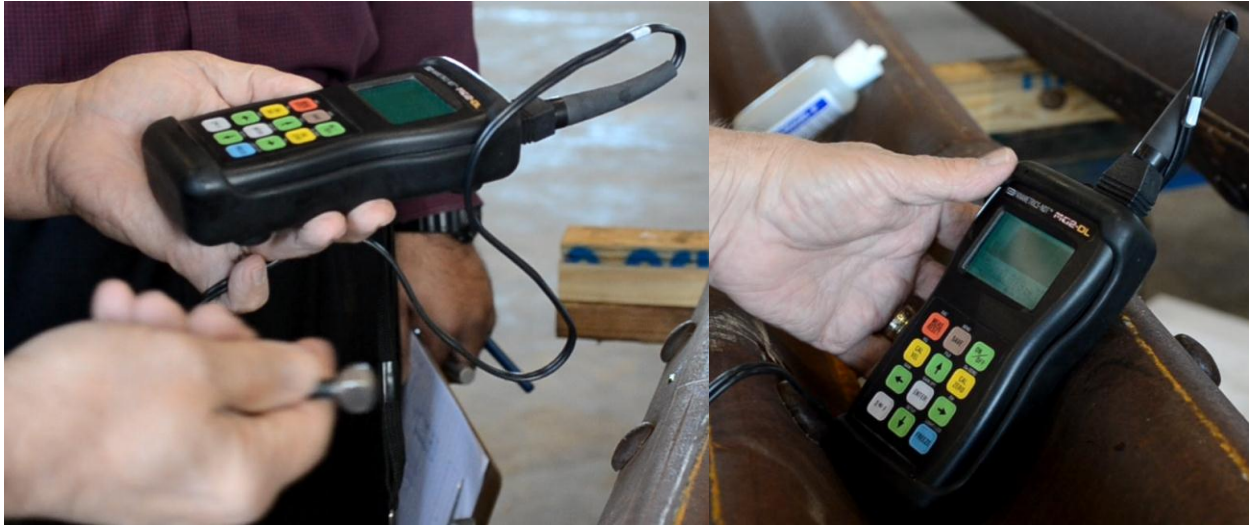
Figure 3.1 Handheld ultrasonic thickness gauge with probe.

The ultrasonic thickness gauge is a rectangular handheld device, and is thus very portable. The front face of the gauge is comprised of a digital screen and a keyboard. The top of the device has a port for attaching an external probe to the gauge. The probe usually comes attached to a cable, which allows greater flexibility in taking measurements of hard to reach areas.

As mentioned above, the researchers used Olympus MG2 Series Ultrasonic Thickness Gauge (shown in figure 3.1) for measuring thicknesses of the weathering steel guardrail samples during this project. Detailed information about various capabilities and instructions on using a specific make and model of an ultrasonic thickness gauge device are best obtained from the user's manual. However, a basic and a general description on the use of handheld ultrasonic thickness gauges, as applicable to this project, is included in this section.

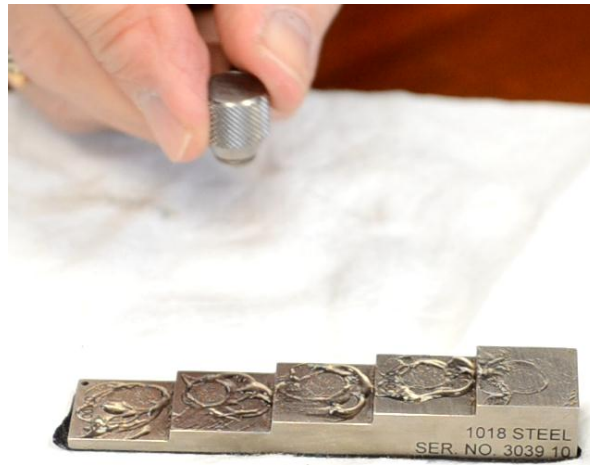
When the gauge is first turned on, it needs to be calibrated using a certified calibration block such as the one shown in figure 3.2. During the calibration process, the gauge is used to measure two known thickness from the calibration block. Any difference in the measured and the known values is zeroed to achieve calibration.

Figure 3.2 Calibration steel block.

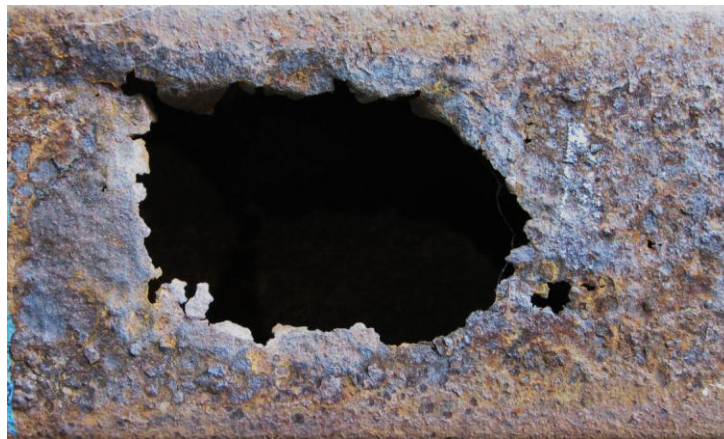
Figure 3.3 Advanced rail corrosion with pitting.

Advanced corrosion in weathering steel can lead to irregular surfaces with pitting, such as the one shown in figure 3.3. Taking a reliable thickness reading in these regions can be difficult. Furthermore, thickness of the metal beam can vary significantly in these regions. Therefore, it is recommended that parts showing such clear signs of advanced corrosion be replaced, regardless of the ability to take a thickness measurement.

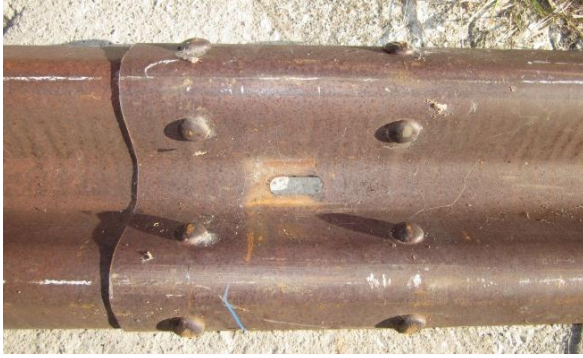
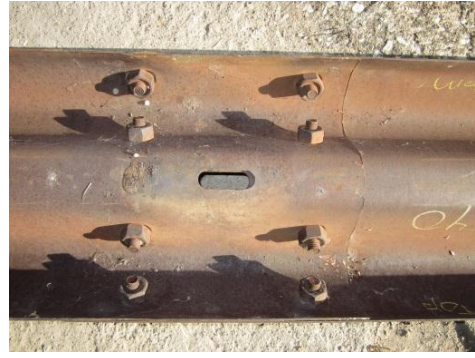
California W-beam rail splice

Figure 3.4 Photos of the weathering steel guardrail samples.

The researchers collected samples of weathering steel guardrail that had been in service for a considerable amount of time. Samples were collected from California, New York, Vermont, and Washington, and are shown in figure 3.4. A brief description of the samples is presented in table 3.1.

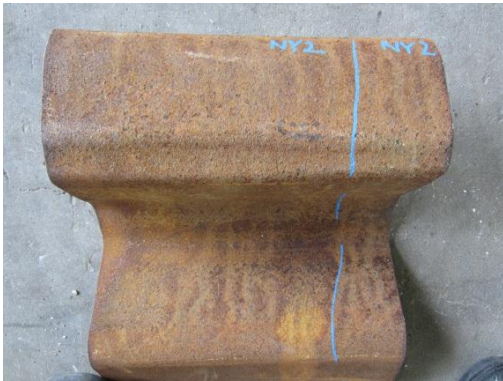
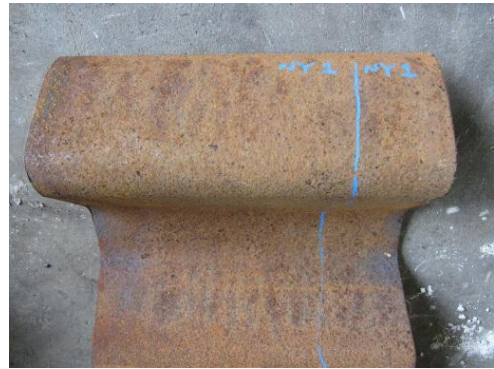
New York W-beam

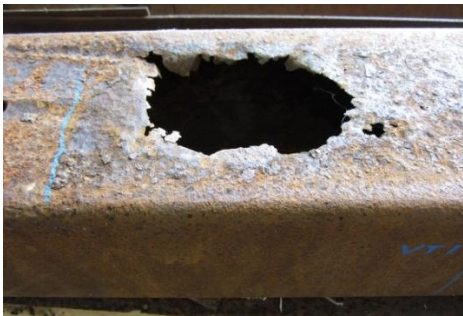
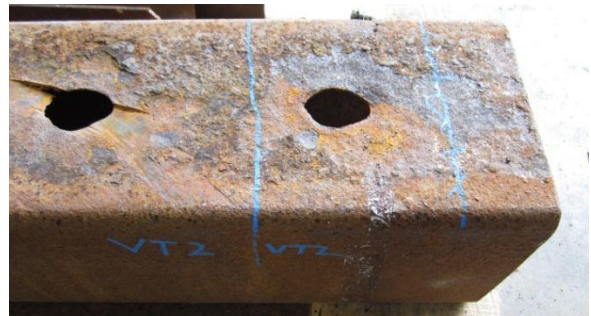
Vermont box-beam

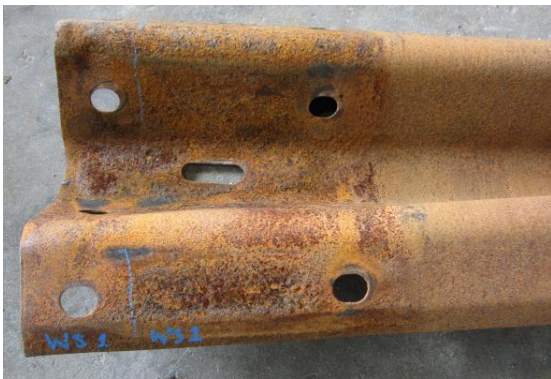
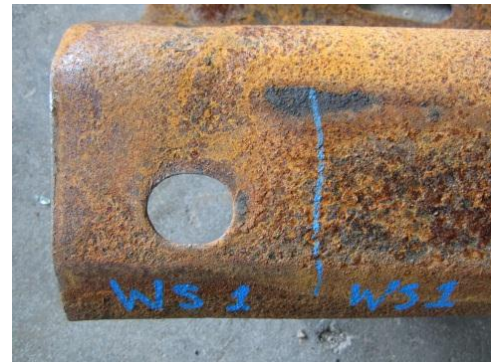
Washington W-beam from splice region

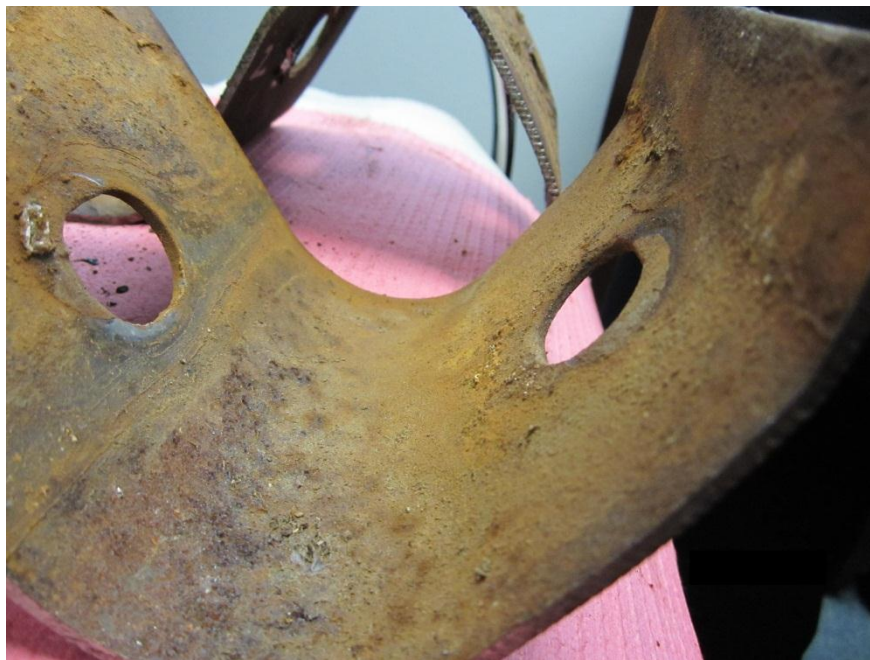
By comparing the different thickness values, it was determined that measuring thickness of the rail elements with the splices assembled had no significant effect on the measurement. Thus the use of ultrasonic thickness gauge is suitable for use with assembled lapped splices. Figure 3.7 shows typical debris and rust collected between the splices used in the thickness measurements.

Figure 3.7 Debris and rust collected between lapped splices of the samples used.

The researchers first measured the thickness of the rail elements with the lapped splices intact, and without taking off the patina layer. In the second step, the splices were unassembled and thicknesses were measured again (without removing patina). In the final step, the patina layer was removed and the thicknesses were measured again.

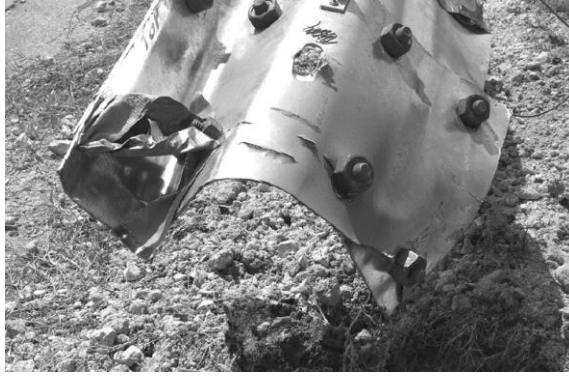
In 1999, Texas Transportation Institute (TTI) performed a crash test with a galvanized W-beam guardrail under National Cooperative Highway Research Program (NCHRP) Report 350 Test 3-11 impact conditions (i.e., 4409 lb pickup impacting the rail at 62.2 mi/h and 25 degrees). (4)(5) This test was performed to evaluate the performance of the W-beam guardrail system with stronger W6×12 steel blockouts instead of the standard W6×8.5 blockouts. The W-beam guardrail in this test was instrumented using strain gauges to measure the tensile load in the rail immediately upstream and downstream of the impact region. As the vehicle passed by a splice 14.75 ft. downstream of the initial impact point, a tear developed in the rail at the interface of the overlapping splice, which then propagated to cause rail rupture (see figure 3.8). At the time of the rupture, the rail had deflected 3.28 ft. laterally. The pickup truck penetrated the guardrail system and subsequently rolled on its side. Even though the rail ruptured during the test, the tensile force measured just upstream of the impact region had peaked at 33.72 kips prior to the rupture. Thus the force data measured from the test is a good estimation of the tensile load in a rail due to an NCHRP Report 350 Test 3-11 vehicle impact.

Figure 3.8: Rail rupture in TTI test with instrumented W-beam guardrail

Using the peak tensile load measured in the test and the tensile capacity of the rail, it was determined that a significant reserve tensile capacity (factor of safety of 2.2) is available when using the specified minimum rail thickness of 0.096 inches. However, it should be noted that the test described above was performed using the NCHRP Report 350 criteria, which has now been superseded by AASHTO's Manual for Assessing Safety Hardware (MASH). In the MASH criteria, the impact severity of test 3-11 has increased by 13.5% due to the increase in the mass of the design test vehicle from 4409 lb. to 5000 lb. (6) Thus a slightly higher tensile load is expected in a MASH test than what was measured in the NCHRP Report 350 test.

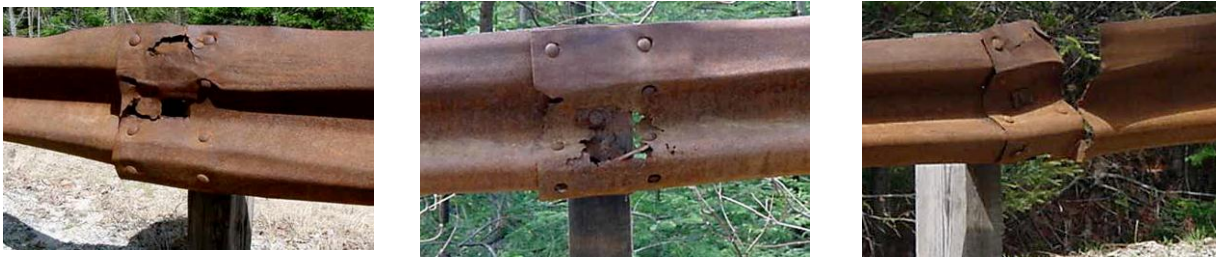
Visual inspection is an integral part of the inspection procedure described herein. If at any time during the inspection (first or second-level), visible signs of advanced corrosion are observed with tears or holes in the rail, or other signs indicating loss, or imminent loss of rail integrity or functionality, the effected parts should be identified as having inadequate structural integrity. (see figure 4.1 for examples) (1).

Figure 4.1: Examples of failed guardrails that can be visually identified.

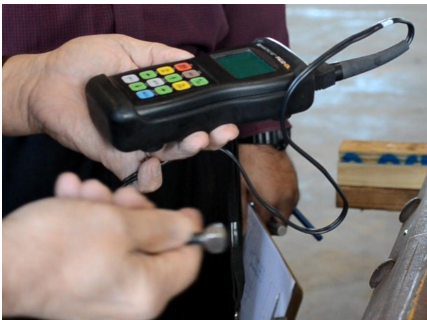
Olympus MG2 Series

An ultrasonic corrosion thickness gauge, which is a non-destructive testing (NDT) device, can be used for the purposes of weathering steel guardrail inspection. Using an ultrasonic thickness gauge eliminates the need to disassemble the guardrail, especially in overlapping splice areas. Detailed instructions on using a specific make and model of an ultrasonic thickness gauge device are best obtained from the user's manual. These devices have an approximate price range of \$1,500 to \$3,000.

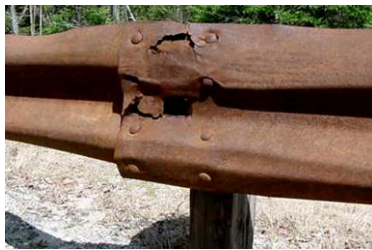
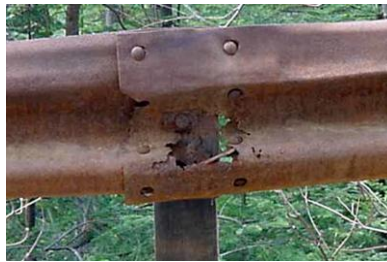
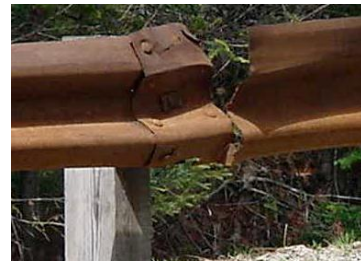
Visual inspection should be performed at all stages of the guardrail inspection. If at any time during the inspection (first or second-level), visible signs of advanced corrosion are observed with tears or holes in the rail, or other signs indicating excessive section loss, or imminent loss of the system's functionality, the effected parts should be identified as having inadequate structural integrity (see examples below).

If significant visual signs of advanced corrosion exist, such as rust build up, pitting, rust flakes, etc., but a visible hole or tear is not present, several thickness measurements should be taken in the suspected region to verify integrity of the system.

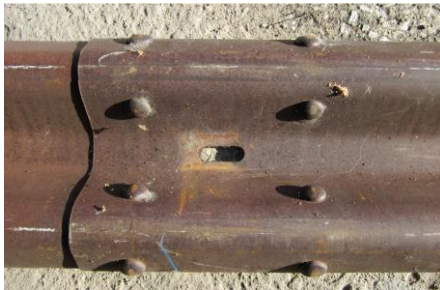
Mark spot 1: Traffic side splice bolt

Mark splice bolt locations at which rail thickness was measured in the figures below. Do not select same bolt for traffic and field sides)

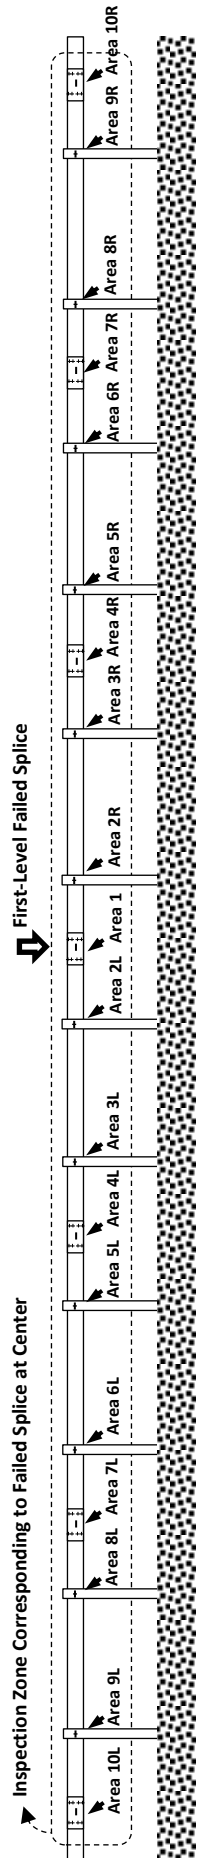
Inspection zone comprises three splices left and right of the splice or spot that failed in first-level inspection. Thickness readings are taken in regions marked as Area 1, Area 2L through Area 7L, and Area 2R through Area 7R in the figure on right.
