DEVELOPMENT AND EVALUATION OF A *MASH* TL-3 31-INCH W-BEAM MEDIAN BARRIER

Test Report 9-1002-12-8

TEXAS A&M TRANSPORTATION INSTITUTE
COLLEGE STATION, TEXAS

This project developed and evaluated a 31-inch tall W-beam median barrier that would meet the strength and safety performance criteria of *MASH* for TL-3 impact conditions.

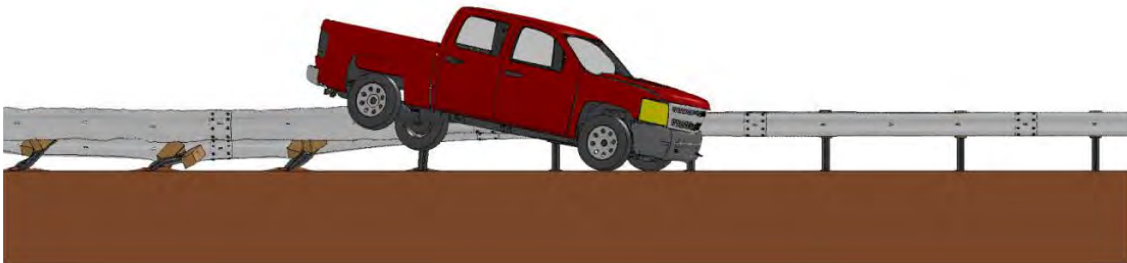
Figure 2.16. Silverado Model at Maximum Pitch for At-Post Impact.

TRAP was used to determine the maximum roll, pitch, and yaw, as well as the specific time the vehicle reached these values. Figure 2.15 shows the maximum roll at -9.1 degrees at 0.4822 s. The maximum pitch of the truck was -9.0 degrees at 0.6507 s, which is provided in Figure 2.16. Figure 2.17 shows the maximum yaw of the vehicle at 51.0 degrees at 0.6084 s.

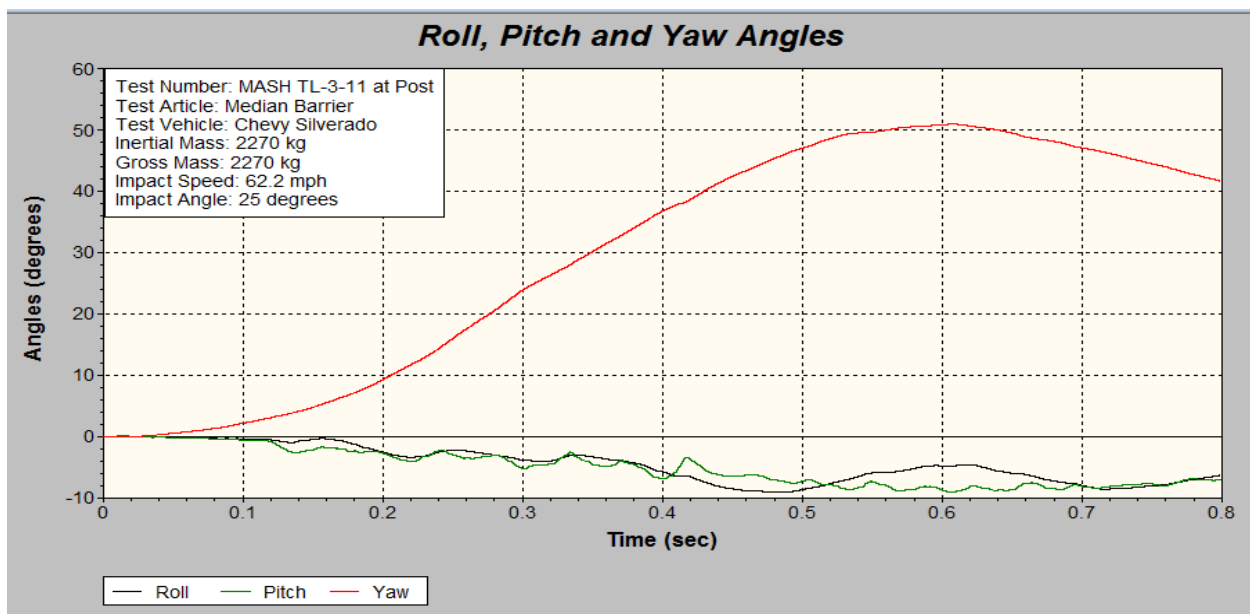
Figure 2.21. Roll, Pitch, and Yaw Angles for At-Post Impact.

Figure 2.21 provides the graph for angular displacements. A summary of results and sequential photos for this run are provided in Figure 2.22.

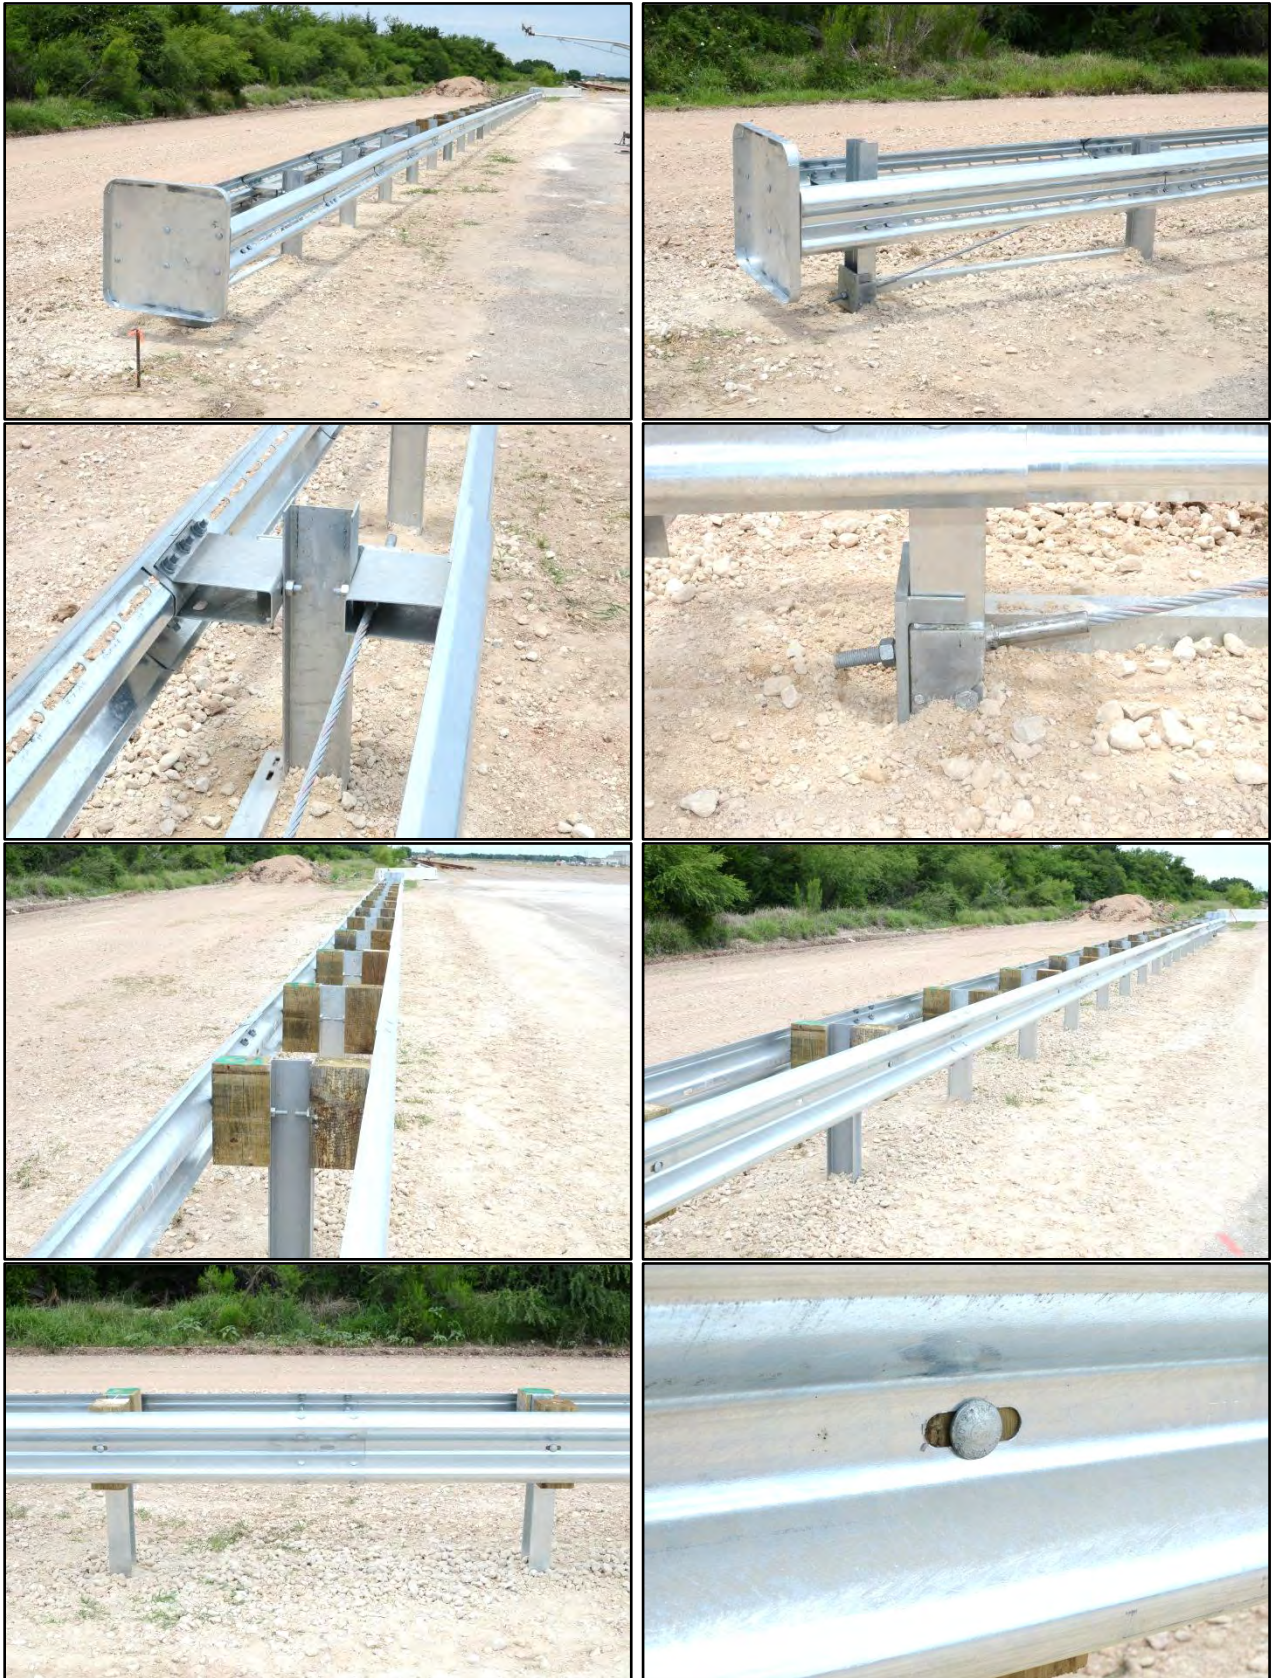
Figure 3.3. TxDOT 31-Inch W-Beam Median Barrier before Testing.

Figures 3.1 and 3.2 provide a layout and cross-section of the TxDOT 31-inch W-Beam Median Barrier. Photographs of the completed installation are shown in Figure 3.3. Appendix A presents more detailed information on the barrier.

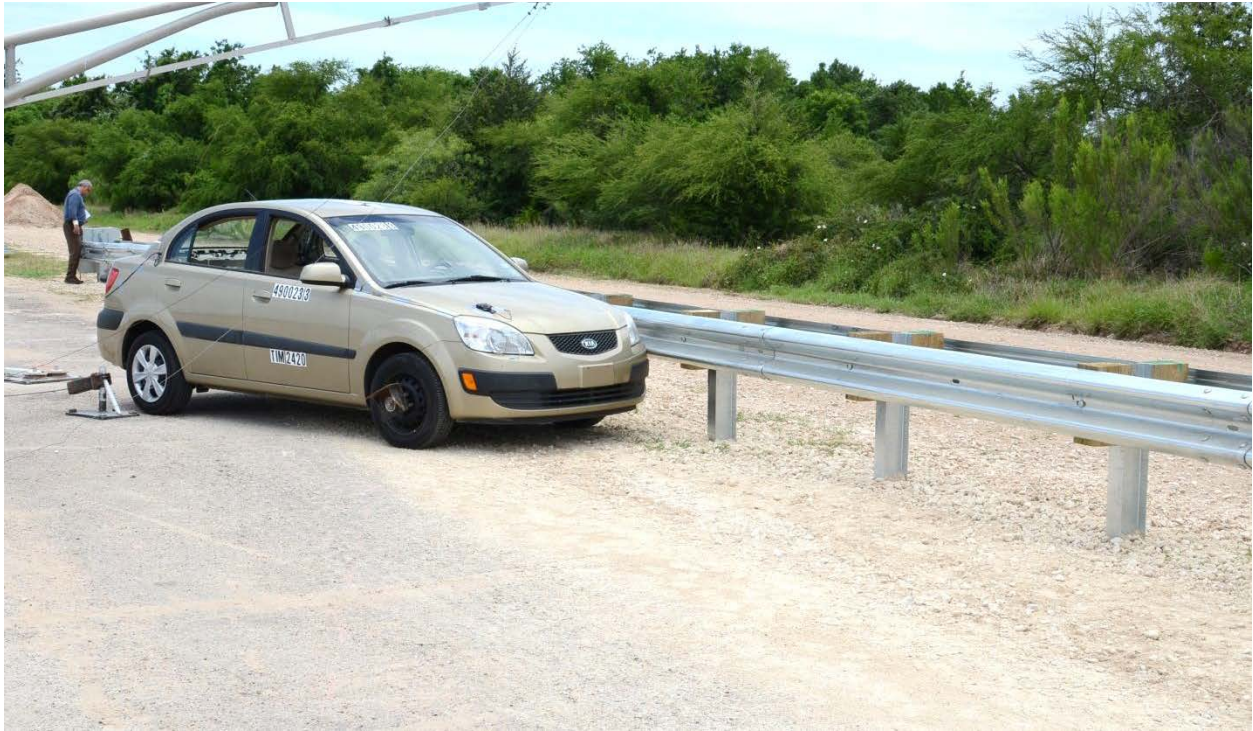
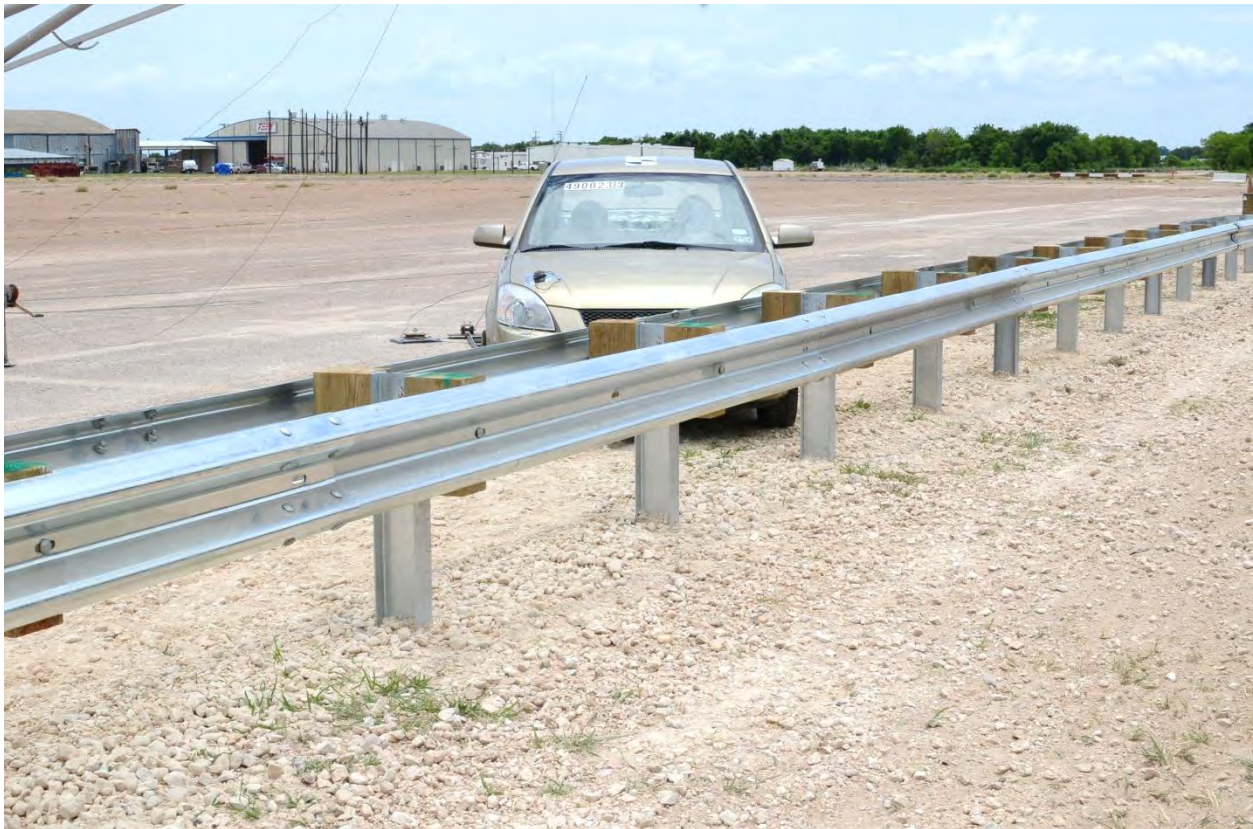
Figure 6.1. Vehicle/Installation Geometrics for Test No. 490023-3.

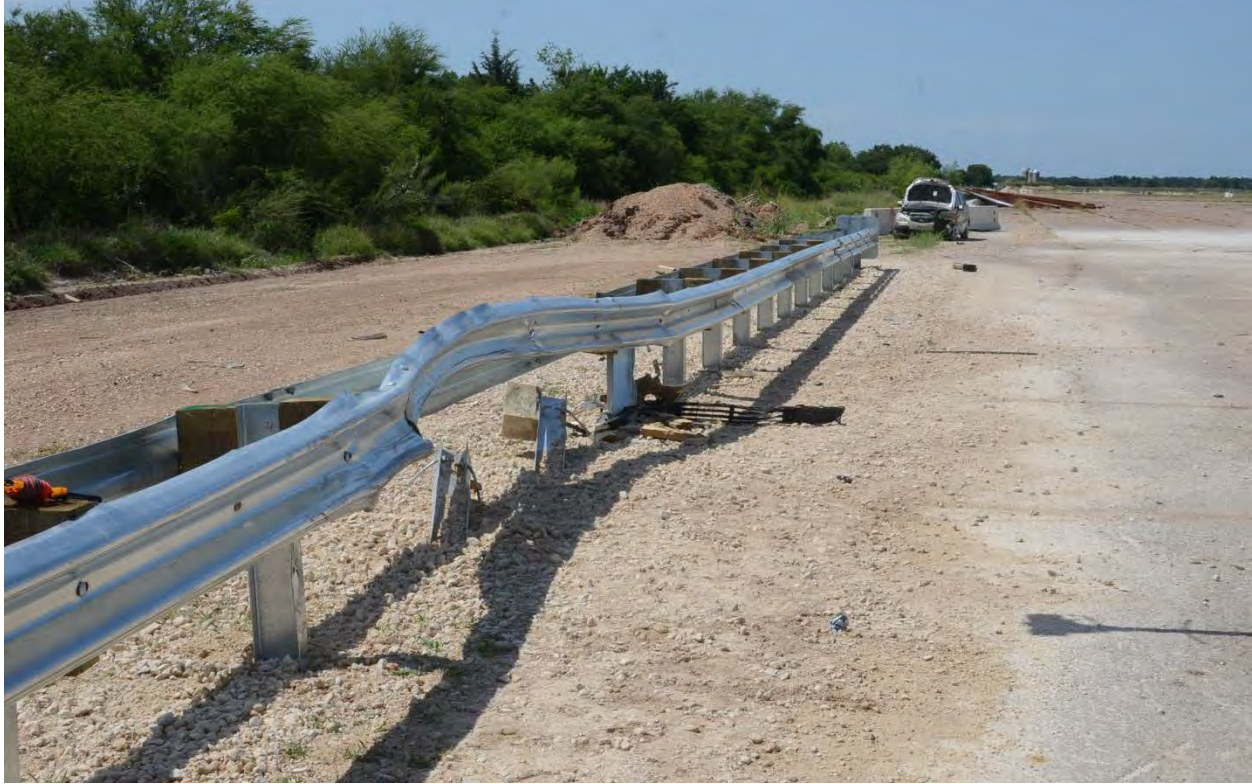
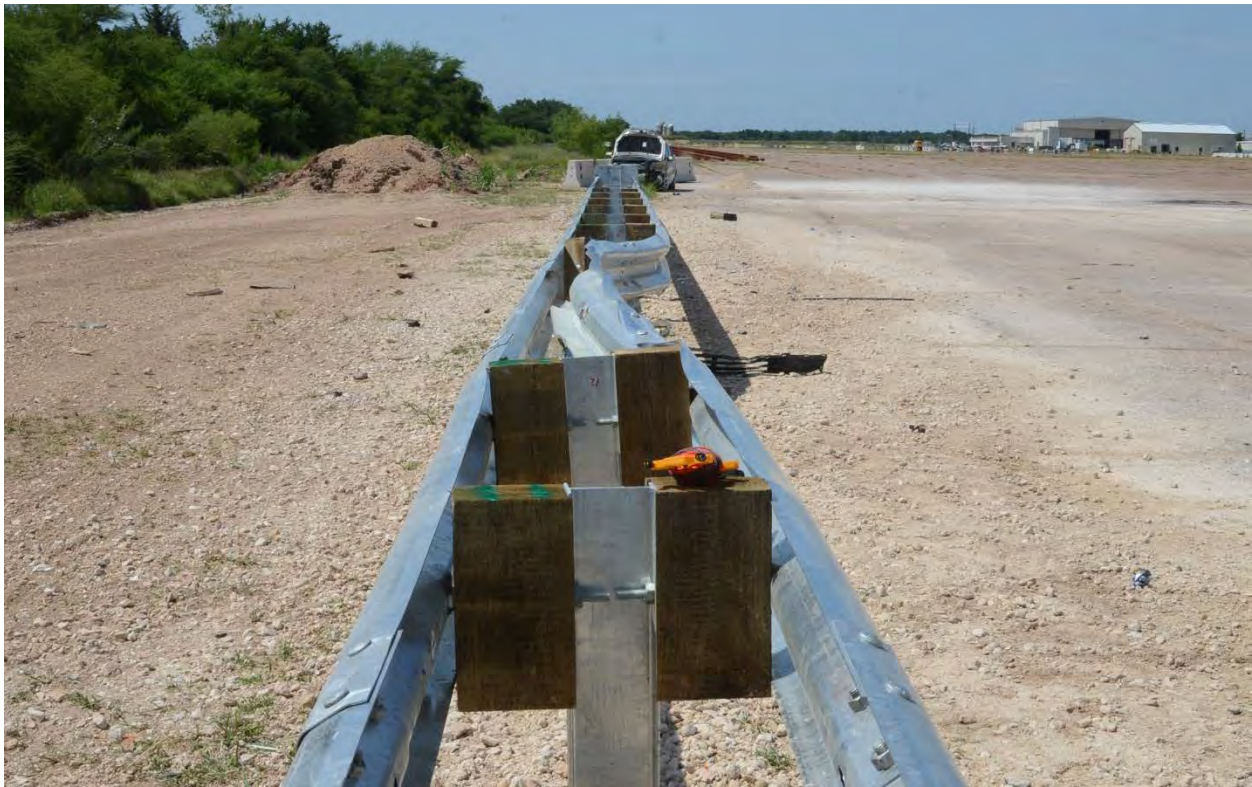
Figure 6.3. Vehicle/Installation Positions after Test No. 490023-3.

Figures 6.3 and 6.4 show damage to the TxDOT 31-inch W-Beam Median Barrier. No apparent movement was noted at post 1 or post 26 (the end posts). Post 11 and 12 were displaced through the soil toward the side opposite impact 0.25 inch and 1.75 inches, respectively. Posts 13 and 14 were leaning 70 degrees toward the side opposite impact and the rail element on the impact side separated from the posts. Both blockouts at post 13 separated from the post and the blockout on the side opposite impact separated from post 14. Post 15 rotated 45 degrees in the soil, the blockout on impact side separated from the post, and both rail elements separated from the post. The rail element on the impact side ruptured upward two-thirds of the width of the rail element at the upstream bolts on the splice between posts 12 and 13. The length of contact of the 1100C vehicle with the rail was 22.0 ft. Maximum permanent deformation of the rail was 20.25 inches between posts 13 and 14.

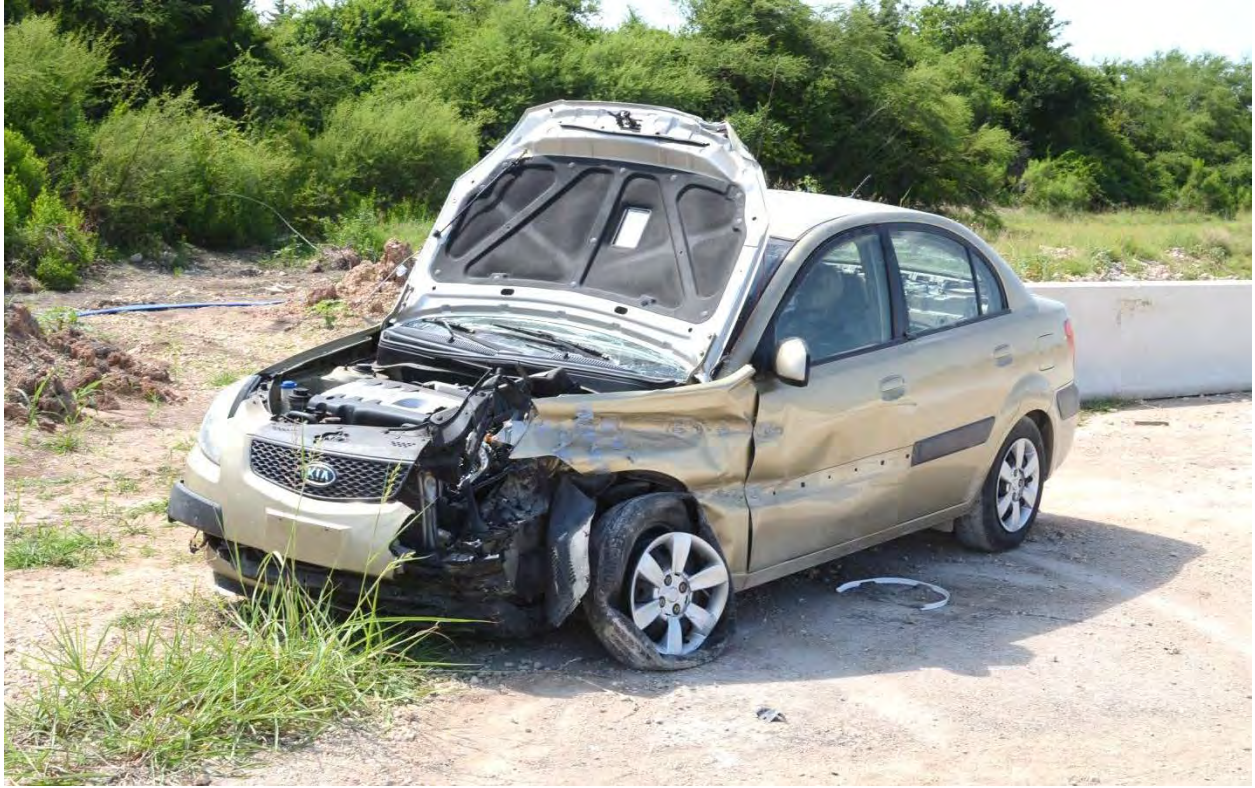
Figure 6.5. Vehicle after Test No. 490023-3.

Figure 6.5 shows damage to the 1100C vehicle. The front bumper, hood, radiator and support, left front strut and tower, left front tire and wheel rim, left front fender, and left front door were damaged. The hood was pushed into the windshield, which shattered the lower portion of the windshield. Maximum exterior crush to the 1100C vehicle was 13.0 inches in the side plane at the left front corner just above bumper height. No occupant compartment deformation was noted. Figure 6.6 provides photographs of the interior of the vehicle, and Tables D1 and D2 provide exterior and occupant compartment measurements.

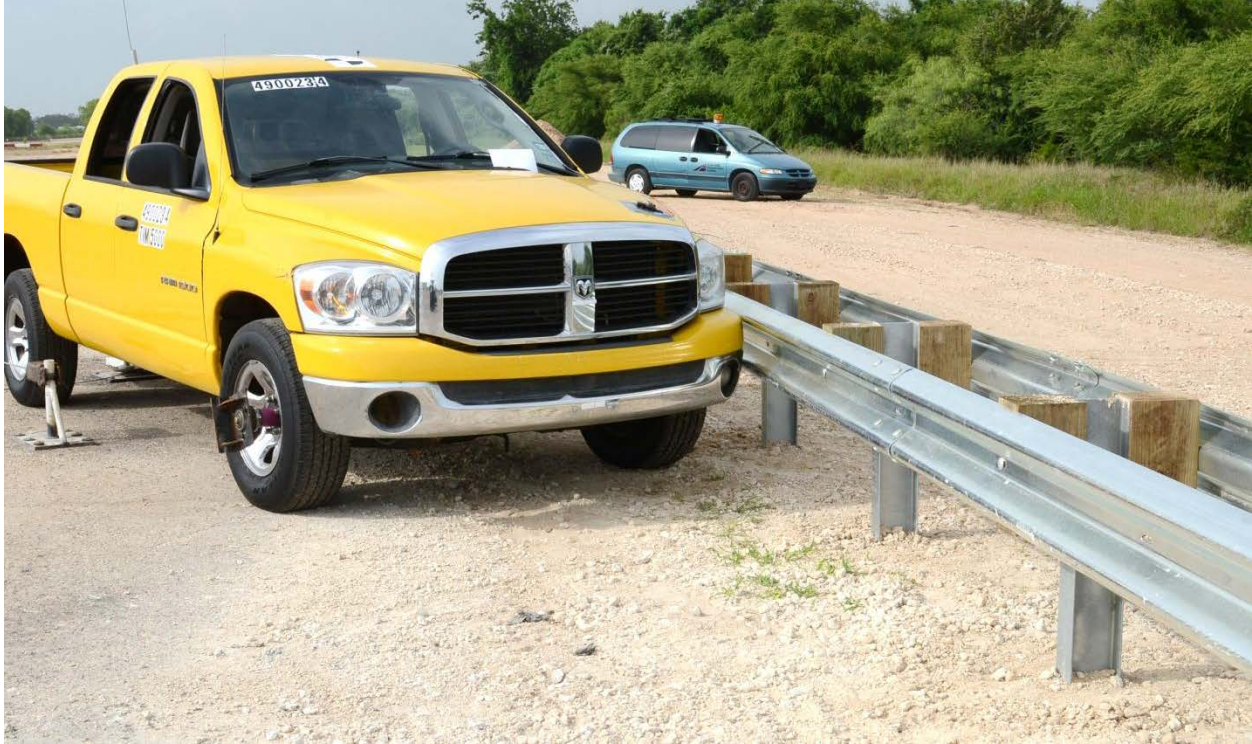
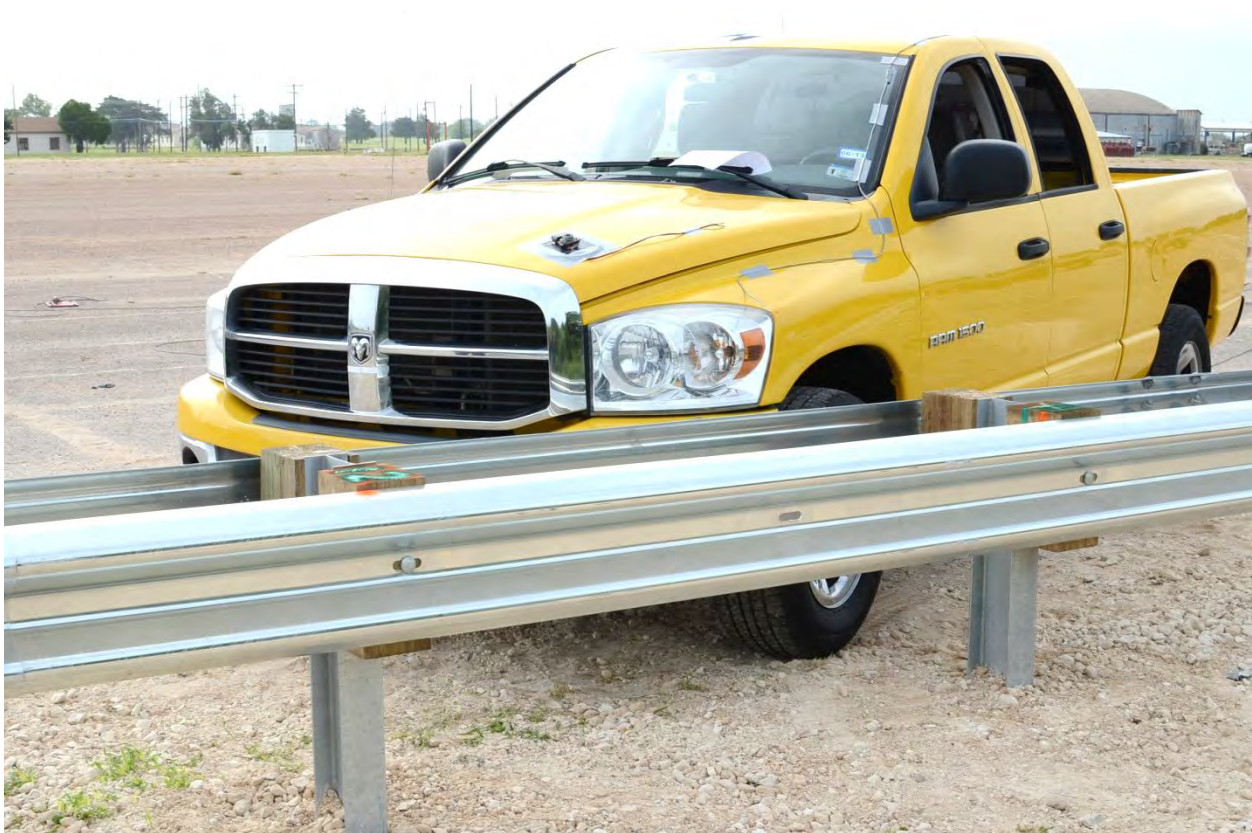
Figure 7.1. Vehicle/Installation Geometrics for Test No. 490023-4.

A 2007 Dodge Ram 1500 pickup truck, shown in Figures 7.1 and 7.2, was used for the crash test. Test inertia weight of the vehicle was 5014 lb, and its gross static weight was 5017 lb. The height to the lower edge of the vehicle bumper was 15.50 inches, and it was 28.00 inches to the upper edge of the bumper. The height to the vehicle's center of gravity was 28.50 inches. Tables E1 and E2 in Appendix E give additional dimensions and information on the vehicle. The vehicle was directed into the installation using the cable reverse tow and guidance system, and was released to be free-wheeling and unrestrained just prior to impact.

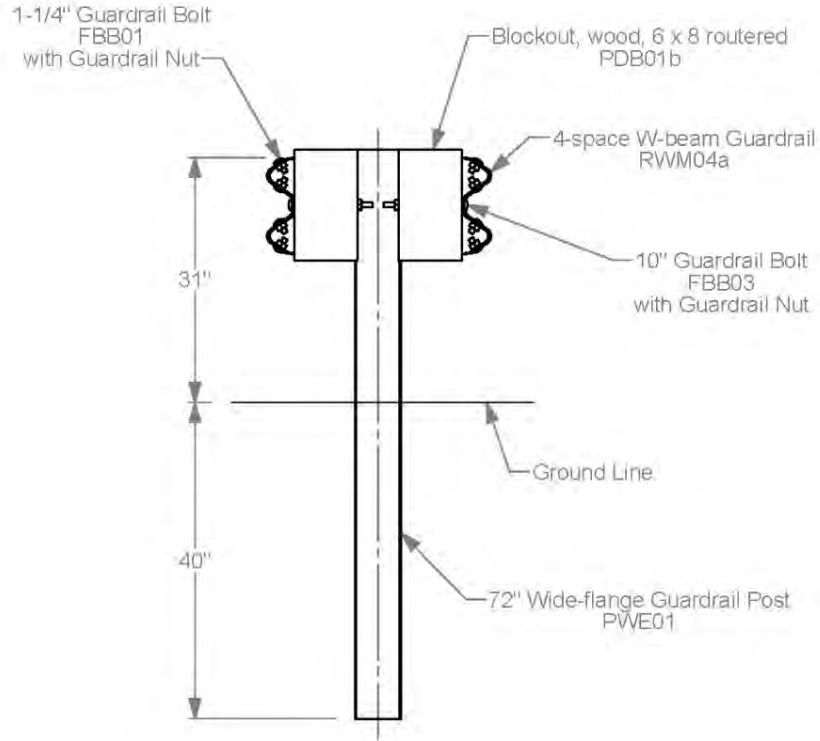
SECTION B-B
SCALE 1 : 20
TYP at Posts 6 - 21

Project 490023-3	31" Median Rail	2013-06-11
Drawn By GES	Scale:1:150	Sheet 2 of 2 Length of Need

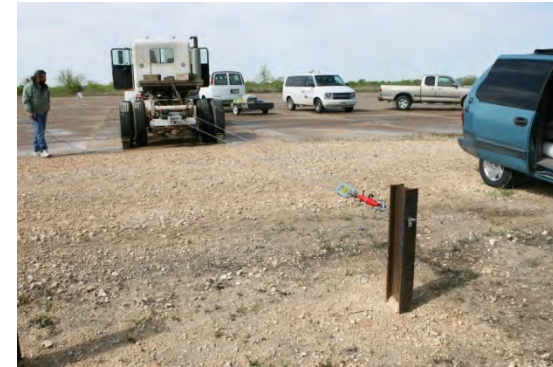
Static Load Setup

Table C2. Test Day Static Soil Strength Documentation for Test No. 490023-4.

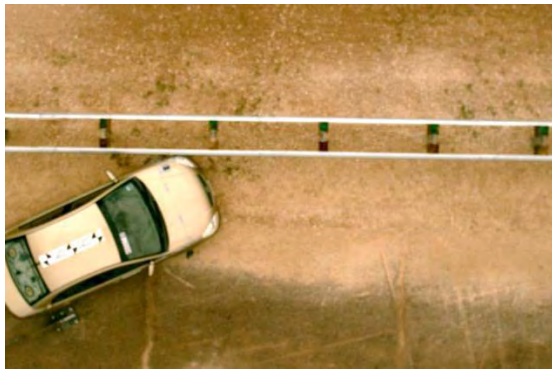
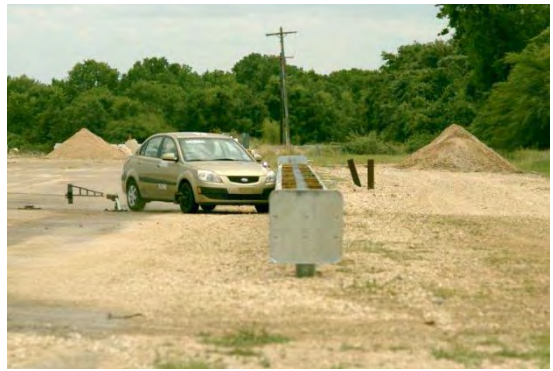
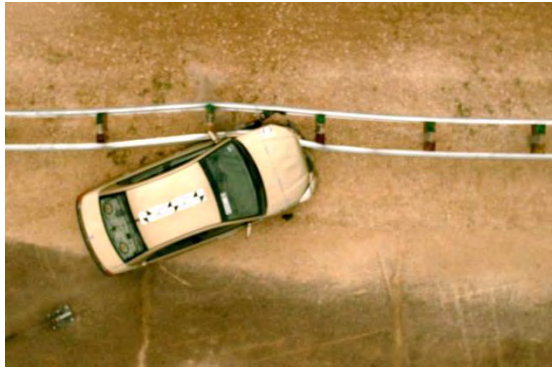
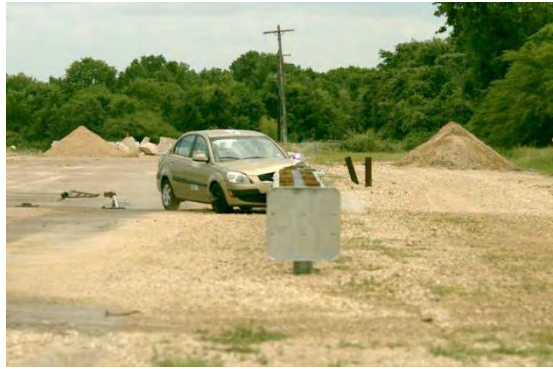
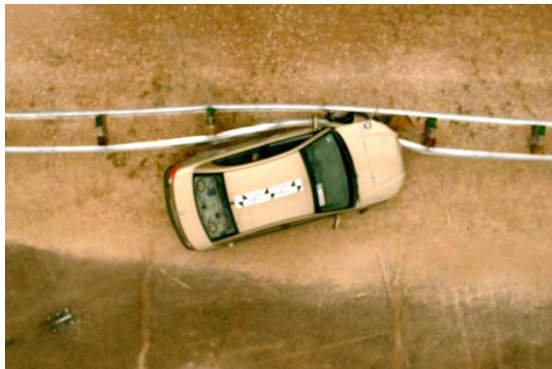
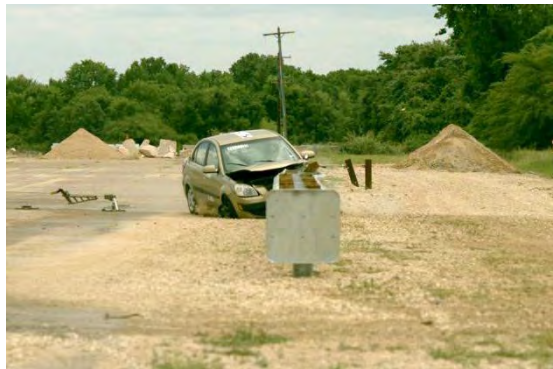
Figure D1. Sequential Photographs for Test No. 490023-3 (Overhead and Frontal Views).

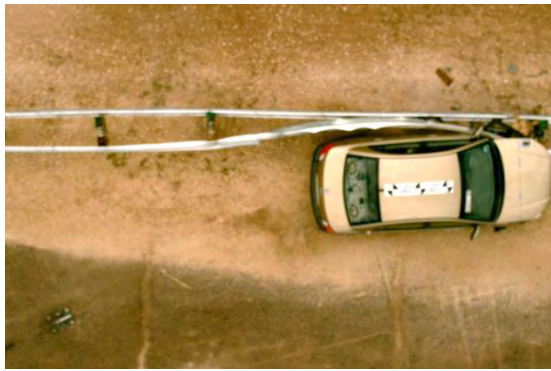
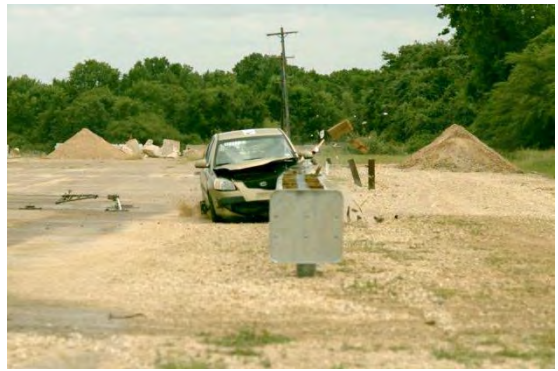
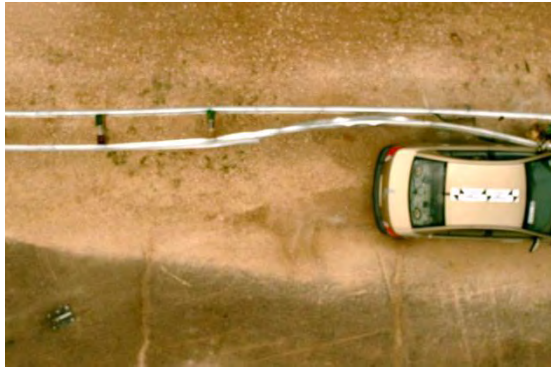
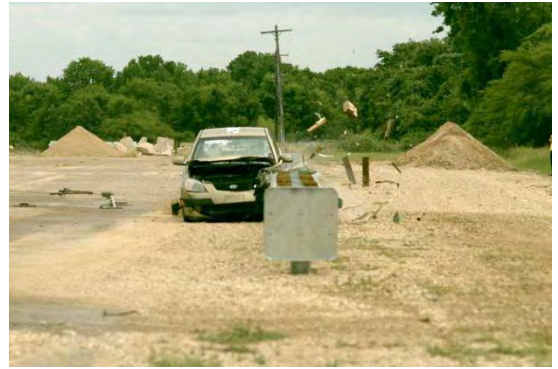
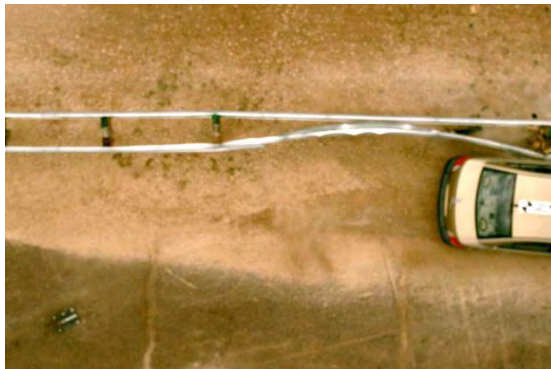
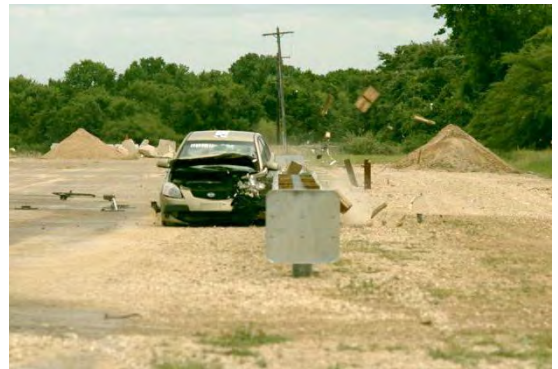
Figure D1. Sequential Photographs for Test No. 490023-3 (Overhead and Frontal Views) (continued).

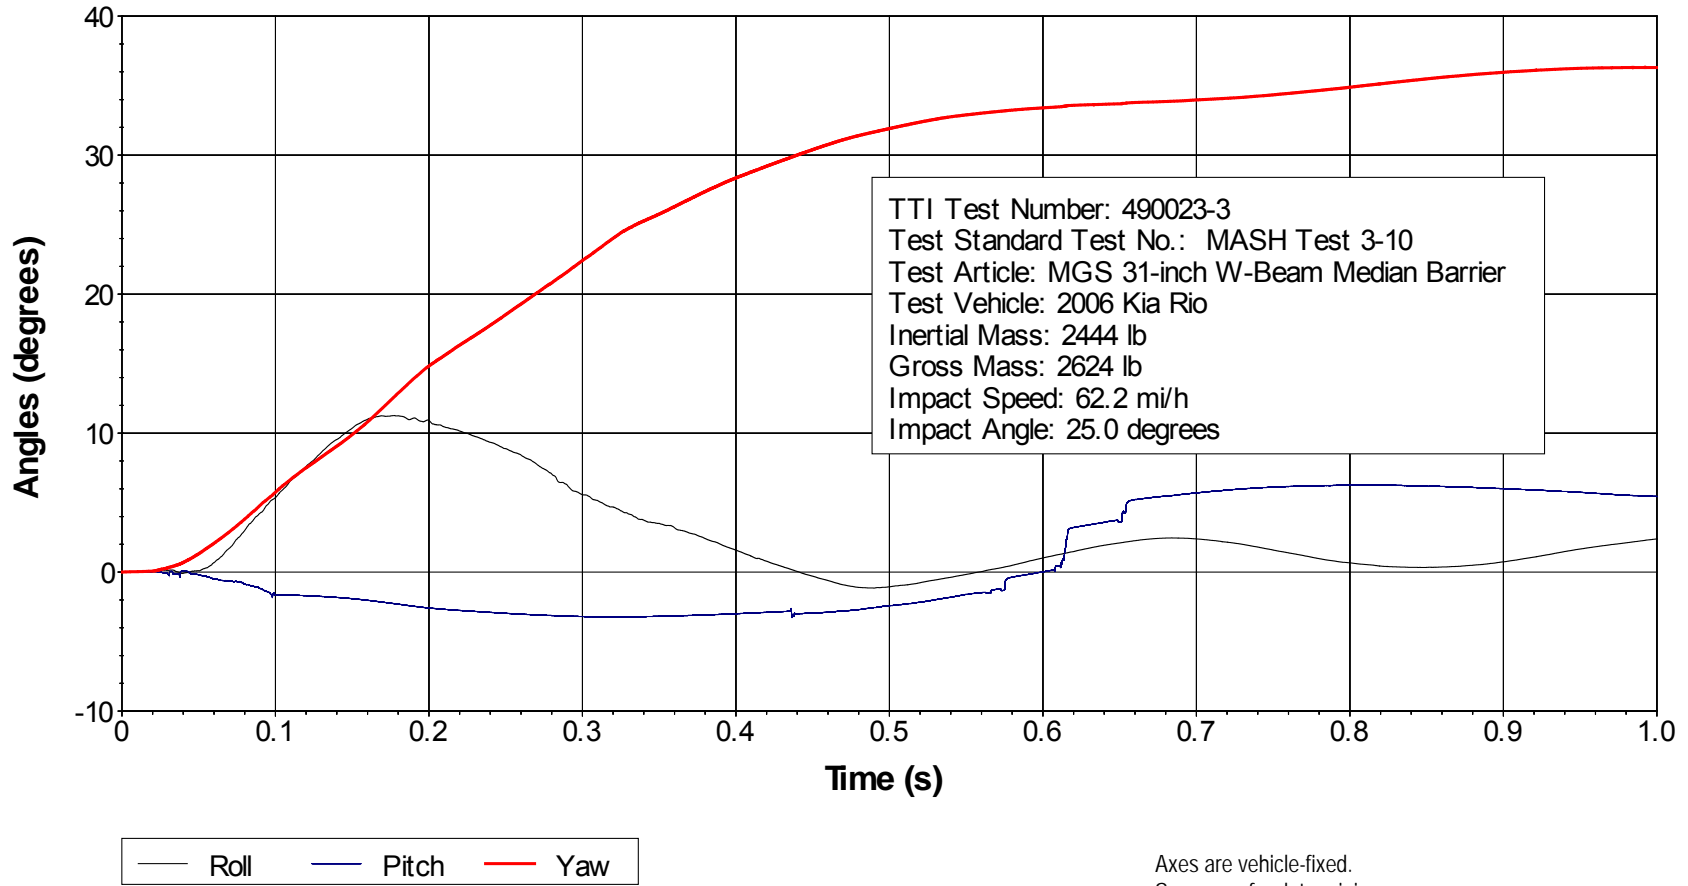
Figure D3. Vehicle Angular Displacements for Test No. 490023-3.

Roll, Pitch, and Yaw Angles

Axes are vehicle-fixed.
Sequence for determining orientation:

1. Yaw.
2. Pitch.
3. Roll.

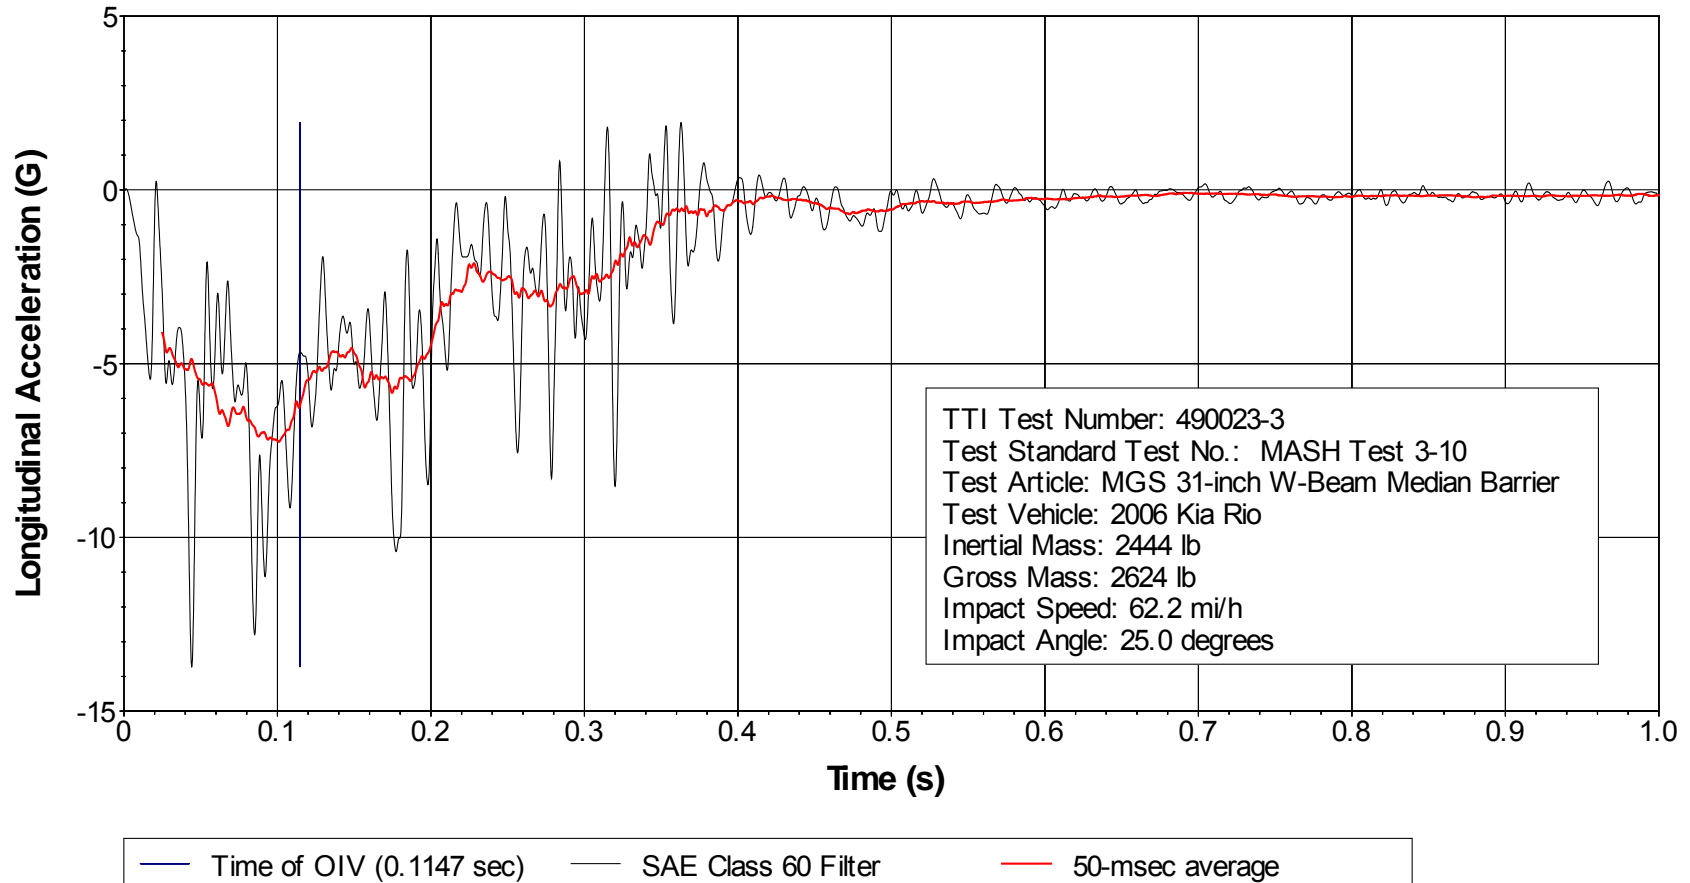
Figure D4. Vehicle Longitudinal Accelerometer Trace for Test No. 490023-3 (Accelerometer Located at Center of Gravity).

X Acceleration at CG

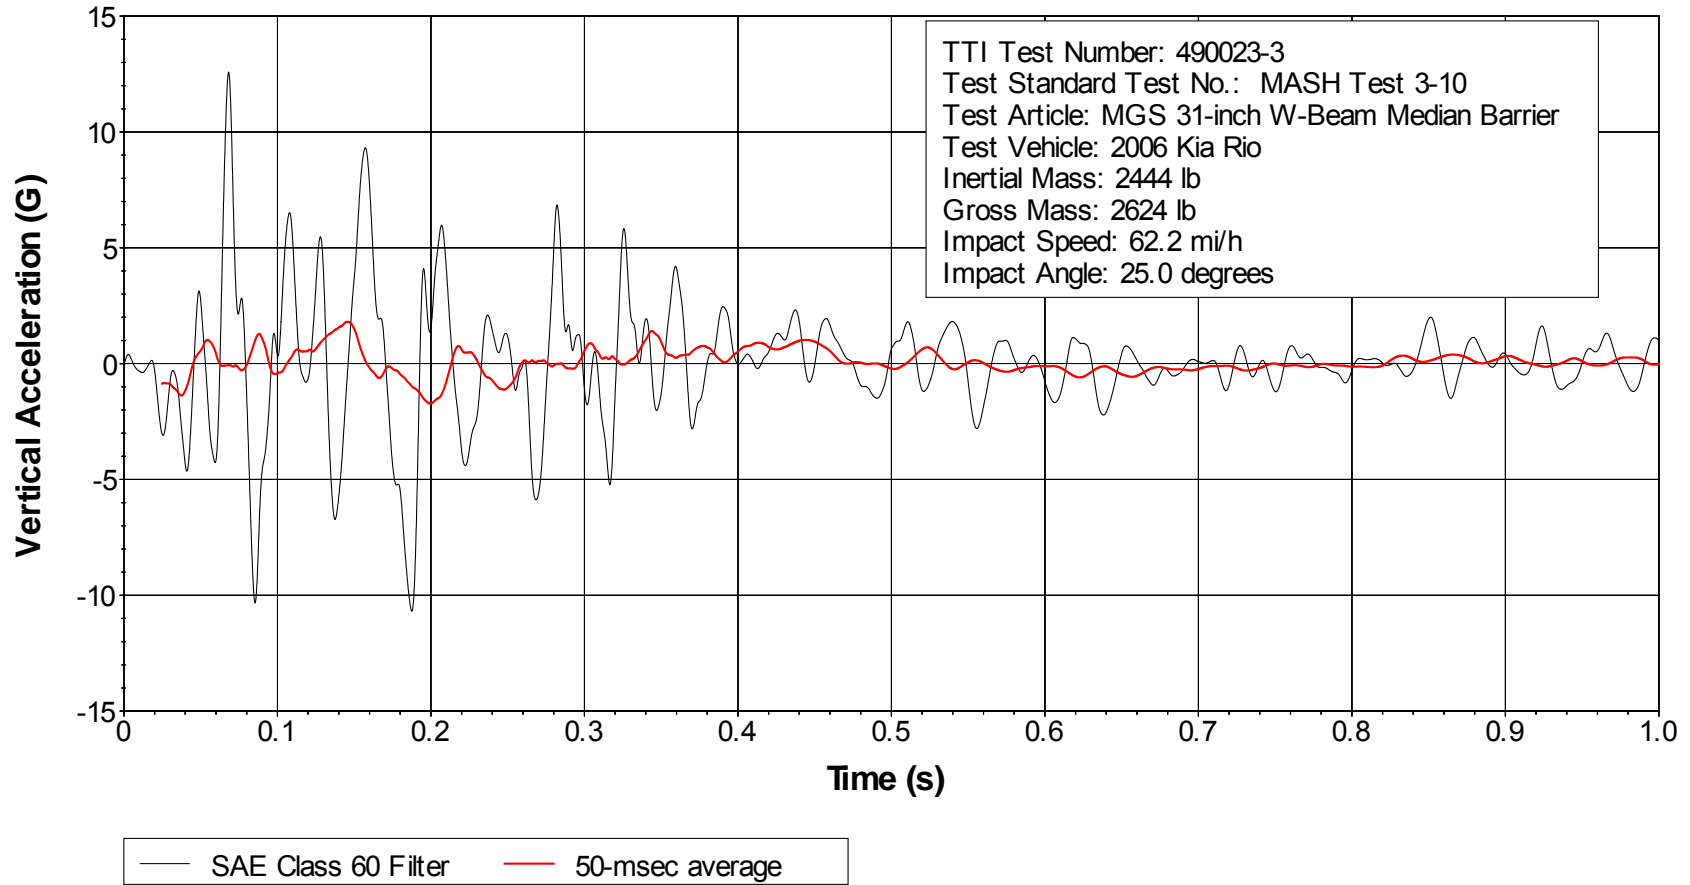
Figure D9. Vehicle Vertical Accelerometer Trace for Test No. 490023-3 (Accelerometer Located Rear of Center of Gravity).

Z Acceleration Rear of CG

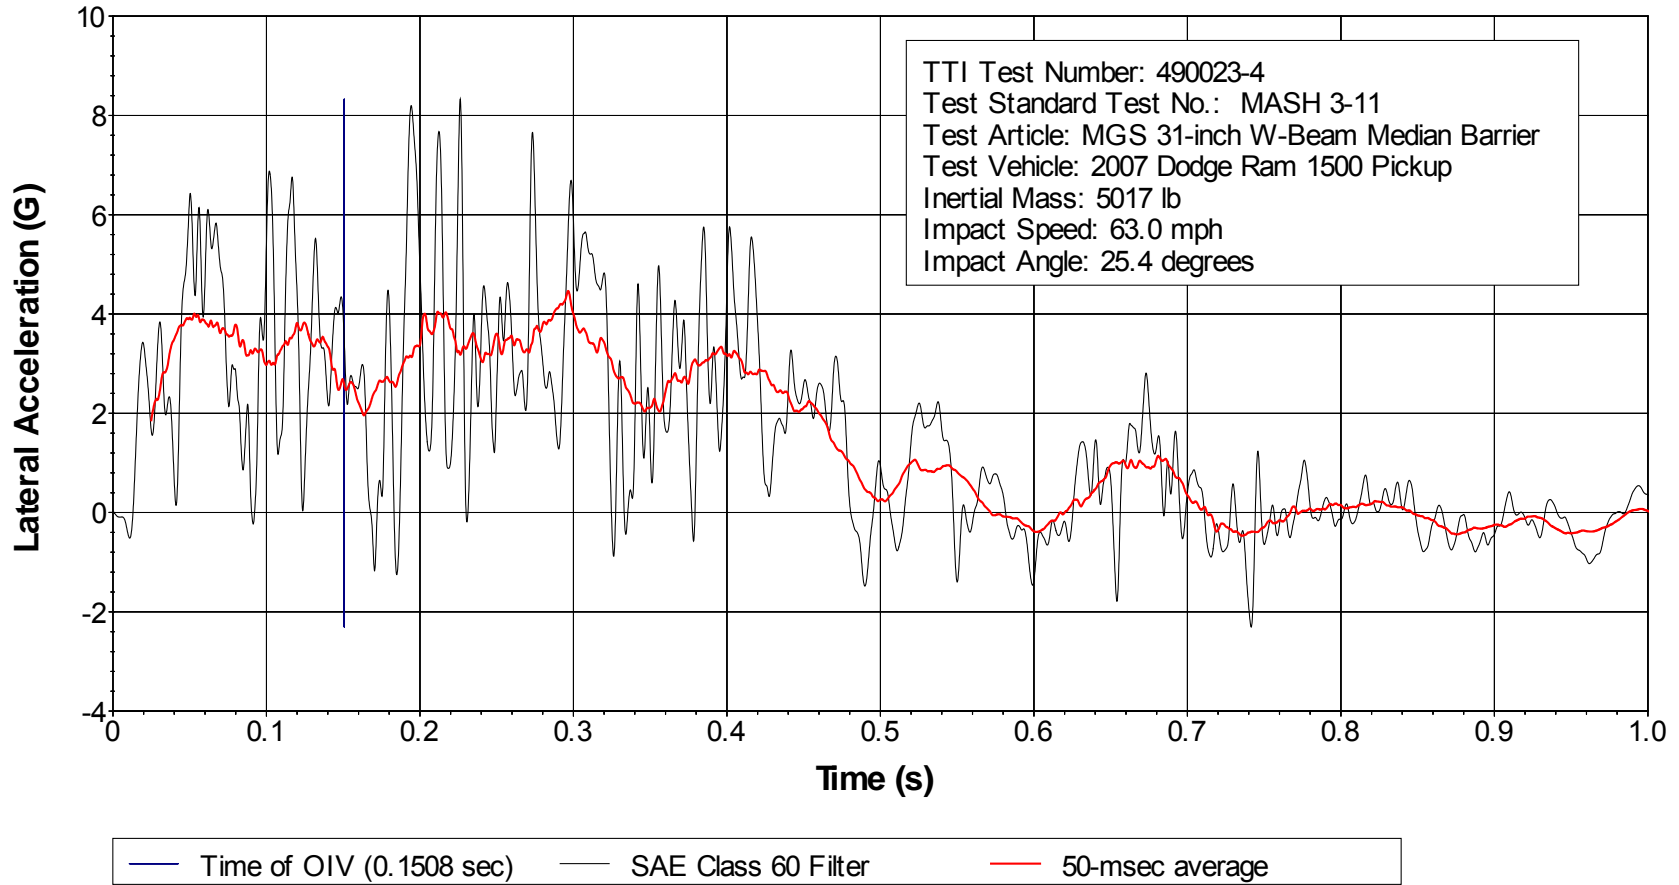
Y Acceleration at CG

Figure E5. Vehicle Lateral Accelerometer Trace for Test No. 490023-4 (Accelerometer Located at Center of Gravity).

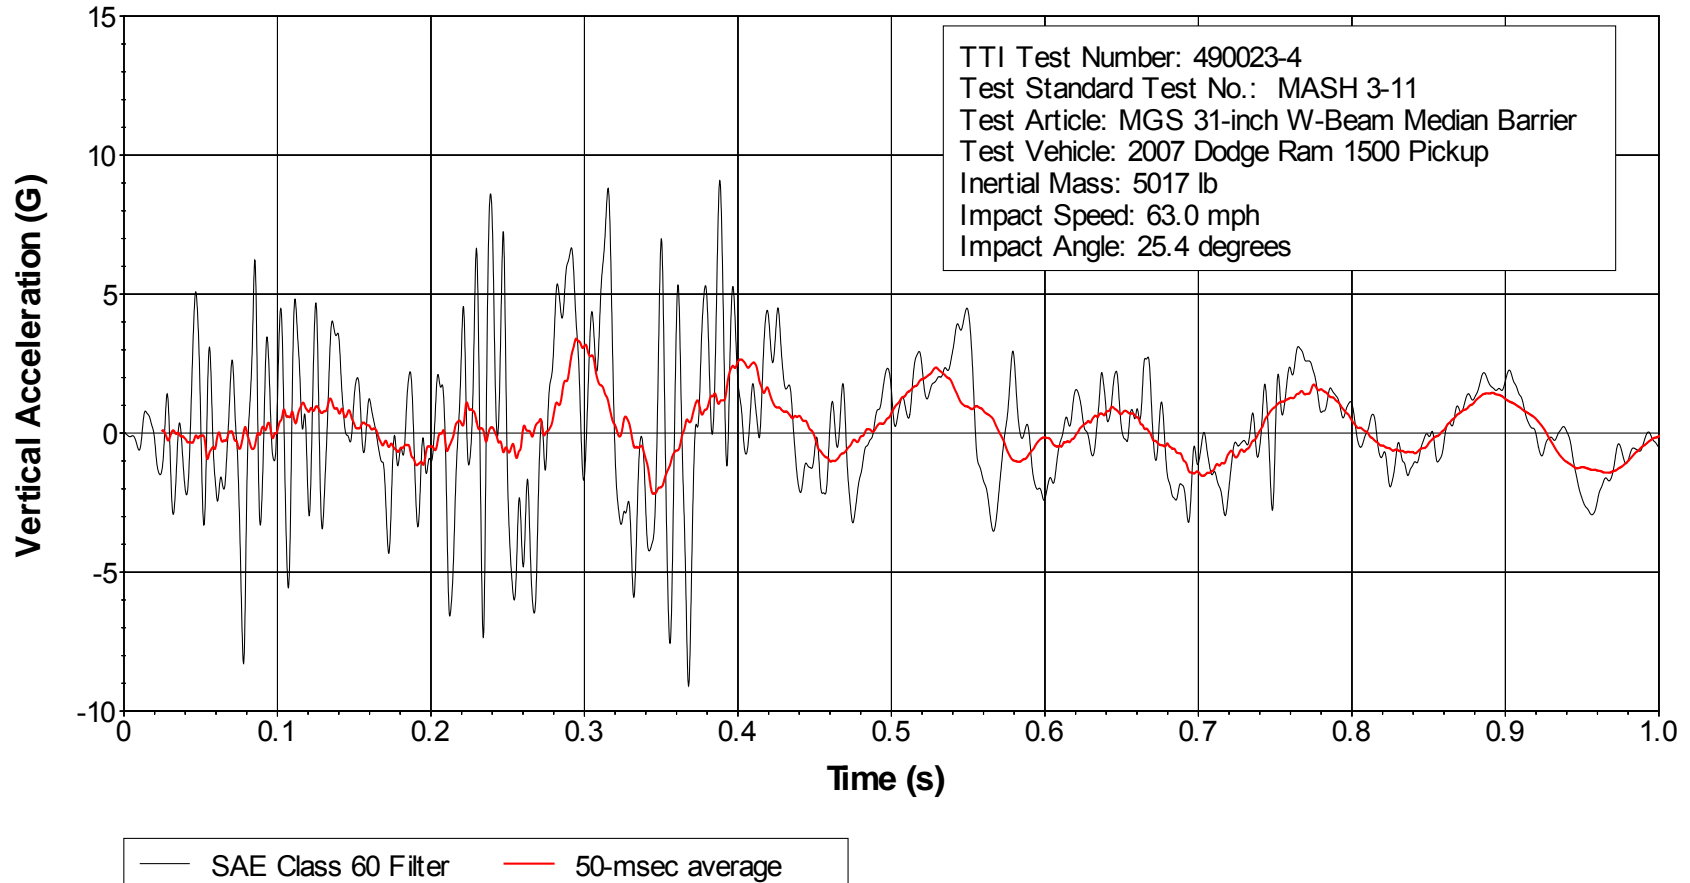
Z Acceleration at CG

Figure E6. Vehicle Vertical Accelerometer Trace for Test No. 490023-4 (Accelerometer Located at Center of Gravity).
