DEVELOPMENT AND EVALUATION OF A *MASH* TL-3 31-INCH W-BEAM MEDIAN BARRIER

Test Report 9-1002-12-8

TEXAS A&M TRANSPORTATION INSTITUTE
COLLEGE STATION, TEXAS

This project developed and evaluated a 31-inch tall W-beam median barrier that would meet the strength and safety performance criteria of *MASH* for TL-3 impact conditions.

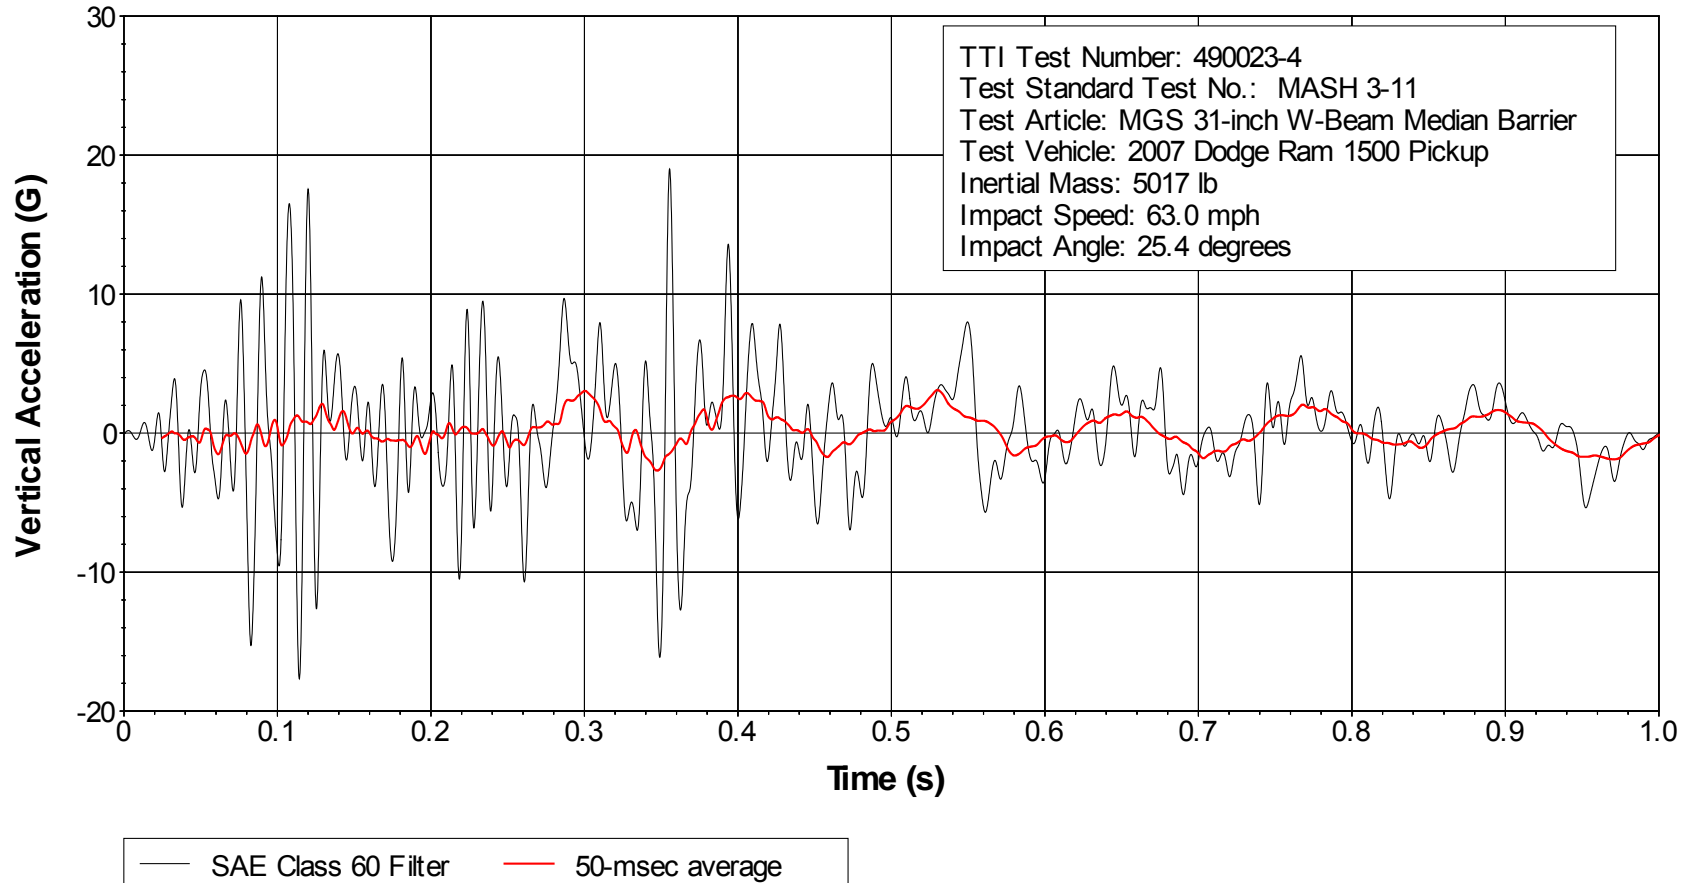
Z Acceleration Rear of CG

Figure E9. Vehicle Vertical Accelerometer Trace for Test No. 490023-4 (Accelerometer Located Rear of Center of Gravity).
