U.S. Department
of Transportation

**Federal Highway
Administration**

June 15, 2017

- Brifen MASH Terminal

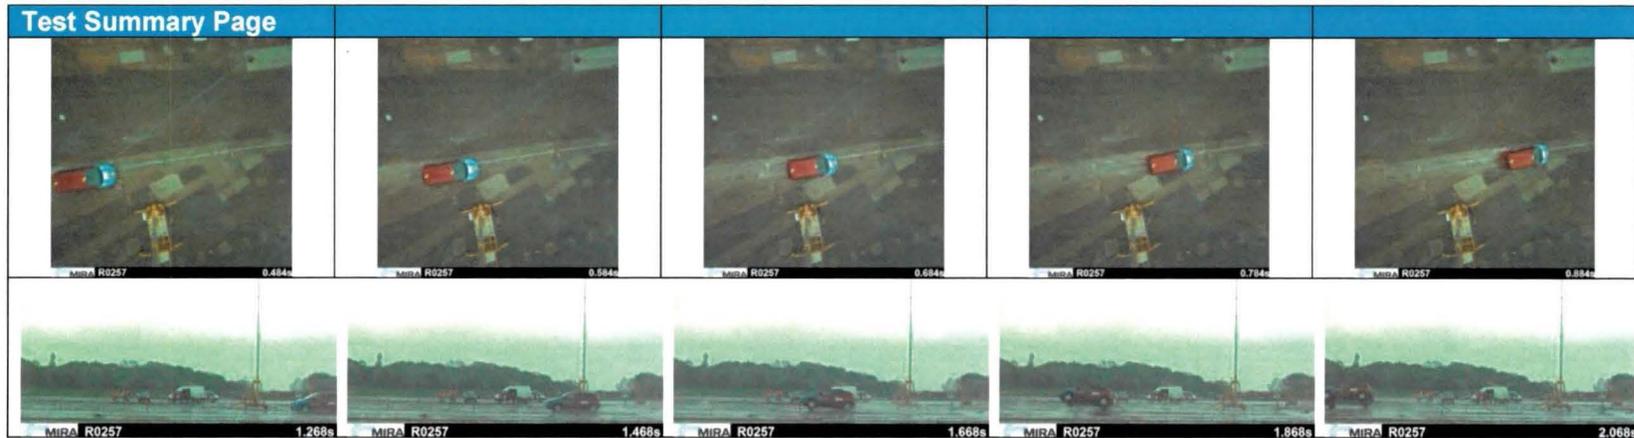
4. General Information		10. Post-Impact Trajectory	
Test Agency	HORIBA MIRA Ltd	Vehicle Stability	Satisfactory
Test no.	R0257	Stopping distance ft. (m)	241 (73.5) downstream 56 (17) laterally
Test Date	10 th May 2016	11. Occupant Risk Values

5. Test Article		Impact Velocity ft./s (m/s)	X-direction
Type	Wire Rope Terminal		Y-direction
Installation Length, ft. (m)	36.75 (11.2) Terminal + 178 (54.4) full height system + 21 (6.4) departing end anchor	THIV (optional), mph (km/h)	5.8 (9.4) @ 443.7ms
Size and/or dimension and material key elements, in. (mm)	Posts: 2.875 OD x 0.134 (76.1 x 3.0) x 28.15 (715), 39.39 (695), 50 (1270) Galvanised steel wire rope: 0.75 (19) dia, 3 x 7 (6 x 1) construction	Occupant Ride down Acceleration (g)	X-direction 8 @ 1258.0ms Y-direction 6 @ 1208.0ms

6. Soil Conditions, in. (mm)		PHD (g) (optional)	8.2 @ 1258.0ms
12 (305) deep steel sockets cast in continuous concrete bed		ASI (optional)	0.3 @ 1254.0ms

7. Test Vehicle		12. Test Article Damage	
Designation	1100C Small Car	Post 1 to 17 heavily bent. Post 18 to 21 slightly bent. Ropes and ground anchor not damaged.	
Make / Model	Nissan Note	13. Test Article Deflections	
Mass, lb (kg)	2338 (1060.5)	Dynamic, in. (m)	n/a
Kerb	2428 (1101.5)	Permanent Set, in. (m)	n/a
Test Inertial	2600 (1179.5)	Working Width, in. (m)	n/a
Gross Static		14. Vehicle Damage

8. Impact Conditions		Front bumper destroyed, coolant pack holder detached, radiator damaged, headlight smashed, n/s doors and sill damaged, n/s/f wheel pushed back. Dented oil sump and deformed lower front left wishbone arm. Scuffs and scratches along under side of car. 1 severed brake line.	
Speed, mile/h (km/h)	61 (98.3)		
Angle (deg)	0.2		
Location	Start of terminal, parallel with roadway, quarter offset to road side

9. Exit Conditions			
Speed, mile/h (km/h)	25 (40.2)		
Angle (deg)	24.9		
Exit Box	n/a

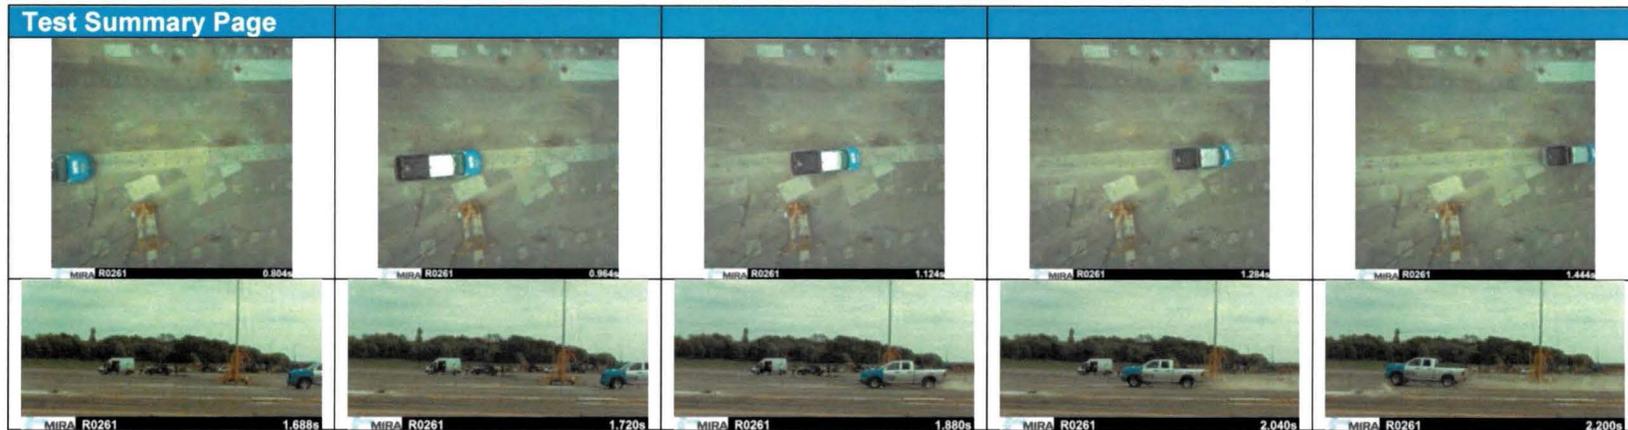
4. General Information		10. Post-Impact Trajectory		
Test Agency	HORIBA MIRA Ltd	Vehicle Stability	Satisfactory	
Test no.	R0261	Stopping distance, ft. (m)	310 (94.4) downstream 9 (2.8) laterally	
Test Date	13 th May 2016	11. Occupant Risk Values

5. Test Article		Impact Velocity, ft./s (m/s)	X-direction	7.2 (2.2) @ 504.1ms
Type	MASH Brifen Terminal		Y-direction	0.3 (0.1) @ 34.4ms
Installation Length, ft. (m)	36.75 (11.2) Terminal + 178 (54.4) full height system + 21 (6.4) departing end anchor	THIV (optional), mile/h (km/h)		5.8 (9.4) @ 505.6ms
Size and/or dimension and material key elements, in. (mm)	Posts: 2.875 OD x 0.134 (76.1 x 3.0) x 28.15 (715), 39.39 (695), 50 (1270) Galvanised steel wire rope: 0.75 (19) dia, 3 x 7 (6 x 1) construction	Occupant Ride down Acceleration (g)	X-direction	2 @ 1798.0ms

6. Soil Conditions, in (mm)		PHD (g) (optional)	Y-direction	1 @ 3628.0ms
7. Test Vehicle		ASI (optional)	0.4 @ 3640.0ms	
Designation	2270P Pickup Truck	12. Test Article Damage		
Make / Model	Dodge Ram	IP anchor undamaged, all posts bent. Wire support tabs on deflection post broken off. Tabs on end support post bent/snapped.		
Mass, lb (kg)	Kerb 5108 (2317)	13. Test Article Deflections		
	Test Inertial 5054 (2292.5)	Dynamic, in. (m)	n/a	
	Gross Static 5054 (2292.5)	Permanent Set, in. (m)	n/a

8. Impact Conditions		Working Width, in. (m)	n/a	
Speed, mile/h (km/h)	62.7 (100.9)	14. Vehicle Damage		
Angle, (deg)	0.2	Front bumper/grill deformed heavily 100mm left from centreline. F/R tyre deflated. Radiator burst. Scrapes on underside.		
Location	0 degrees to end terminal, parallel to roadway

9. Exit Conditions				
Speed, mph (km/h)	n/a			
Angle, (deg)	n/a			
Exit Box	n/a

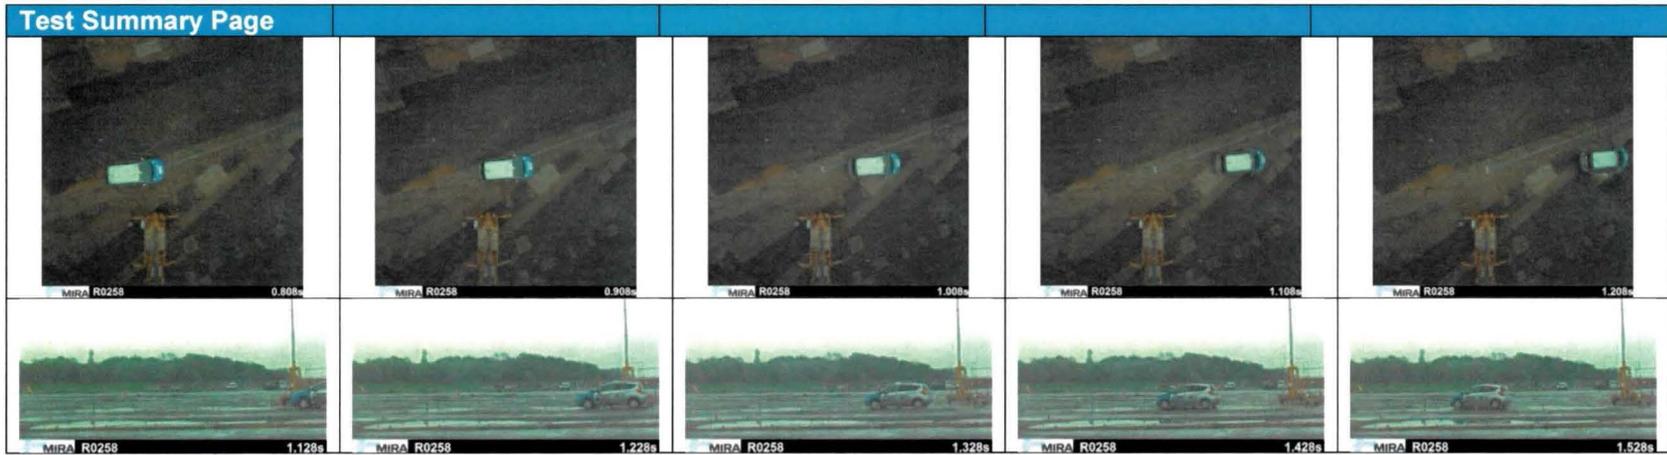
4. General Information		10. Post-Impact Trajectory	
Test Agency	HORIBA MIRA Ltd	Vehicle Stability	Satisfactory
Test no.	R0258	Stopping distance ft. (m)	273.3 (83.3) downstream 62 (18.9) laterally
Test date	11 th May 2016	Vehicle stopped using remote braking system.

5. Test Article		11. Occupant Risk Values	
Type	MASH Brifen Terminal	Impact Velocity, ft./s (m/s)	X-direction 1.15 (0.4) at 559.7ms
Installation Length, ft (m)	36.75 (11.2) Terminal + 178 (54.4) full height system + 21 (6.4) departing end anchor		Y-direction 0.00 (0.00) at 5.40ms
Size and/or dimension and material key elements, in (mm)	Posts: 2.875 OD x 0.134 (76.1 x 3.0) x 28.15 (715mm), 39.39 (695), 50 (1270) Galvanised steel wire rope: 0.75 (19) dia, 3 x 7 (6 x 1) construction	THIV (optional), mile/h (km/h)

2.1 (3.4) at 689.4ms	
6. Soil conditions, in (mm)		Occupant Ride down	X-direction 1 at 1387.0ms
7. Test Vehicle		Acceleration (g)	Y-direction 1 at 4480.0ms
Designation	1100C Small Car	PHD (g) (optional)	1.4 at 1387.0ms
Make / Model	Nissan Note	ASI (optional)	0.1 at -2819.0ms
Mass, lb (kg)	Kerb 2321.5 (1053)	12. Test Article Damage	
	Test Inertial 2425 (1100)	Top wire passed over the 2 nd post downstream from IP, coming to rest on the opposite side.	
	Gross Static 2597 (1178)	13. Test Article Deflections

8. Impact Conditions		Dynamic, in. (m)	n/a
Speed, mile/h (km/h)	62.1 (100)	Permanent Set, in. (m)	n/a
Angle (deg)	15.4	Working Width, in. (m)	n/a
Location	End/nose of terminal.	14. Vehicle Damage

9. Exit Conditions		No damage.	
Speed, mile/h (km/h)	n/a		
Angle (deg)	n/a		
Exit Box	n/a

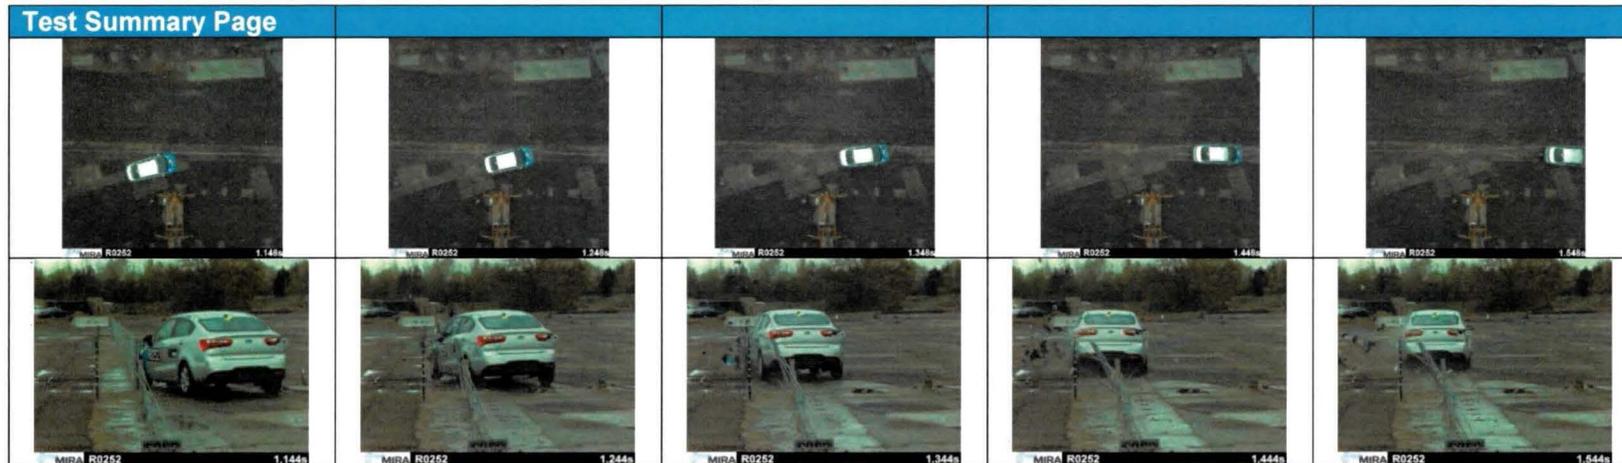
4. General Information		10. Post-Impact Trajectory	
Test Agency	HORIBA MIRA Ltd	Vehicle Stability	Satisfactory
Test no.	R0252	Stopping distance ft. (m)	252.9 (77.1) downstream 7.2 (2.2) laterally
Test date	25/04/2016	Vehicle redirected but then turned back in to barrier and redirected again

5. Test Article		11. Occupant Risk Values	
Type	MASH Brifen Terminal Wire Rope Terminal	Impact Velocity, ft/s (m/s)	X-direction 6.9 (2.1) at 153.8ms Y-direction 12.8 (-3.9) at 150.7ms
Installation Length, ft. (m)	36.75 (11.2) Terminal + 178 (54.4) full height system + 21 (6.4) departing end anchor	THIV (optional), mph (km/h)	9.8 (15.8) at 166ms
Size and/or dimension and material key elements, in. (mm)	Posts: 2.875 OD x 0.134 (76.1 x 3.0) x 28.15 (715), 39.39 (695), 50 (1270) Galvanised steel wire rope: 0.75 (19) dia, 3 x 7 (6 x 1) construction	Occupant Ride down Acceleration (g)	X-direction 6 at 391.2ms Y-direction -8 at 177ms

6. Soil conditions, in. (mm)		PHD (g) (optional)	7.7 at 176.2ms
7. Test Vehicle		ASI (optional)	0.4 at 176.4ms
Designation	1100C Small Car	12. Test Article Damage	
Make / Model	Kia Rio (USA Spec)	The deflection post and all posts up to and including DP+5 were bent to the ground. DP+12, +13 and +14 were also bent to the ground. The end anchors were undamaged and all of the wires were in-tact.	
Mass, lb (kg)	Kerb 2535 (1150)	13. Test Article Deflections	
Test Inertial	2521 (1143.5)	Dynamic, in. (m)	35.5, (0.9)
Gross Static	2655 (1200)	Permanent Set, in. (m)	15.75, (0.4)

8. Impact Conditions		Working Width, in. (m)	35.5, (0.9) at 27.6 (0.7) above ground
Speed, mile/h (km/h)	62.6 (100.7)	14. Vehicle Damage	
Angle (deg)	15.3	Front bumper smashed, n/s/f wheel/susp. Pushed back. Gearbox & sub frame damaged. Driver airbag deployed.	
Location	Critical impact point

9. Exit Conditions			
Speed, mile/h (km/h)	49.7 (80) at post #9 (19.2m downstream of impact)		
Angle (deg)	2.9 degrees (after post #9)		
Exit Box	Vehicle remained within exit box

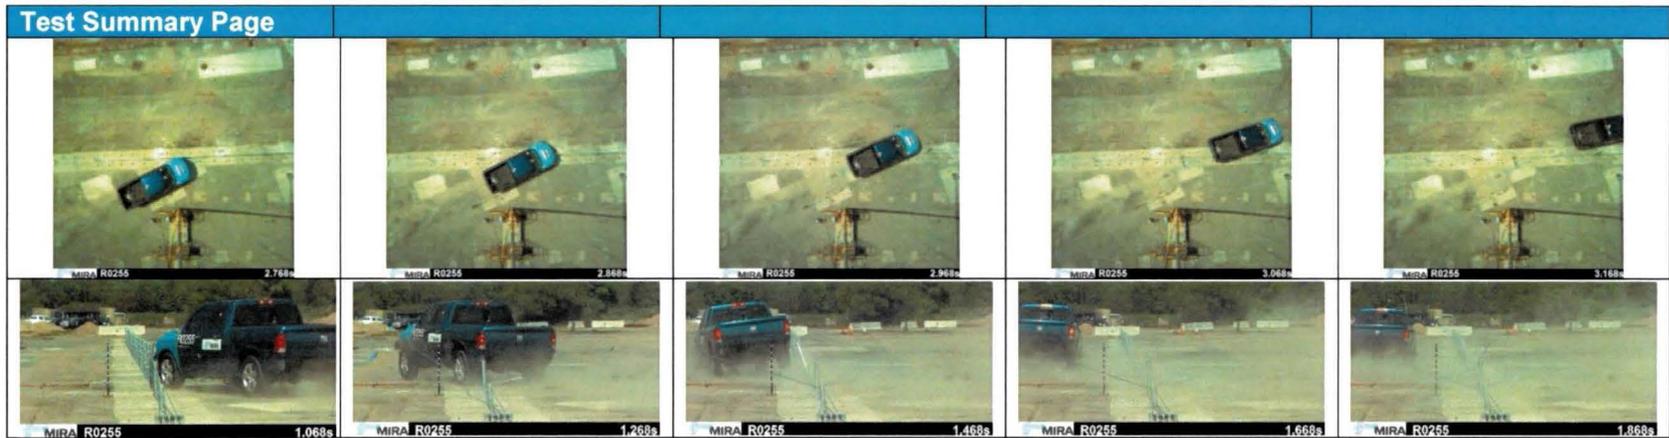
4. General Information		10. Post-Impact Trajectory	
Test Agency	HORIBA MIRA Ltd	Vehicle Stability	Satisfactory
Test no.	R0255	Stopping distance ft. (m)	185.0 (56.4) downstream 4.6 (1.4) laterally
Test date	9 th May 2016	Vehicle stopped on barrier trapped between top 2 ropes, one each side

5. Test Article		11. Occupant Risk Values	
Type	MASH Brifen Terminal Wire Rope Terminal	Impact Velocity, ft./s (m/s)	X-direction 5.6 (1.7) at 251.2ms Y-direction -8.5 (-2.6) at 251.5ms
Installation Length, ft. (m)	36.75 (11.2) Terminal + 178 (54.4) full height system + 21 (6.4) departing end anchor	THIV (optional), mile/h (km/h)	6.8 (10.9) at 245.6ms
Size and/or dimension and material key elements, in. (mm)	Posts: 2.875 OD x 0.134 (76.1 x 3.0) x 28.15 (715), 39.39 (695), 50 (1270) Galvanised steel wire rope: 0.75 (19) dia, 3 x 7 (6 x 1) construction	Occupant Ride down Acceleration (g)	X-direction 5.0 at 2003.0ms Y-direction -4.0 at 647.7ms

6. Soil conditions, in (mm)		PHD (g) (optional)	4.9 at 2000ms
12 (305) deep steel sockets cast in continuous concrete bed		ASI (optional)	0.4 at 471.4ms

7. Test Vehicle		12. Test Article Damage	
Designation	2270P Pickup Truck	All posts upstream from impact either bent or completely bent down to ground. Rope cables still intact and connected to mechanical fixings at end anchor. Hooks on deflection post bent.	
Make / Model	Dodge Ram Crew Cab (RWD)	13. Test Article Deflections	
Mass, lb (kg)	Kerb 5254.7 (2383.5)	Dynamic, in. (m)	153.5 (3.9)
	Test Inertial 5114.7 (2320)	Permanent Set, in. (m)	47.2 (1.2)
	Gross Static 5114.7 (2320)	Working Width, in. (m)	153.5 (3.9) at 32.5 (0.8) above ground

8. Impact Conditions		14. Vehicle Damage	
Speed, mile/h (km/h)	62.8 (101.1)	Vehicle engine still running. Damage to front bumper and lights. Scrapes and dents along both sides.	
Angle (deg)	23.6		
Location	Start of full height re-directive VRS / beginning of length of need

9. Exit Conditions			
Speed, mile/h (km/h)	Vehicle did not exit barrier		
Angle (deg)	Vehicle did not exit barrier		
Exit Box	Not required

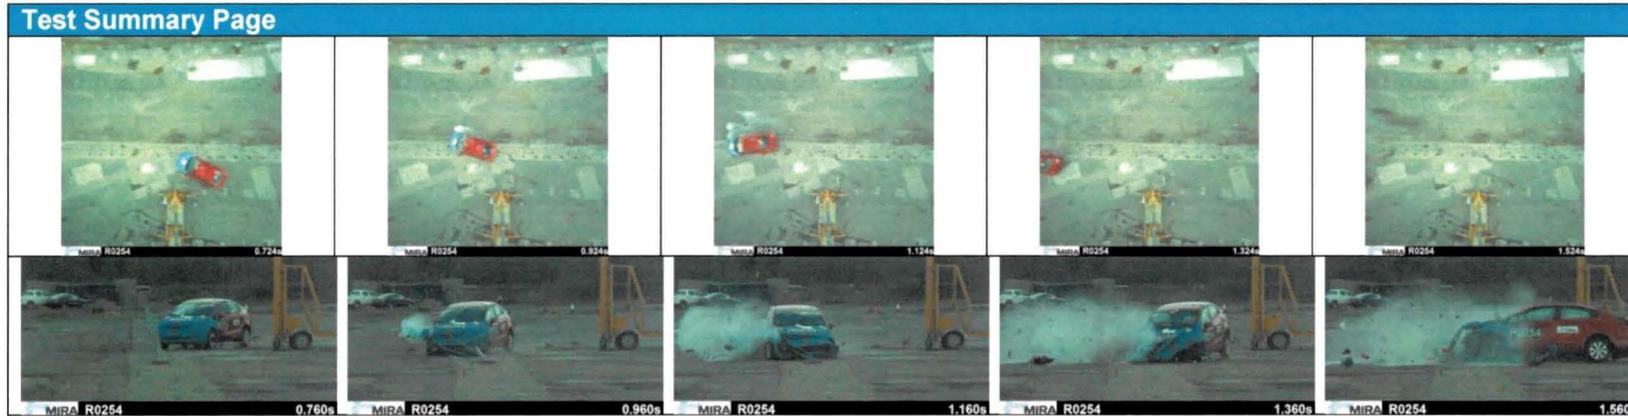
4. General Information		10. Post-Impact Trajectory	
Test Agency	HORIBA MIRA Ltd	Vehicle Stability	Satisfactory
Test no.	R0254	Stopping distance ft. (m)	62.3 (19) downstream 14.8 (4.5) laterally
Test date	26/04/2016	The vehicle became entangled in the barrier and impacted end anchor.

5. Test Article		11. Occupant Risk Values	
Type	MASH Brifen Terminal Wire Rope Terminal	Impact Velocity, ft./s (m/s)	X-direction 14.8 (4.5) at 172.9ms Y-direction 15.4 (4.7) at 168.3ms
Installation Length, ft. (m)	36.75 (11.2) Terminal + 178 (54.4) full height system + 21 (6.4) departing end anchor	THIV (optional), mile/h (km/h)	13.9 (22.3) at 173.2ms
Size and/or dimension and material key elements, in (mm)	Posts: 2.875 OD x 0.134 (76.1 x 3.0) x 28.15 (715), 39.39 (695), 50 (1270) Galvanised steel wire rope 0.75 (19) dia, 3 x 7 (6 x 1) construction	Occupant Ride down Acceleration (g)	X-direction 17 at 575.5ms Y-direction -12 at 588.0ms

6. Soil conditions, in (mm)	12 (305) deep steel sockets cast in continuous concrete bed	PHD (g) (optional)	16.7 at 588.0ms
7. Test Vehicle		ASI (optional)	1.3 at 607.3ms
Designation	1100C Small Car (2270P required by standard)	12. Test Article Damage	
Make / Model	Kia Rio (USA Spec)	The end anchor (downstream) was undamaged/unmoved. All ropes were in-tact and undamaged. The deflection post (DFP), DFP +1 and DFP +2 were bent to the ground. DFP -1, -2, -3 and -4 were slightly bent.	
Mass, lb (kg)	Kerb 2538.5 (1151.5)	13. Test Article Deflections	
	Test Inertial 2584 (1172)	Dynamic, in. (m)	67 (1.7)

61.7 (28) (water ballast dummy)	Permanent Set, in. (m)	19.7 (0.5)
	Gross Static 2645.5 (1200)	Working Width in. (m)	70.9 (1.8)
8. Impact Conditions		14. Vehicle Damage	
Speed, mile/h (km/h)	63.75 (100.9)	Front right wheel, hub and suspension detached. Front right corner deformed and stripped of outer wing. Front cross-member pushed back on right hand side. Front right door dented. SRS deployed. Oil leaks.	
Angle (deg)	23.5		
Location	Critical impact point for reverse direction impact.

9. Exit Conditions			
Speed, mile/h (km/h)	n/a		
Angle (deg)	n/a		
Exit Box	n/a
