U.S. Department
of Transportation
**Federal Highway
Administration**

In Reply Refer To:
HSST-1/CC-156

- Hercules Crash Cushion

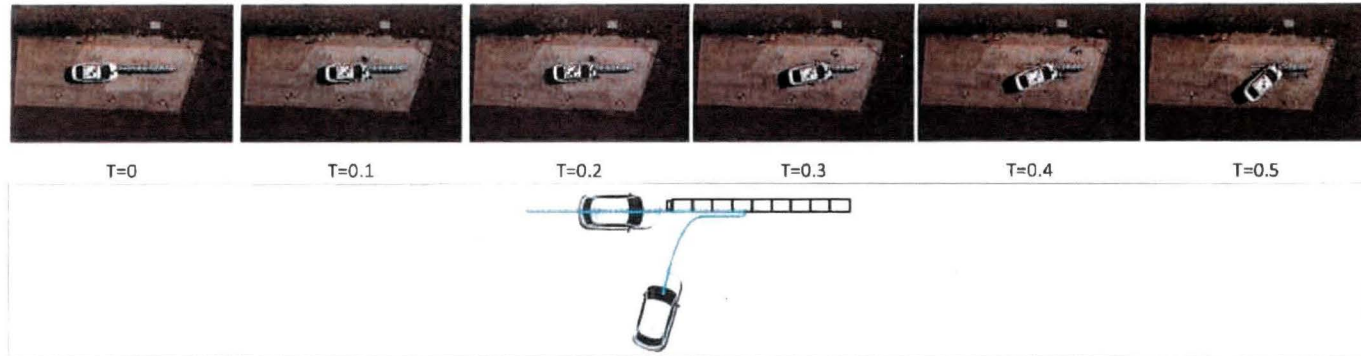
N° 0059\ME\HRB\18 Rev. 3

Test agency..... CSI S.p.A.
Test No. 0059/ME/HRB/18
Date..... 01/06/2018

Type..... HERCULES
Installation length [m]..... 5.83
Size and/or dimension and material of key
Elements..... See attached drawings

Type/ Designation..... 1100C
Model..... Kia Rio
Mass [kg]
Curb..... 1065.0
Test Inertial..... 1114.2
Gross static..... 1189.8

Speed [km/h]..... 97.2
Angle [deg]..... 0.0
Impact Severity [kJ]..... 433.7
Impact Location..... Frontal, offset W/4, 0°
Exit Speed [km/h]..... < 10
Exit Angle [deg]..... 60.0

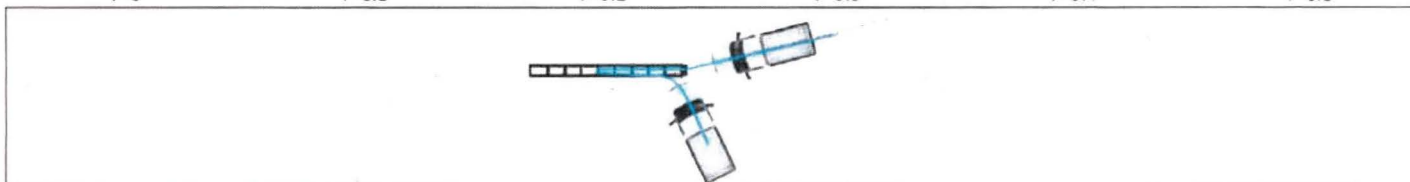
Test agency..... CSI S.p.A.
Test No. 0050/ME/HRB/18
Date..... 28/05/2018
Test Article
Type..... HERCULES
Installation length (m)..... 5.83
Size and/or dimension and material of key
Elements..... See attached drawings
Foundation type and condition..... Concrete (anchored)

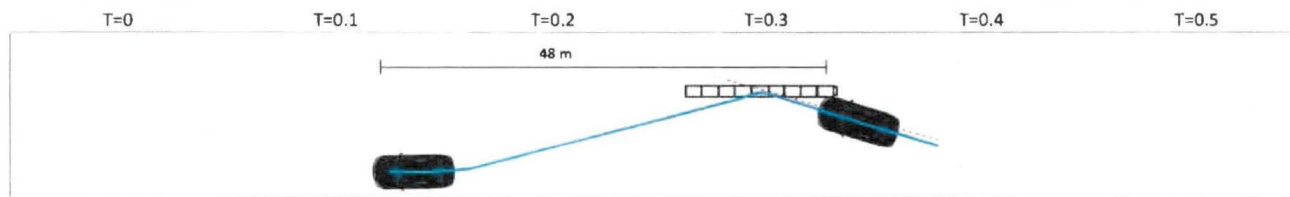
N° 0058\ME\HRB\18 Rev. 3

Test agency..... CSI S.p.A.
Test No. 0058/ME/HRB/18
Date..... 31/05/2018

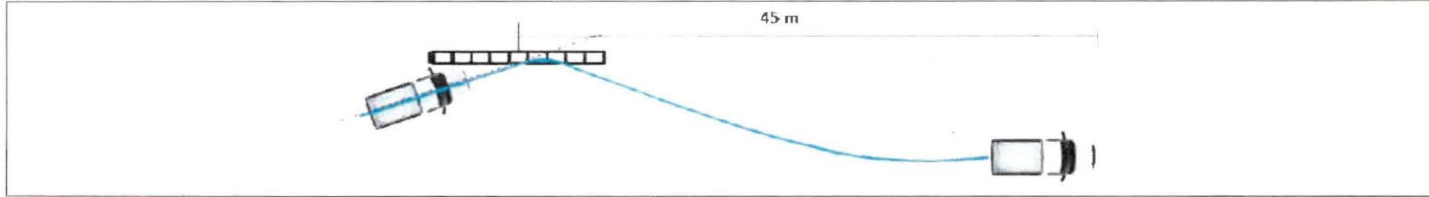
Test agency..... CSI S.p.A.
Test No. 0046/ME/HRB/18
Date..... 22/05/2018
Test Article
Type..... HERCULES
Installation length [m]..... 5.83
Size and/or dimension and material of key
Elements..... See attached drawings
Foundation type and condition..... Concrete (anchored)

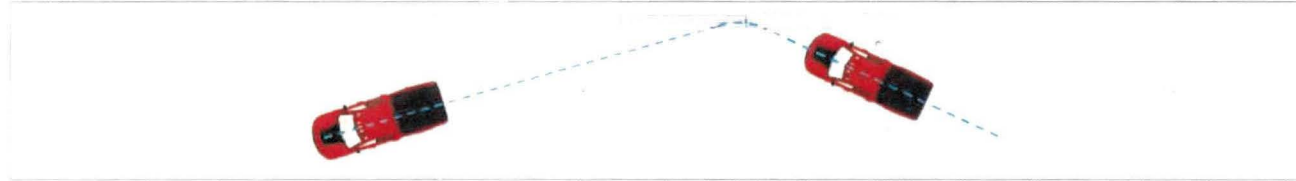
N° 0099\ME\HRB\18 Rev. 3

Test agency..... CSI S.p.A.
Test No. 0099/ME/HRB/18
Date..... 13/09/2018
