Test Report No. 612261-04-1, -05-1, & -05-2

**TESTING AND EVALUATION OF LARGE SIGNS SLIP BASE
SUPPORT ON SLOPE AT MASH TEST LEVEL 3 IMPACT
CONDITIONS**

1. Report No.	2. Government Accession No.	3. Recipient's Catalog No.	
4. Title and Subtitle TESTING AND EVALUATION OF LARGE SIGNS SLIP BASE SUPPORT ON SLOPE AT MASH TEST LEVEL 3 IMPACT CONDITIONS		5. Report Date January 2023

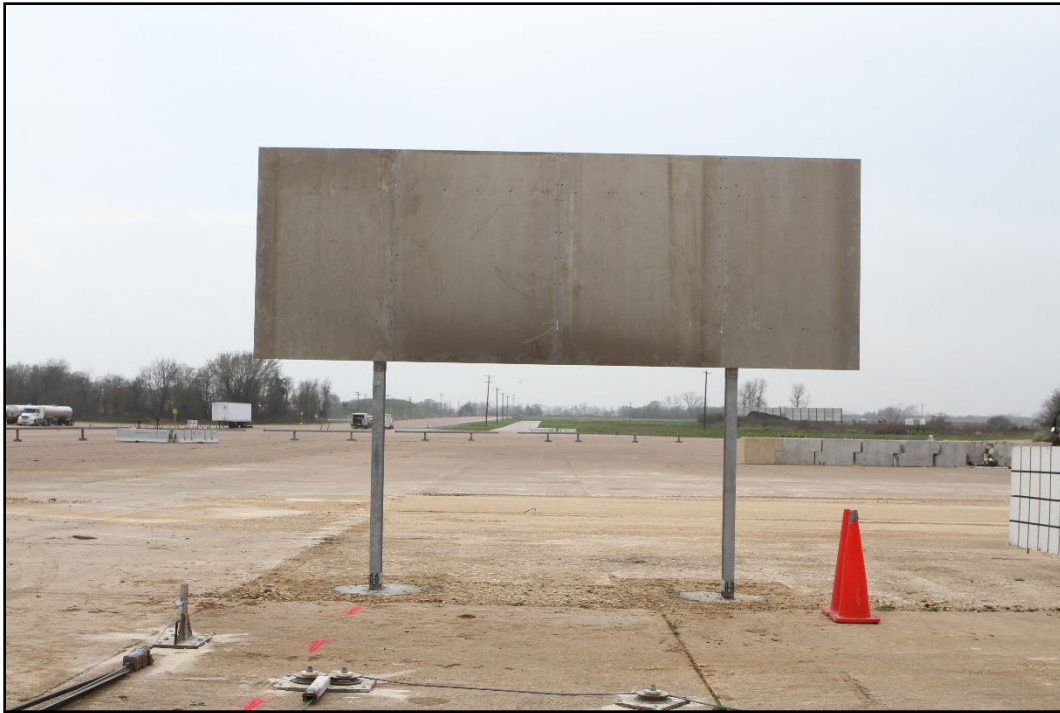
Figure 2.2. Large Sign Slip Base Support from the Impact Side Prior to Testing 612261-05-1.

Figure 2.1 presents the overall information on the large sign slip base support, and Figure 2.2 thru Figure 2.7 provide photographs of the installation for crash tests 612261-05-1.

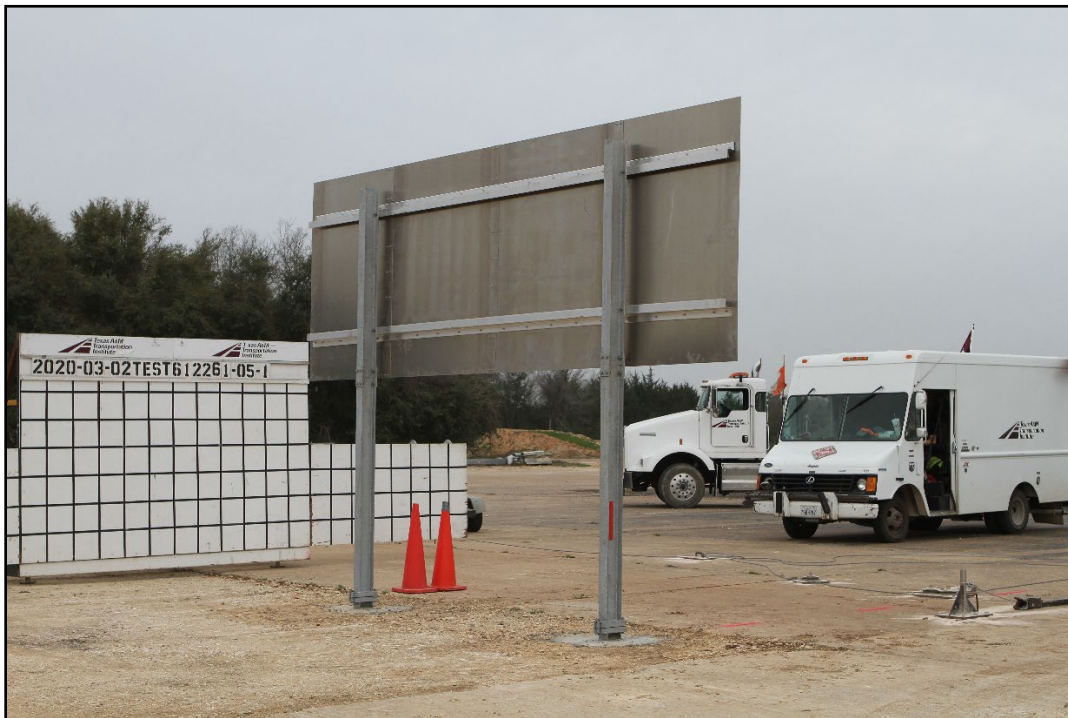
Figure 2.3. Large Sign Slip Base Support from Opposite of the Impact Side Prior to Testing 612261-05-1.

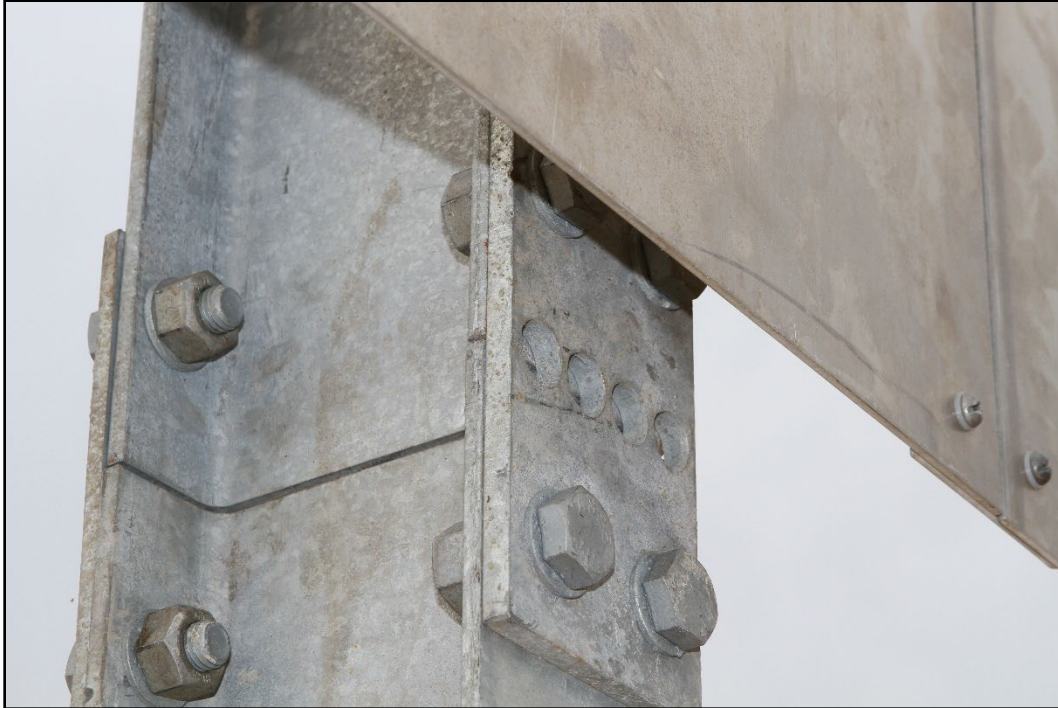
Figure 2.4. Front Plate of the Large Sign Slip Base Support Prior to Testing 612261-05-1.

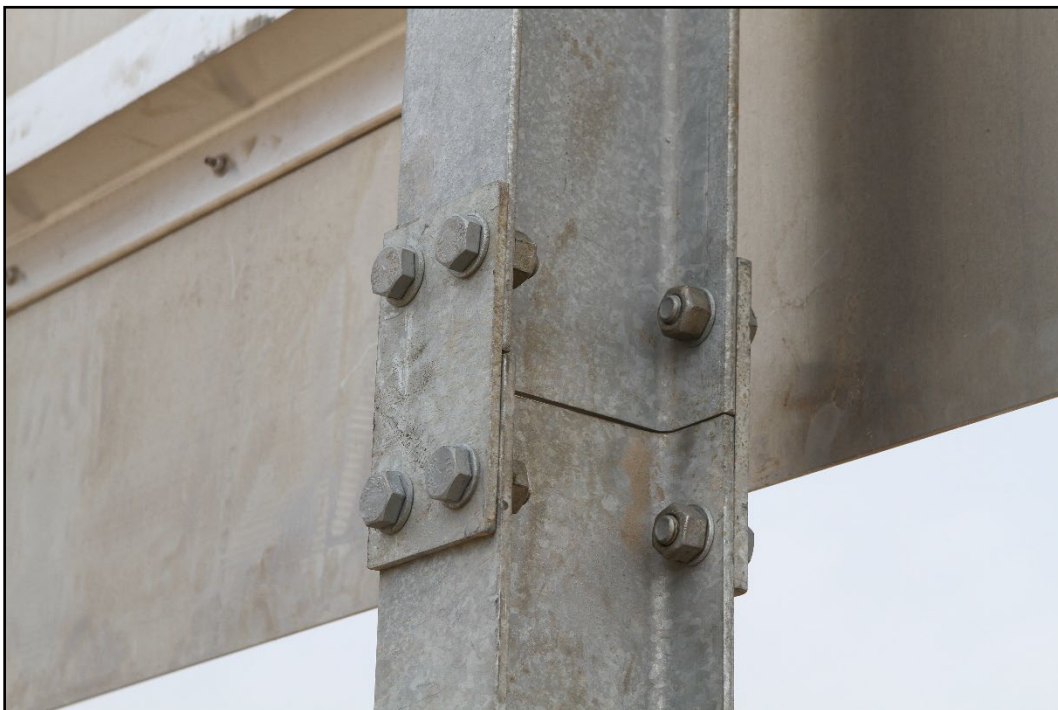
Figure 2.5. Hinge Plate of the Large Sign Slip Base Support Prior to Testing 612261-05-1.

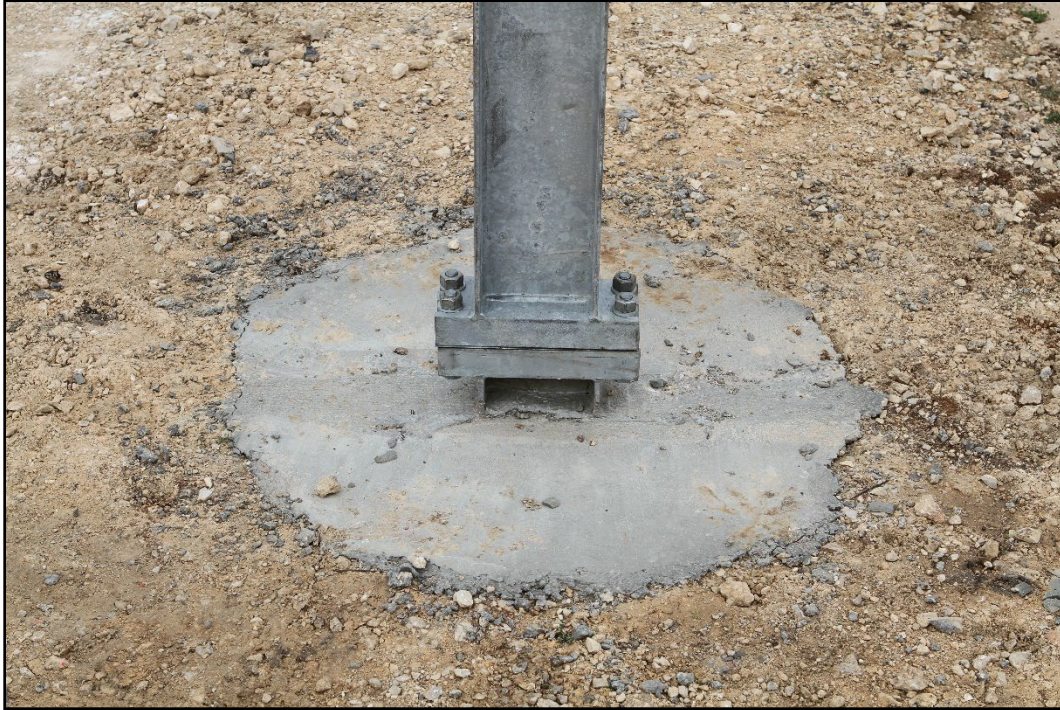
Figure 2.6. Base of the Large Sign Slip Base Support Prior to Testing 612261-05-1.

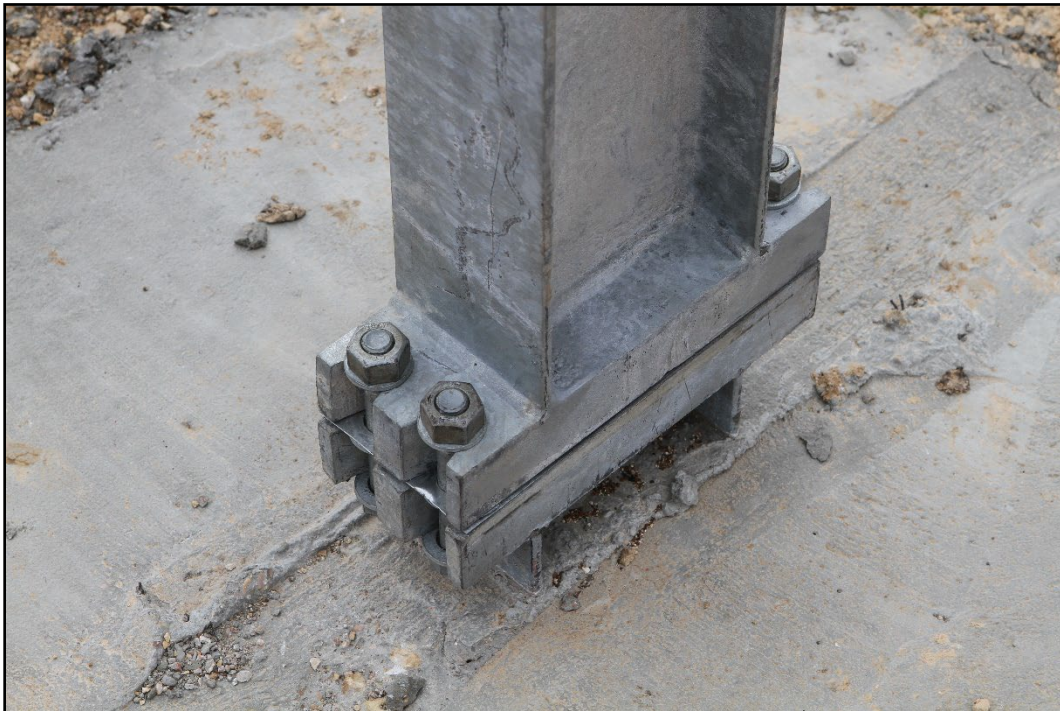
Figure 2.7. Opposite of the Impact Side of the Base of the Large Sign Slip Base Support Prior to Testing 612261-05-1.

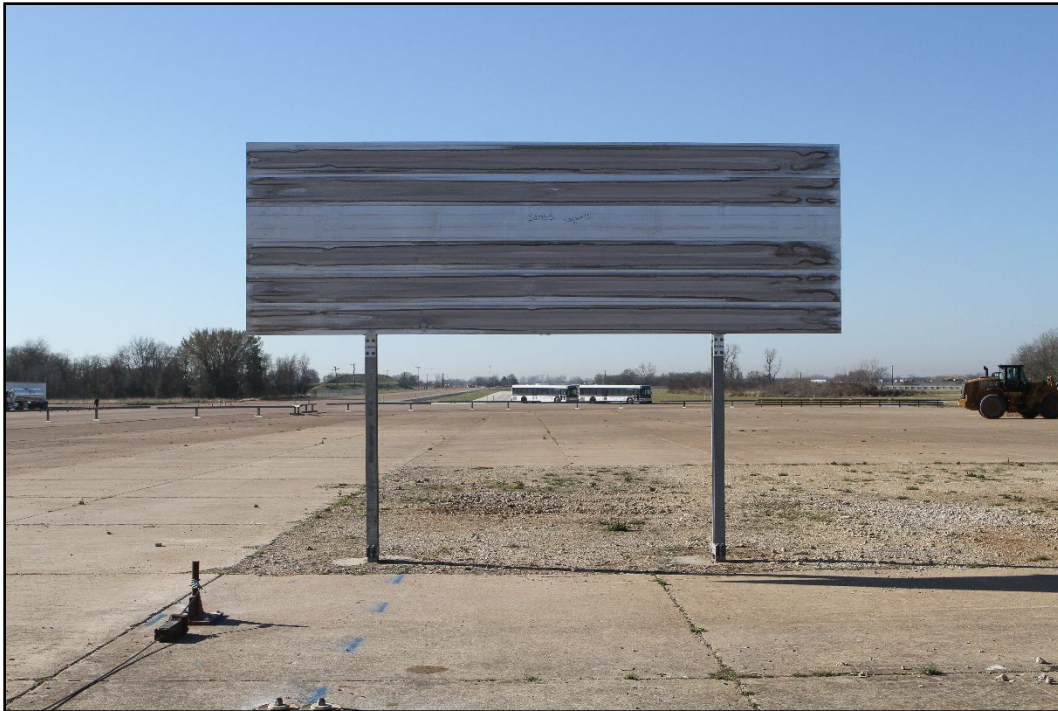
Figure 2.9. Large Sign Slip Base Support from the Impact Side Prior to Testing 612261-04-1.

Figure 2.8 presents the overall information on the large sign slip base support, and Figure 2.9 thru Figure 2.14 provide photographs of the installation for crash tests 612261-04-1

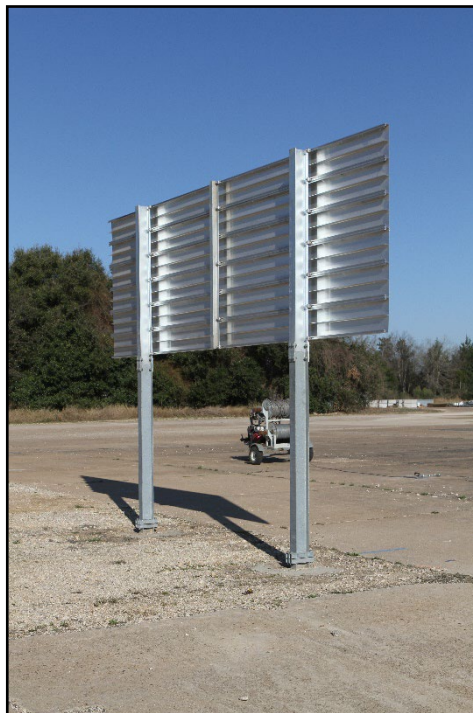
Figure 2.10. Large Sign Slip Base Support from Opposite of the Impact Side Prior to Testing 612261-04-1.

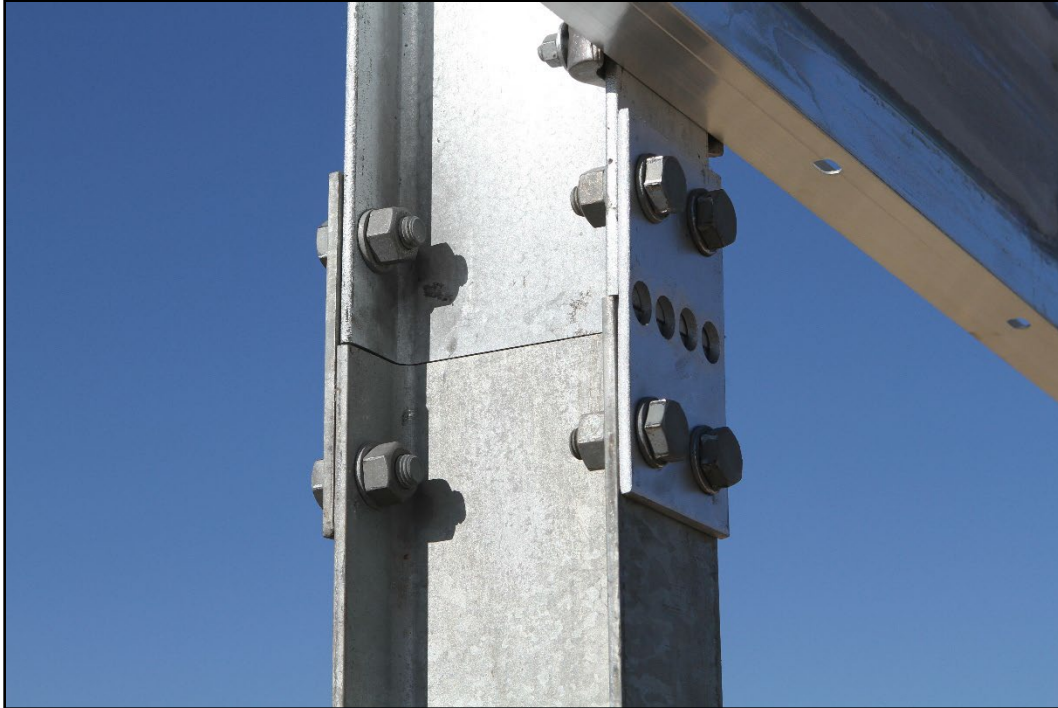
Figure 2.11. Front Plate of the Large Sign Slip Base Support Prior to Testing 612261-04-1.

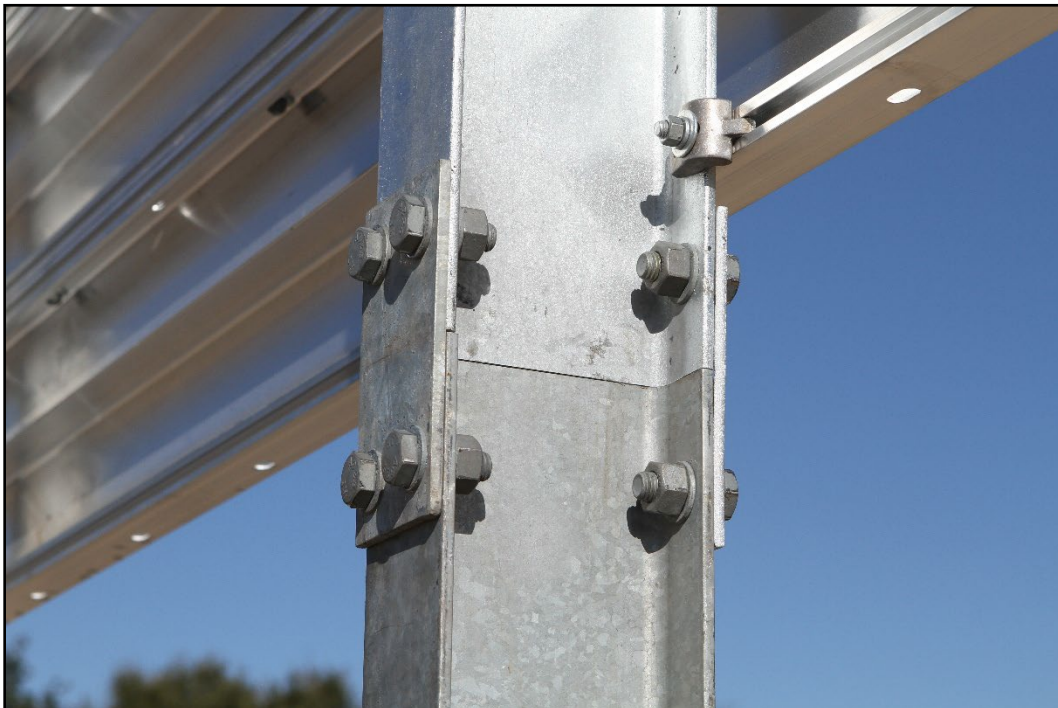
Figure 2.12. Hinge Plate of the Large Sign Slip Base Support Prior to Testing 612261-04-1.

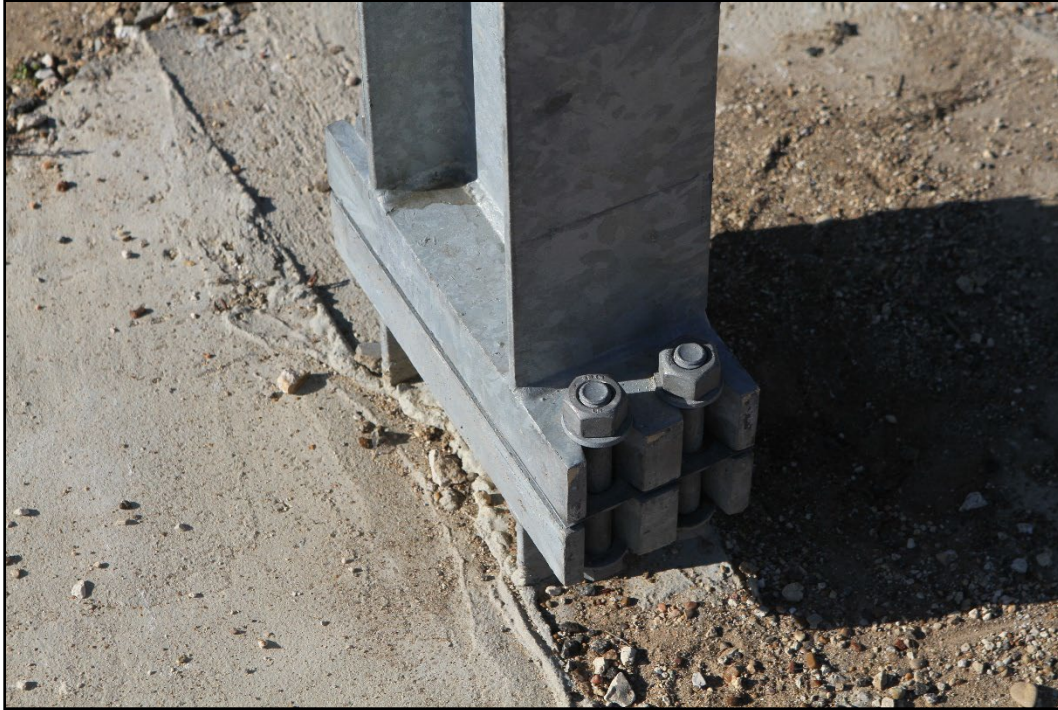
Figure 2.13. Impact Side of the Base of the Large Sign Slip Base Support Prior to Testing 612261-04-1.

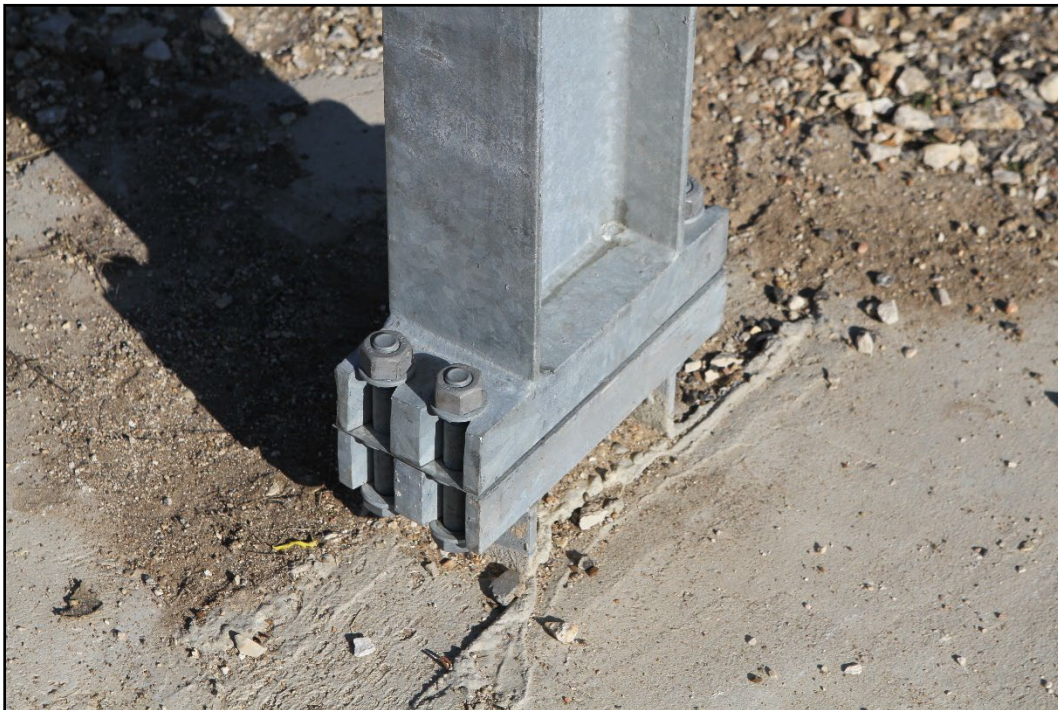
Figure 2.14. Opposite of the Impact Side of the Base of the Large Sign Slip Base Support Prior to Testing 612261-04-1.

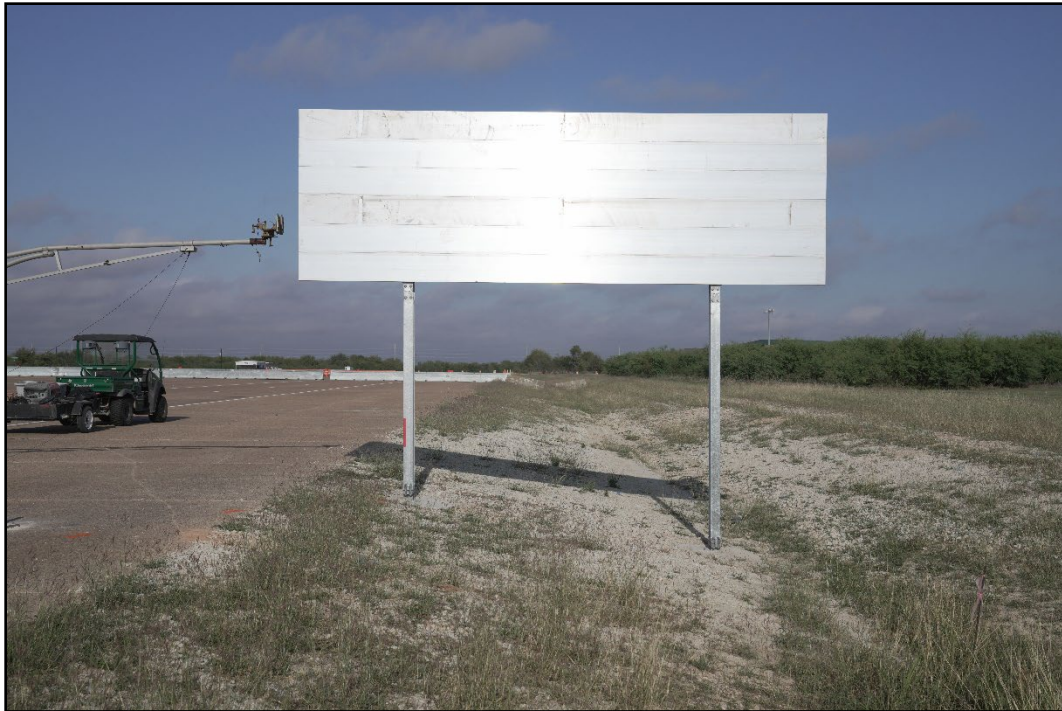
Figure 2.16. Large Sign Slip Base Support on a Slope Prior to Testing 612261-05-2.

Figure 2.15 presents the overall information on the large sign slip base support, and Figure 2.16 thru Figure 2.19 provide photographs of the installation for crash test 612261-05-2.

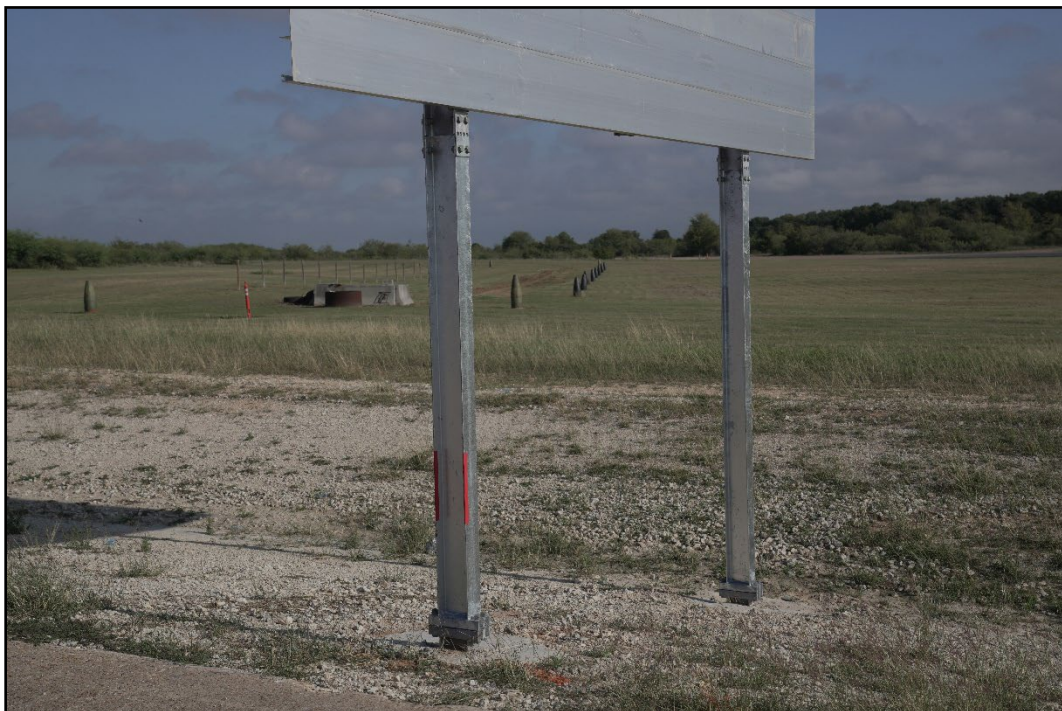
Figure 2.17. Large Sign Slip Base Support on a Slope In-line with the Impact Path Prior to Testing 612261-05-2.

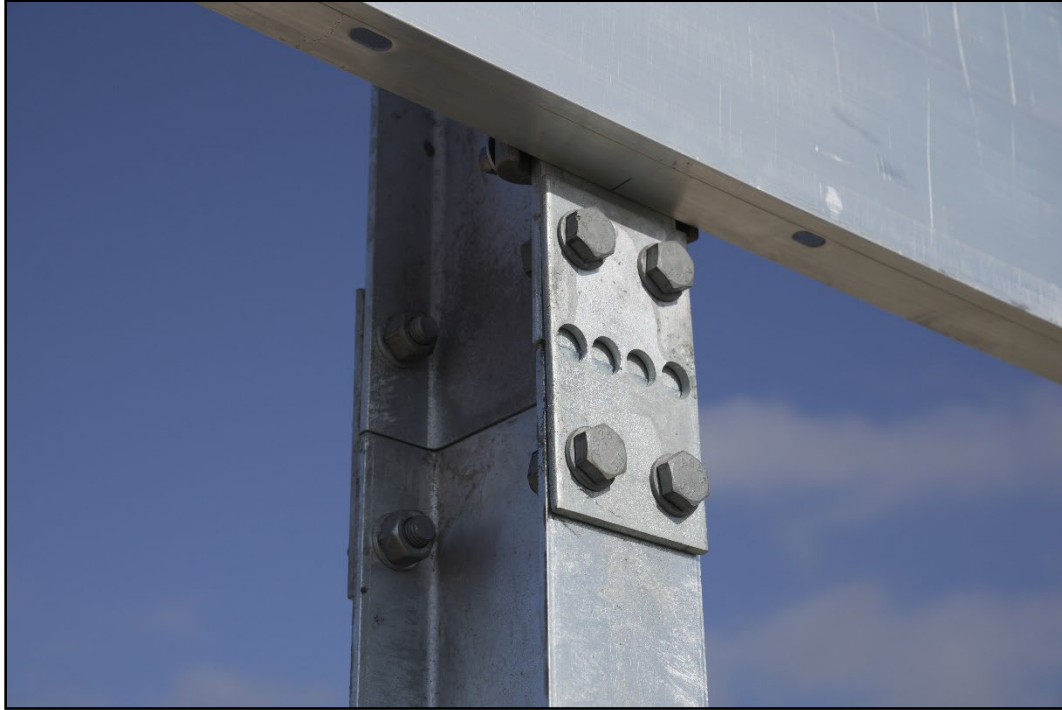
Figure 2.18. Front Plate of the Large Sign Slip Base Support on a Slope Prior to Testing 612261-05-2.

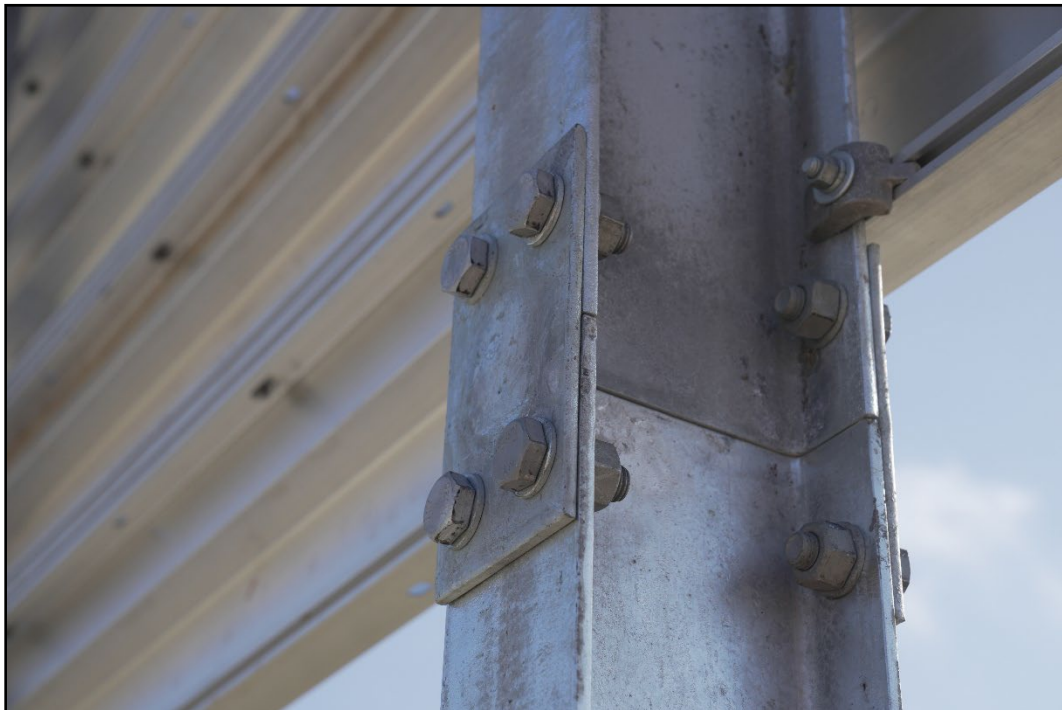
Figure 2.19. Hinge Plate of the Large Sign Slip Base Support on a Slope Prior to Testing 612261-05-2.

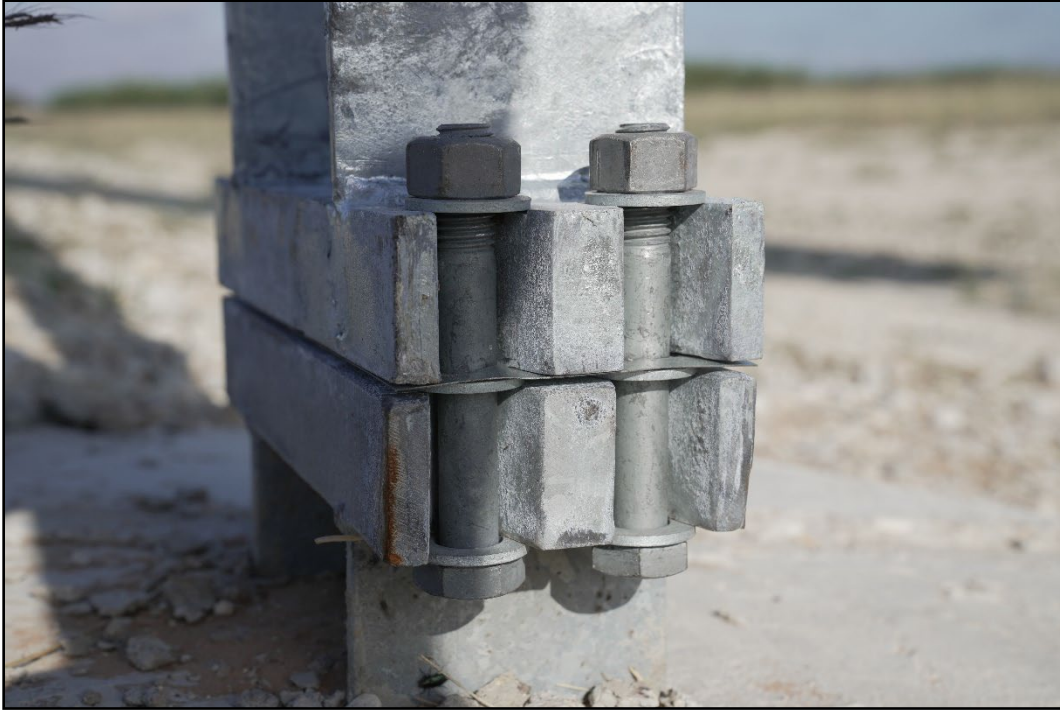
Figure 2.20. Front View of the Base of the Large Sign Slip Base Support on a Slope Prior to Testing 612261-05-2.

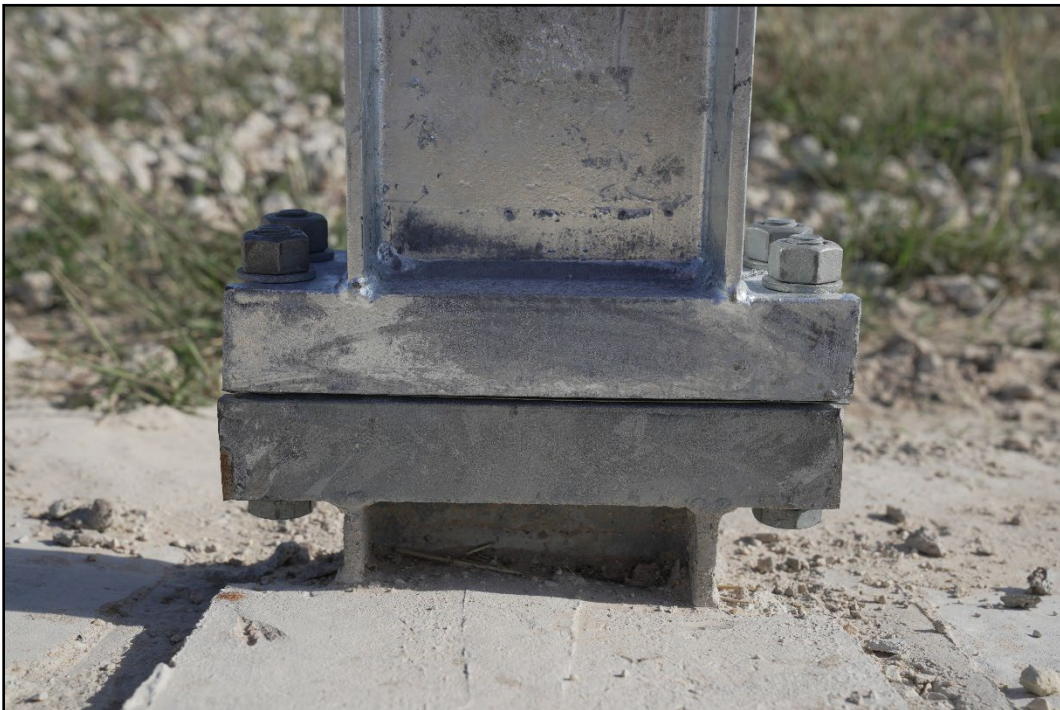
Figure 2.21. Side View of the Base of the Large Sign Slip Base Support on a Slope Prior to Testing 612261-05-2.

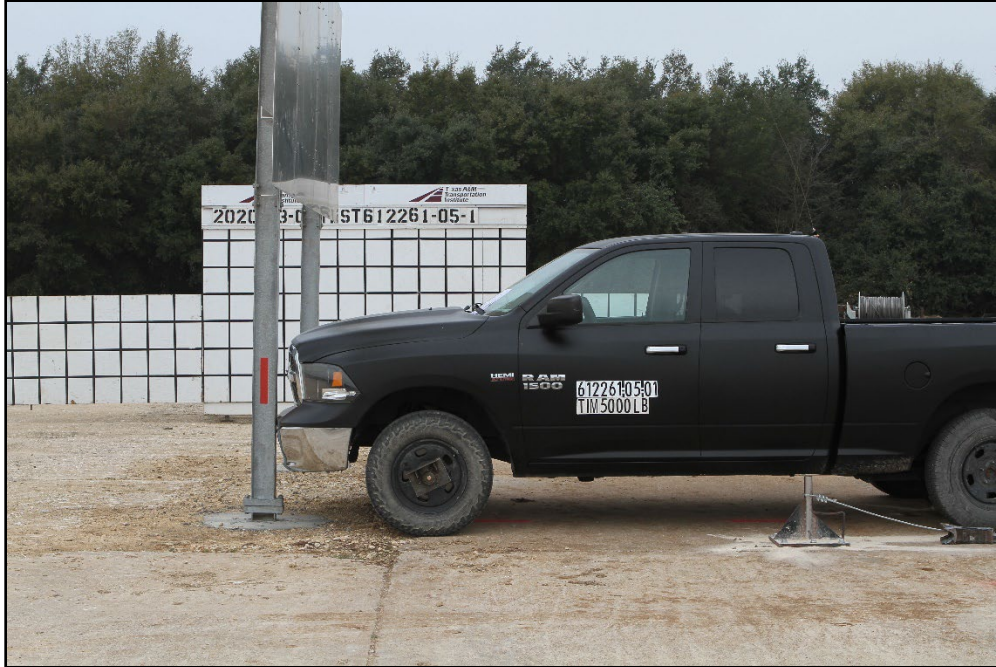
Figure 5.1. Large Sign Slip Base Support/Test Vehicle Geometrics for Test 6122561-05-1.

See Table 5.1 for details on *MASH* impact conditions for this test and Table 5.2 for the exit parameters. Figure 5.1 and Figure 5.2 depict the target impact setup.

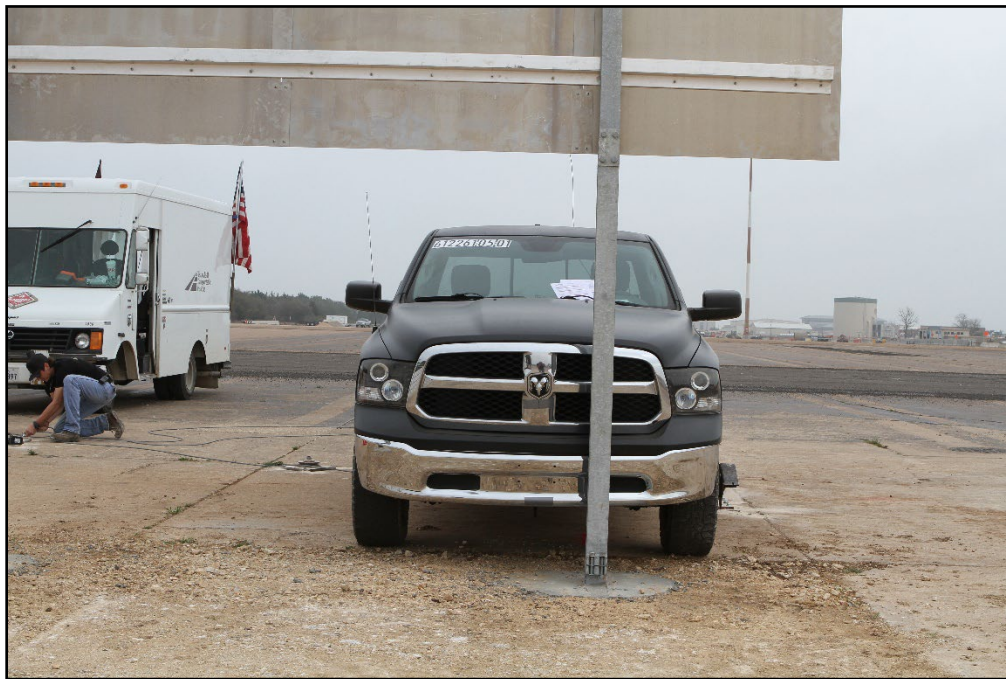
Figure 5.2. Large Sign Slip Base Support/Test Vehicle Impact Location 6122561-05-1.

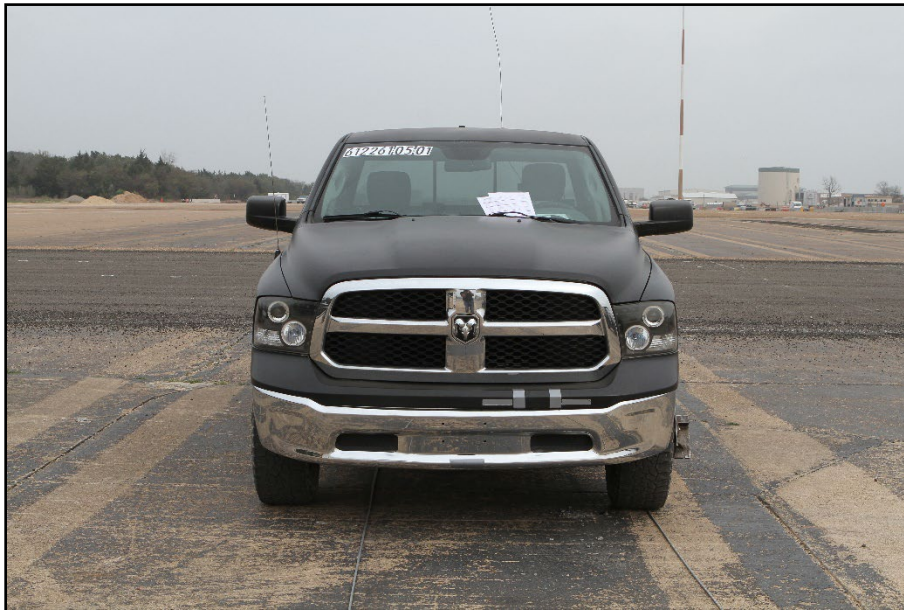
Figure 5.3. Impact Side of Test Vehicle before Test 6122561-05-1.

Figure 5.3 and Figure 5.4 show the 2014 RAM 1500 used for the crash test. Table 5.4 shows the vehicle measurements. Figure C.1 in Appendix C.1 gives additional dimensions and information on the vehicle.

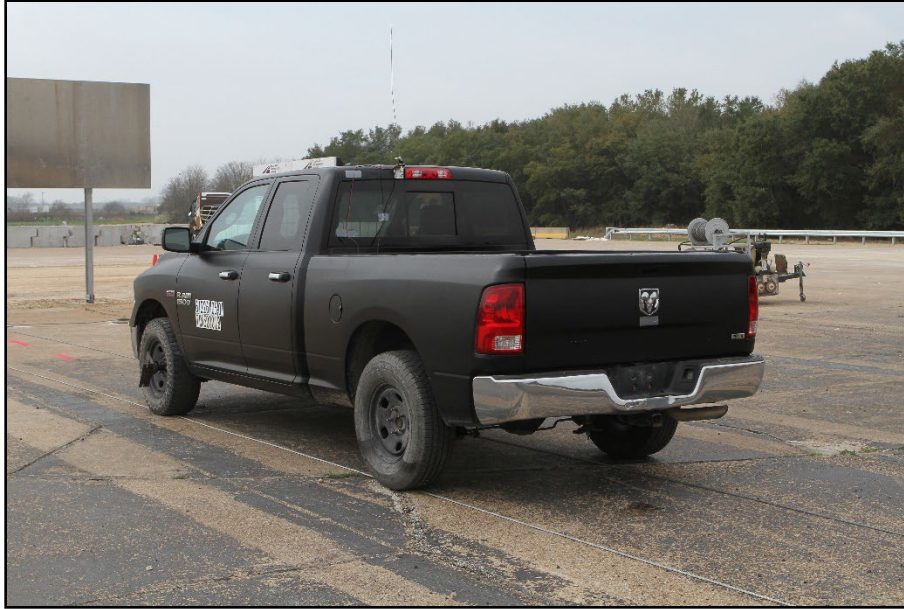
Figure 5.4. Opposite Impact Side of Test Vehicle before Test 6122561-05-1.

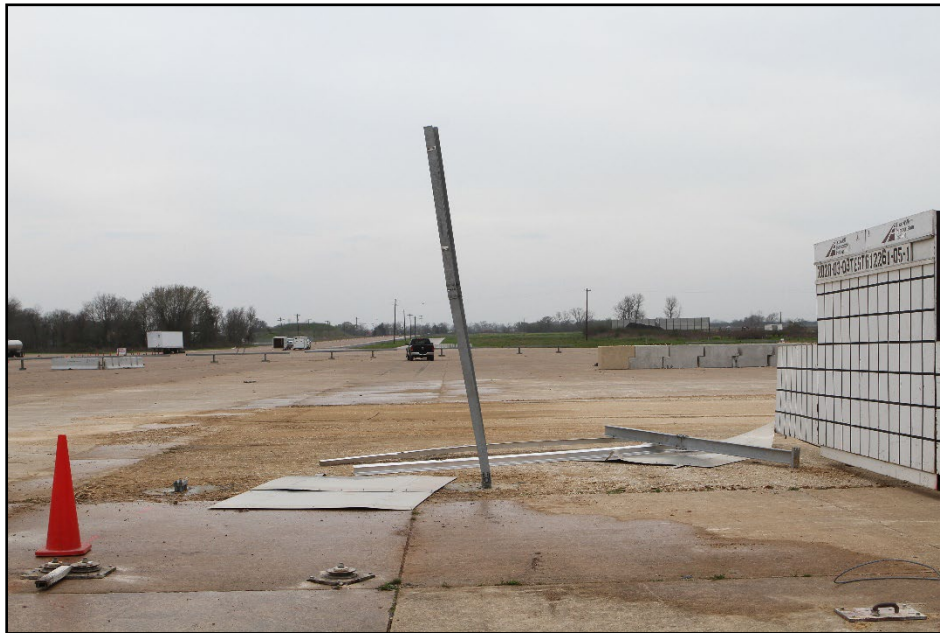
Figure 5.5. Large Sign Slip Base Support after Test at Impact Location 6122561-05-1.

The left support slip base activated at impact. The field side bolts dislodged from the fuse plate at impact. The sign panel detached from the right-side support post and landed 6 feet to the right of impact. The left support post and part of the sign panel landed 22 feet to the right and 11 feet downstream. The right support did not activate and was leaning to the left 9.75 degrees from vertical, with a slight clockwise twist. Figure 5.5 and Figure 5.6 show the damage to the large sign slip base support system.

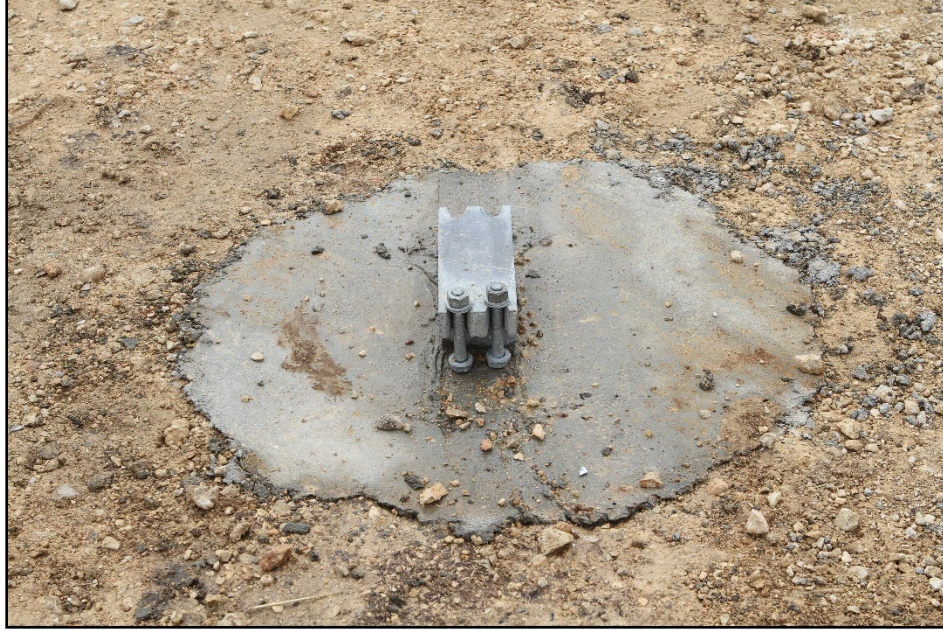
Figure 5.6. Left/Driver Large Sign Slip Base Support after Test at the Left Support Base 6122561-05-1.

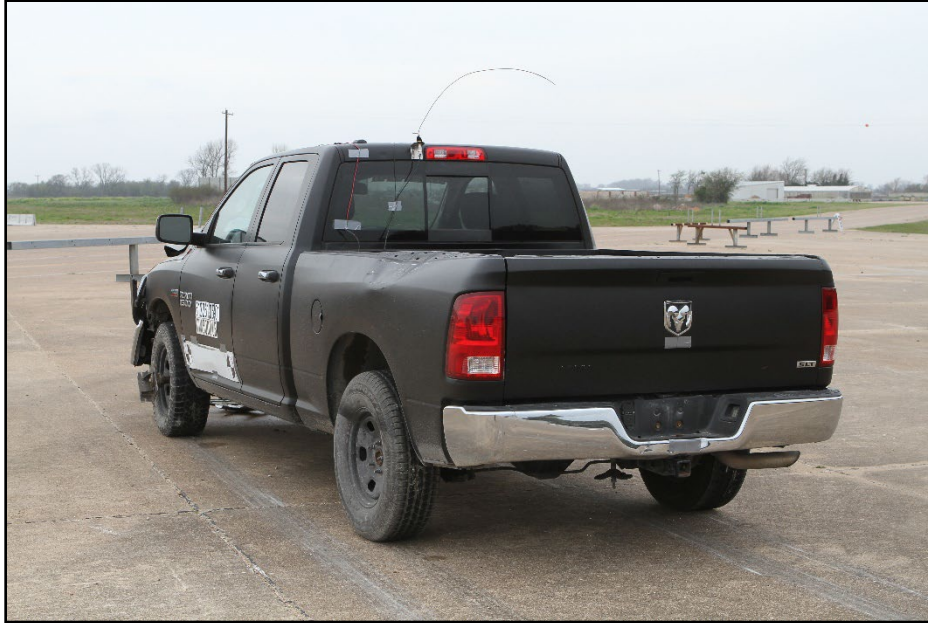
Figure 5.8. Rear Impact Side of Test Vehicle after Test 6122561-05-1.

Figure 5.7 and Figure 5.8 show the damage sustained by the vehicle. Figure 5.9 and Figure 5.10 show the interior of the test vehicle. Table 5.6 and Table 5.7 provide details on the occupant compartment deformation and exterior vehicle damage. Figures C.2 and C.3 in Appendix C.1 provide exterior crush and occupant compartment measurements.

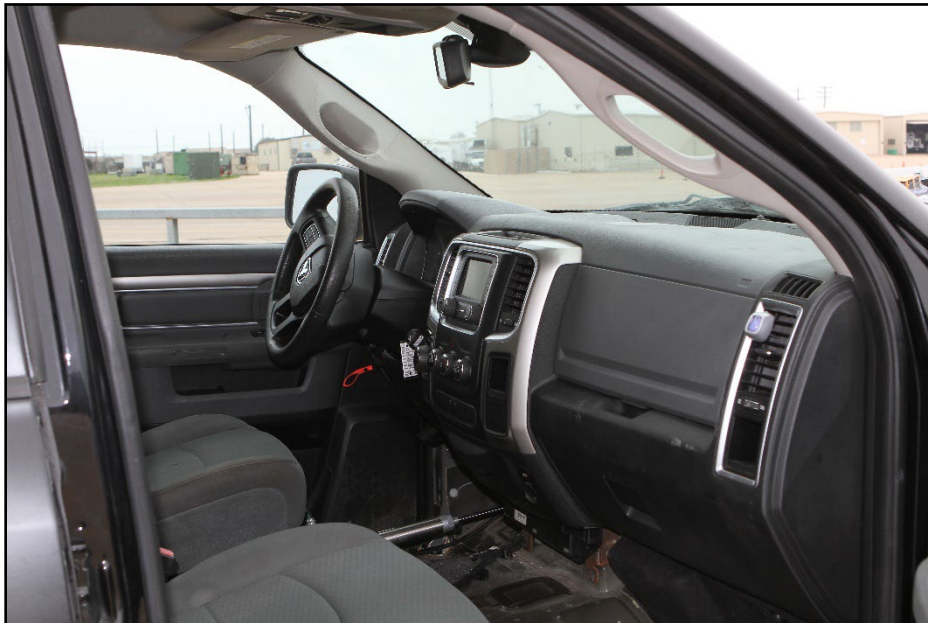
Figure 5.9. Overall Interior of Test Vehicle after Test 6122561-05-1.

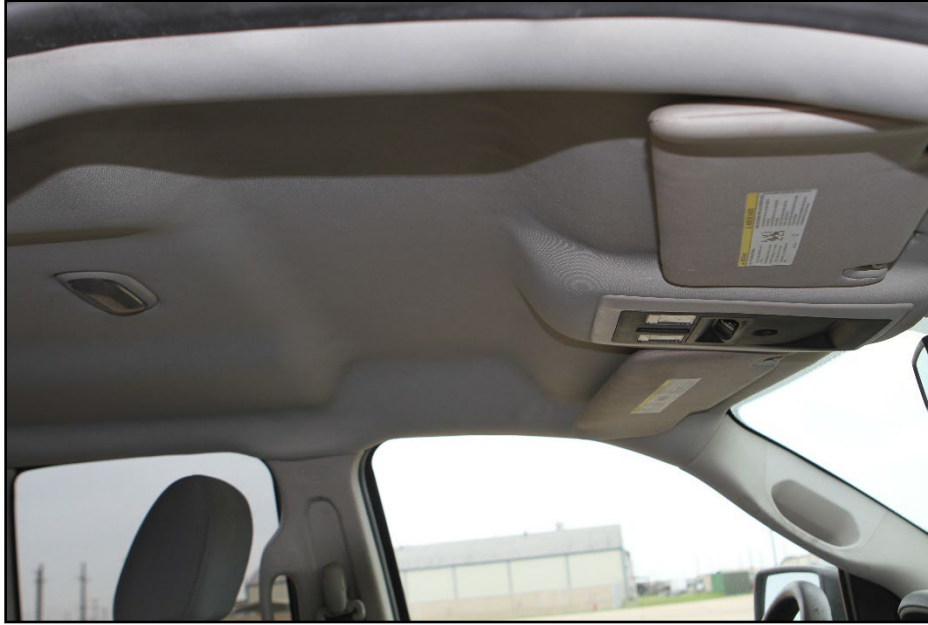
Figure 5.10. Interior Roof of Test Vehicle after Test 6122561-05-1.

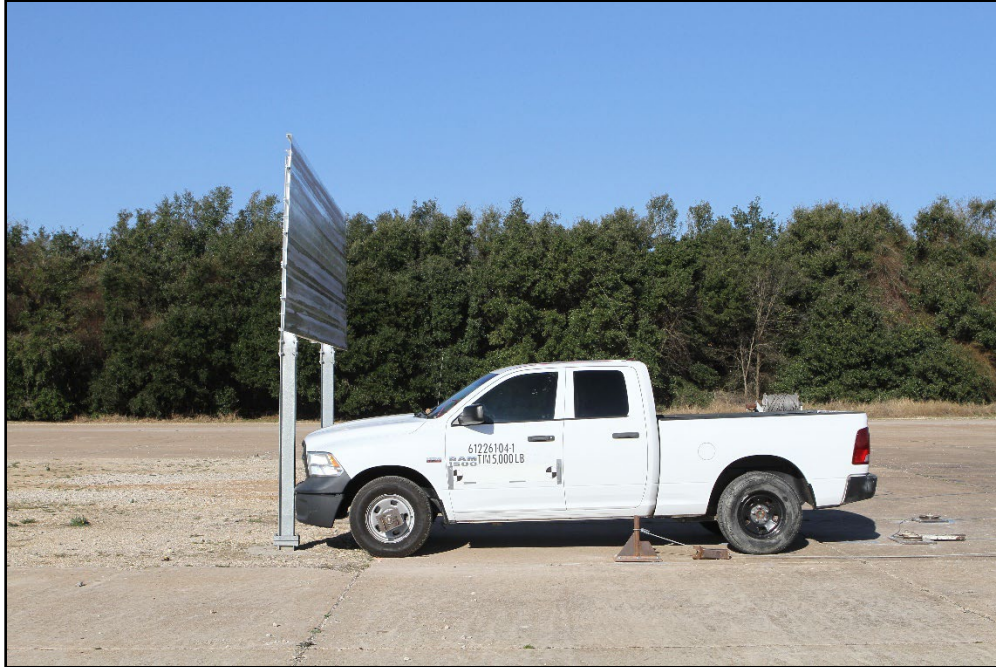
Figure 6.1. Large Sign Slip Base Support/Test Vehicle Geometrics for Test 612261-04-1.

See Table 6.1 for details on *MASH* impact conditions for this test and Table 6.2 for the exit parameters. Figure 6.1 and Figure 6.2 depict the target impact setup.

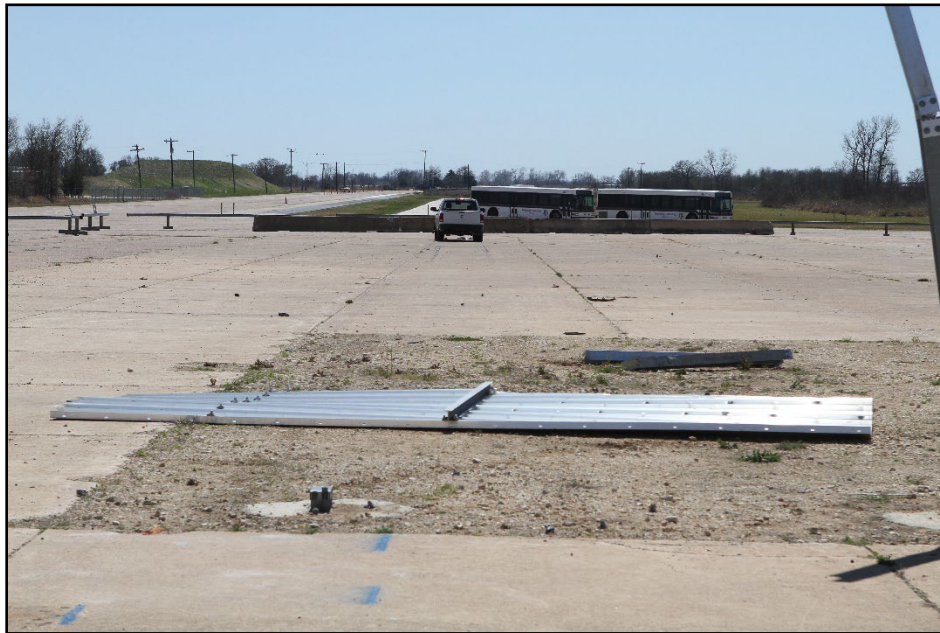
Figure 6.5. Large Sign Slip Base Support after Test at Impact Location 612261-04-1.

The sign panel released from the support posts and landed 20 feet downstream from impact. The front fuse plate on the left support post fractured, and the support post released from the slip base, landing 40 feet downstream from impact. The front fuse plate on the right support post fractured, but the support post did not release from the slip base, causing a lean of the upper section of the support post of 8 degrees to the left. Figure 6.5 and Figure 6.6 show the damage to the large sign slip base support.

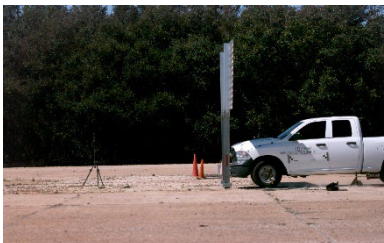
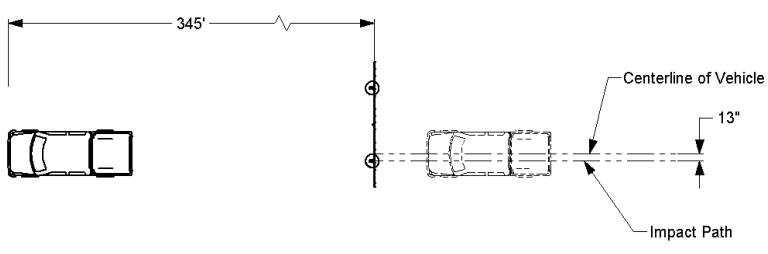
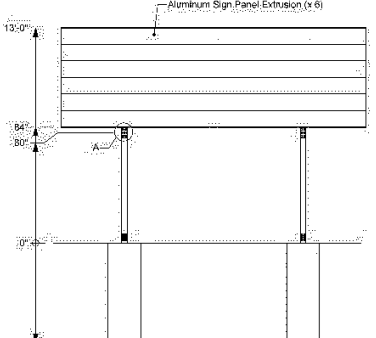
Figure 6.11. Summary of Results for MASH Test 3-62 on Large Sign Slip Base Support.

<p style="text-align: center;">0.000 s</p>	Test Agency		Texas A&M Transportation Institute (TTI)	
	Test Standard/Test No.		MASH 2016, Test 3-62	
	TTI Project No.		612261-04-1	
	Test Date		2022-03-16	
TEST ARTICLE				
		Type	Support Structure	
		Name	Large Sign Slip Base Support with Fuse Plate	
		Height	13 ft - 0 inches	
		Key Materials	Extruded aluminum sign panel w/ 6 Horiz Sections Two W6×12 ASTM A36 steel support posts	
		Soil Type and Condition	AASHTO M147-17 Grading D Crushed Concrete

<p style="text-align: center;">0.100 s</p>	TEST VEHICLE			
	Type/Designation		2270P	
	Year, Make and Model		2016 RAM 1500	
	Inertial Weight (lb)		5064	
		Dummy (lb)	N/A	
		Gross Static (lb)	5064	
IMPACT CONDITIONS				
		Impact Speed (mi/h)	61.4	
		Impact Angle (deg)	0	
		Impact Location	13 inches to the left of the centerline of the vehicle aligned with the center of the left post	
		Kinetic Energy (kip-ft)	638.2

<p style="text-align: center;">0.200 s</p>	EXIT CONDITIONS			
	Exit Speed (mi/h)		61.3	
	Stopping Distance		345 ft downstream In-line with the installation	
	VEHICLE DAMAGE			
		VDS	12FC2	
		CDC	12FCAW1	
		Max. Ext. Deformation	4	
		Max Occupant Compartment Deformation	1-inch in the roof

<p style="text-align: center;">0.300 s</p>	OCCUPANT RISK VALUES			
	Long. OIV (ft/s)	2.4	Max 50-ms Long. (g)	-1.4
	Lat. OIV (ft/s)	0.6	Max 50-ms Lat. (g)	-0.4
	Long. Ridedown (g)	0.3	Max 50-ms Vert. (g)	-1.1
Lat. Ridedown (g)	0.4	Max Roll (deg)	4	
THIV (m/s)	0.8	Max Pitch (deg)	4	
ASI	0.2	Max Yaw (deg)	3

Figure 6.11 summarizes the results of *MASH* Test 612261-04-1. Though the roof did have a cut that went through the metal, it was determined that the due to the angle and direction of contact and the shape of the part contacting the roof there was no danger for penetration into the occupant compartment.

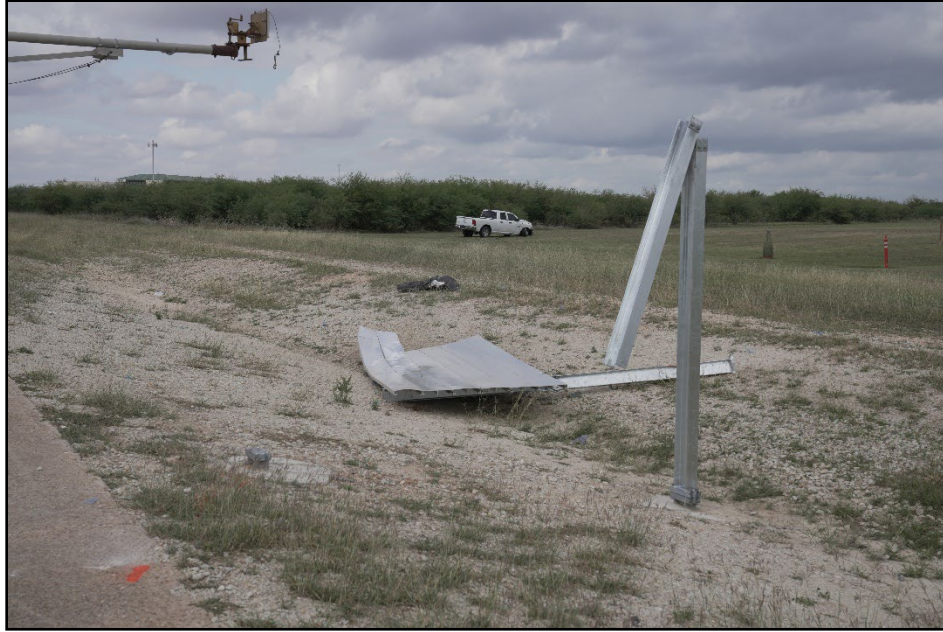
Figure 7.5. Large Sign Slip Base Support after Test at Impact Location 612261-05-2.

The left side impacted support post slip base activated and the fuse plate fractured. The sign panel released from the non-impacted right side support post and was deformed. The fuse plate activated on the non-impacted right side support post and a bolt connecting the support post to the hinge plate sheared. Figure 7.5 and Figure 7.6 show the damage to the large sign slip base support.
