Test Report No. 612261-04-1, -05-1, & -05-2

**TESTING AND EVALUATION OF LARGE SIGNS SLIP BASE
SUPPORT ON SLOPE AT MASH TEST LEVEL 3 IMPACT
CONDITIONS**

1. Report No.	2. Government Accession No.	3. Recipient's Catalog No.	
4. Title and Subtitle TESTING AND EVALUATION OF LARGE SIGNS SLIP BASE SUPPORT ON SLOPE AT MASH TEST LEVEL 3 IMPACT CONDITIONS		5. Report Date January 2023

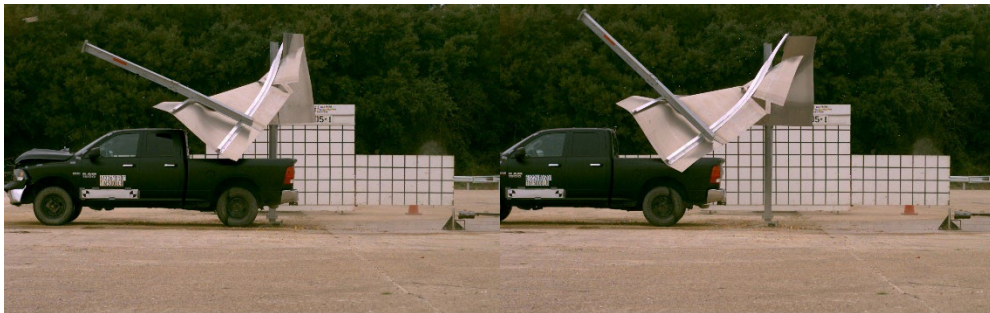
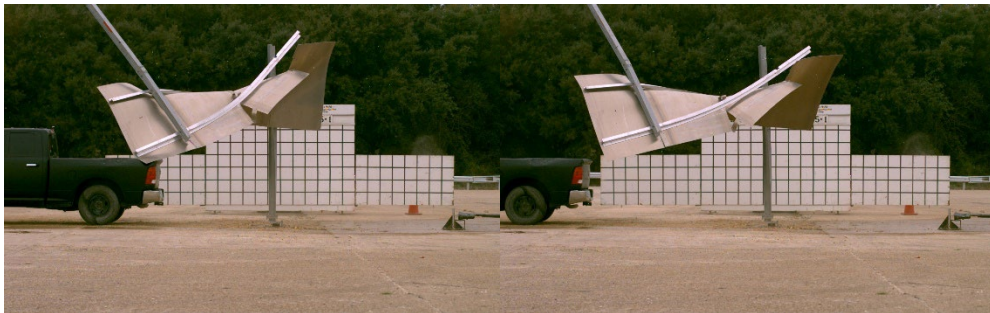
Figure C.4. Sequential Photographs for Test No. 6122561-05-1 (Right Angle Views).

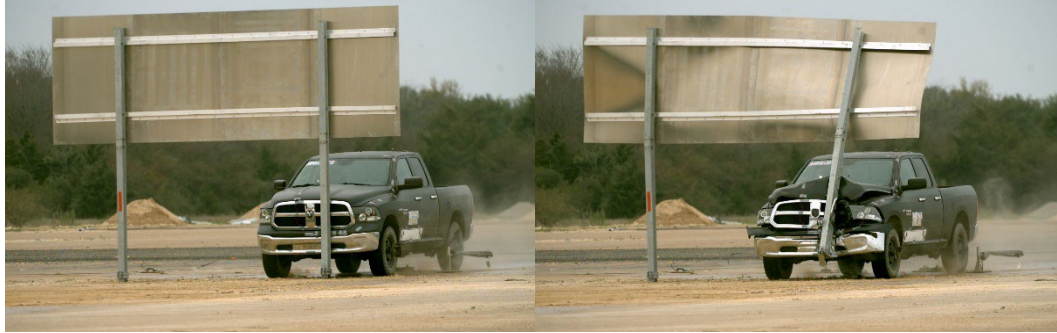
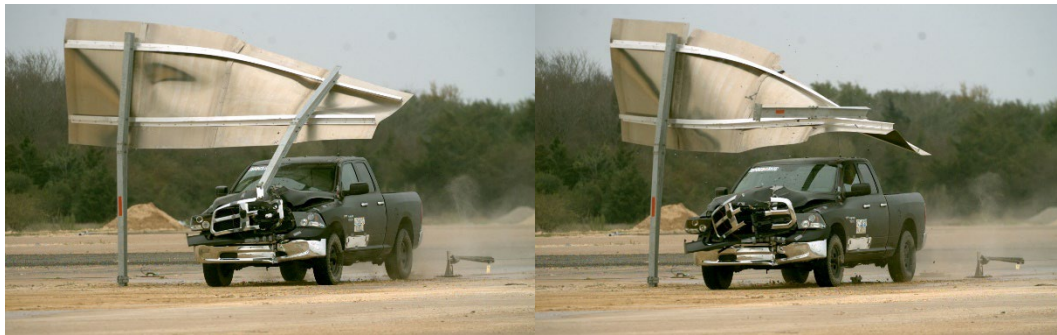
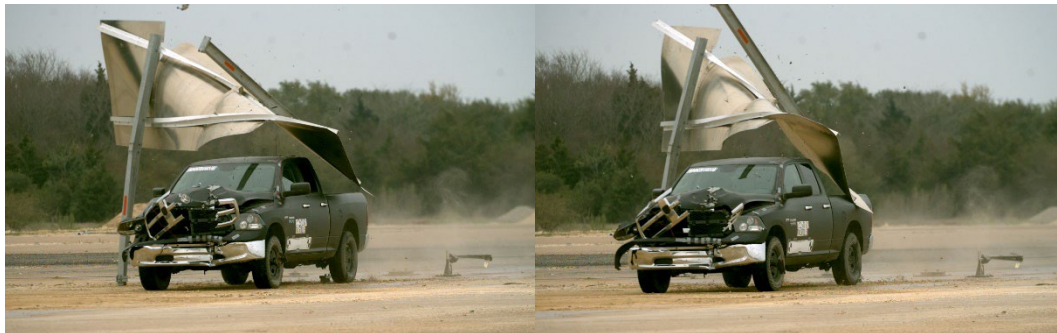
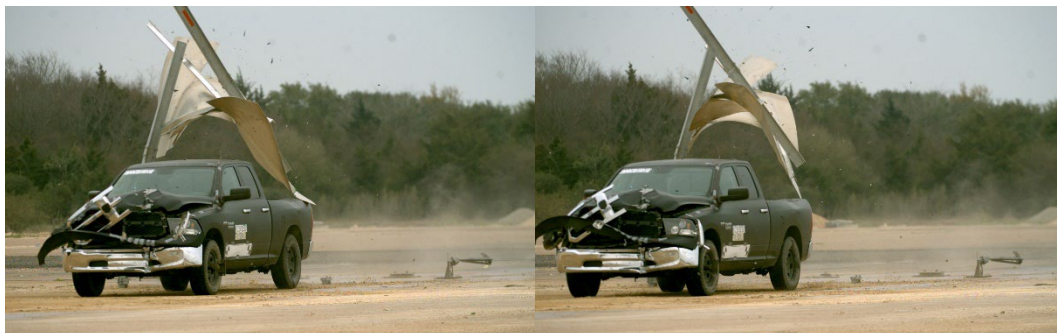
Figure C.5. Sequential Photographs for Test No. 6122561-05-1 (Left Oblique Views).

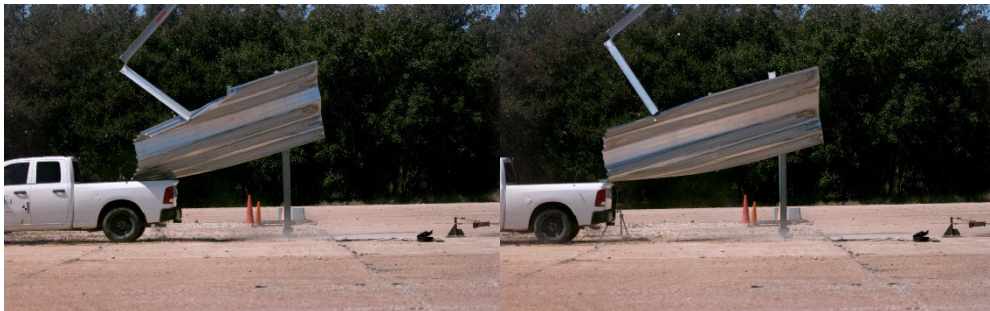
(g) 0.600 s

(h) 0.700 s

Figure D.4. Sequential Photographs for Test No. 612261-04-1 (Right Angle Views).

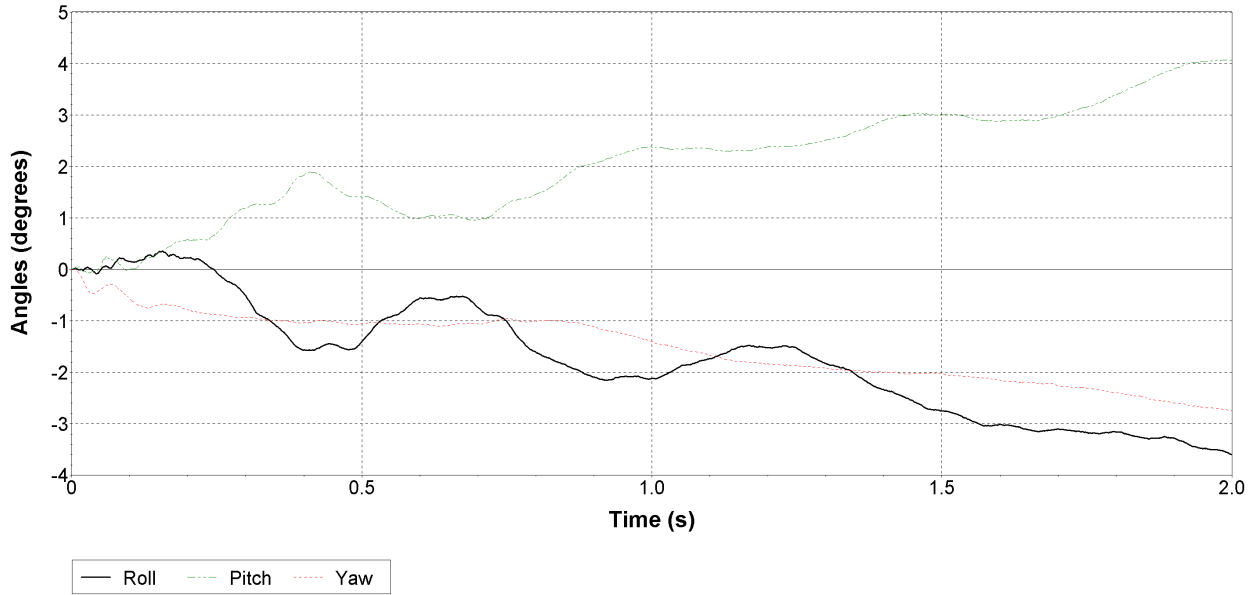
Figure D.6. Vehicle Angular Displacements for Test No. 612261-04-1.

Axes are vehicle-fixed.
 Sequence for determining orientation:
 4. Yaw.
 5. Pitch.
 6. Roll.

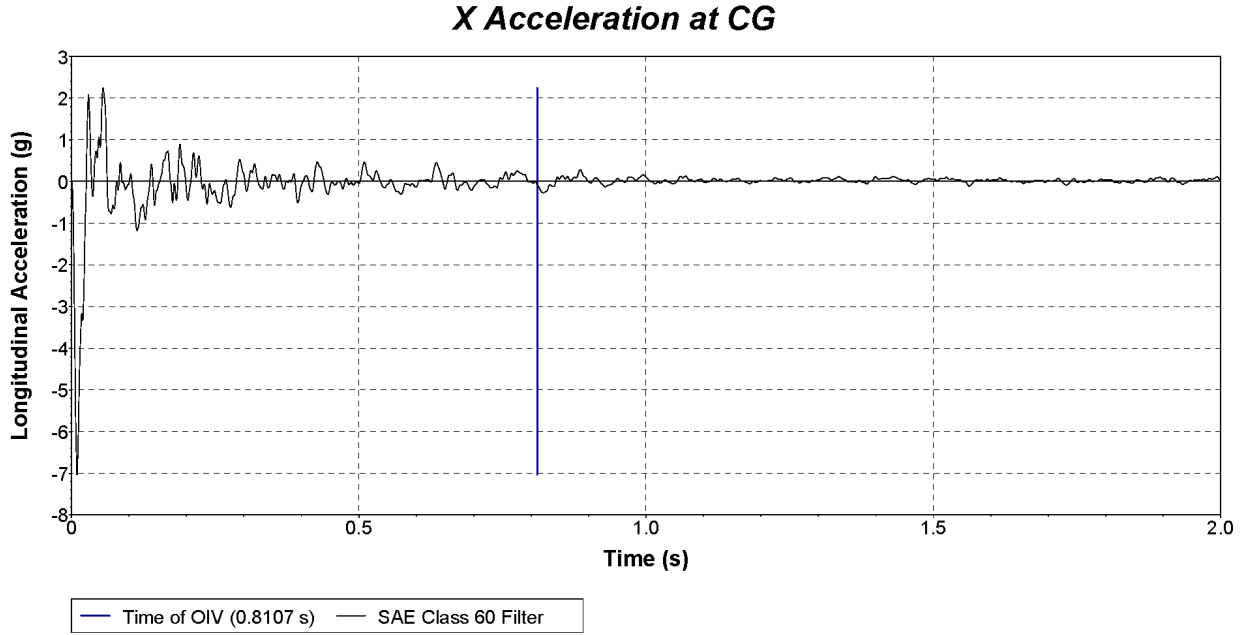
Figure D.7. Vehicle Longitudinal Accelerometer Trace for Test No. 612261-04-1 (Accelerometer Located at Center of Gravity).
