# Test Report No. 617771-01&02

# **MASH** TESTING OF A GUARDRAIL SYSTEM ON 1H:1V SLOPE

snsnTechnical Report Documentation Page		
1. Report No.     2. Government Accession No.		3. Recipient's Catalog No.		
4. Title and Subtitle		5. Report Date		
MASH Testing of a Guardrail System on 1H:1V Slope		November 2023

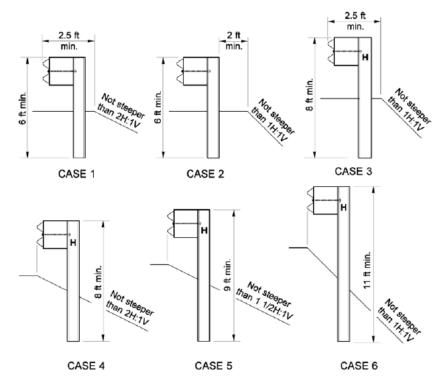
#### Figure 1.1. Allowable Post on Slope Installation Cases from WSDOT Design Manual; Beam Guardrail Post Installation — Exhibit 1610-11 (2).

The American Association of State Highway and Transportation Officials (AASHTO) Roadside Design Guide (1) recommends that guardrail be installed with the back edges of the guardrail post being 2 ft from a slope break. In many areas with tight environmental controls, this width is difficult to provide. As a result, designers often make a trade-off between reduced shoulder width and a less than optimal guardrail placement. The Washington State Department of Transportation (WSDOT) Design Manual (2) provides for the placement of the guardrail post closer to or on slopes as steep as 1:1 slope as shown in Figure 1.1.

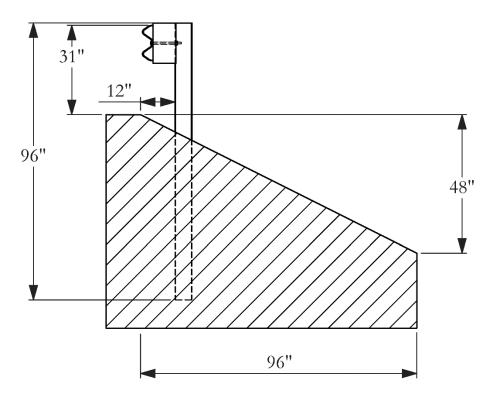
Figure 1.2. Cross Section of the Guardrail on Slope System Tested by Abu-Odeh et al. (3).

In an earlier project, Abu-Odeh et al. (3) conducted two full scale crash tests of a 31-in high guardrail system placed on 2:1 slope. The posts were placed 1-ft from the slope break such that the face of the guardrail was aligned with the slope break as shown in Figure 1.2.

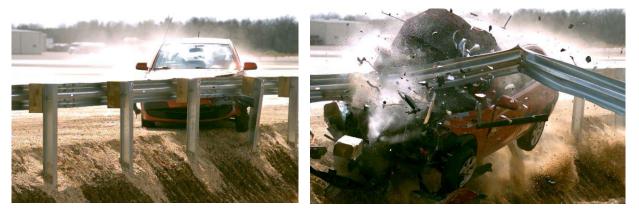
Figure 1.4. MASH 3-10 Test Resulted in Rupture of the W-Beam Rail Element (5).

Abu-Odeh *et al.* (5) investigated the feasibility of guardrail placement on steeper slopes such as 1:1 through nonlinear finite element analyses. Simulations for both *MASH* Tests 3-10 and 3-11 indicated a likelihood of successful outcome of testing for a regularly spaced posts, 31-inch tall W-beam guardrail system. The posts were placed 1-ft from the slope break such a design was tested in pool fund project, but the w-beam rail ruptured once impacted by the small car as shown in Figure 1.4.

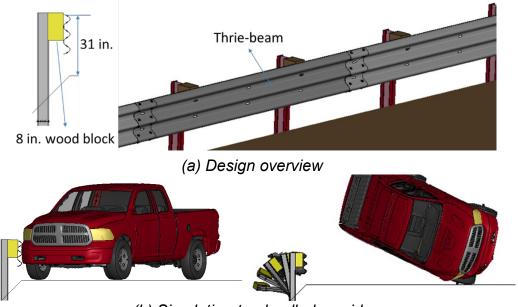
(b) Simulation-truck rolled on side Figure 2.1. Option 1: 31-inch Thrie-beam

Figure 2.1 through Figure 2.5 show key components of each design option and key simulation results, respectively. To simulate *MASH* TL-3 tests, the impact angle and speed were set at 25 degrees and 62 mi/h.

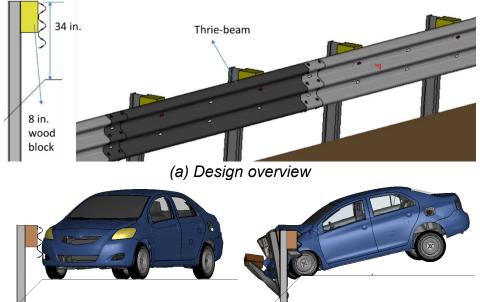
(b) Simulation - small car resulted in high occupant ridedown acceleration Figure 2.2. Option 2: 34-inch Thrie-beam

A 34-inch high thrie-beam guardrail system was proposed to address the pickup truck overriding and rolling over. The simulation results indicated that the 34-inch tall thrie system met *MASH* Test 3-11 evaluation criteria. However, a tire snagging potential (see Figure 2.2(b)) and a higher value of longitudinal occupant ridedown acceleration than *MASH* evaluation criteria limit was observed on the small car simulation for the *MASH* Test 3-10.

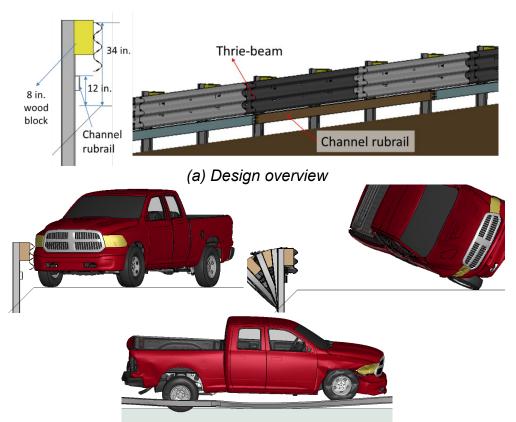
(b) Simulation - truck rode on channel rubrail and rolled on side Figure 2.3. Option 3: 34-inch Thrie-beam with channel rubrail at 12-in height

To avoid under riding and tire snagging behavior, a rubrail was added to the 34-inch thriebeam guardrail system. Two design options for the rubrail were considered: (a) C6×8.2 steel channel rubrail with 12-inch height from the flat ground and (b) 5.5-inch (wide) ×  $\frac{1}{4}$ inch (thick) steel plate rubrail with 12-inch height from the flat ground. The simulations showed that with the channel rubrail, the pickup truck overrode the channel and rolled on the side (see Figure 2.3(b)), while with the plate rubrail system, the longitudinal occupant ridedown acceleration for the small car was 23.3 g which exceeded *MASH* evaluation limit of 20.49 g.

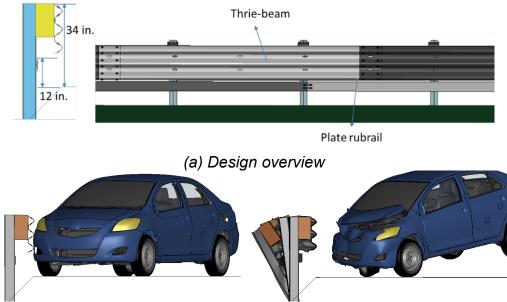
(b) Simulation – small car resulted in high occupant ridedown acceleration Figure 2.4. Option 4: 34-inch Thrie-beam with plate rubrail at 12-in height

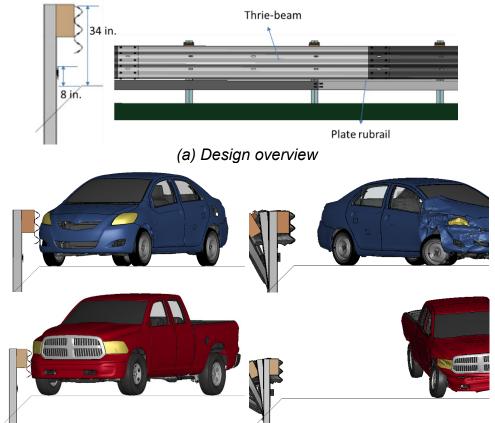
(b) Simulation – both small car and truck tests met MASH TL-3 evaluation criteria Figure 2.5. Option 5: 34-inch Thrie-beam with plate rubrail at 8-in height

To address these issues, a system with a lowered plate rubrail was proposed. This system consists of 34-inch Thrie-beam guardrail and a steel plate rubrail with 8-inch height from the flat ground. The simulations showed that this system met *MASH* requirements with both small car and pickup (see Figure 2.5(b)).

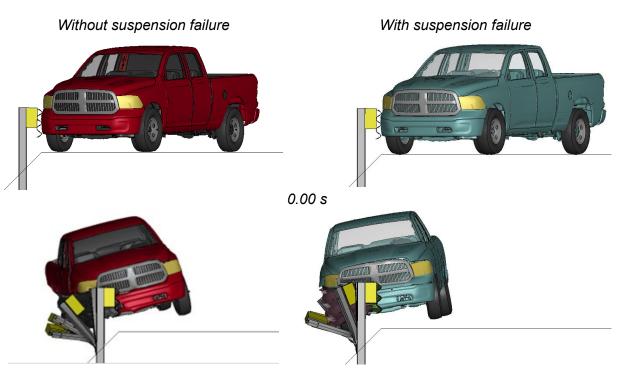
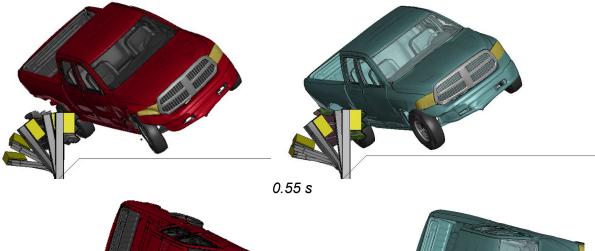
Figure 2.6 Sequential Images of Truck Simulation with 31-inch Thrie-beam Guardrail.

Figure 2.6 shows sequential images for the truck simulations at different time markers. Images in the left column show the initial simulation without suspension and tire failure, while the images in the right column show the new simulation result with the updated suspension failure model. Even with the tire and suspension failure in the vehicle model, the truck rolled on a side and failed to meet *MASH* evaluation criteria. Since the truck simulation did not pass the *MASH* evaluation criteria, the small car simulation was not performed.

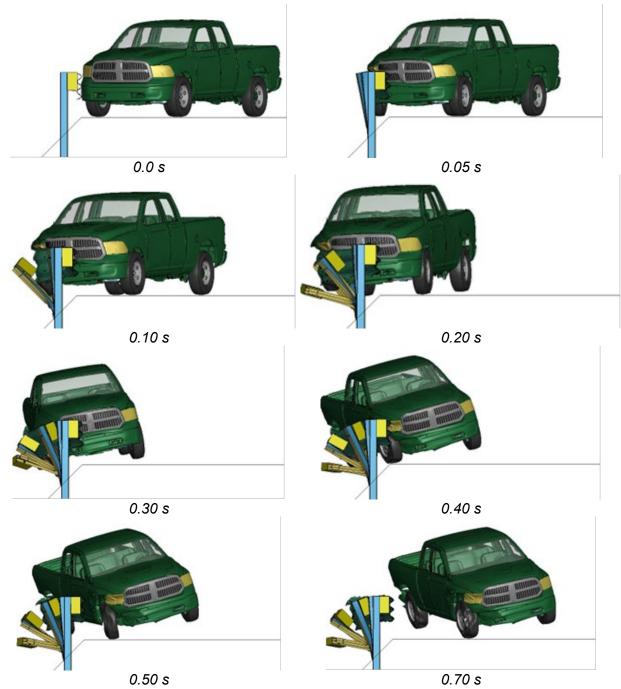
Figure 2.11 Sequential Images of Pickup Truck Impacting at Post (CIP) of 34-inch Thrie-Beam System on 1H:1V Slope.

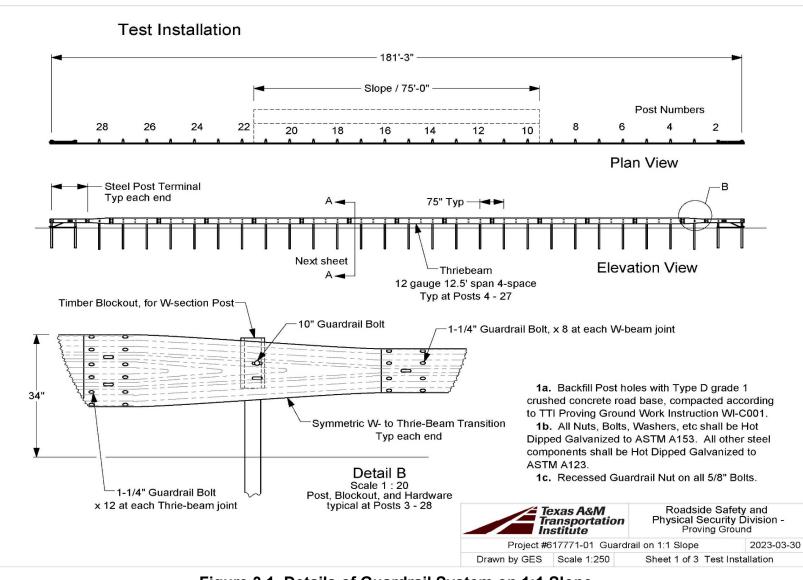
Figure 3.1. Details of Guardrail System on 1:1 Slope.

Figure 3.1 presents the overall information on the Guardrail System on 1:1 Slope, and Figure 3.2 thru Figure 3.7 provide photographs of the installation. Appendix A provides further details on the Guardrail System on 1:1 Slope. Drawings were provided by the Texas A&M Transportation Institute (TTI) Proving Ground, and construction was performed by DMA Construction LLC and supervised by TTI Proving Ground personnel.

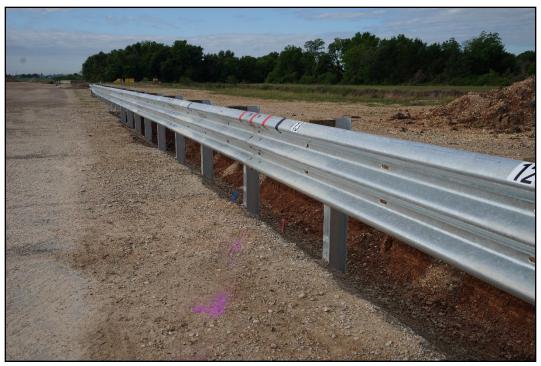
Figure 3.2. Overall View of the Guardrail System on 1:1 Slope Prior to Testing.

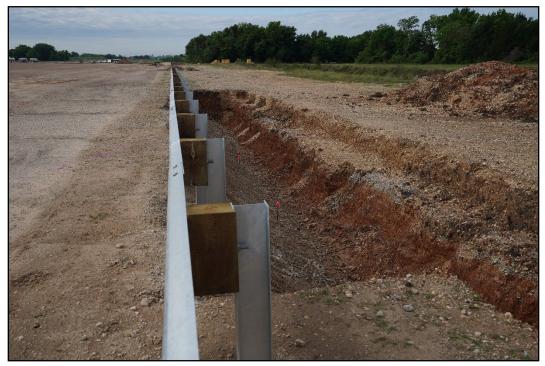
Figure 3.3.Upstream In-Line View of the Guardrail System on 1:1 Slope Prior to Testing.

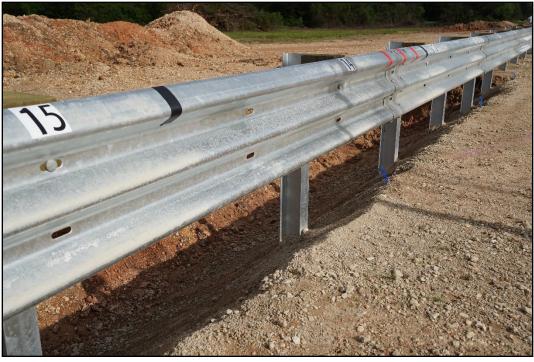
Figure 3.4. Guardrail System on 1:1 Slope at Impact Prior to Testing.

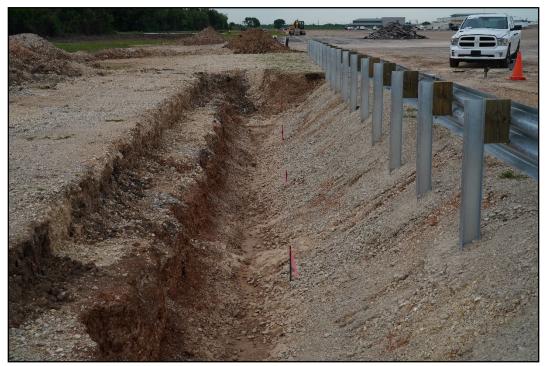
Figure 3.5. Field Side View of the Guardrail System on 1:1 Slope Prior to Testing.

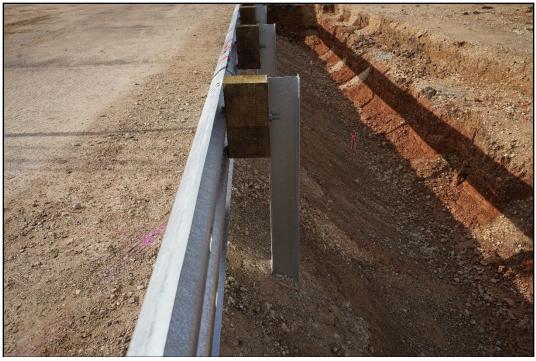
Figure 3.6. Detail of Posts in Guardrail System on 1:1 Slope Prior to Testing.

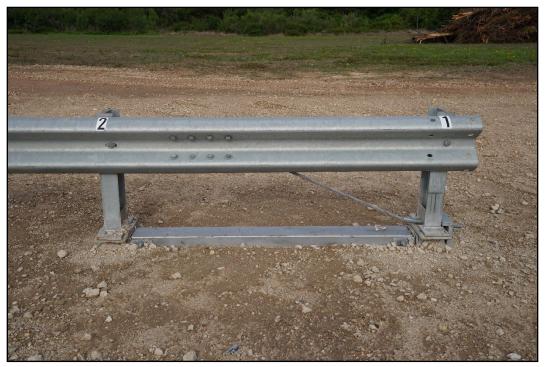
Figure 3.7.The Guardrail System on 1:1 Slope End Terminal Prior to Testing.

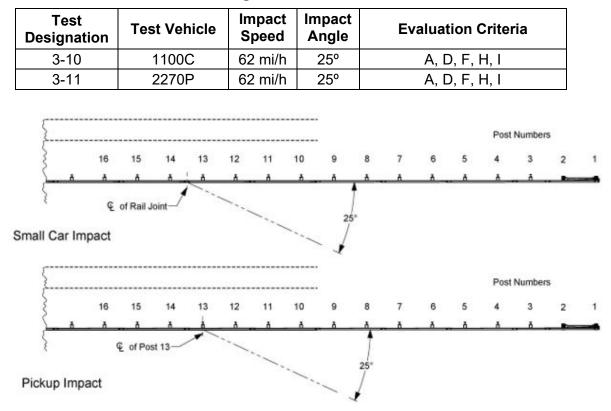
#### Figure 4.1. Target CIP for MASH TL-3 Tests on Guardrail System on 1:1 Slope.

Table 4.1 shows the test conditions and evaluation criteria for *MASH* TL-3 for Longitudinal Barrier. The target critical impact points (CIPs) for each test were determined using the information provided in *MASH* Section 2.2.1 and Section 2.3.2. Figure 4.1 shows the target CIP for *MASH* TL-3 tests on the Guardrail System on 1:1 Slope.

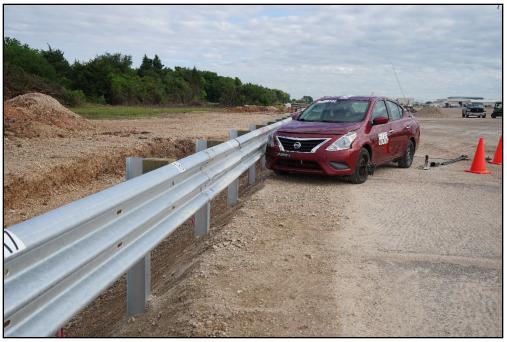
Figure 6.1. Guardrail System on 1:1 Slope/Test Vehicle Geometrics for Test 617771-01-1.

See Table 6.1 for details of *MASH* impact conditions for this test and Table 6.2 for the exit parameters. Figure 6.1 and Figure 6.2 depict the target impact setup.

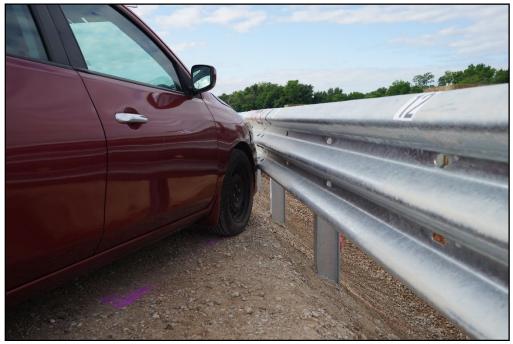
Figure 6.2. Guardrail System on 1:1 Slope/Test Vehicle Impact Location 617771-01-1.

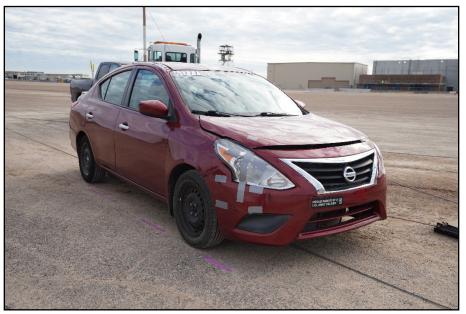
Figure 6.3. Impact Side of Test Vehicle before Test 617771-01-1.

Figure 6.3 and Figure 6.4 show the 2018 Nissan Versa used for the crash test. Table 6.4 shows the vehicle measurements. Figure C.1 in Appendix C.1 gives additional dimensions and information on the vehicle.

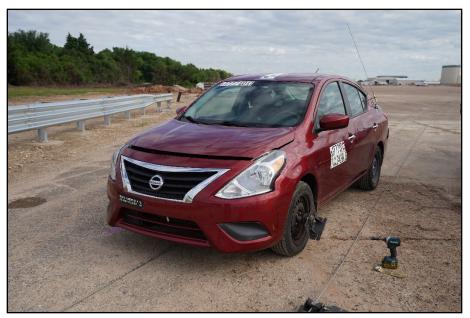
Figure 6.4. Opposite Impact Side of Test Vehicle before Test 617771-01-1.

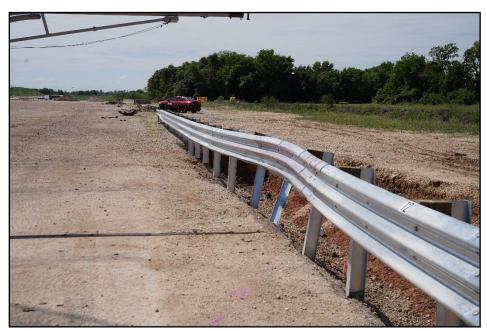
Figure 6.5. Guardrail System on 1:1 Slope at Impact Location after Test 617771-01-1.

Table 6.6 describes the damage to the Guardrail System on 1:1 Slope. Table 6.7 describes the deflection and working width of the Guardrail System on 1:1 Slope. Figure 6.5 and Figure 6.6 show the damage to the Guardrail System on 1:1 Slope.

Test Parameter	Measured
Permanent Deflection/Location	17.5 inches toward field side, at Post 15
Dynamic Deflection	33.0 inches toward field side 1 foot downstream of Post 15
Working Width <sup>a</sup> and Height	47.8 inches, at a height of 0 inches at Post 15

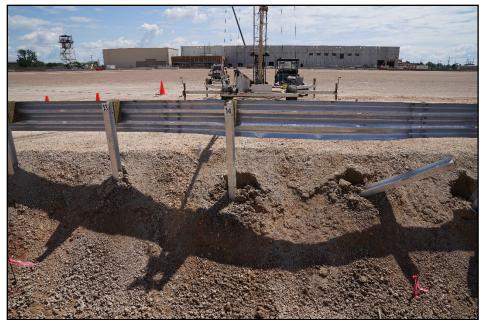
Figure 6.6. Guardrail System on 1:1 Slope from the Field Side after Test 617771-01-1.

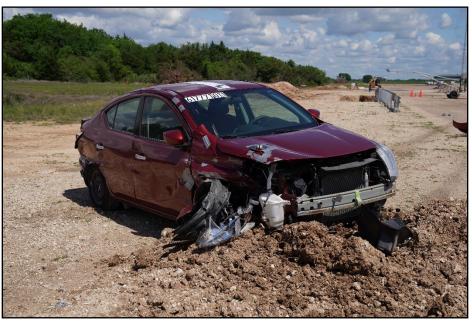
Figure 6.7. Impact Side of Test Vehicle after Test 617771-01-1.

Figure 6.7 and Figure 6.8 show the damage sustained by the vehicle. Figure 6.9 and Figure 6.10 show the interior of the test vehicle. Table 6.8 and Table 6.9 provide details on the occupant compartment deformation and exterior vehicle damage. Figures C.2 and C.3 in Appendix C.1 provide exterior crush and occupant compartment measurements.

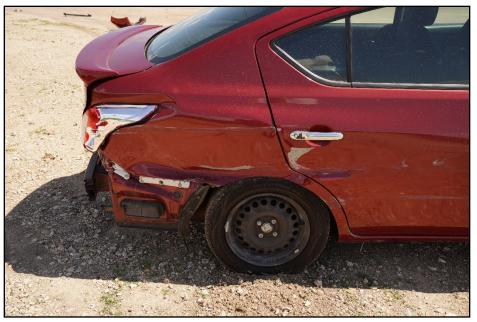
Figure 6.8. Opposite Rear Impact Side of Test Vehicle after Test 617771-01-1

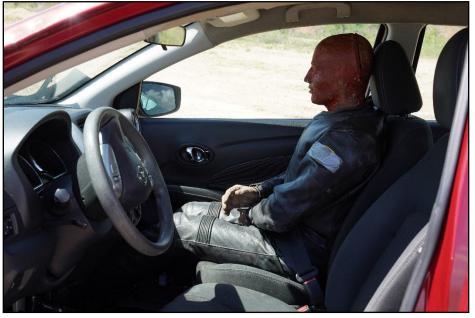
Figure 6.9. Overall Interior of Test Vehicle after Test 617771-01-1.

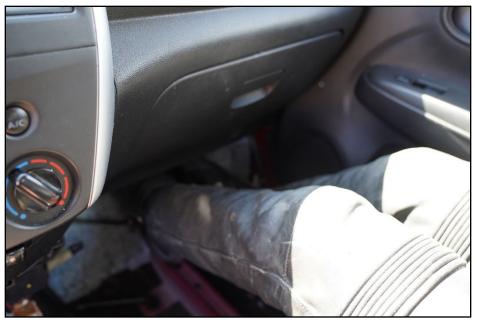
Figure 6.10. Interior of Test Vehicle on Impact Side after Test 617771-01-1.

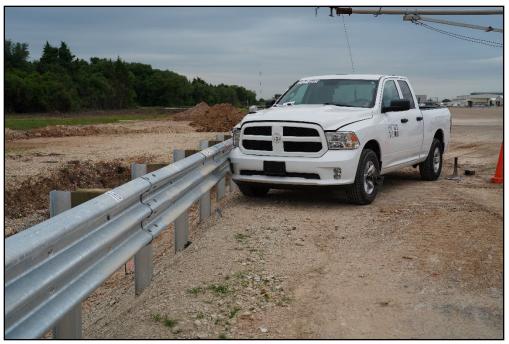
Figure 7.1. Guardrail System on 1:1 Slope/Test Vehicle Geometrics for Test 617771-01-2.

See Table 7.1 for details of *MASH* impact conditions for this test and Table 7.2 for the exit parameters. Figure 7.1 and Figure 7.2 depict the target impact setup.

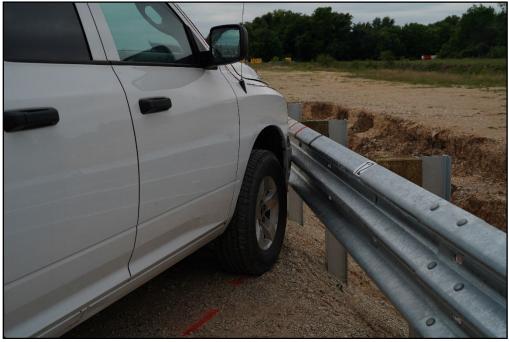
Figure 7.2. Guardrail System on 1:1 Slope/Test Vehicle Impact Location 617771-02-2.

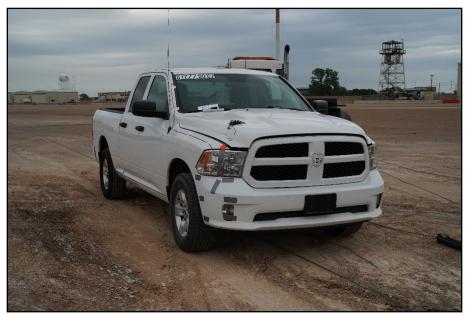
Figure 7.3. Impact Side of Test Vehicle before Test 617771-01-2.

Figure 7.3 and Figure 7.4 show the 2017 RAM 1500 used for the crash test. Table 7.4 shows the vehicle measurements. Figure D.1 in Appendix D.1 gives additional dimensions and information on the vehicle.

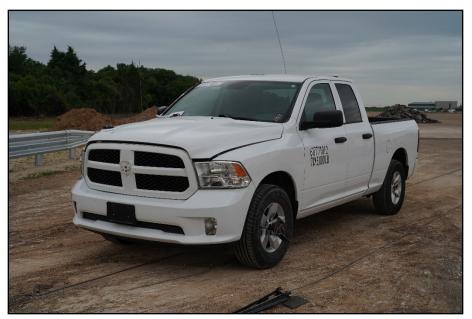
Figure 7.4. Opposite Impact Side of Test Vehicle before Test 617771-01-2.

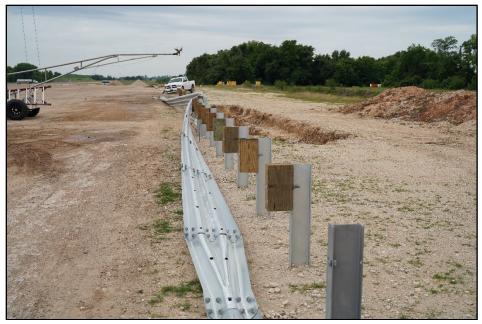
Figure 7.5. Overall View of the Guardrail System on 1:1 Slope after Test 617771-01-2.

Table 7.6. Damage to the Guardrail System on 1:1 Slope for Test 617771-01-2.describes the damage to the Guardrail System on 1:1 Slope. Table 7.7. Deflection and Working Width of the Guardrail System on 1:1 Slope for Test 617771-01-2.describes the deflection and working width of the Guardrail System on 1:1 Slope. Figure 7.5 through Figure 7.7 show the damage to the Guardrail System on 1:1 Slope.

Test Parameter	Measured
Permanent Deflection/Location	Not Measurable, guardrail released from posts
Dynamic Deflection	79.4 inches toward field side, at post 16 before rail released
Working Width <sup>a</sup> and Height	82.6 inches, at a height of 28.6 inches, at the thrie-beam at post 16

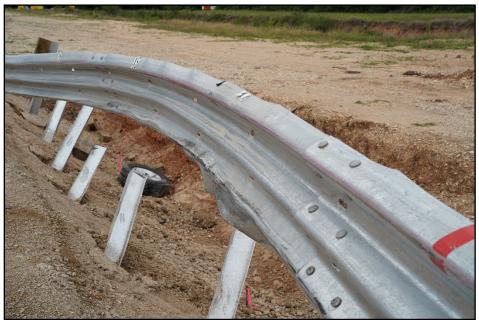
Figure 7.6. Guardrail System on 1:1 Slope at Impact Location after Test 617771-01-2.

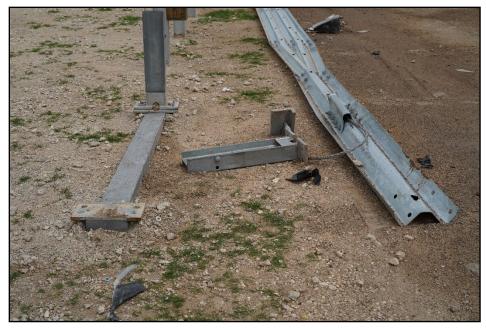
Figure 7.7. Guardrail System on 1:1 Slope at the Downstream Anchor after Test 617771-01-2.

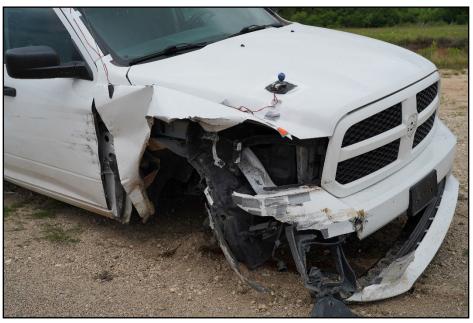
Figure 7.8. Impact Side of Test Vehicle after Test 617771-01-2.

Figure 7.8 and Figure 7.9 show the damage sustained by the vehicle. Figure 7.10 and Figure 7.11 show the interior of the test vehicle. Table 7.8 and Table 7.9 provide details on the occupant compartment deformation and exterior vehicle damage. Figures D.2 and D.3 in Appendix D.1 provide exterior crush and occupant compartment measurements.

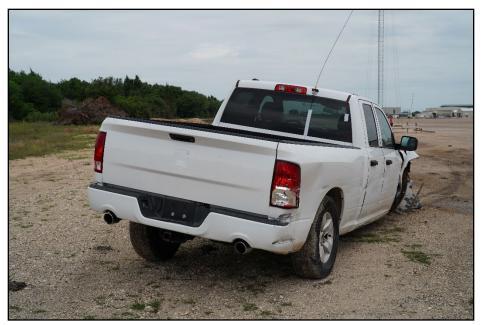
Figure 7.9. Rear Impact Side of Test Vehicle after Test 617771-01-2.

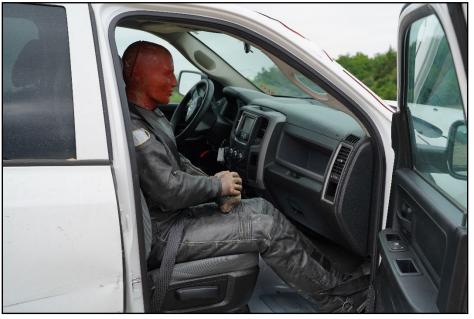
Figure 7.10. Overall Interior of Test Vehicle after Test 617771-01-2.

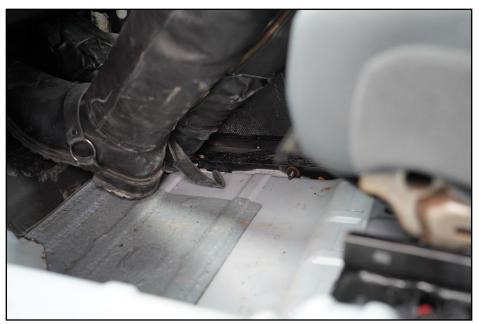
Figure 7.11. Interior of Test Vehicle on Impact Side after Test 617771-01-2.

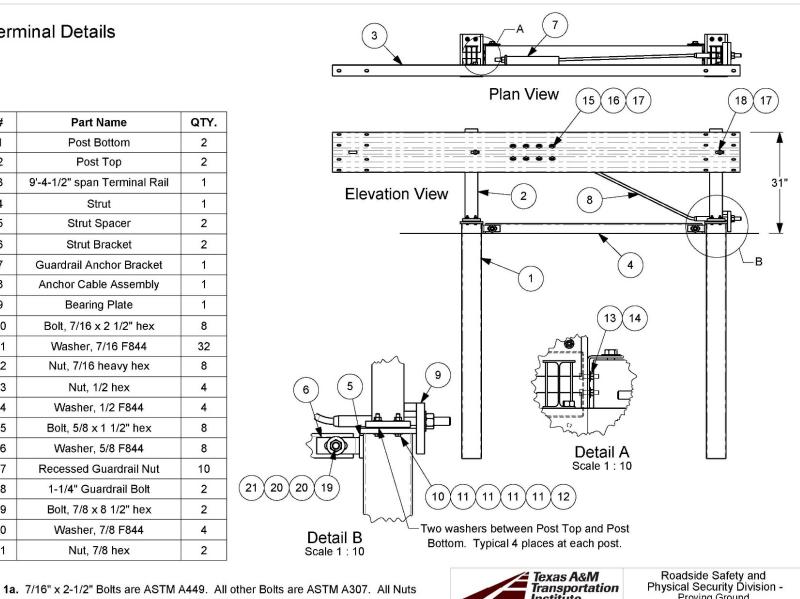
# **Terminal Details**

#	Part Name	QTY.			
1	Post Bottom	2			
2	2 Post Top				
3	9'-4-1/2" span Terminal Rail	1			
4	Strut	1			
5	Strut Spacer	2			
6	Strut Bracket	2			
7	Guardrail Anchor Bracket	1			
8	Anchor Cable Assembly	1			
9	Bearing Plate	1			
10	Bolt, 7/16 x 2 1/2" hex	8			
11	11 Washer, 7/16 F844				
12	Nut, 7/16 heavy hex	8			
13	Nut, 1/2 hex	4			
14	Washer, 1/2 F844	4			
15	Bolt, 5/8 x 1 1/2" hex	8			
16	Washer, 5/8 F844	8			
17	Recessed Guardrail Nut	10			
18	1-1/4" Guardrail Bolt	2			
19	Bolt, 7/8 x 8 1/2" hex	2			
20	Washer, 7/8 F844	4			
21	Nut, 7/8 hex	2

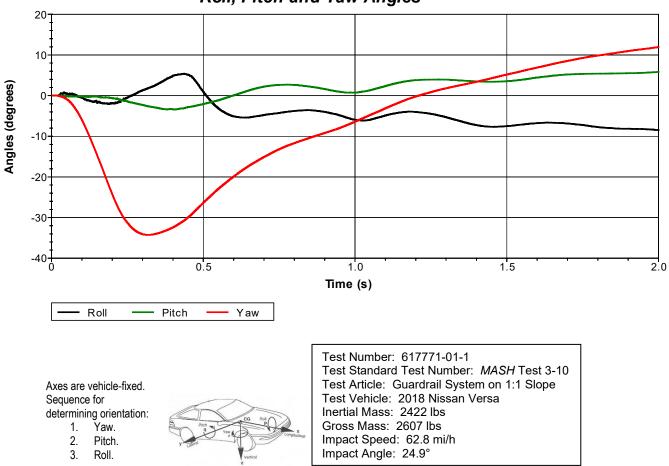
Roll, Pitch and Yaw Angles

Figure C.7. Vehicle Angular Displacements for Test 617771-01-1.

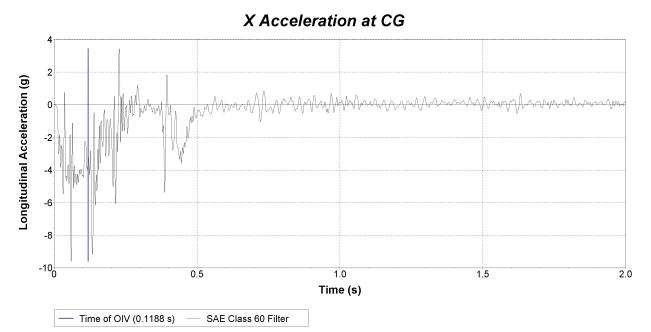
Figure C.8. Vehicle Longitudinal Accelerometer Trace for Test 617771-01-1 (Accelerometer Located at Center of Gravity).

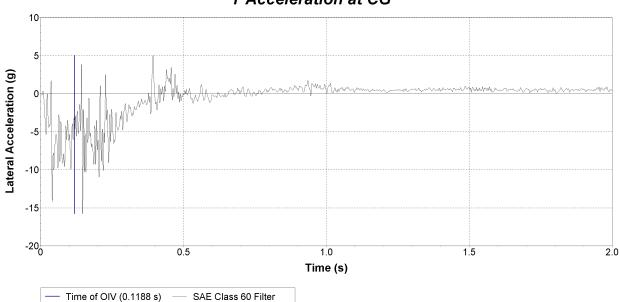
Figure C.9. Vehicle Lateral Accelerometer Trace for Test 617771-01-1 (Accelerometer Located at Center of Gravity).

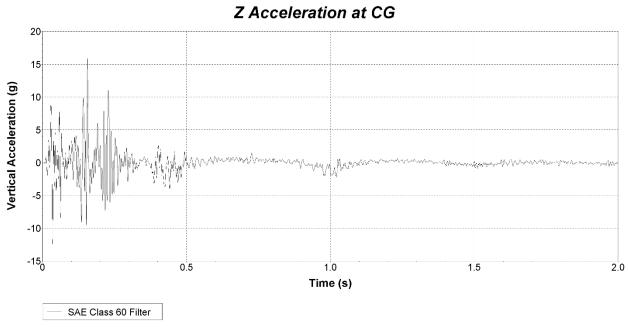
Figure C.10. Vehicle Vertical Accelerometer Trace for Test 617771-01-1 (Accelerometer Located at Center of Gravity).

Figure 7.10. Overall Interior of Test Vehicle after Test 617771-01-2	
Figure 7.11. Interior of Test Vehicle on Impact Side after Test 617771-01-2.	
Figure 7.12. Summary of Results for <i>MASH</i> Test 3-11 on Guardrail System on 1:1 Slope.	
Figure C.2. Exterior Crush Measurements for Test 617771-01-1	. 37
Figure C.3. Occupant Compartment Measurements for Test 617771-01-1	
Figure C.4. Sequential Photographs for Test 617771-01-1 (Overhead Views).	
Figure C.5. Sequential Photographs for Test 617771-01-1 (Eventead Views).	
Figure C.6. Sequential Photographs for Test 617771-01-1 (Rear Views).	
Figure C.7. Vehicle Angular Displacements for Test 617771-01-1	. 82
Figure C.8. Vehicle Longitudinal Accelerometer Trace for Test 617771-01-1	~ ~
(Accelerometer Located at Center of Gravity).	. 83
Figure C.9. Vehicle Lateral Accelerometer Trace for Test 617771-01-1	
(Accelerometer Located at Center of Gravity)	. 83
Figure C.10. Vehicle Vertical Accelerometer Trace for Test 617771-01-1

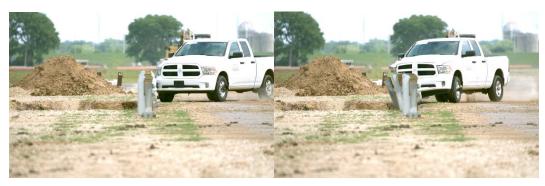
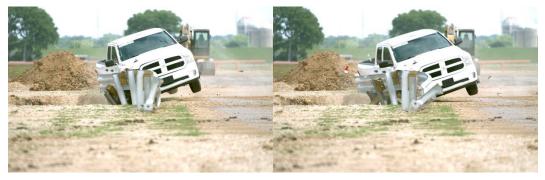
(g) 0.600 s (h) 0.700 s Figure D.4. Sequential Photographs for Test 617771-01-2 (Overhead Views).

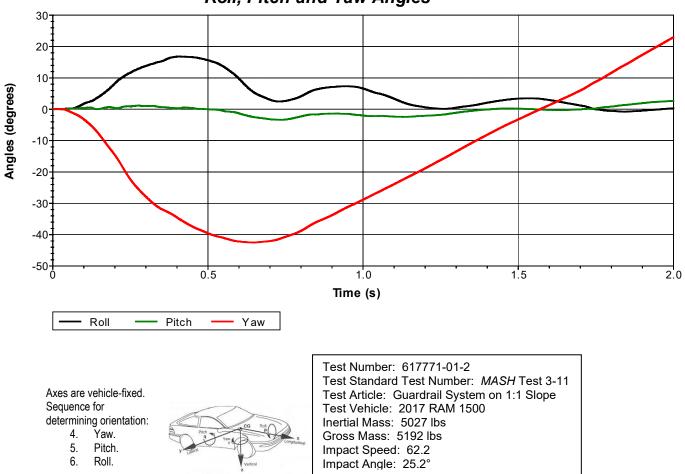
#### Roll, Pitch and Yaw Angles

Figure D.7. Vehicle Angular Displacements for Test 617771-01-2.

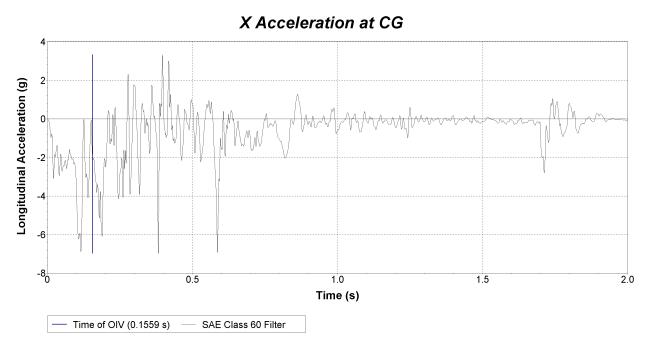
Figure D.8. Vehicle Longitudinal Accelerometer Trace for Test 617771-01-2 (Accelerometer Located at Center of Gravity).

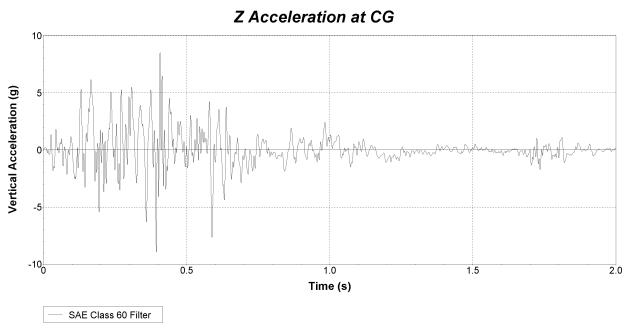
Figure D.10. Vehicle Vertical Accelerometer Trace for Test 617771-01-2
