Test Report No. 619441-01 09&10

**DESIGN AND EVALUATION OF ASPHALT VEGETATION CONTROL
TREATMENT FOR STEEL-POST W-BEAM GUARDRAIL SYSTEM**

1. Report No.		2. Government Accession No.		3. Recipient's Catalog No.	
4. Title and Subtitle Design and Evaluation of Asphalt Vegetation Control Treatment for Steel-Post W-Beam Guardrail System				5. Report Date January 2024

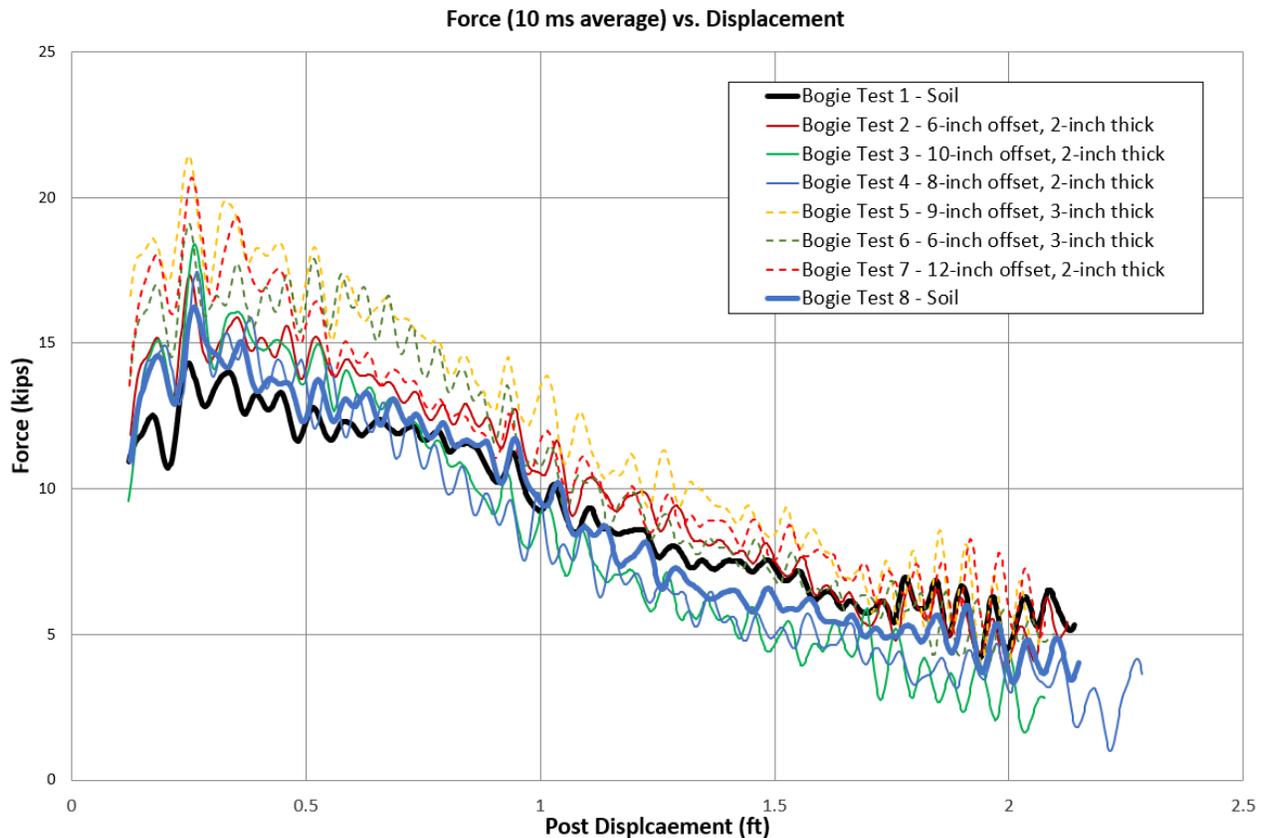
Figure 2.20. Force Versus Deflection Response of Posts for all Bogie Tests.

Acceleration data was collected from each of the eight bogie tests close to the center of gravity of the bogie vehicle. Using the bogie vehicle's mass, acceleration-time data in the test, and post deflection-time data from high-speed videos, the researchers

determined the force-deflection response of the post for each bogie test. Figure 2.20 shows the 10-ms average force versus the deflection of the post for all bogie tests.

The force-deflection response is a good representation of how the post is expected to deflect in response to vehicle impact. By comparing the force-deflection response of the posts installed in asphalt to the posts installed only in soil, the researchers picked the asphalt thickness and offset from the edge of the asphalt pad that would allow the post to behave like the post installed in soil.

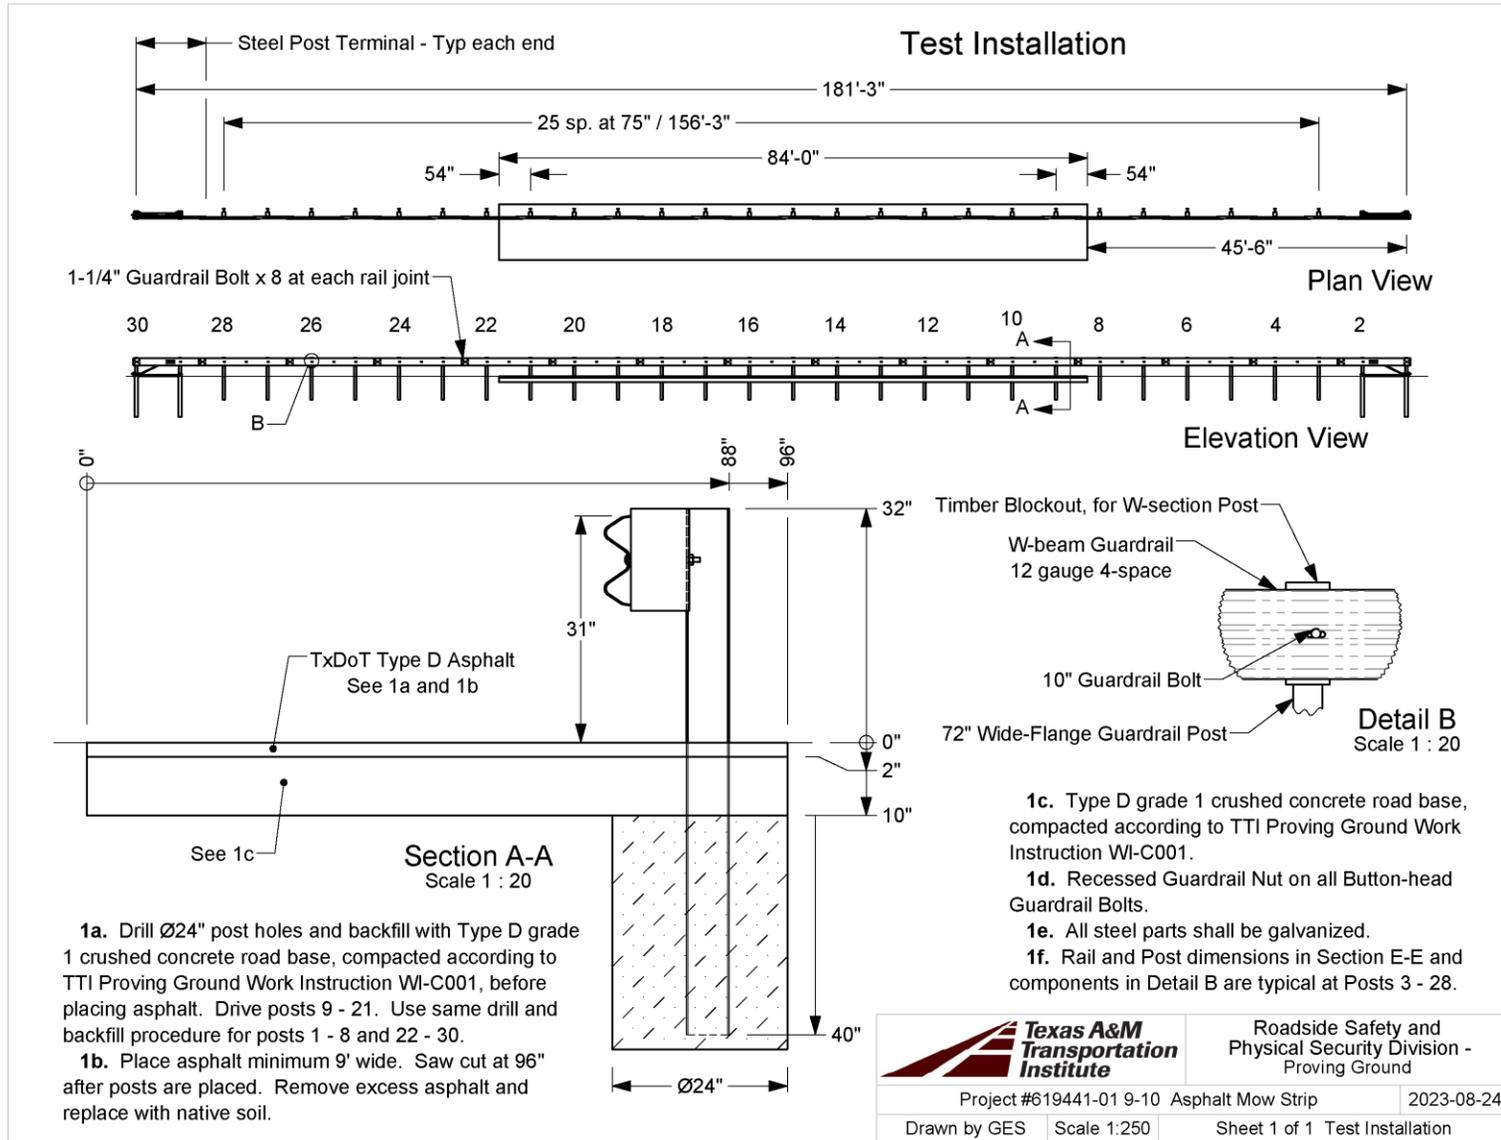
Figure 3.1. Details of Steel Post W-beam Guardrail in Asphalt Vegetation Control Treatment.

Figure 3.1 presents the overall information on the Steel Post W-beam Guardrail in Asphalt Vegetation Control Treatment, and Figure 3.2 thru Figure 3.7 provide photographs of the installation. Appendix B provides further details on the Steel Post W-beam Guardrail in Asphalt Vegetation Control Treatment. Drawings were provided by the Texas A&M Transportation Institute (TTI) Proving Ground, and construction was performed by TTI Proving Ground personnel.

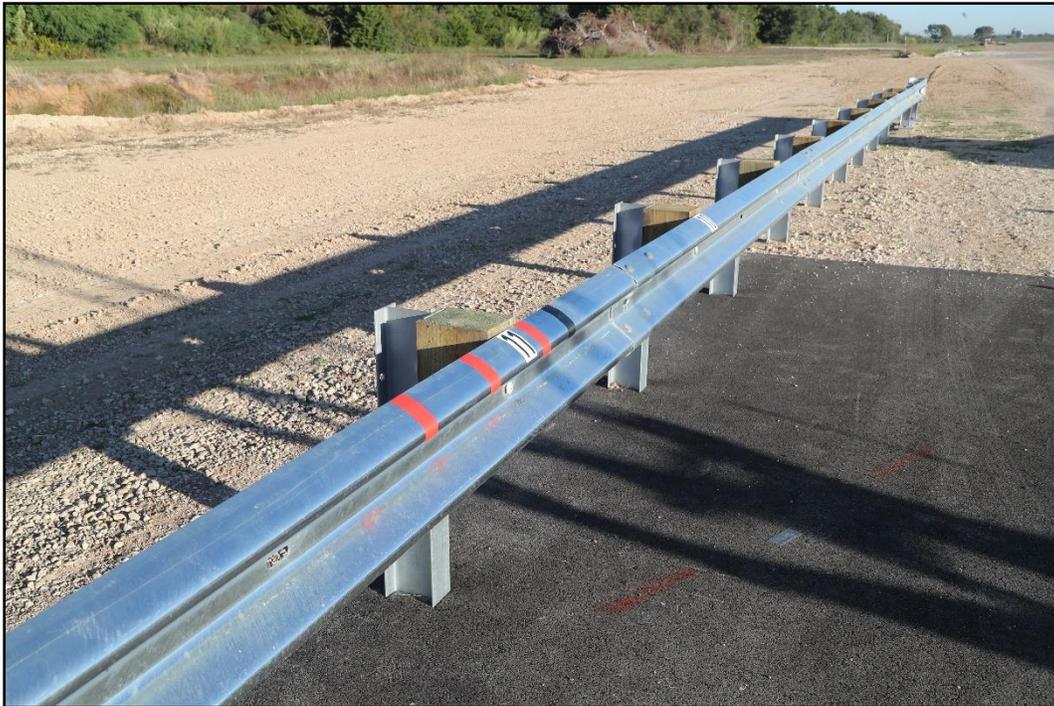
Figure 3.2. Steel Post W-beam Guardrail in Asphalt Vegetation Control Treatment Prior to Testing.

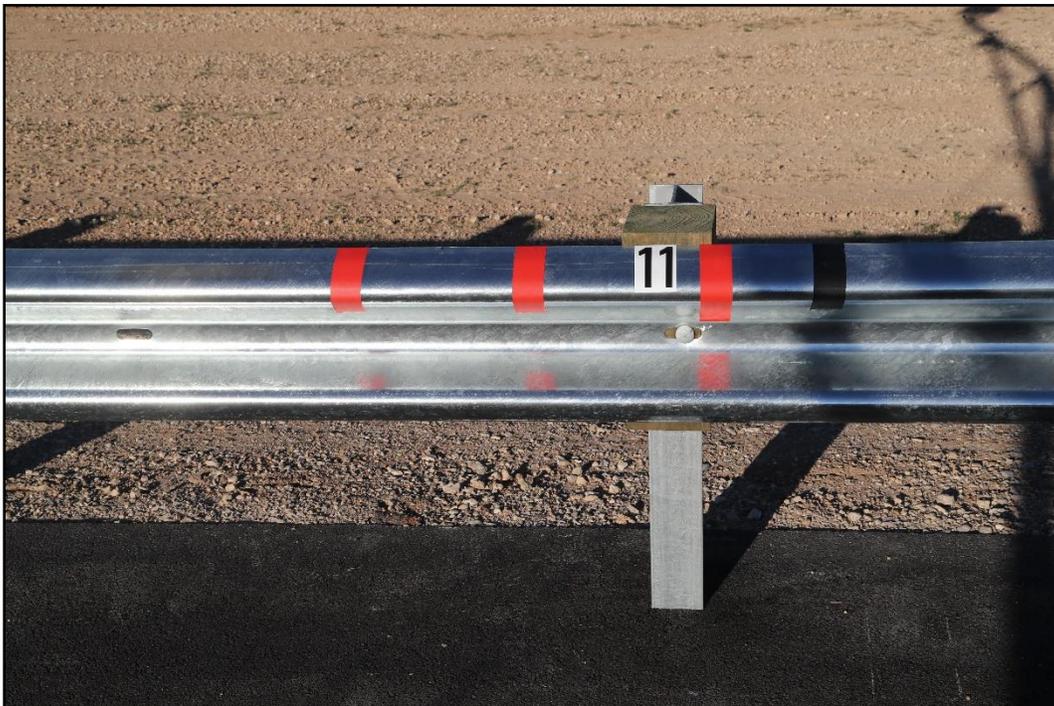
Figure 3.3. Steel Post W-beam Guardrail in Asphalt Vegetation Control Treatment at Impact Prior to Testing.

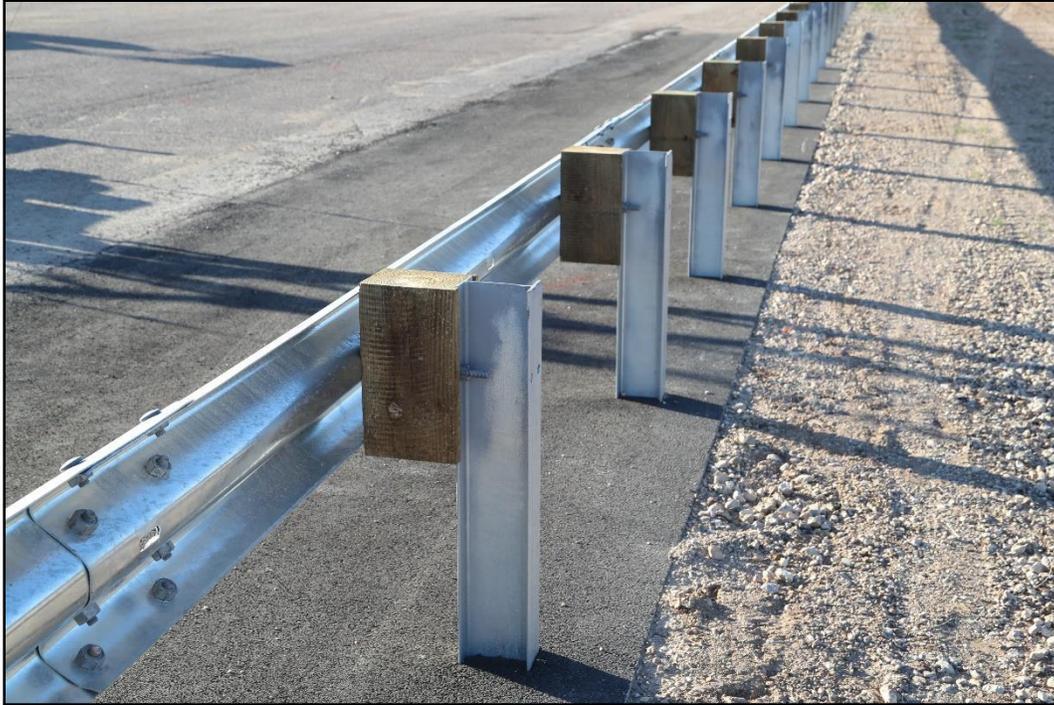
Figure 3.4. Field Side View of Steel Post W-beam Guardrail in Asphalt Vegetation Control Treatment Prior to Testing.

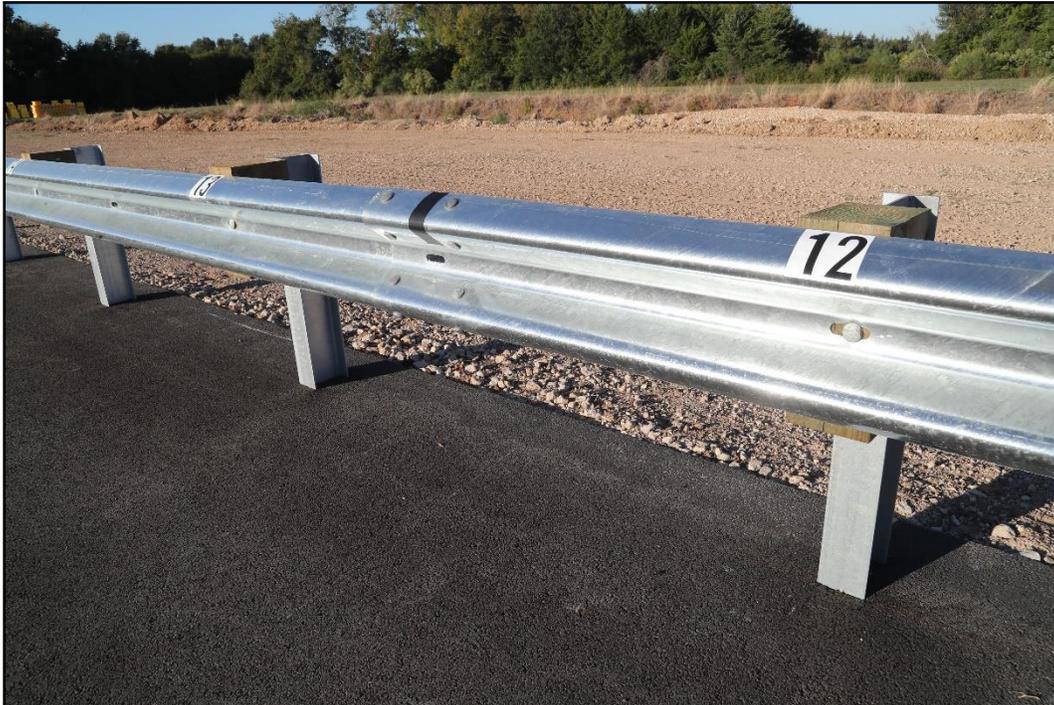
Figure 3.5. Oblique Downstream View of Steel Post W-beam Guardrail in Asphalt Vegetation Control Treatment Prior to Testing.

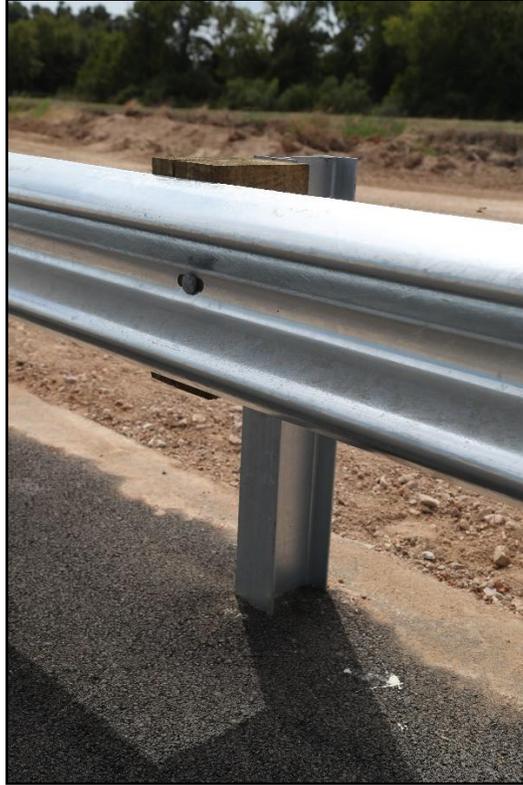
Figure 3.6. Closeup of Steel Post with Timber Blockout on Asphalt Vegetation Control Treatment with Guardrail Prior to Testing.

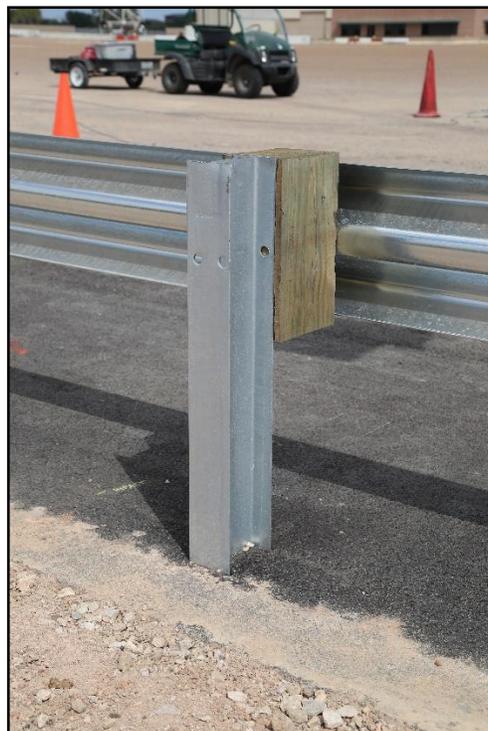
Figure 3.7. Field Side Closeup View of Steel Post with Timber Blockout on Steel Post W-beam Guardrail in Asphalt Vegetation Control Treatment Prior to Testing.

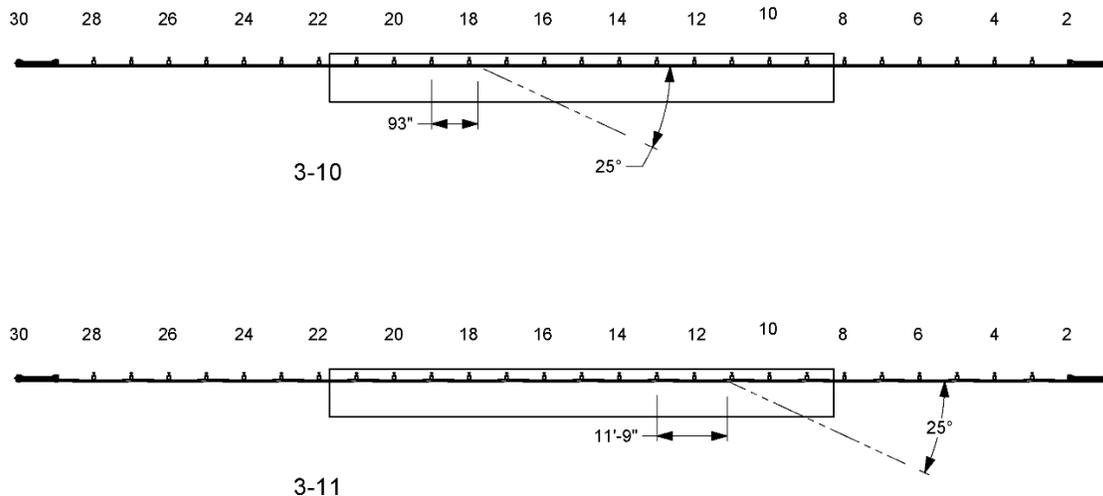
Figure 4.1. Target CIP for *MASH* TL-3 Tests on Steel Post W-beam Guardrail in Asphalt Vegetation Control Treatment.

Table 4.1 shows the test conditions and evaluation criteria for *MASH* TL-3 for longitudinal barriers. The target critical impact points (CIPs) for each test were determined using the information provided in *MASH* Section 2.2.4 and Section 2.3.2. Figure 4.1 shows the target CIP for *MASH* TL-3 tests on the Steel Post W-beam Guardrail in Asphalt Vegetation Control Treatment.

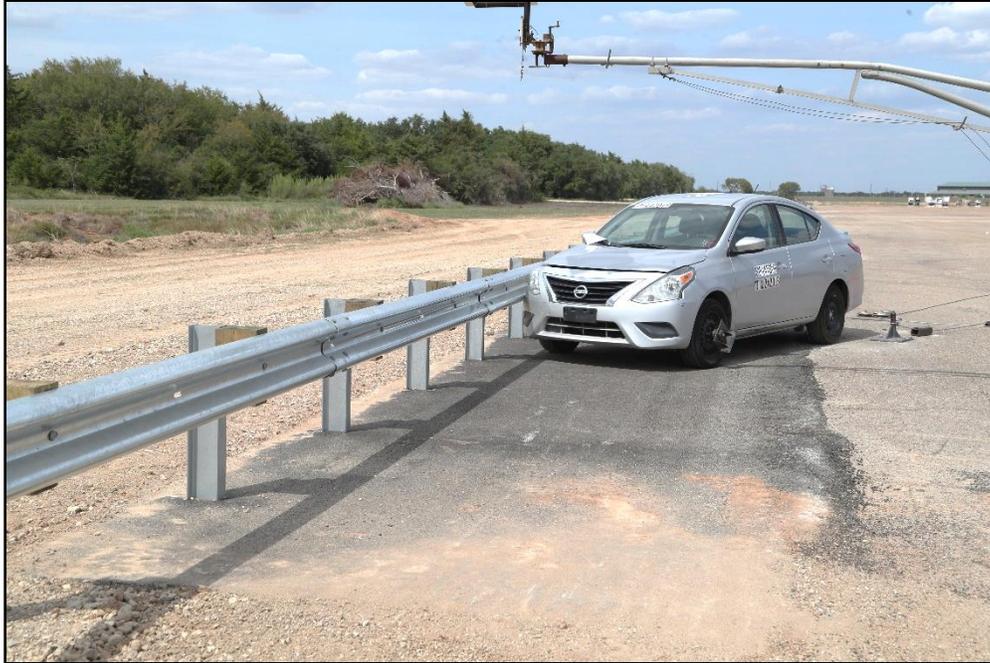
Figure 6.1. Steel Post W-beam Guardrail in Asphalt Vegetation Control Treatment/Test Vehicle Geometrics for Test 619441-01-9.

See Table 6.1 for details of impact conditions for this test and Table 6.2 for the exit parameters. Figure 6.1 and Figure 6.2 depict the target impact setup.

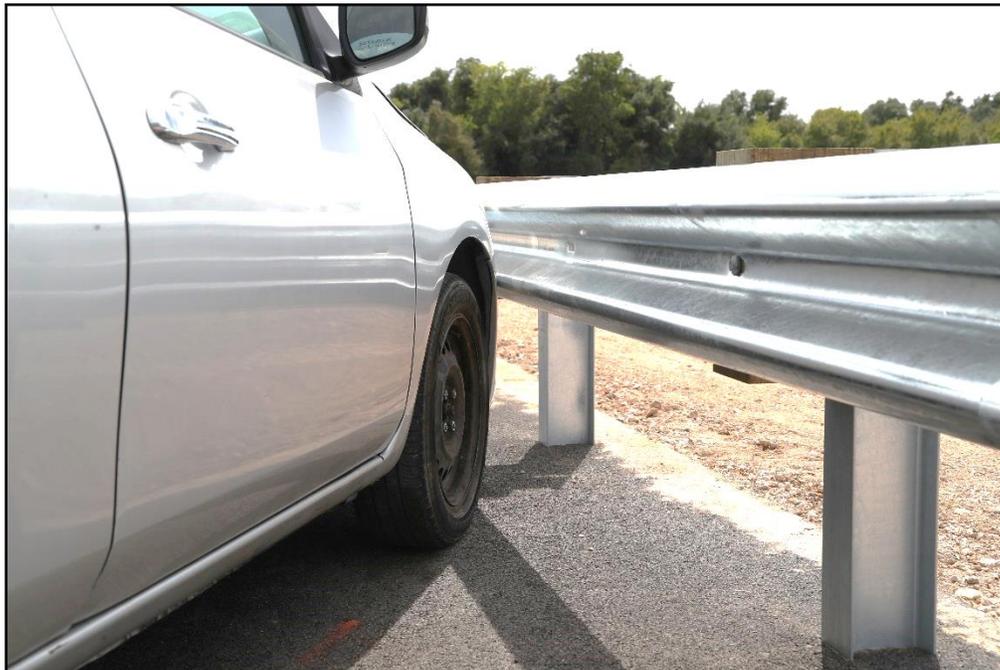
Figure 6.2. Steel Post W-beam Guardrail in Asphalt Vegetation Control Treatment/Test Vehicle Impact Location 619441-01-9.

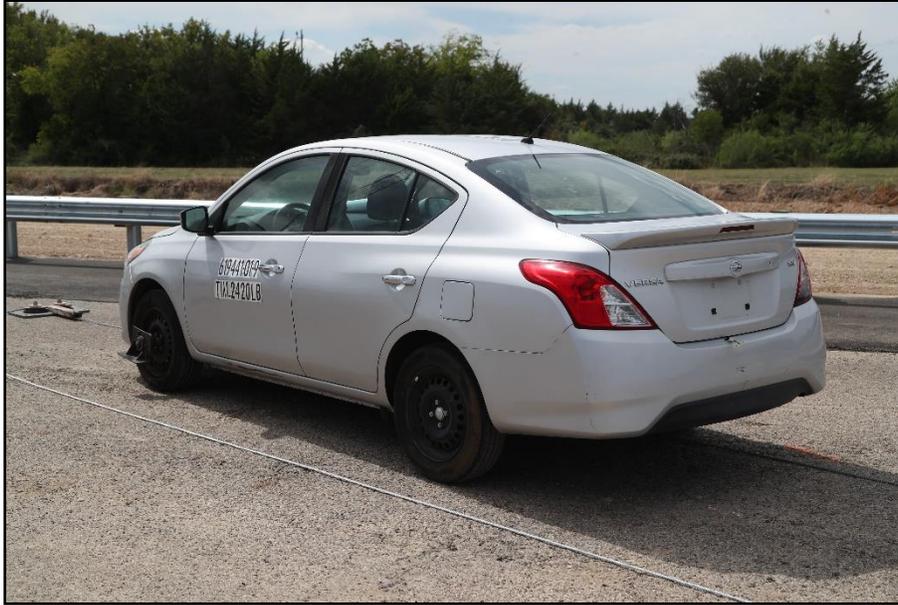
Figure 6.4. Opposite Impact Side of Test Vehicle Before Test 619441-01-9.

Figure 6.3 and Figure 6.4 show the 2018 Nissan Versa used for the crash test. Table 6.4 shows the vehicle measurements. Figure D.1 in Appendix D.1 gives additional dimensions and information on the vehicle.

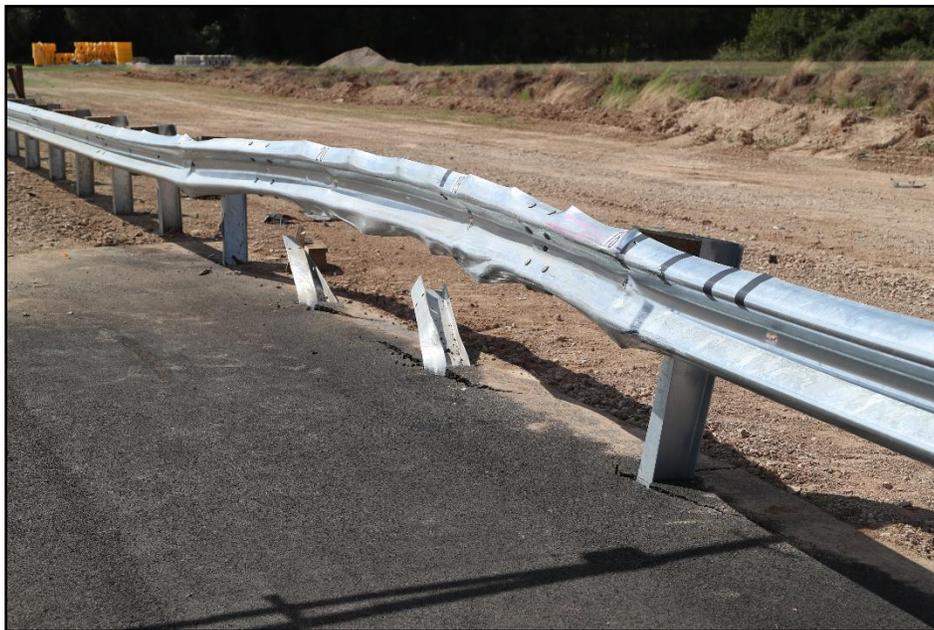
Figure 6.5. Steel Post W-beam Guardrail in Asphalt Vegetation Control Treatment at Impact Location After Test 619441-01-9.

Post 18 had a clockwise twist, and the rail was deformed around the blockout. The asphalt at this post location had a large crack that ran parallel to the rail on the traffic side with one large crack running perpendicular to the rail on the field side. The rail detached from Post 19 and the blockout was removed. The asphalt at this post location had the same cracking as Post 18. Post 20 had the blockout removed, and the asphalt had the same cracking as Post 18. The slot in the rail for the guardrail bolt tore. Post 25 also released from the rail. The rail between Posts 18-21 was deformed and scuffed. Table 6.6 describes the soil gap and post lean of the Steel Post W-beam Guardrail in Asphalt Vegetation Control Treatment.

Table 6.7 describes the deflection and working width of the Steel Post W-beam Guardrail in Asphalt Vegetation Control Treatment. Figure 6.5 through Figure 6.11 show the damage to the Steel Post W-beam Guardrail in Asphalt Vegetation Control Treatment.

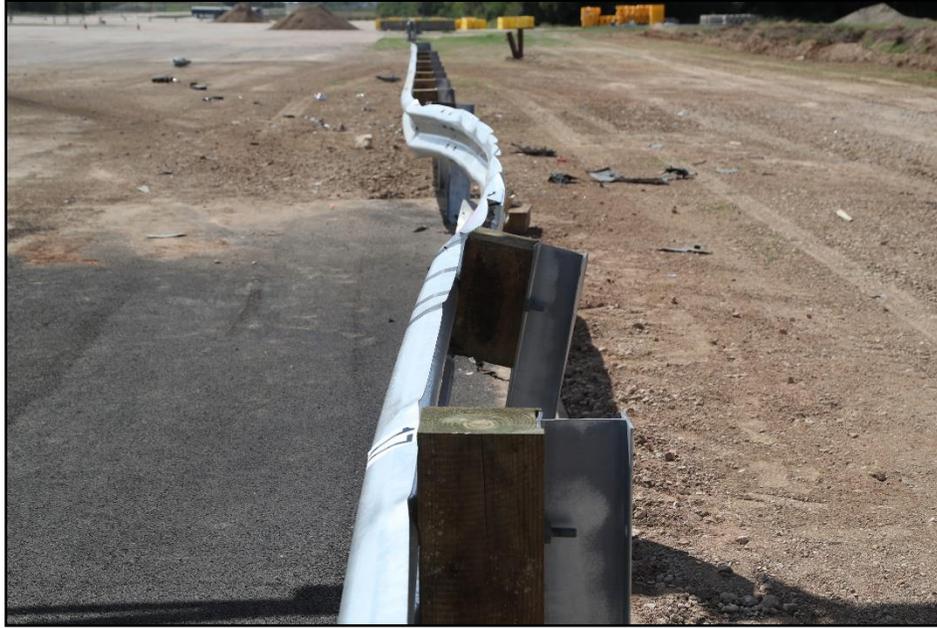
Figure 6.6. Upstream View of Steel Post W-beam Guardrail in Asphalt Vegetation Control Treatment After Test 619441-01-9.

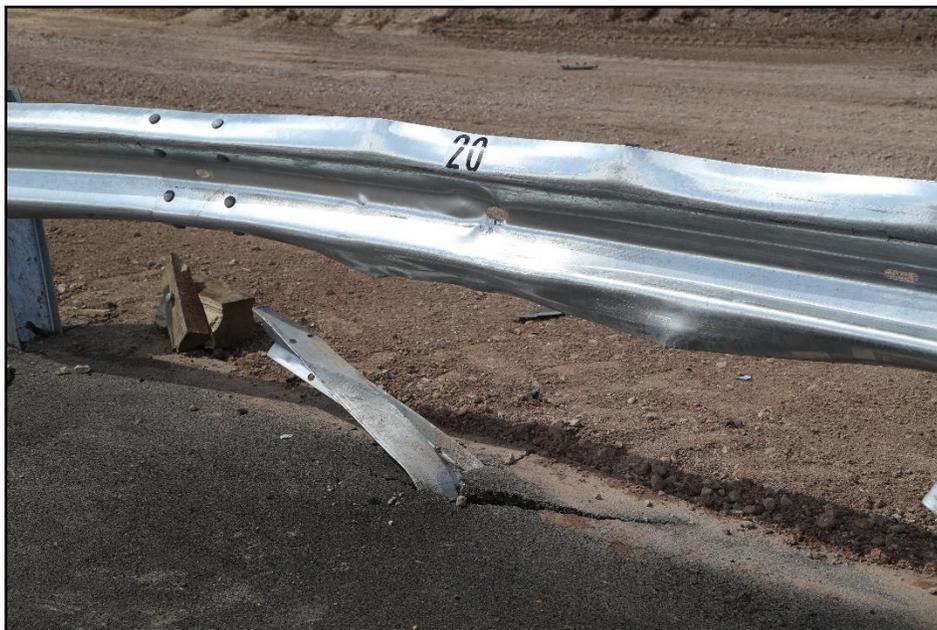
Figure 6.7. View at Post 20 of Steel Post W-beam Guardrail in Asphalt Vegetation Control Treatment After Test 619441-01-9

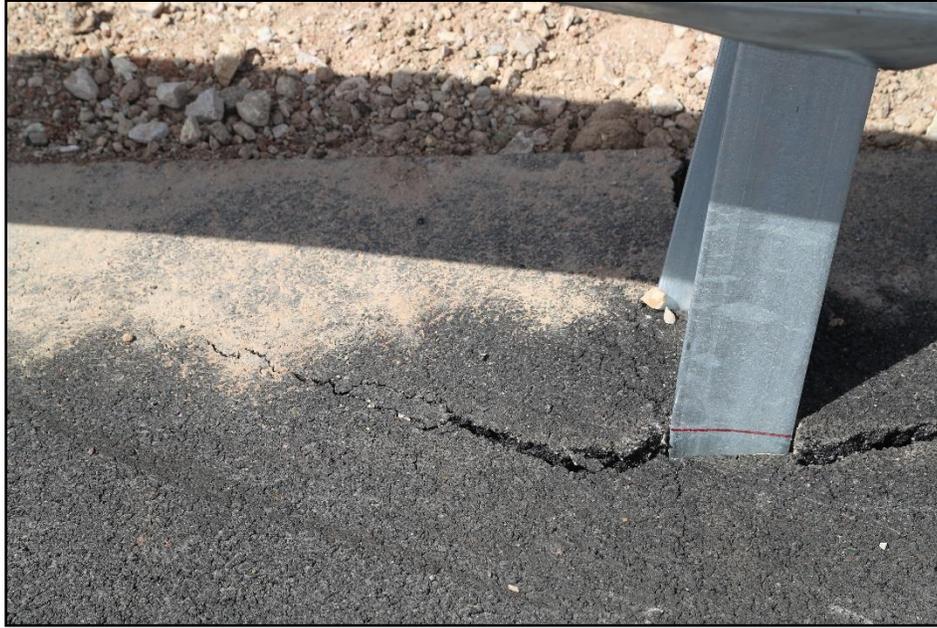
Figure 6.8. View of Asphalt Cracking at Post 18 of Steel Post W-beam Guardrail in Asphalt Vegetation Control Treatment After Test 619441-01-9

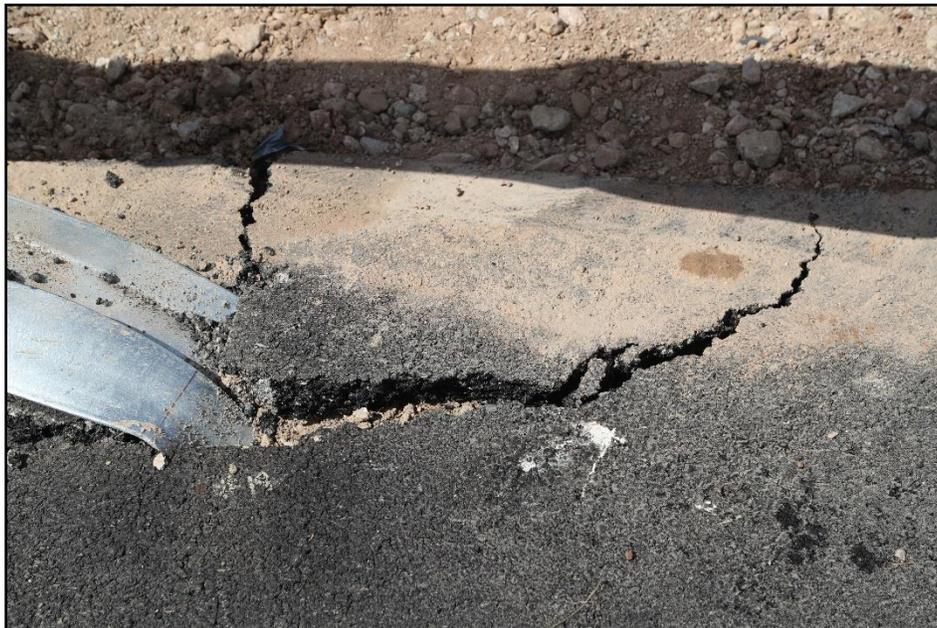
Figure 6.9. View of Asphalt Cracking at Post 19 of Steel Post W-beam Guardrail in Asphalt Vegetation Control Treatment After Test 619441-01-9

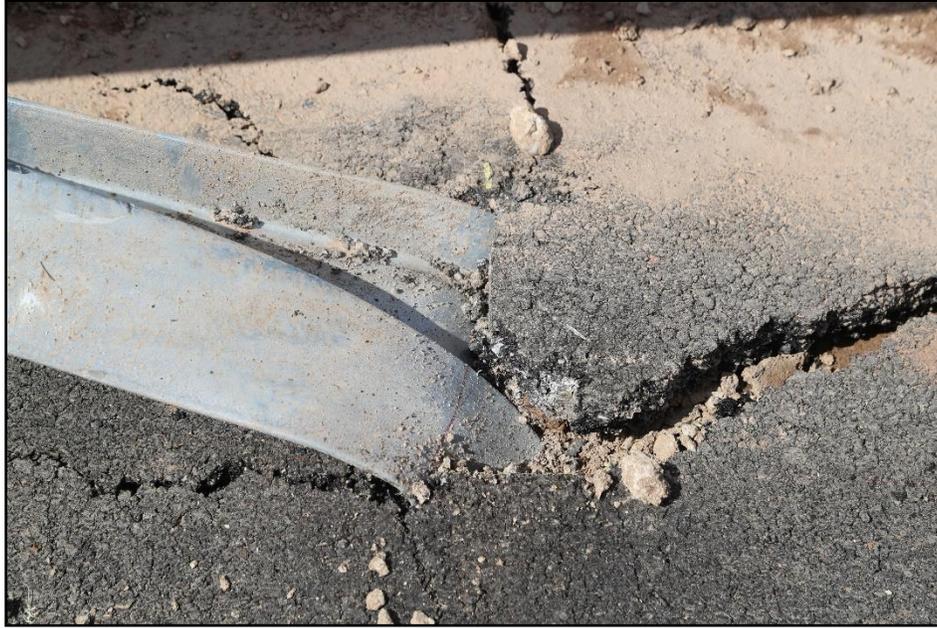
Figure 6.10. View of Asphalt Cracking at Post 20 of Steel Post W-beam Guardrail in Asphalt Vegetation Control Treatment After Test 619441-01-9

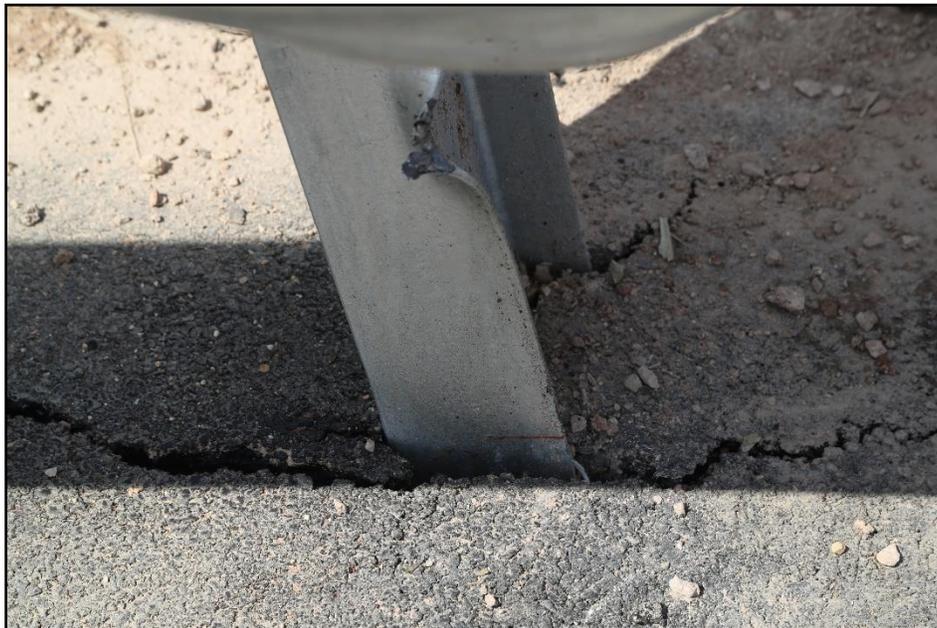
Figure 6.11. View of Asphalt Cracking at Post 21 of Steel Post W-beam Guardrail in Asphalt Vegetation Control Treatment After Test 619441-01-9

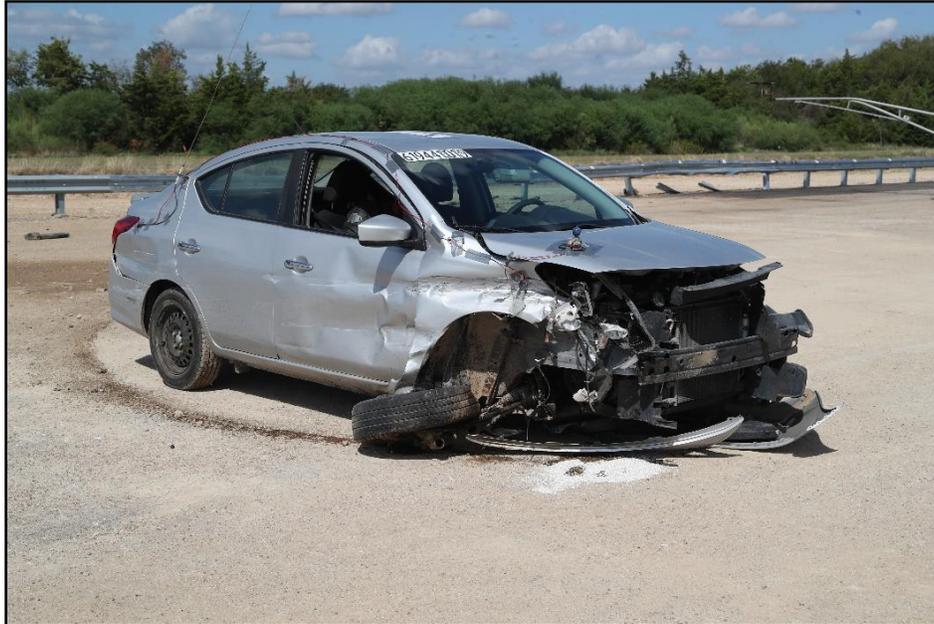
Figure 6.12. Impact Side of Test Vehicle After Test 619441-01-9.

Figure 6.12 and Figure 6.13 show the damage sustained by the vehicle. Figure 6.14 and Figure 6.15 show the interior of the test vehicle. Table 6.8 and Table 6.9 provide details on the occupant compartment deformation and exterior vehicle damage. Figures D.2 and D.3 in Appendix D.1 provide exterior crush and occupant compartment measurements.

Side Windows	Right front window was shattered.
Maximum Exterior Deformation	9 inches above the front bumper.
VDS	01RFQ4
CDC	01FREN2
Fuel Tank Damage	None
Description of Damage to Vehicle:	The headlights, bumper, and grill were removed. The right front door was dented with a 5-inch gap at the top and the glass was shattered. There was a small dent in the right rear door. The right rear had its quarter panel dented, taillight broken, and bumper cover scratched. The right front wheel was dented, and the tire was flat. The right control arm was ripped off with the right front brake line broken and frame rail bent.

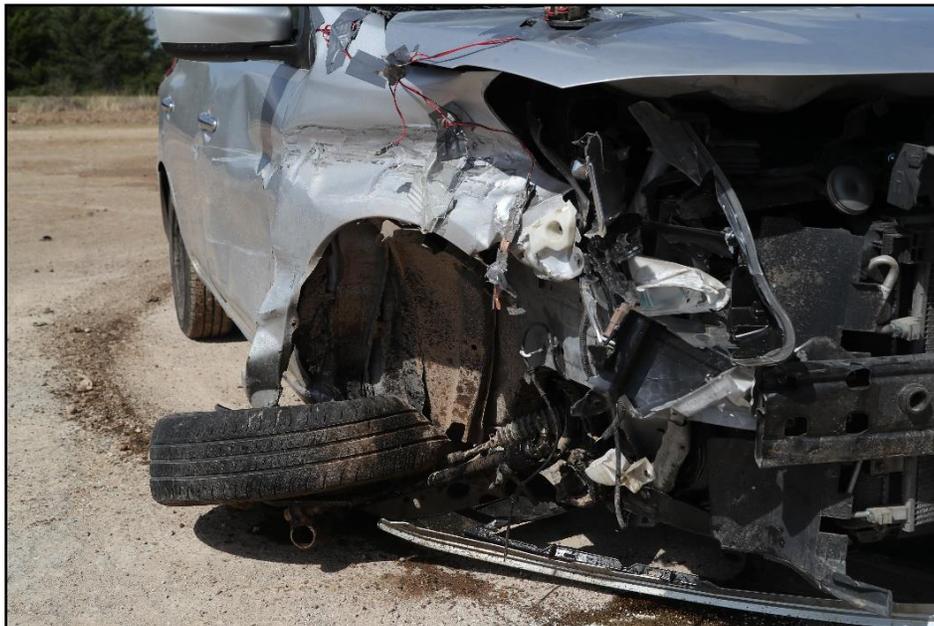
Figure 6.13. Close-Up of the Impact Side of Test Vehicle After Test 619441-01-9.

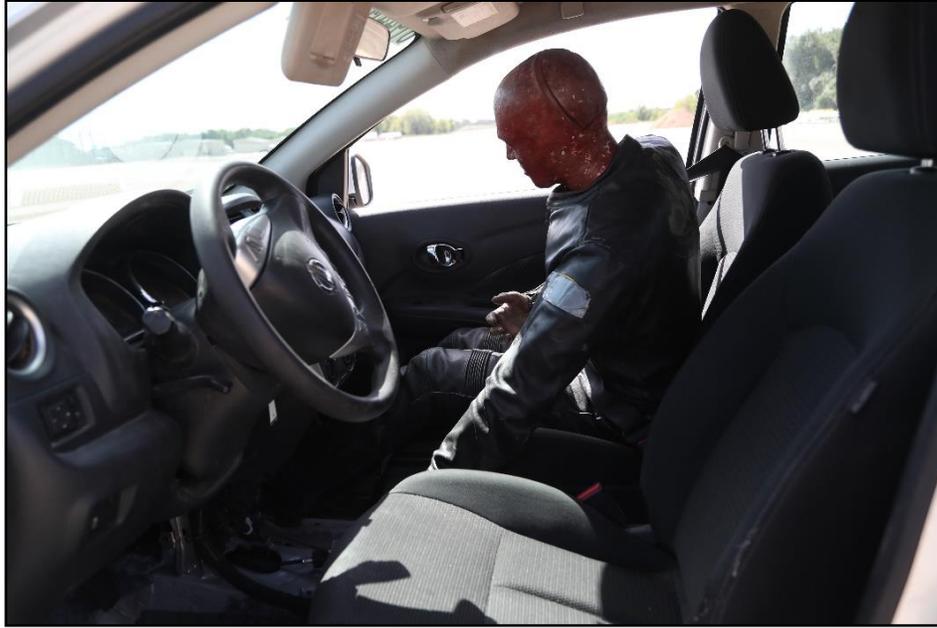
Figure 6.14. Overall Interior of Test Vehicle After Test 619441-01-9.

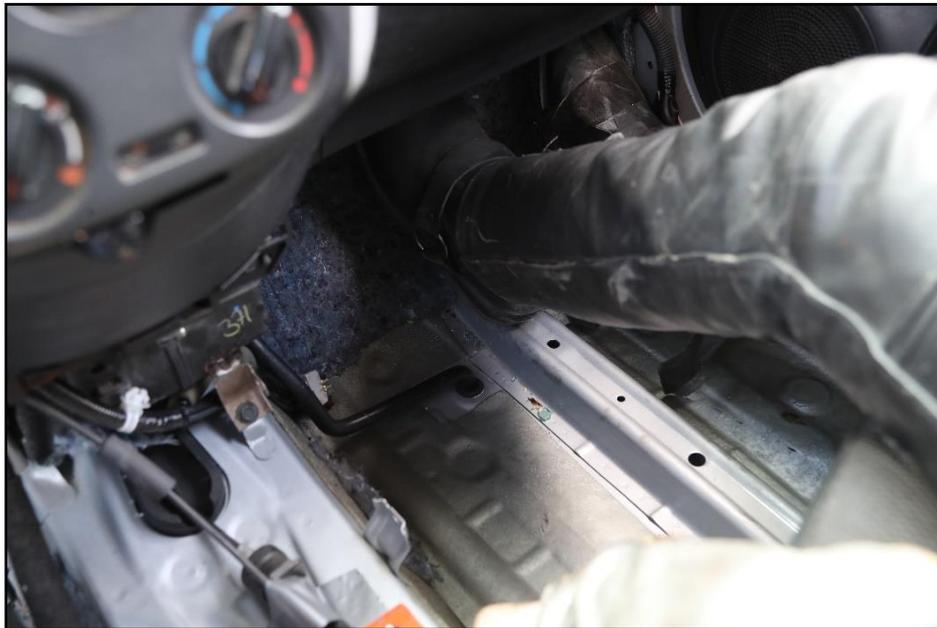
Figure 6.15. Interior of Test Vehicle on Impact Side After Test 619441-01-9.

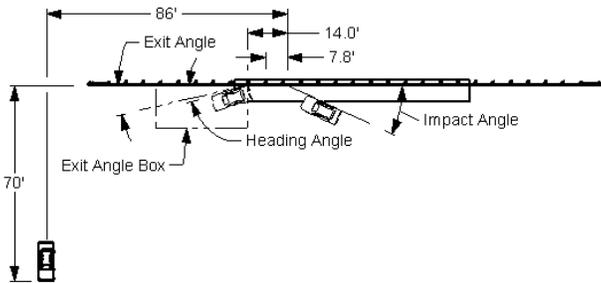
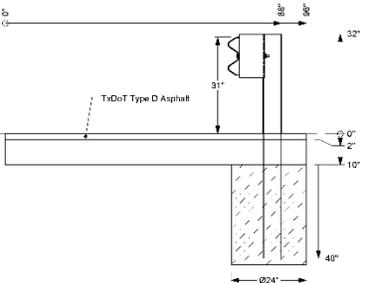
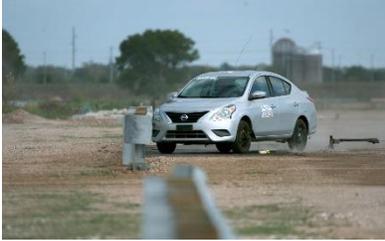
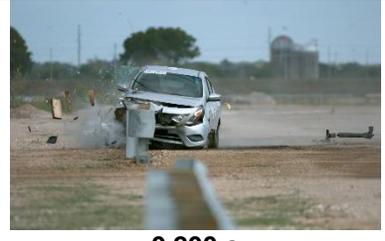
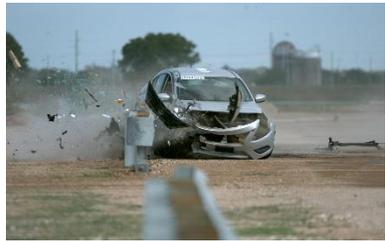
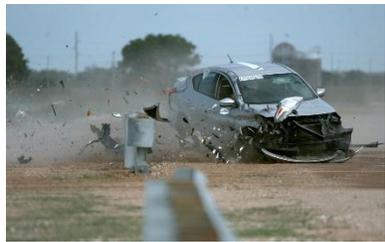
Test Agency	Texas A&M Transportation Institute (TTI)					
	Test Standard/Test No.	MASH 2016, Test 3-10					
	TTI Project No.	619441-01-9					
	Test Date	2023-10-03

TEST ARTICLE						
	Type	Longitudinal Barrier					
	Name	Steel Post W-beam Guardrail in Asphalt Vegetation Control Treatment					
	Length	181 feet and 3 inches

Key Materials	Galvanized steel posts, w-beam guardrail, timber blockouts, Type D asphalt					
	Soil Type and Condition	Type D grade 1 crushed concrete road base					
	TEST VEHICLE						
	Type/Designation	1100C

Year, Make and Model	2018 Nissan Versa					
	Inertial Weight (lb)	2430					
	Dummy (lb)	165					
	Gross Static (lb)	2595					
IMPACT CONDITIONS							
Impact Speed (mi/h)	62.1						
Impact Angle (deg)	25						
Impact Location	93.2 inches upstream from centerline of post 19						
Impact Severity (kip-ft)	56						
EXIT CONDITIONS							
Exit Speed (mi/h)	34.5

Trajectory/Heading Angle (deg)	13.3 / 15.7						
Exit Box Criteria	The vehicle did not meet the exit box criteria						
Stopping Distance	86 ft downstream 70 ft to the traffic side						
TEST ARTICLE DEFLECTIONS							
Dynamic (inches)	24.4						
Permanent (inches)	17 inches						
Working Width / Height (inches)	38.7 / 1.0						
VEHICLE DAMAGE							
VDS	01FREN2						
CDC	01RFQ4						
Max. Ext. Deformation (inches)	9 inches above front bumper						
Max Occupant Compartment Deformation	No occupant compartment deformation						
OCCUPANT RISK VALUES							
Long. OIV (ft/s)	18	Long. Ridedown (g)	9.7	Max 50-ms Long. (g)	-6.5	Max Roll (deg)	8.8
Lat. OIV (ft/s)	18	Lat. Ridedown (g)	10.3	Max 50-ms Lat. (g)	-7.5	Max Pitch (deg)	7.7
THIV (m/s)	7.7	ASI	1	Max 50-ms Vert. (g)	-4.1	Max Yaw (deg)	66.1

Figure 6.16. Summary of Results for *MASH* Test 3-10 on Steel Post W-beam Guardrail in Asphalt Vegetation Control Treatment.

Figure 6.16 summarizes the results of MASH Test 619441-01-9.

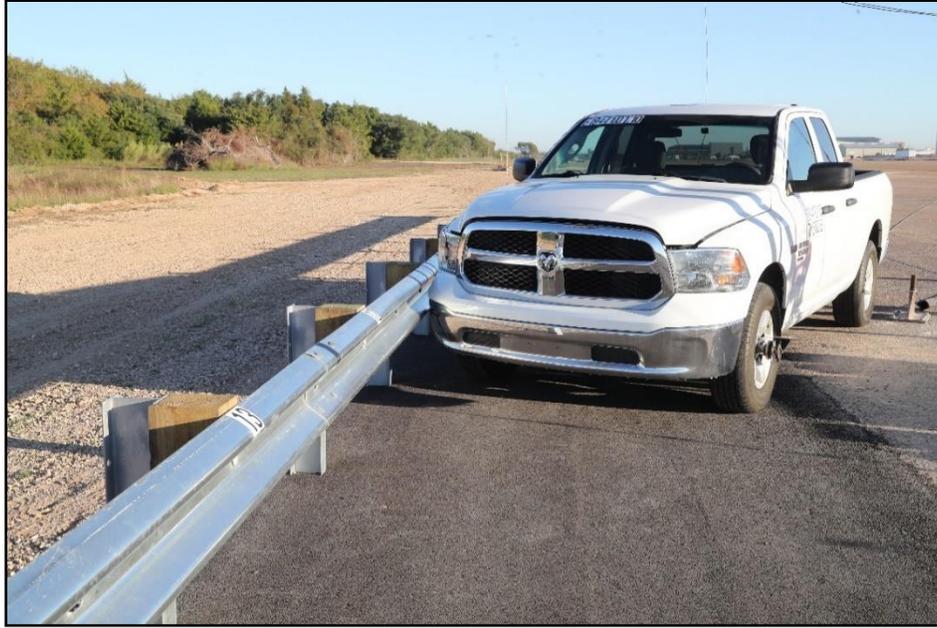
Figure 7.1. Steel Post W-beam Guardrail in Asphalt Vegetation Control Treatment/Test Vehicle Geometrics for Test 619441-01-10.

See Table 7.1 for details of impact conditions for this test and Table 7.2 for the exit parameters. Figure 7.1 and Figure 7.2 depict the target impact setup.

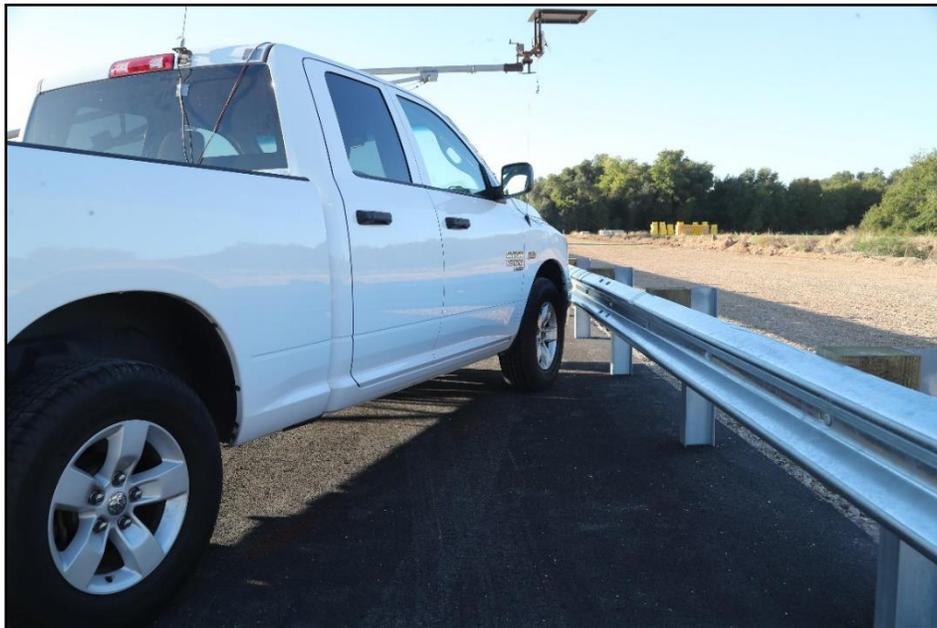
Figure 7.2. Steel Post W-beam Guardrail in Asphalt Vegetation Control Treatment/Test Vehicle Impact Location for Test 619441-01-10.

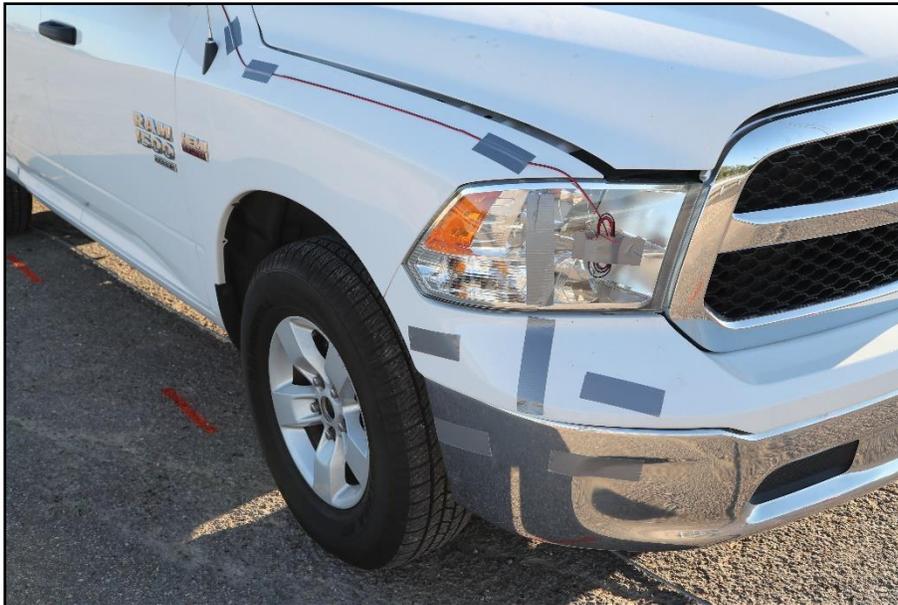
Figure 7.3. Impact Side of Test Vehicle Before Test 619441-01-10.

Figure 7.3 and Figure 7.4 show the 2019 RAM 1500 used for the crash test. Table 7.4 shows the vehicle measurements. Figure E.1 in Appendix E.1 gives additional dimensions and information on the vehicle.

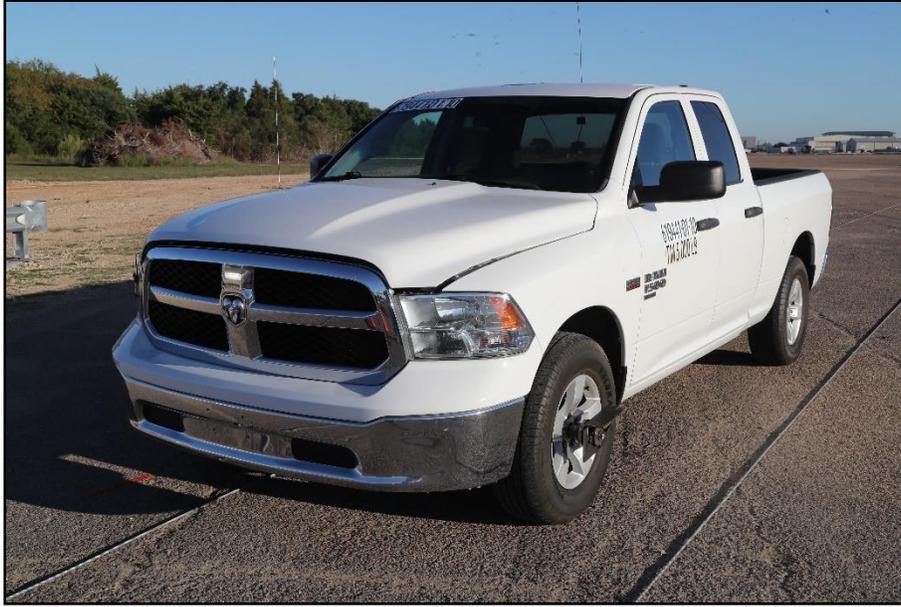
Figure 7.4. Opposite Impact Side of Test Vehicle Before Test 619441-01-10.

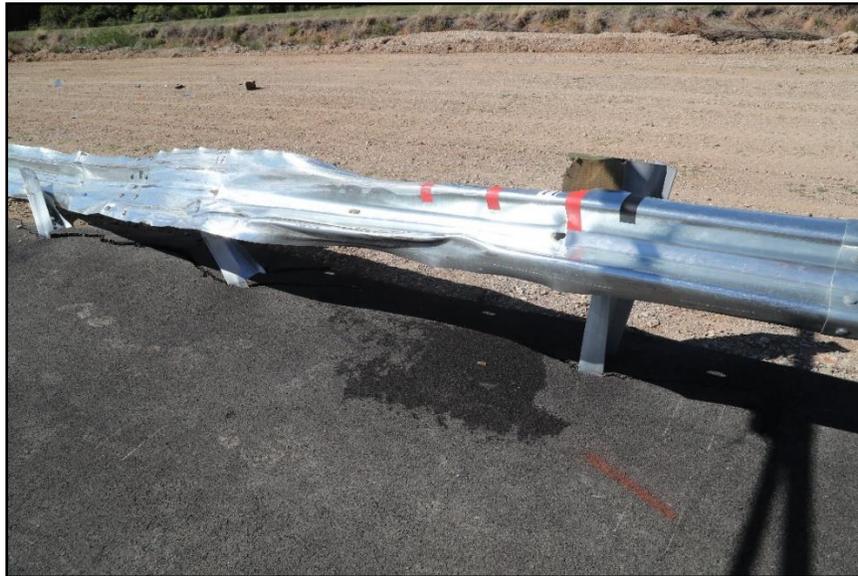
Figure 7.5. Steel Post W-beam Guardrail in Asphalt Vegetation Control Treatment at Impact Location After Test 619441-01-10.

The rail released from posts 3, 5-9, and 11-21. Posts 4 and 10 rotated 15 degrees and 20 degrees clockwise, respectively. Post 11 also rotated 20 degrees clockwise. The blockout was removed from posts 11 and 12. There was major asphalt damage from posts 12-16, and the rail was warped with some tearing around the guardrail bolt slots where the blockouts were released. Post 17 also rotated 10 degrees clockwise. Table 7.6 describes the soil gap (the gap formed between the edge of the soil and the post) and post lean of the Steel Post W-beam Guardrail in Asphalt Vegetation Control Treatment.

Table 7.7 describes the deflection and working width of the Steel Post W-beam Guardrail in Asphalt Vegetation Control Treatment. Figure 7.5 through Figure 7.12 show the damage to the Steel Post W-beam Guardrail in Asphalt Vegetation Control Treatment.

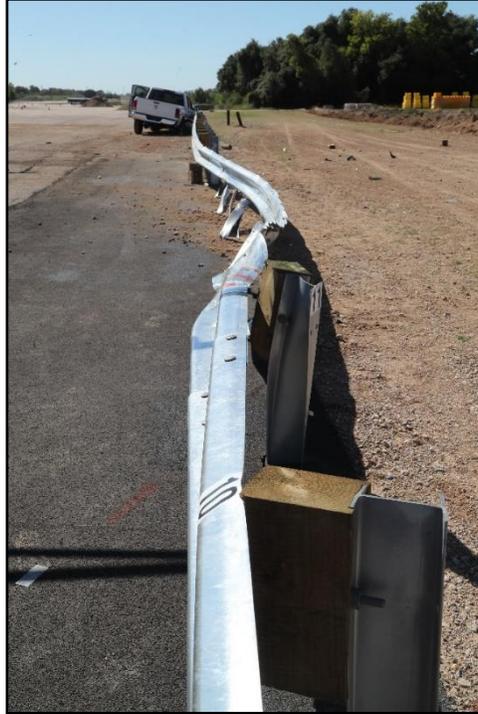
Figure 7.6. Upstream View of Steel Post W-beam Guardrail in Asphalt Vegetation Control Treatment After Test 619441-01-10.

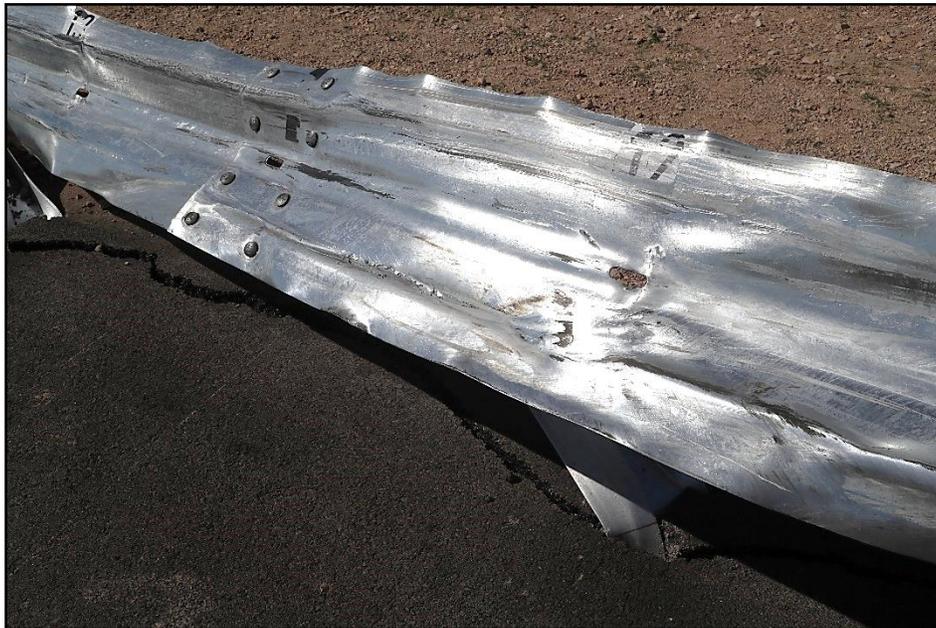
Figure 7.7. View at Post 12 of Steel Post W-beam Guardrail in Asphalt Vegetation Control Treatment after Test 619441-01-10
