Test Report No. 619441-01 09&10

**DESIGN AND EVALUATION OF ASPHALT VEGETATION CONTROL
TREATMENT FOR STEEL-POST W-BEAM GUARDRAIL SYSTEM**

1. Report No.		2. Government Accession No.		3. Recipient's Catalog No.	
4. Title and Subtitle Design and Evaluation of Asphalt Vegetation Control Treatment for Steel-Post W-Beam Guardrail System				5. Report Date January 2024

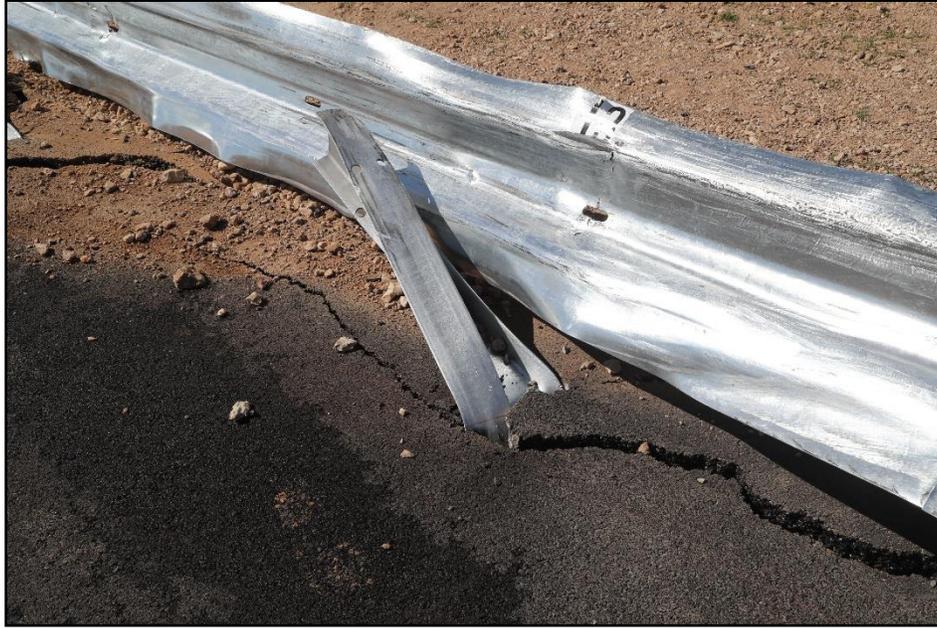
Figure 7.8. View at Post 13 of Steel Post W-beam Guardrail in Asphalt Vegetation Control Treatment After Test 619441-01-10

Table 7.7 describes the deflection and working width of the Steel Post W-beam Guardrail in Asphalt Vegetation Control Treatment. Figure 7.5 through Figure 7.12 show the damage to the Steel Post W-beam Guardrail in Asphalt Vegetation Control Treatment.

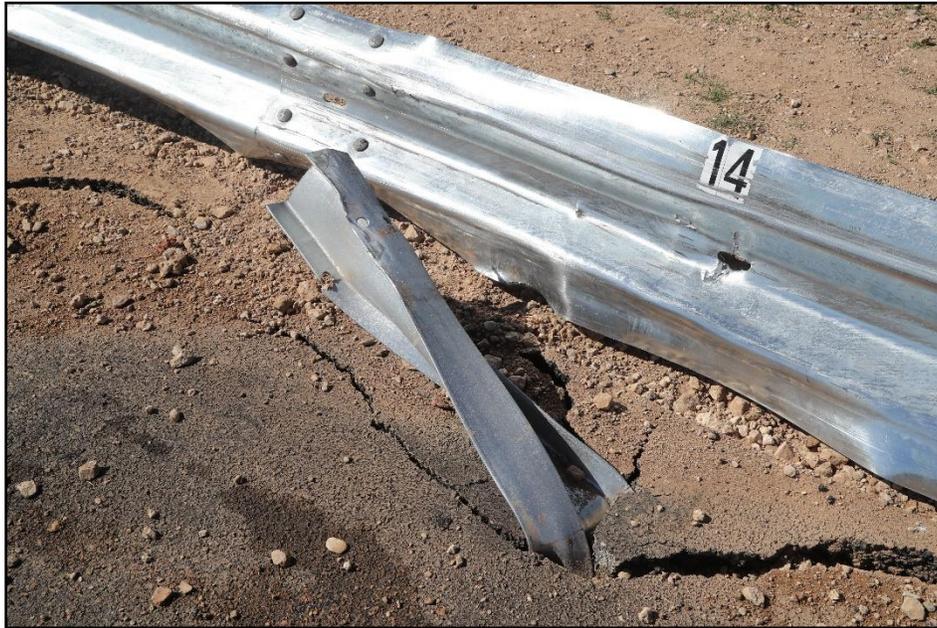
Figure 7.9. View at Post 14 of Steel Post W-beam Guardrail in Asphalt Vegetation Control Treatment After Test 619441-01-10

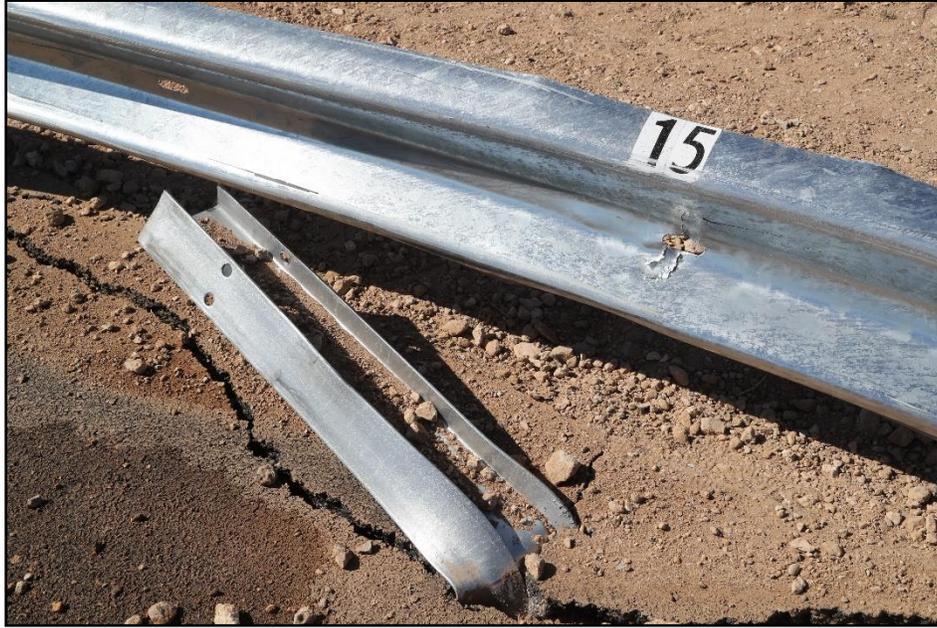
Figure 7.10. View at Post 15 of Steel Post W-beam Guardrail in Asphalt Vegetation Control Treatment After Test 619441-01-10

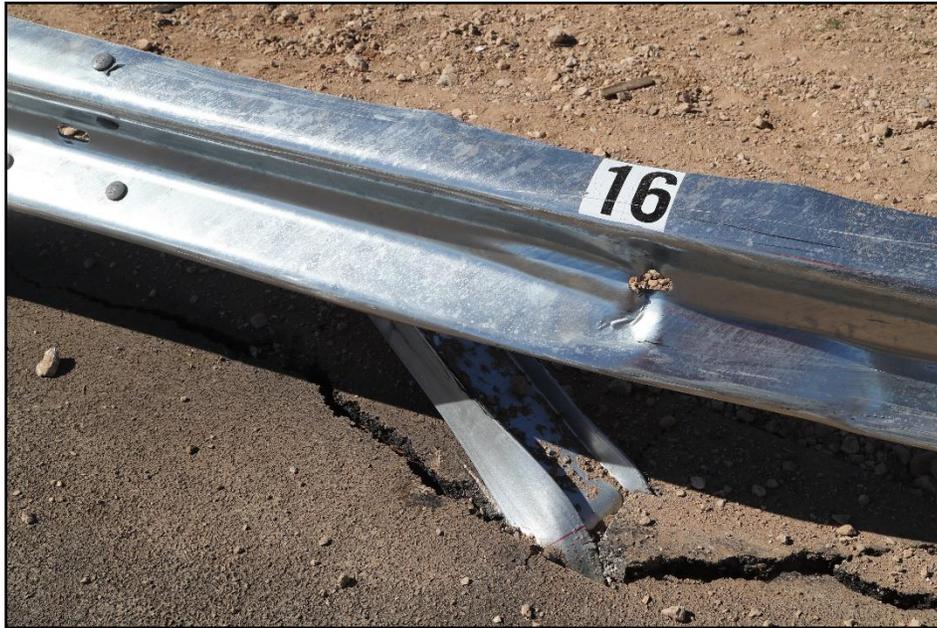
Figure 7.11. View at Post 16 of Steel Post W-beam Guardrail in Asphalt Vegetation Control Treatment After Test 619441-01-10

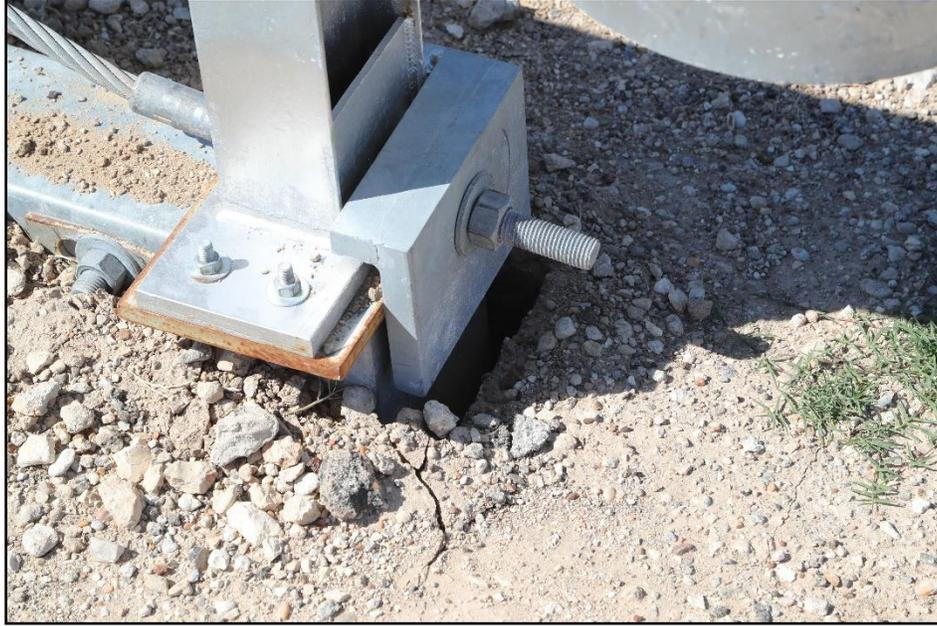
Figure 7.12. View of Anchor Movement at Post 1 of Steel Post W-beam Guardrail in Asphalt Vegetation Control Treatment After Test 619441-01-10

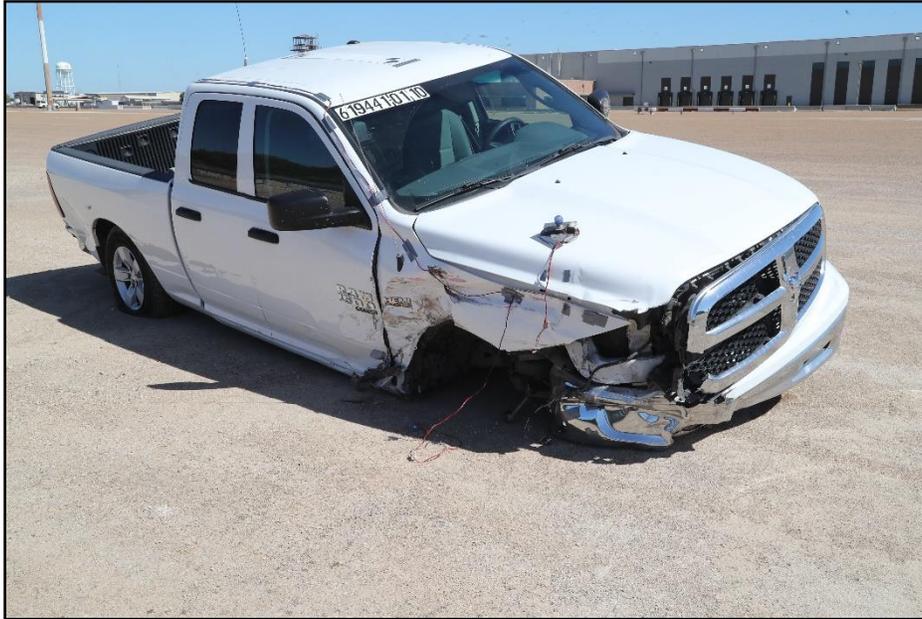
Figure 7.13. Impact Side of Test Vehicle After Test 619441-01-10.

Figure 7.13 and Figure 7.14 show the damage sustained by the vehicle. Figure 7.15 and Figure 7.16 show the interior of the test vehicle. Table 7.8 and Table 7.9 provide details on the occupant compartment deformation and exterior vehicle damage. Figures E.2 and E.3 in Appendix E.1 provide exterior crush and occupant compartment measurements.

Side Windows	Side windows remained intact
Maximum Exterior Deformation	15 inches at front bumper
VDS	01RFQ4
CDC	01FREN2
Fuel Tank Damage	None
Description of Damage to Vehicle:	The hood, bumper, grill, and right headlight were damaged. The right front fender was dented, the control arm ripped off, the brake line was broken, front wheel was damaged, and the tire was blown out. The right front door was also dented and scratched with a 0.5-inch gap at the top of the door. There were small scratches and dents in the right rear door and bed. The right rear bumper was dented, and the tire was flat.

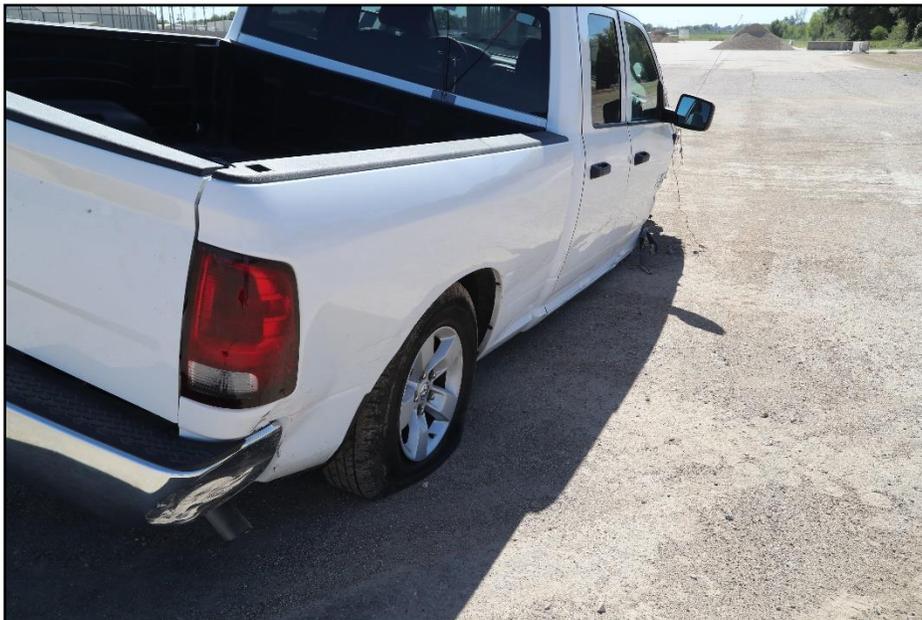
Figure 7.14. Rear Impact Side of Test Vehicle After Test 619441-01-10.

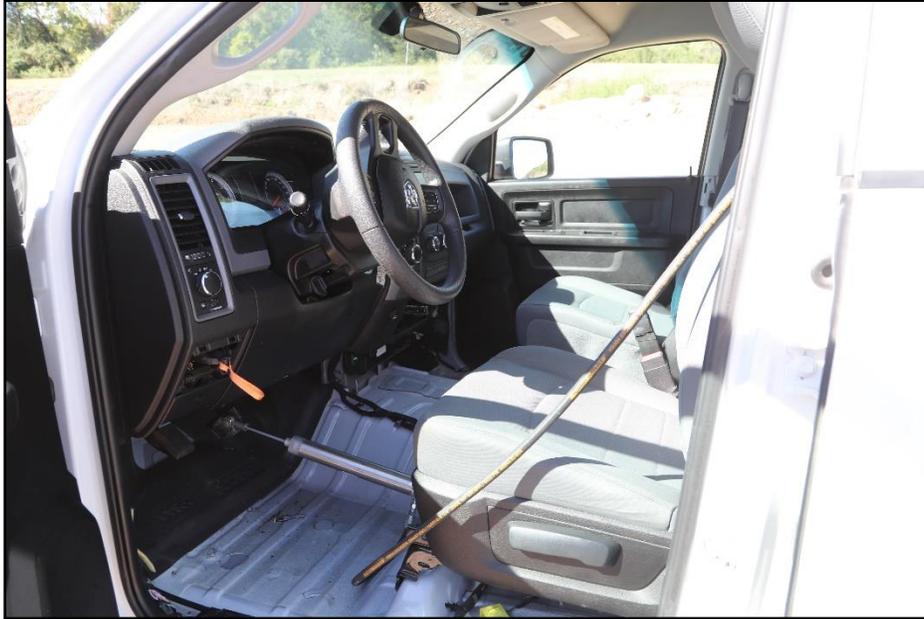
Figure 7.15. Overall Interior of Test Vehicle After Test 619441-01-10.

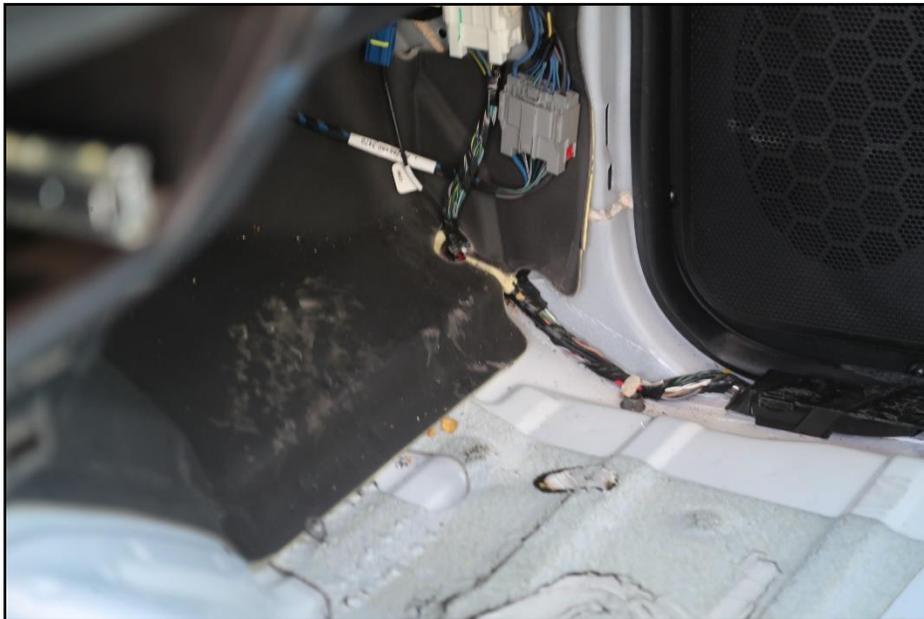
Figure 7.16. Interior of Test Vehicle on Impact Side After Test 619441-01-10.

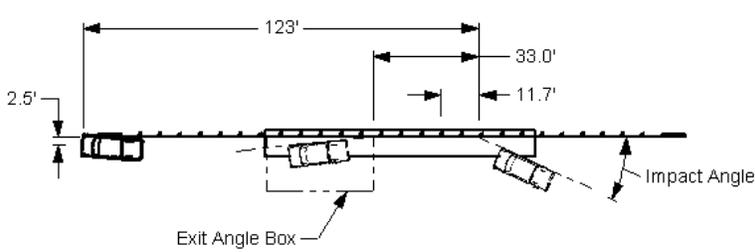
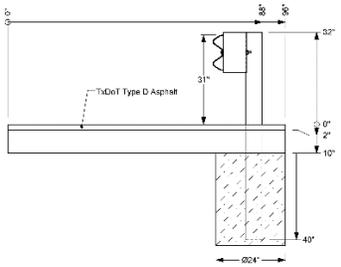
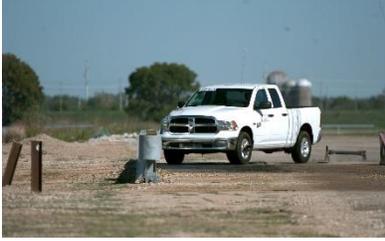
Test Agency	Texas A&M Transportation Institute (TTI)							
	Test Standard/Test No.	MASH 2016, Test 3-11							
	TTI Project No.	619441-01-10							
	Test Date	2023-10-18							
TEST ARTICLE									
	Type	Longitudinal Barrier							
	Name	Steel Post W-beam Guardrail in Asphalt Vegetation Control Treatment							
	Length	181 feet and 3 inches							
	Key Materials	Galvanized steel posts, w-beam guardrail, timber blockouts, Type D asphalt							
	Soil Type and Condition	Type D grade 1 crushed concrete road base

TEST VEHICLE								
	Type/Designation	2270P							
	Year, Make and Model	2019 RAM 1500							
	Inertial Weight (lb)	5049							
	Dummy (lb)	N/A							
	Gross Static (lb)	5049							
IMPACT CONDITIONS									
	Impact Speed (mi/h)	61.2							
	Impact Angle (deg)	24.88							
	Impact Location	140.5 inches upstream from centerline of post 13							
	Impact Severity (kip-ft)	111.9							
EXIT CONDITIONS

TEST ARTICLE DEFLECTIONS								
		Dynamic (inches)	45.6						
		Permanent (inches)	34 inches						
		Working Width / Height (inches)	53.7 / 65.1						
VEHICLE DAMAGE									
	VDS	01RFQ4							
	CDC	01FREN2							
	Max. Ext. Deformation (inches)	15 inches at front bumper							
	Max Occupant Compartment Deformation	No occupant compartment deformation							
OCCUPANT RISK VALUES									
Long. OIV (ft/s)	17.3	Long. Ridedown (g)	10.3	Max 50-ms Long. (g)	-4.3	Max Roll (deg)	10.3		
Lat. OIV (ft/s)	14.8	Lat. Ridedown (g)	7.0	Max 50-ms Lat. (g)	-5.1	Max Pitch (deg)	3.5		
THIV (m/s)	6.5	ASI	0.6	Max 50-ms Vert. (g)	1.8	Max Yaw (deg)	32.5

Figure 7.17. Summary of Results for MASH Test 3-11 on Steel Post W-beam Guardrail in Asphalt Vegetation Control Treatment.

Figure 7.17 summarizes the results of *MASH* Test 619441-01-10.

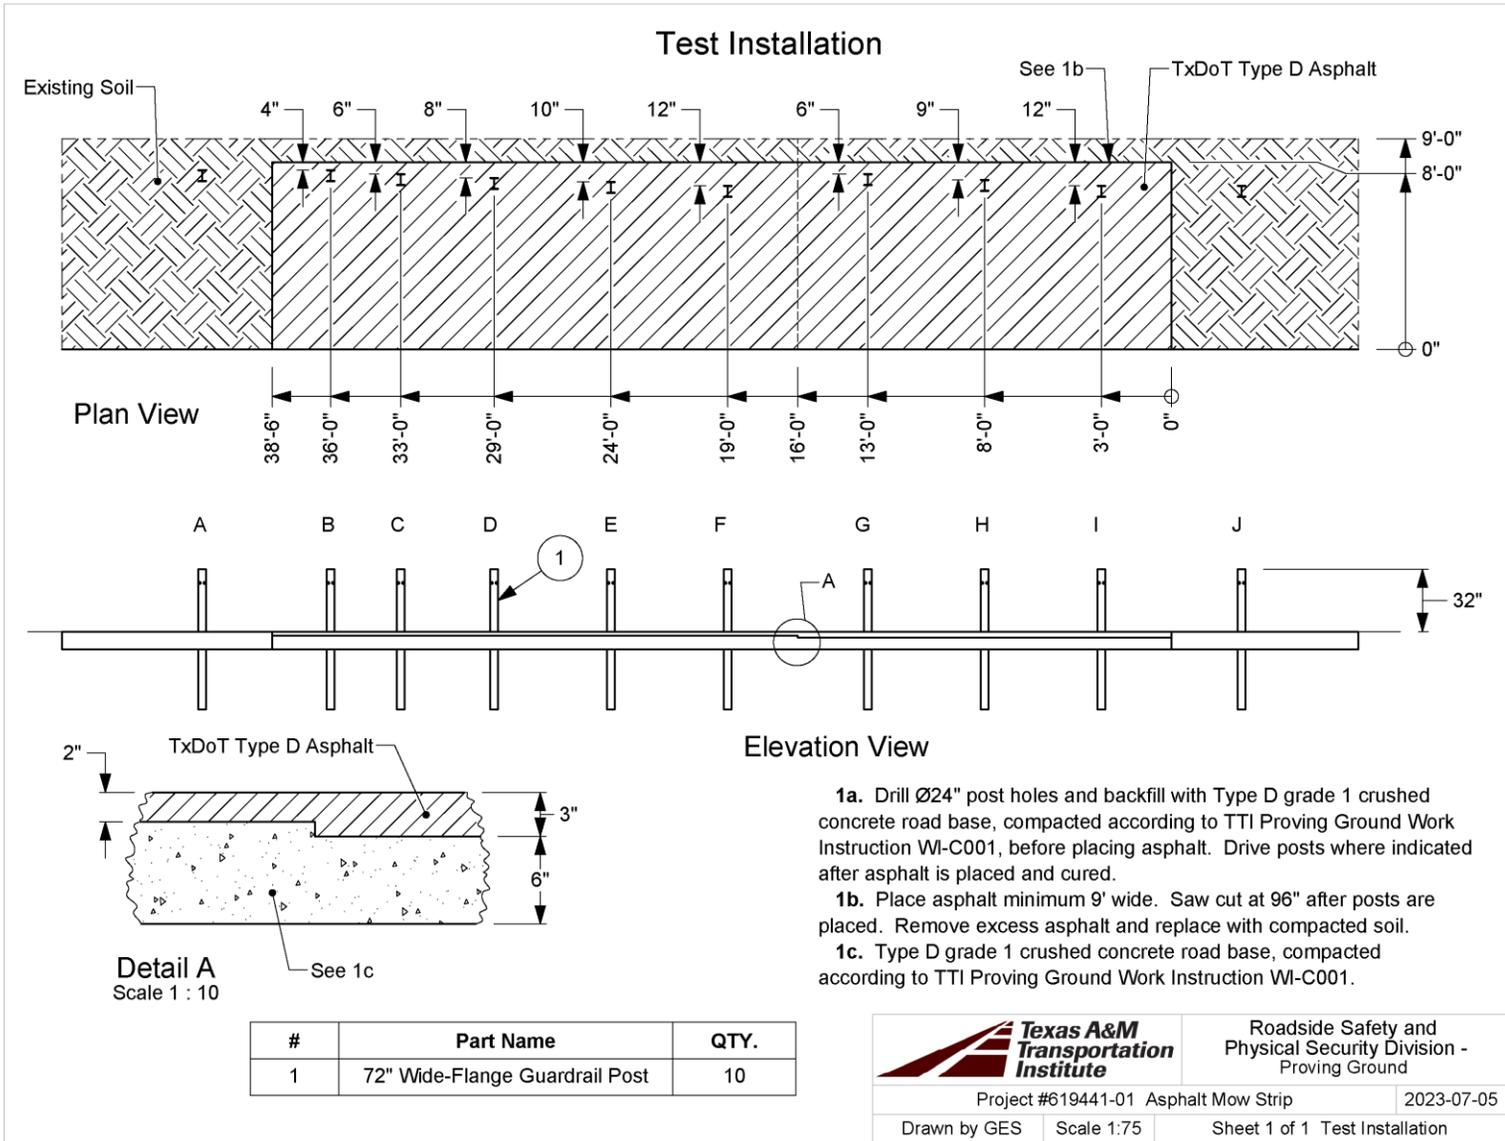
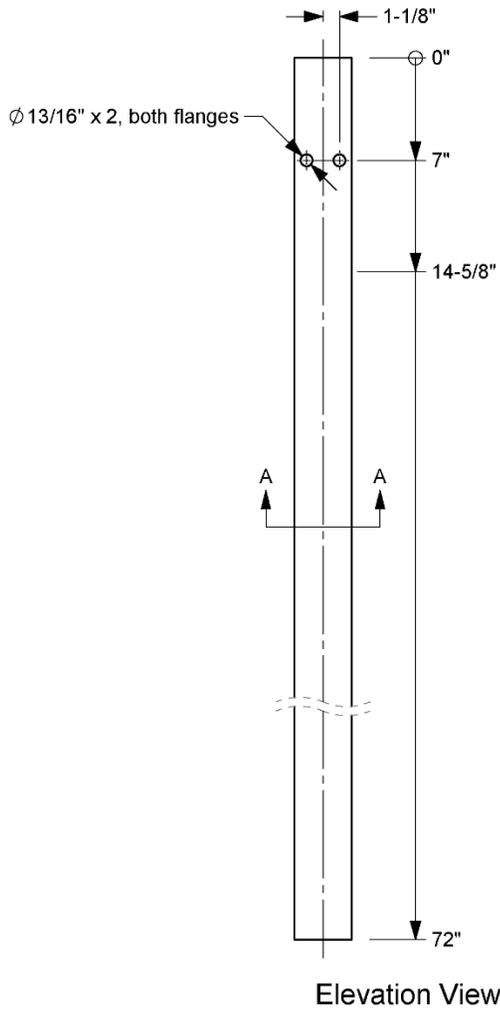
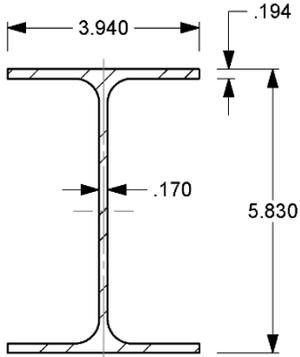
72" Wide Flange Guardrail Post

Section A-A
Scale 1 : 3

**APPENDIX A. DETAILS OF TEST INSTALLATION FOR SURROGATE
BOGIE VEHICLE TESTING**

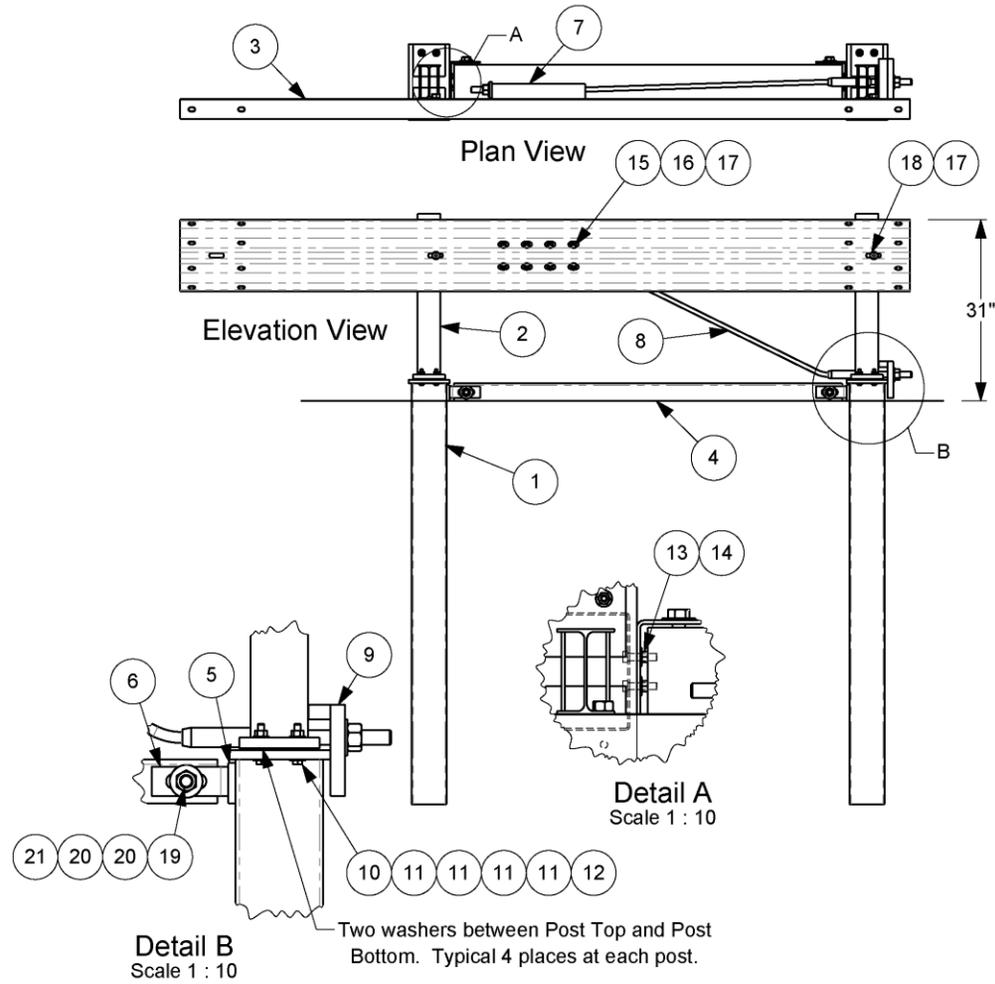
Project #	Terminal	2022-11-10
Drawn by	GES	Scale 1:25
Sheet 1 of 6	Terminal Details

Terminal Details

1a. 7/16" x 2-1/2" Bolts are ASTM A449. All other Bolts are ASTM A307. All Nuts (except Recessed Guardrail Nuts) are ASTM A563A unless otherwise indicated.

1c. All steel parts shall be galvanized.

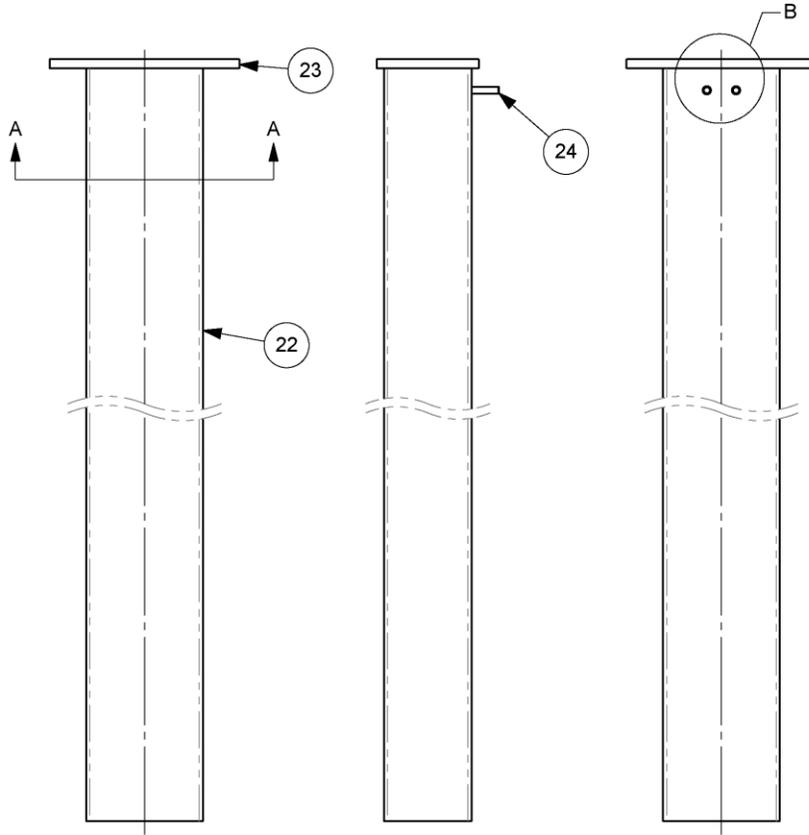
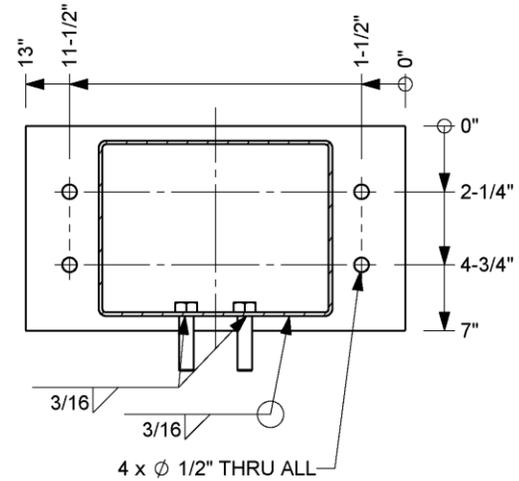
Project #	Terminal	2022-11-10
Drawn by	Scale	Sheet
GES	1:10	2 of 6 Post Bottom

Elevation Views

#	Description	Length	Material	Qty
22	HSS 8" x 6" x 1/8"	72"	ASTM A500 Grade B	1
23	Plate, 7" x 5/8"	13"	ASTM A36	1
24	Bolt, 1/2 x 2 hex		ASTM A307	2

Detail B
Scale 1 : 5

Section A-A
Scale 1 : 5

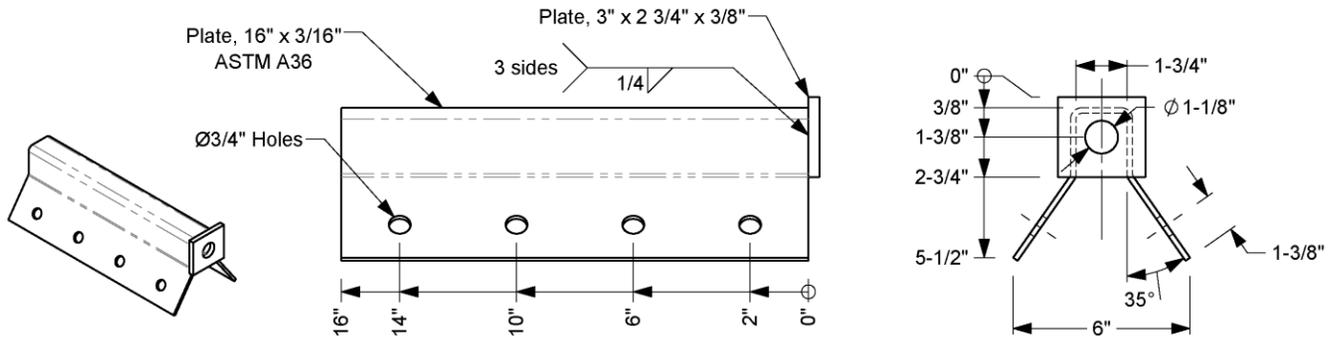
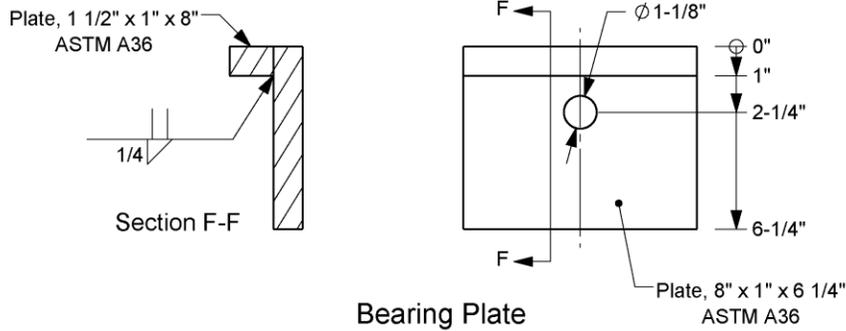
Roadside Safety and Physical Security Division - Proving Ground
Project #	Terminal	2022-11-10
Drawn by GES	Scale 1:5	Sheet 5 of 6 Assorted Parts A

Guardrail Anchor Bracket

Bearing Plate

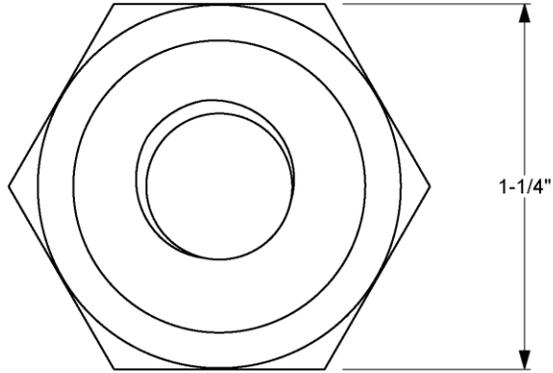
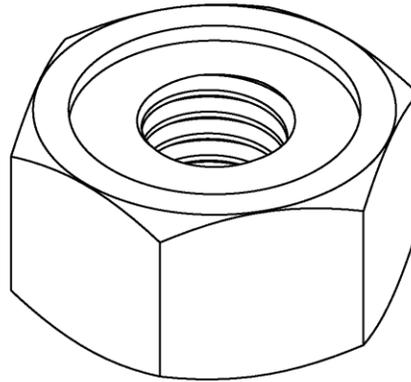
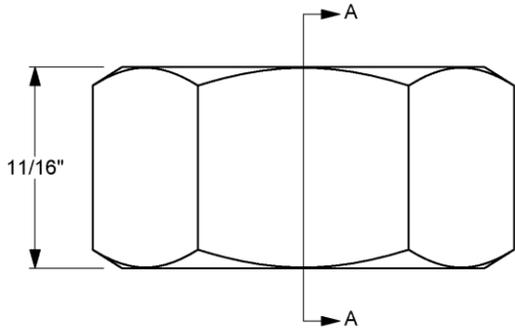
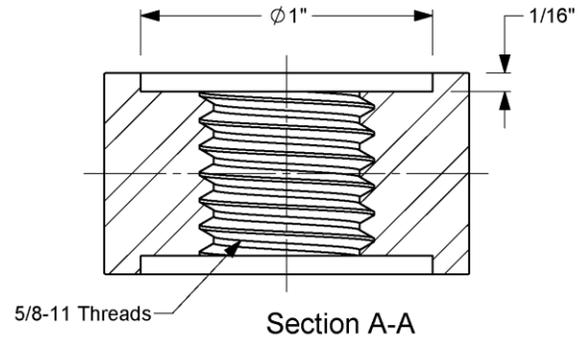
Recessed Guardrail Nut

1a. Material is ASTM A 563 Grade A.

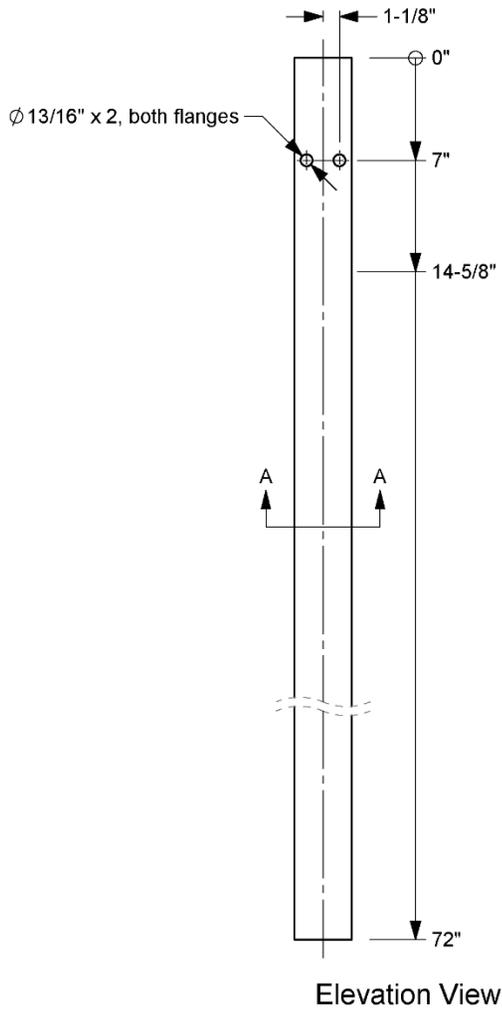
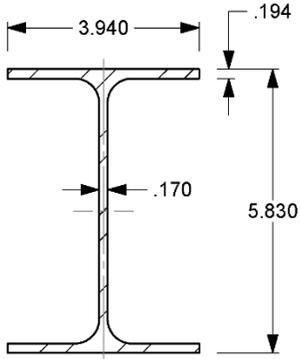
72" Wide Flange Guardrail Post

Isometric View

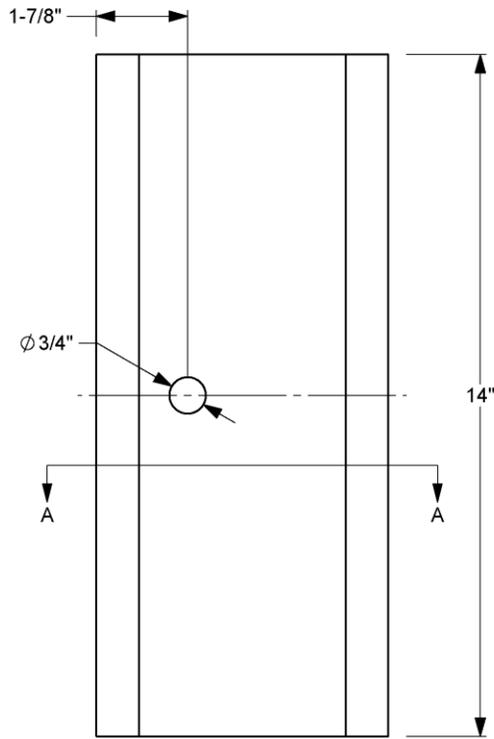
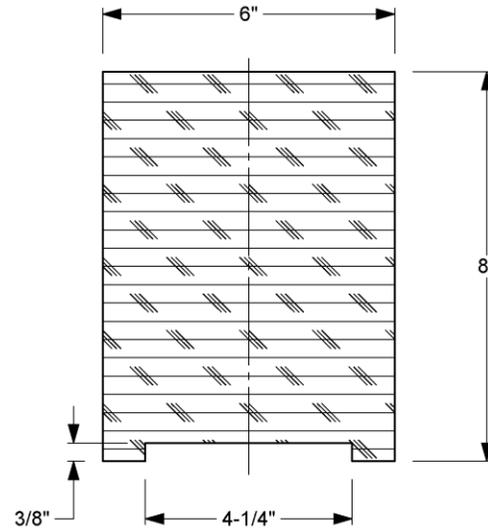
Timber Blockout for W-section Post

All dimensions except hole diameter are nominal

Elevation View

Section A-A

1a. Timber blockouts are treated with a preservative in accordance with AASHTO M 133 after all cutting and drilling.

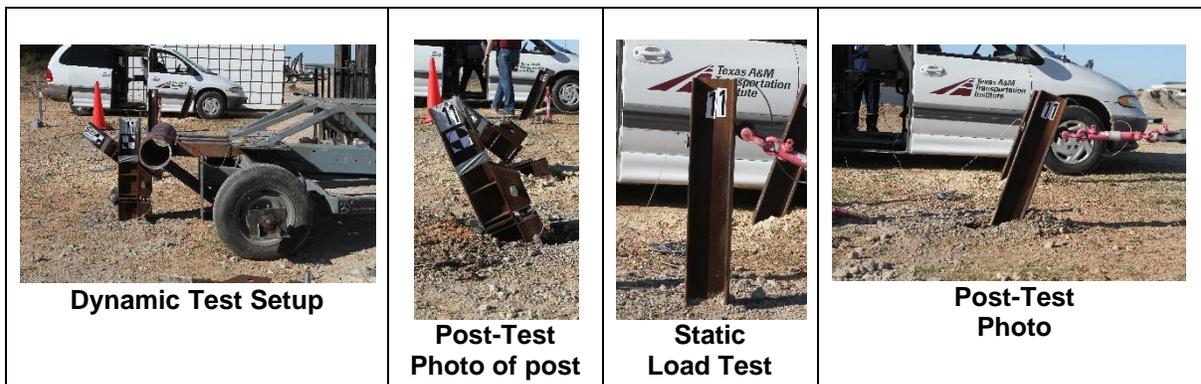
Dynamic Test Setup

Post-Test Photo of post

Dynamic Test Installation Details

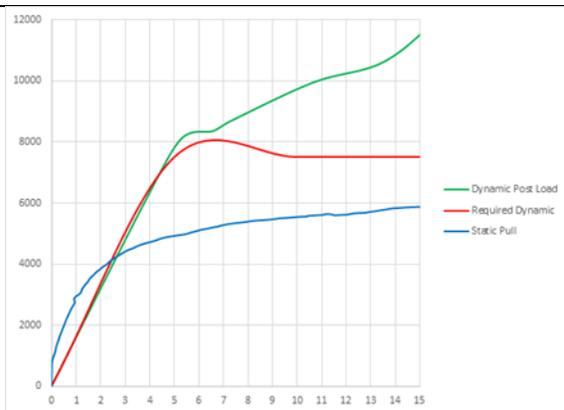
Comparison of Load vs. Displacement

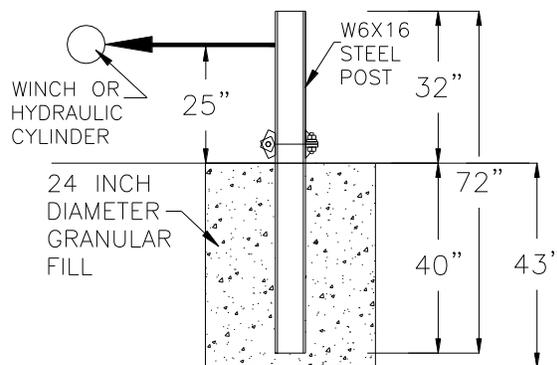
Static Load Test Installation Details

Date	2020-02-02
Test Facility and Site Location	TTI Proving Ground, 3100 SH 47, Bryan, TX 77807
In Situ Soil Description (ASTM D2487)	Sandy gravel with silty fines
Fill Material Description (ASTM D2487) and sieve analysis	Type 1 Grade D Crushed Concrete Road Base
Description of Fill Placement Procedure	12-inch lifts tamped with a pneumatic compactor for 20 sec
Bogie Weight	2020 lb
Impact Velocity	19.2 mph

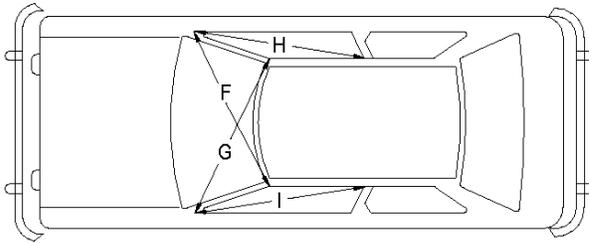
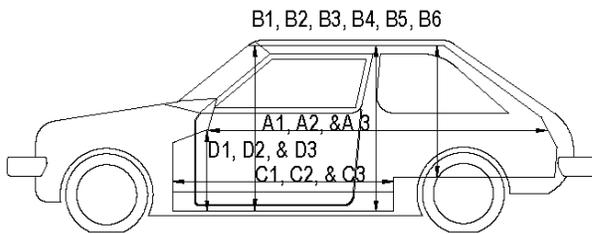
Figure D.3. Occupant Compartment Measurements for Test 619441-01-9.

OCCUPANT COMPARTMENT DEFORMATION MEASUREMENT

Before	After (inches)	Differ.
A1	67.50	67.50	0.00
A2	67.25	67.25	0.00
A3	67.75	67.75	0.00
B1	40.50	40.50	0.00
B2	39.00	39.00	0.00
B3	40.50	40.50	0.00
B4	36.25	36.25	0.00
B5	36.00	36.00	0.00
B6	36.25	36.25	0.00
C1	26.00	26.00	0.00
C2	0.00	0.00	0.00
C3	26.00	26.00	0.00
D1	9.50	9.50	0.00
D2	0.00	0.00	0.00
D3	9.50	9.50	0.00
E1	51.50	51.50	0.00
E2	51.00	51.00	0.00
F	51.00	51.00	0.00
G	51.00	51.00	0.00
H	37.50	37.50	0.00
I	37.50	37.50	0.00
J*	51.00	51.00	0.00

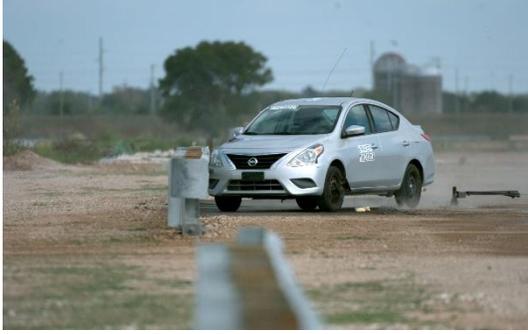
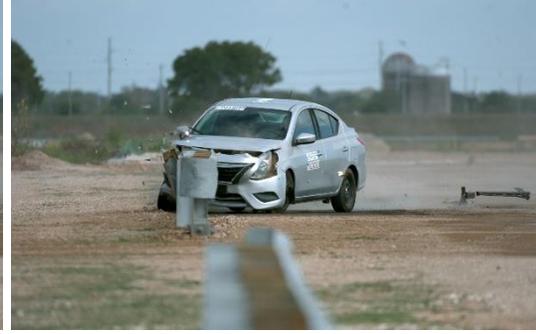
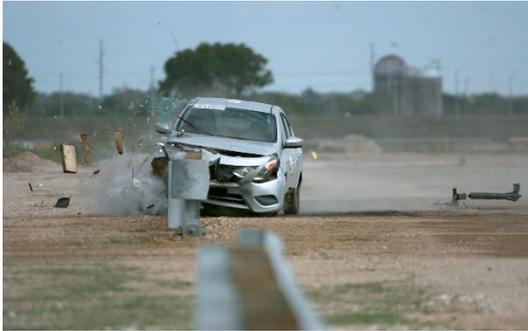
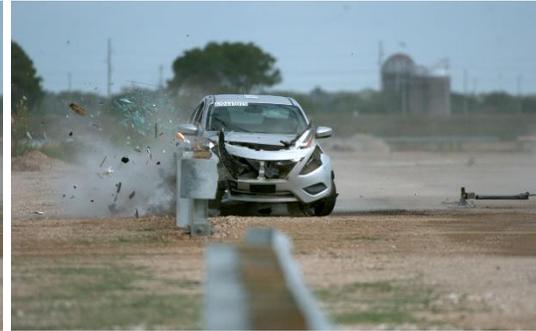
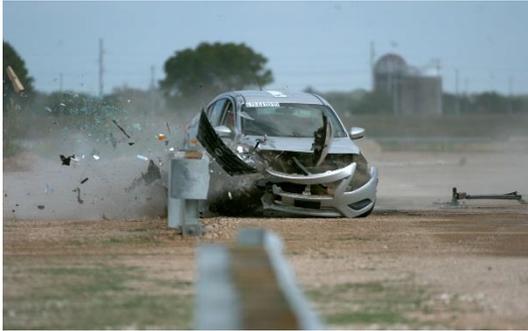
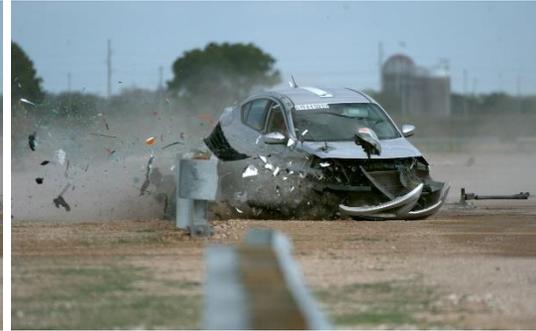
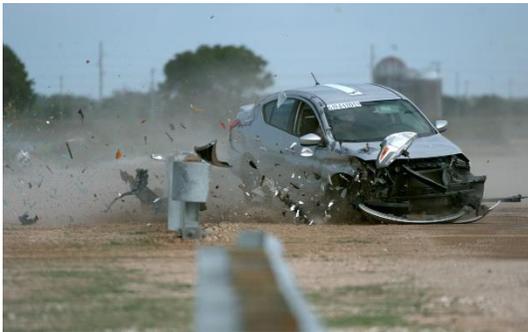
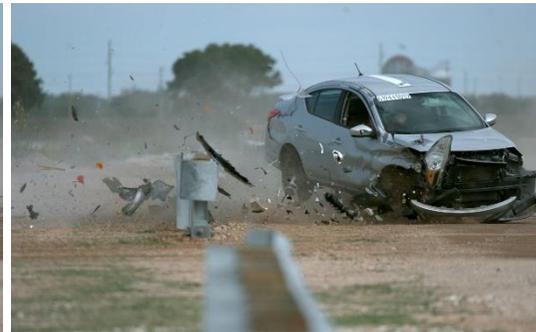
Figure D.5. Sequential Photographs for Test 619441-01-9 (Frontal Views).

(a) 0.000 s

(b) 0.100 s

(c) 0.200 s

(d) 0.300 s

(e) 0.400 s

(f) 0.500 s

(g) 0.600 s

(h) 0.700 s

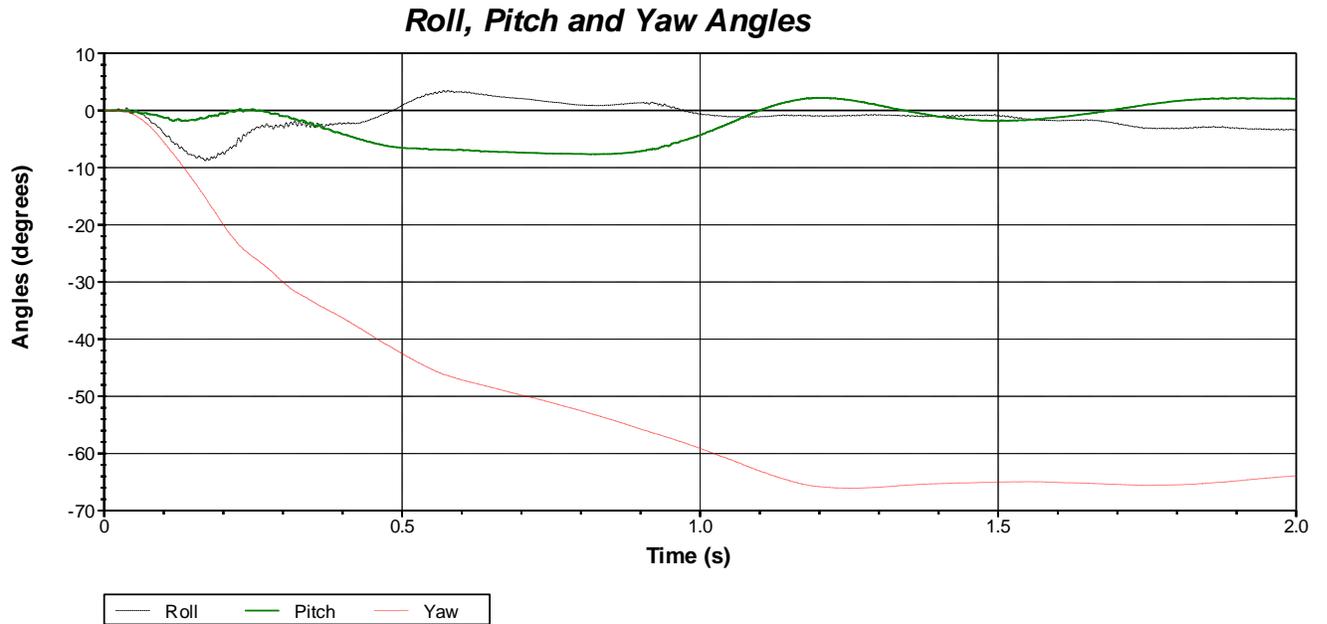
Figure D.7. Vehicle Angular Displacements for Test 619441-01-9.

Axes are vehicle-fixed.
Sequence for determining orientation:

1. Yaw.
2. Pitch.
3. Roll.

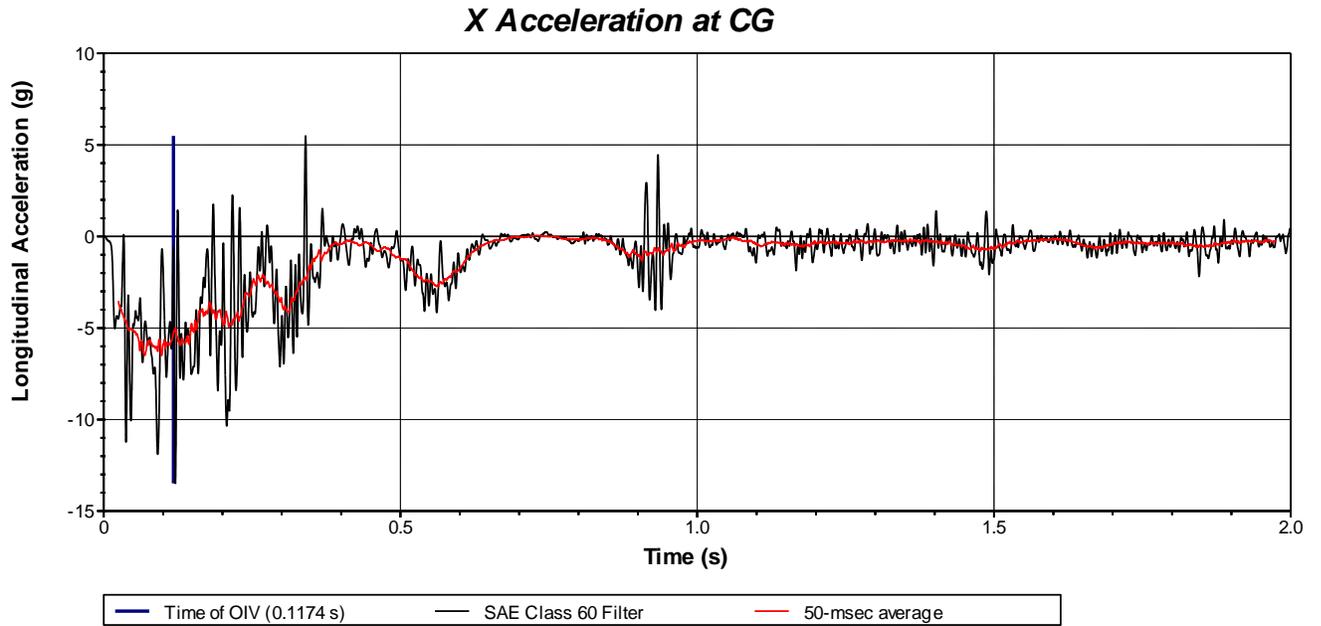
**Figure D.8. Vehicle Longitudinal Accelerometer Trace for Test 619441-01-9
(Accelerometer Located at Center of Gravity).**

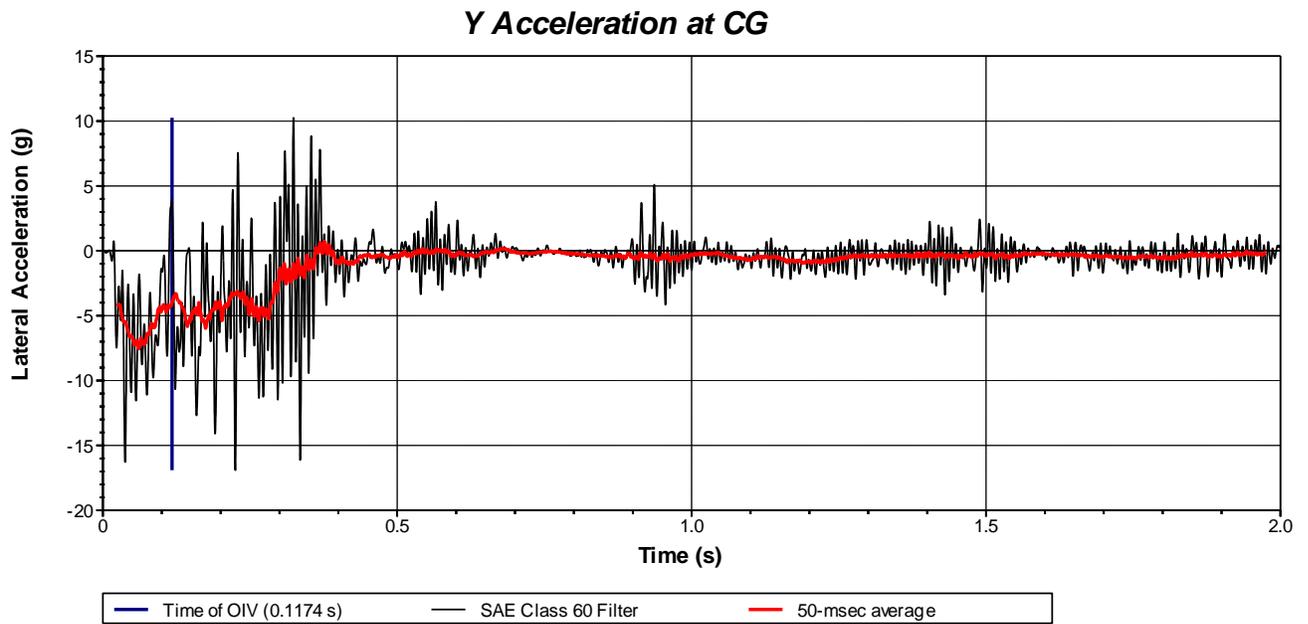
**Figure D.9. Vehicle Lateral Accelerometer Trace for Test 619441-01-9
(Accelerometer Located at Center of Gravity).**

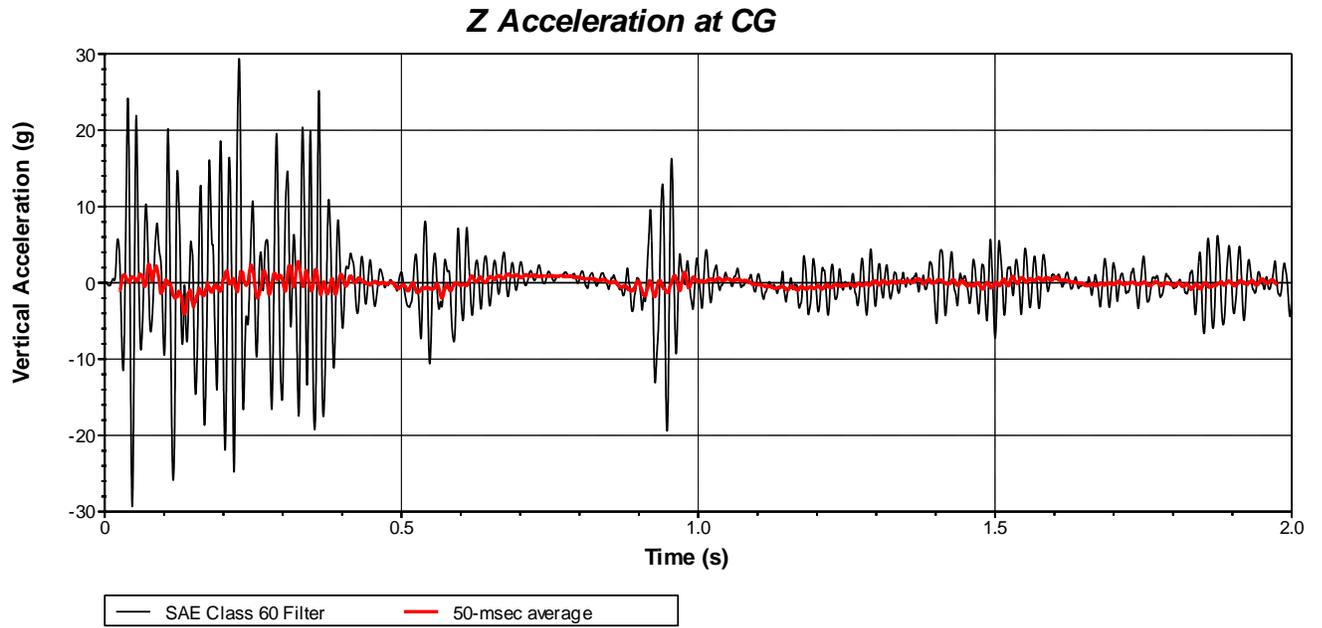
**Figure D.10. Vehicle Vertical Accelerometer Trace for Test 619441-01-9
(Accelerometer Located at Center of Gravity).**

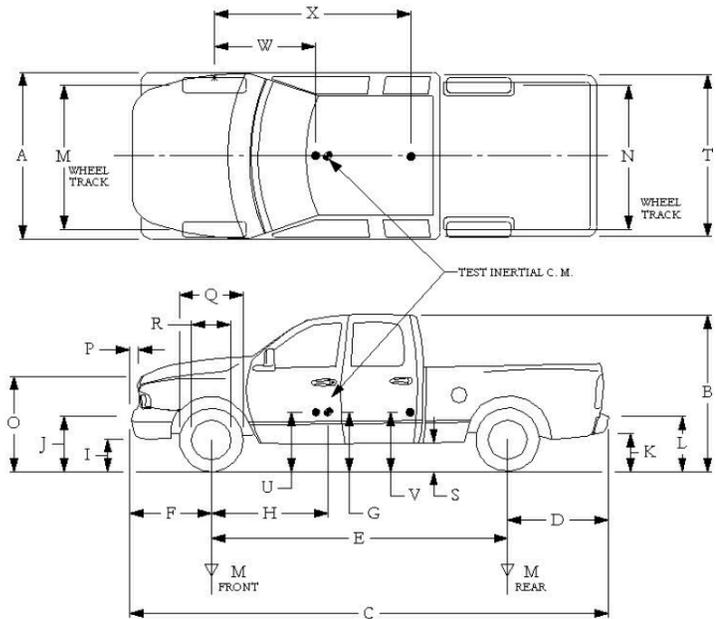
Geometry: inches

A	78.50	F	40.00	K	20.00	P	3.00	U	26.75
B	74.00	G	28.75	L	30.00	Q	30.50	V	30.25
C	227.50	H	61.22	M	68.50	R	18.00	W	61.00
D	44.00	I	11.75	N	68.00	S	13.00	X	79.00
E	140.50	J	27.00	O	46.00	T	77.00		
Wheel Center Height Front	14.75	Wheel Well Clearance (Front)	6.00	Bottom Frame Height - Front	12.50				
Wheel Center Height Rear	14.75	Wheel Well Clearance (Rear)	9.25	Bottom Frame Height - Rear	22.50

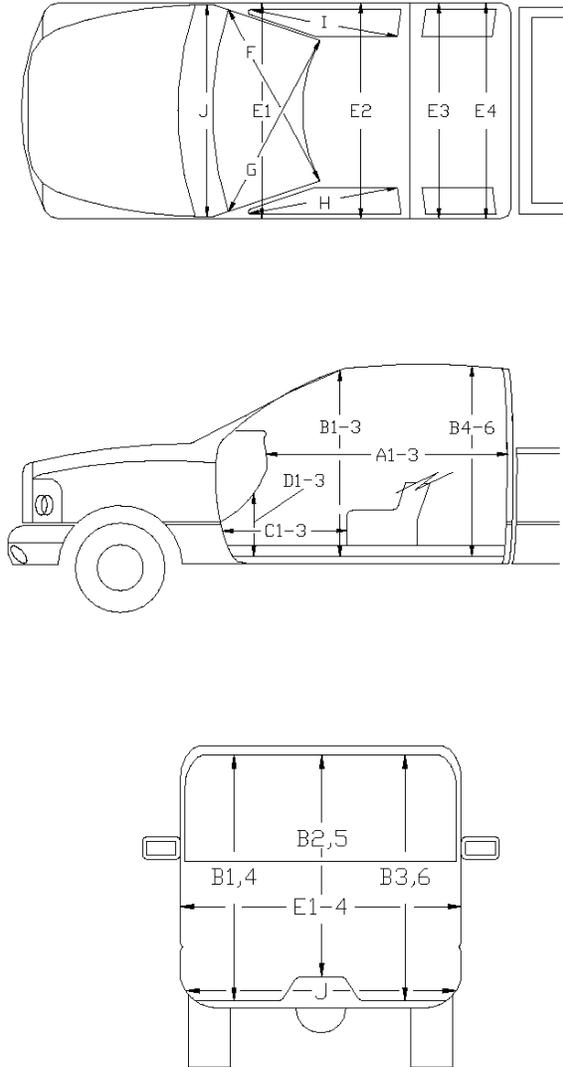
Figure E.3. Occupant Compartment Measurements for Test 619441-01-10.

OCCUPANT COMPARTMENT DEFORMATION MEASUREMENT

Before	After (inches)	Differ.
A1	65.00	65.00	0.00
A2	63.00	63.00	0.00
A3	65.50	65.50	0.00
B1	45.00	45.00	0.00
B2	38.00	38.00	0.00
B3	45.00	45.00	0.00
B4	39.50	39.50	0.00
B5	43.00	43.00	0.00
B6	39.50	39.50	0.00
C1	26.00	26.00	0.00
C2	0.00	0.00	0.00
C3	26.00	26.00	0.00
D1	11.00	11.00	0.00
D2	0.00	0.00	0.00
D3	11.50	11.50	0.00
E1	58.50	58.50	0.00
E2	63.50	63.50	0.00
E3	63.50	63.50	0.00
E4	63.50	63.50	0.00
F	59.00	59.00	0.00
G	59.00	59.00	0.00
H	37.50	37.50	0.00
I	37.50	37.50	0.00
J*	25.00	25.00	0.00

*Lateral area across the cab from driver's side kickpanel to passenger's side kickpanel.

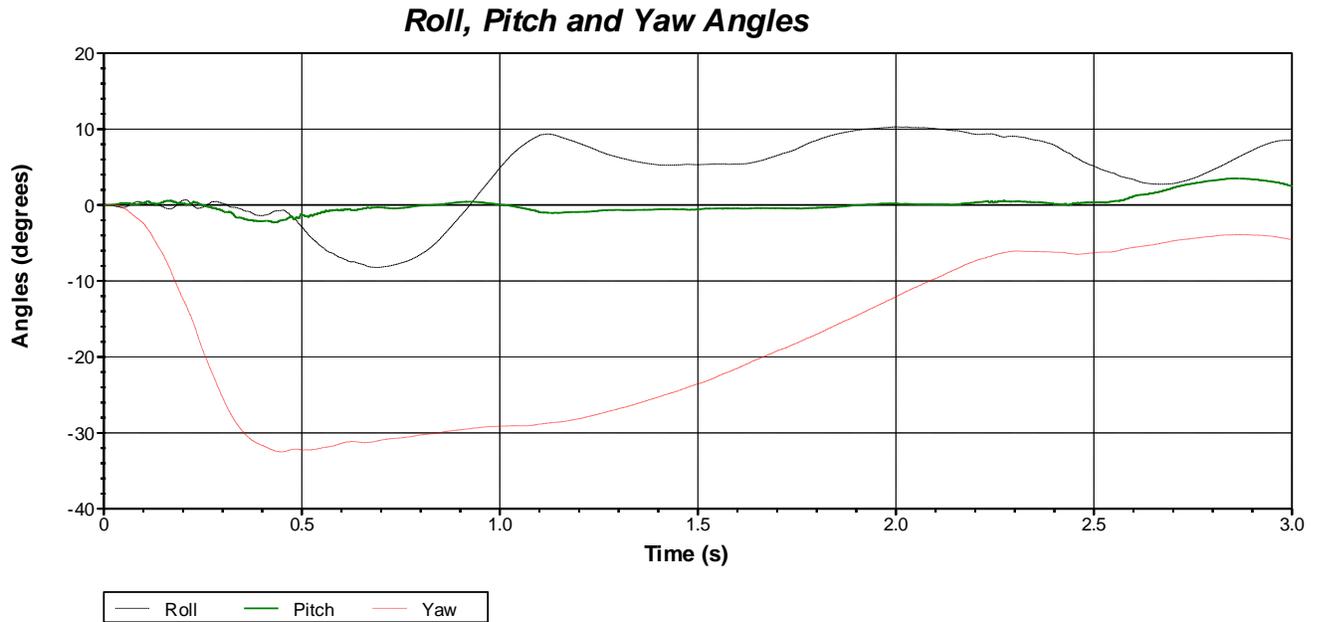
Figure E.7. Vehicle Angular Displacements for Test 619441-01-10.

Axes are vehicle-fixed.
Sequence for determining orientation:

4. Yaw.
5. Pitch.
6. Roll.
