Test Report No. 619441-01 09&10

**DESIGN AND EVALUATION OF ASPHALT VEGETATION CONTROL
TREATMENT FOR STEEL-POST W-BEAM GUARDRAIL SYSTEM**

1. Report No.		2. Government Accession No.		3. Recipient's Catalog No.	
4. Title and Subtitle Design and Evaluation of Asphalt Vegetation Control Treatment for Steel-Post W-Beam Guardrail System				5. Report Date January 2024

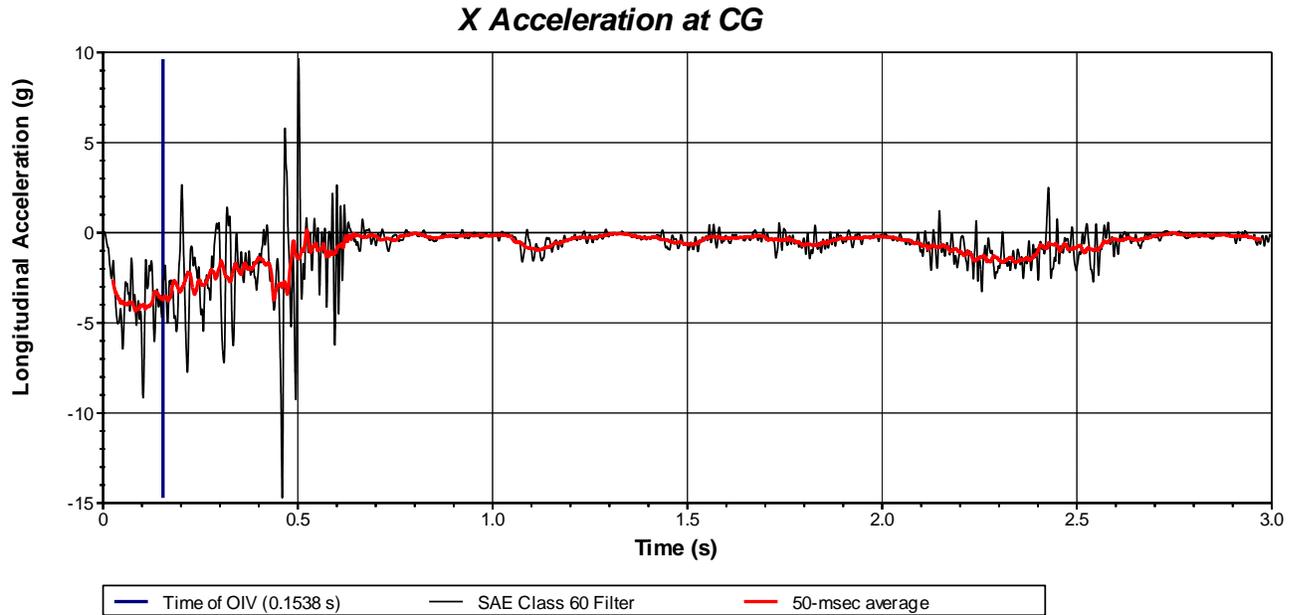
Figure E.8. Vehicle Longitudinal Accelerometer Trace for Test 619441-01-10 (Accelerometer Located at Center of Gravity).

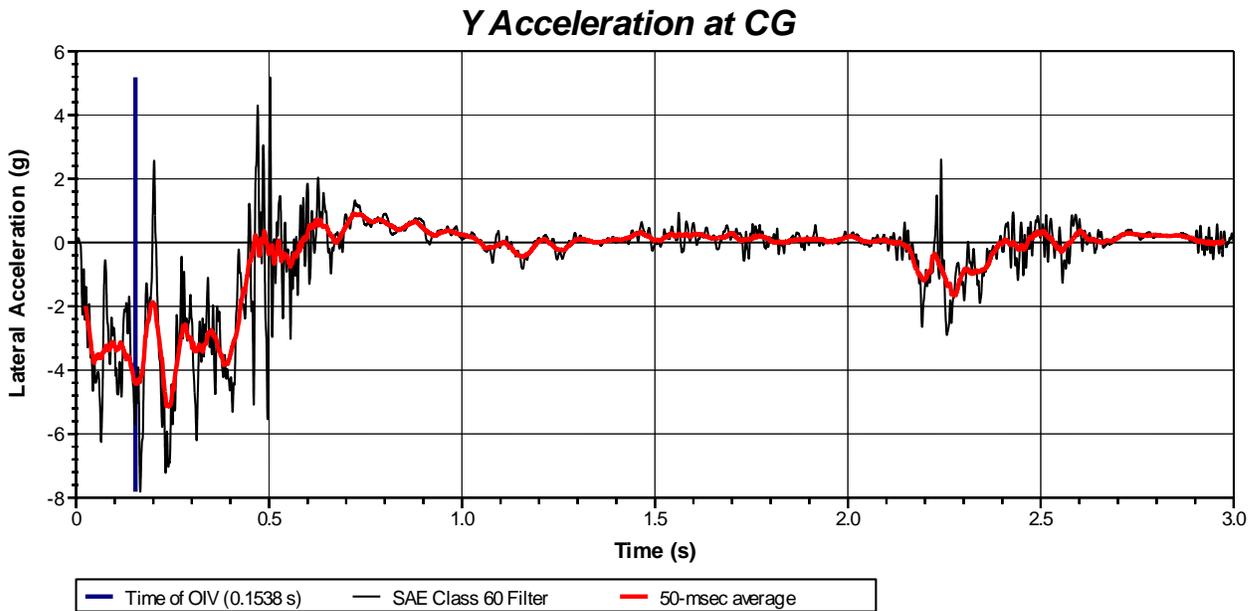
Figure E.9. Vehicle Lateral Accelerometer Trace for Test 619441-01-10 (Accelerometer Located at Center of Gravity).

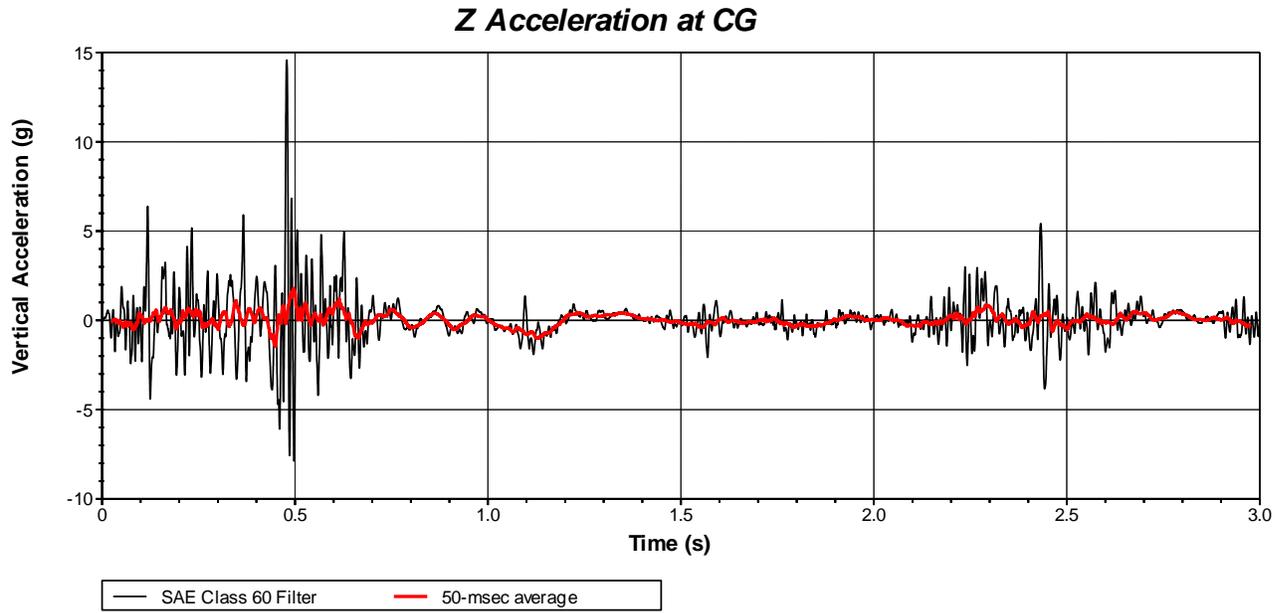
**Figure E.10. Vehicle Vertical Accelerometer Trace for Test 619441-01-10
(Accelerometer Located at Center of Gravity).**
