Test Report No. 620061-01-1:6

## DESIGN AND EVALUATION OF THE MERRITT PARKWAY GUIDERAIL ACCORDING TO *MASH* TL-3

Sponsored by  
Connecticut DOT and

Roadside Safety Pooled Fund

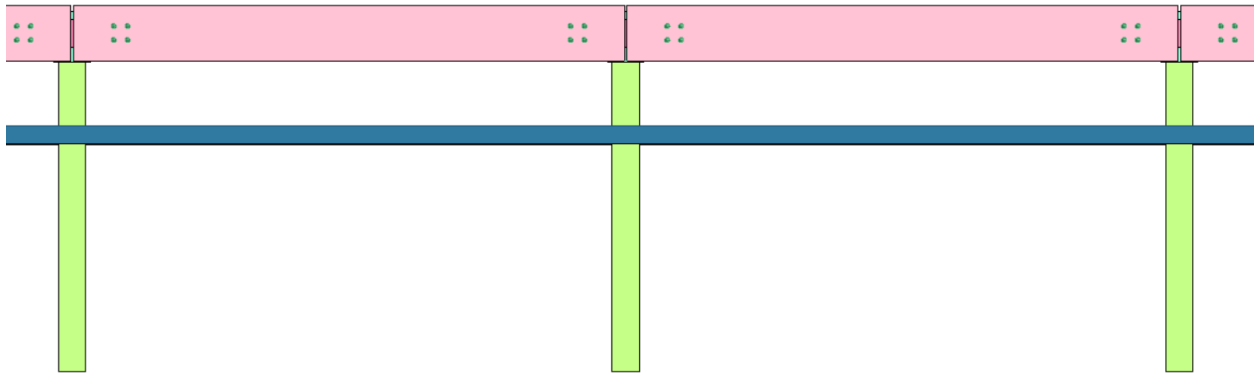
Figure 2.1. Elevation View of FE Model.

screws. The timber components were modeled using MAT\_WOOD. The guiderail posts, splice plates, and steel-backed plates were modeled using MAT\_SIMPLIFIED\_JOHNSOON\_COOK. At each lag screw location, the surrounding nodes between the steel plate and timber rail were constrained using CONTACT\_TIED\_NODES\_TO\_SURFACE. Figure 2.1 and Figure 2.2 show elevation and plan views of the FE model. This model represents the original system prior to the integration of the components for the four different design concepts. This model also includes a 4-inch curb.

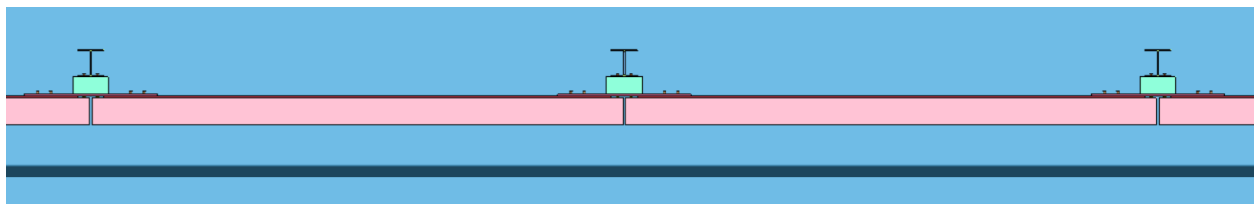
Figure 2.2. Plan View of FE Model.

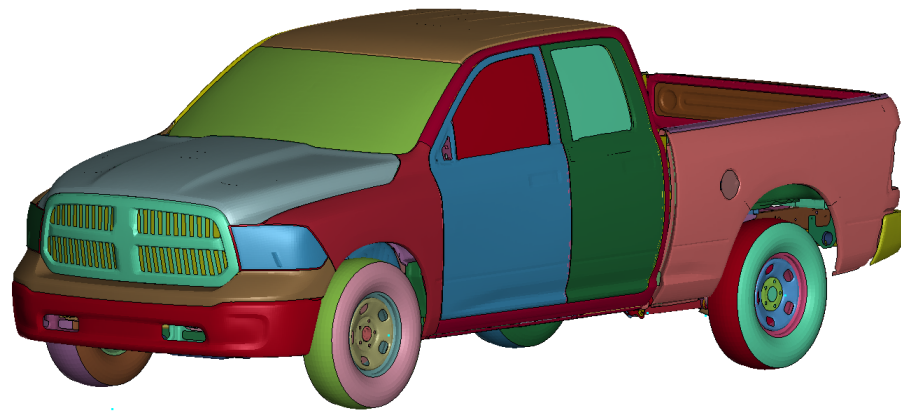
Figure 2.3. 2270P FE Vehicle Model.

LS-DYNA, which is a commercially available general purpose FE software, was used for all the finite element analyses. A 5,000-lb Dodge Ram pickup truck vehicle model was used for the *MASH* Test 3-11 computer simulations (Figure 2.3). A 2,425-lb Toyota Yaris small car vehicle model was used for the *MASH* Test 3-10 computer simulations (Figure 2.4).

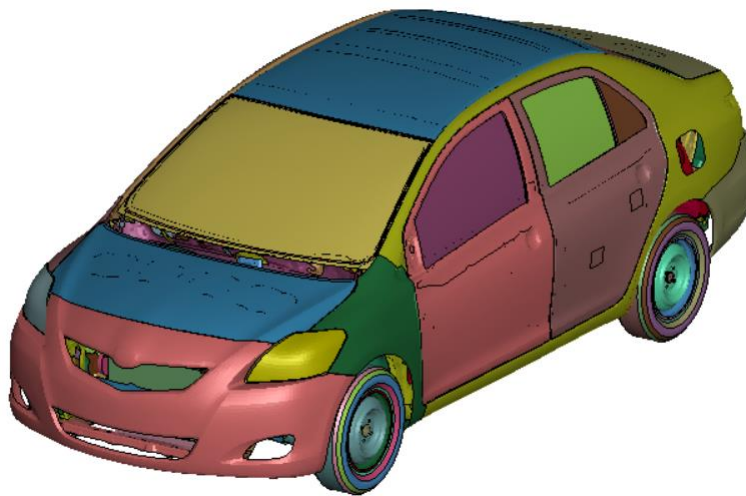
Figure 2.4. 1100C FE Vehicle Model.

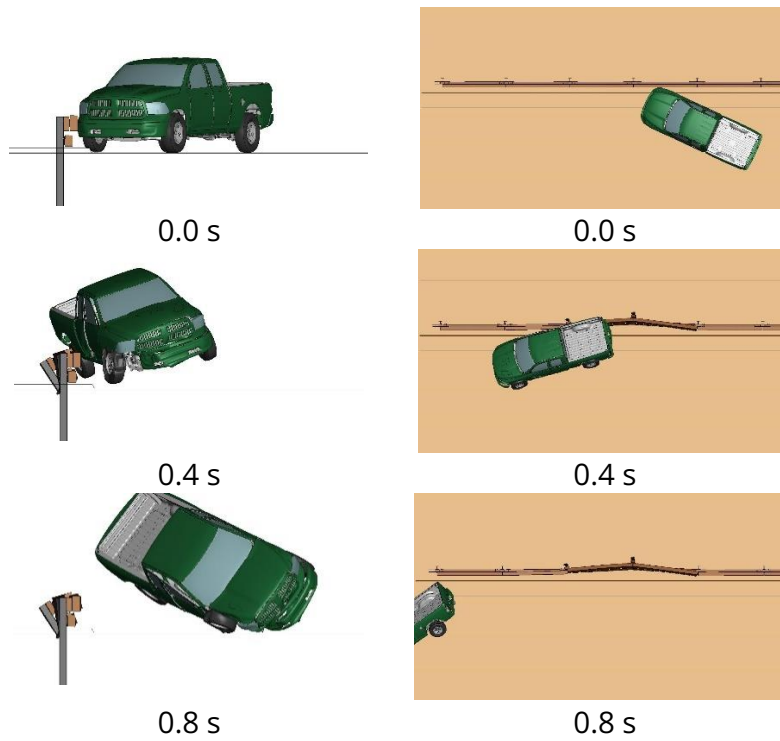
Figure 2.5. Sequential Images for MASH Test 3-11 Simulation – Rubrail.

*MASH* Test 3-11 computer simulations were performed for all four design concepts. Figure 2.5 through Figure 2.8 show sequential images for the simulation runs. Table 2.1 shows the occupant risk values for the simulation runs.

The rubrail and W6x9 (i.e., smaller posts) design concepts both indicated unsatisfactory crashworthy performance due to vehicle rollover. The front splice plate design concept indicated satisfactory crashworthy performance. The vehicle remained stable throughout the simulation and the occupant risk results were below the *MASH* limits. However, there was concern about the edge of the steel plate being exposed to the vehicle if the timber rail were to sustain any fractures during impact. Thus, this design concept was not considered for further evaluation. The 1-inch-thick splice plate design concept

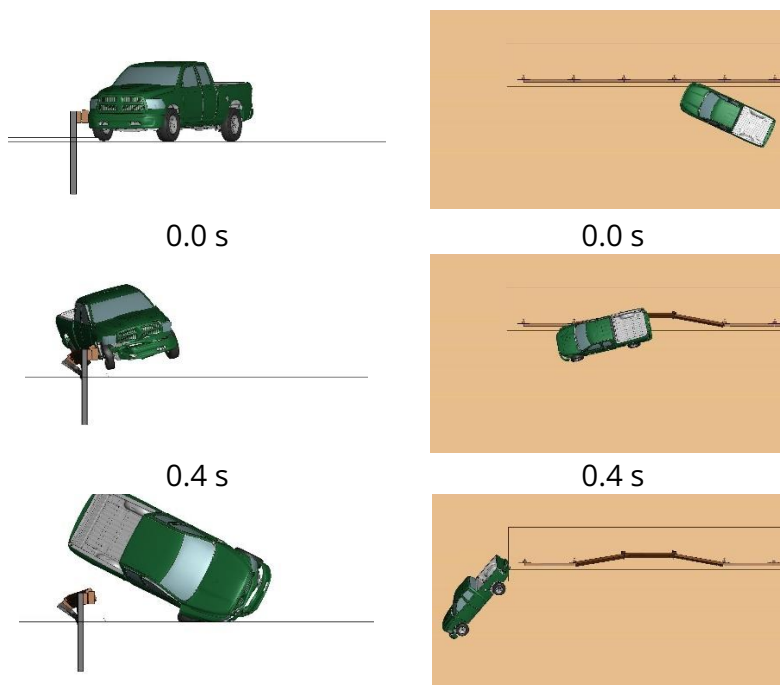
Figure 2.8. Sequential Images for MASH Test 3-11 Simulation – 1 inch Thick Splice Plate.

indicated satisfactory crashworthy performance. The vehicle remained stable throughout the simulation and the occupant risk results were below the *MASH* limits.

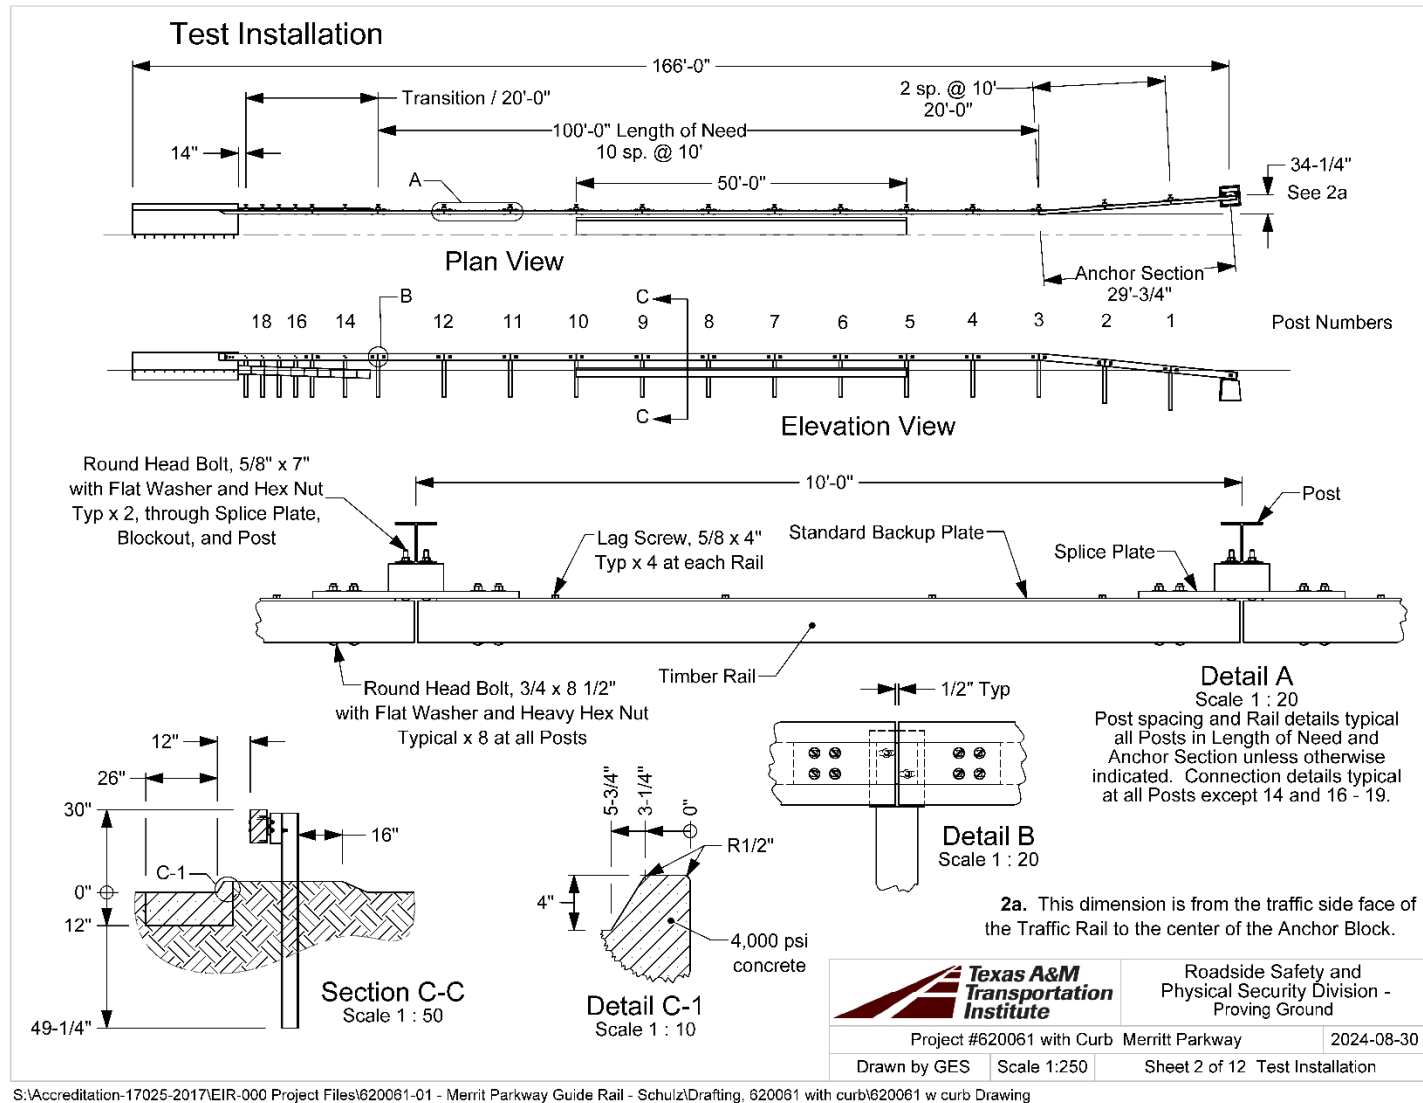
Figure 3.1. Details of Merritt Parkway Guiderail for Test 620061-01-2.

Figure 3.1 presents the overall information on the Merritt Parkway Guiderail, and Figure 3.2 thru Figure 3.7 provide photographs of the installation. A.1 provides further

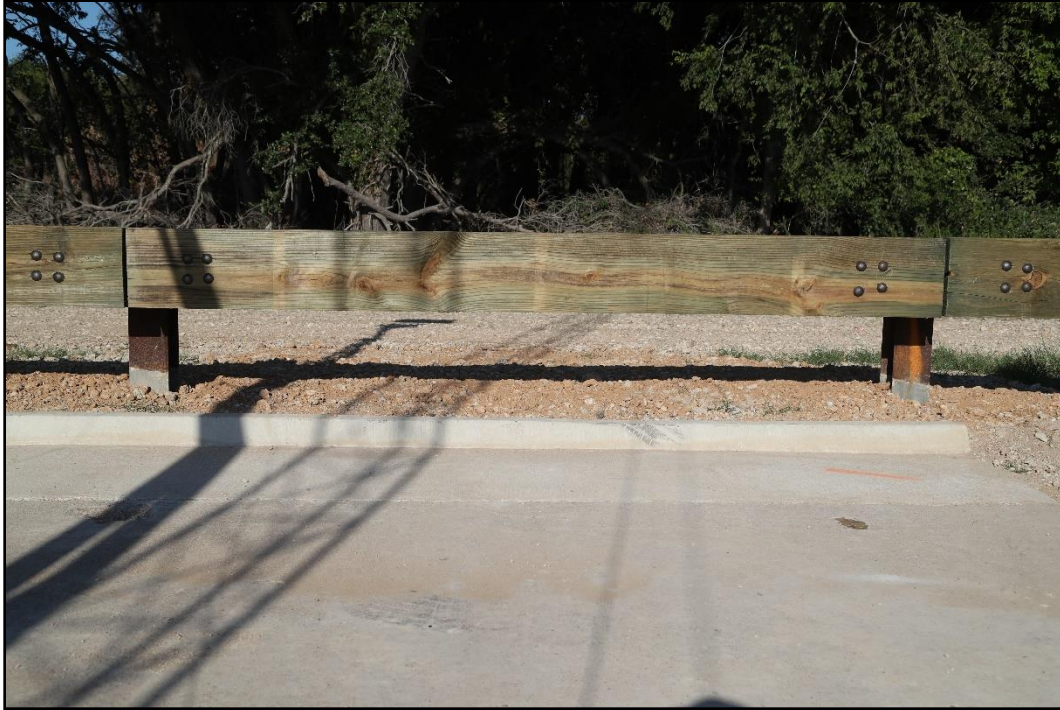
Figure 3.2. Merritt Parkway Guiderail Test Installation prior to Test 620061-01-2.

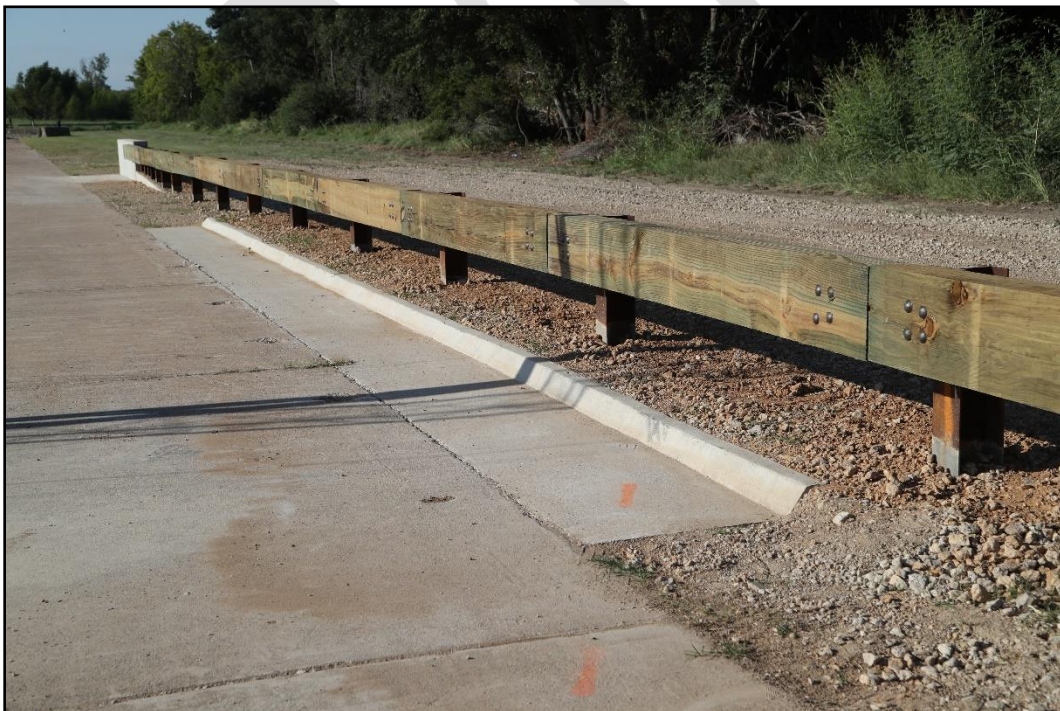
Figure 3.3. Merritt Parkway Guiderail Oblique Downstream View of Test Installation prior to Test 620061-01-2.

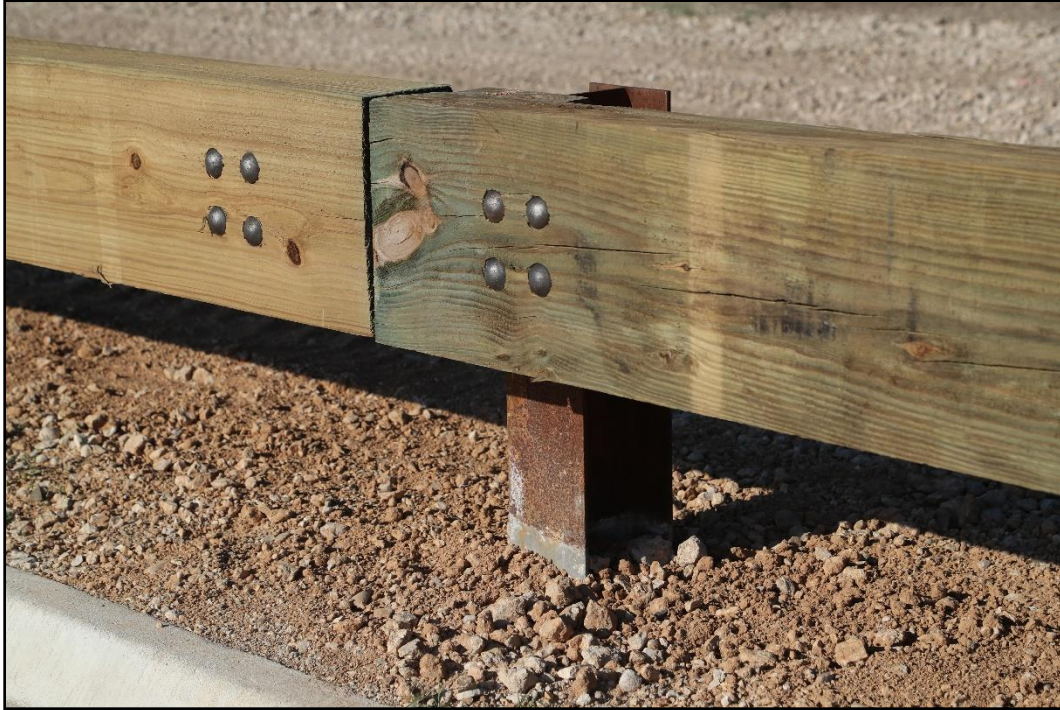
Figure 3.4. Merritt Parkway Guiderail Traffic Side View of Joint between Posts 7 and 8 prior to Test 620061-01-2.

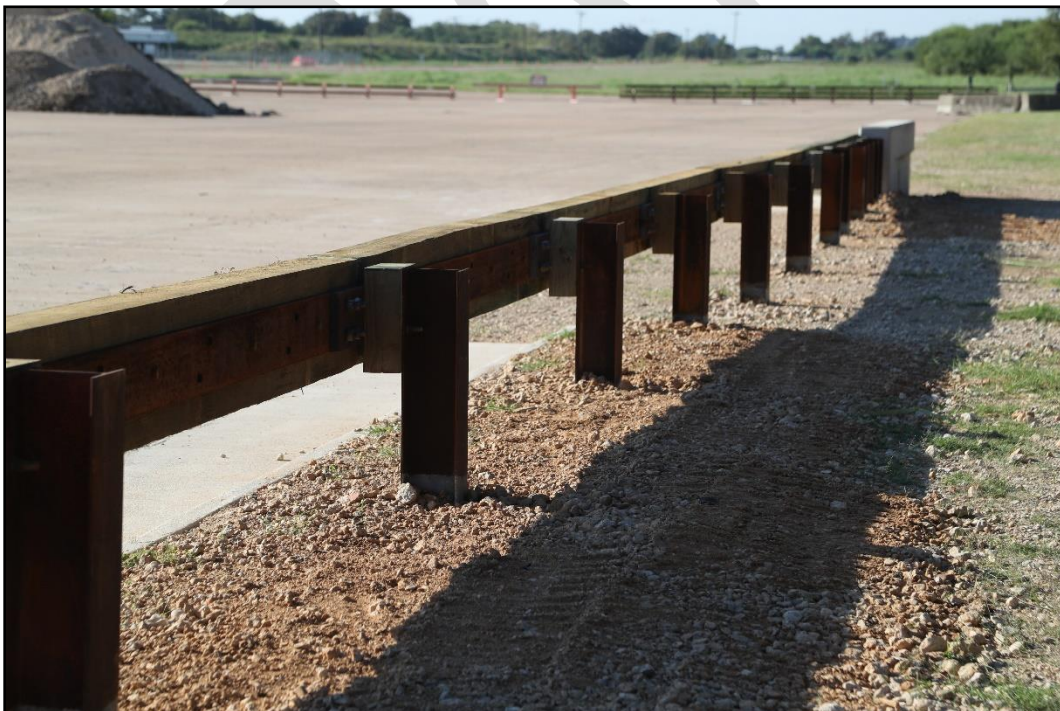
Figure 3.5. Merritt Parkway Guiderail Field Side Oblique Downstream View of Test Installation prior to Test 620061-01-2.

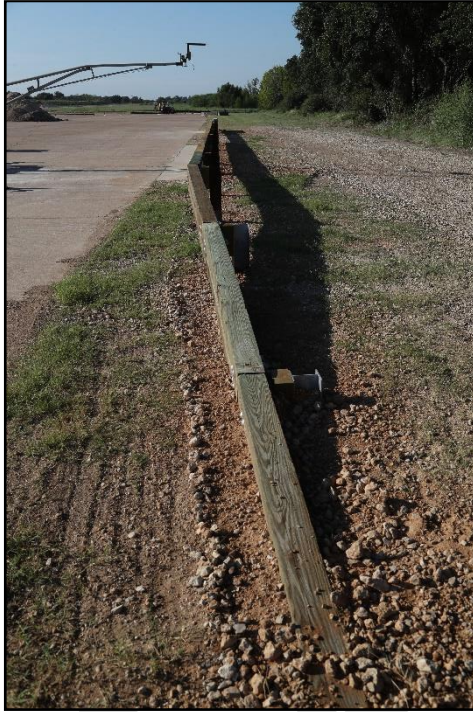
Figure 3.6. Merritt Parkway Guiderail Anchor Section prior to Test 620061-01-2.

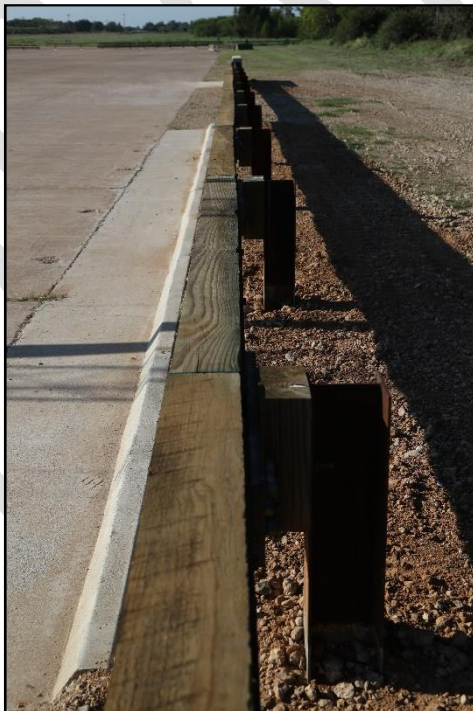
Figure 3.7. Merritt Parkway Guiderail Downstream In-Line View of Test Installation prior to Test 620061-01-2.

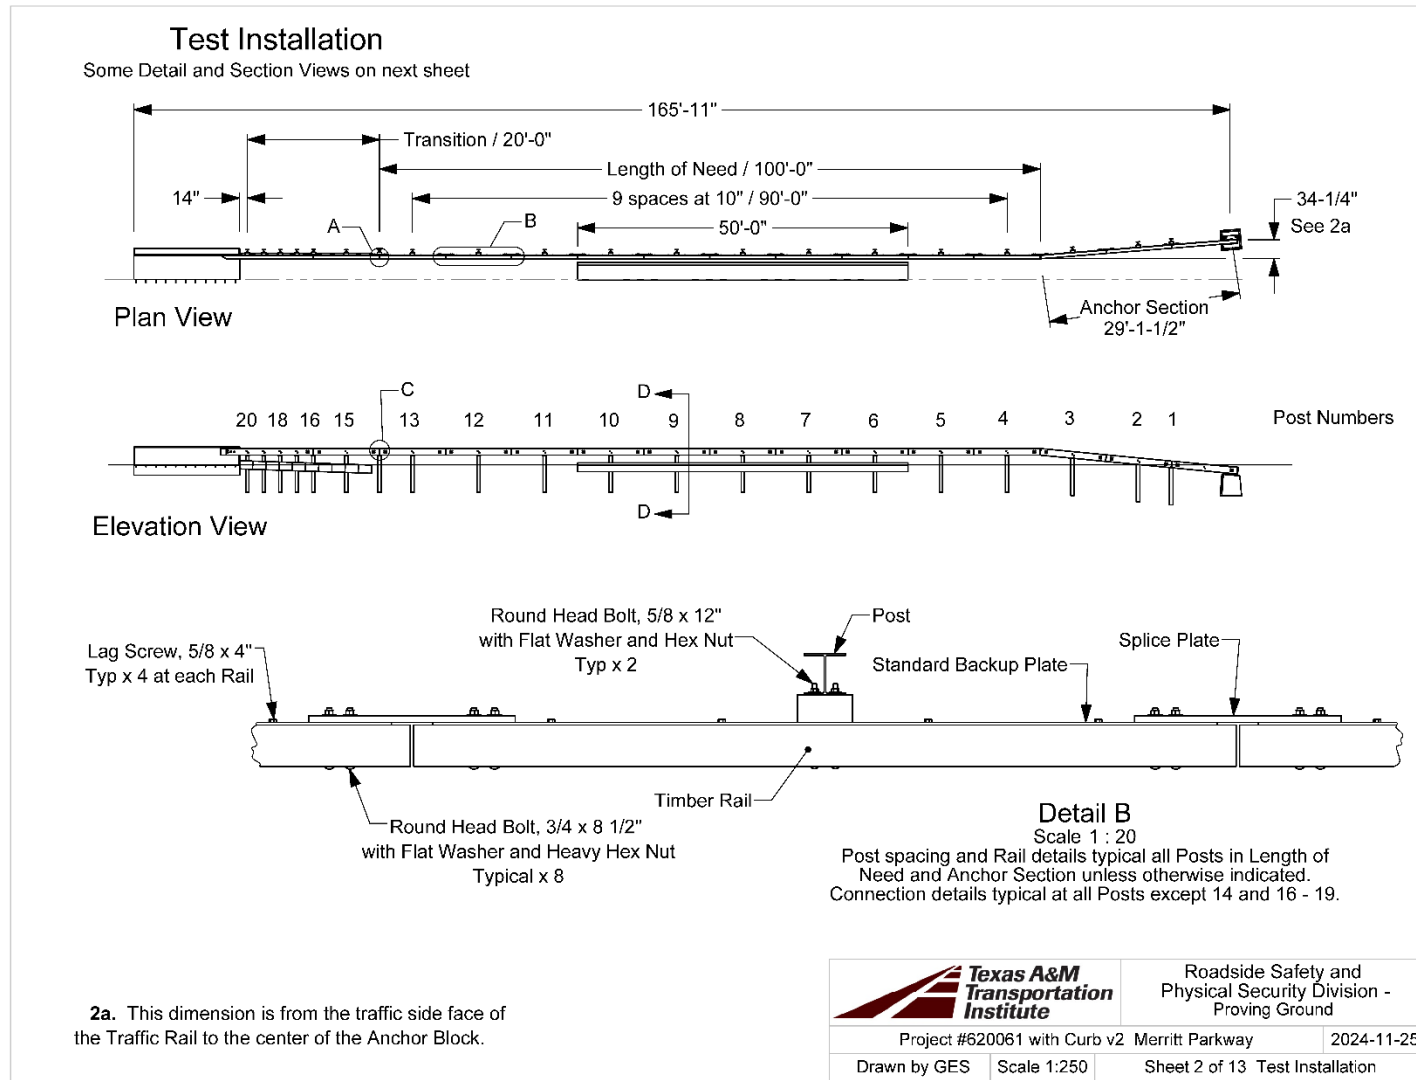
Figure 3.8. Details of Merritt Parkway Guiderrail for Tests 620061-01-1&amp;3.

Figure 3.8 presents the overall information on the Merritt Parkway Guiderail, and Figure 3.9 thru Figure 3.14 provide photographs of the installation. A.2 provides further details on the Merritt Parkway Guiderail for Tests 620061-01-1&3. Drawings were provided by the Texas A&M Transportation Institute (TTI) Proving Ground, and construction was performed by TTI Proving Ground personnel.

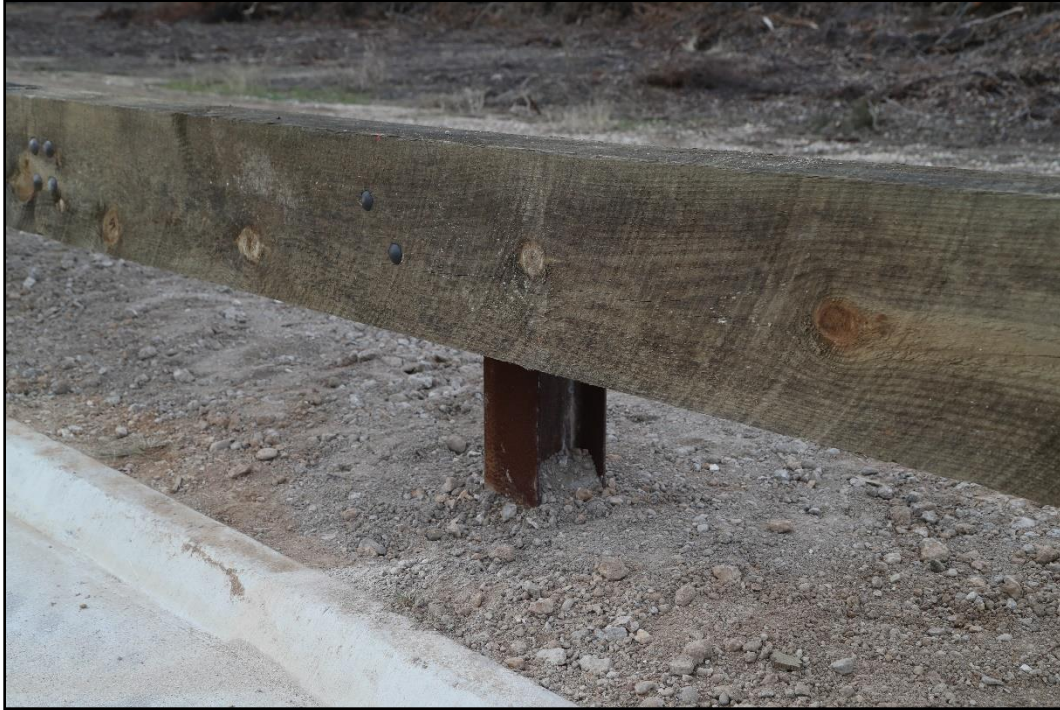
Figure 3.9. Merritt Parkway Guiderrail Test Installation prior to Tests 620061-01-1&3.

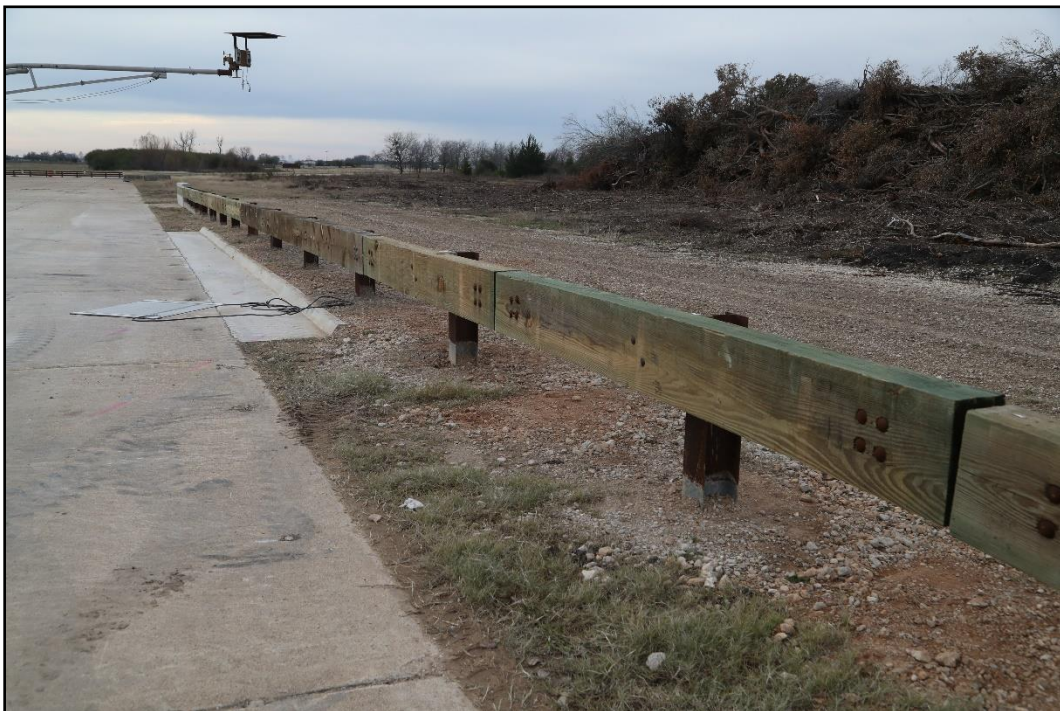
Figure 3.10. Merritt Parkway Guiderrail Oblique Downstream View of Test Installation prior to Tests 620061-01-1&3.

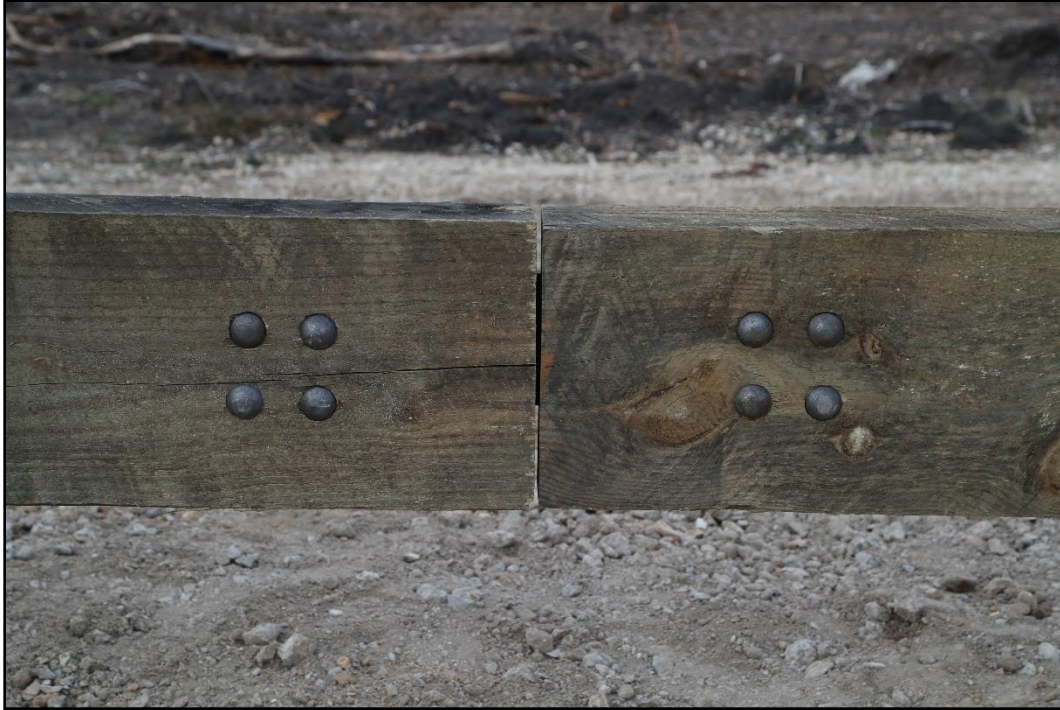
Figure 3.11. Merritt Parkway Guidetail Traffic Side View of Joint at Midspan between Posts 7 and 8 prior to Tests 620061-01-1&3.

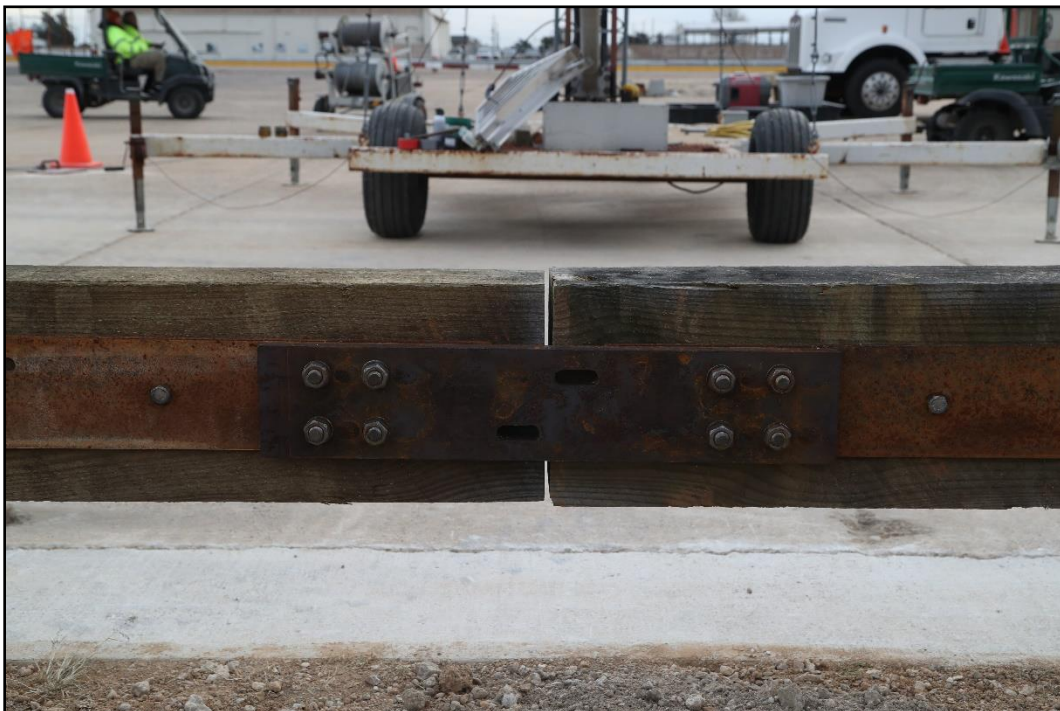
Figure 3.12. Merritt Parkway Guidetail Field Side View of Joint at Midspan between Posts 7 and 8 prior to Tests 620061-01-1&3.

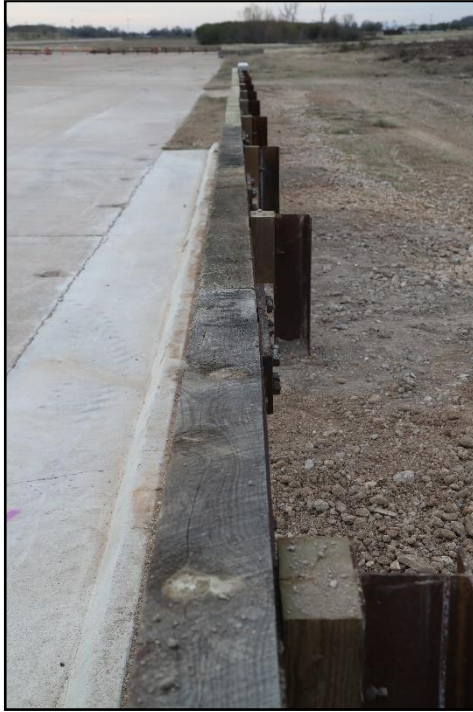
Figure 3.13. Merritt Parkway Guiderail Downstream In-Line View of Test Installation prior to Tests 620061-01-1&3.

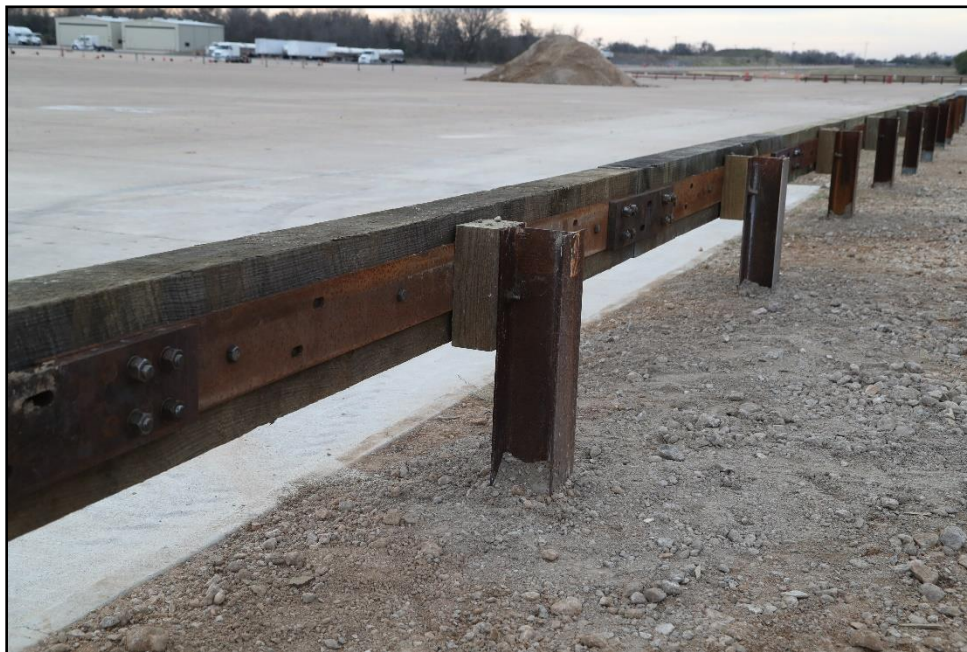
Figure 3.14. Merritt Parkway Guiderail Field Side Downstream View of Test Installation prior to Tests 620061-01-1&3.

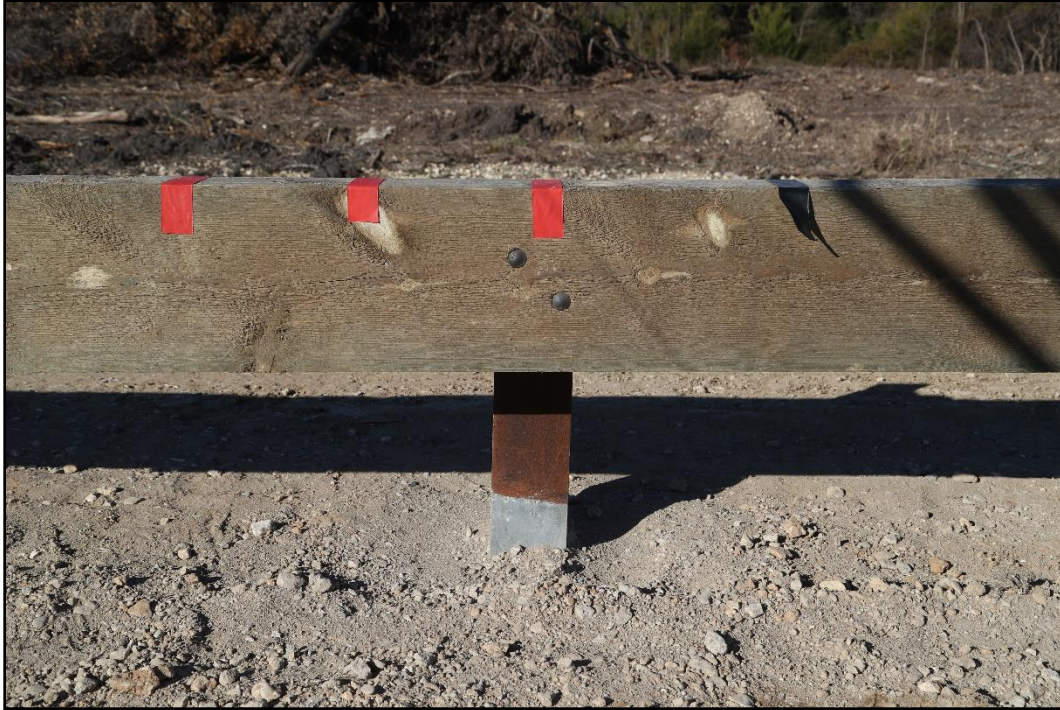
Figure 3.16. Merritt Parkway Guiderrail Test Installation prior to Test 620061-01-4.

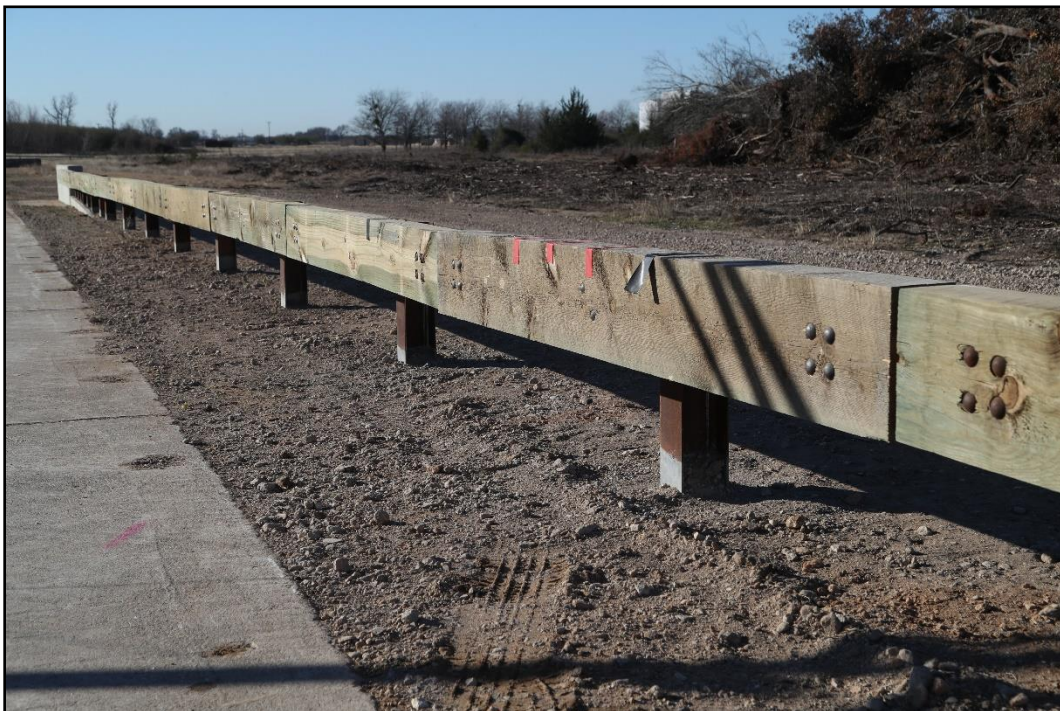
Figure 3.17. Merritt Parkway Guiderrail Oblique Downstream View of Test Installation prior to Tests 620061-01-1&3.

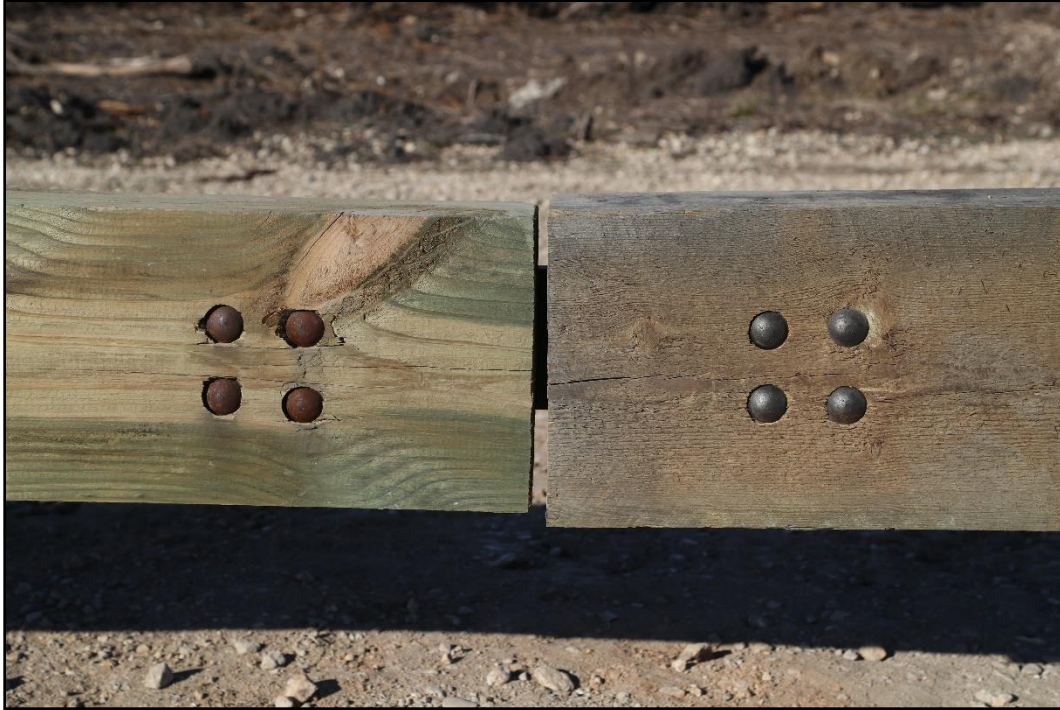
Figure 3.18. Merritt Parkway Guiderail Traffic Side View of Joint at Midspan between Posts 7 and 8 prior to Test 620061-01-4.

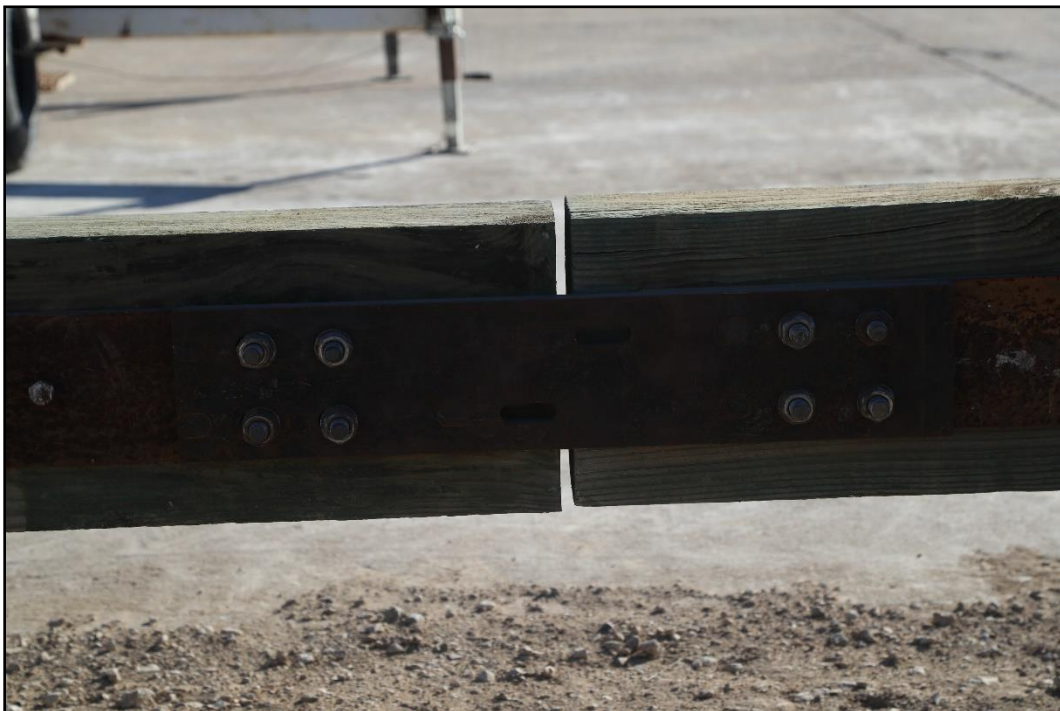
Figure 3.19. Merritt Parkway Guiderail Field Side View of Joint at Midspan between Posts 7 and 8 prior to Test 620061-01-4.

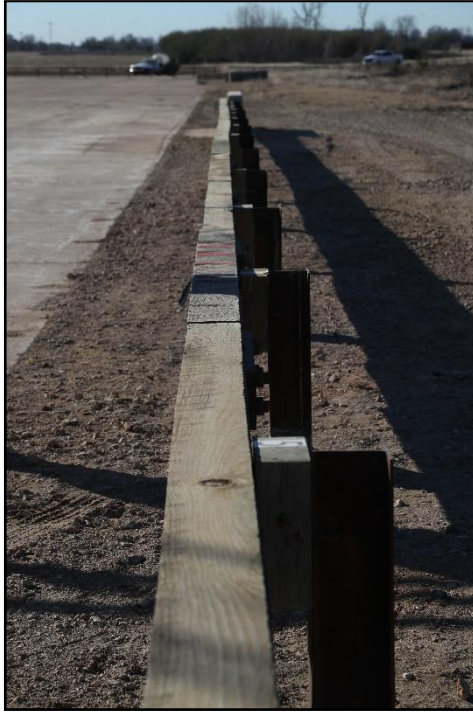
Figure 3.20. Merritt Parkway Guiderail Downstream In-Line View of Test Installation prior to Test 620061-01-4.

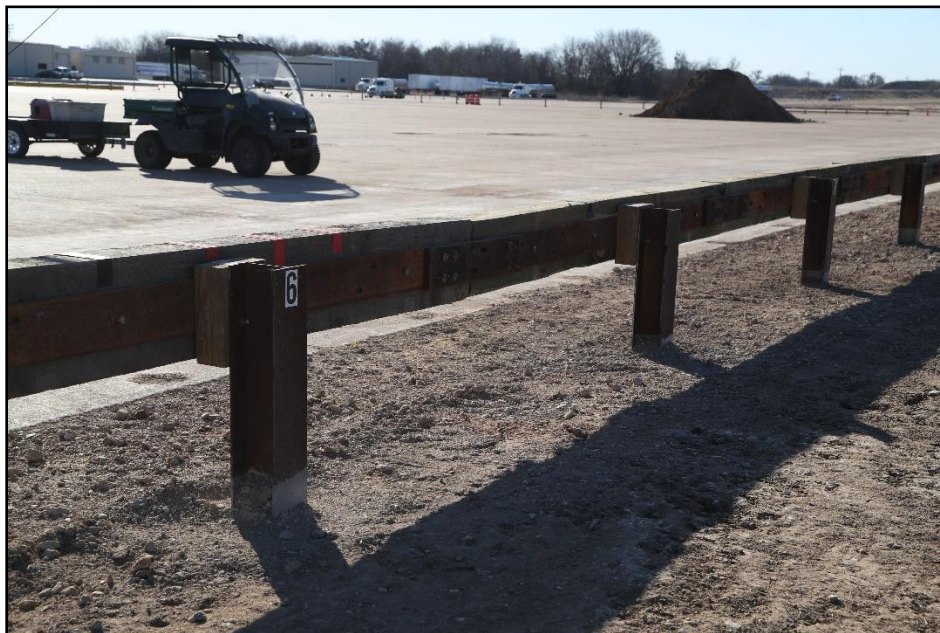
Figure 3.21. Merritt Parkway Guiderail Field Side Downstream View of Test Installation prior to Test 620061-01-4.

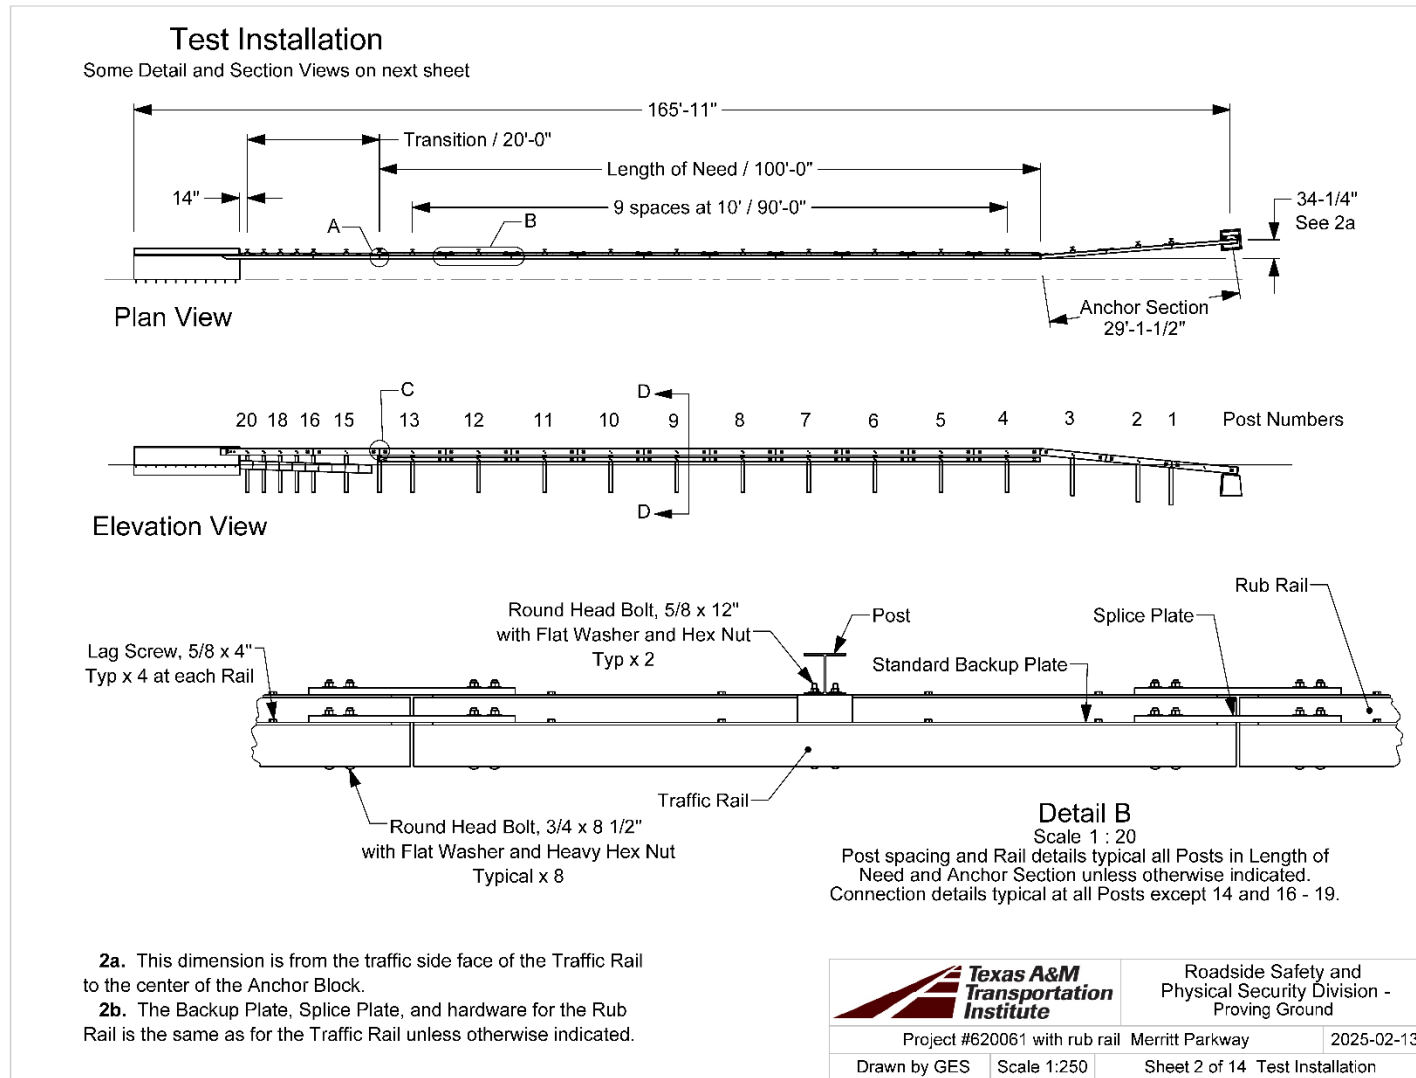
Figure 3.22. Details of Merritt Parkway Guiderail for Test 620061-01-5&6.

Figure 3.22 presents the overall information on the Merritt Parkway Guiderail, and Figure 3.23 thru Figure 3.28 provide photographs of the installation. A.4 provides further details on the Merritt Parkway Guiderail for Tests 620061-01-5&6. Drawings were provided

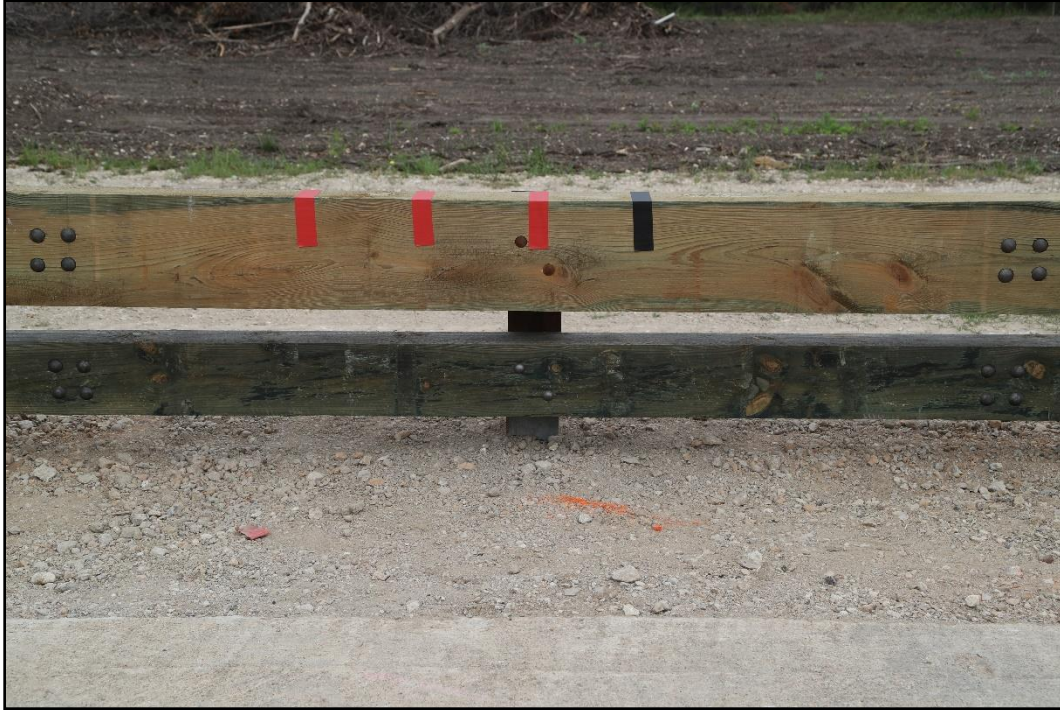
Figure 3.23. Merritt Parkway Guiderail Test Installation prior to Tests 620061-01-5&6.

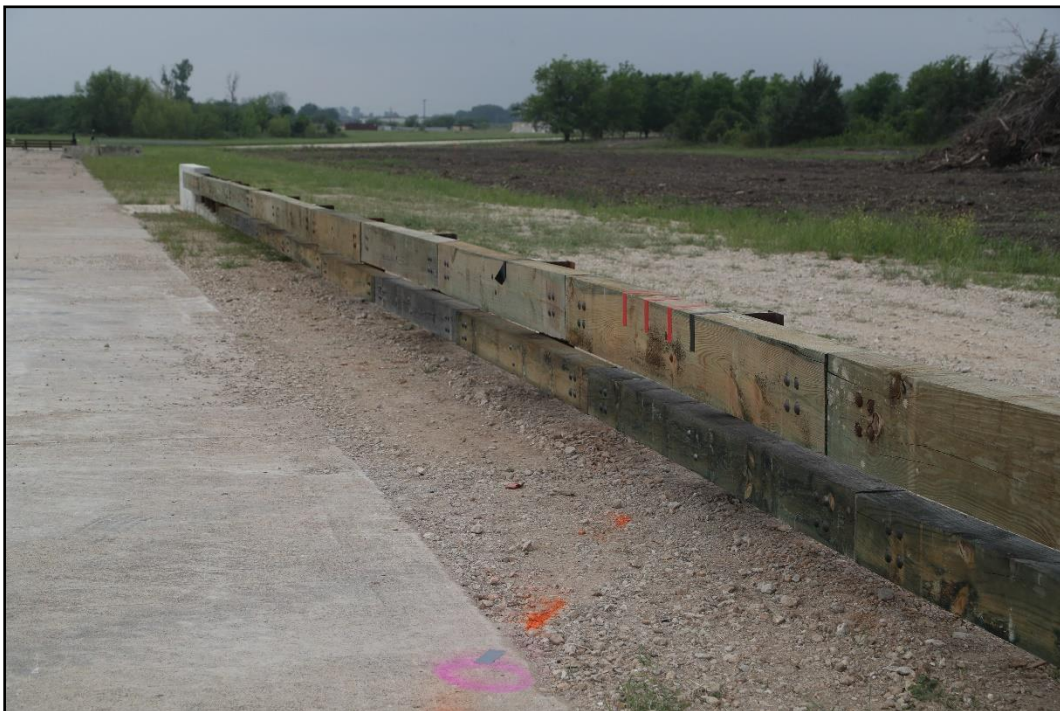
Figure 3.24. Merritt Parkway Guiderail Oblique Downstream View of Test Installation prior to Tests 620061-01-1&3.

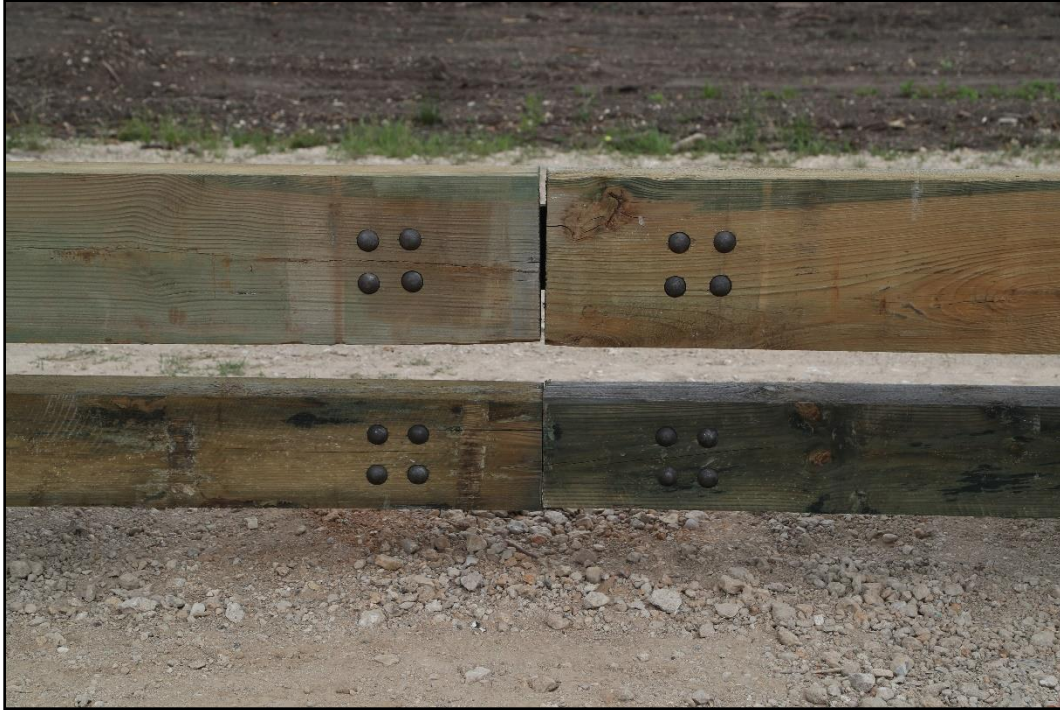
Figure 3.25. Merritt Parkway Guidrail Traffic Side View of Joint at Midspan between Posts 7 and 8 prior to Tests 620061-01-5&6.
