Test Report No. 620061-01-1:6

## DESIGN AND EVALUATION OF THE MERRITT PARKWAY GUIDERAIL ACCORDING TO *MASH* TL-3

Sponsored by  
Connecticut DOT and

Roadside Safety Pooled Fund

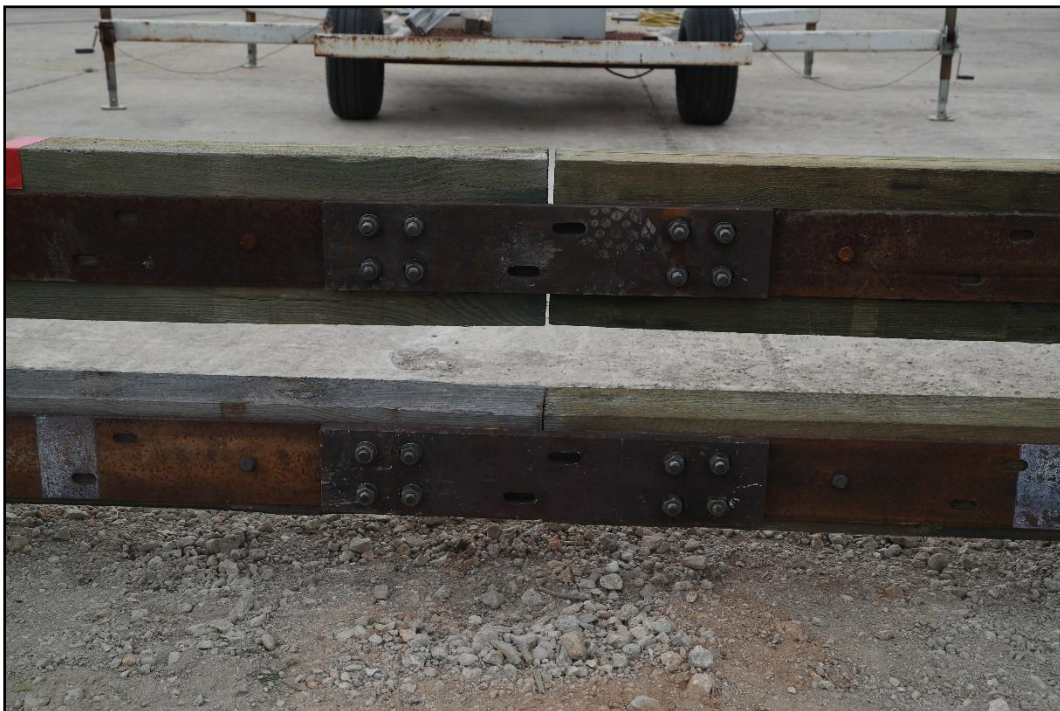
Figure 3.26. Merritt Parkway Guidrail Field Side View of Joint at Midspan between Posts 7 and 8 prior to Tests 620061-01-5&6.

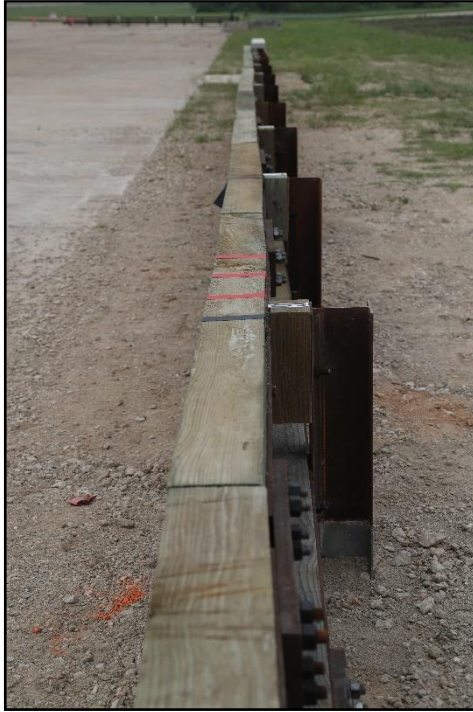
Figure 3.27. Merritt Parkway Guiderail Downstream In-Line View of Test Installation prior to Tests 620061-01-5&6.

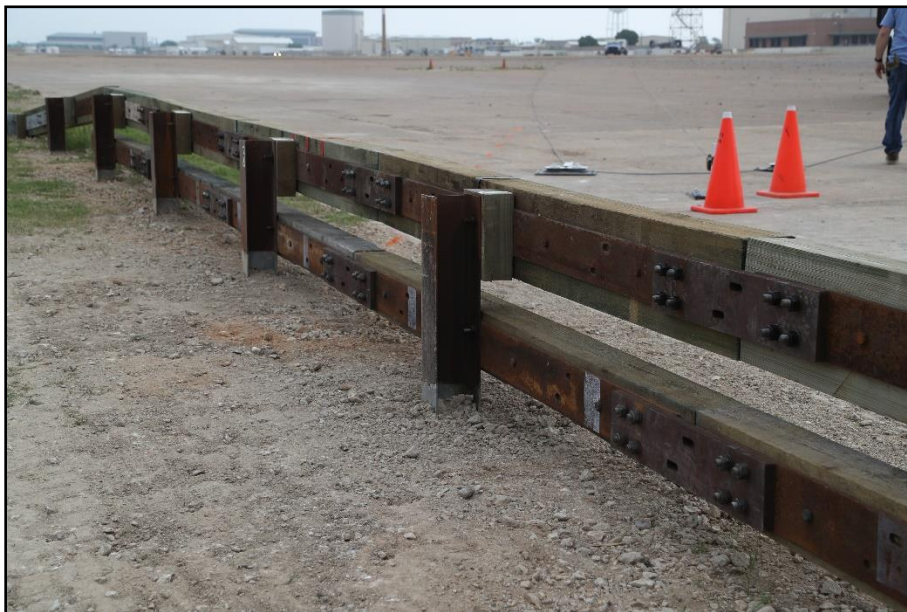
Figure 3.28. Merritt Parkway Guiderail Field Side Upstream View of Test Installation prior to Tests 620061-01-5&6.

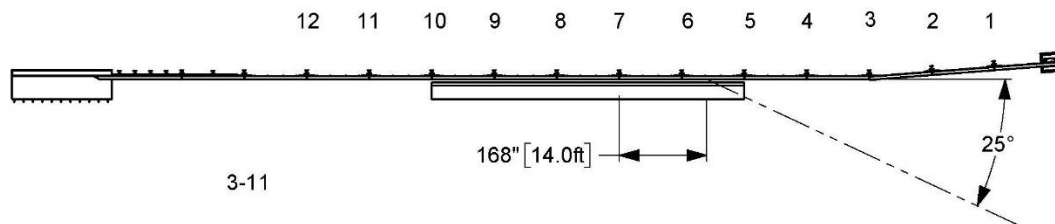
Figure 6.1. Target CIP for Test 620061-01-2.

The Critical Impact Point (CIP) for this test was 168 inches (14ft) upstream from the centerline of post 7 at 25 degrees. The target CIP for this test was determined using the information provided in *MASH* Section 2.2.1 and *MASH* Section 2.3.2. Figure 6.1 shows the target CIP for Test 620061-01-2. Figure 6.2 and Figure 6.3 depict the vehicle at the CIP prior to Test 620061-01-2.

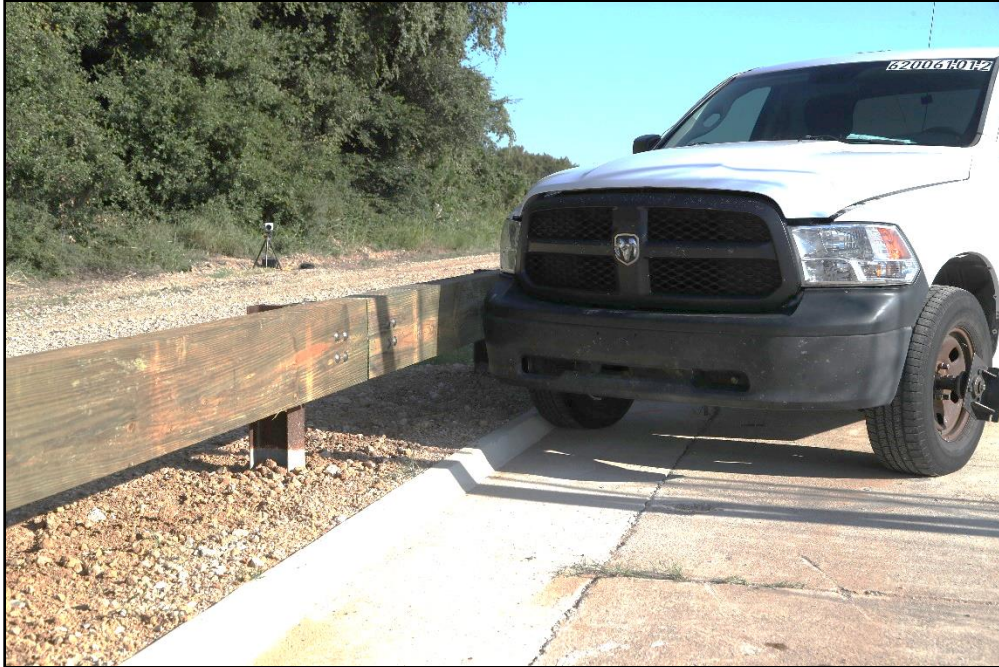
Figure 6.2. Merritt Parkway Guidrail/Test Vehicle Geometrics for Test 620061-01-2.

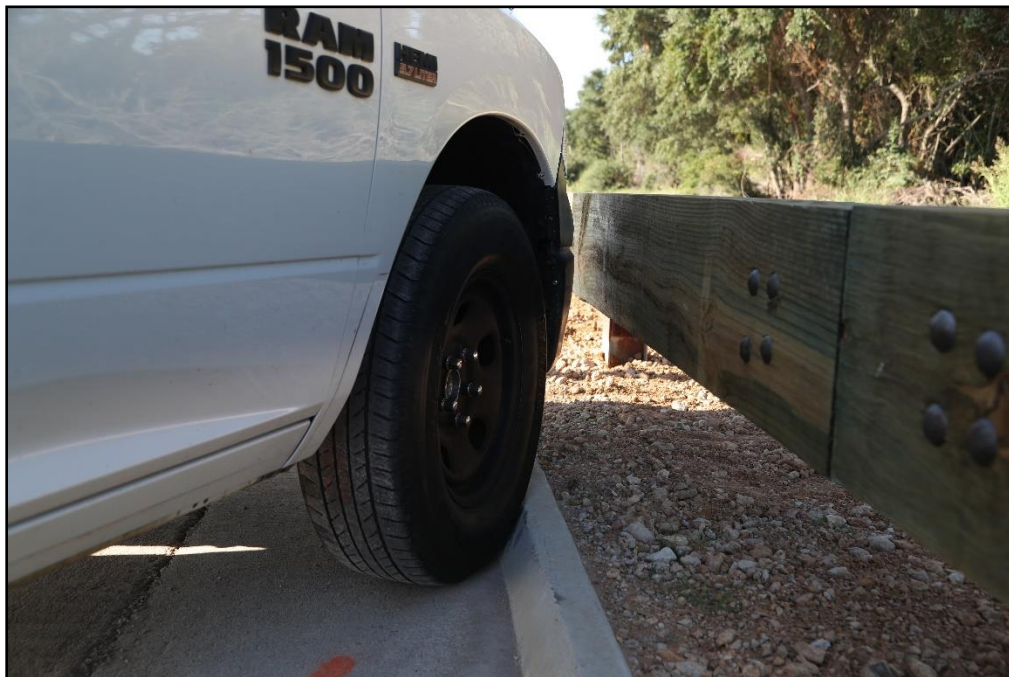
Figure 6.3. Merritt Parkway Guidrail/Test Vehicle Impact Location 620061-01-2.

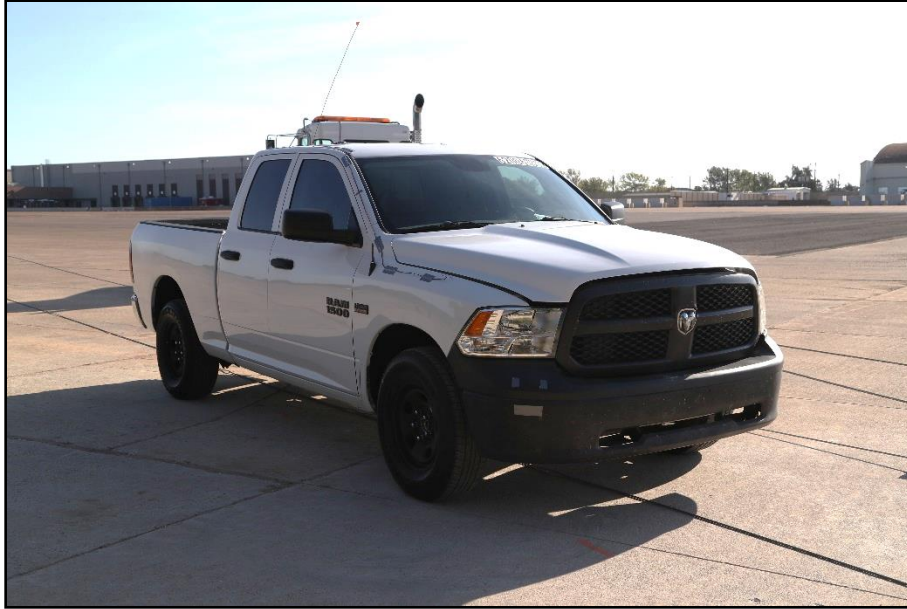
Figure 6.4. Impact Side of Test Vehicle before Test 620061-01-2.

Table 6.1 shows the vehicle measurements. Figure 6.4 and Figure 6.5 show the 2018 RAM 1500 used for the crash test. Figure C.1 in Appendix C.1 gives additional dimensions and information on the vehicle.

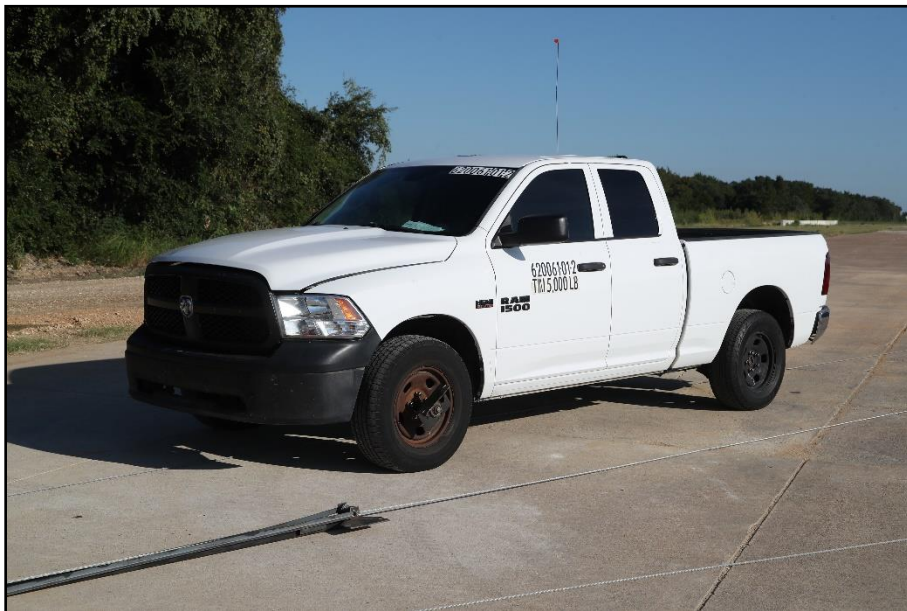
Figure 6.5. Opposite Impact Side of Test Vehicle before Test 620061-01-2.

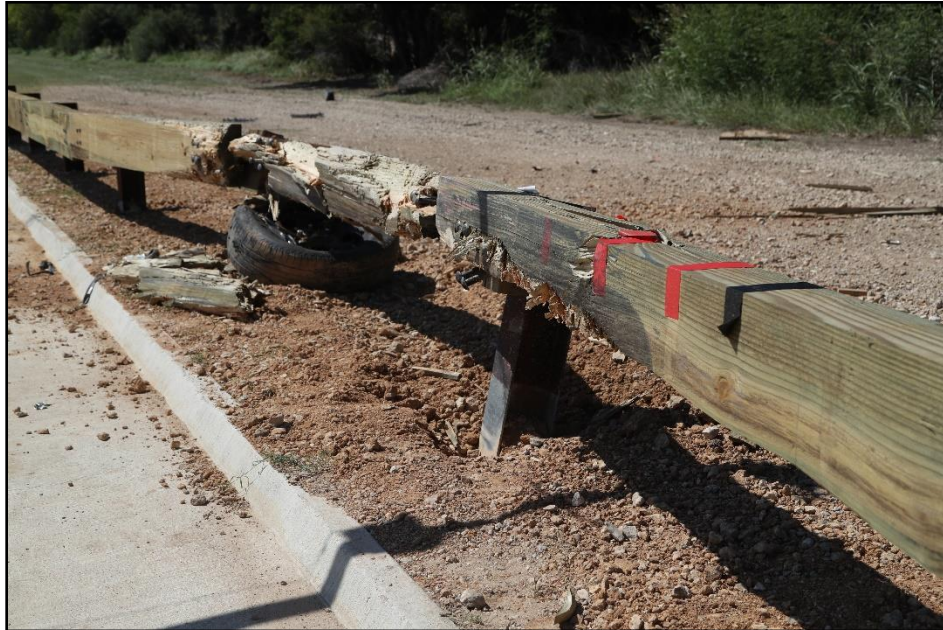
Figure 6.6. Merritt Parkway Guiderail at Impact Location after Test 620061-01-2.

The rail between posts 5 and 6 split, with multiple places gouged and scuffed. The rail between posts 6 and 7 shattered and was heavily damaged, with the backing plate deformed. The splice plate at post 7 was deformed. The upstream rail at the joint between post 7 and 8 was splintered and gouged. At the upstream end of post 7, the tire snagged and tore off.

Table 6.6 describes the damage to the test installation and Table 6.7 describes the deflection and working width of the Merritt Parkway Guiderail. Figure 6.6 and Figure 6.7 show the damage to the Merritt Parkway Guiderail.

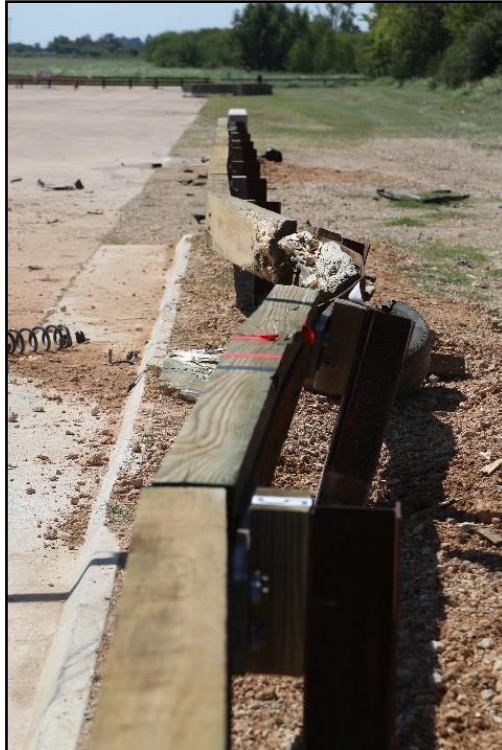
Figure 6.7. Merritt Parkway Guiderail In-Line Downstream View after Test 620061-01-2.

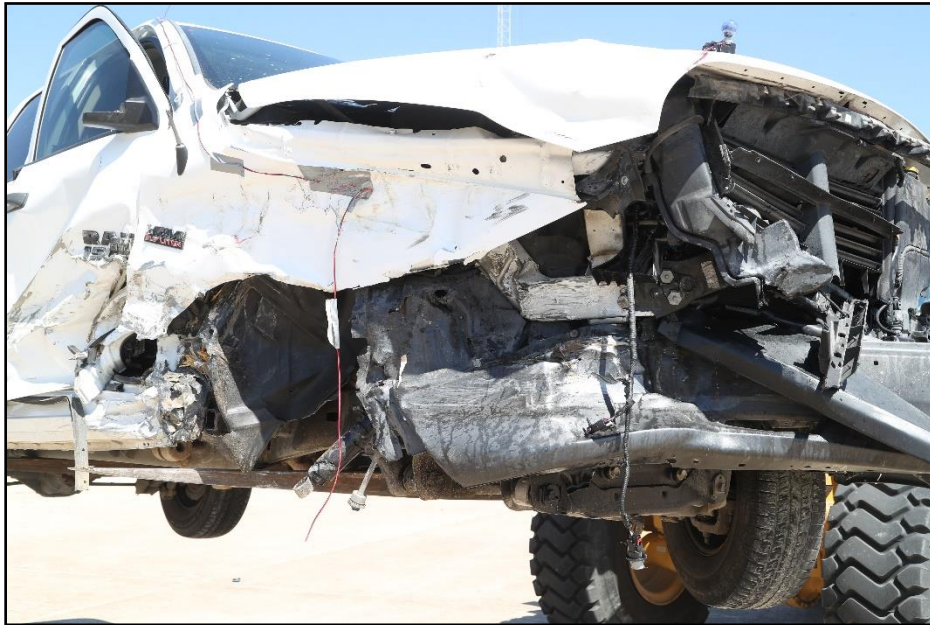
Figure 6.8. Impact Side of Test Vehicle after Test 620061-01-2.

Figure 6.8 and Figure 6.9 show the damage sustained by the vehicle. Figure 6.10 and Figure 6.11 show the interior of the test vehicle. Table 6.8 and Table 6.9 provide details on the occupant compartment deformation and exterior vehicle damage. Figure C.2 and Figure C.3 in Appendix C.1 provide exterior crush and occupant compartment measurements.

Test Parameter	Details
Side Windows	Remained intact
Maximum Exterior Deformation	20 inches at front bumper
VDS	01RFQ5
CDC	01FREE5
Fuel Tank Damage	None
Description of Damage to Vehicle:	Both headlights were fractured and the grill, bumper, hood, fender, radiator, and support were damaged, and the control arm was fractured. The left front frame was bent and the right front tire and wheel were separated. The right front door was scraped and dented and the lower portion deformed and created an 8-inch long × 7.5-inch wide hole where the floor pan was visible and elements of the test article had penetrated through. The right front door also had a 5.5-inch gap at the top, and its side view mirror was dislodged.

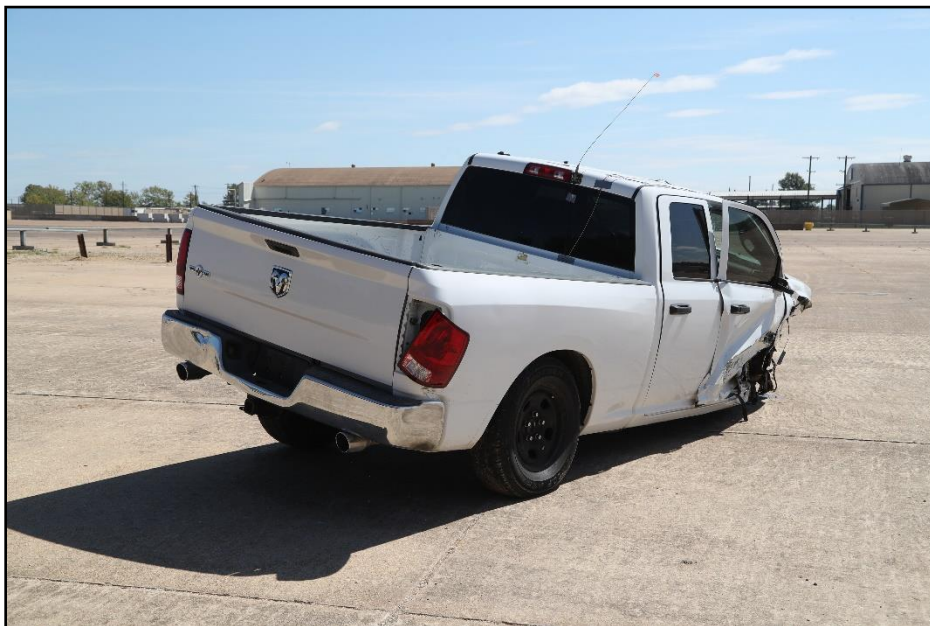
Figure 6.9. Rear Impact Side of Test Vehicle after Test 620061-01-2.

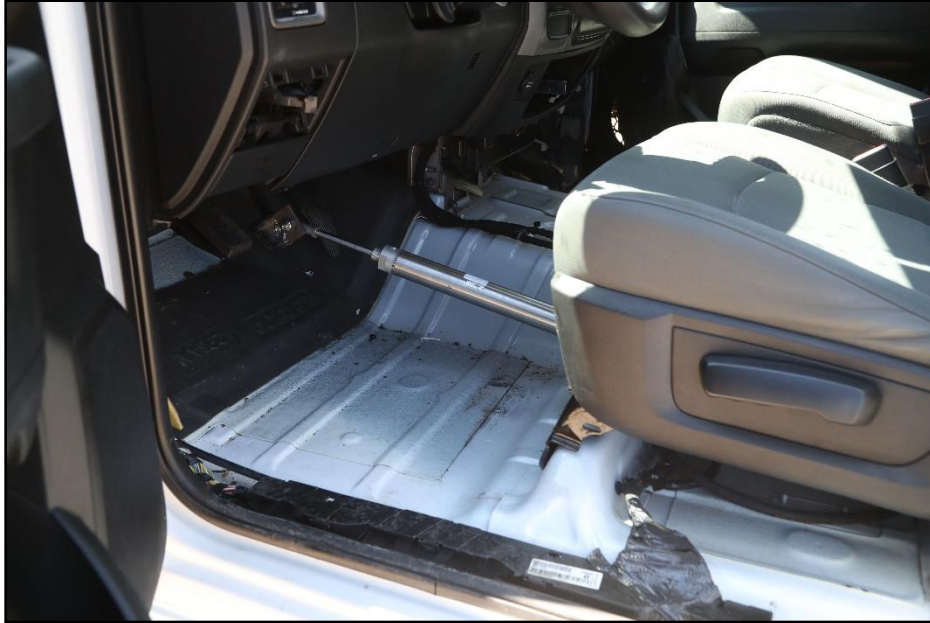
Figure 6.10. Overall Interior of Test Vehicle after Test 620061-01-2.

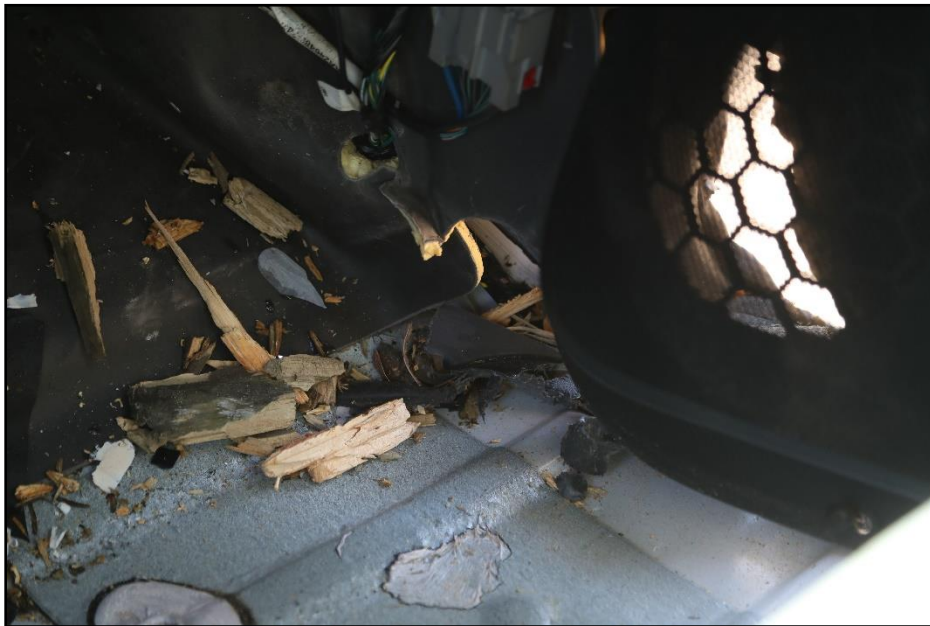
Figure 6.11. Interior of Test Vehicle on Impact Side after Test 620061-01-2.

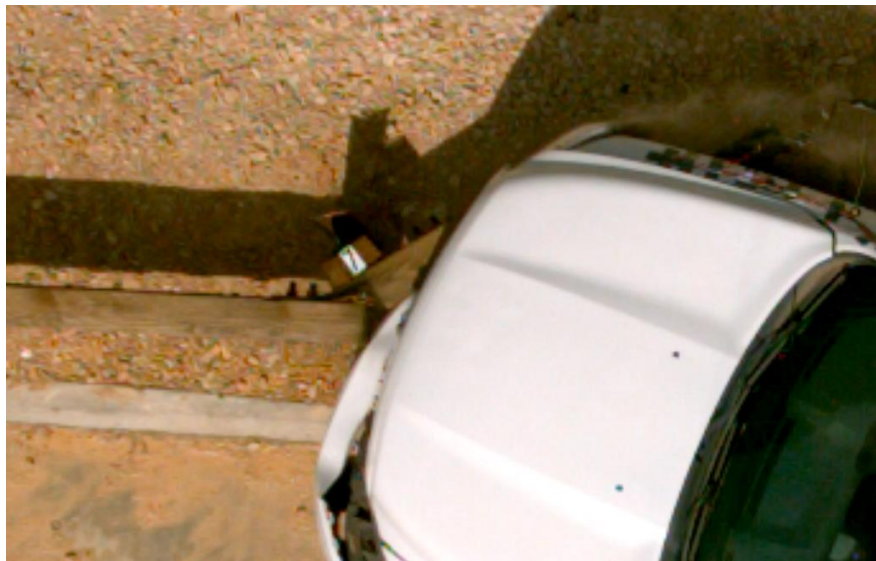
The snagging of the pickup truck door on the rail occurred near the joint location at post 7. Figure 7.1 shows the rail deflection profile as the pickup truck vehicle is being redirected after impact. This joint displacement presented edges of the rail that snagged on the pickup truck vehicle door.

Figure 7.1. Rail Displacement at Post 7 in Crash Test 620061-01-2.

Figure 7.4 shows sequential images for the simulation run. Table 7.1 shows the occupant risk values for the simulation run compared to the previous design. The occupant risk values were similar when comparing the two simulation outputs for the systems. Figure 7.5 shows the rail deflection profile as the vehicle is being redirected and is beginning to engage the critical joint between posts 7 and 8. The alternative design indicated improved deflection and less relative displacement of the rails at the splice joint in comparison to the crash tested system (see Figure 7.1).

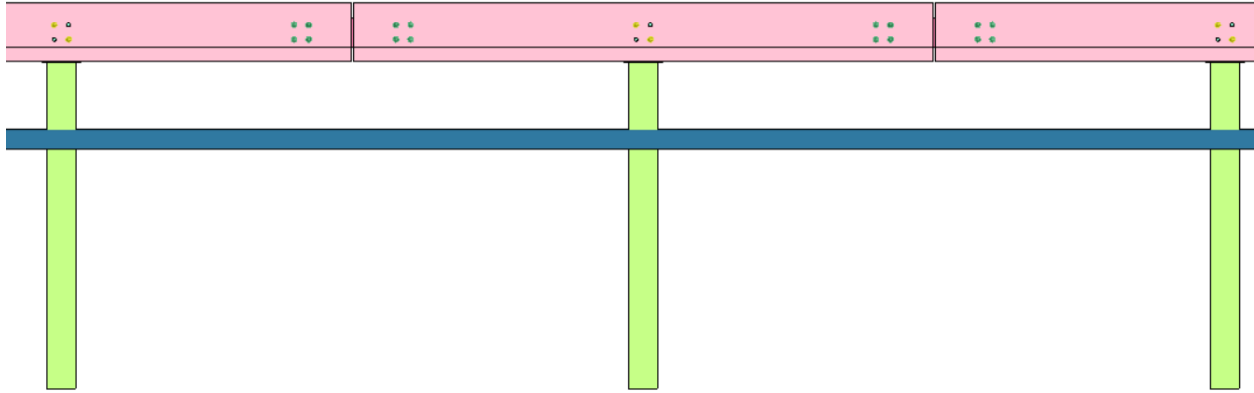
Figure 7.2. Elevation View of FE Model.

Using the FE model developed in Chapter 2, computer simulations were performed to evaluate this alternative design. The 1-inch-thick splice plates were incorporated into the model along with moving the joint to midspan between posts. Figure 7.2 and Figure 7.3 show elevation and plan views of the FE model.

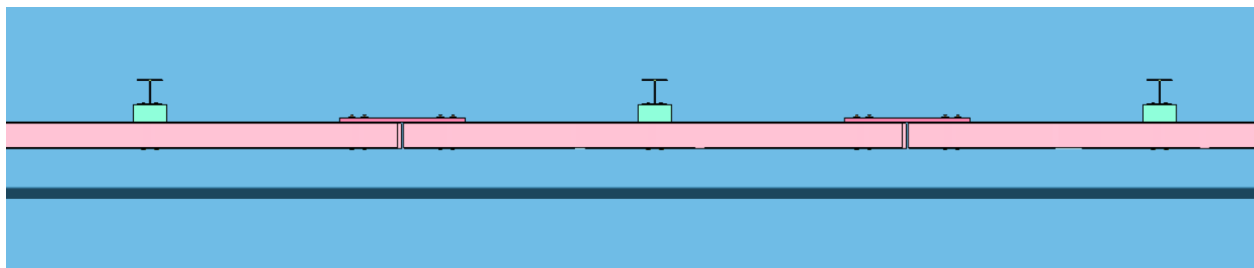
Figure 7.3. Plan View of FE Model.

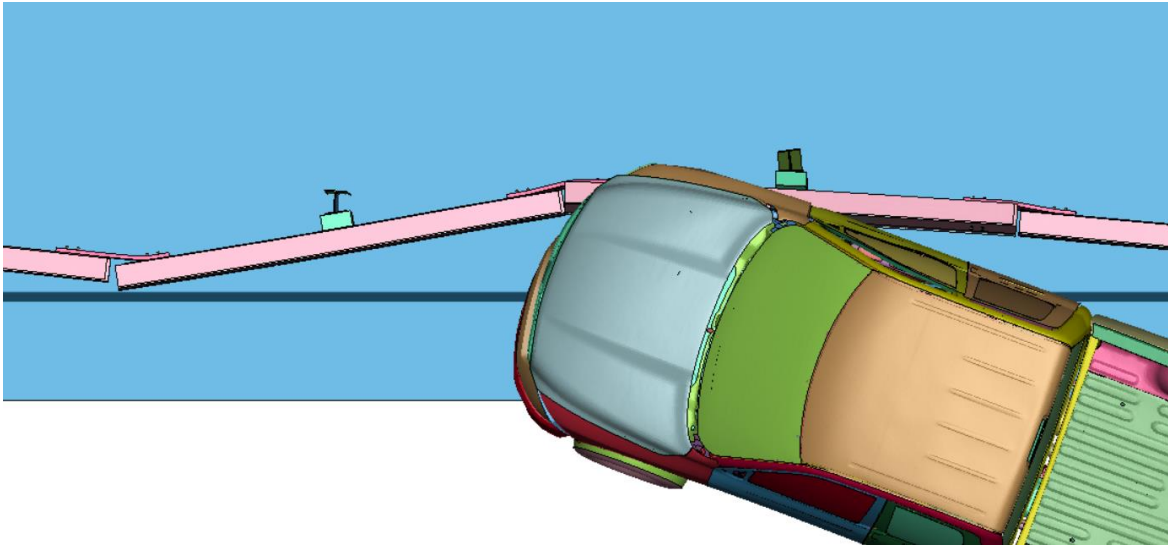
Figure 7.5. Rail Deflection Profile as Truck Engages CIP Joint.

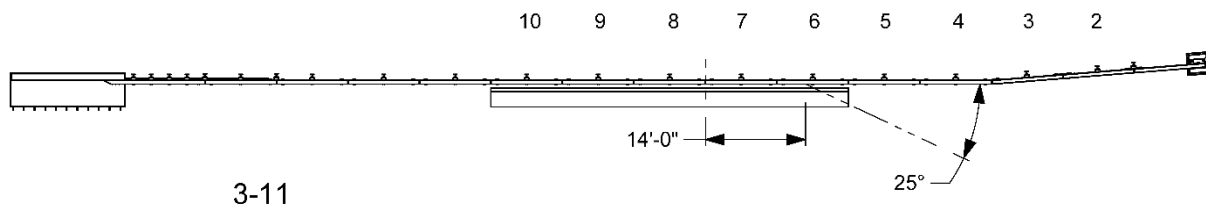
Figure 8.1. Target CIP for Test 620061-01-1.

The Critical Impact Point (CIP) for this test was 168 inches (14ft) upstream from the centerline of the joint between posts 7 and 8 at 25 degrees. The target CIP for this test was determined using the information provided in *MASH* Section 2.2.1 and *MASH* Section 2.3.2. Figure 8.1 shows the target CIP for Test 620061-01-1. Figure 8.2 and Figure 8.3 depict the vehicle at the CIP prior to Test 620061-01-1.

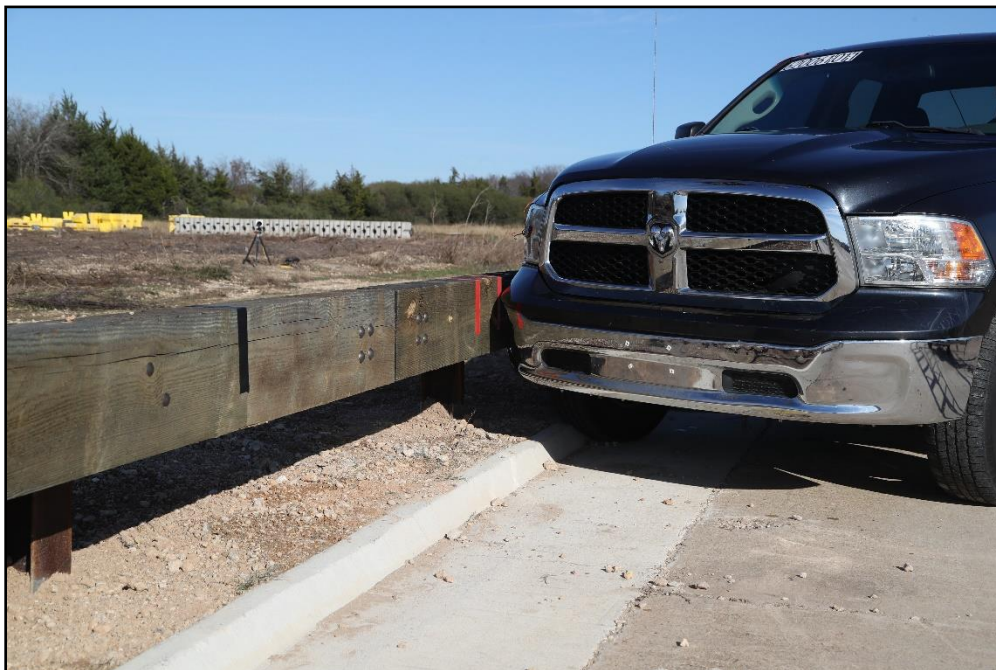
Figure 8.2. Merritt Parkway Guidrail/Test Vehicle Geometrics for Test 620061-01-1.

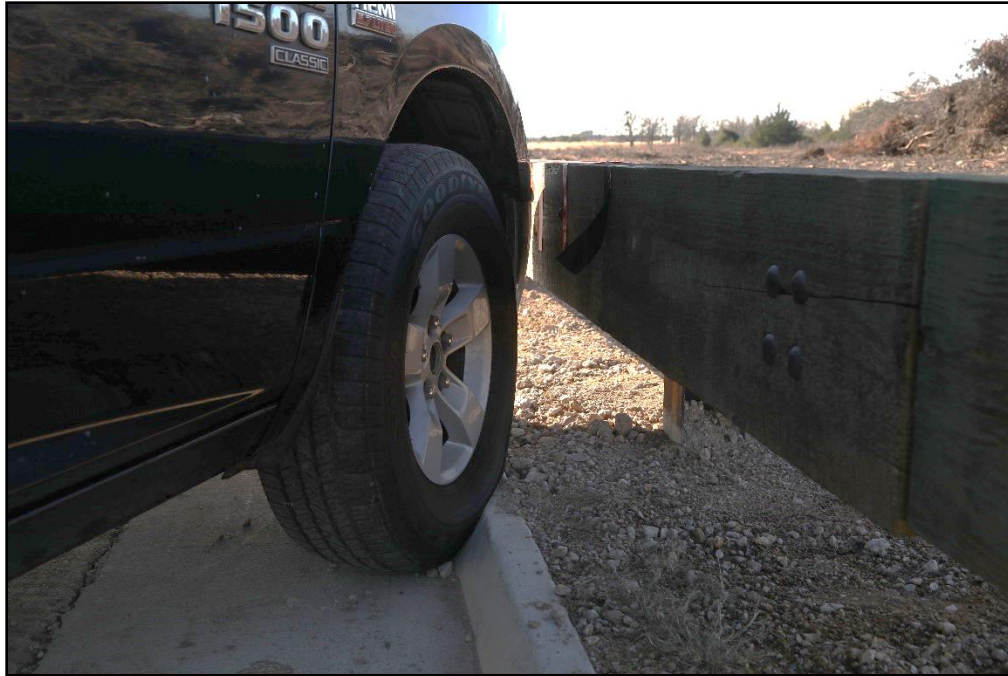
Figure 8.3. Merritt Parkway Guiderail/Test Vehicle Impact Location for Test 620061-01-1.

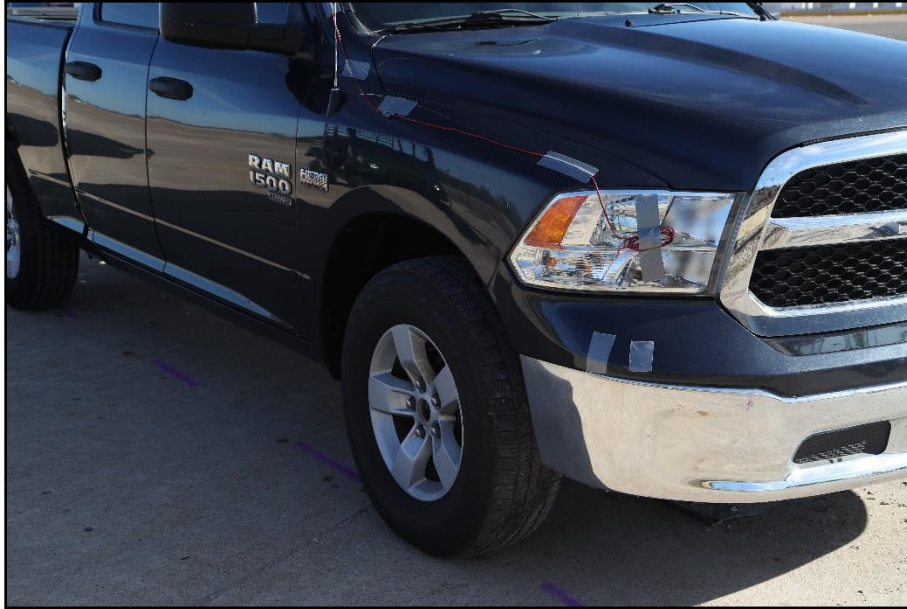
Figure 8.4. Impact Side of Test Vehicle before Test 620061-01-1.

Table 8.1 shows the vehicle measurements. Figure 8.4 and Figure 8.5 show the 2019 RAM 1500 used for the crash test. Figure D.1 in Appendix D.1 gives additional dimensions and information on the vehicle.

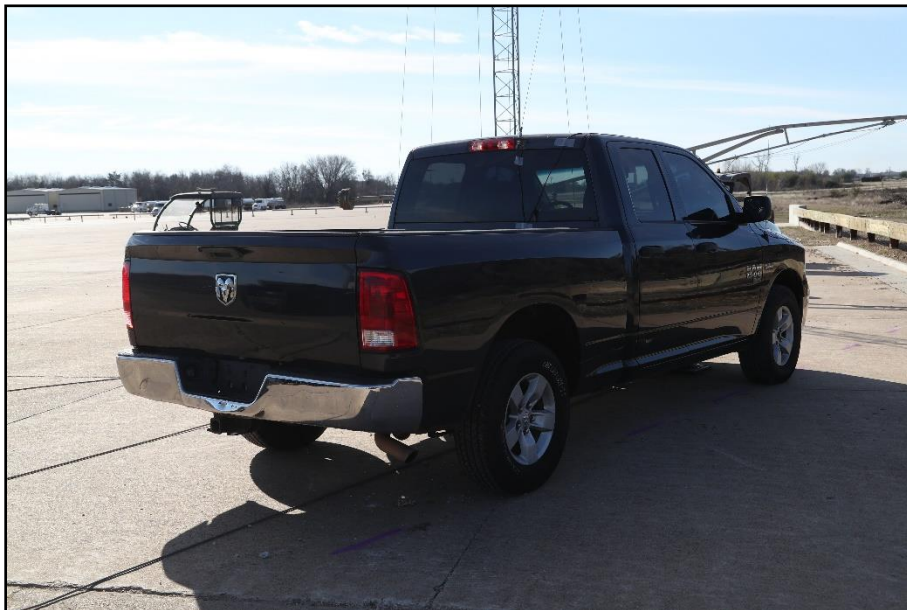
Figure 8.5. Impact Side Rear View of Test Vehicle before Test 620061-01-1.

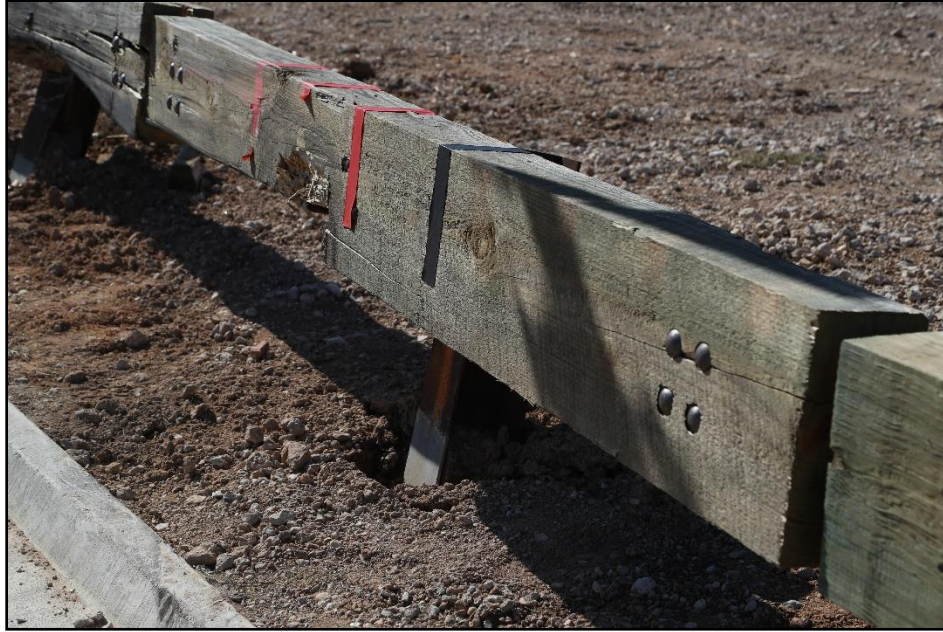
Figure 8.6. Merritt Parkway Guidrail at Impact Location after Test 620061-01-1.

There was a large gouge on the rail approximately 1-inch downstream of post 6. The full length of the rail at post 7, along with the blockout, was split and fractured. At post 8, the rail split and was gouged from upstream end to 2 feet downstream of post. The system experienced a secondary impact near the end of the installation where the vehicle came to rest.

Table 8.6 describes the damage to the test installation and Table 8.7 describes the deflection and working width of the Merritt Parkway Guiderail. Figure 8.6 and Figure 8.7 show the damage to the Merritt Parkway Guiderail.

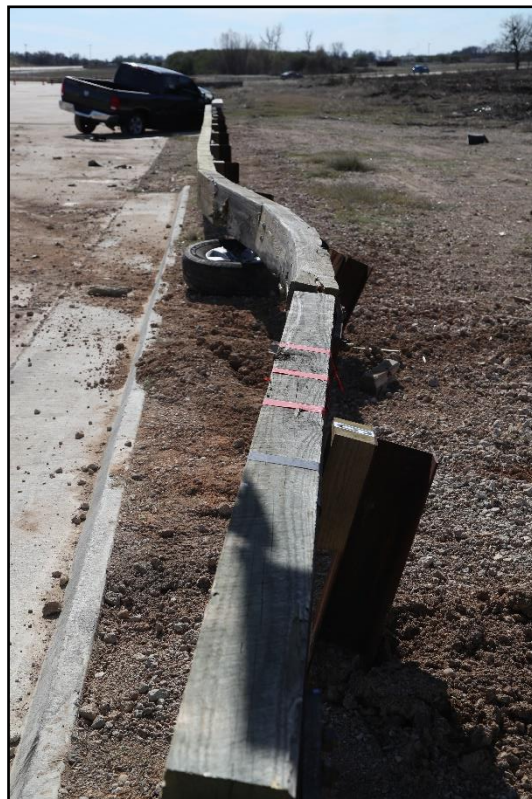
Figure 8.7. Merritt Parkway Guidrail In-Line Downstream View after Test 620061-01-1.

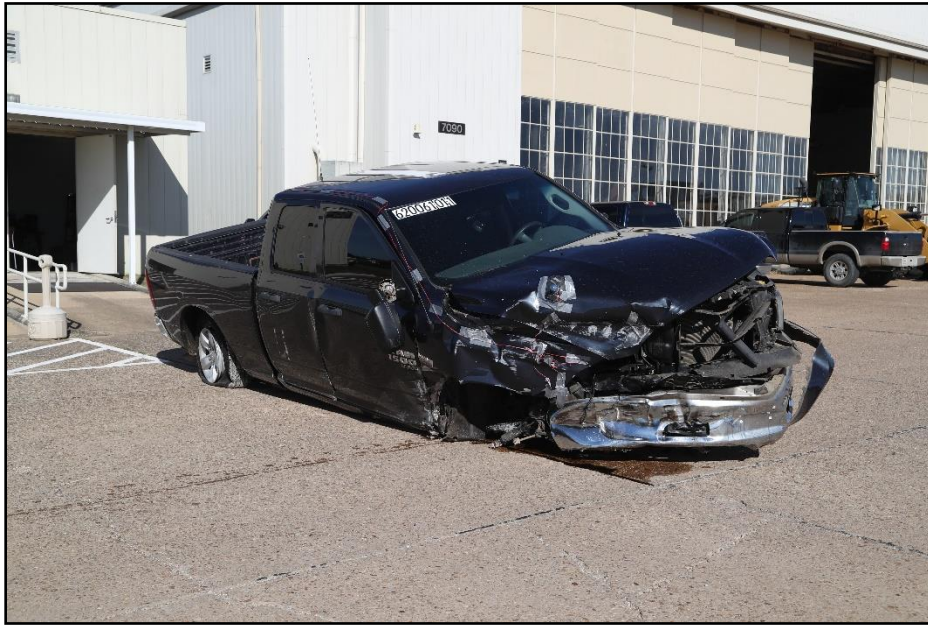
Figure 8.8. Impact Side of Test Vehicle after Test 620061-01-1.

Figure 8.8 and Figure 8.9 show the damage sustained by the vehicle. Figure 8.10 and Figure 8.11 show the interior of the test vehicle. Table 8.8 and Table 8.9 provide details on the occupant compartment deformation and exterior vehicle damage. Figure D.2 and Figure D.3 in Appendix D.1 provide exterior crush and occupant compartment measurements.

Test Parameter	Details
Side Windows	Remained intact
Maximum Exterior Deformation	22 inches at front bumper
VDS	01RFQ5
CDC	01FREE4
Fuel Tank Damage	None
Description of Damage to Vehicle:	On the impact side of vehicle, the headlight was removed, the front fender was crushed, the front door was deformed, the front tire ruptured, and the front wheel was dislodged at the A-Arm. The right and left mirrors fractured and the right rear tire was deflated. The hood, bumper, grill, and radiator were significantly damaged. On the lower right rear bed there was a small deformation and a 1.5-inch gap at the top of the right front door. Visible cracks in the right-side windshield were evident.

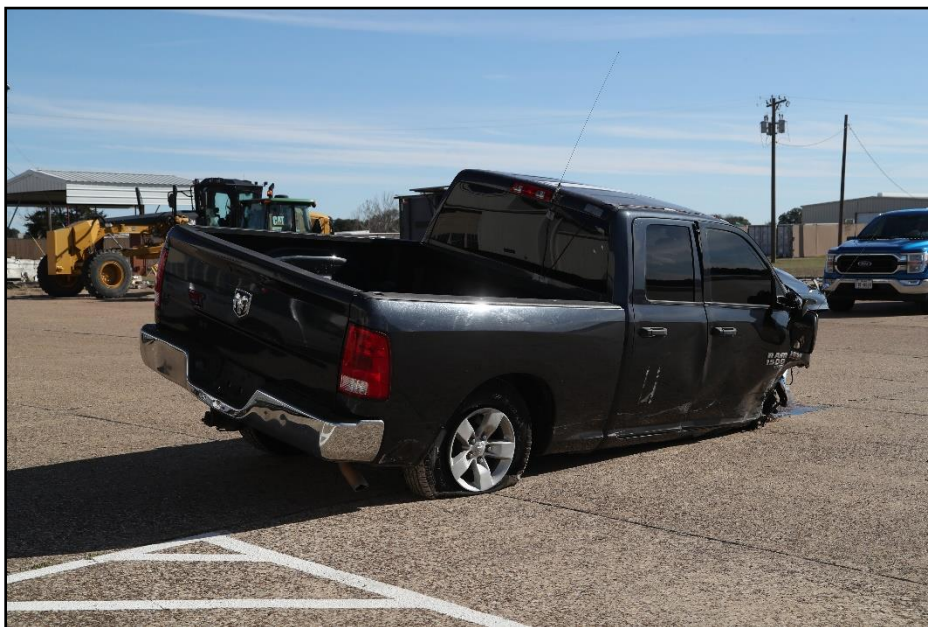
Figure 8.9. Rear Impact Side of Test Vehicle after Test 620061-01-1.

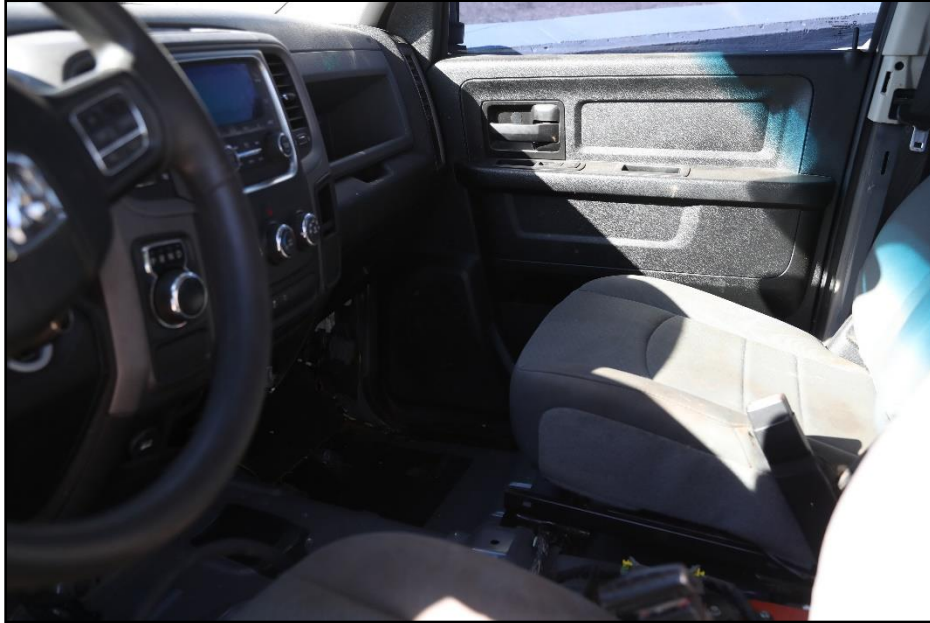
Figure 8.10. Overall Interior of Test Vehicle after Test 620061-01-1.

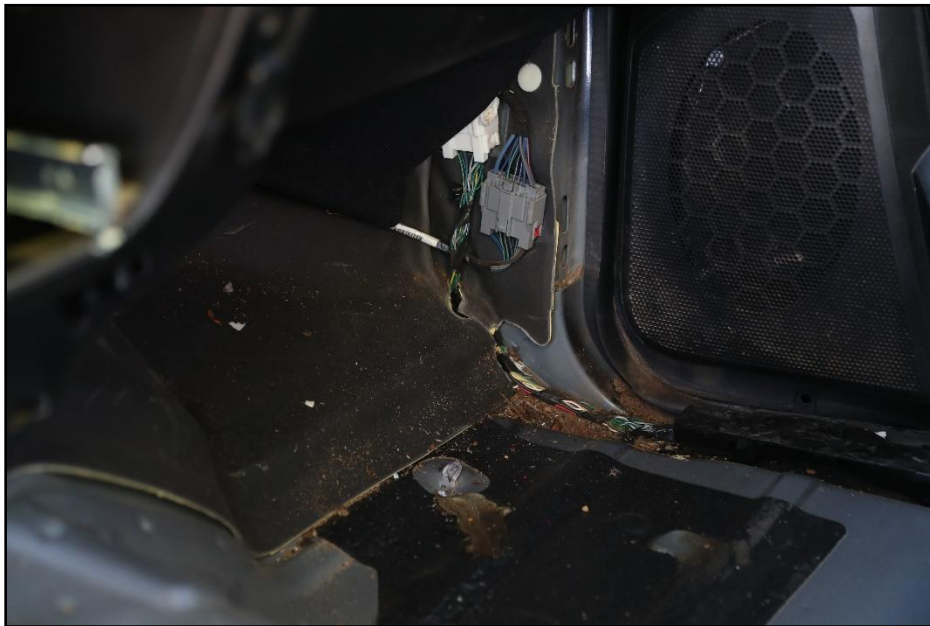
Figure 8.11. Interior of Test Vehicle on Impact Side after Test 620061-01-1.

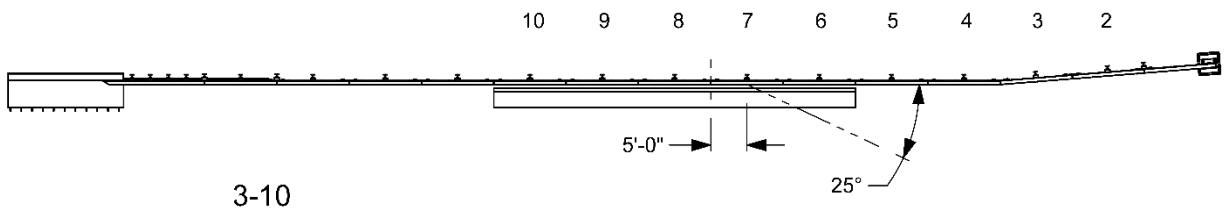
Figure 9.1. Target CIP for Test 620061-01-3.

The Critical Impact Point (CIP) for this test was 60 inches (5 ft) upstream from the centerline of the joint between posts 7 and 8 at 25 degrees. The target CIP for this test was determined using the information provided in *MASH* Section 2.2.1 and *MASH* Section 2.3.2. Figure 9.1 shows the target CIP for Test 620061-01-3. Figure 9.2 and Figure 9.3 depict the vehicle at the CIP prior to Test 620061-01-3.

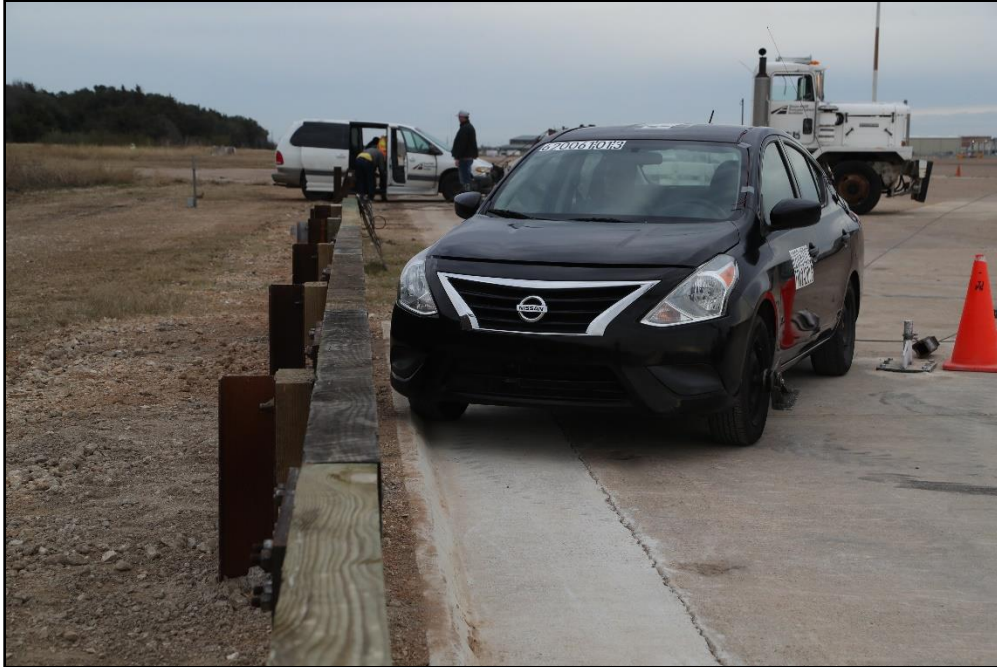
Figure 9.2. Merritt Parkway Guiderail/Test Vehicle Geometrics for Test 620061-01-3.

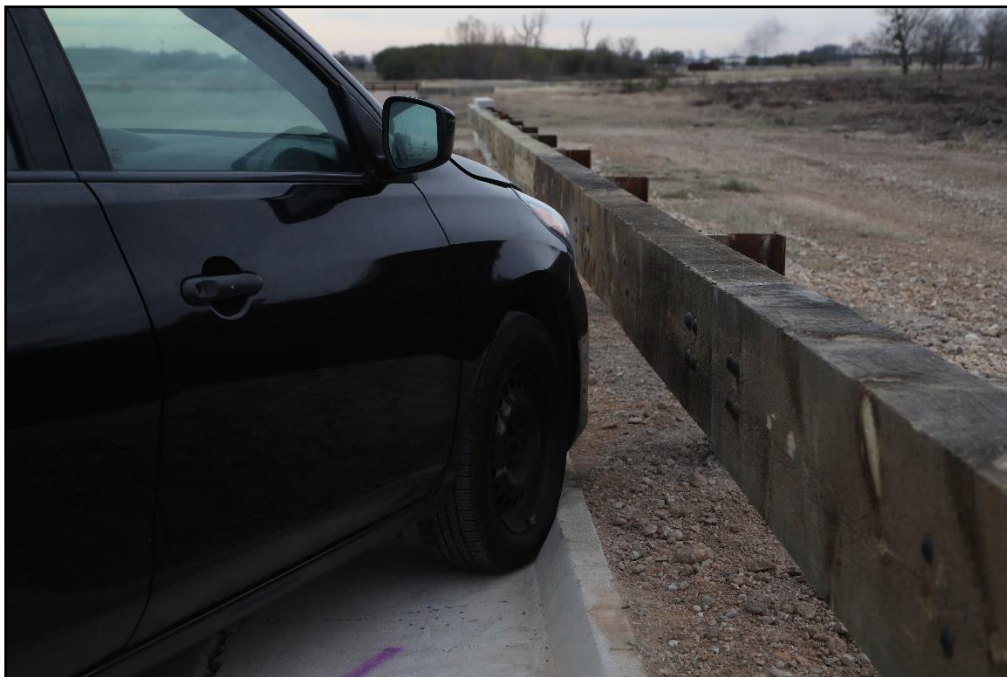
Figure 9.3. Merritt Parkway Guiderail/Test Vehicle Impact Location for Test 620061-01-3.

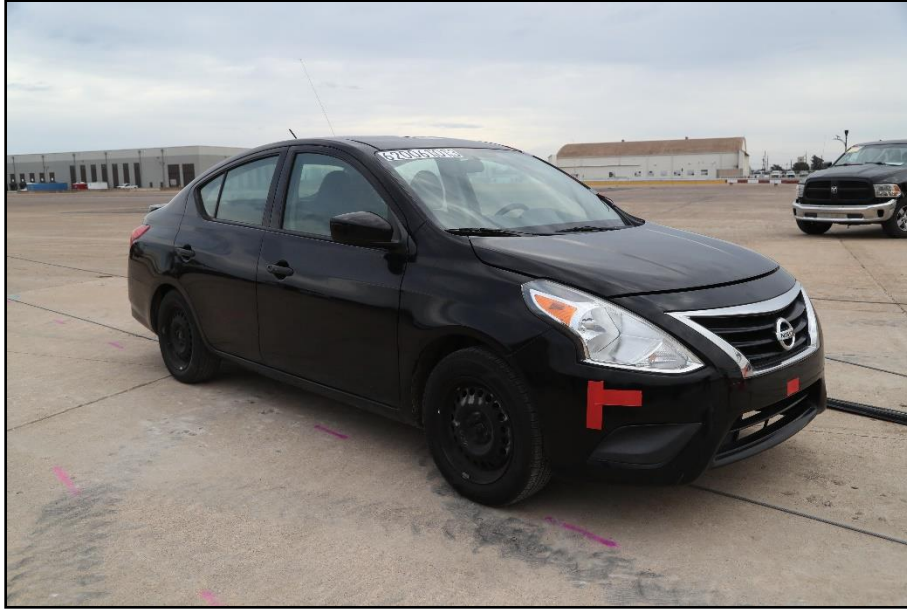
Figure 9.4. Impact Side of Test Vehicle before Test 620061-01-3.

Table 9.1 shows the vehicle measurements. Figure 9.4 and Figure 9.5 show the 2019 Nissan Versa used for the crash test. Figure E.1 in Appendix E.1 gives additional dimensions and information on the vehicle.

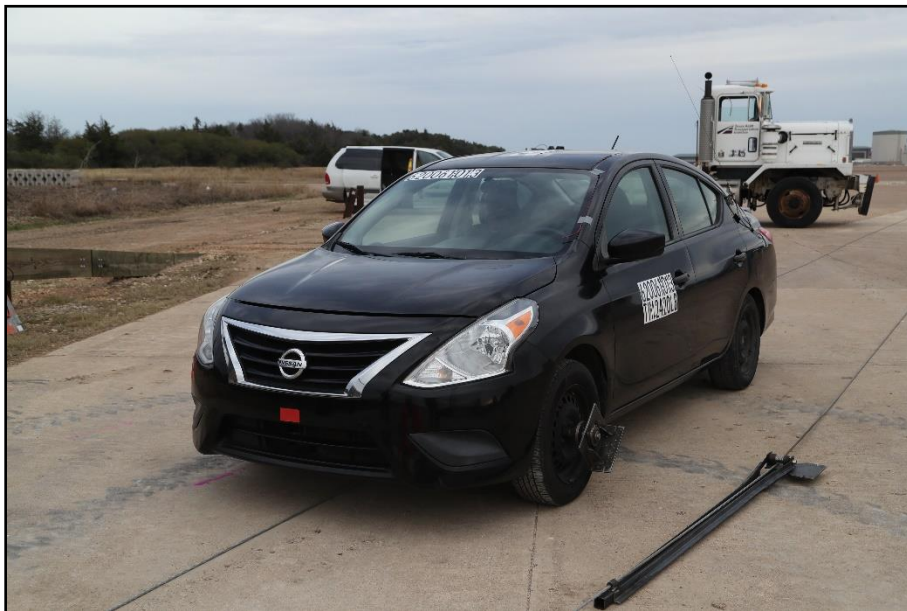
Figure 9.5. Opposite Impact Side of Test Vehicle before Test 620061-01-3.

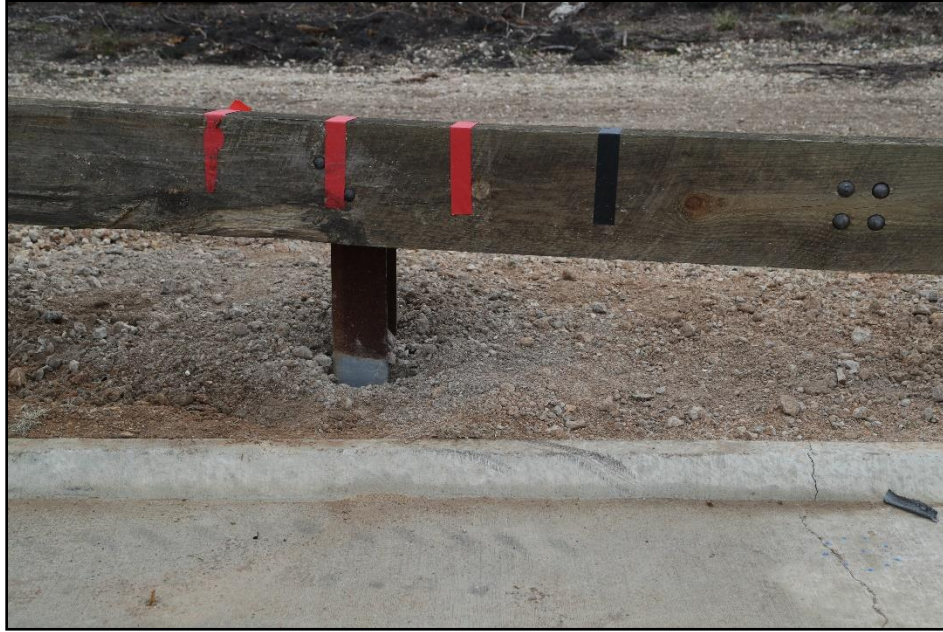
Figure 9.6. Merritt Parkway Guidrail at Impact Location after Test 620061-01-3.

Table 9.6 describes the damage to the test installation and Table 9.7 describes the deflection and working width of the Merritt Parkway Guiderail. Figure 9.6 and Figure 9.7 show the damage to the Merritt Parkway Guiderail.

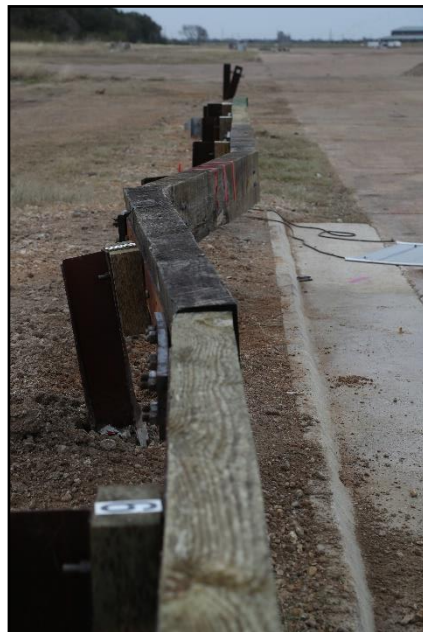
Figure 9.7. Merritt Parkway Guidrail In-Line Downstream View after Test 620061-01-3.

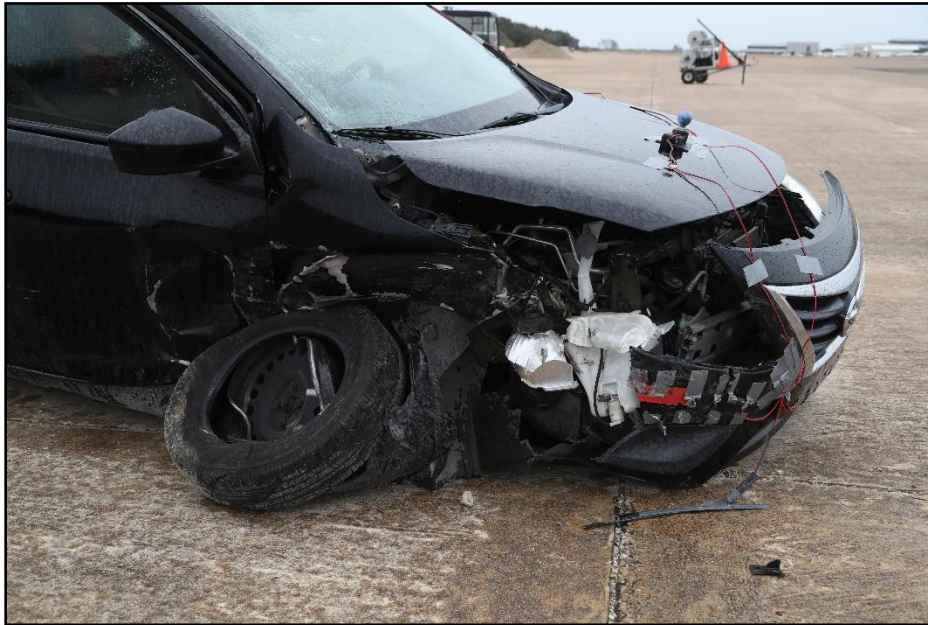
Figure 9.8. Impact Side of Test Vehicle after Test 620061-01-3.

Figure 9.8 and Figure 9.9 show the damage sustained by the vehicle. Figure 9.10 and Figure 9.11 show the interior of the test vehicle. Table 9.8 and Table 9.9 provide details on the occupant compartment deformation and exterior vehicle damage. Figure E.2 and Figure E.3 in Appendix E.1 provide exterior crush and occupant compartment measurements.

Test Parameter	Details
Side Windows	Remained intact
Maximum Exterior Deformation	12 inches at front bumper
VDS	01FRQ5
CDC	01FREN4
Fuel Tank Damage	None
Description of Damage to Vehicle:	The bumper and bumper cover were damaged, the radiator was fractured, and the support was deformed. The right headlight dislodged, there were cracks on the right side of the windshield along with scratches and deformations on the front door and rear quarter panel. The right front tire ruptured and the wheel dislodged. The right front subframe, A-arm, and strut were all deformed. The ball joint was separated from the strut and the control arm at the CV axle were deformed. There was a 3.5-inch gap at top of the right front door.
