Test Report No. 620061-01-1:6

## DESIGN AND EVALUATION OF THE MERRITT PARKWAY GUIDERAIL ACCORDING TO *MASH* TL-3

Sponsored by  
Connecticut DOT and

Roadside Safety Pooled Fund

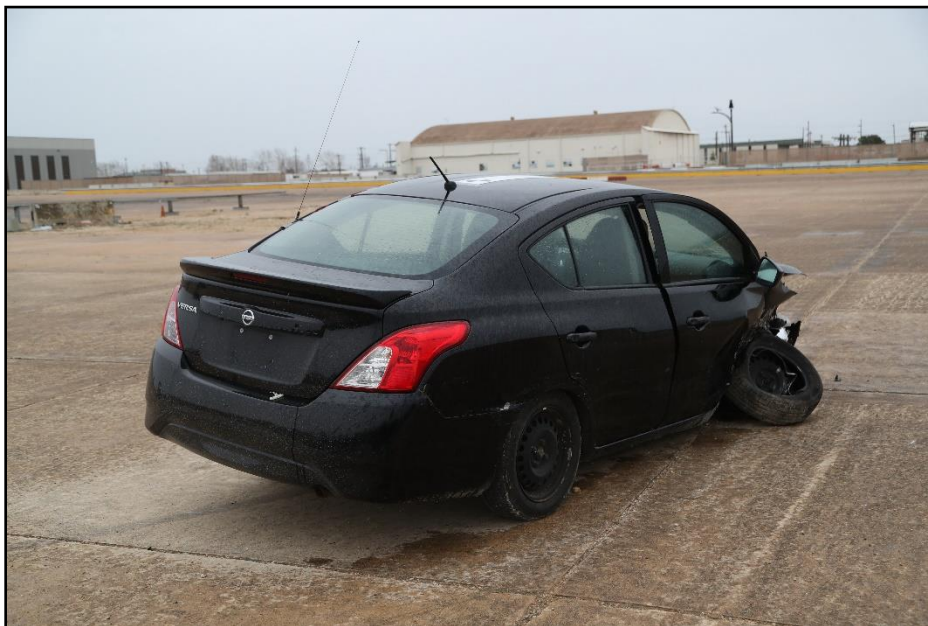
Figure 9.9. Rear Impact Side of Test Vehicle after Test 620061-01-3.

Figure 9.8 and Figure 9.9 show the damage sustained by the vehicle. Figure 9.10 and Figure 9.11 show the interior of the test vehicle. Table 9.8 and Table 9.9 provide details on the occupant compartment deformation and exterior vehicle damage. Figure E.2 and Figure E.3 in Appendix E.1 provide exterior crush and occupant compartment measurements.

Test Parameter	Details
Side Windows	Remained intact
Maximum Exterior Deformation	12 inches at front bumper
VDS	01FRQ5
CDC	01FREN4
Fuel Tank Damage	None
Description of Damage to Vehicle:	The bumper and bumper cover were damaged, the radiator was fractured, and the support was deformed. The right headlight dislodged, there were cracks on the right side of the windshield along with scratches and deformations on the front door and rear quarter panel. The right front tire ruptured and the wheel dislodged. The right front subframe, A-arm, and strut were all deformed. The ball joint was separated from the strut and the control arm at the CV axle were deformed. There was a 3.5-inch gap at top of the right front door.

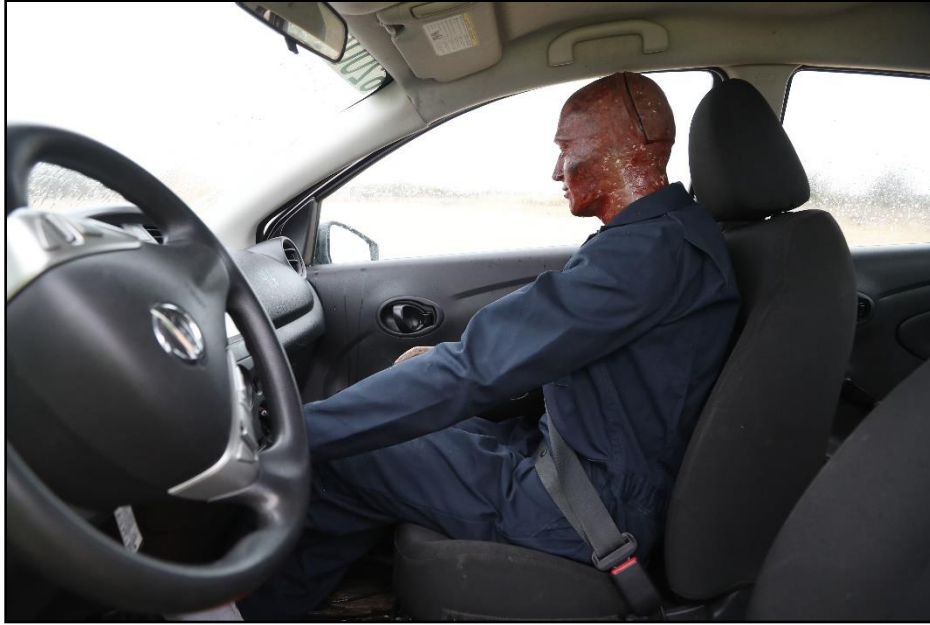
Figure 9.10. Overall Interior of Test Vehicle after Test 620061-01-3.

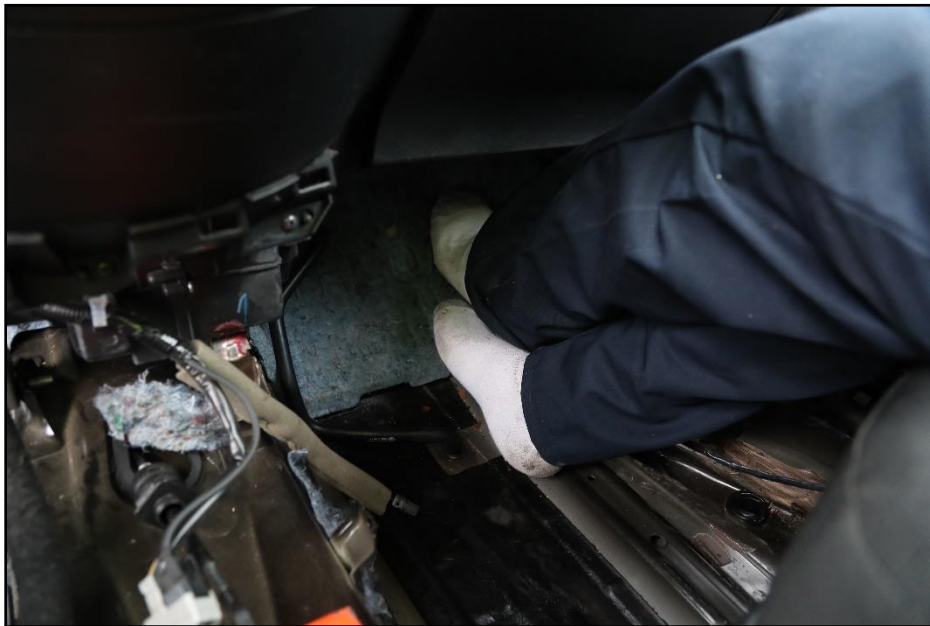
Figure 9.11. Interior of Test Vehicle on Impact Side after Test 620061-01-3.

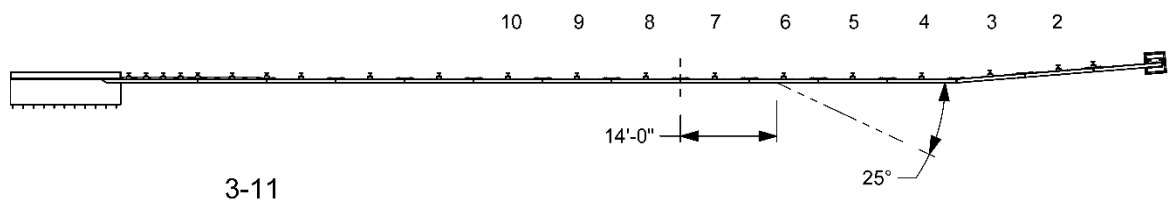
Figure 10.1. Target CIP for Test 620061-01-4.

The Critical Impact Point (CIP) for this test was 168 inches (14 ft) upstream from the centerline of the joint between posts 7 and 8 at 25 degrees. The target CIP for this test was determined using the information provided in *MASH* Section 2.2.1 and *MASH* Section 2.3.2. Figure 10.1 shows the target CIP for Test 620061-01-4. Figure 10.2 and Figure 10.3 depict the vehicle at the CIP prior to Test 620061-01-4.

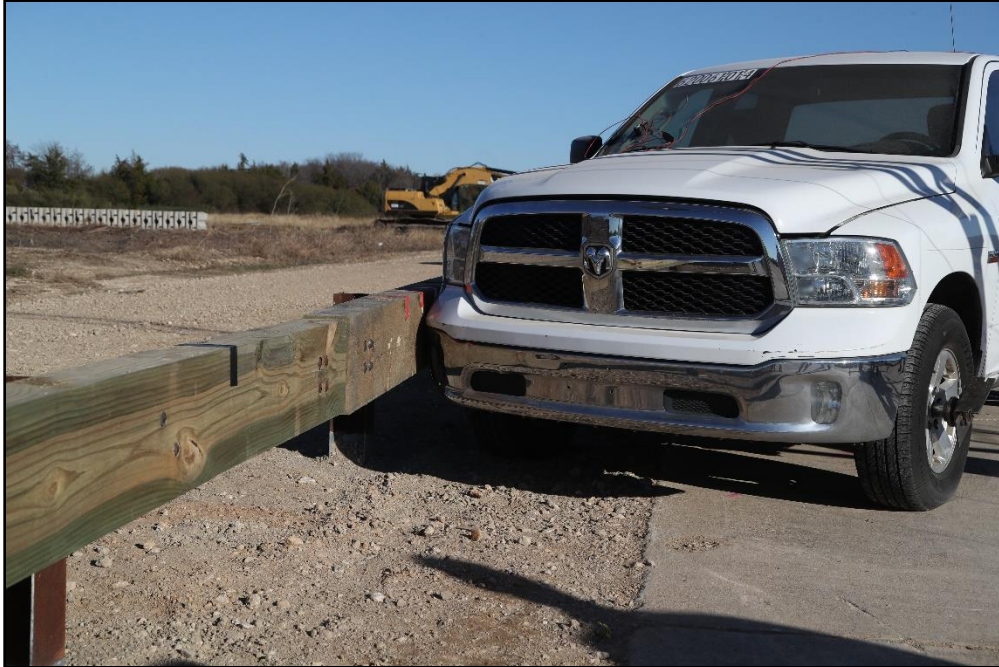
Figure 10.2. Merritt Parkway Guidrail/Test Vehicle Geometrics for Test 620061-01-4.

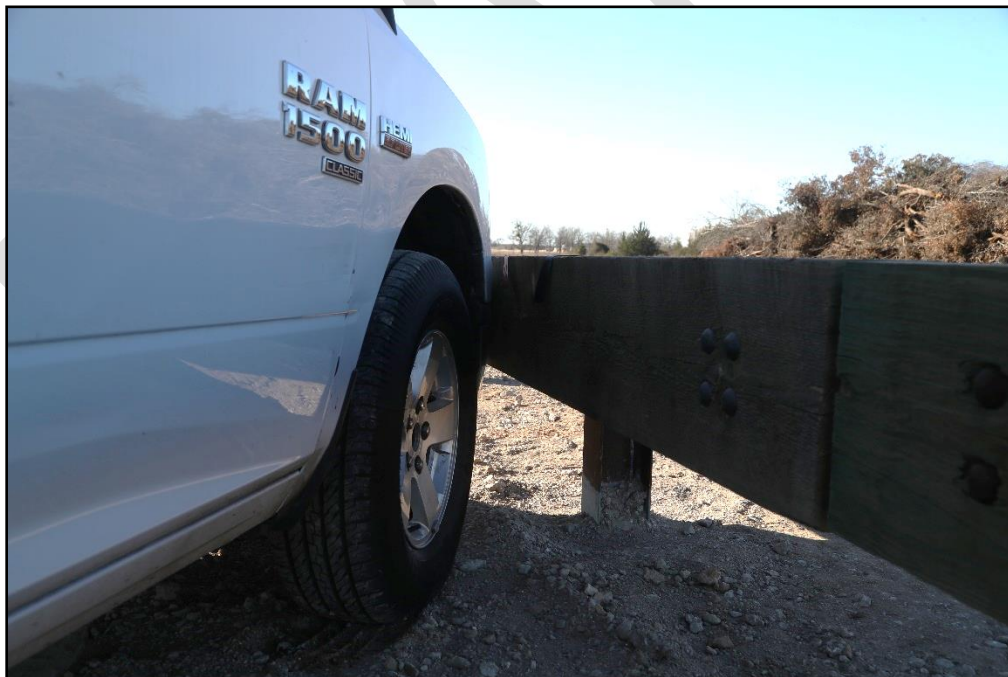
Figure 10.3. Merritt Parkway Guidrail/Test Vehicle Impact Location 620061-01-4.

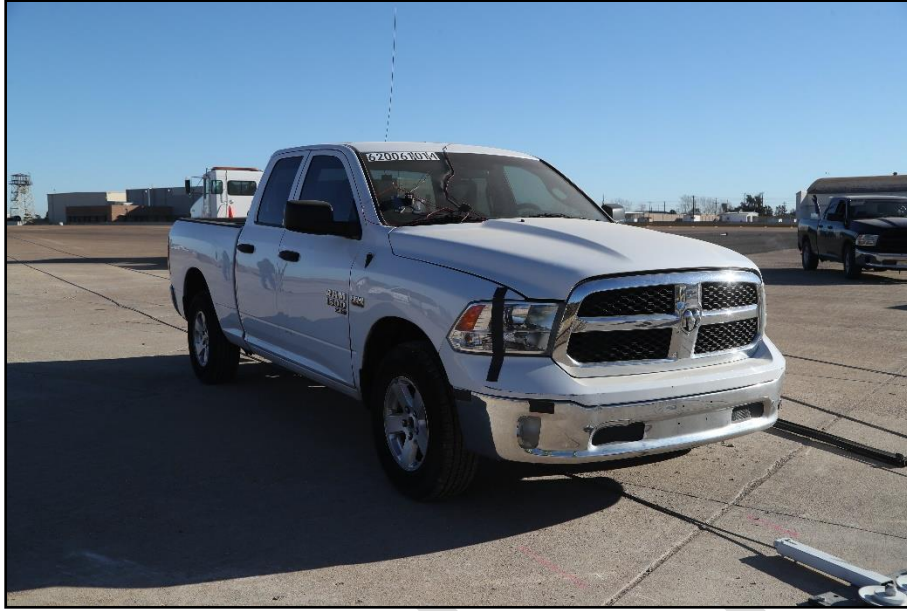
Figure 10.4. Impact Side of Test Vehicle before Test 620061-01-4.

Table 10.1 shows the vehicle measurements. Figure 10.4 and Figure 10.5 show the 2019 RAM 1500 used for the crash test. Figure F.1 in Appendix F.1 gives additional dimensions and information on the vehicle.

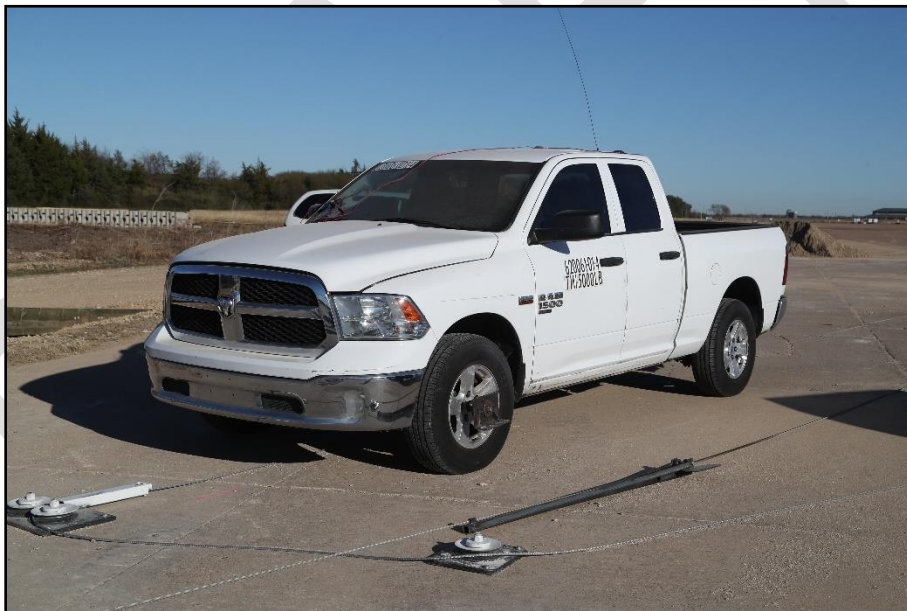
Figure 10.5. Opposite Impact Side of Test Vehicle before Test 620061-01-4.

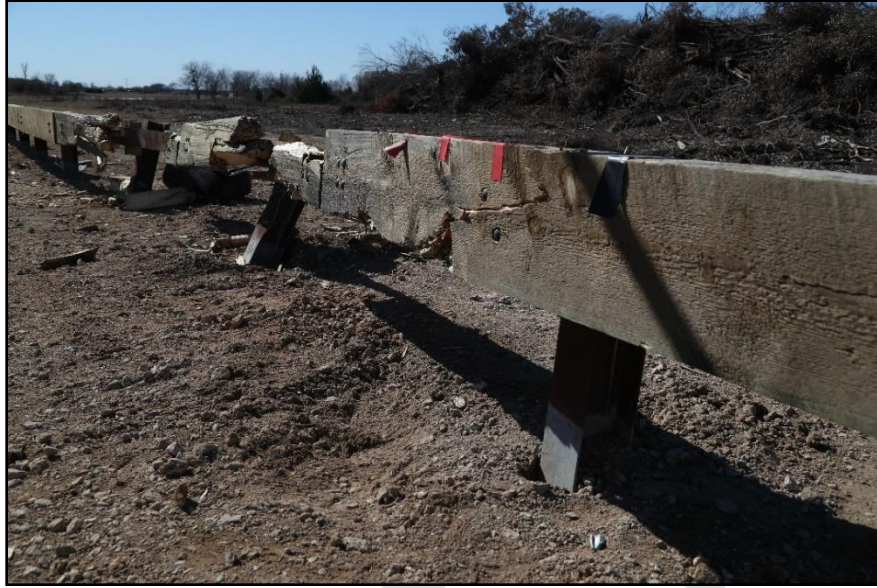
Figure 10.6. Merritt Parkway Guidrail at Impact Location after Test 620061-01-4.

Table 10.6 describes the damage to the test installation and Table 10.7 describes the deflection and working width of the Merritt Parkway Guiderail. Figure 10.6 and Figure 10.7 show the damage to the Merritt Parkway Guiderail.

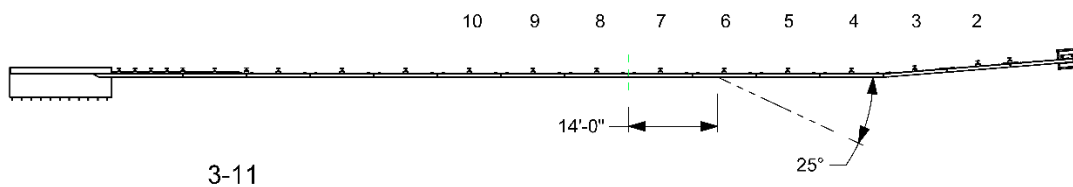
Figure 12.1. Target CIP for Test 620061-01-5.

The Critical Impact Point (CIP) for this test was 14 ft upstream from the centerline of the joint between posts 7 and 8 at 25°. The target CIP for this test was determined using the information provided in *MASH* Section 2.2.1 and *MASH* Section 2.3.2. Figure 12.1 shows the target CIP for Test 620061-01-5. Figure 12.2 and Figure 12.3 depict the vehicle at the CIP prior to Test 620061-01-5.

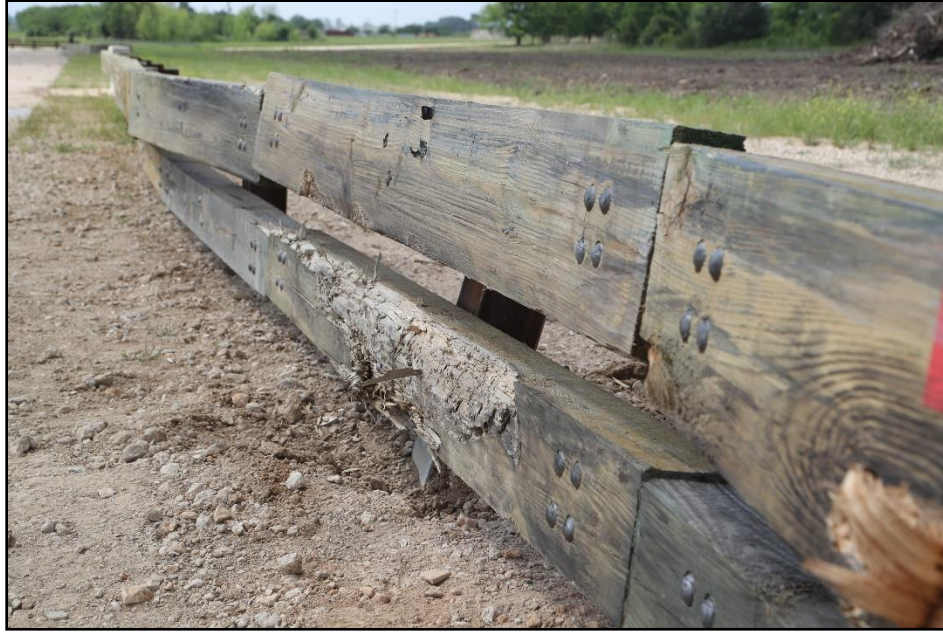
Figure 12.6. Merritt Parkway Guidrail at Impact Location after Test 620061-01-5.

The rub rail fractured at post 5 and 2 feet upstream from post 6, and both rails were gouged 2 feet downstream from post 6. There was a 4 foot long section of the downstream traffic rail at the joint between posts 6 and 7 that was fractured on the top field side corner. The rub rail was severely gouged 3 feet upstream from post 7 to the joint between 7 and 8. At the joint between posts 7 and 8, the upstream traffic rail had a 1.5-inch vertical displacement and the upstream rub rail had 0.5 inches of vertical displacement.

Table 12.6 describes the damage to the test installation and Table 12.6 describes the deflection and working width of the Merritt Parkway Guiderail. Figure 12.6 and Figure 12.7 show the damage to the Merritt Parkway Guiderail.

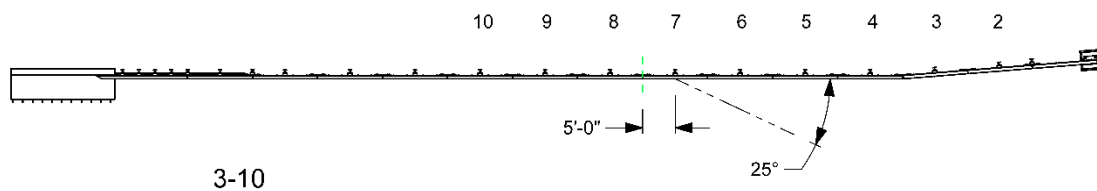
Figure 13.1. Target CIP for Test 620061-01-6.

The Critical Impact Point (CIP) for this test was 5 ft upstream from the centerline of the joint between posts 7 and 8 at 25 degrees. The target CIP for this test was determined using the information provided in *MASH* Section 2.2.1 and *MASH* Section 2.3.2. Figure 13.1 shows the target CIP for Test 620061-01-6. Figure 13.2 and Figure 13.3 depict the vehicle at the CIP prior to Test 620061-01-6.

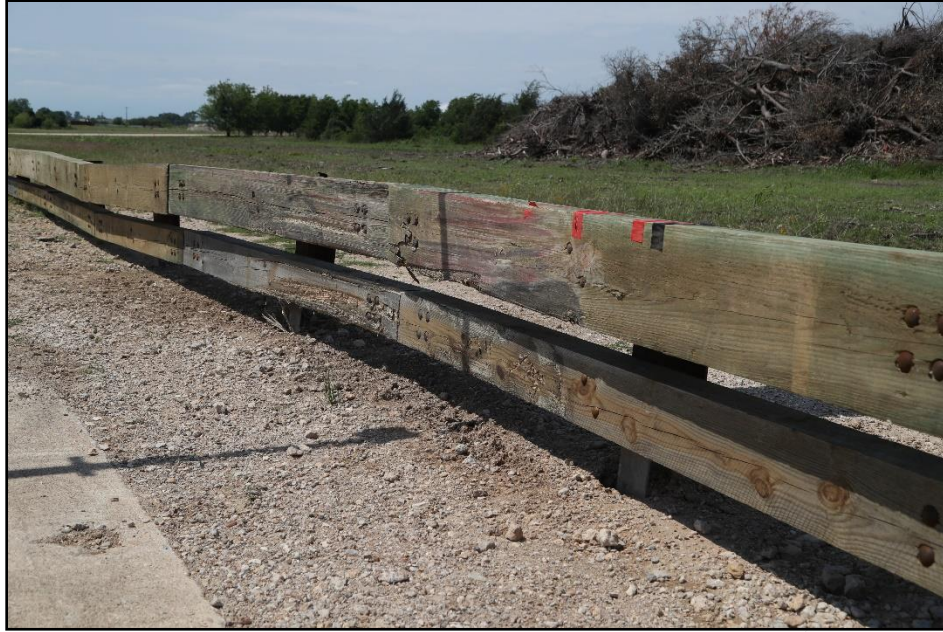
Figure 13.6. Merritt Parkway Guidrail at Impact Location after Test 620061-01-6.

The rail was scuffed and gouged at impact. There was heavy gouging on the rub rail downstream of joint 7 and 8. The rail upstream of joint 7 and 8 was slightly fractured.

Table 13.6 describe the damage to the test installation and Table 13.7 describes the deflection and working width of the Merritt Parkway Guiderail. Figure 13.6 and Figure 13.7 show the damage to the Merritt Parkway Guiderail.

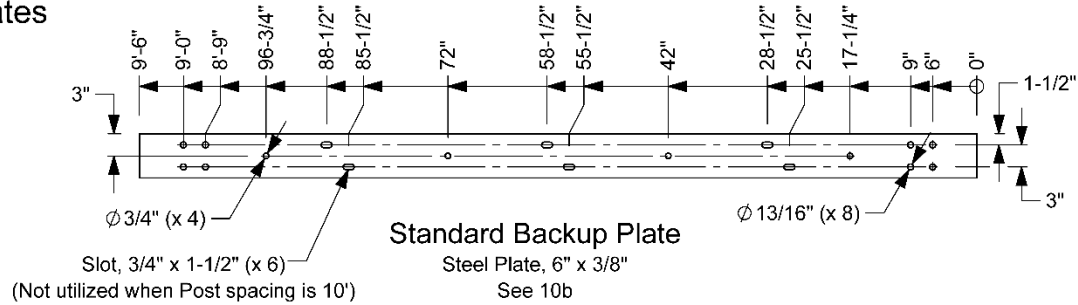
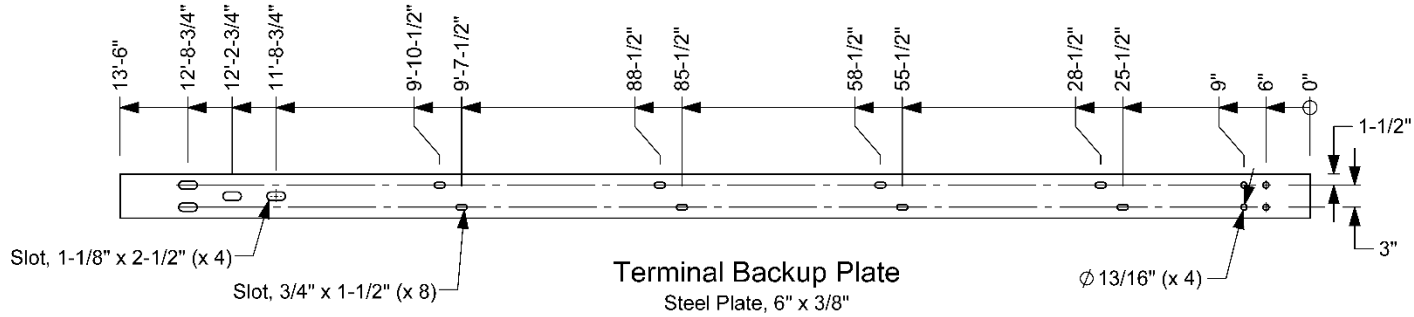
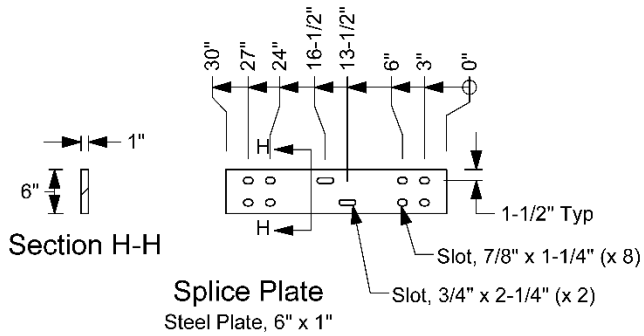
Sheet 10 of 12 Backup Plates

# Backup Plates

**10a.** Galvanize two Standard Backup Plates (used from Anchor Block to Post 1 and Post 1 to Post 2) and two Splice Plates (used at Posts 1 and 2).

**10b.** Slots at 25-1/2" , 28-1/2" , 85-1/2" , and 88-1/2" are not used in this installation. Slots at 55-1/2" and 58-1/2" are used only at Post 14.

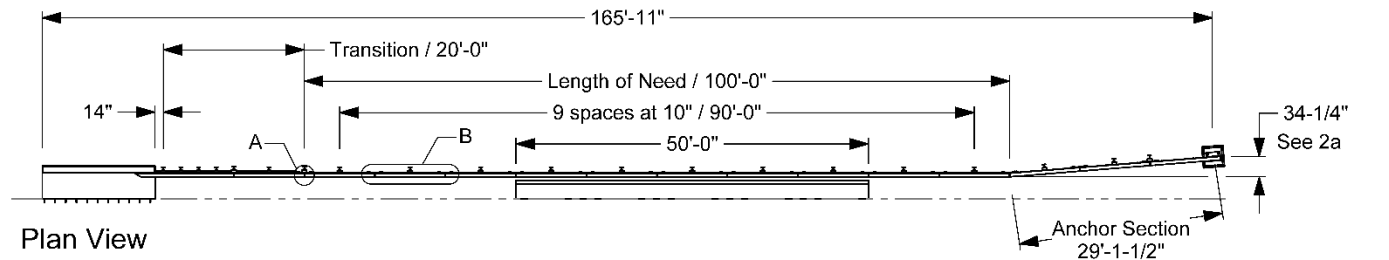
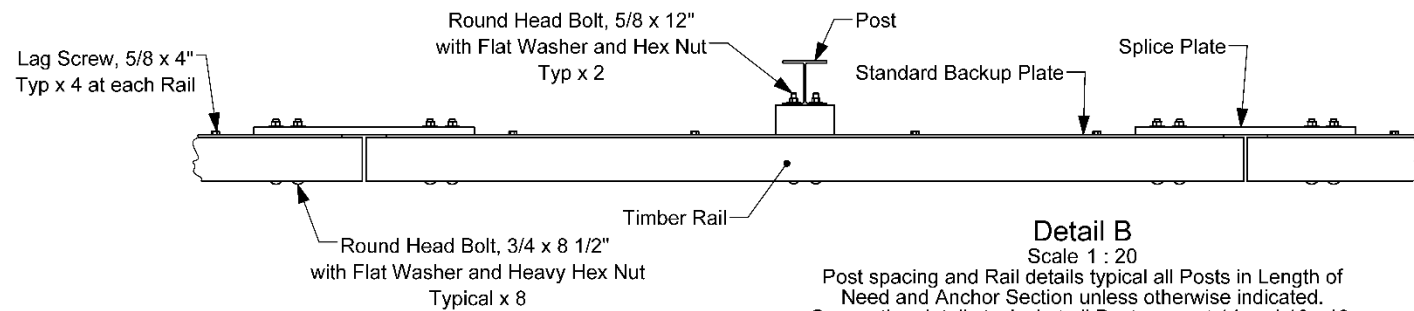
Drawn by GES Scale 1:250 Sheet 2 of 13 Test Installation

## Test Installation

Some Detail and Section Views on next sheet

**2a.** This dimension is from the traffic side face of the Traffic Rail to the center of the Anchor Block.

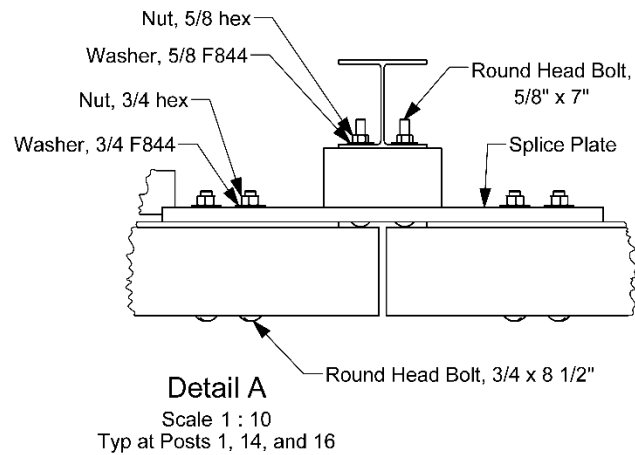
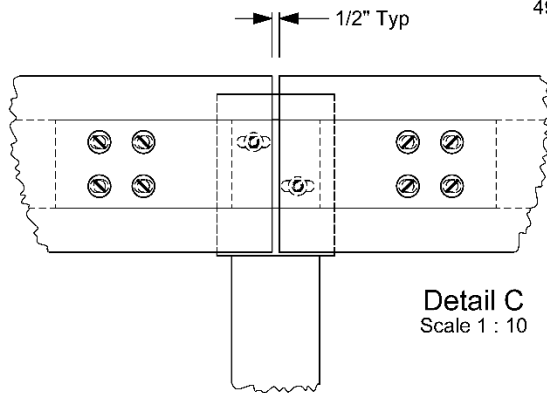
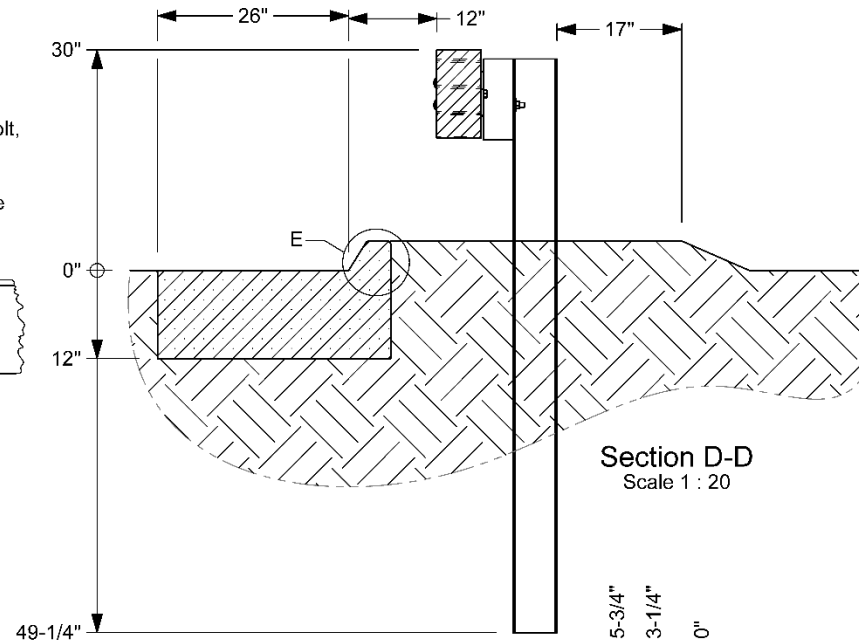
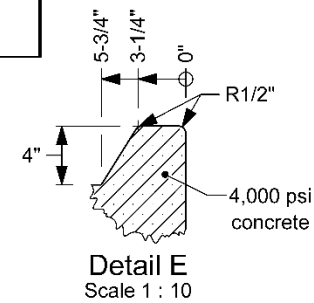
Sheet 3 of 13 Detail and Section Views

## Detail and Section Views

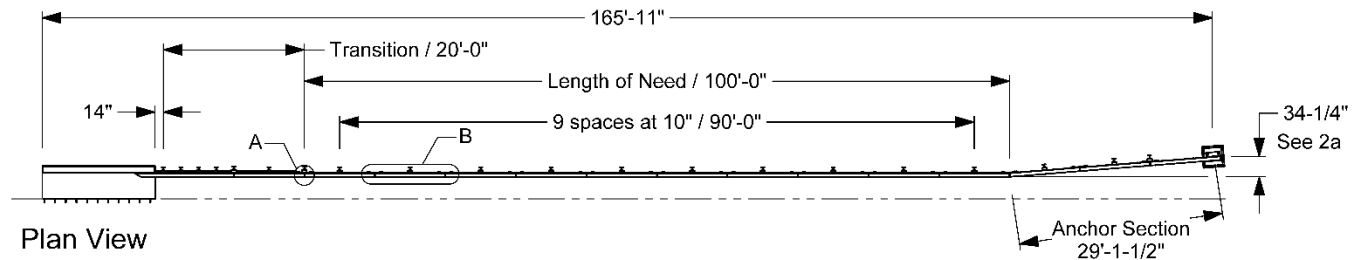
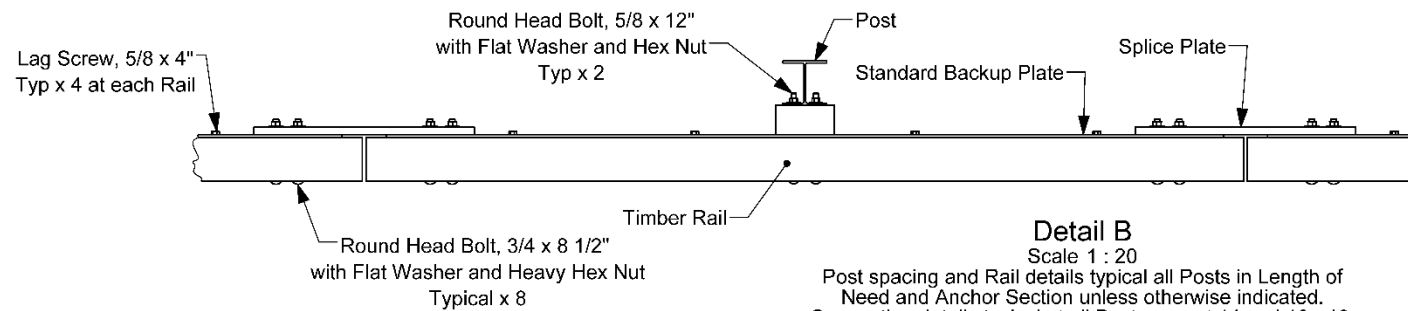
Sheet 2 of 13 Test Installation

## Test Installation

Some Detail and Section Views on next sheet

**2a.** This dimension is from the traffic side face of the Traffic Rail to the center of the Anchor Block.

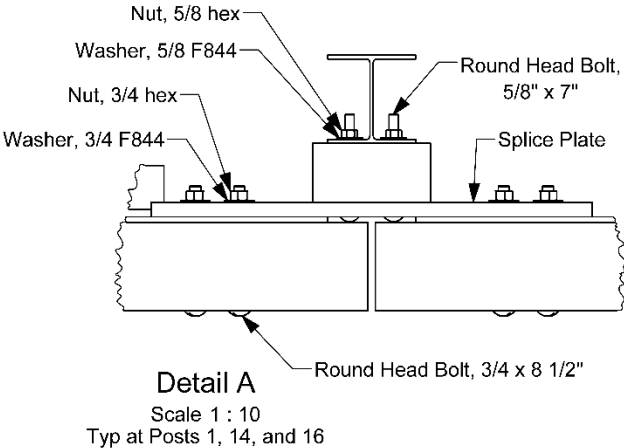
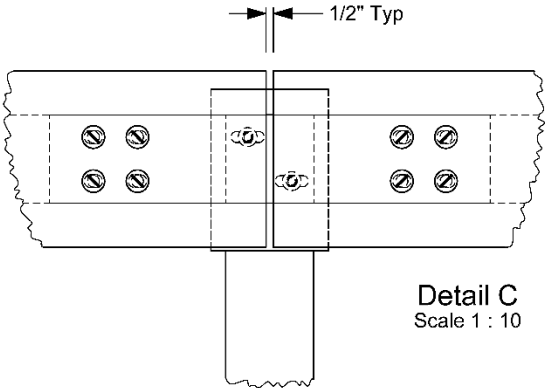
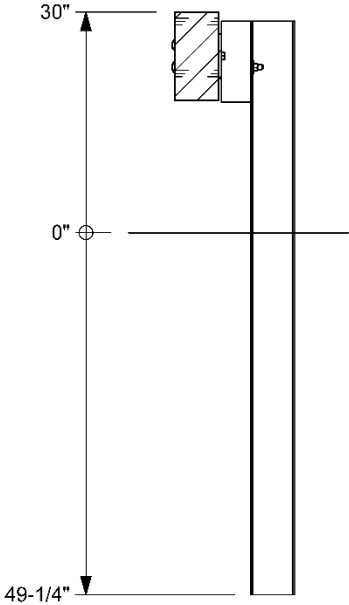
Roadside Safety and Physical Security Division - Proving Ground	
Project #620061 without Curb v2 Merritt Parkway		2025-01-17	
Drawn by GES	Scale 1:250	Sheet 3 of 13 Detail and Section Views

Detail and Section Views

Section D-D  
Scale 1 : 20

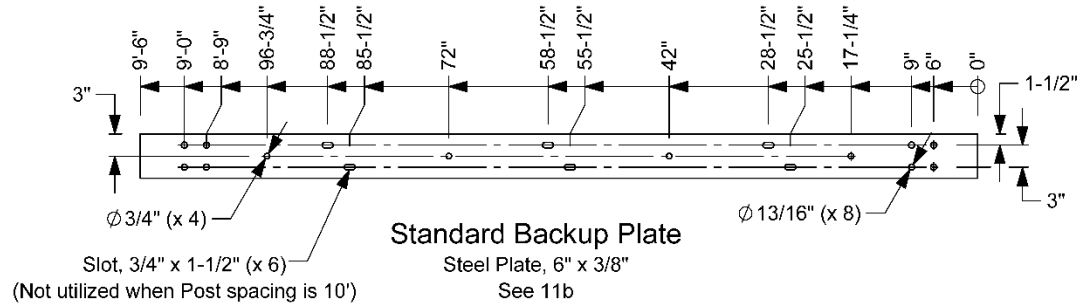
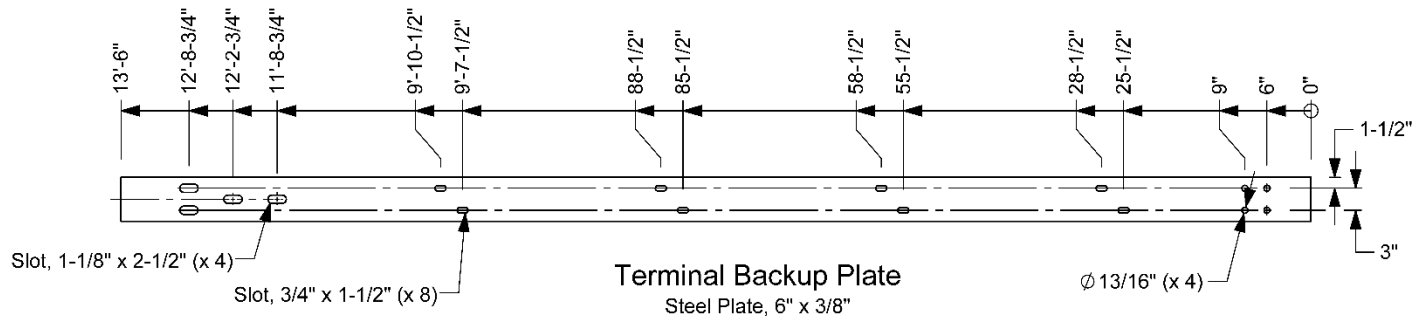
Sheet 11 of 13 Backup Plates

## Backup Plates

See 11a

**11a.** Galvanize two Standard Backup Plates (used from Anchor Block to Post 1 and Post 1 to the joint between Posts 2 and 3.

**11b.** Slots at 25-1/2", 28-1/2", 85-1/2", and 88-1/2" are not used in this installation. Slots at 55-1/2" and 58-1/2" are not used at all locations.

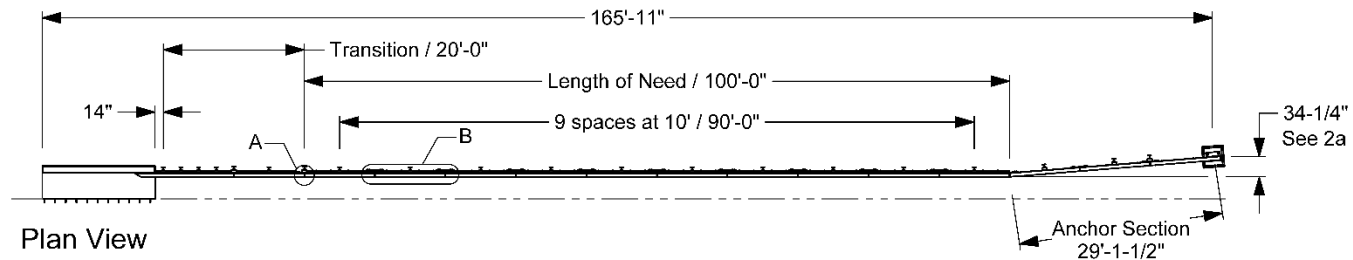
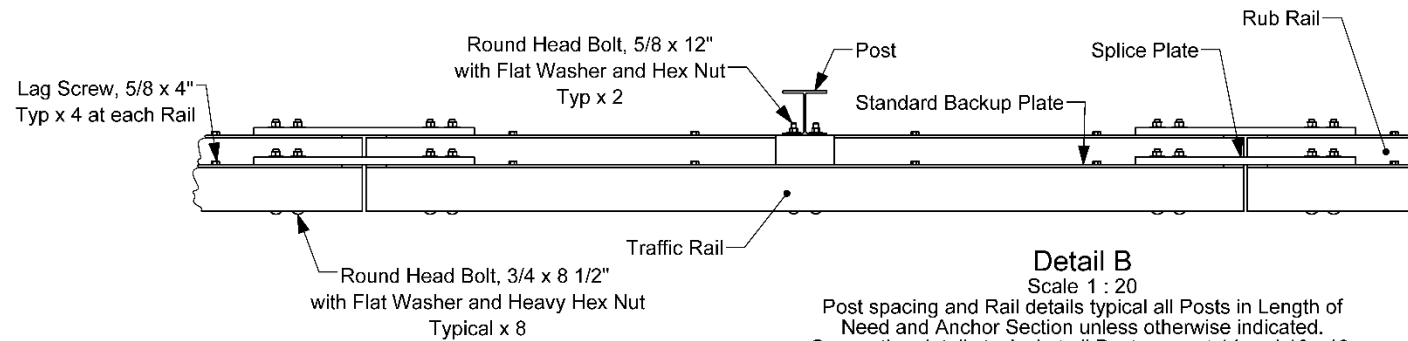
## Test Installation

Some Detail and Section Views on next sheet

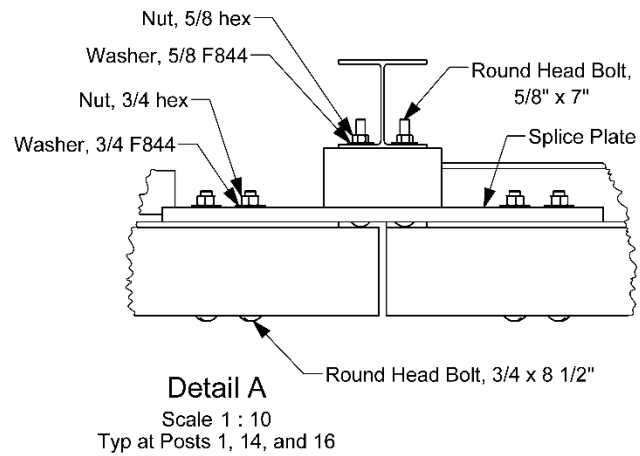
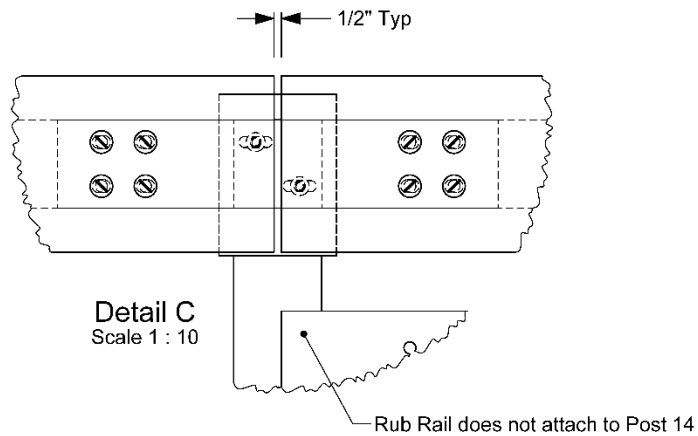
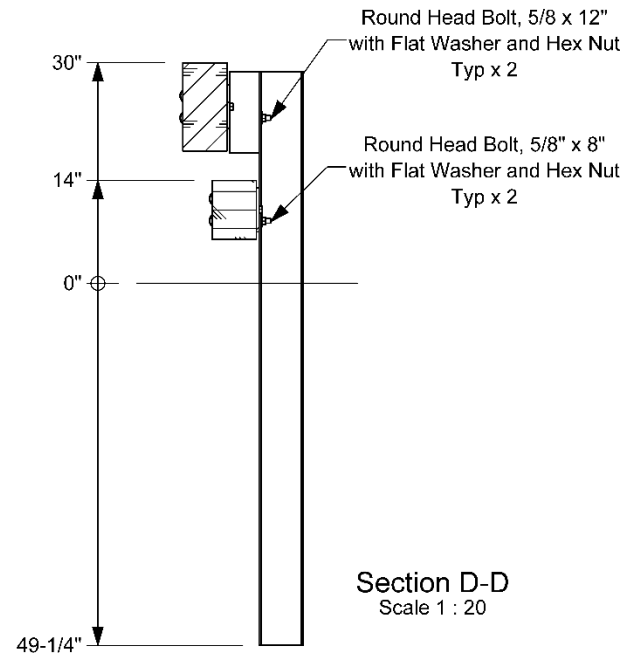
Sheet 3 of 14 Detail and Section Views

## Detail and Section Views

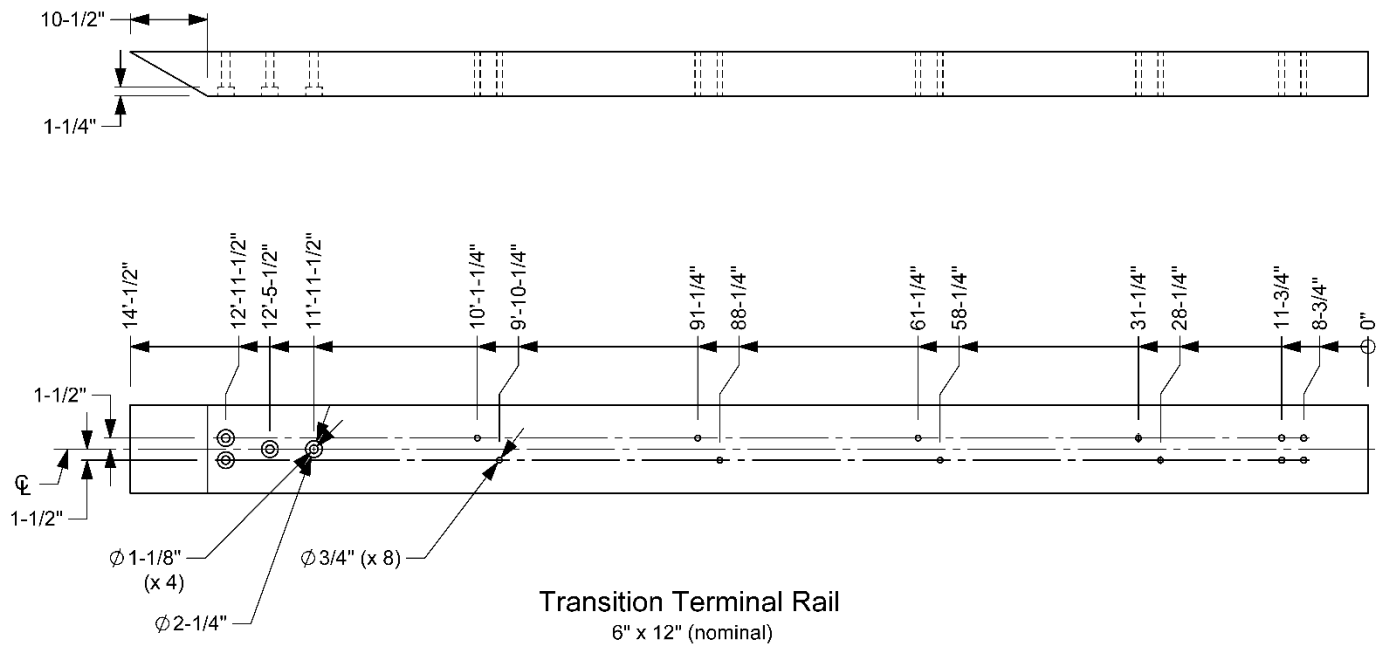
## Transition Rail Details

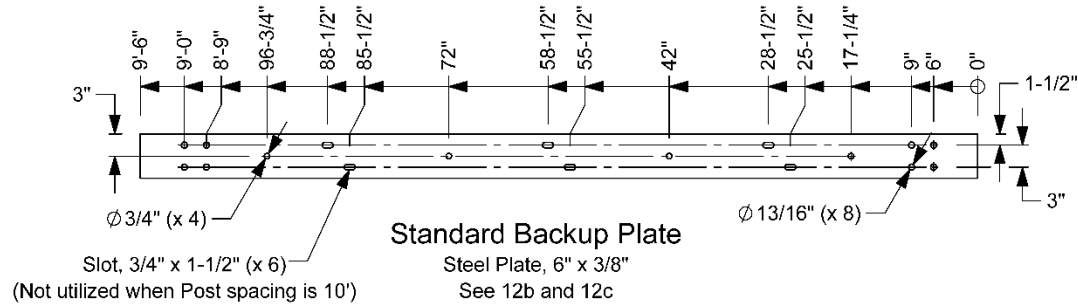
Sheet 12 of 14 Backup Plates

## Backup Plates

**12a.** Galvanize two Standard Backup Plates (used from Anchor Block to Post 1 and Post 1 to the joint between Posts 2 and 3.

**12b.** Slots at 25-1/2", 28-1/2", 85-1/2", and 88-1/2" are not used in this installation. Slots at 55-1/2" and 58-1/2" are not used at all locations.

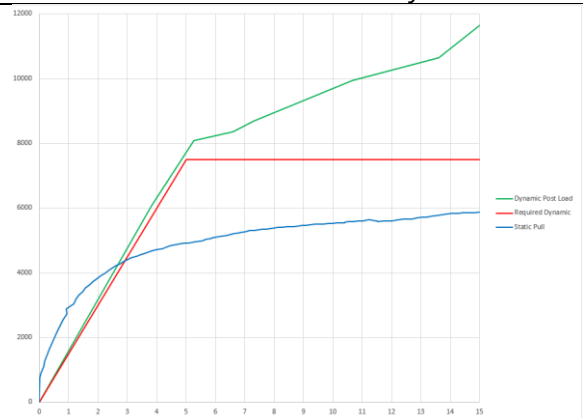
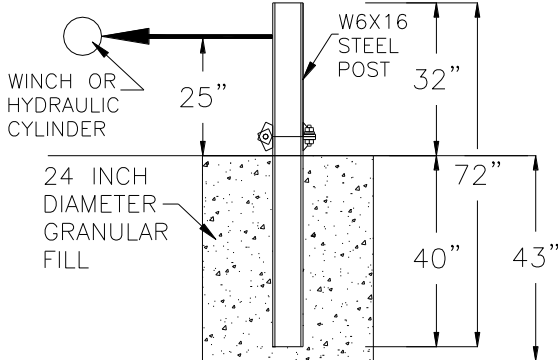
</div></div> <div>Dynamic Test Installation Details</div>

Comparison of Load vs. Displacement		Static Load Test Installation Details	
Date			2020-02-02
Test Facility and Site Location			TTI Proving Ground, 3100 SH 47, Bryan, TX 77807
In Situ Soil Description (ASTM D2487)			Sandy gravel with silty fines
Fill Material Description (ASTM D2487) and sieve analysis			Type 1 Grade D Crushed Concrete Road Base
Description of Fill Placement Procedure			12-inch lifts tamped with a pneumatic compactor for 20 sec
Bogie Mass			2020 lb
Impact Velocity			19.2 mph

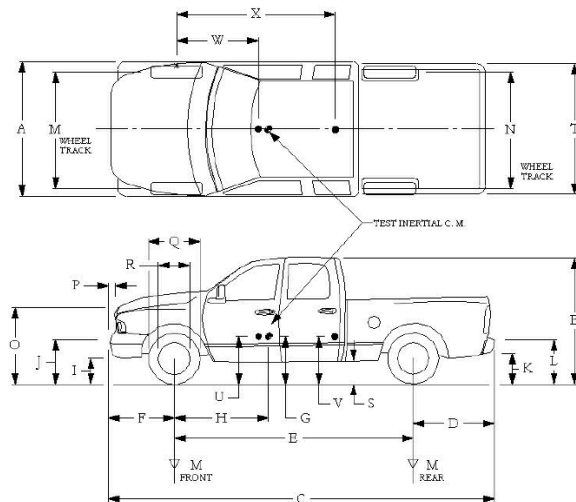
#### Geometry: inches

A	78.50	F	40.25	K	20.00	P	3.00	U	26.75
B	74.00	G	28.50	L	30.00	Q	30.50	V	30.25
C	229.00	H	61.50	M	68.50	R	18.00	W	61.50
D	48.25	I	11.75	N	68.00	S	13.00	X	79.00
E	140.50	J	27.00	O	46.00	T	77.00		
Wheel Center Height Front	14.75	Wheel Well Clearance (Front)	6.00	Bottom Frame Height - Front	12.50				
Wheel Center Height Rear	14.75	Wheel Well Clearance (Rear)	9.25	Bottom Frame Height - Rear	22.50

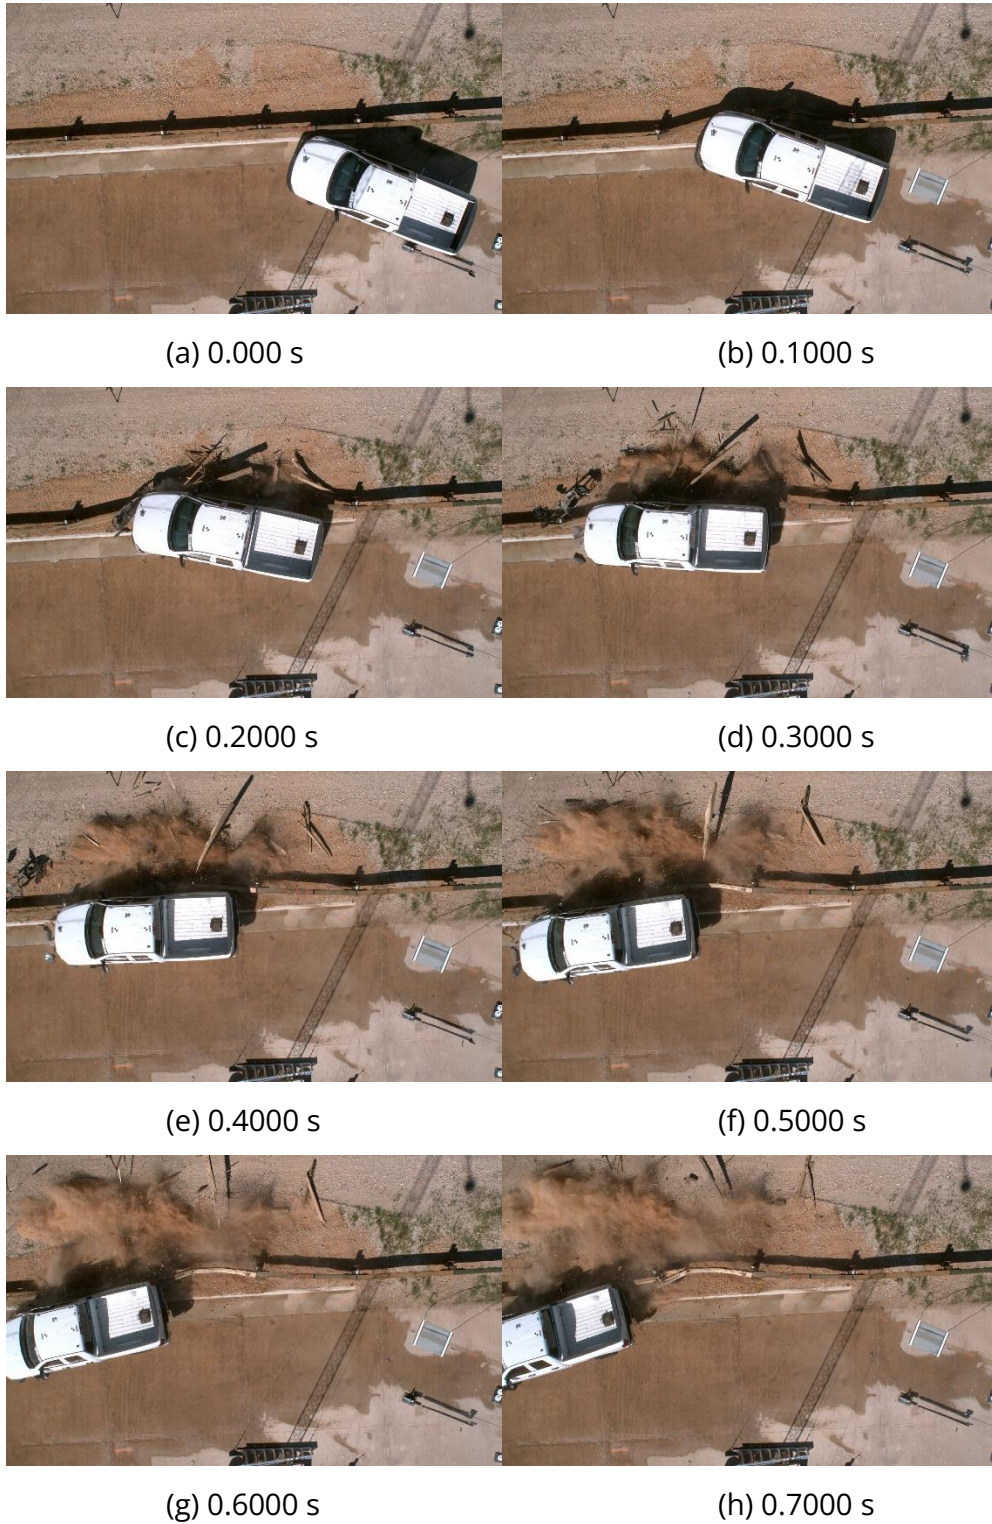
Figure C.4. Sequential Photographs for Test 620061-01-2 (Overhead Views).

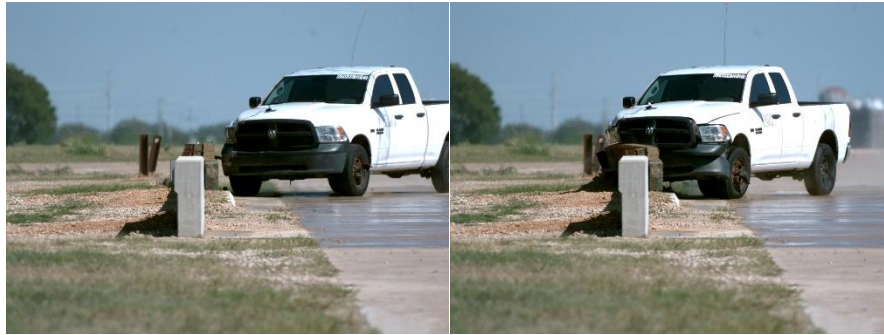
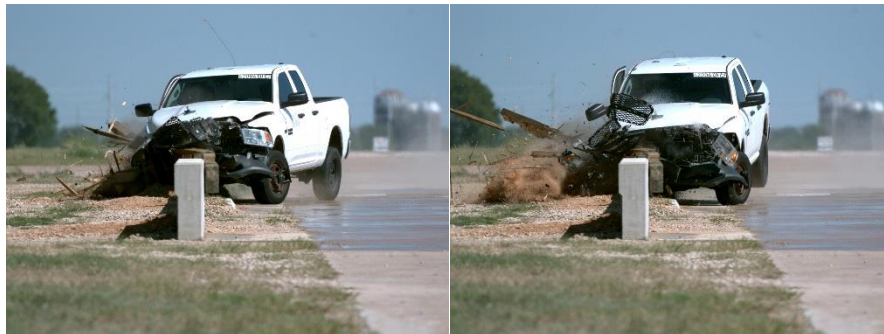
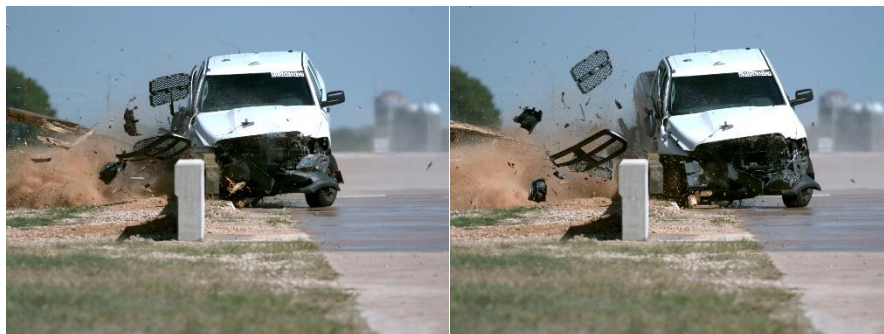
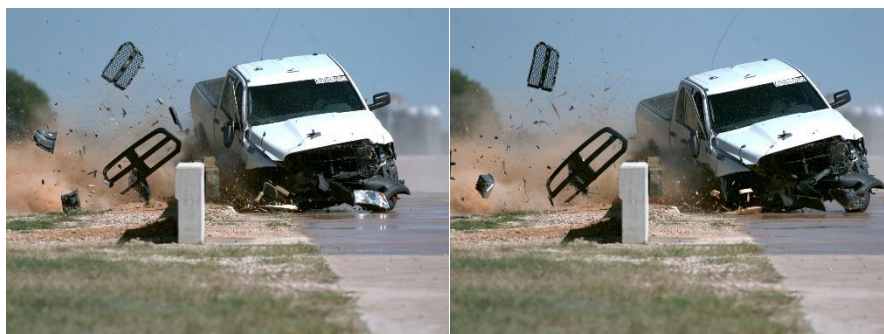
Figure C.5. Sequential Photographs for Test 620061-01-2 (Downstream In-Line Views).

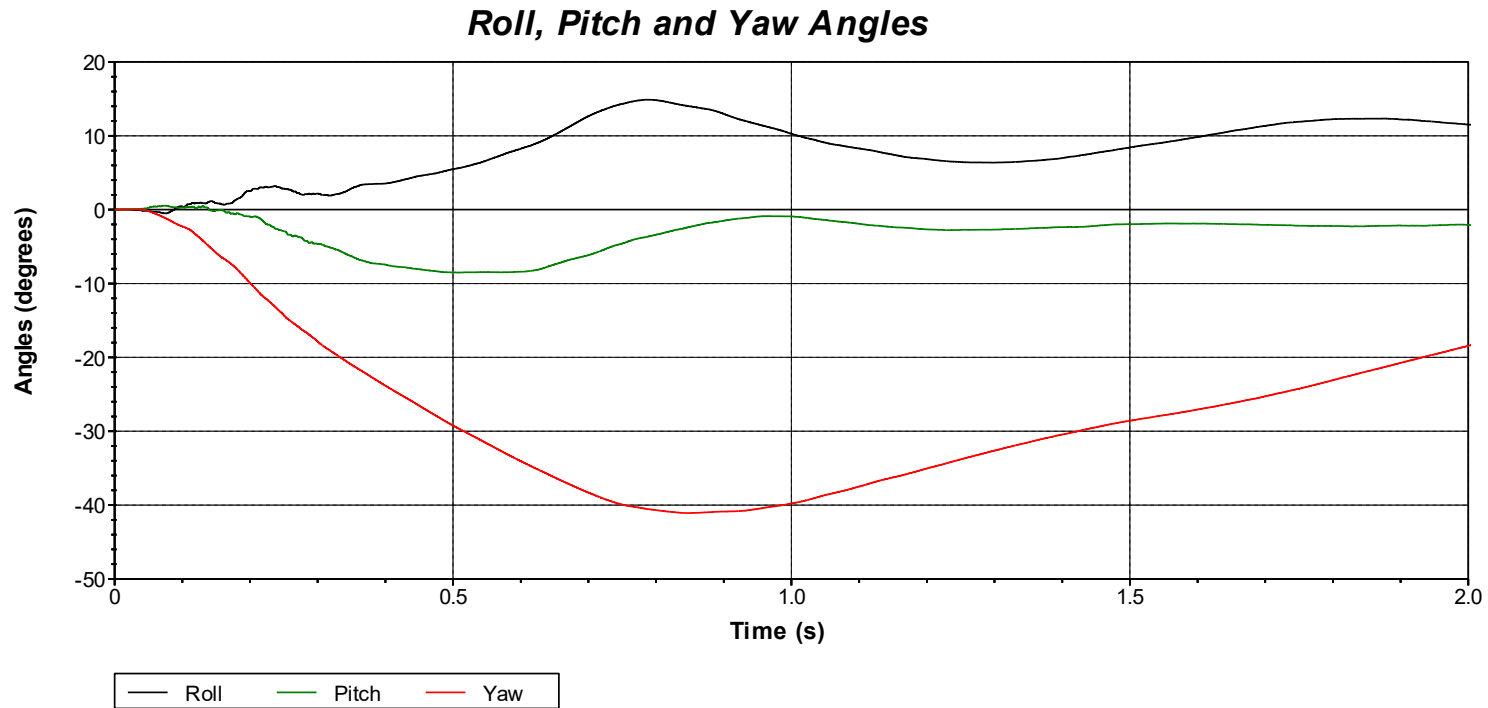
Axes are vehicle-fixed.  
Sequence for determining  
orientation:

1. Yaw.
2. Pitch.
3. Roll.

Figure C.6. Vehicle Angular Displacements for Test 620061-01-2.
