Test Report No. 620061-01-1:6

## DESIGN AND EVALUATION OF THE MERRITT PARKWAY GUIDERAIL ACCORDING TO *MASH* TL-3

Sponsored by  
Connecticut DOT and

Roadside Safety Pooled Fund

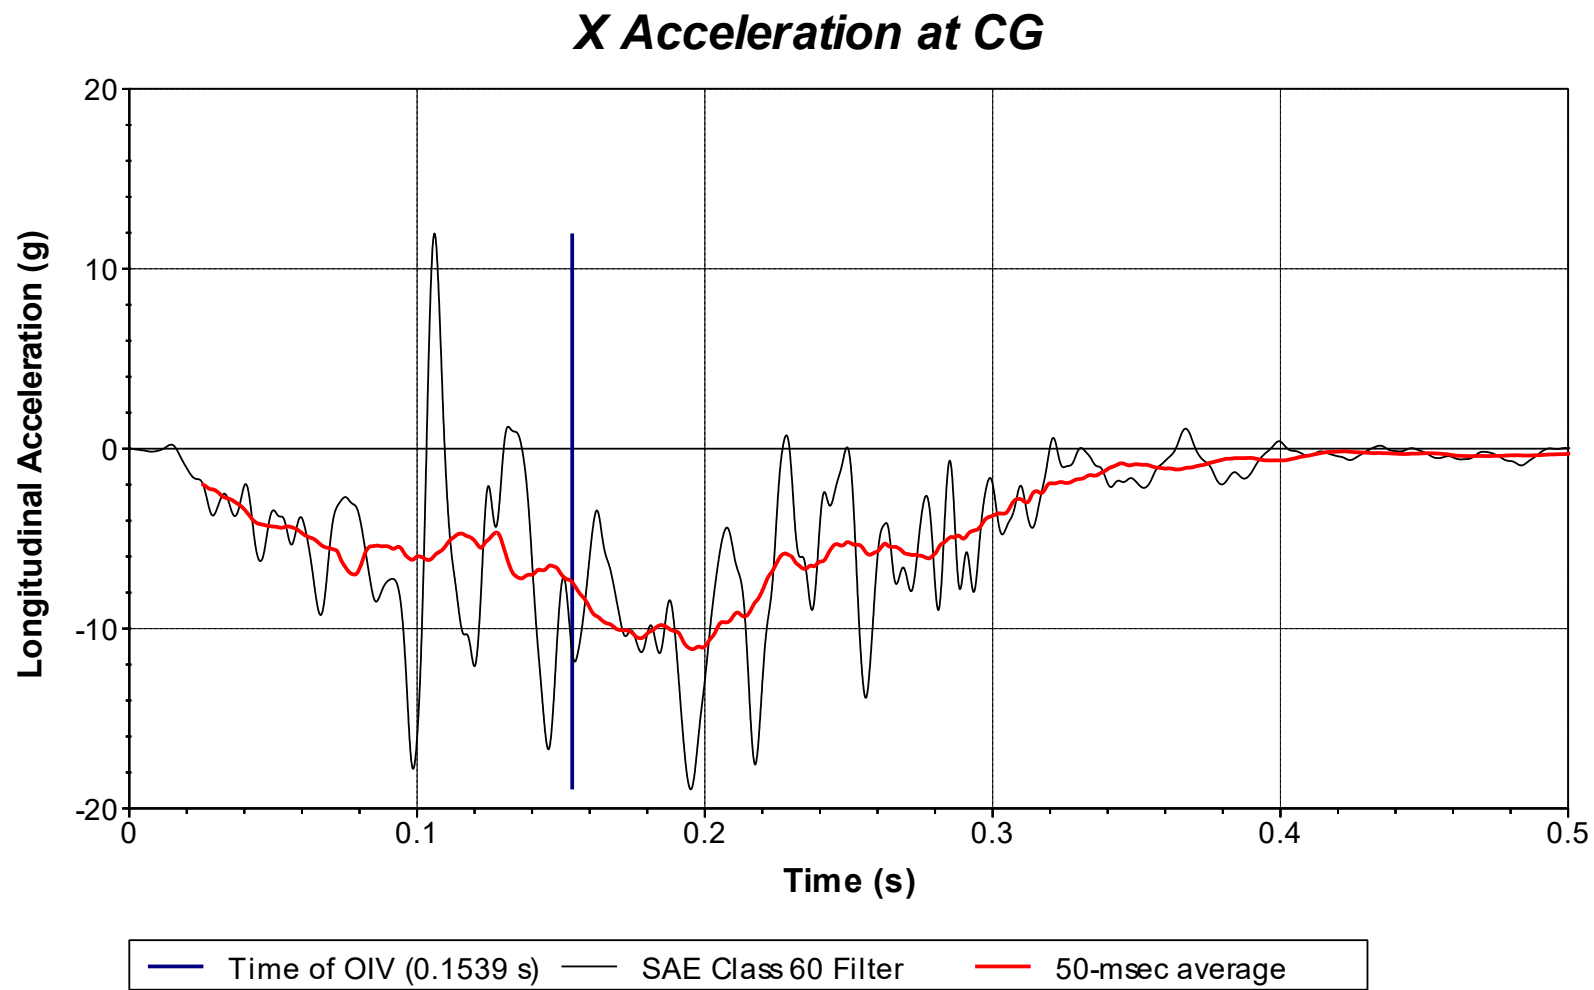
Figure C.7. Vehicle Longitudinal Accelerometer Trace for Test 620061-01-2  
(Accelerometer Located at Center of Gravity).

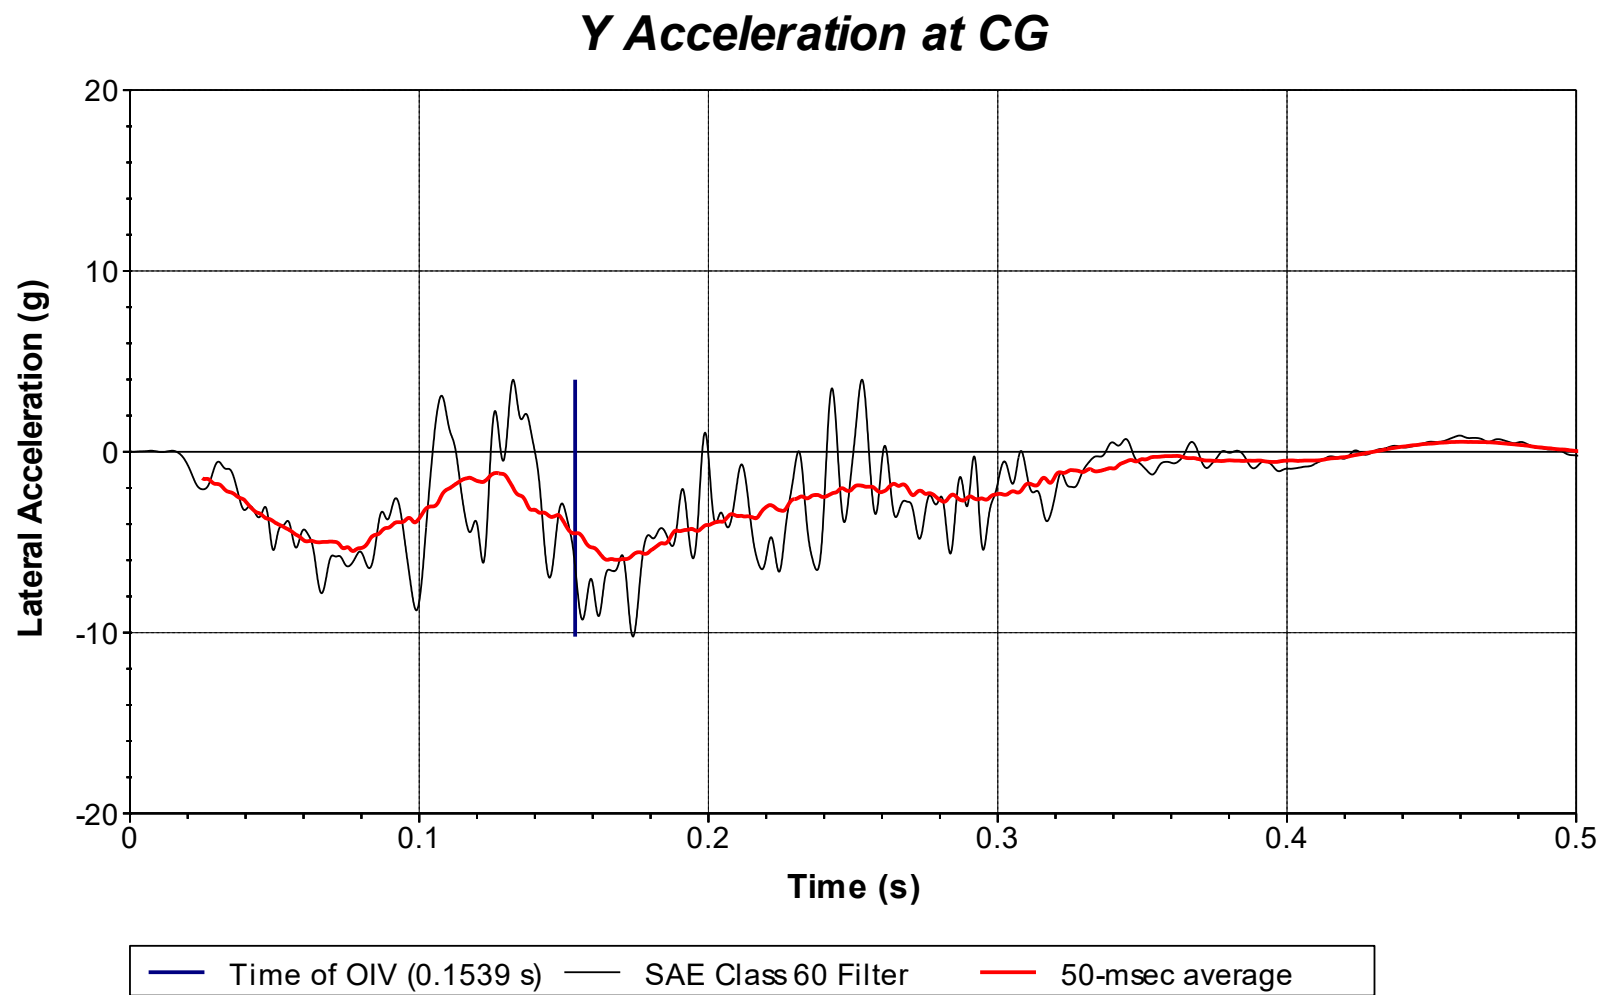
Figure C.8. Vehicle Lateral Accelerometer Trace for Test 620061-01-2  
(Accelerometer Located at Center of Gravity).

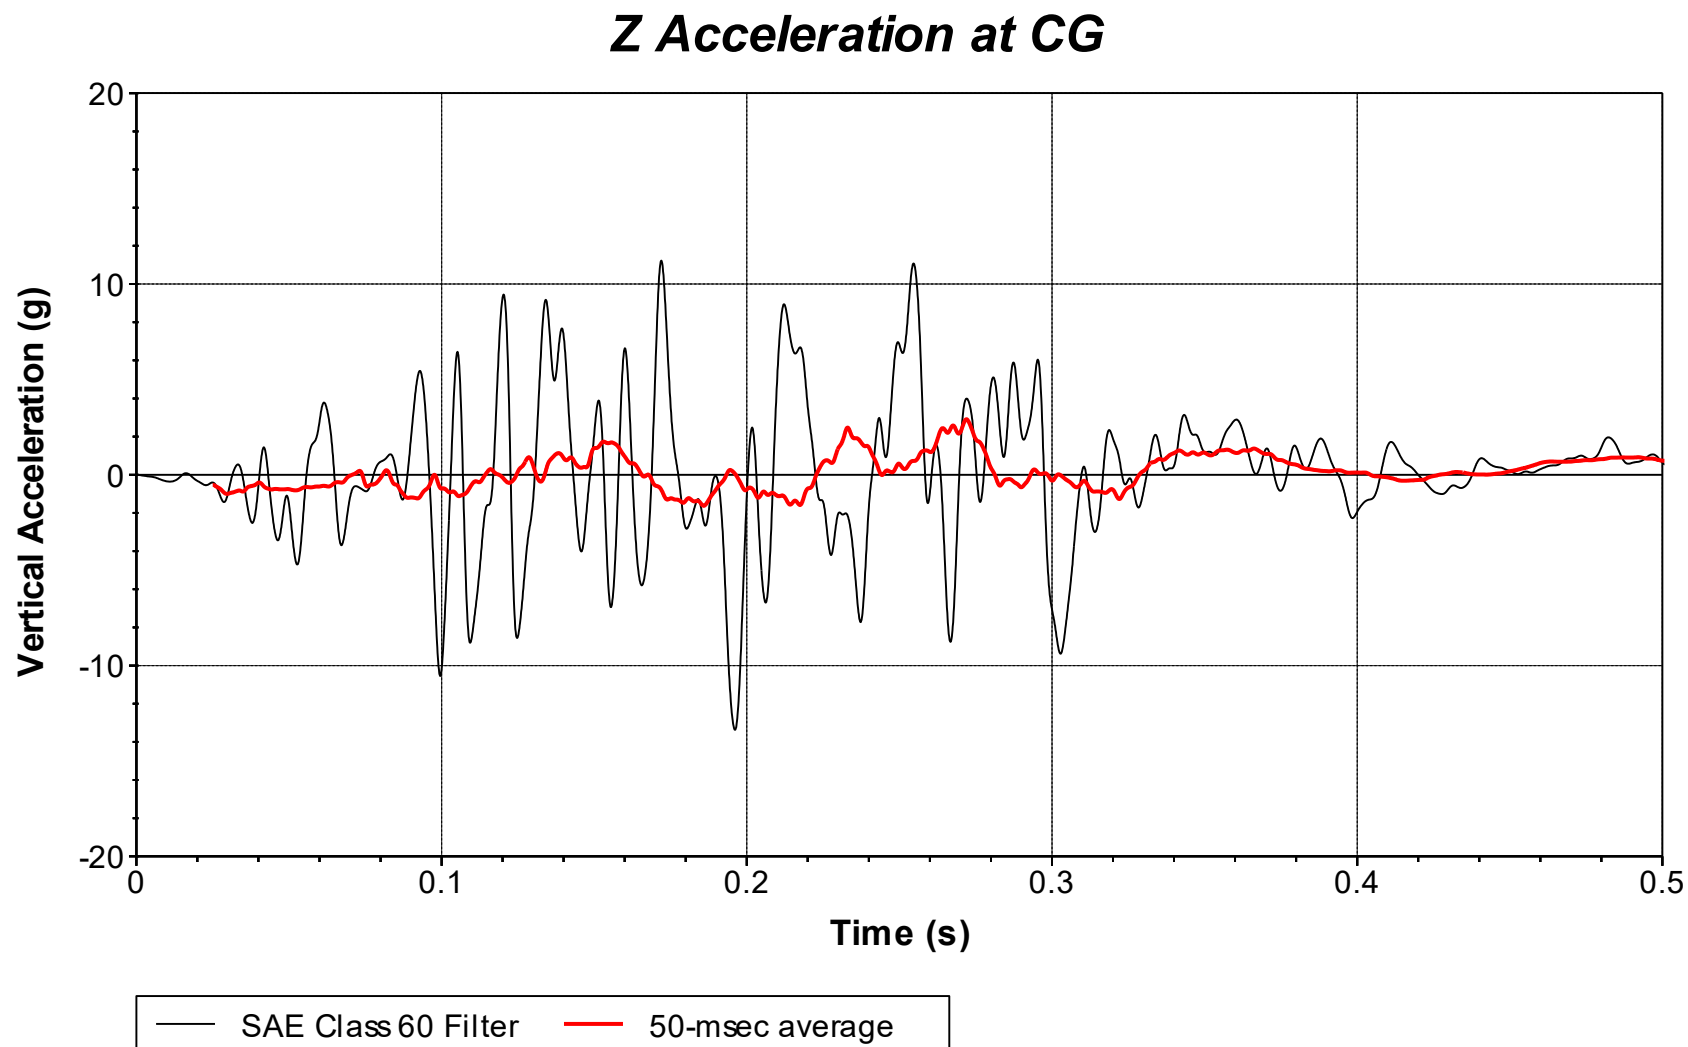
Figure C.9. Vehicle Vertical Accelerometer Trace for Test 620061-01-2  
(Accelerometer Located at Center of Gravity).

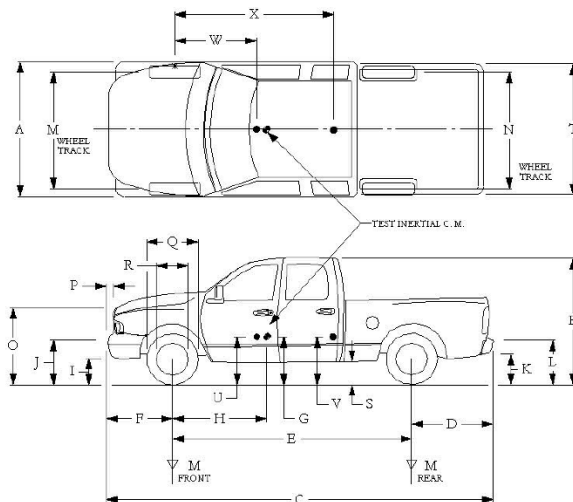
**Geometry:** inches

A	78.50	F	40.25	K	20.00	P	3.00	U	26.75
B	74.00	G	28.50	L	30.00	Q	30.50	V	30.25
C	229.00	H	60.80	M	68.50	R	18.00	W	61.00
D	48.25	I	11.75	N	68.00	S	13.00	X	79.00
E	140.50	J	27.00	O	46.00	T	77.00		
Wheel Center Height Front	14.75	Wheel Well Clearance (Front)	6.00	Bottom Frame Height - Front	12.50				
Wheel Center Height Rear	14.75	Wheel Well Clearance (Rear)	9.25	Bottom Frame Height - Rear	22.50

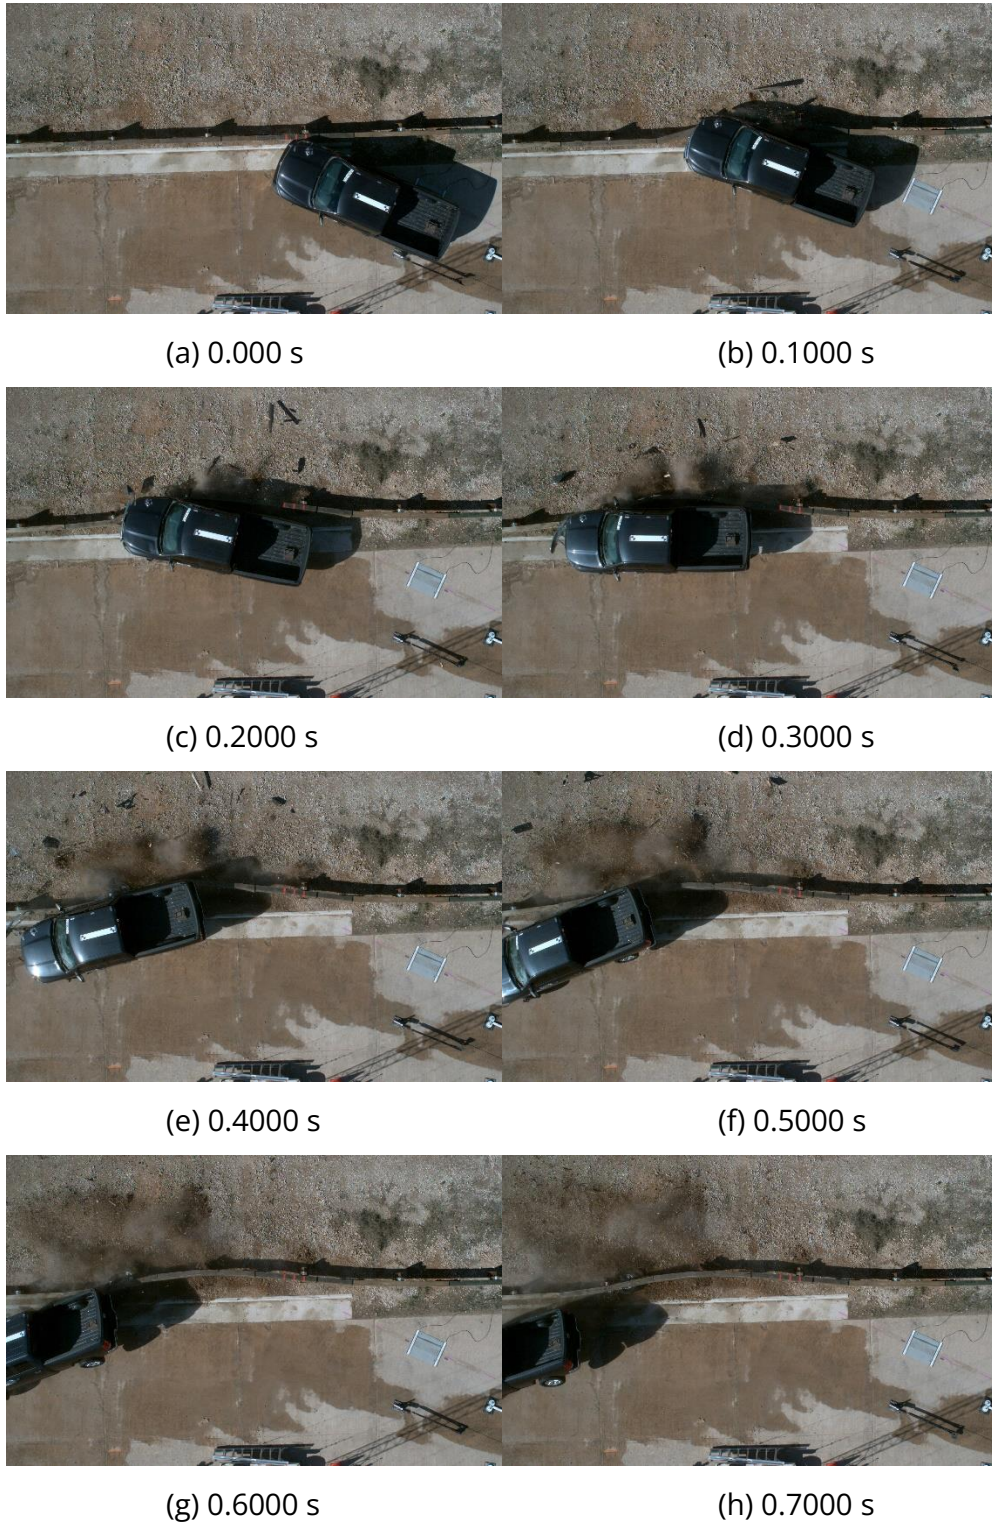
Figure D.4. Sequential Photographs for Test 620061-01-1 (Overhead Views).

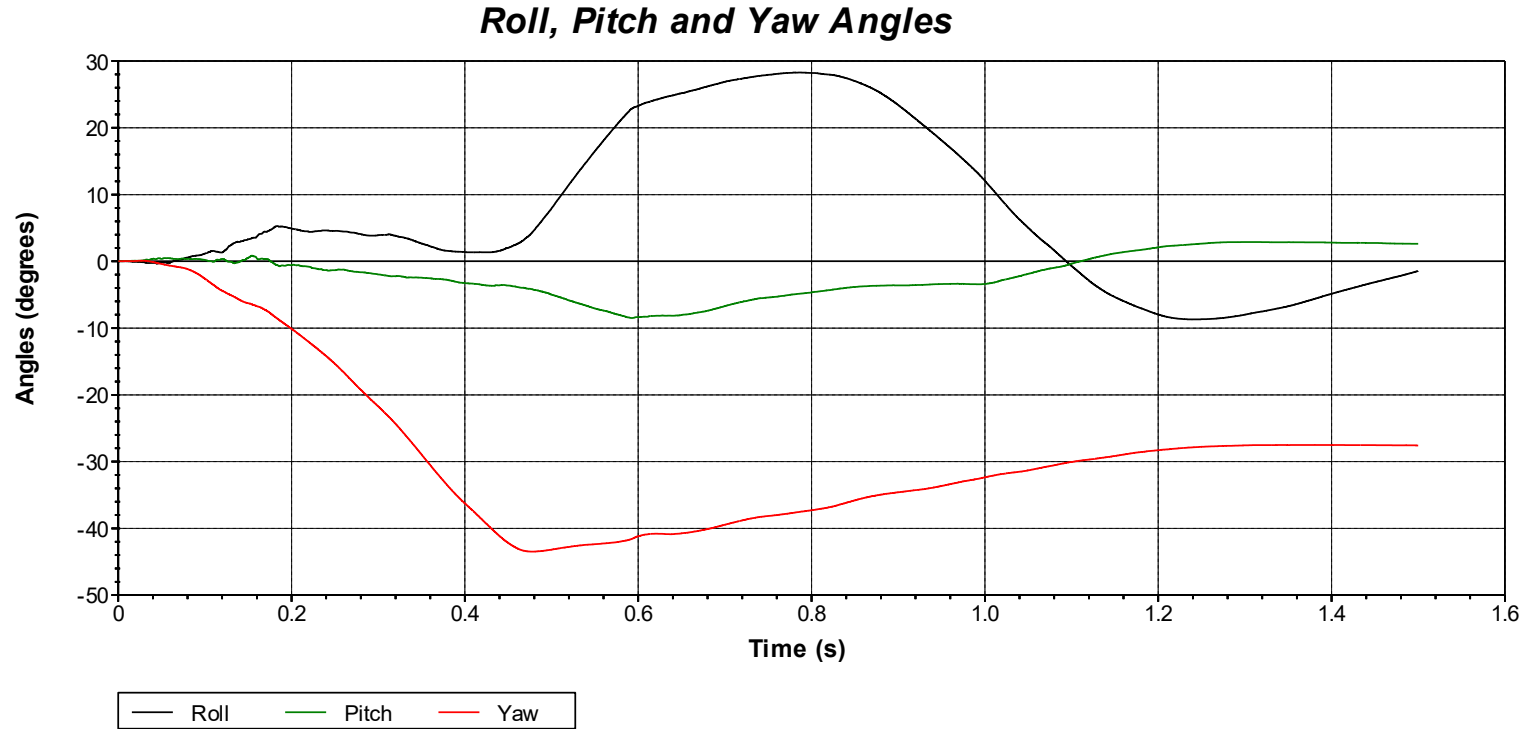
Figure D.7. Vehicle Angular Displacements for Test 620061-01-1.

Axes are vehicle-fixed.  
Sequence for determining  
orientation:

4. Yaw.
5. Pitch.
6. Roll.

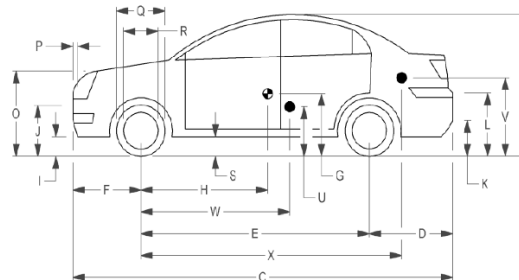
**Geometry:** inches

A 66.70 F 32.50 K 12.50 P 4.50 U 15.50

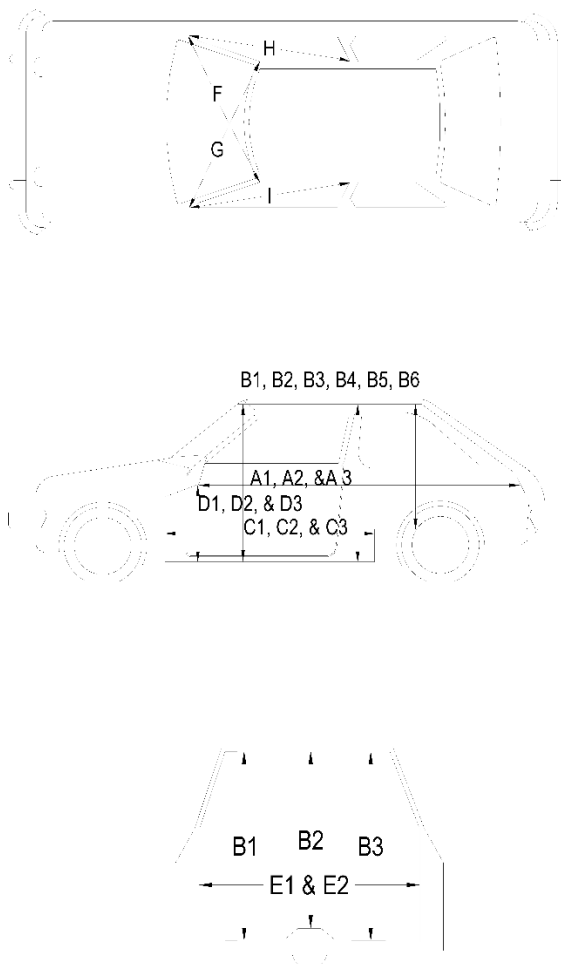
Figure E.3. Occupant Compartment Measurements for Test 620061-01-3.

### OCCUPANT COMPARTMENT DEFORMATION MEASUREMENT

Before	After (inches)	Differ.
A1	67.50	67.50	0.00
A2	67.25	67.25	0.00
A3	67.75	67.75	0.00
B1	40.50	40.50	0.00
B2	39.00	39.00	0.00
B3	40.50	39.75	-0.75
B4	36.25	36.25	0.00
B5	36.00	36.00	0.00
B6	36.25	36.25	0.00
C1	26.00	26.00	0.00
C2	0.00	0.00	0.00
C3	26.00	24.75	-1.25
D1	9.50	9.50	0.00
D2	0.00	0.00	0.00
D3	9.50	7.25	-2.25
E1	51.50	52.25	0.75
E2	51.00	51.00	0.00
F	51.00	51.00	0.00
G	51.00	51.00	0.00
H	37.50	37.50	0.00
I	37.50	37.50	0.00
J*	51.00	47.25	-3.75

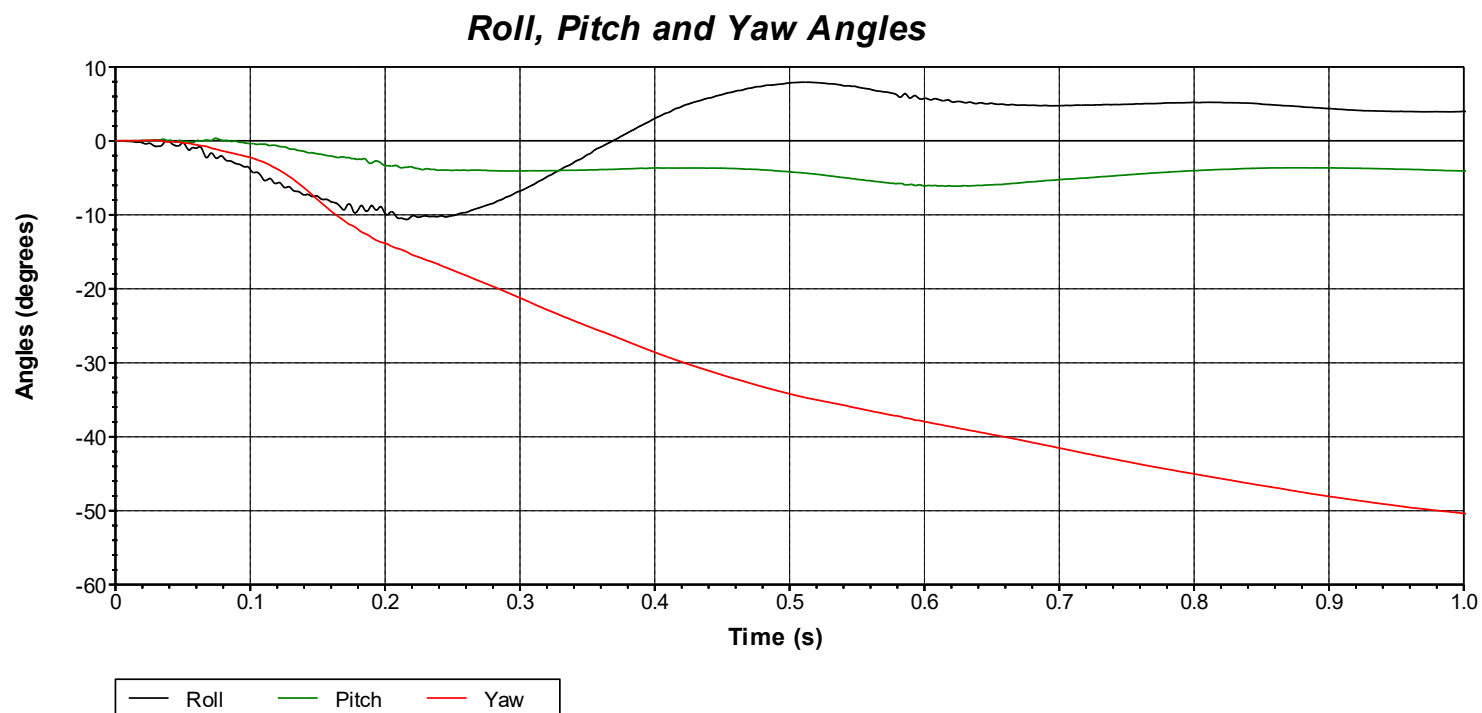
Figure E.7. Vehicle Angular Displacements for Test 620061-01-3.

Axes are vehicle-fixed.  
Sequence for determining  
orientation:

7. Yaw.
8. Pitch.
9. Roll.

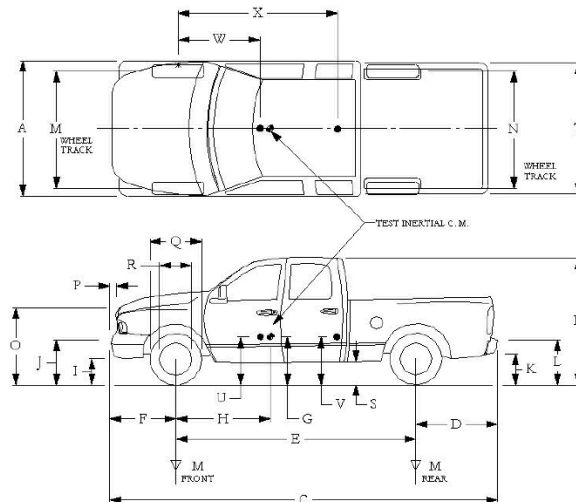
#### Geometry: inches

A	78.50	F	40.25	K	20.00	P	3.00	U	26.75
B	74.00	G	28.50	L	30.00	Q	30.50	V	30.25
C	229.00	H	62.15	M	68.50	R	18.00	W	62.00
D	48.25	I	11.75	N	68.00	S	13.00	X	79.00
E	140.50	J	27.00	O	46.00	T	77.00		
Wheel Center Height Front	14.75	Wheel Well Clearance (Front)	6.00	Bottom Frame Height - Front	12.50				
Wheel Center Height Rear	14.75	Wheel Well Clearance (Rear)	9.25	Bottom Frame Height - Rear	22.50

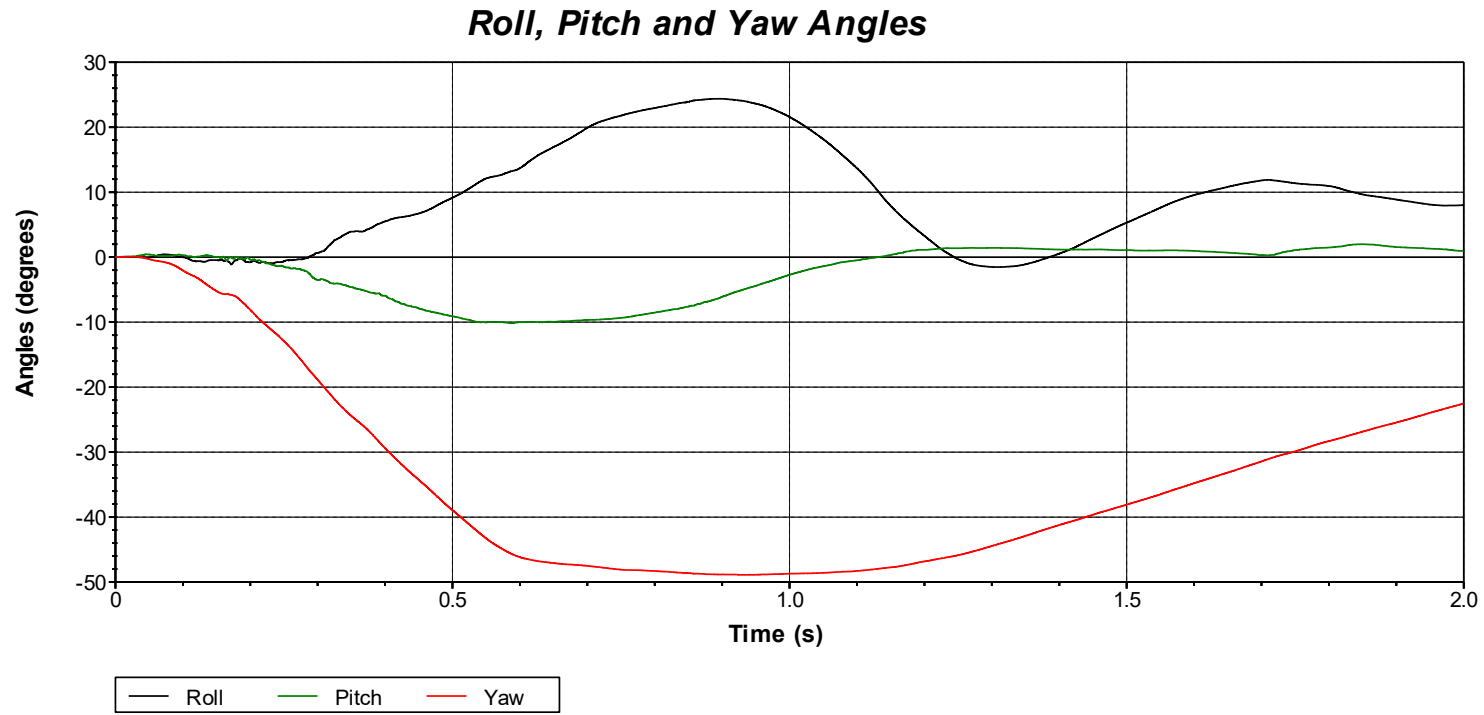
Figure F.6. Vehicle Angular Displacements for Test 620061-01-4.

Axes are vehicle-fixed.  
Sequence for determining  
orientation:

10. Yaw.
11. Pitch.
12. Roll.

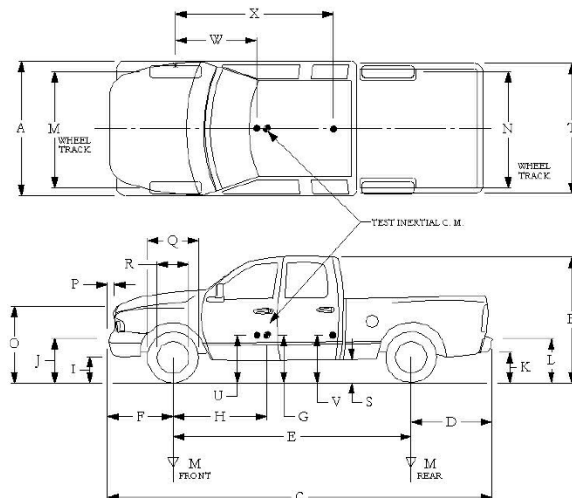
Figure G.1. Vehicle Properties for Test 620061-01-5.

**Mass Distribution:**  
 lb LF: 1407 RF: 1434 LR: 1100 RR: 1083

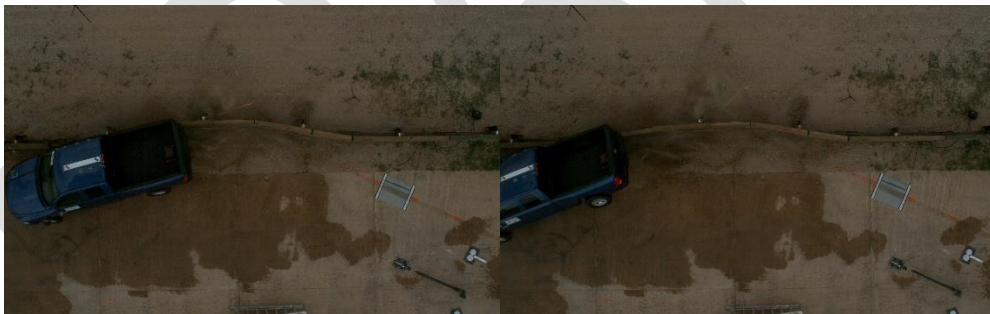
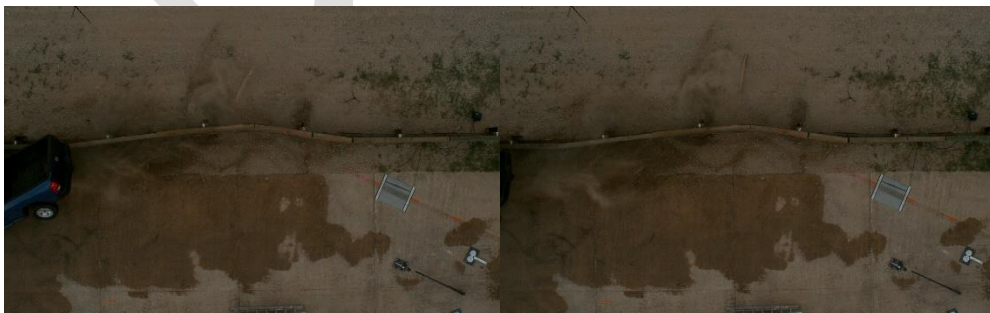
Figure G.4. Sequential Photographs for Test 620061-01-5 (Overhead Views).

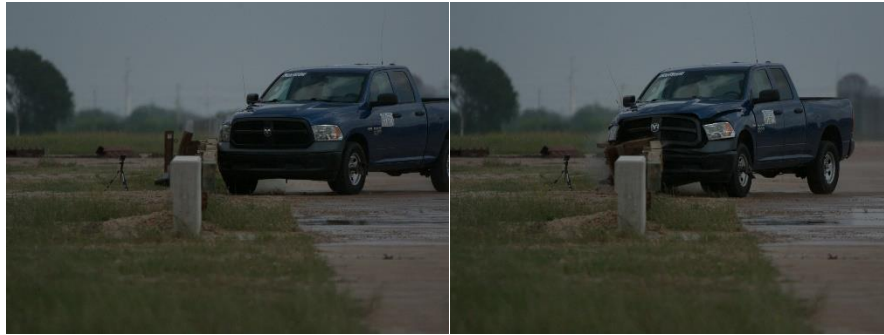
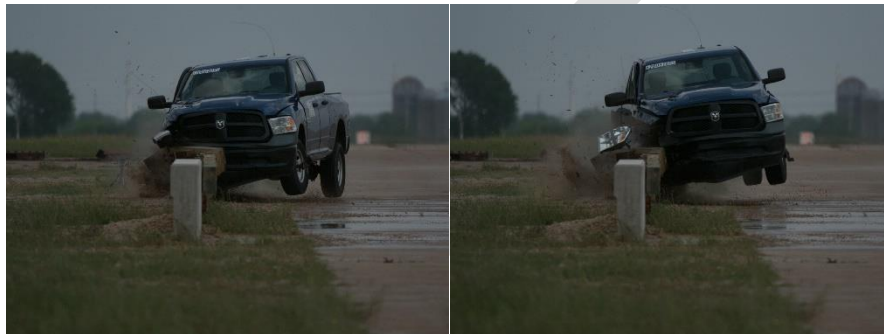
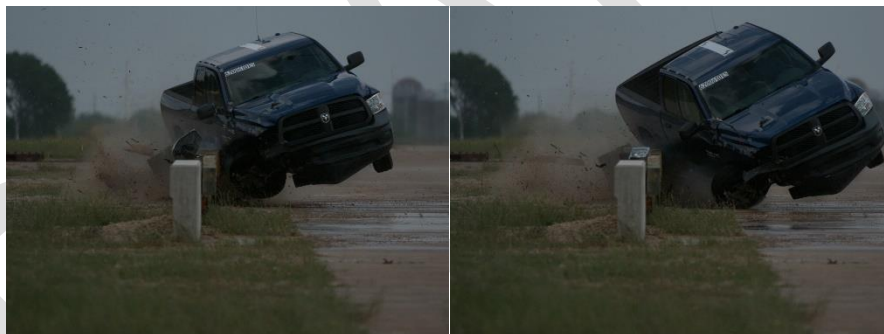
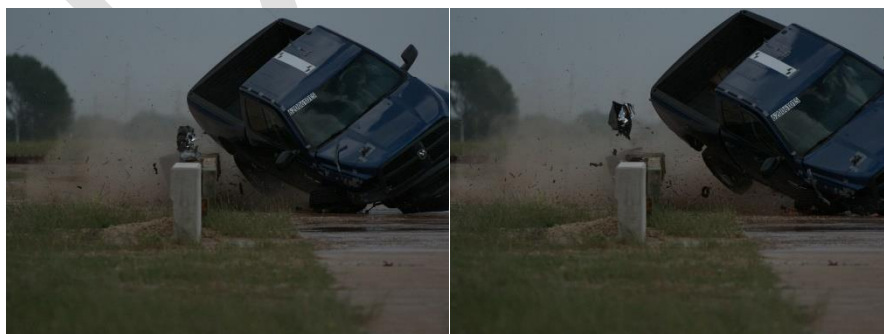
Figure G.5. Sequential Photographs for Test 620061-01-5 (Downstream In-Line Views).

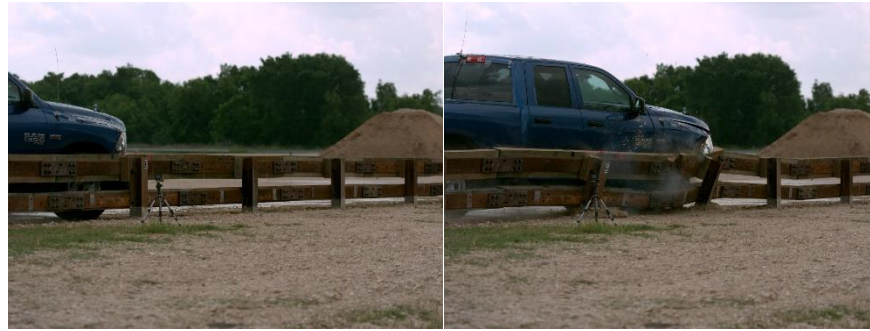
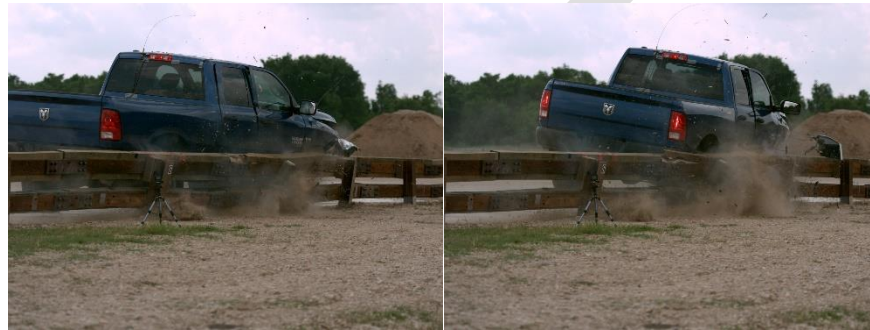
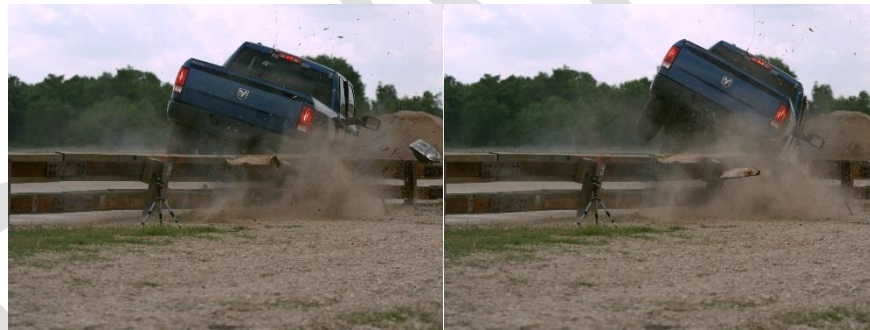
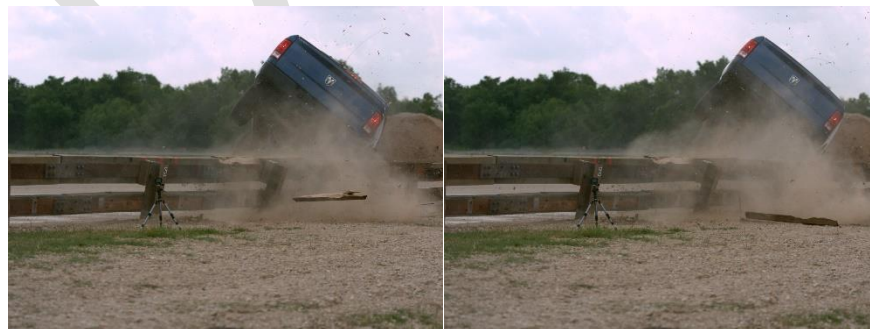
Figure G.6. Sequential Photographs for Test 620061-01-5 (Upstream Field Side Oblique Views).

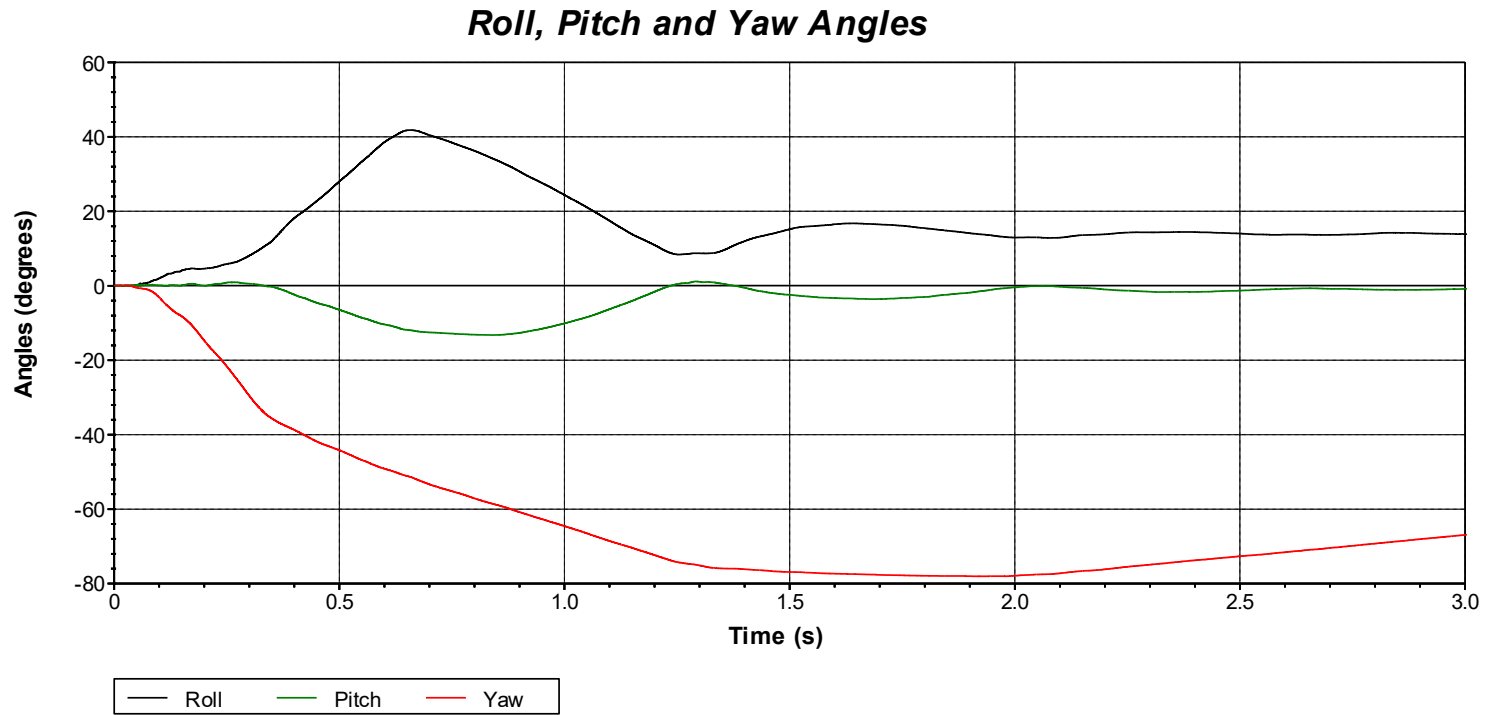
Axes are vehicle-fixed.  
Sequence for determining  
orientation:

13. Yaw.
14. Pitch.
15. Roll.

Figure G.7. Vehicle Angular Displacements for Test 620061-01-5.

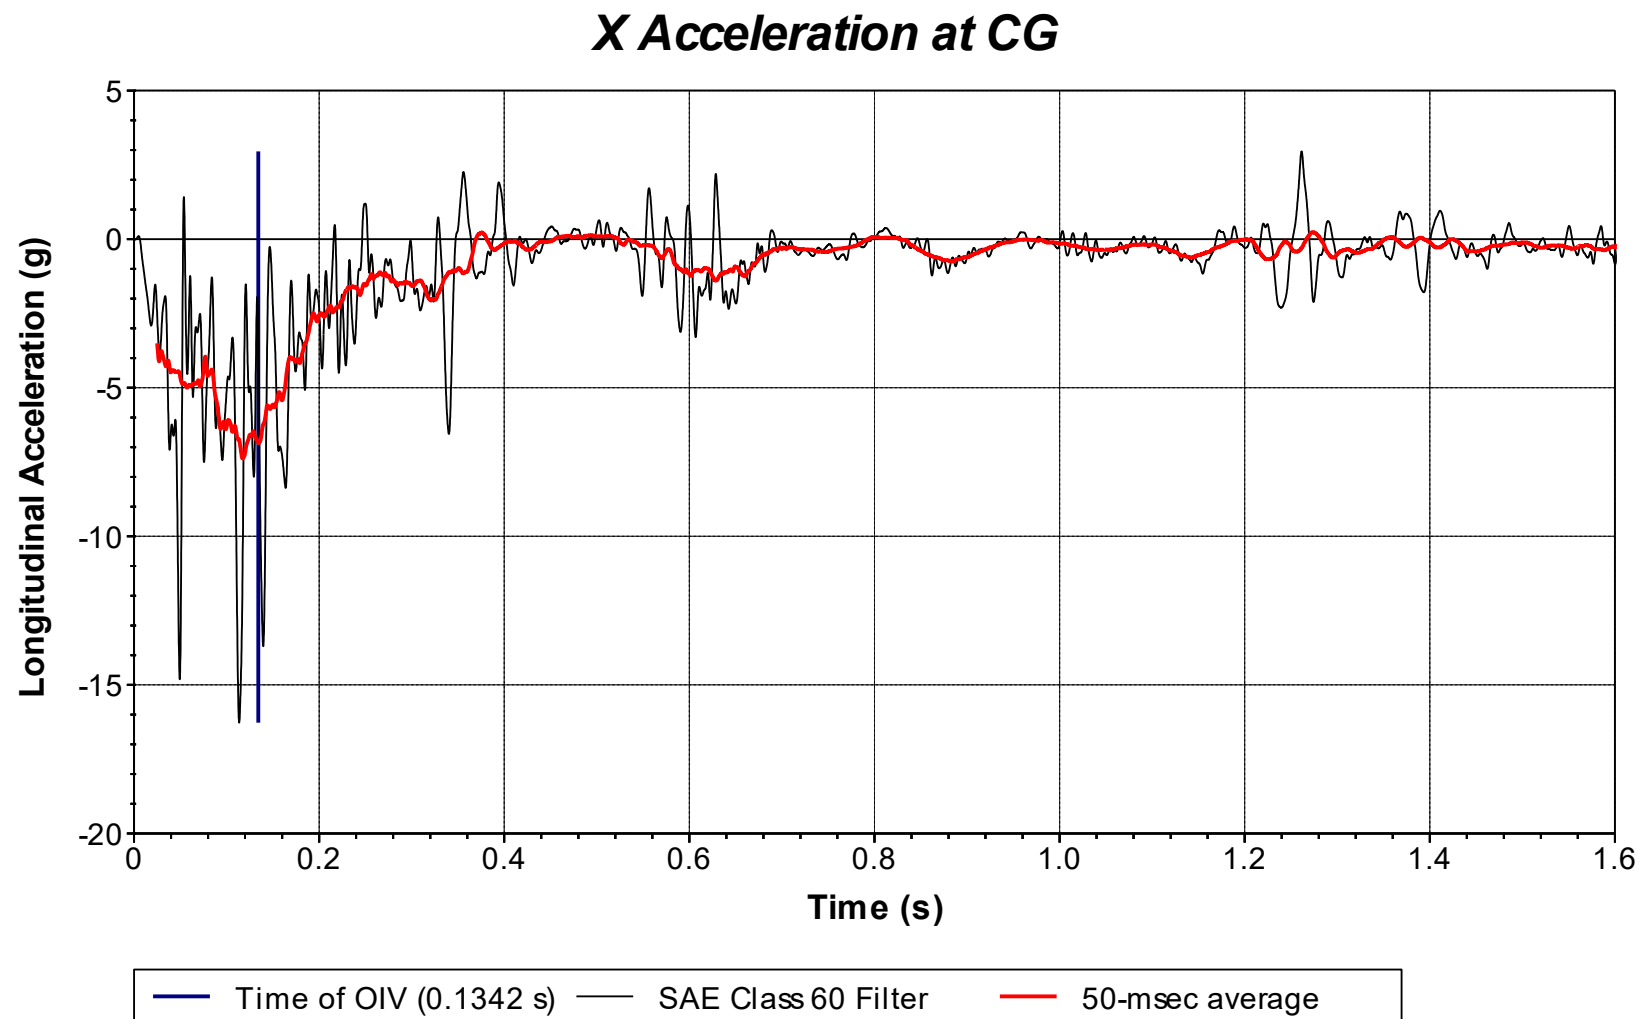
Figure G.8. Vehicle Longitudinal Accelerometer Trace for Test 620061-01-5  
(Accelerometer Located at Center of Gravity).

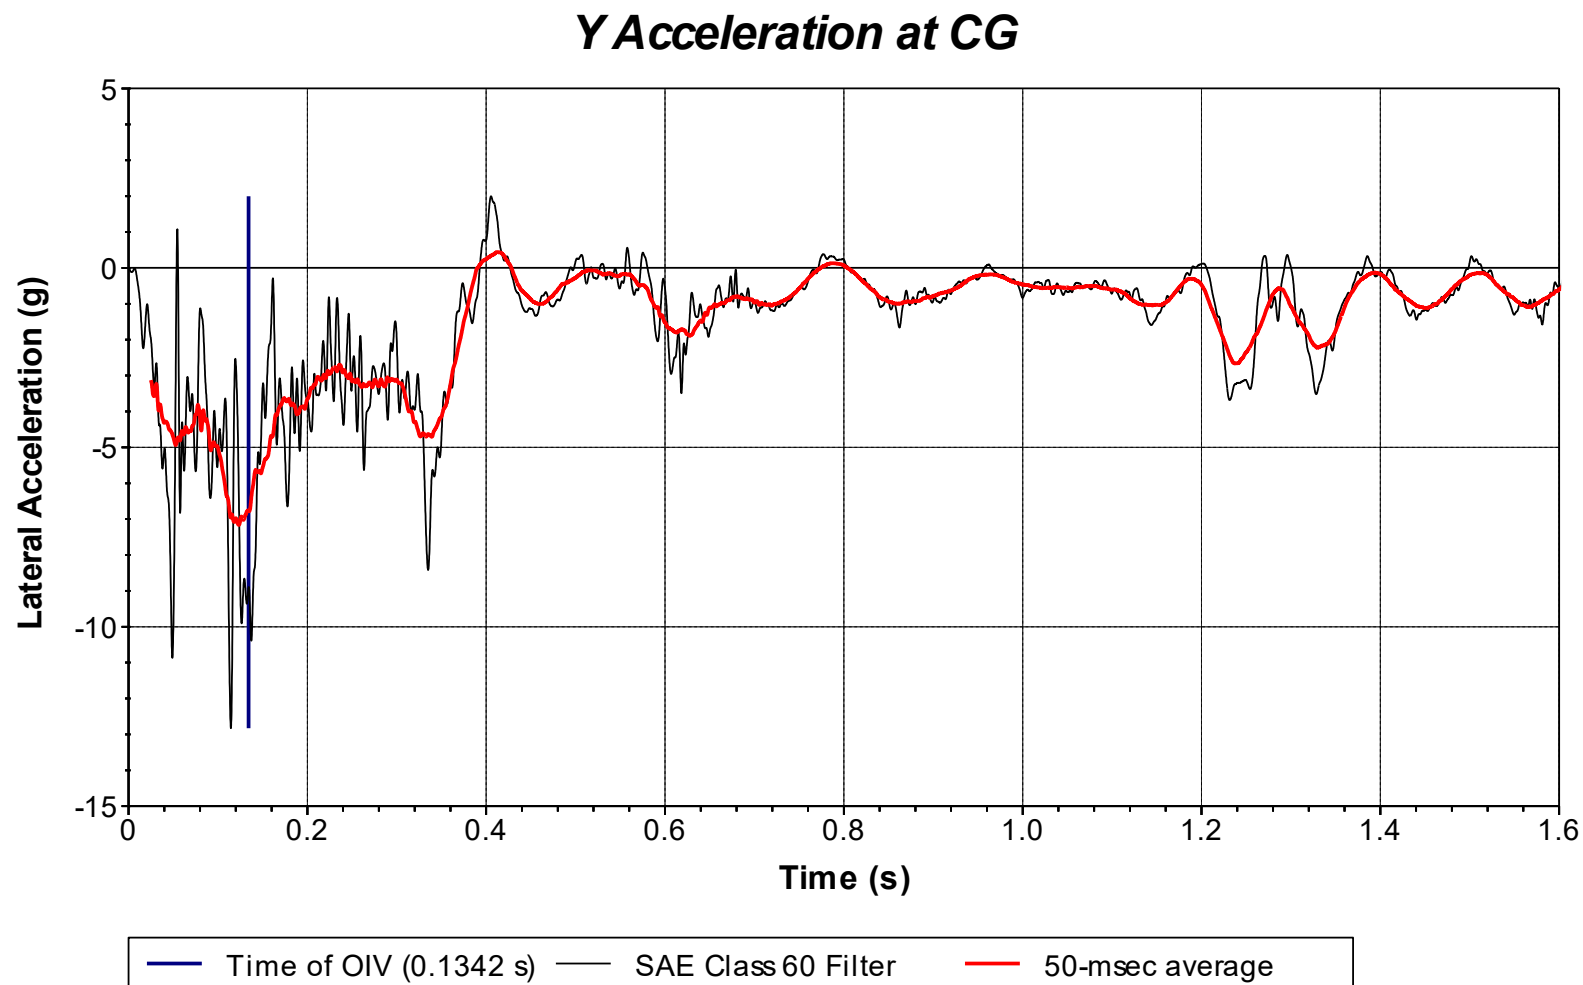
Figure G.9. Vehicle Lateral Accelerometer Trace for Test 620061-01-5  
(Accelerometer Located at Center of Gravity).

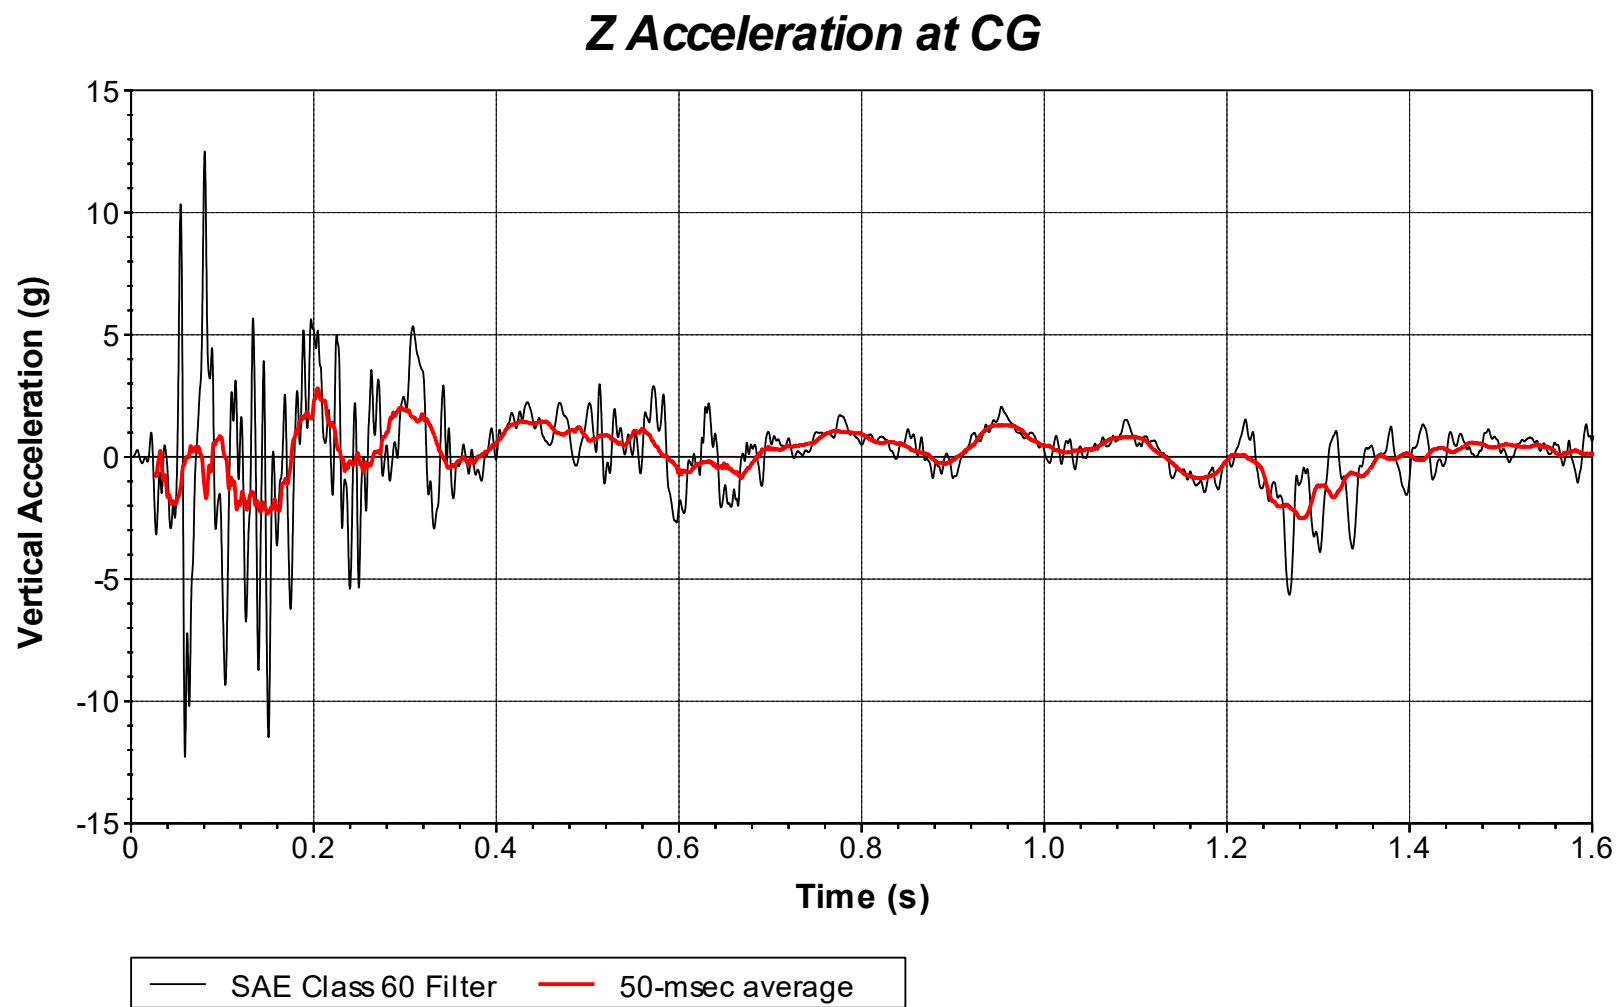
Figure G.10. Vehicle Vertical Accelerometer Trace for Test 620061-01-5  
(Accelerometer Located at Center of Gravity).

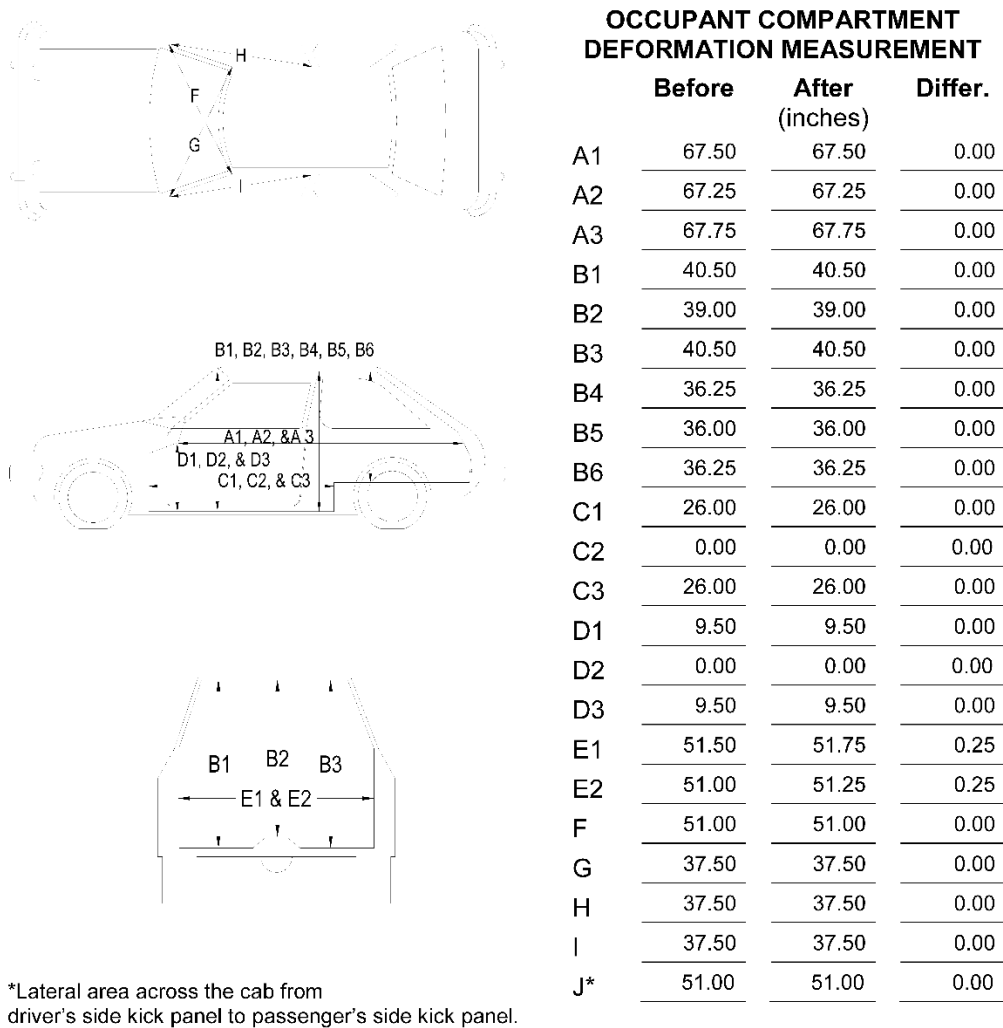
Figure H.3. Occupant Compartment Measurements for Test 620061-01-6.
