Test Report No. 620061-01-1:6

## DESIGN AND EVALUATION OF THE MERRITT PARKWAY GUIDERAIL ACCORDING TO *MASH* TL-3

Sponsored by  
Connecticut DOT and

Roadside Safety Pooled Fund

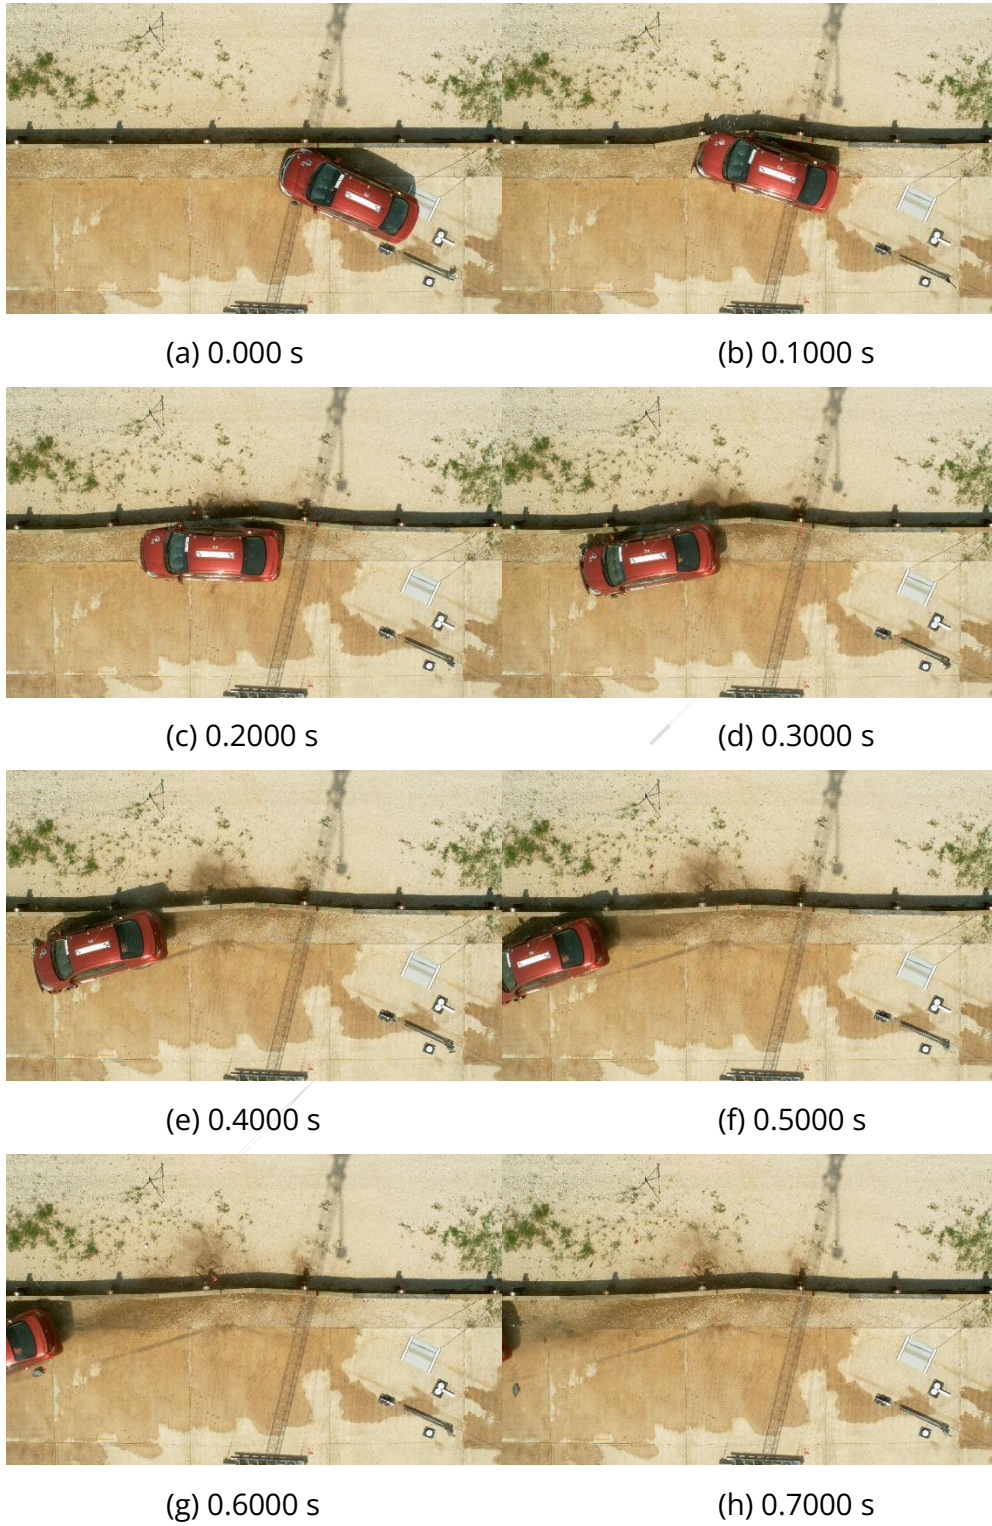
Figure H.4. Sequential Photographs for Test 620061-01-6 (Overhead Views).

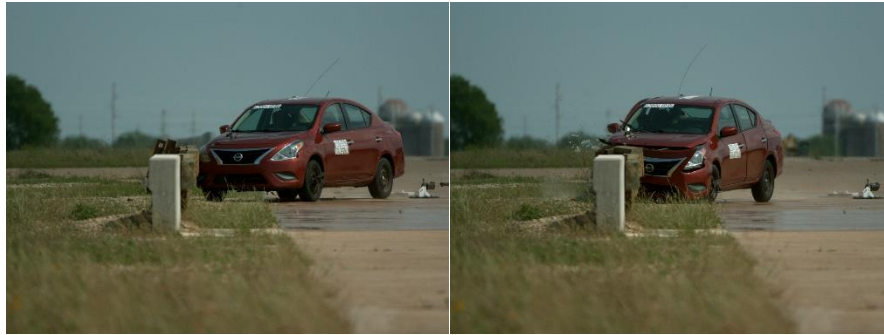
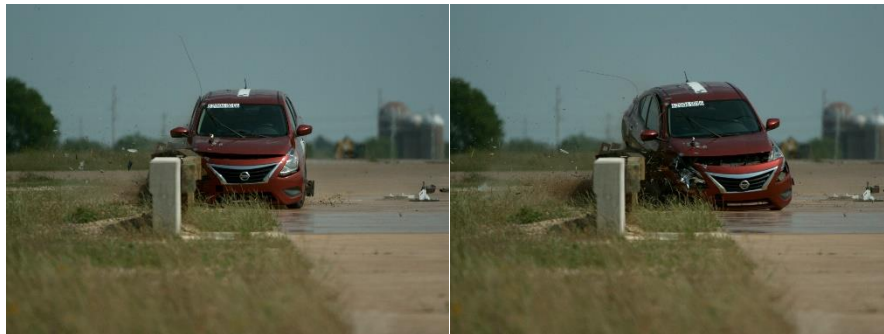
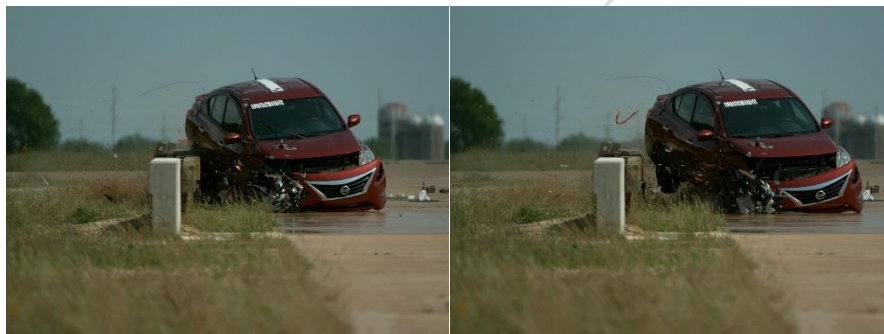
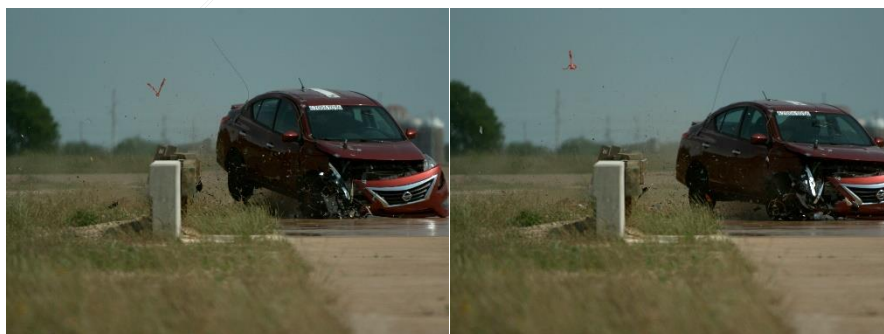
Figure H.5. Sequential Photographs for Test 620061-01-6 (Downstream In-Line Views).

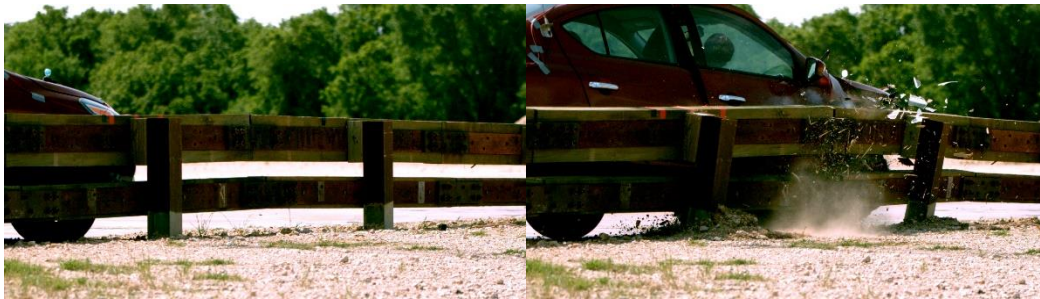
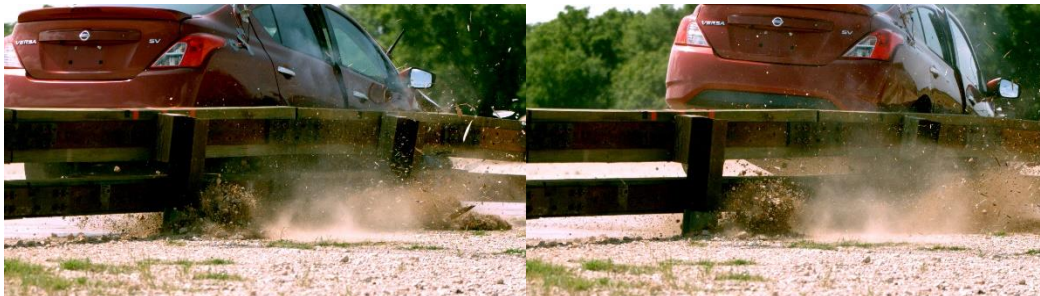
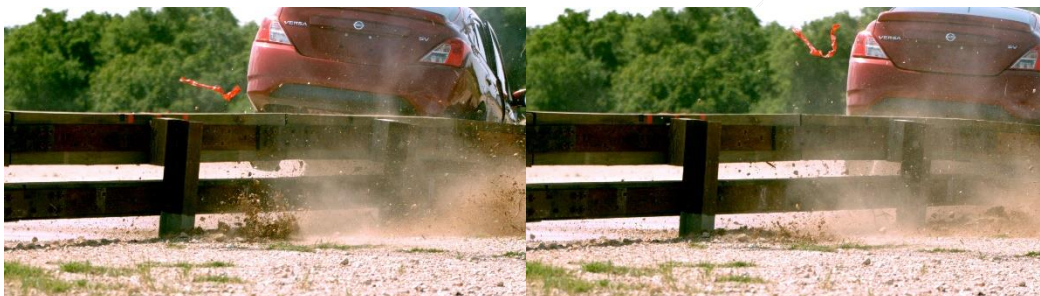
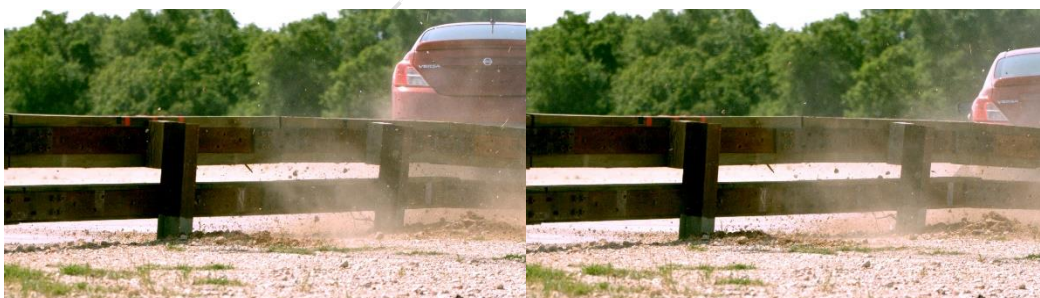
Figure H.6. Sequential Photographs for Test 620061-01-6 (Upstream Field Side Oblique Views).

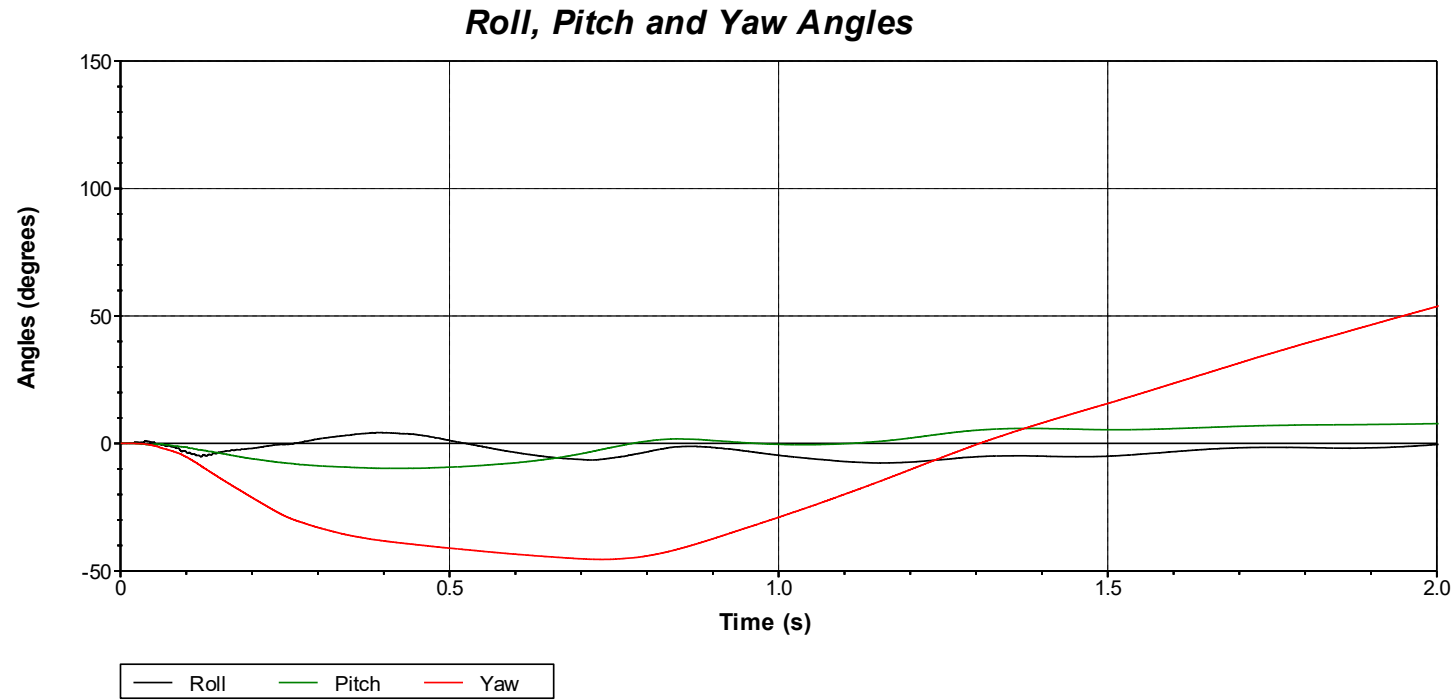
Axes are vehicle-fixed.  
Sequence for determining  
orientation:

16. Yaw.
17. Pitch.
18. Roll.

Figure H.7. Vehicle Angular Displacements for Test 620061-01-6.

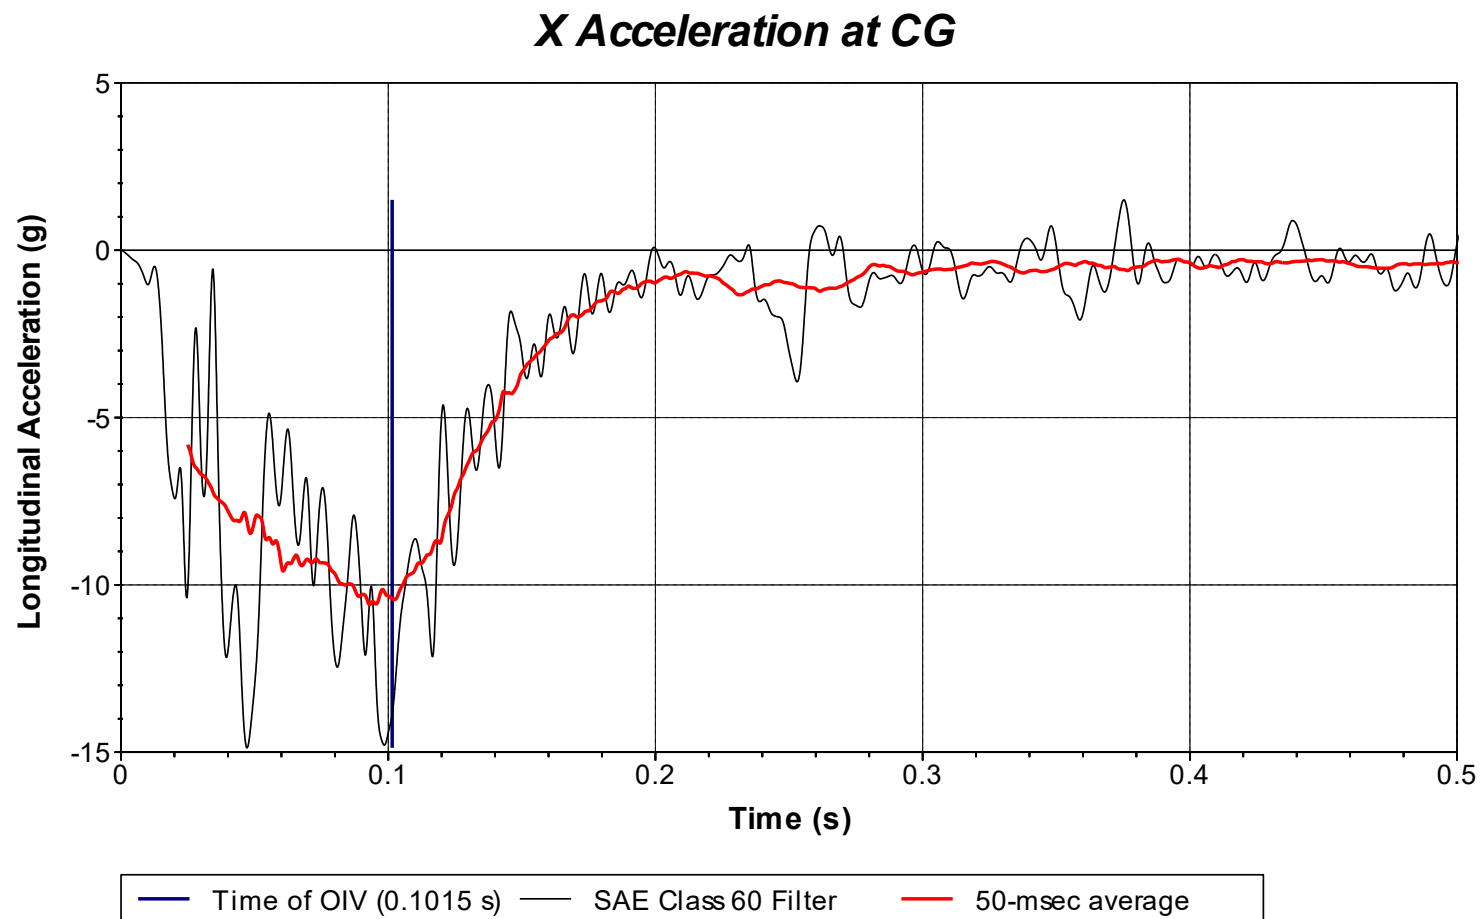
Figure H.8. Vehicle Longitudinal Accelerometer Trace for Test 620061-01-6  
(Accelerometer Located at Center of Gravity).

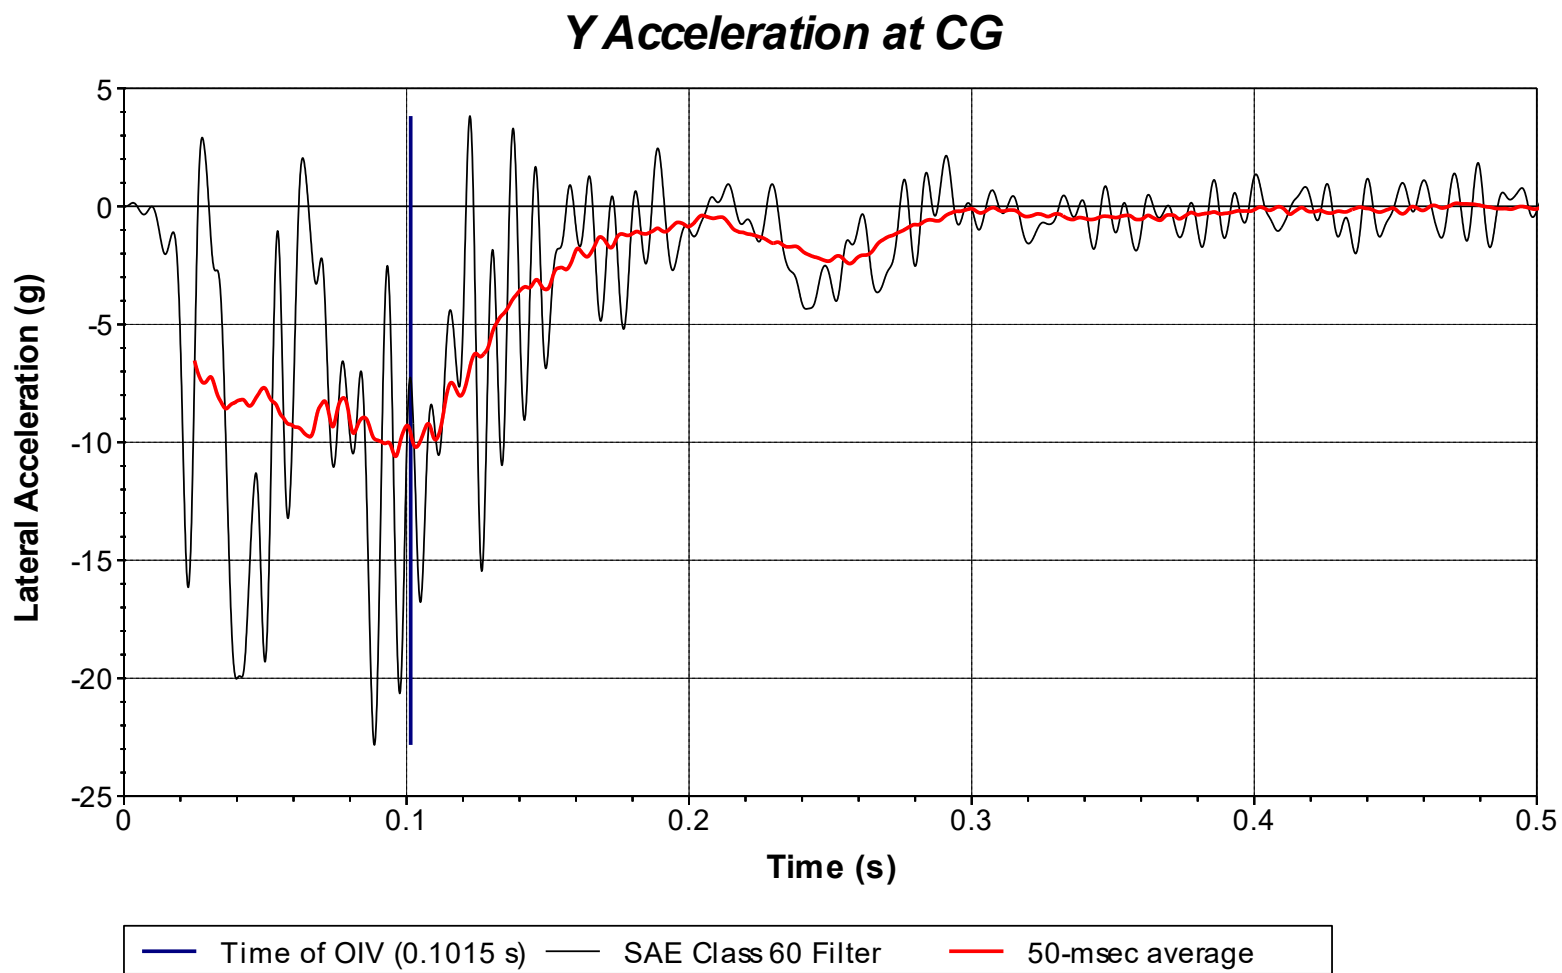
Figure H.9. Vehicle Lateral Accelerometer Trace for Test 620061-01-6  
(Accelerometer Located at Center of Gravity).

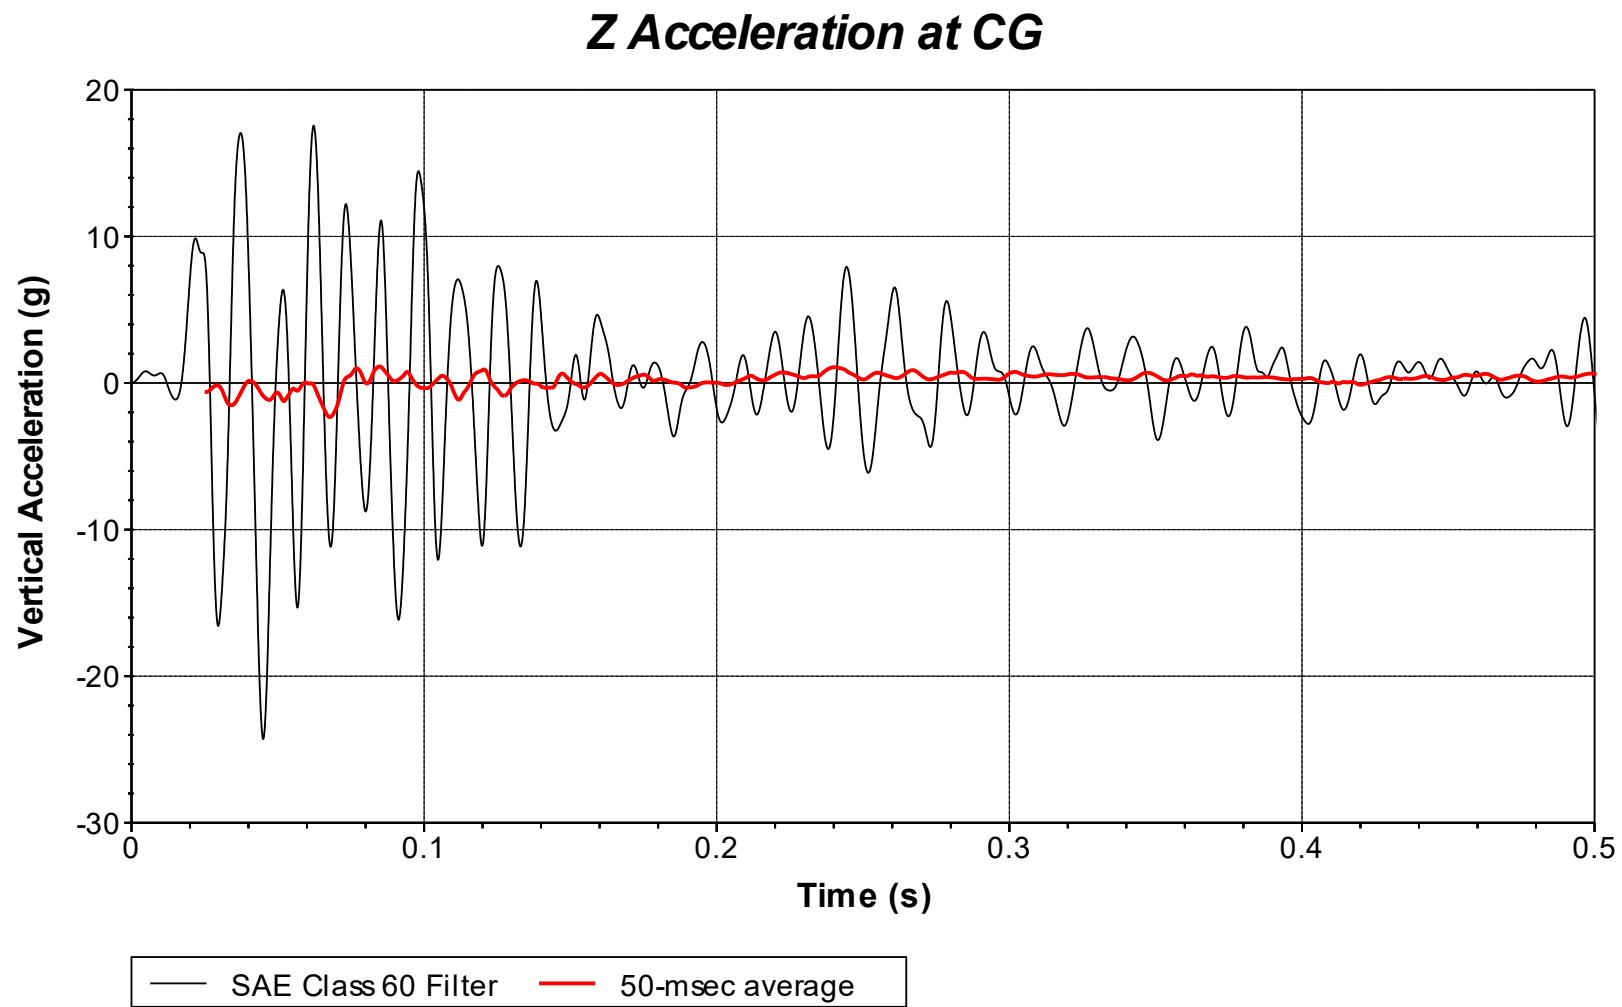
Figure H.10. Vehicle Vertical Accelerometer Trace for Test 620061-01-6  
(Accelerometer Located at Center of Gravity).
