**TPF-5(114)
Roadside Safety
Research Program
Pooled Fund Study**

W-BEAM GUARDRAIL ON BOX CULVERT

INTRODUCTION

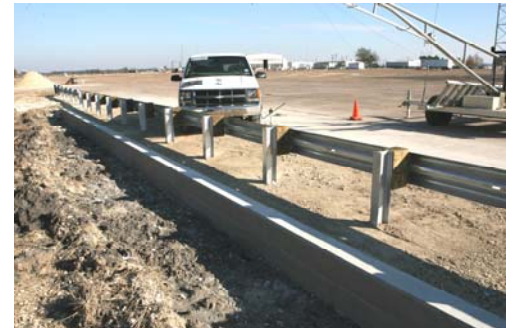
W-Beam Guardrail on Box Culvert

The W6x9 steel posts were welded to 12 inch x 12 inch x 7/8 inch thick base plates. The total length of the posts was 37 inches. Each steel post with base plate was anchored to the 9-inch thick simulated box culvert slab using four 7/8-inch diameter A193 Super HAS all-threaded rods, 8½ inches in length. These threaded rods were embedded 6 inches in the box culvert slab and were anchored using HILTI RE500 Epoxy Anchoring System.

The simulated box culvert slab tested was 105 ft in length by 75 inches in width by 9 inches thick. The fill height constructed on top of the box culvert slab was 9 inches. A 9-inch high by 10-inch wide concrete headwall was constructed on the field side edge of the box culvert slab. The W6x9 steel posts were located 28 inches from the field side edge of the simulated box culvert slab.

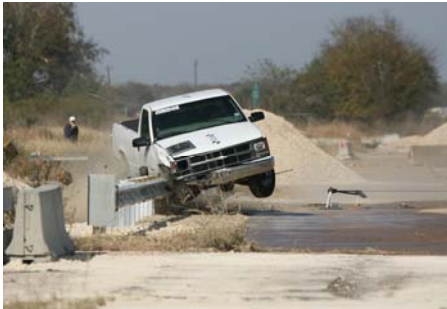
A 1998 Chevrolet C2500 pickup truck, weighing 4614 lb and traveling at an impact speed of 62.9 mi/h, impacted the W-Beam Guardrail on Box Culvert installation just downstream of post 13 at an impact angle of 23.9 degrees.

The W-Beam Guardrail on Box Culvert contained and redirected the 2000P vehicle. The W-beam rail element ruptured, however, the 2000P vehicle did not penetrate the rail.

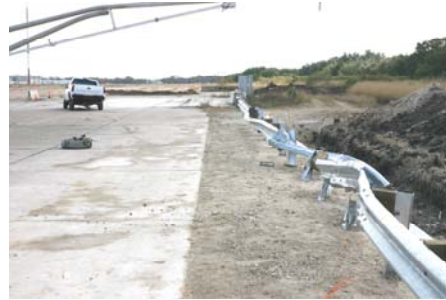
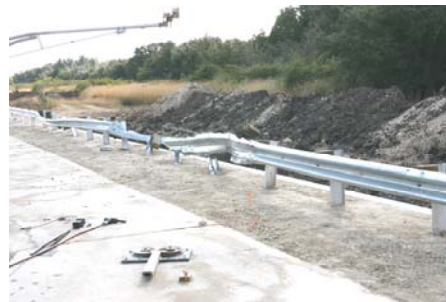
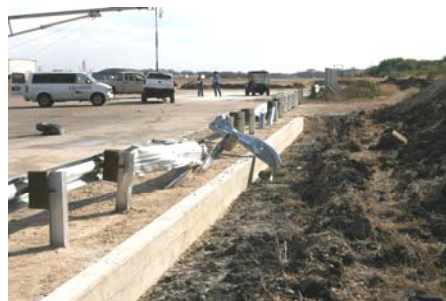
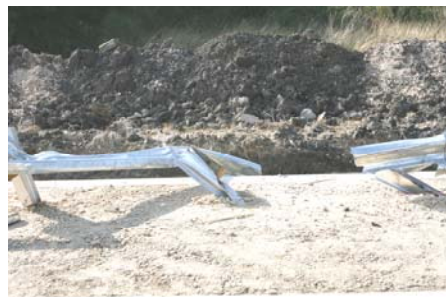
Barrier after Test

Although the rail element ruptured and separated from the posts, the rail element did not penetrate or show potential for penetrating the occupant compartment, or present undue hazard to others. Maximum occupant compartment deformation was 0.71 inch in the lateral area across the floor pan of the vehicle.

NCHRP Report 350 test 3-11 was performed to evaluate a guardrail system across low-fill culvert. The W-beam rail element was ruptured by the impact from the vehicle. Even though the rail element was ruptured, the vehicle was contained and redirected without penetrating, underriding, or overriding the installation. The rail element ruptured after the vehicle was redirected and while it was exiting out of the barrier system. The occupant risk values recorded for this test were acceptable with respect to *NCHRP Report 350* criteria. Based on the review of all available test data, the W-Beam Guardrail on Box Culvert met the required criteria for TL-3 according to the specifications for *NCHRP Report 350* test 3-11.

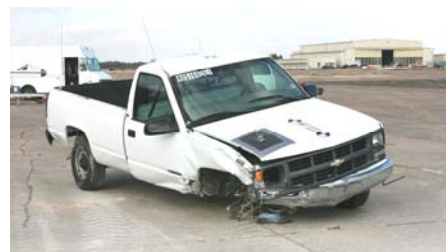
Vehicle after Test

The 2000P vehicle remained upright during and after the collision event. The 2000P vehicle subsequently came to rest 128 ft downstream from impact and 13.5 ft toward traffic lanes.
