In Reply Refer To: HSST-1/ WZ-358

TrafFix Water Wall LCD

MASH TEST 2-90 SUMMARY

MASH TEST 2-91 SUMMARY

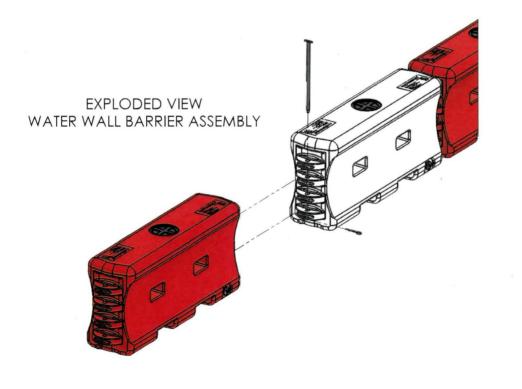
Pre-Test
Article
Vehicle
Post-Test
Article
Vehicle

GENERAL INFORMATION		EXIT CONDITIONS		
TEST AGENCY	KARCO Engineering, LLC.	EXIT VELOCITY		N/A
TEST NUMBER	P36118-01	EXIT ANGLE		N/A
TEST DESIGNATION	2-91	VEHICLE STABILITY		Satisfactory
TEST DATE	5/20/16	FINAL VEHICLE POSITION		73.5 ft. (22.4 m) downstream, 19.4 ft. (5.9 m) towards non-traffic side.
TEST ARTICLE		VEHICLE SNAGGING		None
NAME / MODEL	LCD Wall	VEHICLE POCKETING		None
TYPE	Longitudinal Channelizer	MAXIMUM ROLL ANGLE		-15.0°
KEY ELEMENTS	Water Barricades, Drop T-Pins	MAXIMUM PITCH ANGLE		4.8°
		MAXIMUM YAW ANGLE		6.6°
ARTICLE LENGTH	73.0 in. (1,854 mm)	KINETIC ENERGY		338.2 kip-ft (458.5 kJ)
TOTAL INSTALLATION LENGTH	153.2 ft. (46.7 m)		OCCUPAI	NT RISK VALUES
HEIGHT	32.0 in. (813 mm)	OCCUPANT IMPACT	Longitudinal	21.3 ft/s (6.5 m/s)
MAXIMUM WIDTH	18.0 in. (457 mm)	VELOCITY	Lateral	2.3 ft/s (0.7 m/s)
ROAD SURFACE	Concrete	RIDEDOWN	Longitudinal	-3.4 g
TEST VEHICLE		ACCELERATION	Lateral	2.0 g
TYPE / DESIGNATION	2270P	THIV		21.3 ft/s (6.5 m/s)

YEAR, MAKE AND MODEL	2012 RAM 1500	PHD		3.6 g
CURB MASS	4,977.9 lbs (2,258.0 kg)	ASI		0.37
TEST INERTIAL MASS	5,002.3 lbs (2,269.0 kg)	TEST ARTICL		CLE DEFLECTIONS
GROSS STATIC MASS	5,002.3 lbs (2,269.0 kg)	WORKING WIDTH		N/A
IMPACT CONDITIONS		DYNAMIC DEFLECTION		N/A
IMPACT VELOCITY	44.97 mph (72.37 km/h)	ARTICLE DAMAGE		Damage to Modules 13 through 17.
IMPACT ANGLE	25.4°		VEHIC	CLE DAMAGE
IMPACT LOCATION / ORIENTATION	2.9 ft. (0.9 m) upstream from the joint connecting module 13 and 14	VEHICLE DAMAGE SCALE		1-FD-2
		COLLISION DAMAGE CLASSIFICATION		01FDEW1

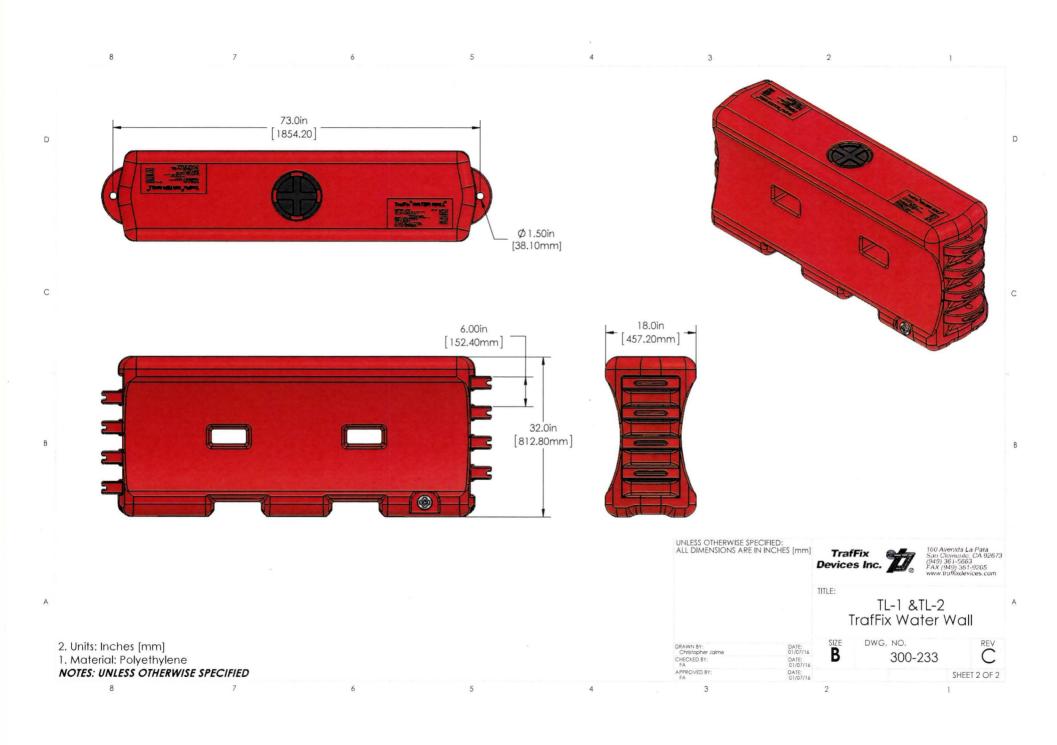
PLAN VIEW
