*Midwest States Regional Pooled Fund Research Program
Fiscal Year 2013 (Year 23)
Research Project Number TPF-5(193) Supplement #56
NDOR Sponsoring Agency Code RFPF-13-MGS-3*

INCREASED SPAN LENGTH FOR THE MGS LONG-SPAN GUARDRAIL SYSTEM PART II: FULL-SCALE CRASH TESTING

MwRSF Research Report No. TRP-03-339-17

April 7, 2017

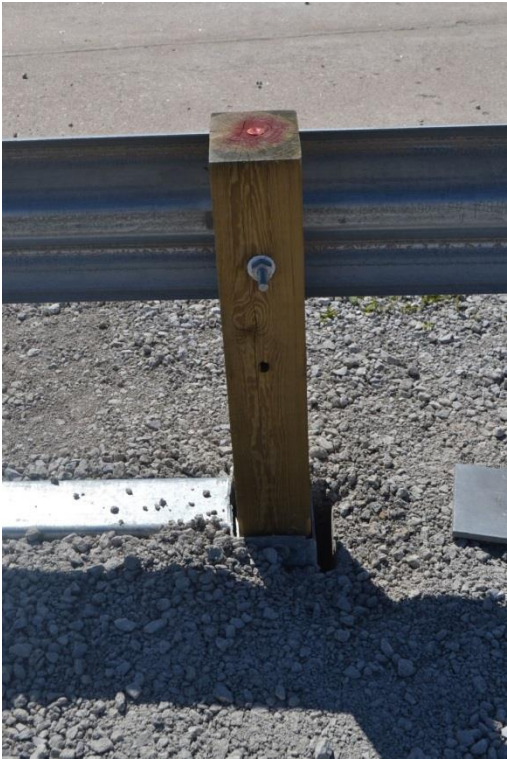
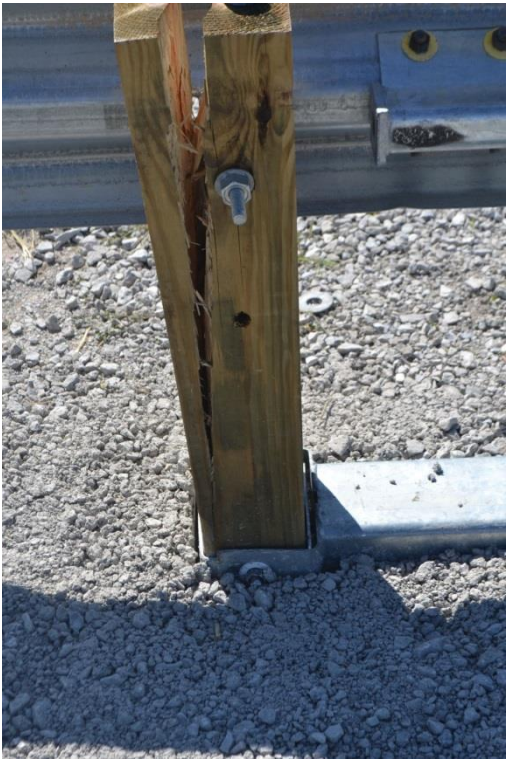
Damage to the barrier was moderate, as shown in Figures 48 through 55. All system damage photographs depicted in Figures 48 through 55 were taken after the cable anchors were disassembled and removed from the system. Barrier damage consisted of rail deformation, disengagement of the W-beam rail from the posts, bending of the steel posts, fracture of the wooden posts, and damage to the culvert. The length of vehicle contact along the barrier was approximately 52 ft – 8 in. (16.1 m), which spanned from 1¾ in. (44 mm) downstream from the center of post no. 11 through 34 in. (864 mm) downstream from the center of post no. 15.

Figure 48. System Damage, Test No. MGSLs-1

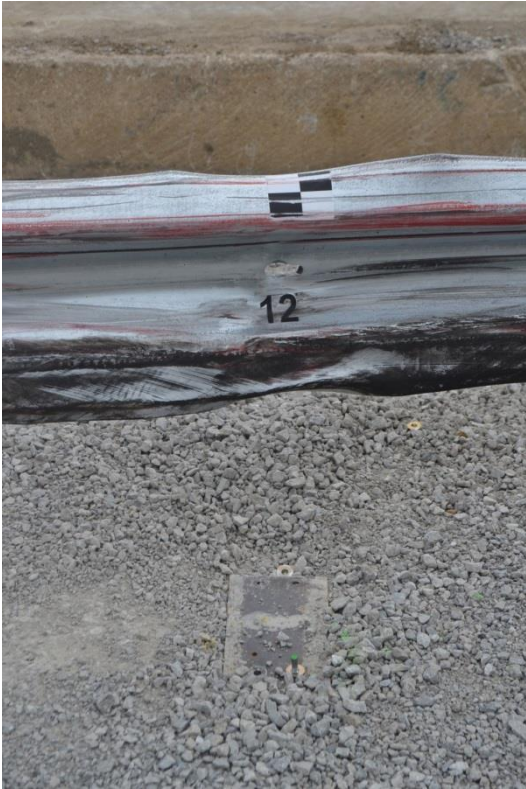
Figure 50. System Damage Between Post Nos. 3 and 9, Test No. MGSL-1

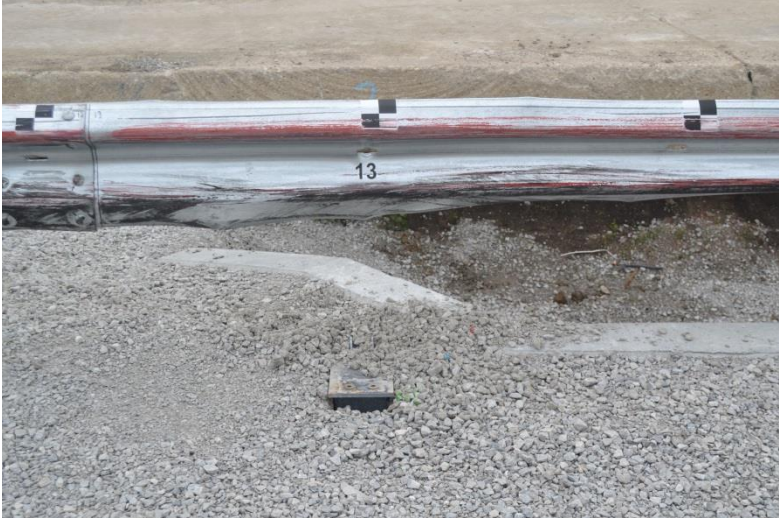
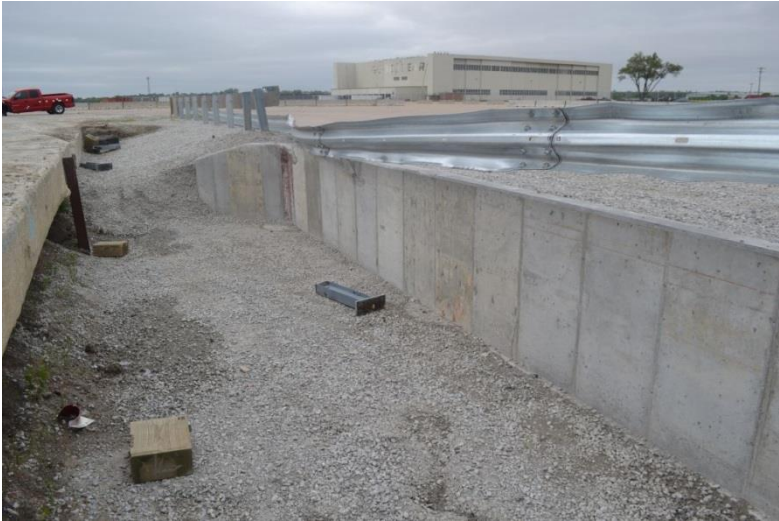
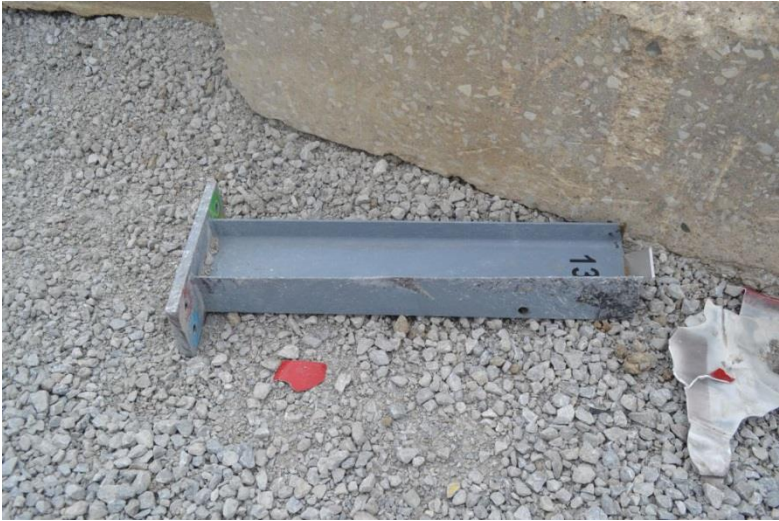
Figure 51. Damage Between Post Nos. 10 and 12, Test No. MGSL-1

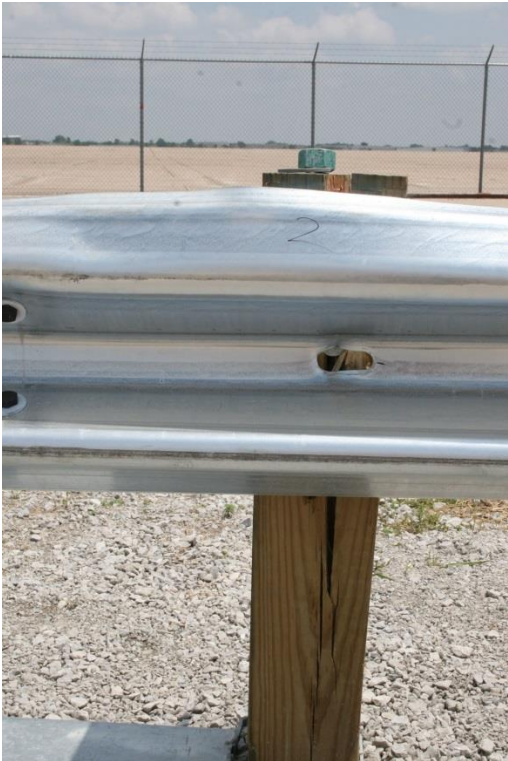
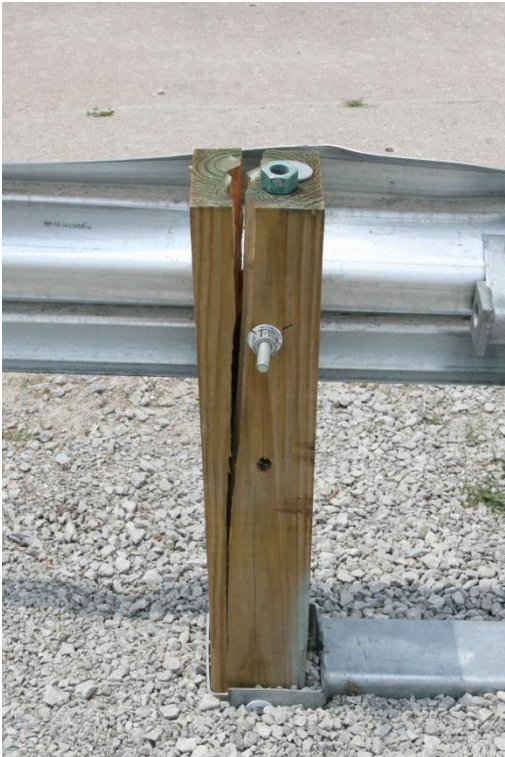
Figure 69. Upstream End Anchor Damage, Test No. MGSLS-2

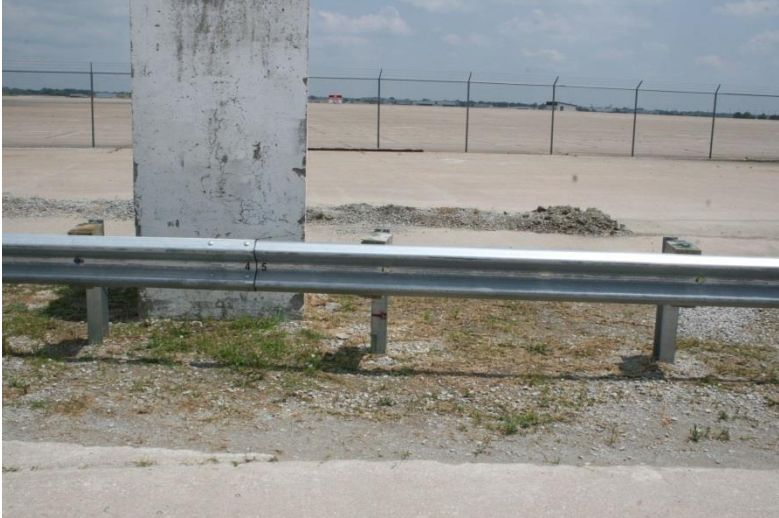
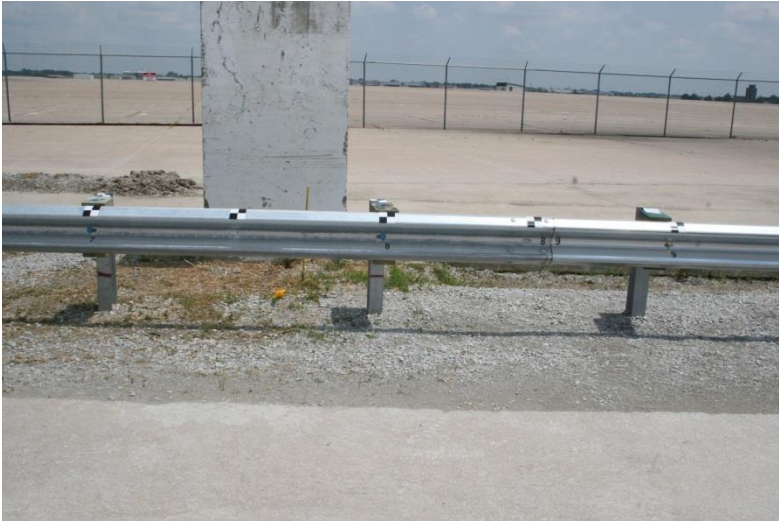
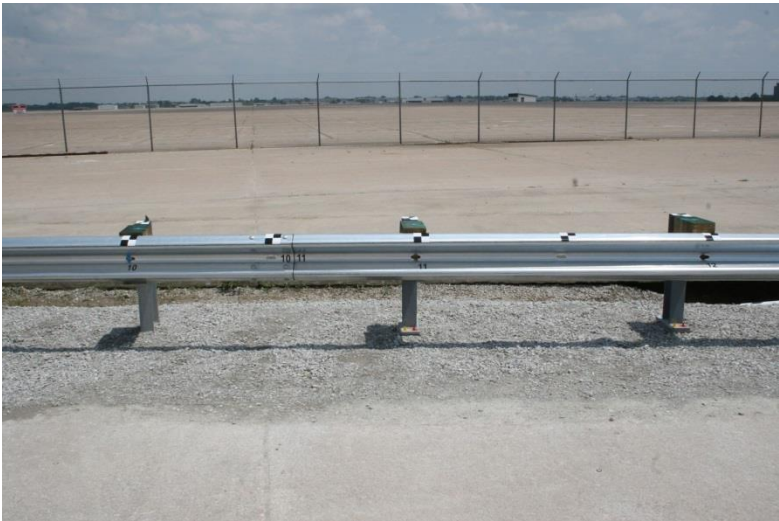
Figure 70. System Damage Between Post Nos. 3 and 12, Test No. MGSLs-2

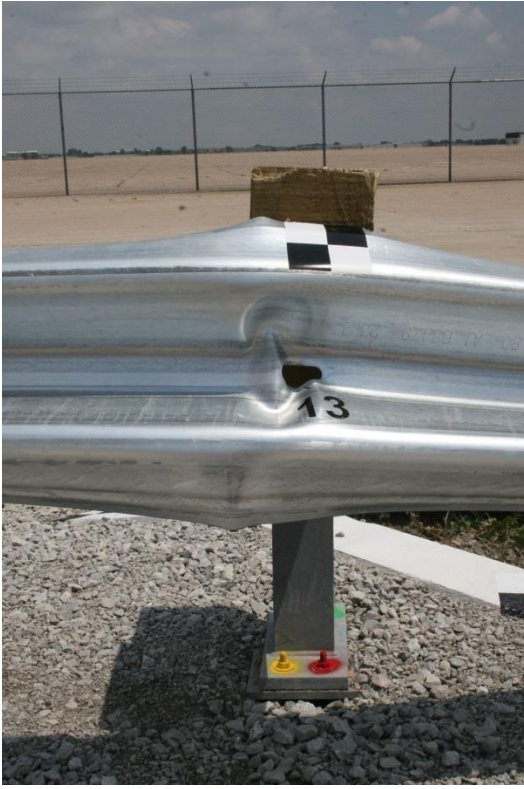
Figure 71. Damage at Post No. 13, Test No. MGSLS-2

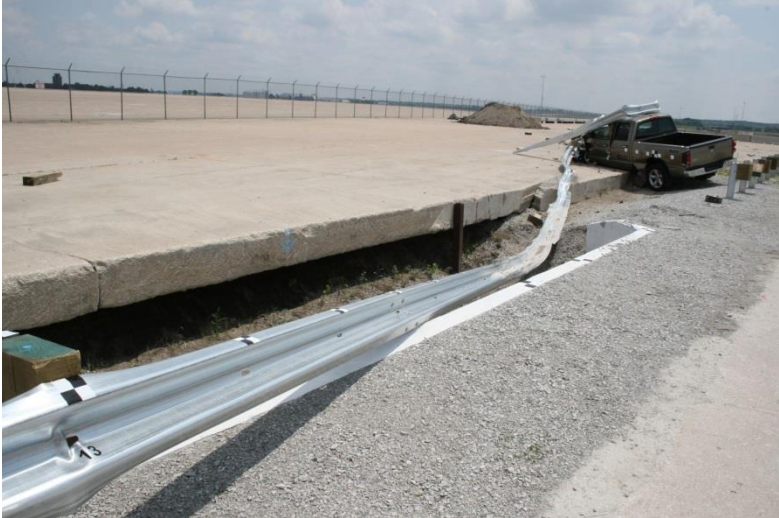
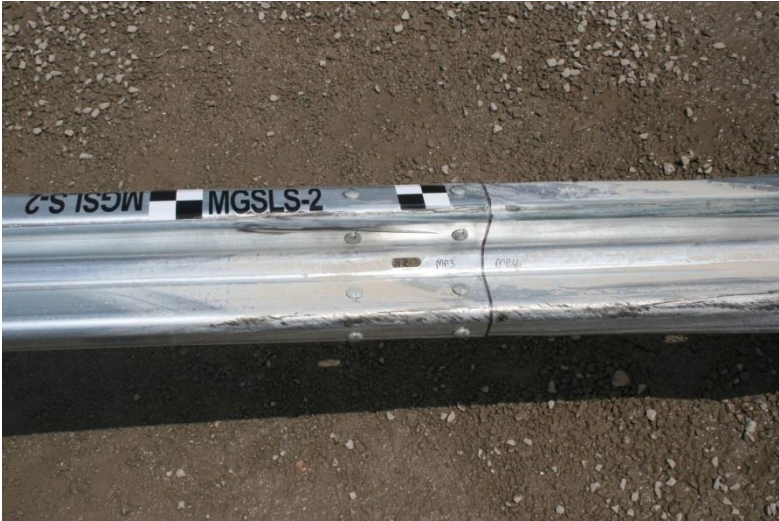
Figure 72. Damage Between Post Nos. 13 and 14, Test No. MGSL-2

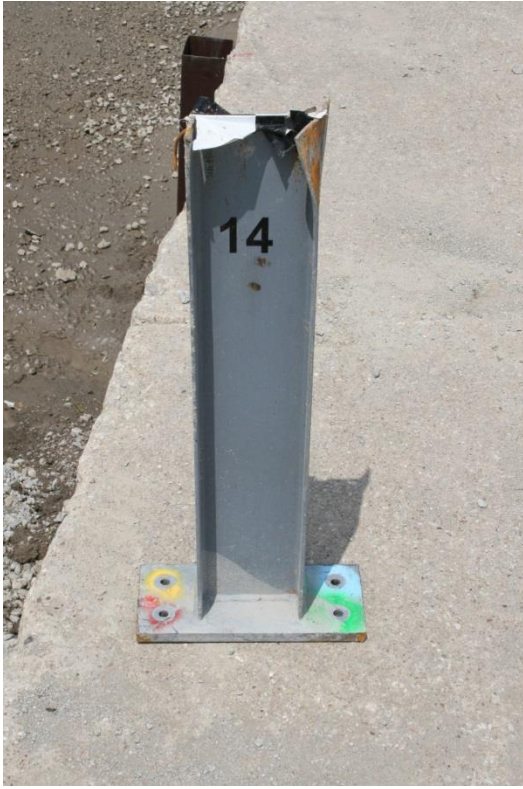
Figure 73. Damage at Post No. 14, Test No. MGSLs-2

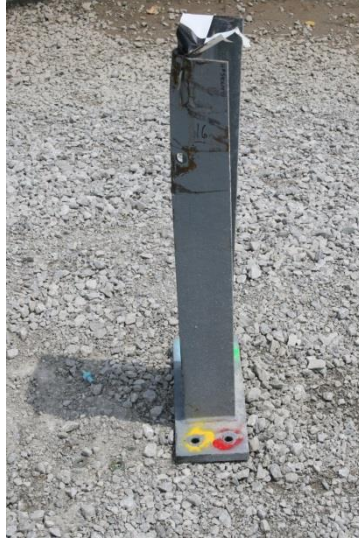
Figure 75. Damage at Post No. 16 and Splice 16-17, Test No. MGSLS-2

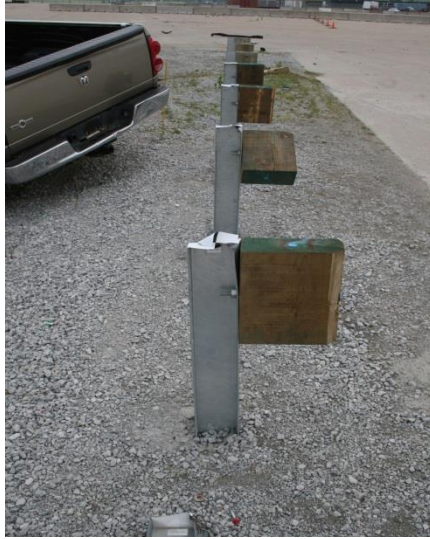
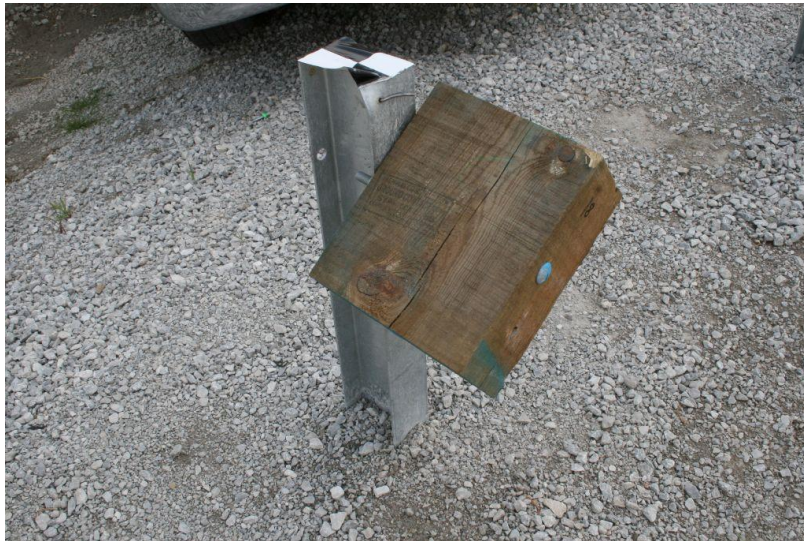
Figure 76. Damage to Post Nos. 17 through 19, Test No. MGSLS-2

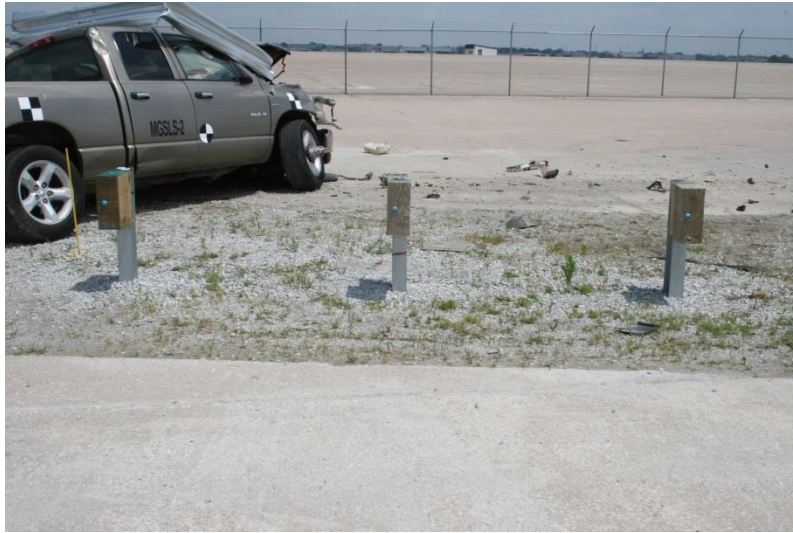
Figure 77. Damage to Rail Between Post Nos. 17 through 19, Test No. MGSL-2

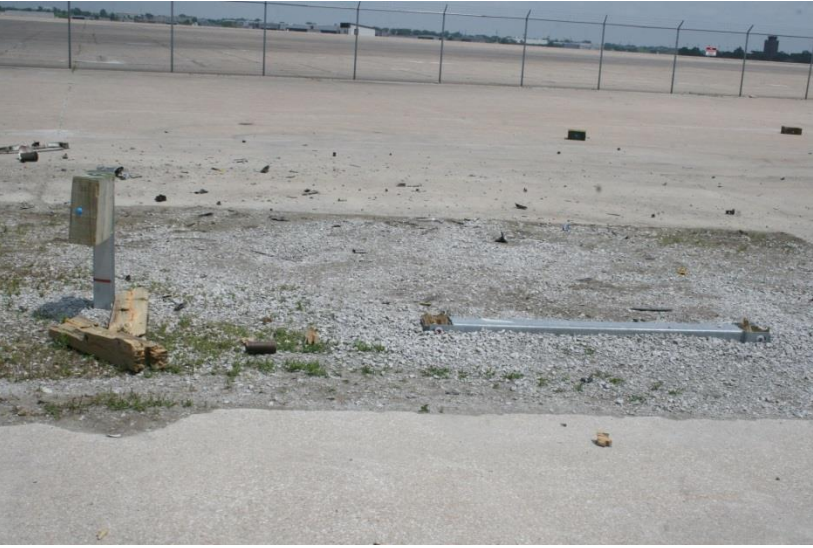
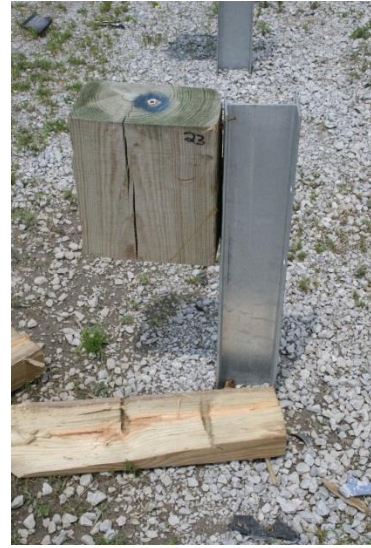
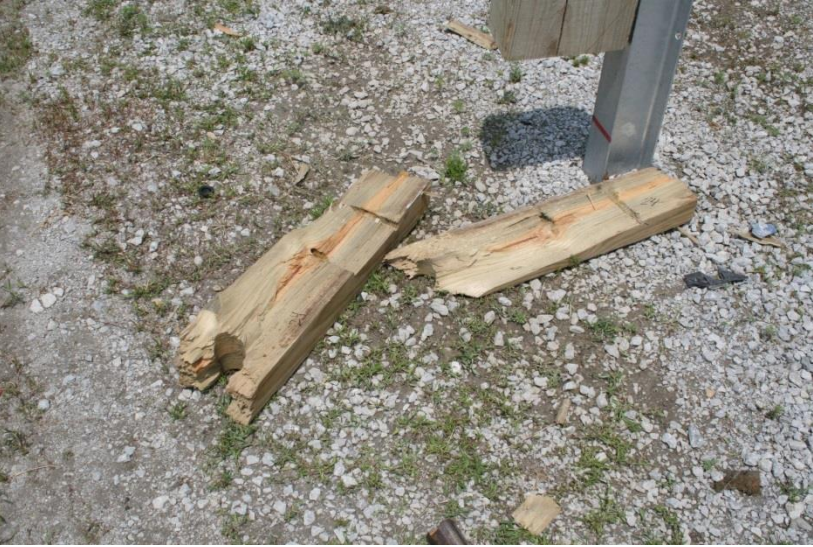
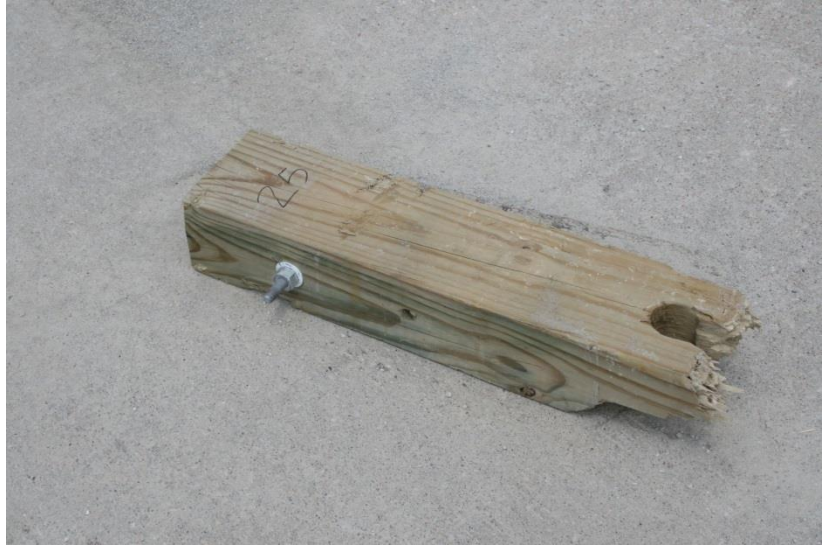
Figure 78. Damage to Barrier System Between Post Nos. 20 through 22, Test No. MGSL-2

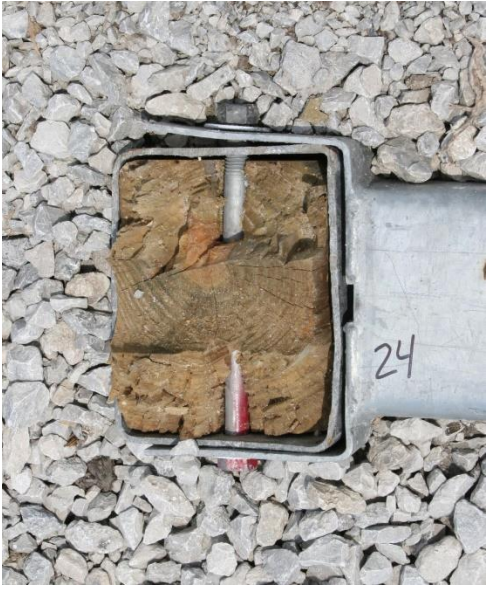
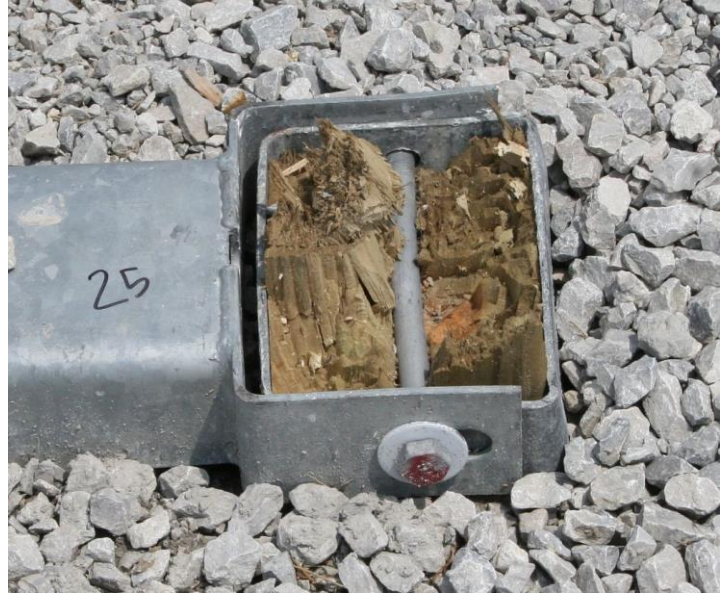
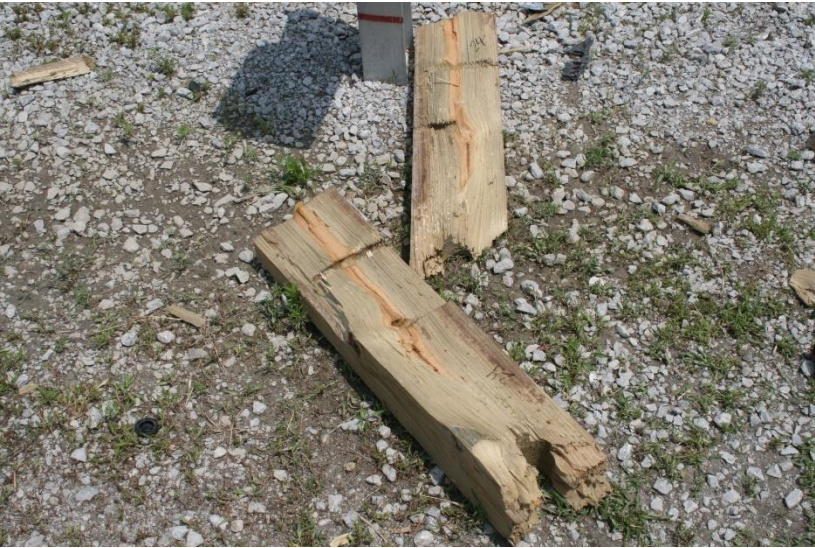
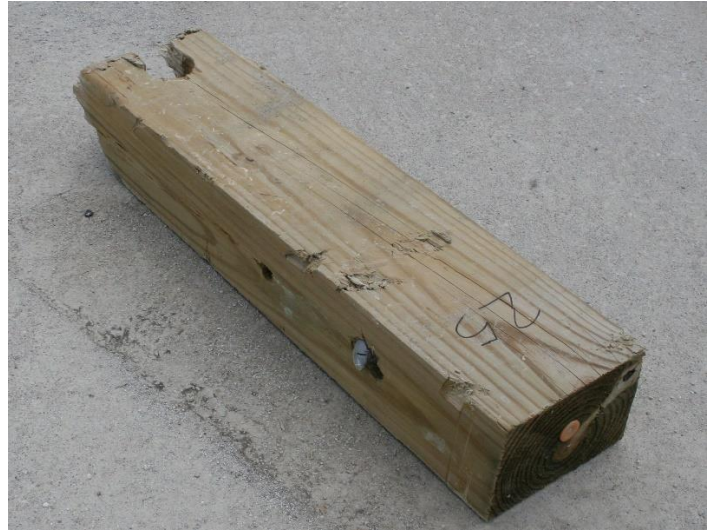
Figure 79. Damage to Post Nos. 23 through 25, Test No. MGSLs-2

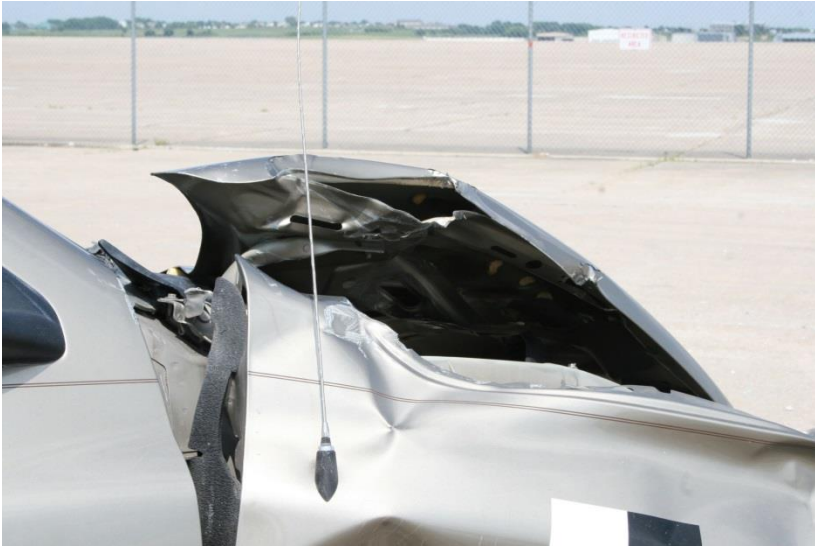
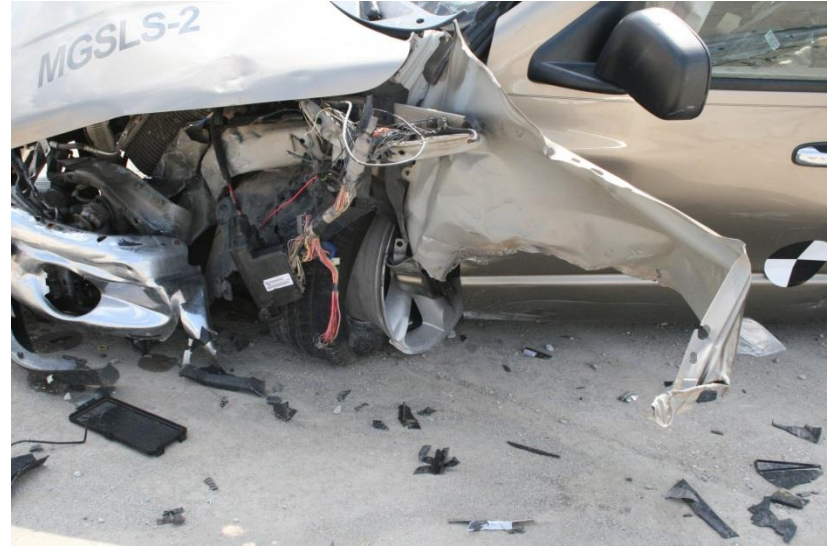
The damage to the vehicle was moderate, as shown in Figures 81 through 85. The maximum occupant compartment deformations are listed in Table 9 along with the deformation limits established in MASH for various areas of the occupant compartment. Note that none of the MASH-established deformation limits were violated. Complete occupant compartment and vehicle deformations and the corresponding locations are provided in Appendix D.

Figure 81. Vehicle Damage, Test No. MGSL-2

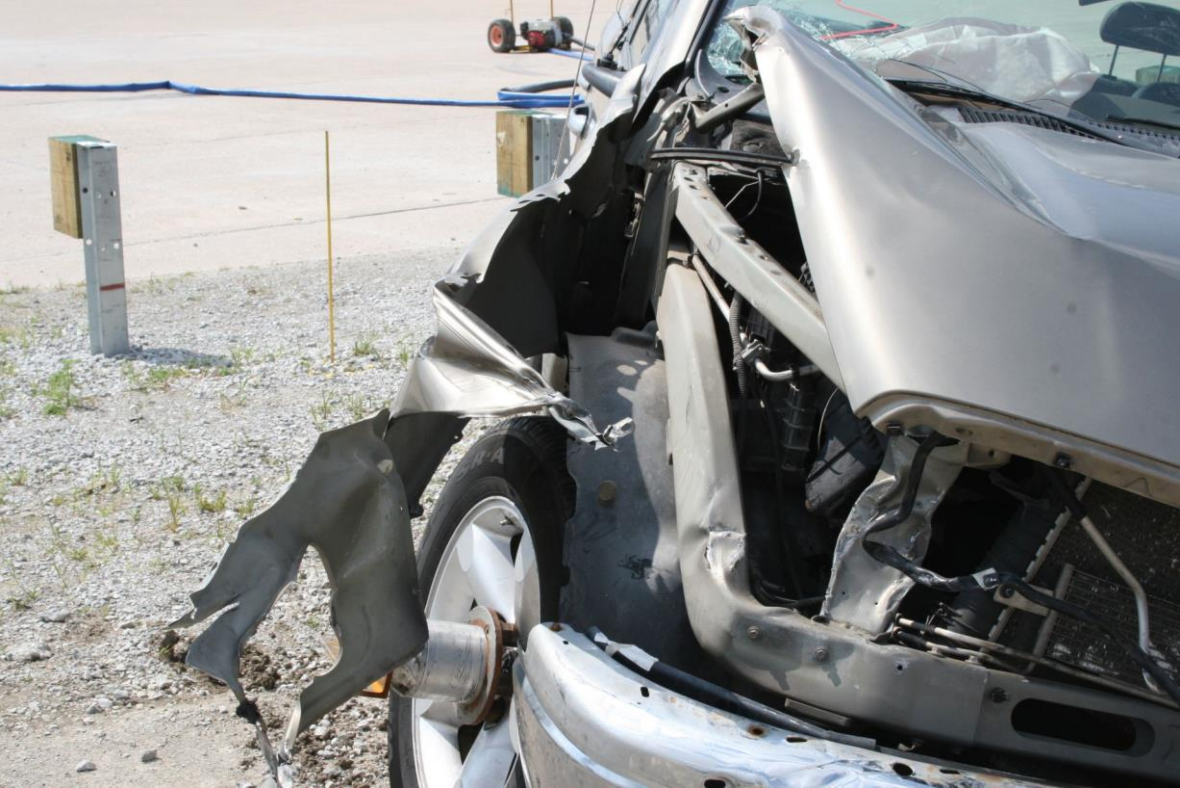
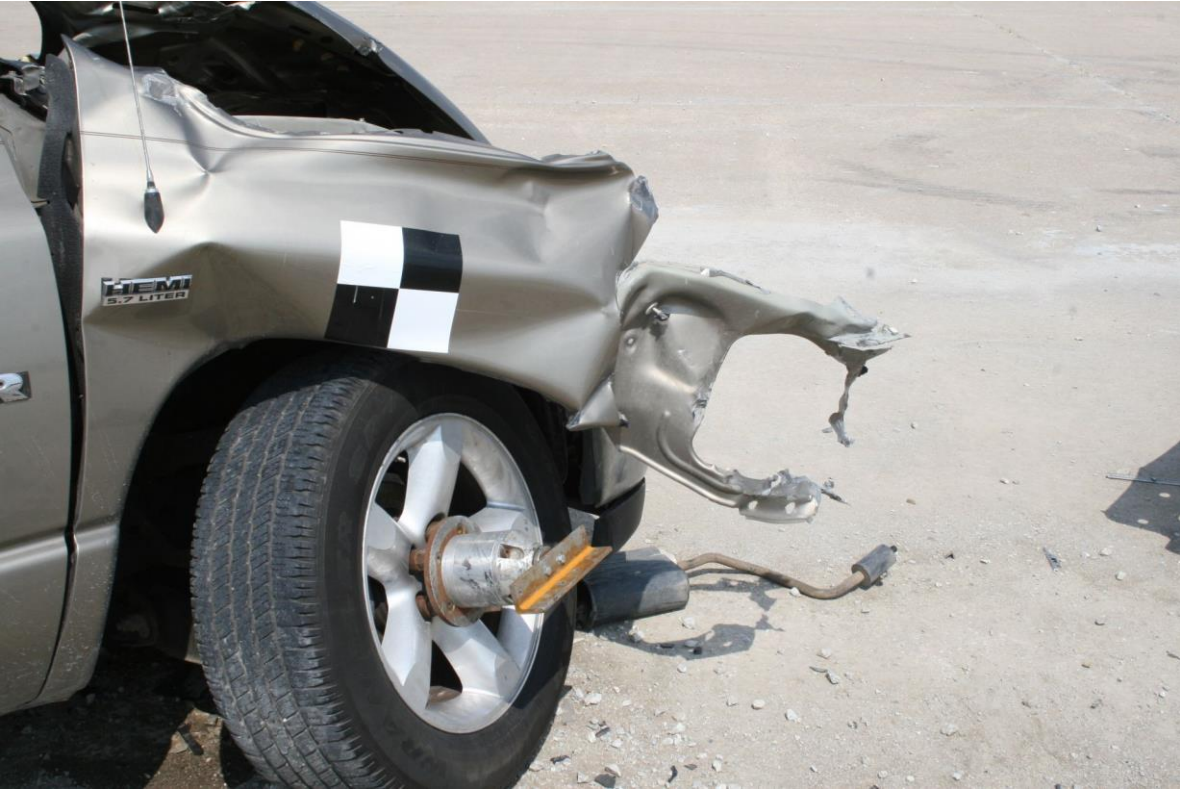
Figure 82. Vehicle Damage, Test No. MGSL-2

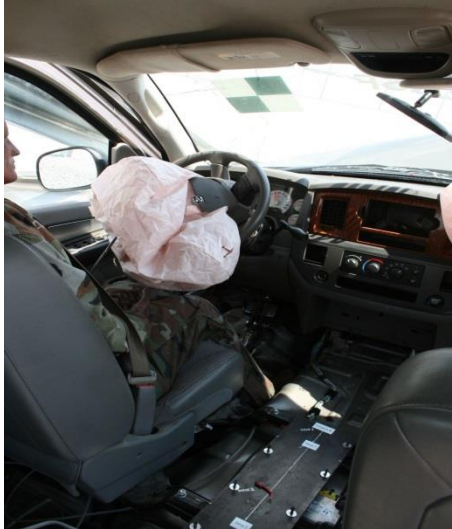
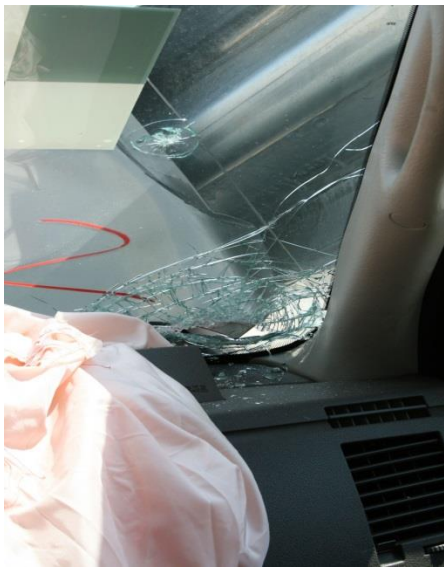
Figure 83. Vehicle Damage, Right Fender, Test No. MGSLS-2
